ORNL-3684
UC-25 - Metals, Ceramics, and Materials
TID-4500 (34th ed.)

SOME OBSERVATIONS OF THE INTERGRANULAR
CORROSION OF IRRADIATED TYPE 304
STAINLESS STEEL

E. L. Long, Jr., and C. Michelson

NOVEMBER 1964

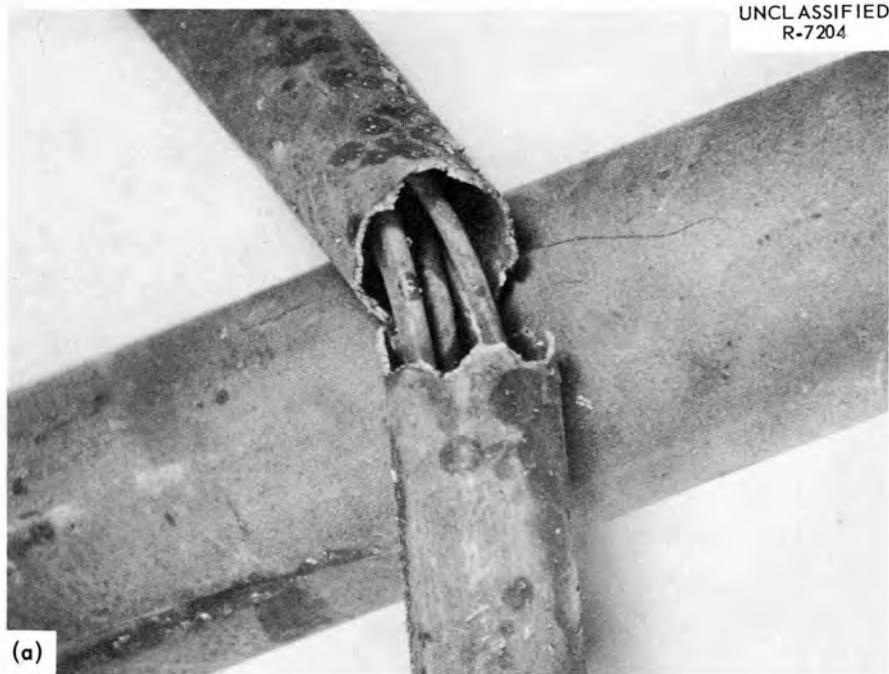
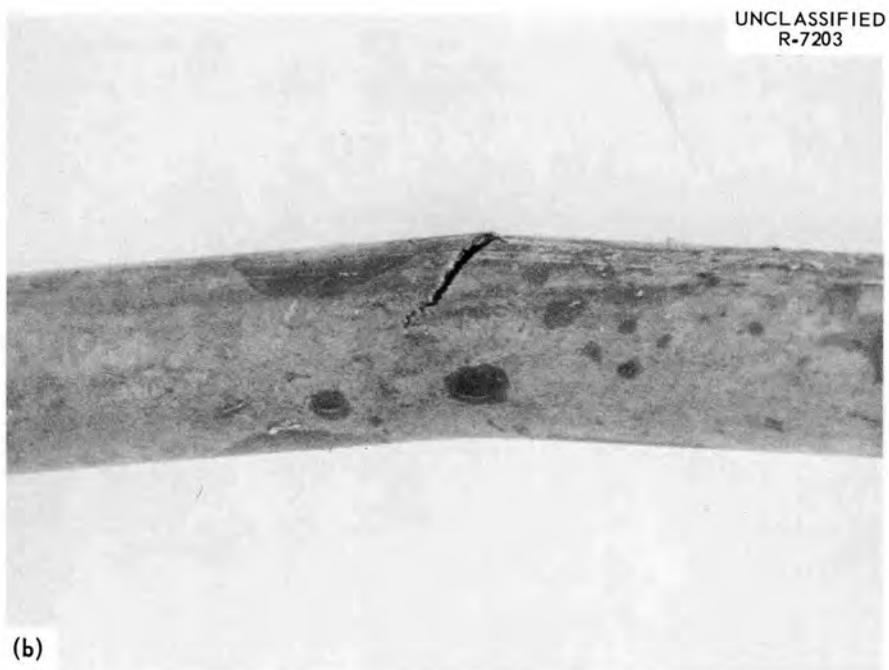
During visual examination, both the shroud covering the test element and the remaining section of lead tube from which the element was originally suspended were found to be covered with a rust-colored corrosion product. Although handled carefully, the lead tube fractured at two points, 6 1/2 and 21 in. above the joint between the lead tube and shroud (see Fig. 3). The thermocouple leads can be seen inside the lead tube. The larger tube in this figure is the stainless steel shroud. Both fractures appeared to be brittle.

Fig. 3. Fractures in Type 304 Stainless Steel Lead Tube for Test Element 5. Fractures Occurred Approximately (a) 6 1/2 in. and (b) 21 in. Above the Test Element.

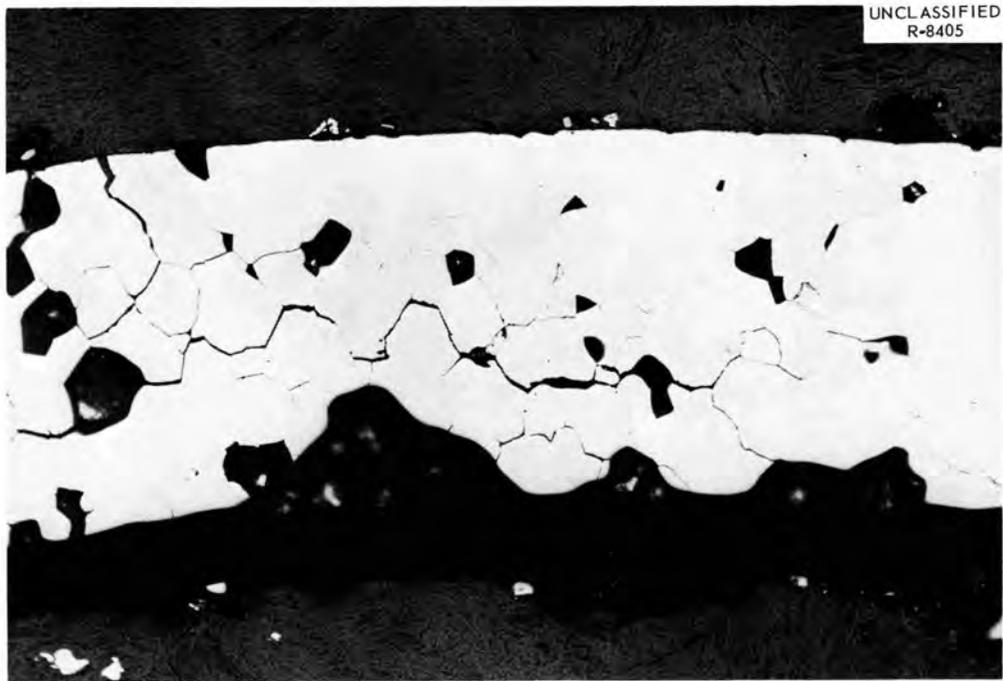
The extreme friability of the lead tube after irradiation was demonstrated when a sample from near one of the fractures was mounted in Bakelite for metallographic examination. During the subsequent lapping and polishing, grains fell out of the sample (see Fig. 4). Another sample was mounted in epoxy resin, thus requiring no pressure. It is shown in Fig. 5. Grain boundary separation was "spotty" rather than general and originated at the outer surface of the tubing in all instances. Intergranular fracturing extended through the tube wall in several areas. Microhardness measurements revealed a maximum hardness of 200 DPH, which negated the possibility of general embrittlement of the microstructure even though embrittlement had obviously taken place in the grain boundaries. Some transgranular fracturing was observed in

Fig. 4. Bakelite-Mounted Transverse Sample Taken from Near a Fracture in the Type 304 Stainless Steel Lead Tube for Test Element 5. As-polished; 100X. Reduced 12%.

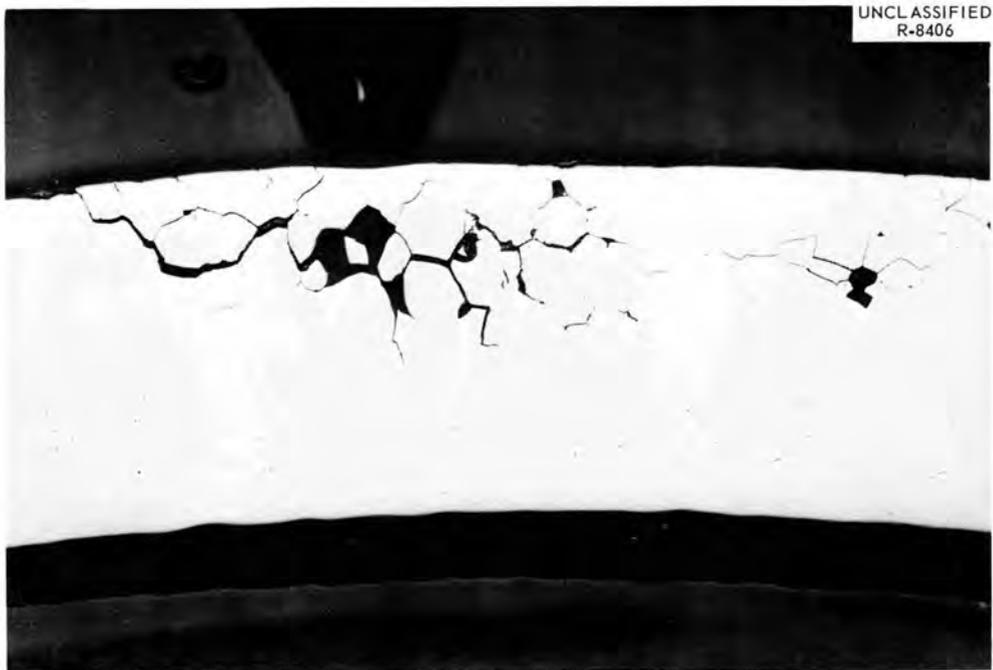
Fig. 5. Epoxy-Mounted Transverse Sample Taken from Near a Fracture in the Type 304 Stainless Steel Lead Tube for Test Element 5. As-polished; 100X. Reduced 12%.

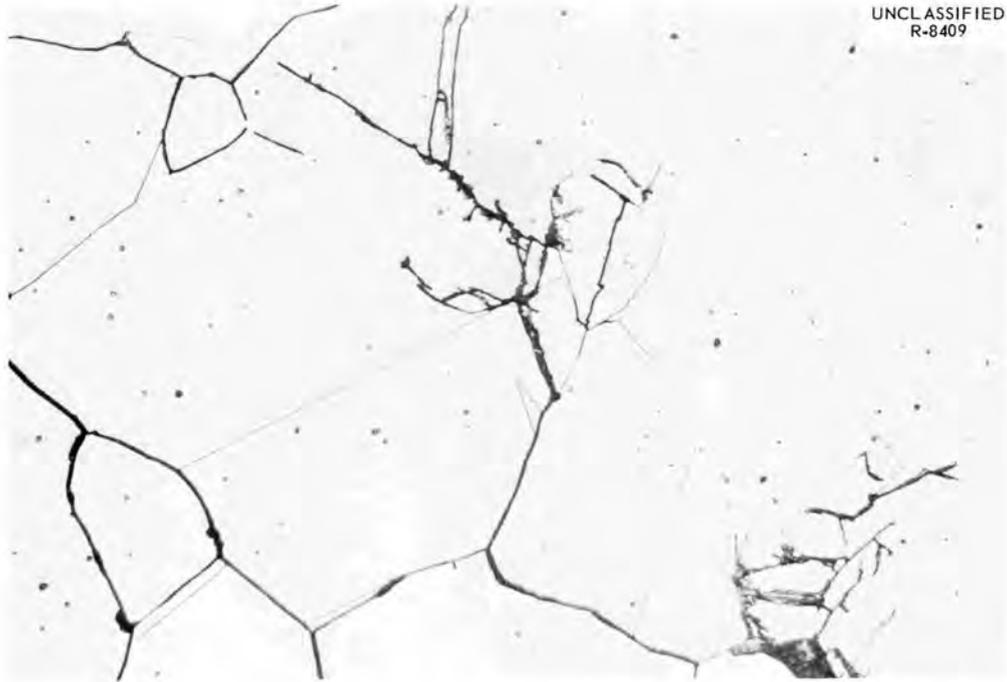
the epoxy-mounted sample (see Fig. 6), but intergranular failure was the predominant mode of fracture propagation. Examination of the fractures in this sample at high magnification revealed the presence of a corrosion product that appeared to be an oxide (see Fig. 7).

Fig. 6. Transverse Section Through the Lead Tube of Test Element 5 Showing both Inter- and Transgranular Fractures. Etchant: aqua regia; 500X. Reduced 12%.

Although intergranular corrosion was the predominate mode of failure, some transgranular corrosion with branching was observed, such as shown in Fig. 6. Transgranular cracks with branches are usually attributed to stress corrosion in austenitic stainless steels. However, the test element shrouds and inserts were not subjected to significant mechanical stresses and the high operating temperatures precluded any significant residual stresses. It is possible that the transgranular cracks observed in Fig. 6 resulted from local stresses created by the intergranular corrosion process.

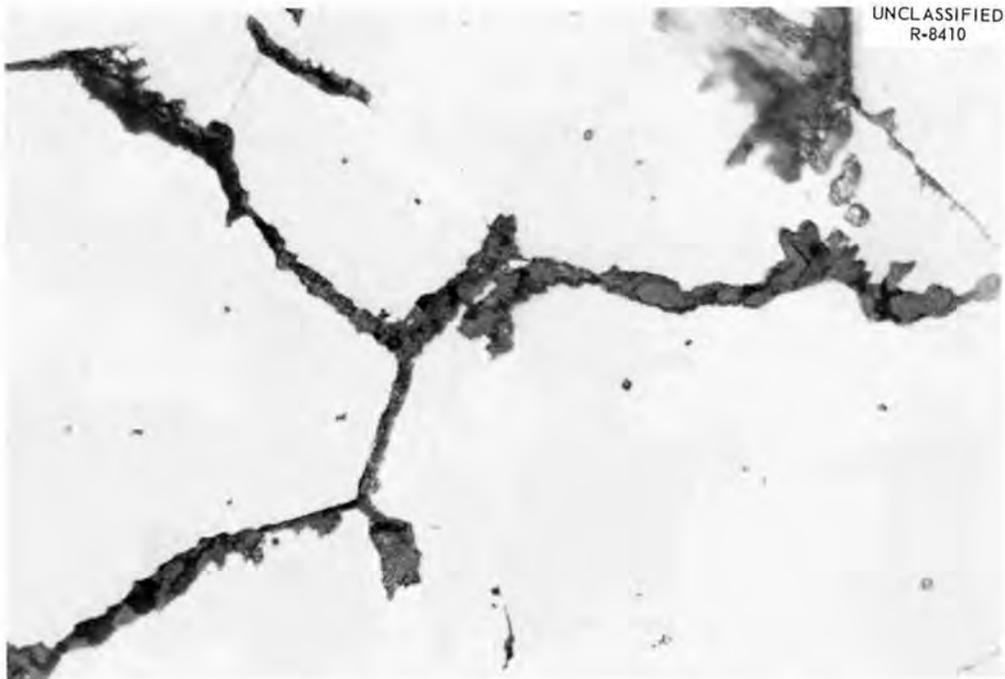
Fig. 7. Corrosion Product in the Fractures of the Transverse Section Through the Lead Tube of Test Element 5. As-polished; 1000X. Reduced 12%.

phase. In this case, an oxidizing solution containing hydrogen peroxide and oxygen is possible. Such a solution could form the corrosive fluid. It is interesting to note that a corrosion product which appeared to be an oxide was observed in the intergranular failure of element 5 (see Fig. 7), and there was evidence of intergranular corrosion products in other components such as the insert for element 7A (see Fig. 10b).

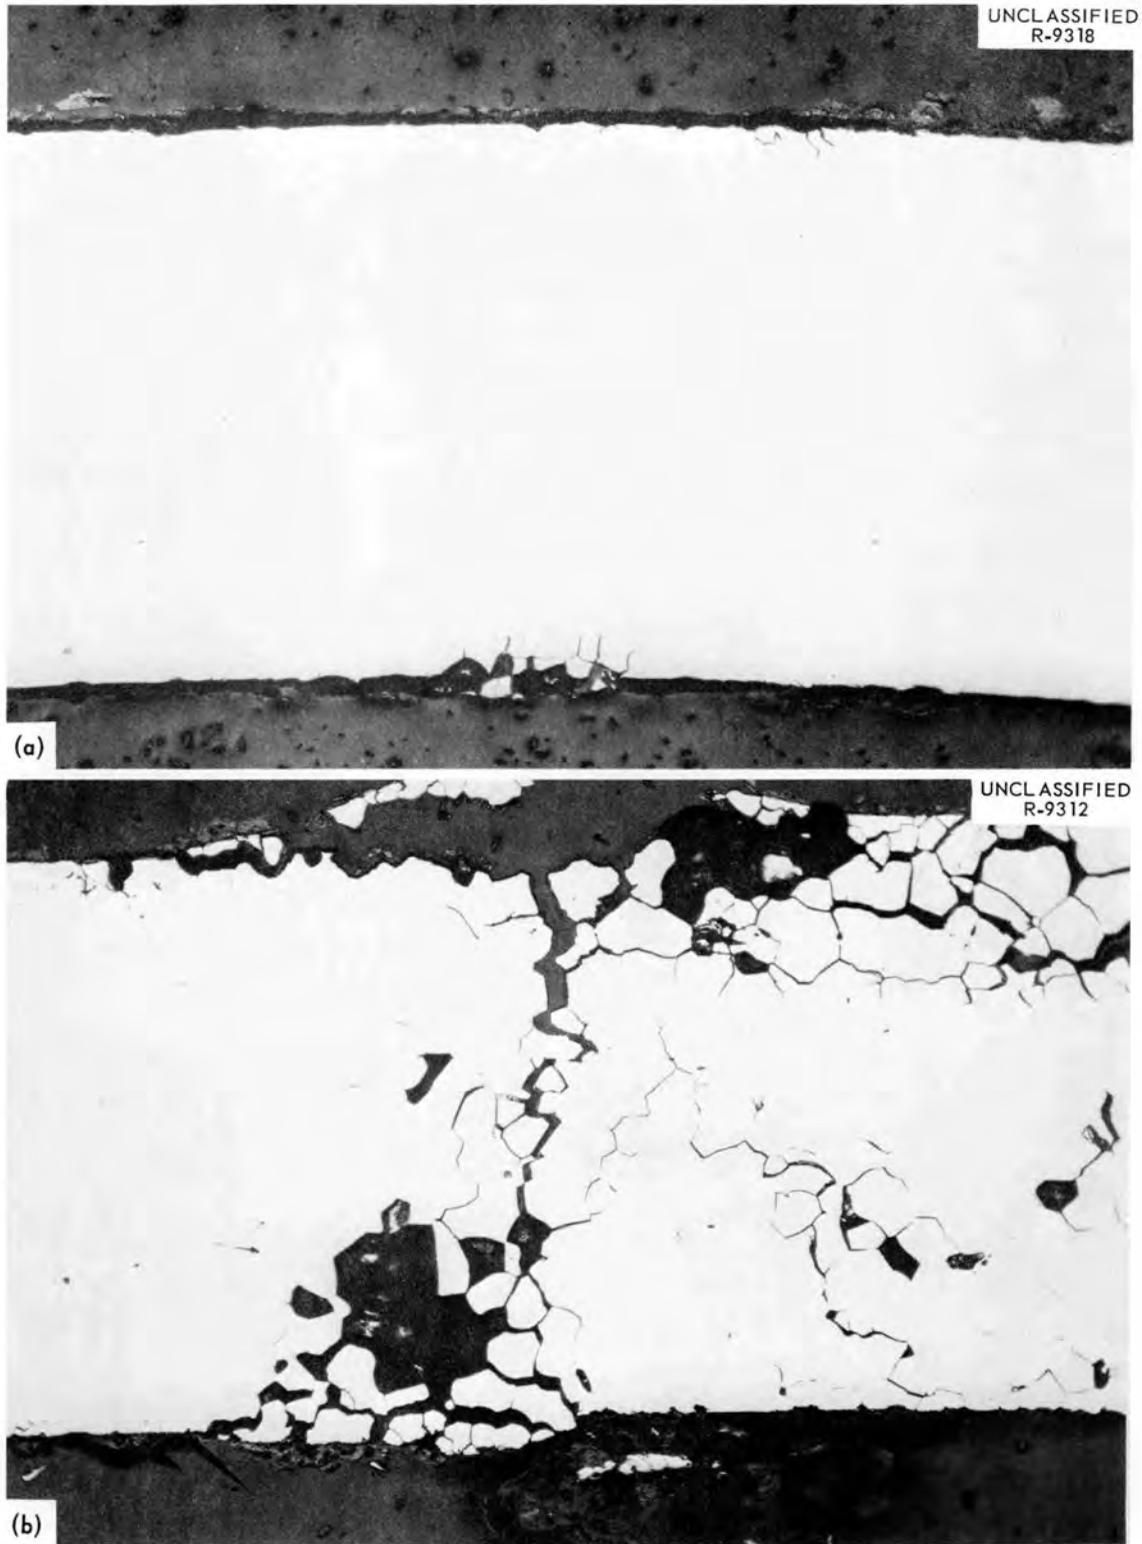
Transverse sections were cut through the shroud opposite points near the midlength and bottom of the test element. The section from near the midlength revealed localized intergranular attack primarily at the inner surface and to a maximum depth of 2 to 3 mils (see Fig. 8a). The section of shroud from near the bottom revealed severe intergranular attack, and in several places intergranular fractures penetrated the entire wall (see Fig. 8b). In general, this specimen was similar in appearance to the lead tube.

Fig. 8. Transverse Sections Through (a) Midlength and (b) Bottom of the Shroud for Test Element 5. As-polished; 150X.

— The unusual severity of the intergranular corrosion of the element 5 shroud might be attributable to the presence of large amounts of water vapor in the loop during irradiation. The loop gas (helium) was initially dry, but a water leak occurred in a compressor during the test. The helium was not analyzed for water, but after two weeks of operation, the hydrogen content was 800 ppm. The hydrogen could have resulted from the reaction of water vapor with various high-temperature components and by radiolytic decomposition in the high-radiation field.

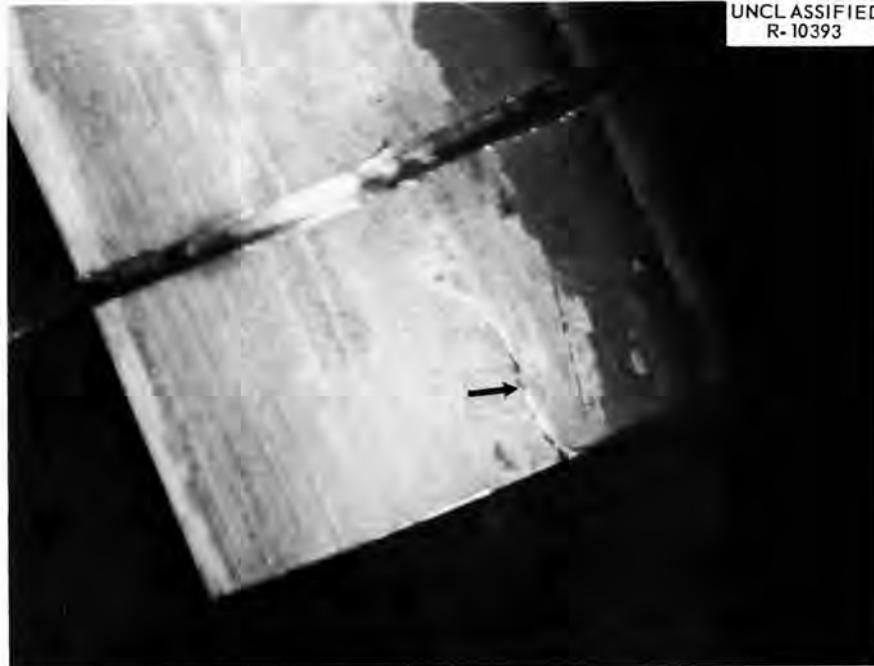
A type 304 stainless steel insert was used for test element 7A in place of the shroud normally used for controlling gas flow. After irradiation, this insert was stored in the ORR pool instead of the fuel loading tube. The bottom portion of the insert, which was irradiated at an average temperature above 770°F (gas outlet temperature), rusted badly while in pool storage. A longitudinal fracture developed at the bottom of the insert while being sectioned for a metallographic specimen (see Fig. 9). A metallographic examination of the specimen revealed an intermittent oxide that penetrated the outside diametral surface to a maximum depth of 0.5 mil (see Fig. 10a). Metallographic examination of the crack that developed during sectioning revealed severe intergranular separation and evidence of an intergranular corrosion product in the fracture region (see Fig. 10b).

Fig. 9. Longitudinal Crack that Appeared While Sectioning the Insert for Test Element 7A.

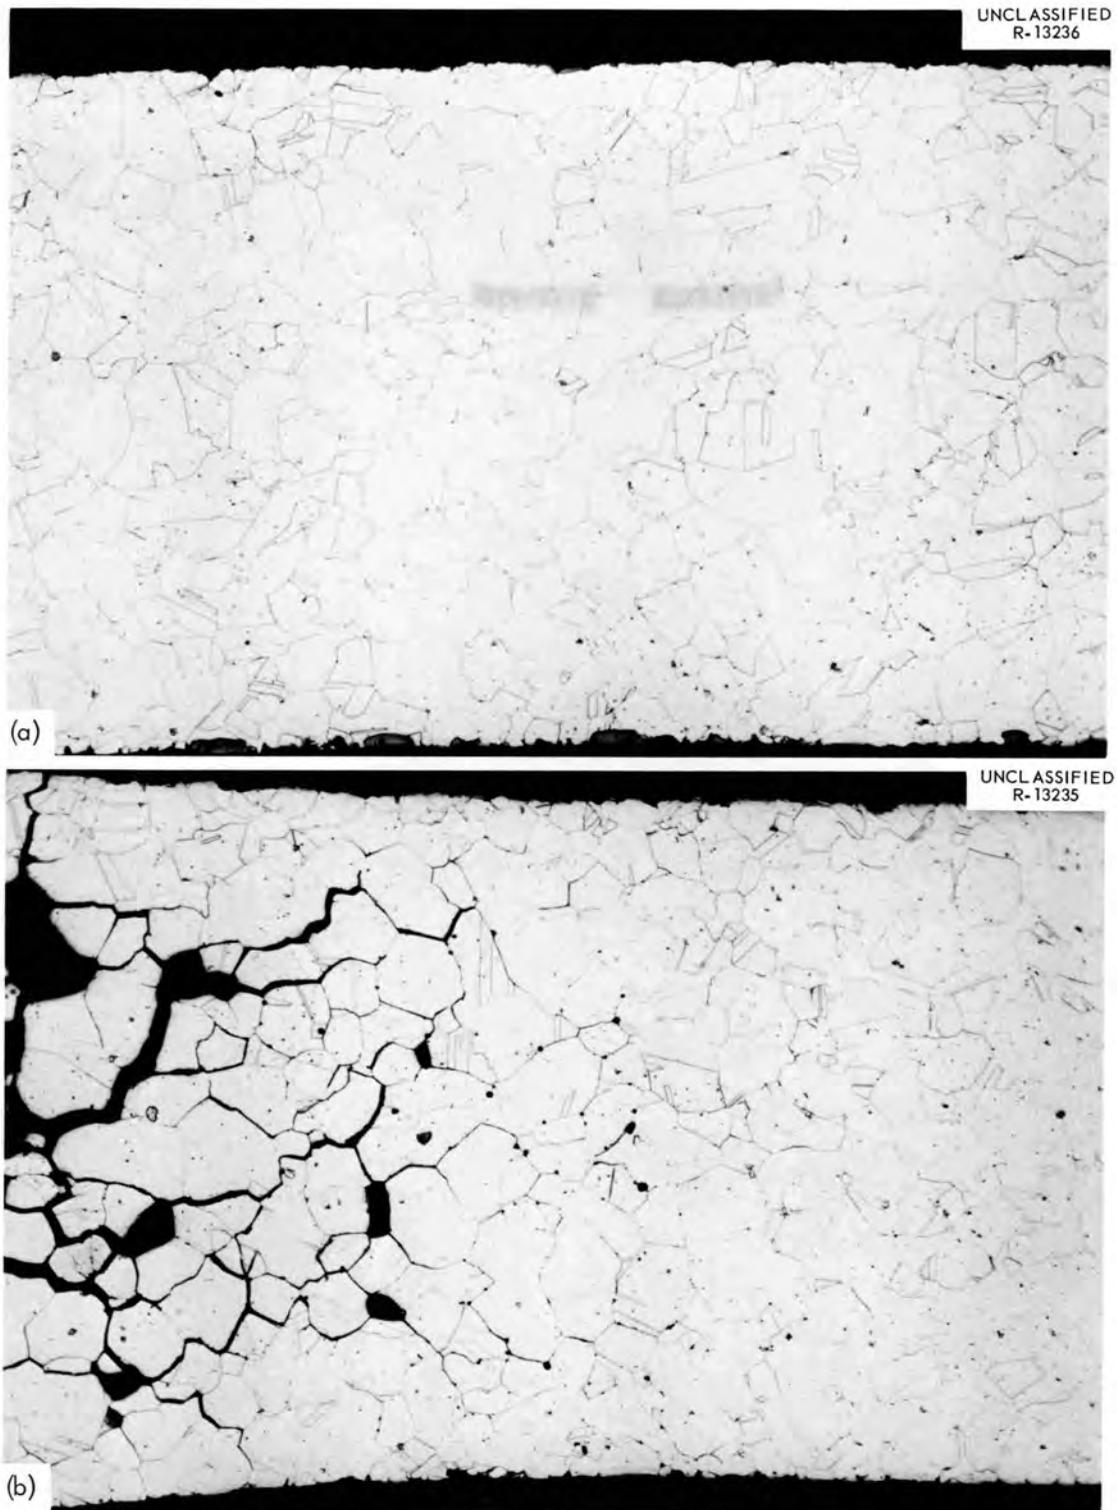
Fig. 10. Transverse Section Through Bottom on Insert for Test Element 7A Showing (a) Intermittent Oxide on Surface and (b) Intergranular Separation. Etchant: aqua regia; 200X. Reduced 11%.

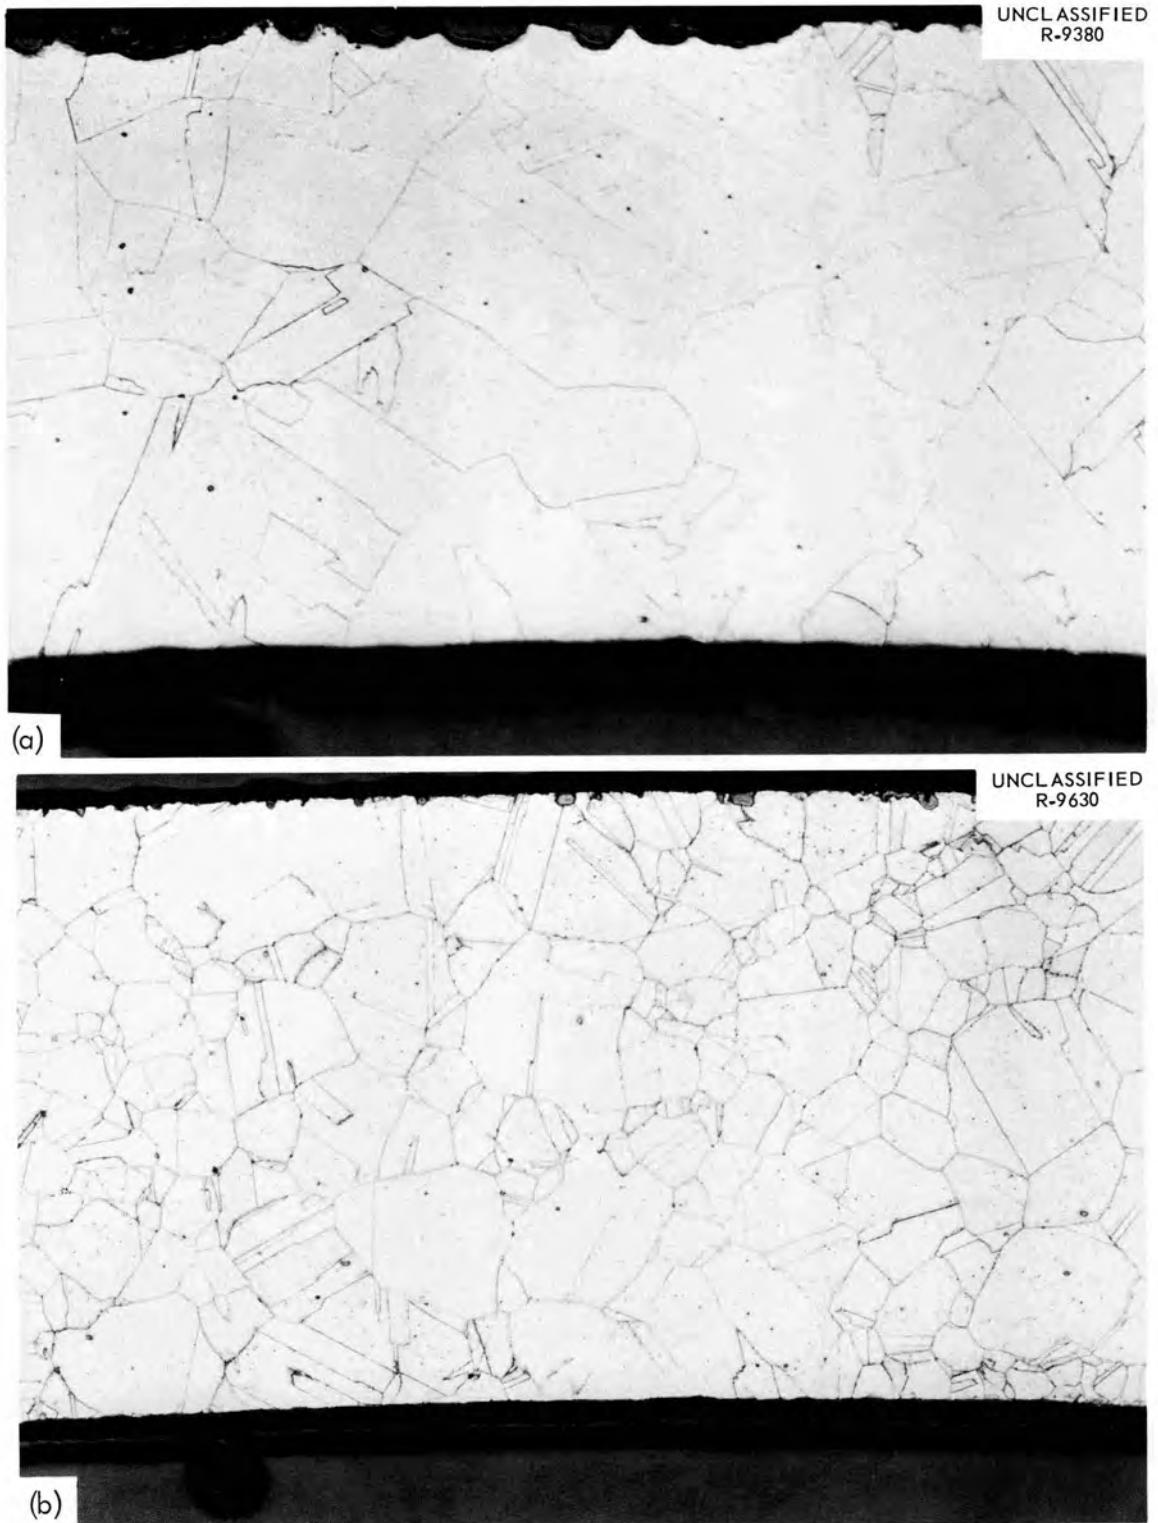
penetrated the outer surface of the cladding to a maximum depth of 0.5 mil (see Fig. 11b). Also, a large variation in grain size was noted in both specimens. There were some areas where only two grains existed across the wall of the cladding. The large grains present after irradiation are the result of germinative grain growth. Profile measurements of this element indicated the maximum bow was in the region where the metallographic specimens were taken. The areas of large grain size were not related to the thermocouple sheath-to-cladding brazed joints. A metallographic study of similar unirradiated tubing which had been through a thermocouple brazing cycle disclosed a fine-grained microstructure.

Fig. 11. Transverse Sections Taken from (a) Middle and (b) 3 in. from Middle of Cladding for Test Element 7A. Etchant: glyceria regia; 150X.

Another effect that should be considered is the grain growth which is observed in certain regions of the type 304 stainless steel cladding following irradiation. This growth is readily apparent in Fig. 11. The extent to which the resulting grain boundaries may be subject to attack by a given corrosive fluid is unknown.

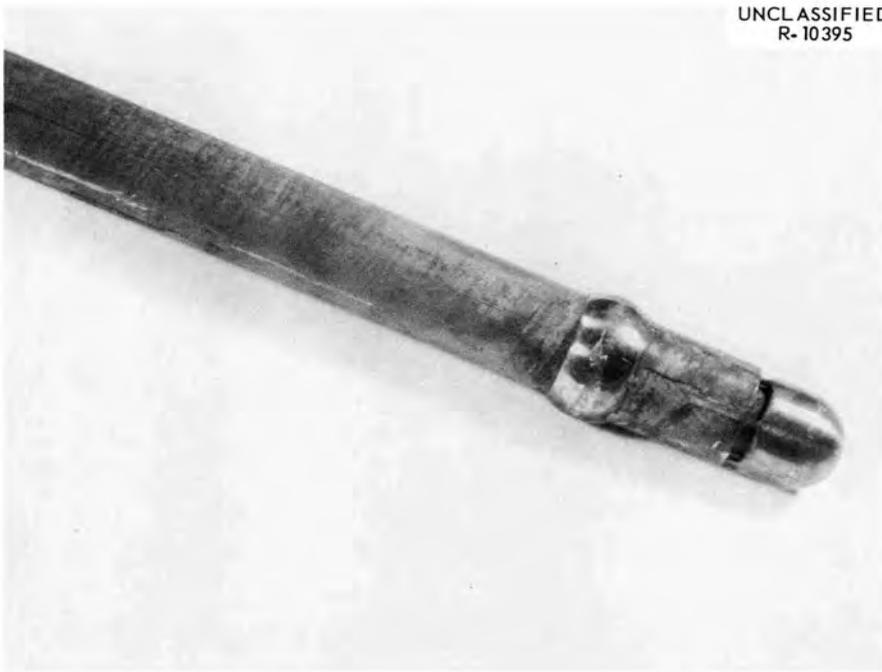
A visual examination of the shroud for test element 7C indicated a loosely adhering rust-colored corrosion product over its entire length (dull areas in Fig. 12) except for the screw threads and spacing ring. Some water was present in the loading tube, and there were rust-colored contour lines on the shroud (see Fig. 13). These lines were attributed

Fig. 12. Type 304 Stainless Steel Shroud for Test Element 7C.

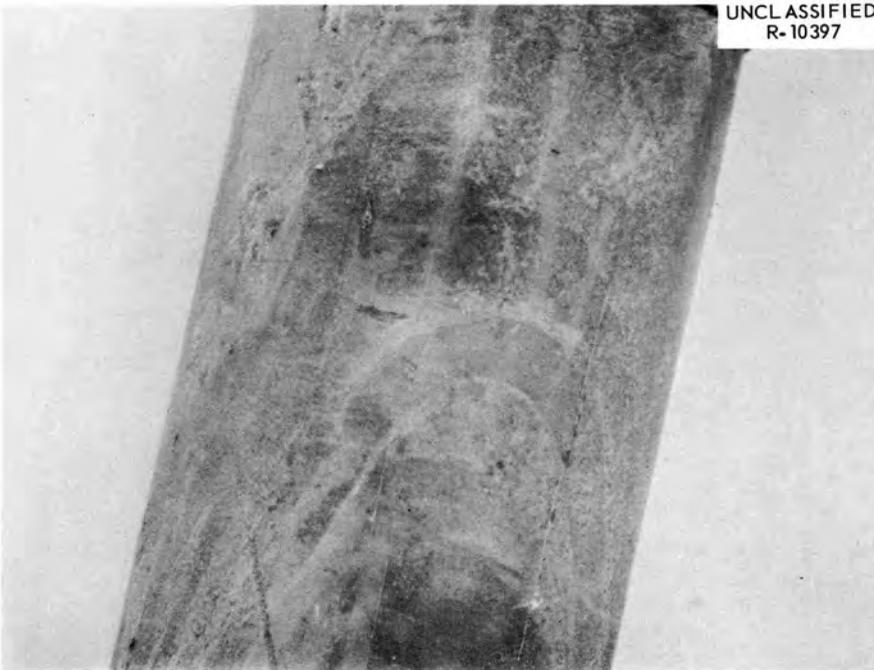
Fig. 13. Rust-Colored Contour Lines on the Shroud for Test Element 7C.

to different water levels caused by changes in position of the tube while in the reactor pool. A transverse section was made at the bottom of the shroud and prepared for metallographic examination. A lack of grain boundary integrity resulted in grains falling out from the inside diametral regions during metallographic preparation (see Fig. 14). This lack of grain boundary integrity in the shroud was sporadic and was observed in only three areas of the specimen.

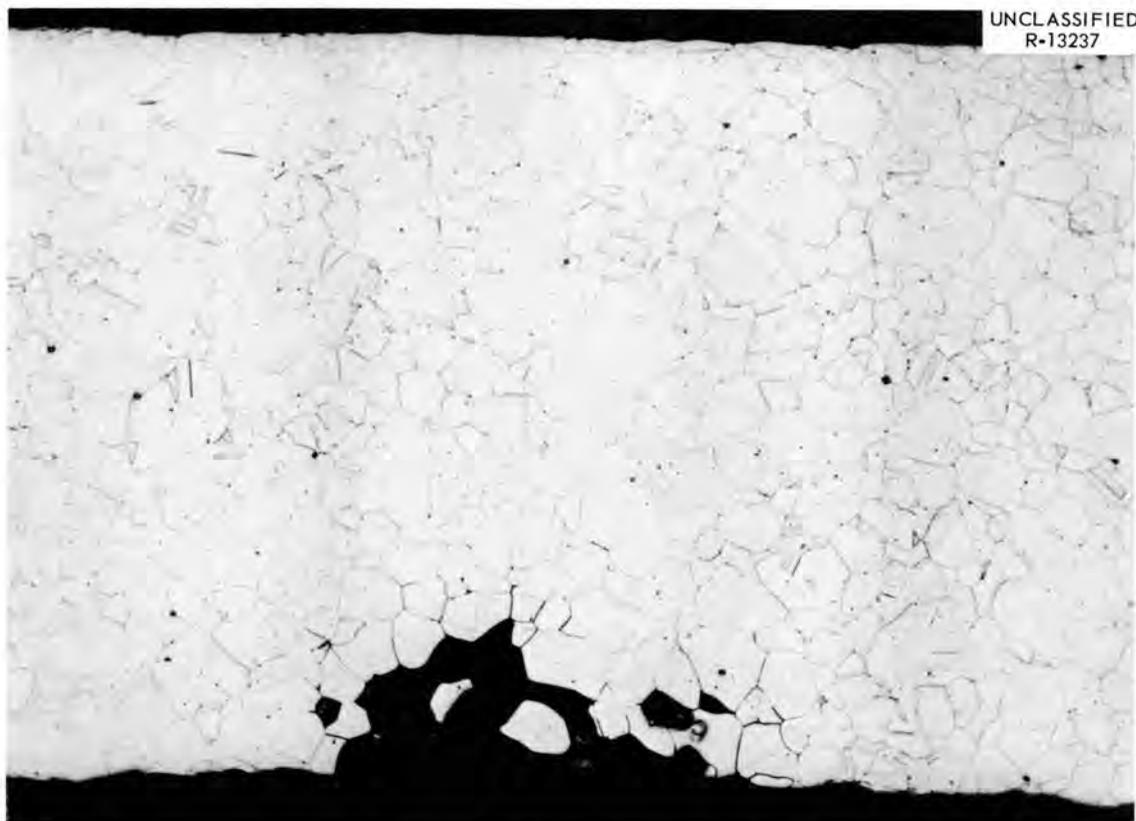
Fig. 14. Area from Bottom Portion of the Shroud for Test Element 7C Showing Lack of Grain Boundary Integrity at the Inside Diameter. Etched; 200X.

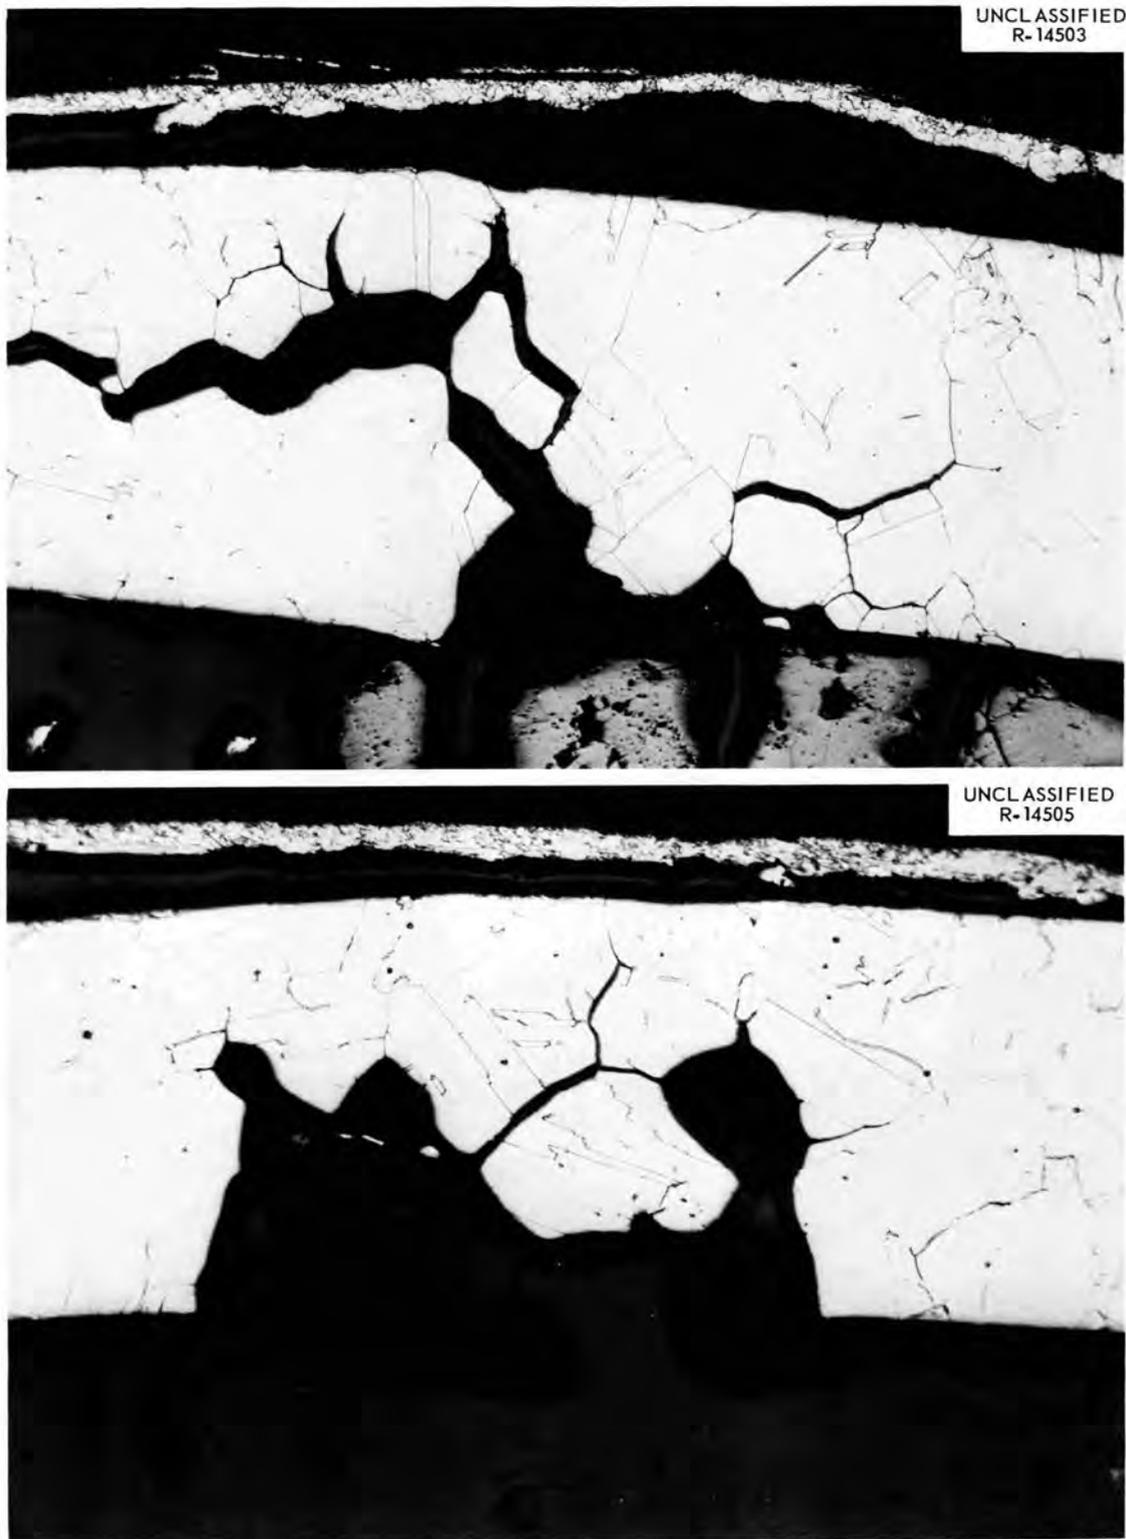
The general appearance of the cladding for element 7C was good, although there were light rust-colored spots near the top and bottom of the element. No changes in the diameter or length of the cladding were observed. However, a bow of 40 mils was measured in the central portion. Four leaks were found in the element by means of a vacuum oil test (element was immersed in an evacuated cylinder containing silicon oil). Two leaks were found $1/4$ in. below the top end cap and two were found about $3\ 1/2$ in. above the bottom end cap. Specimens were cut from these areas for metallographic examination. A transverse section through the capsule at the interface between the top fuel pellet and the MgO insulators revealed two regions where intergranular failure had occurred (see Fig. 15). The failures were similar in appearance to those seen in the shrouds of elements 5 and 7C except that there was no evidence of a corrosion product in the intergranular fractures in the element 7C cladding. Furthermore, the cladding failures began at the inner surface and differed from those seen in the shrouds in that the inner surface of the cladding had not been exposed to water during storage. The failures did not appear to be associated with the copper used to braze the internal thermocouples to the cladding since regions were seen where the copper had penetrated the cladding intergranularly but the cladding remained intact.

Fig. 15. Areas from a Transverse Section from Test Element 7C Showing Intergranular Cladding Failures at Interface Between Top Fuel Pellet and MgO Spacer. Etched; 100X.

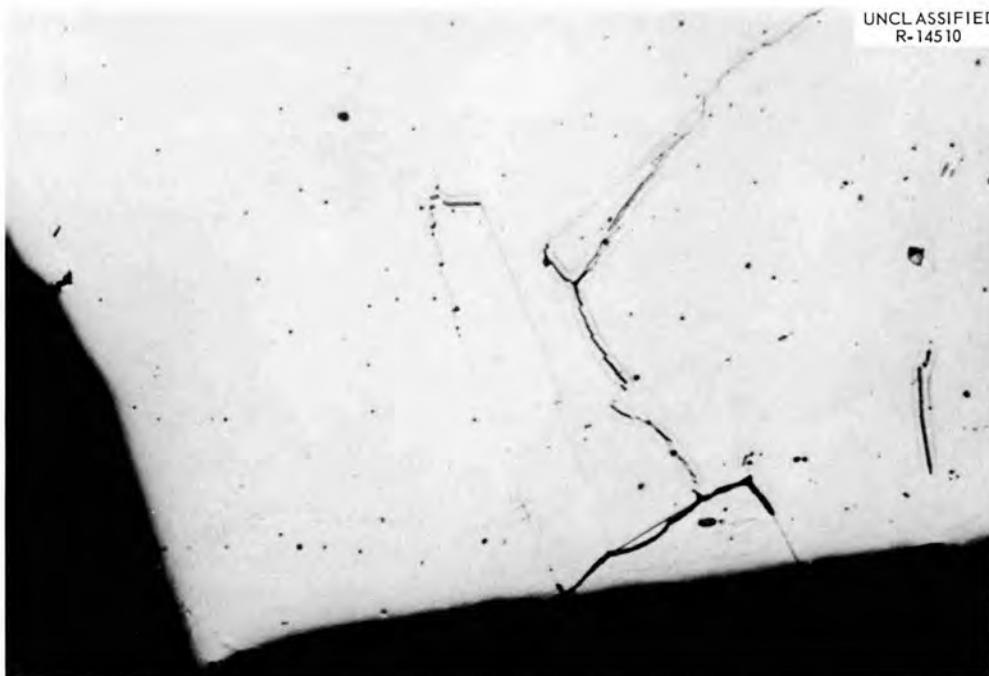
A fine and apparently continuous precipitate was observed along the grain boundaries in the metallographic specimen obtained from the top portion of test element 7C (see Fig. 16). The intergranular precipitate in a specimen from near the midlength of the same element appeared discontinuous (see Fig. 17). A specimen was prepared for x-ray diffraction in an attempt to identify the precipitates. Even though the precipitates were put in relief by etching, the pattern obtained was too weak for identification.

Fig. 16. Transverse Section from Top Portion of Test Element 7C Showing Fine and Apparently Continuous Precipitate Along Grain Boundaries. 500X. Reduced 12%.

It is interesting to note that a fine and apparently continuous precipitate was observed along the grain boundaries in the metallographic specimen taken from the top portion of test element 7C (see Fig. 16). The estimated operating temperature of the cladding in this region was 1200°F. Near the midlength of this same element, the cladding temperature was higher and the intergranular precipitate appeared dendritic (see Fig. 17).

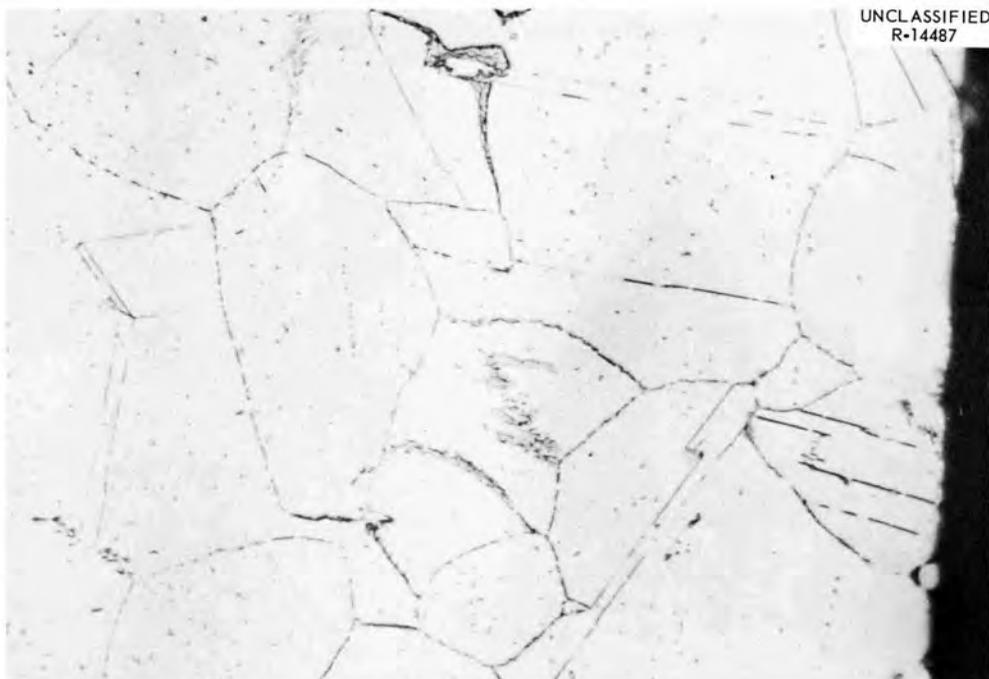
Fig. 17. Transverse Section from Near Midlength of Test Element 7C Showing Discontinuous Precipitate Along Grain Boundaries. Etched; 500X. Reduced 12%.
