CORROSION OF THE VOLATILITY PILOT PLANT
INOR-8 HYDROFLUORINATOR AND NICKEL 201
FLUORINATOR DURING FORTY FUEL-PROCESSING
RUNS WITH ZIRCONIUM-URANIUM ALLOY

ORNL-3623

Chemical Technology Division

MARCH 1965

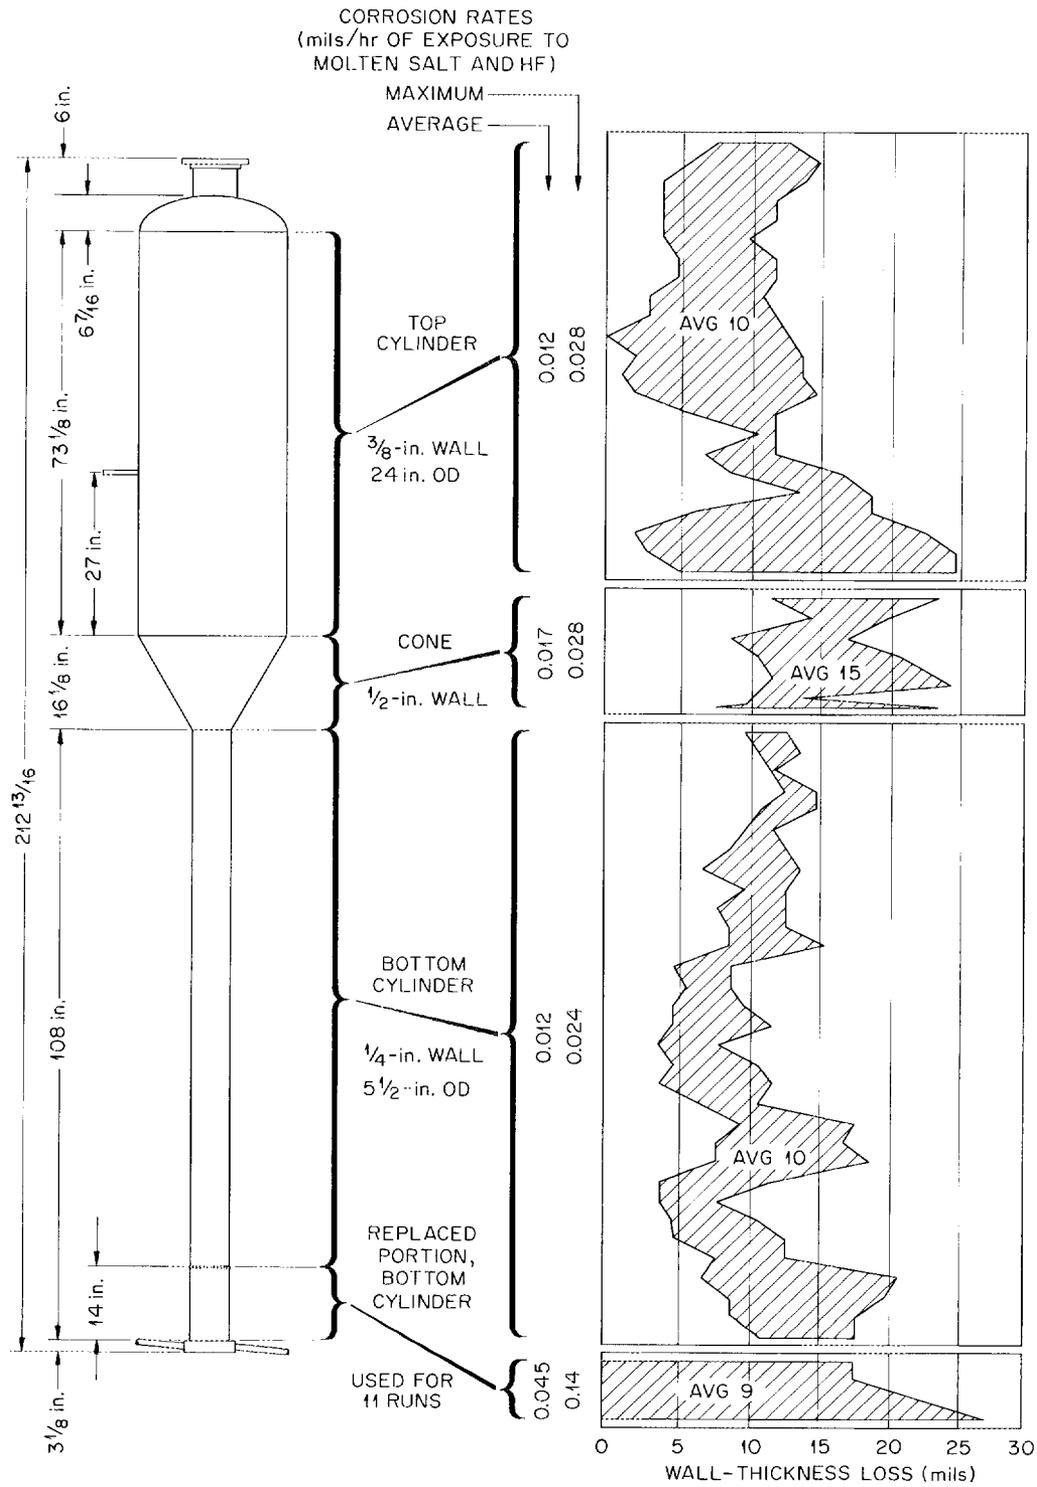
After 40 runs, the 24-in.-diam cylindrical and conical section had a maximum thickness loss (excluding pits or cracks) of 25 mils and an average attack of about half the maximum. The small cylindrical section, excluding the bottom 14 in., had a comparable loss, with a maximum of 21 mils and an average of 10.3. In this section, the maximum corrosion rate since the fourteenth run appears to have reached a rate of about 0.024 mil/hr, based on HF exposure, and 6.7 mils/month based on salt-residence time. Measurements made of the 3/8-in. instrument lines removed after 21 runs agree well with the above rate (excluding the bottom 6 in.). Corrosion rates measured at various times showed more variation in the cone and large cylinder than in the small cylinder, possibly because of the smaller number of readings taken in those areas. However, a maximum rate of about 0.028 mil/hr of HF exposure and 8.1 mils/month of salt-residence time appears fairly consistent with previous measurements in the cone and large cylinder since the fourteenth run. The maximum corrosion rates for the hydrofluorinator after 40 runs are given in Table 5.

Fig. 2. Hydrofluorinator Wall-Thickness Loss During Forty Zirconium Processing Runs.

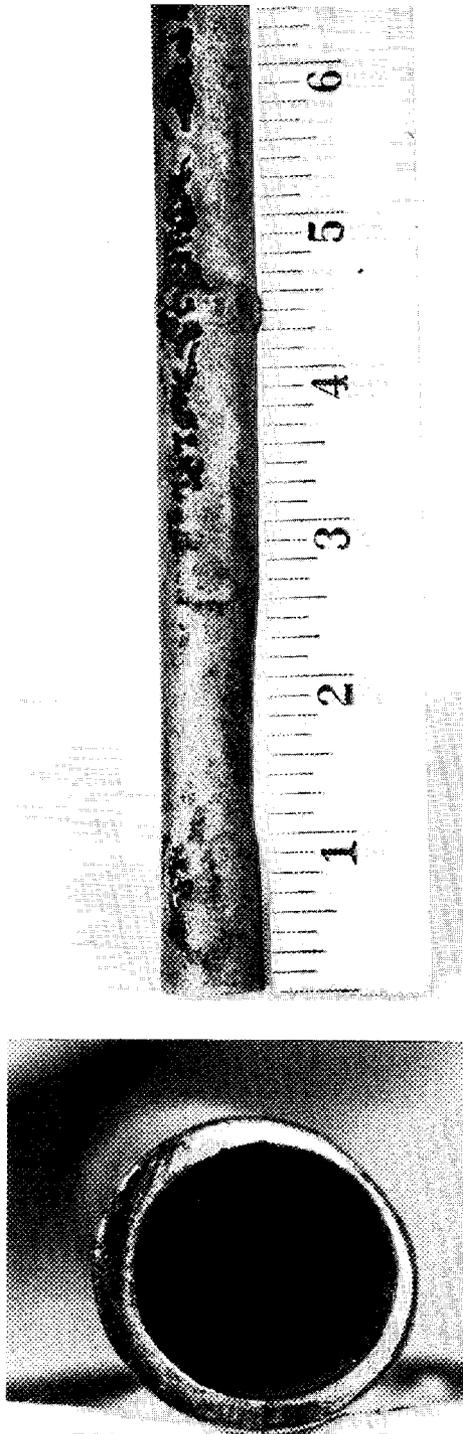
14 runs indicated corrosion rates comparable to those for the upper portion of the section. After 21 runs, the lower section showed a maximum attack of 18 mils (0.036 mil/hr of HF exposure), compared with a maximum of 13 mils (0.026 mil/hr of HF) for the upper portion. An instrument line removed at this time showed a maximum wall-thickness loss of 50 mils (0.10 mil/hr of HF) at a location about 1-1/2 in. above the distributor plate (Fig. 3). A thermocouple well removed at the same time showed a maximum loss of 26 mils (0.05 mil/hr of HF) at about the same location. This corrosion occurred in the vicinity of a clip that held the lines against the vessel wall. The higher corrosion rate at this location was apparently due to turbulence of the HF-salt mixture at that point since the upper section of the line showed only normal losses.

Fig. 3. Corrosion of an Instrument Line Removed From the Bottom of the Hydrofluorinator After Twenty-one Runs.

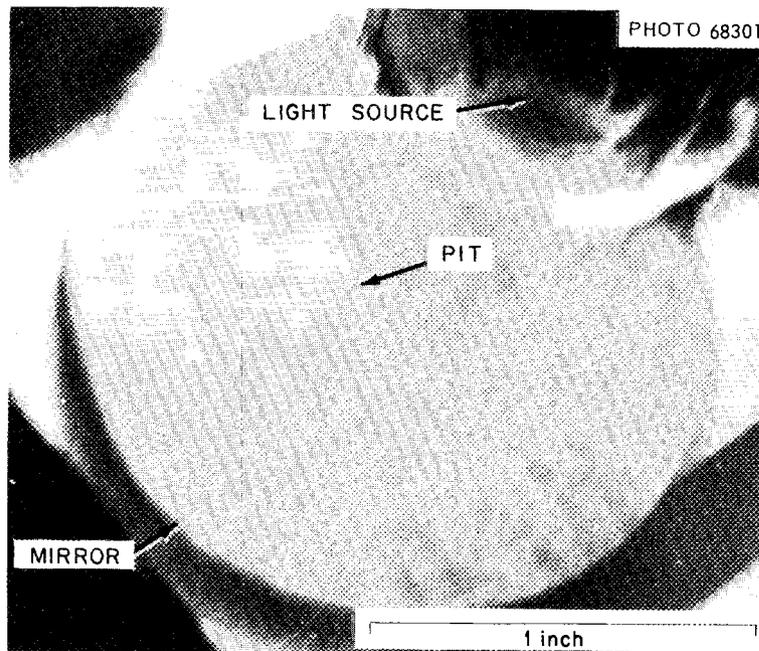
surface of the 5-1/2-in.-diam section and the lower part of the cone section were inspected. This was done with a Questar telescope and mirrors. A few pits were seen in the 5-1/2-in.-diam section, such as the one shown in Fig. 4. The largest pit was estimated to be no more than 20 mils in diameter or 20 mils deep. Several small fissures were seen in the conical section, running upward from the lower weld. These fissures (Fig. 5) were estimated to be not more than 10 mils wide, and they did not appear to be very deep. Welds in the lower part of the hydrofluorinator appeared to be in good condition. No areas of extensive pitting or cracking were seen.

Fig. 4. A Pit Observed in 5-1/2-in.-OD Section of the Hydrofluorinator After Forty Runs.

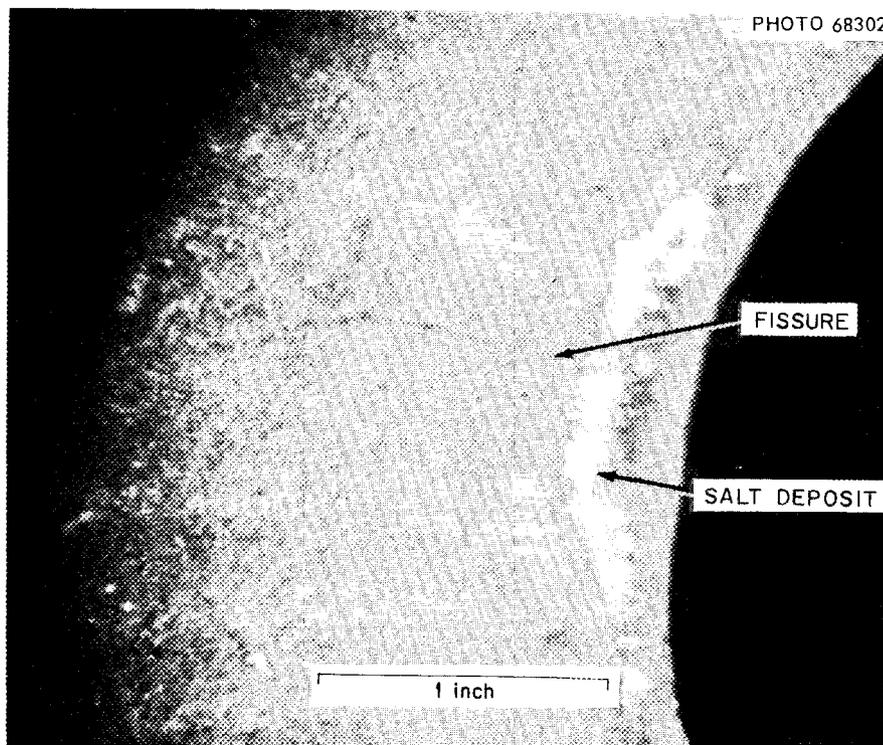
Fig. 5. Fissure in the Conical Section of the Hydrofluorinator After Forty Runs.

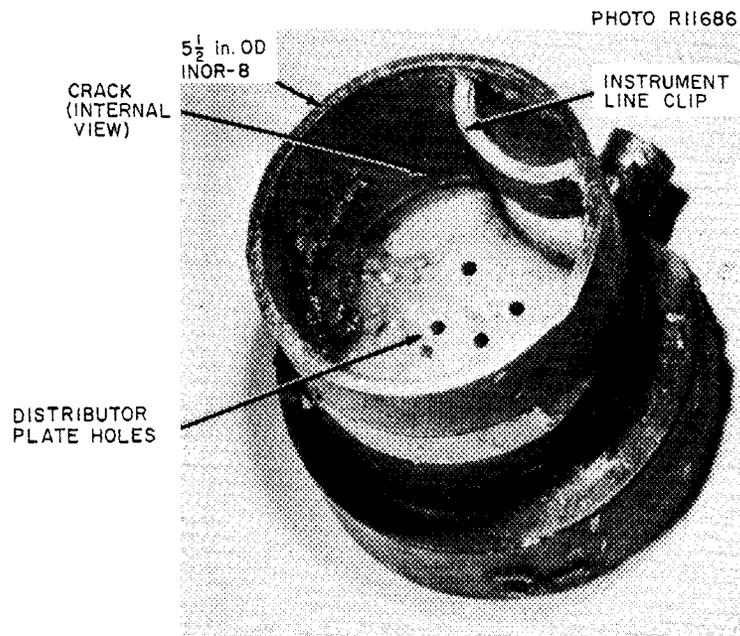
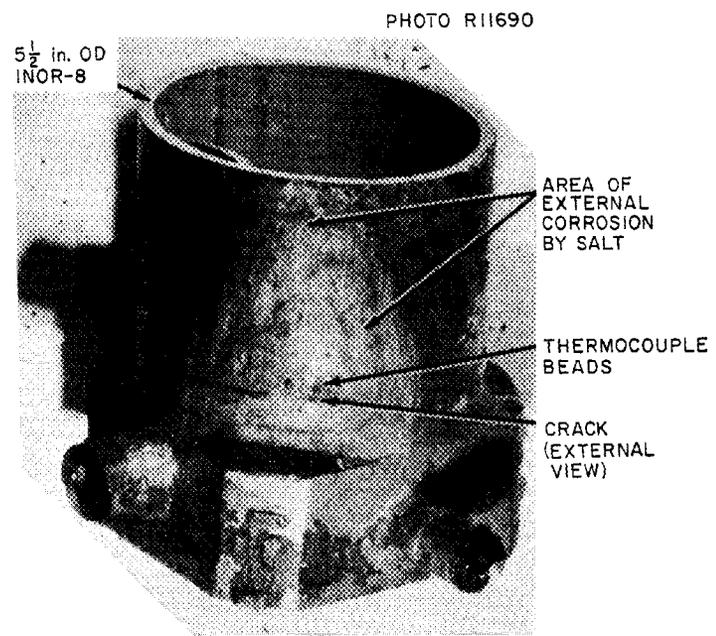
After run T-11 (29 runs) the hydrofluorinator was decontaminated, and a visual inspection was made of the exterior. This examination revealed a salt leak in the 5-1/2-in.-OD section of the vessel just above the girth weld joining the distributor plate to the 5-1/2-in. section. The crack, shown in Fig. 6, occurred in the heat-affected area of two stainless-steel-sheathed thermocouple weld beads. The leakage was through two intersecting cracks. The horizontal crack was 1-1/8 in. long and was located between the thermocouple heads and the girth weld at the distributor plate. The vertical crack was 3/8 in. long and was between the two thermocouple heads. Both cracks were intergranular and appeared to have originated at the exterior. Only a small quantity of salt had leaked through the crack and covered about a 6-in.-diam circle on the exterior. The exterior of the hydrofluorinator and the thermocouples in the area of the leak were severely corroded, as is normal with metals in contact with molten fluorides in air. Since thermocouple failure occurred during run R-1, presumably the crack

Fig. 6. Lower Section of Hydrofluorinator After Failure by Cracking (After Twenty-nine Runs).

also occurred then, and the salt sealed the crack sufficiently to permit continued operation.

The lower 17 in. of the hydrofluorinator was removed for metallurgical examination.¹¹ No gross bulging was found in the bottom section, and test specimens removed from this section showed no loss of tensile strength or brittleness of the INOR-8. However, chemical analyses indicated that it apparently was from an INOR-8 heat (SP-26) known to be susceptible to weld cracking.¹² Other intergranular cracks, up to 65 mils deep, were found on the exterior surface below the lower girth weld. Apparently the leak resulted from the effect of the thermocouple bead welds and the girth weld on substandard INOR-8, susceptible to weld cracking.

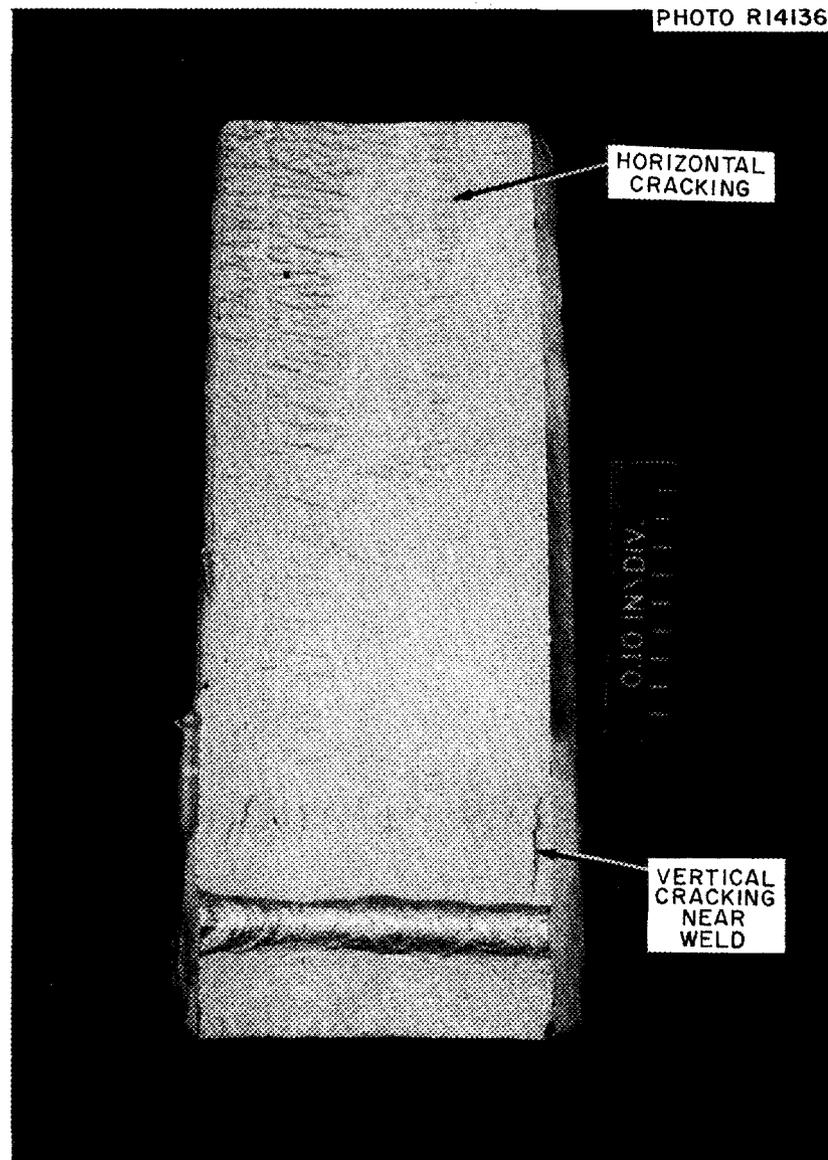
Many cracks between 10 and 40 mils deep were found on the inside surface of the vessel near the leak. These cracks, shown in Fig. 7, were classified into two groups. The first consisted of cracks perpendicular or adjacent to welds and were apparently associated with weld stresses. The second group contained horizontal cracks aligned in vertical rows throughout the lower 12 in. of the vessel. The horizontal cracks may have resulted from the rolling operation used in fabrication.

Fig. 7. INOR-8 Specimen Removed From the Bottom Section of the Hydrofluorinator After Twenty-nine Runs.

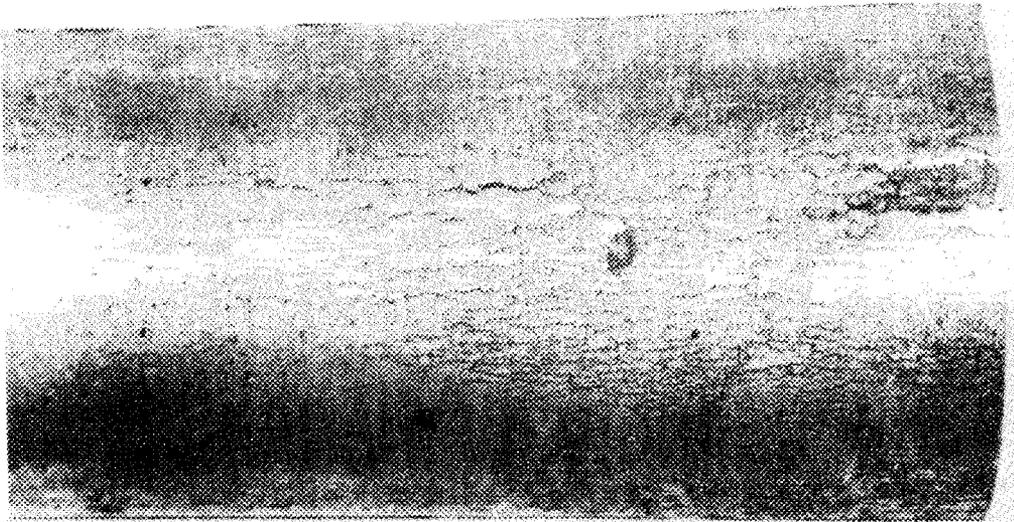
BMI C-1494

A rupture occurred after TU-6 (13 runs) in the 1-in.-OD adapter at the junction between the salt-transfer line and the bottom of the hydrofluorinator. This was the area where the freeze valve was formed. In addition to the rupture there were many other cracks on the outer surface (Fig. 8). Metallography revealed that the rupture and other cracks were intergranular and that they originated on the outside, indicating that they were caused by salt expansion.¹³ Apparently this was a result of salt melting in the center of the freeze valve before the salt at each end became molten. The adapter was replaced temporarily until after TU-7, at which time 3-in.-long adapters were installed in both the salt transfer and HF inlet lines. The shorter adapter allowed more uniform heating, and no further difficulties were experienced. Portions of these 3-in.-long adapters were examined metallographically after they had been used for 15 runs (after T-11) and found in good condition.

Fig. 8. Cracking Due to Salt Expansion in an INOR-8 Adapter on the Hydrofluorinator HF Inlet Line.

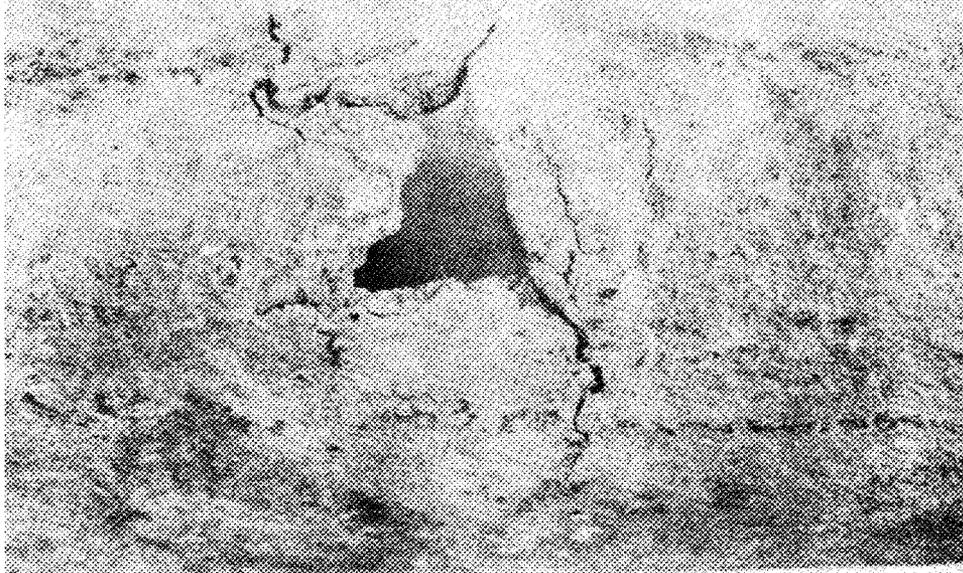
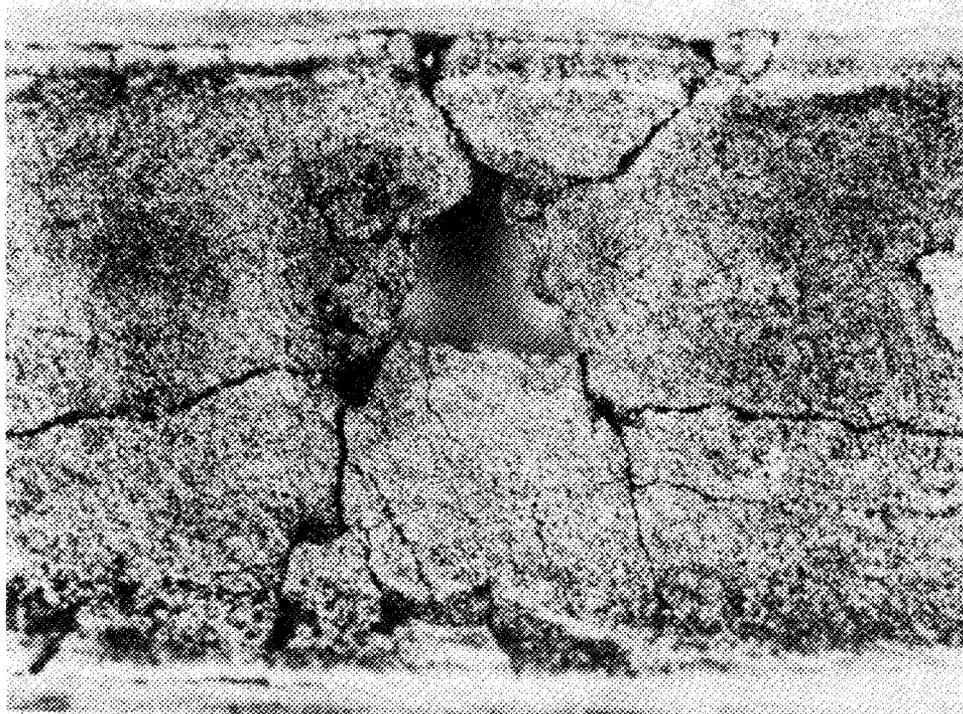
Originally, all three autoresistance-heated lines that entered the hydrofluorinator were made of 3/8-in. sched-40 Inconel pipe. After TU-7 (14 runs) a leak developed in the HF line about 2 ft from the hydrofluorinator. Figure 9 shows a section of pipe in which the leak occurred. Metallography revealed that chromium and iron had been leached from the Inconel pipe in the vicinity of the leak. Leaching occurred all along the pipe but was less severe at greater distances from the hydrofluorinator.¹³ Thinning of the pipe wall by corrosion apparently caused localized overheating (750°C maximum temperature) and even greater corrosion.

Fig. 9. Corrosion of Inconel Pipe in the Hydrofluorinator HF Inlet Line.

than the HF line; however, there was indication of metal loss, particularly in the areas closer to the vessels. The Inconel piping in the three auto-resistance-heated lines attached to the hydrofluorinator was replaced with INOR-8 pipe after TU-7 (14 runs).

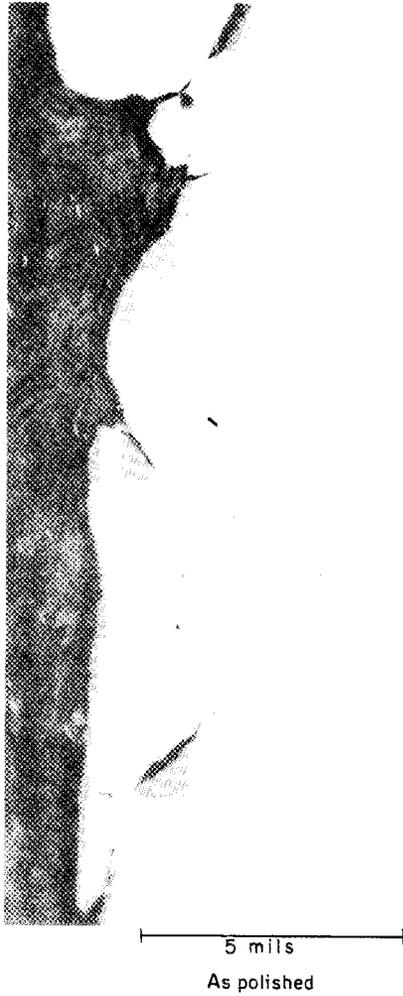
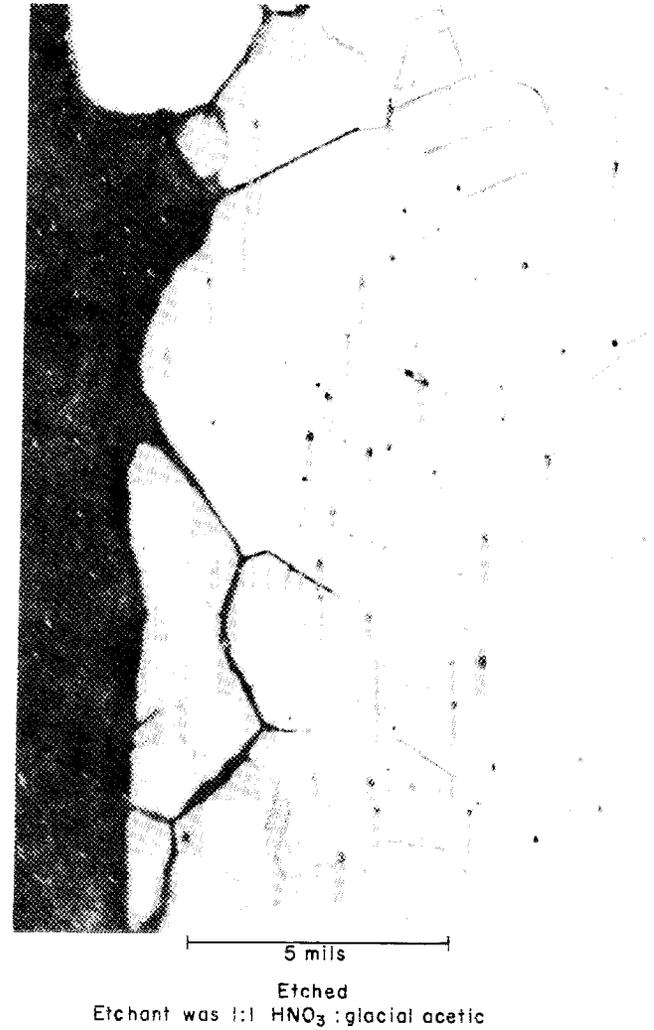
Fig. 11. Grain-Boundary Modification of Nickel 201 Specimens Removed From the Fluorinator Wall After Twenty-nine Runs.

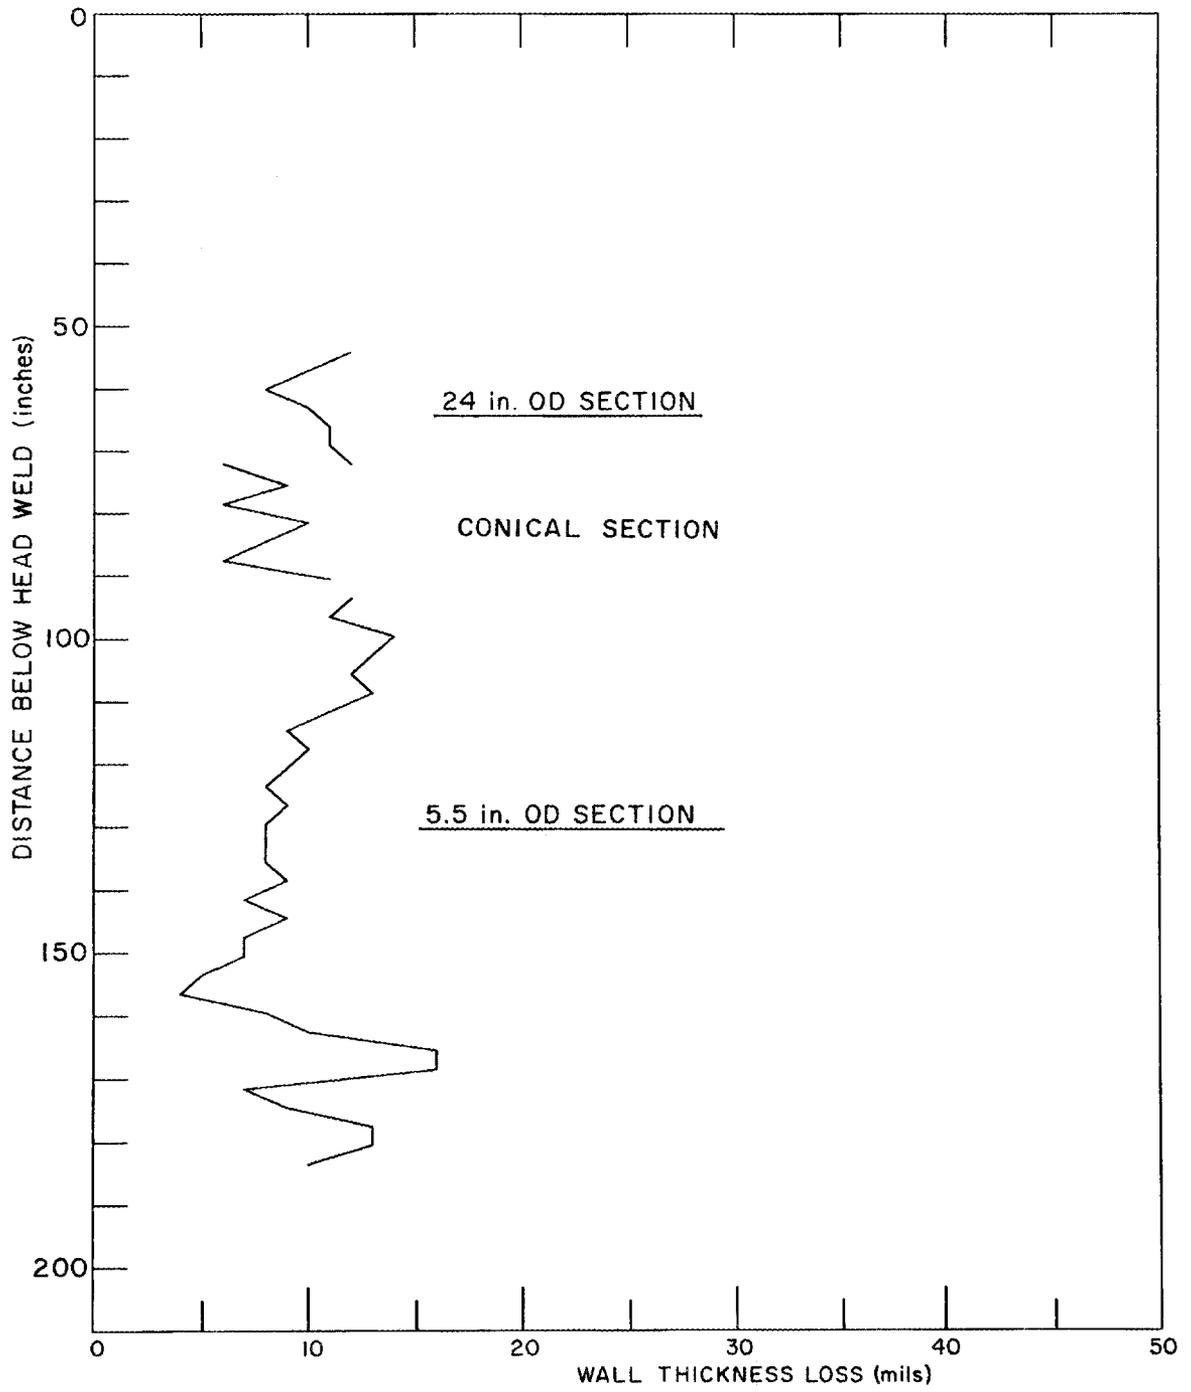
Fig. 2A. Hydrofluorinator Wall-Thickness Losses After 29 Runs.

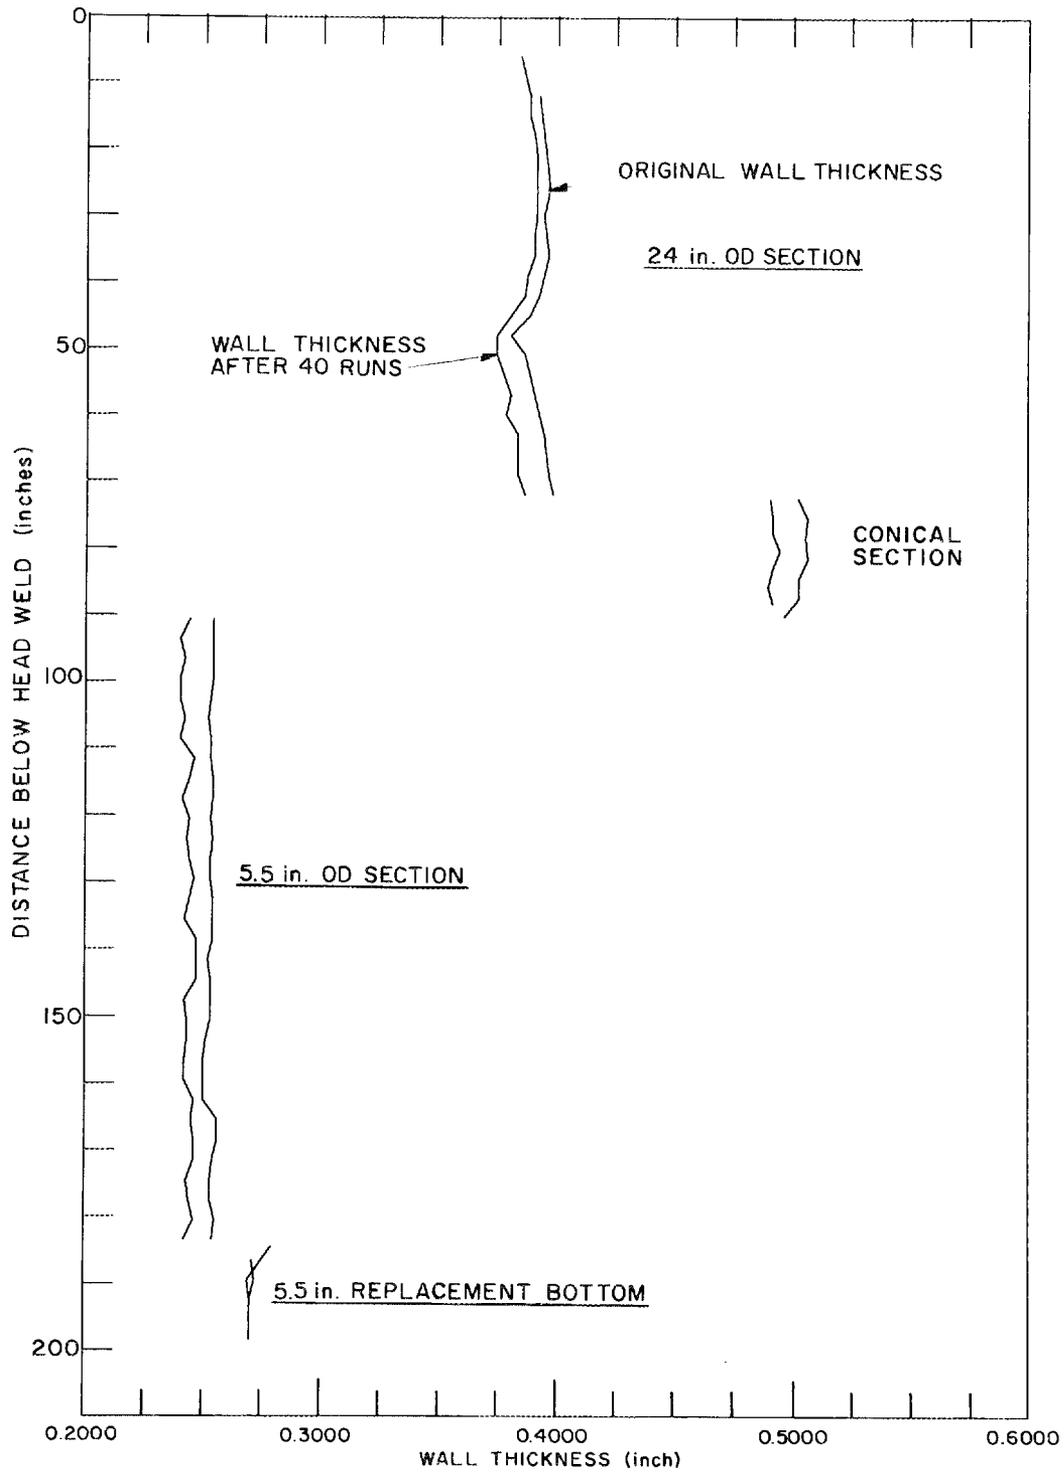
Fig. 3A. Hydrofluorinator Wall-Thicknesses Before and After 40 Zirconium Runs (North Wall).

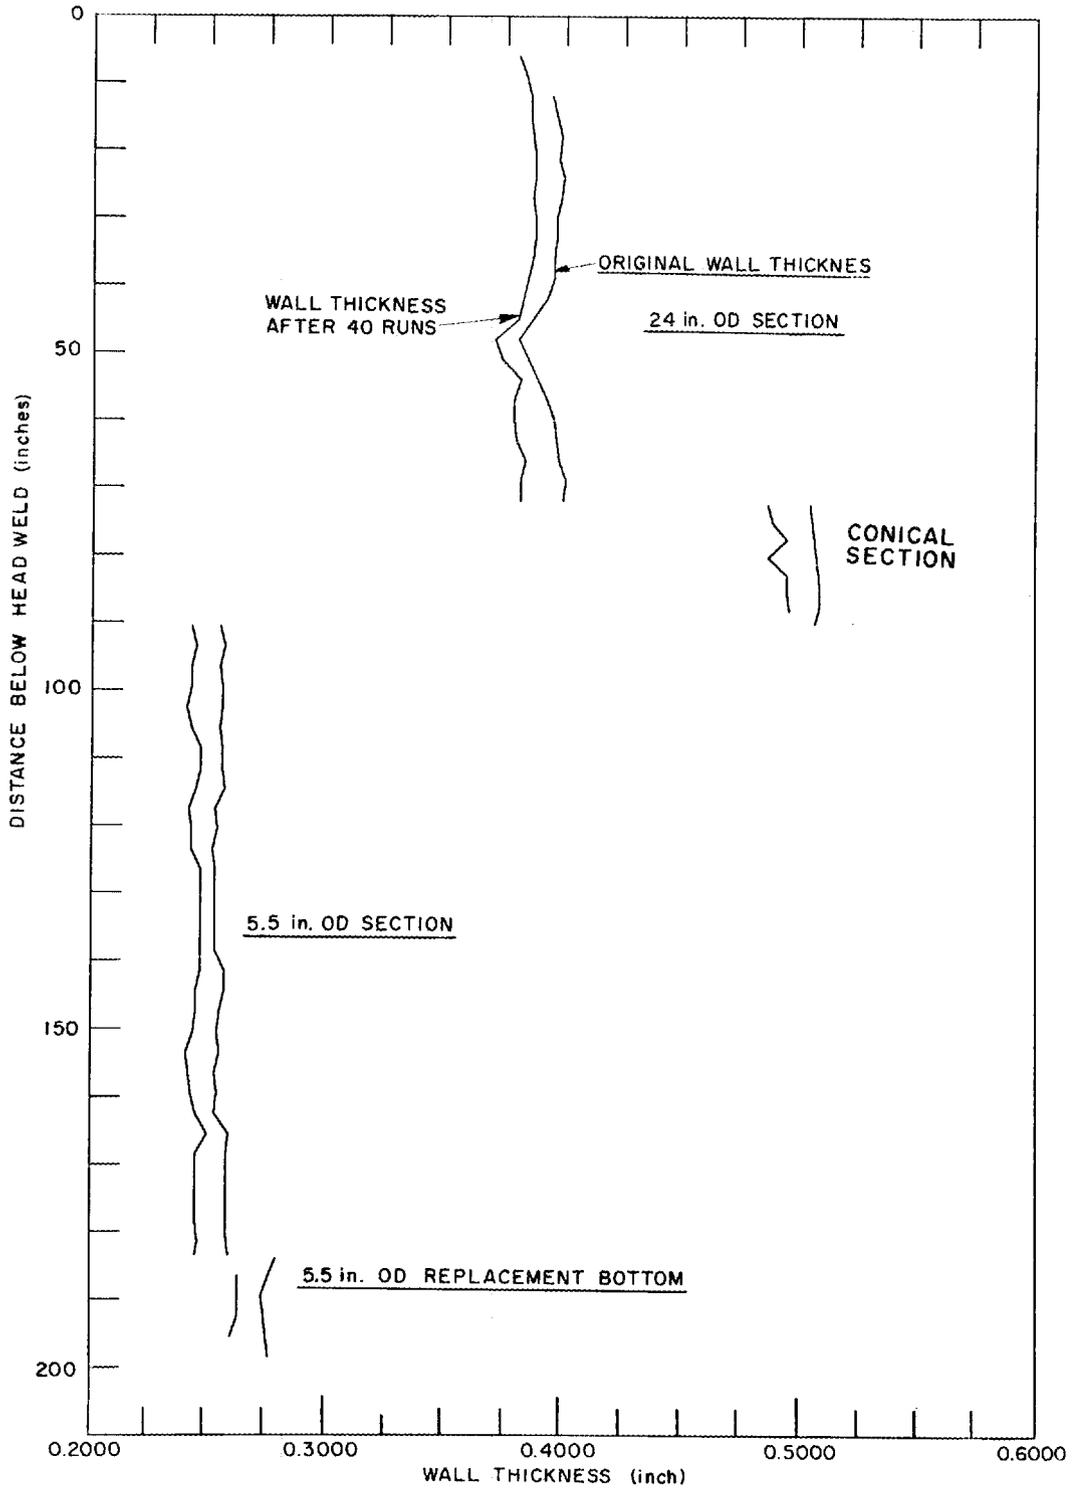
Fig. 4A. Hydrofluorinator Wall Thicknesses Before and After 40 Zirconium Runs (South Wall).

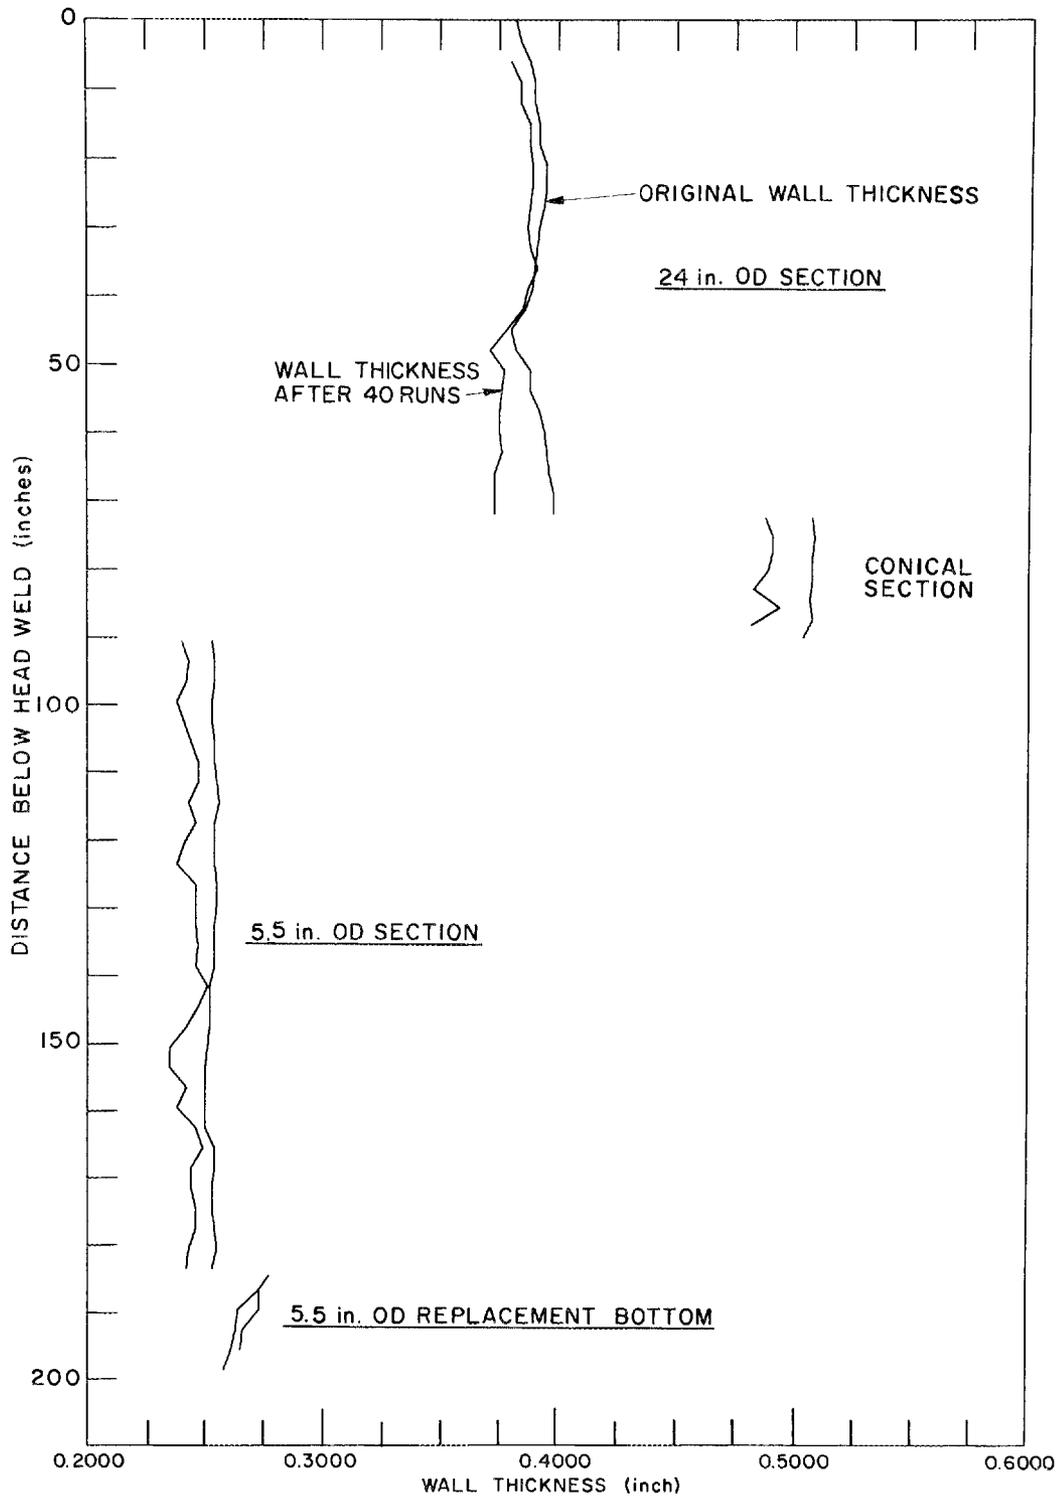
Fig. 5A. Hydrofluorinator Wall-Thicknesses Before and After 40 Zirconium Runs (East Wall).

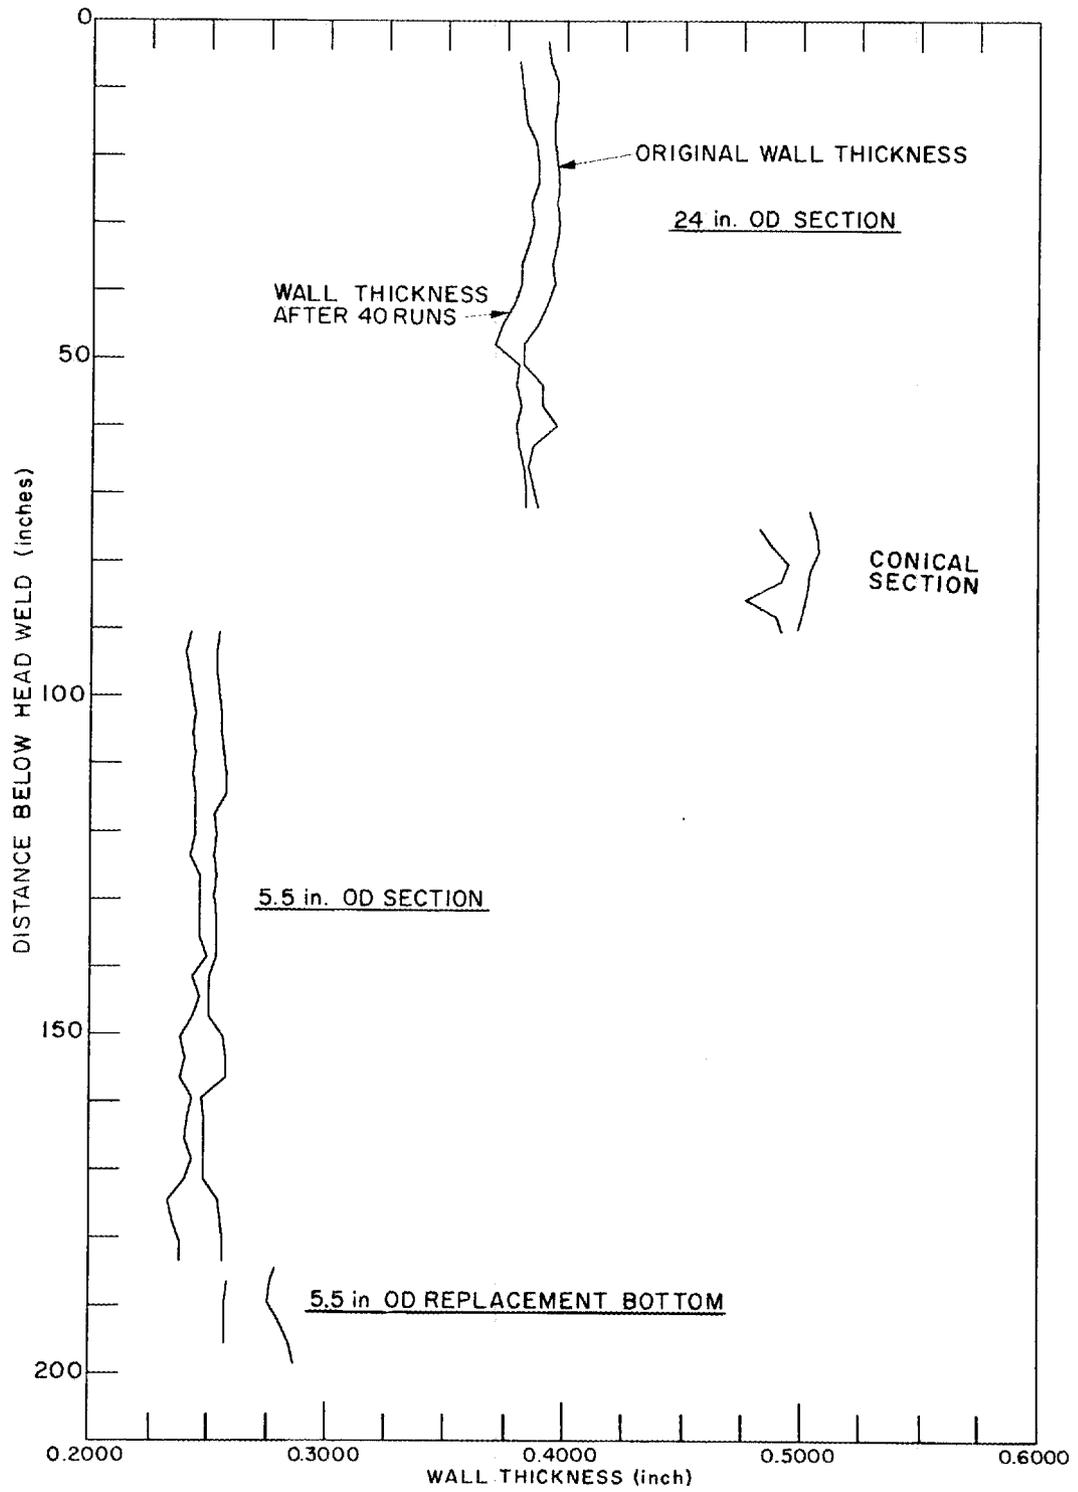
Fig. 6A. Hydrofluorinator Wall Thicknesses Before and After 40 Zirconium Runs (West Wall).
