ORNL-4714 *107*
UC-25 - Metals, Ceramics, and Materials

POSTIRRADIATION EXAMINATION AND
EVALUATION OF THE PERFORMANCE
OF HFIR FUEL ELEMENTS

A. E. Richt
R. W. Knight
G. M. Adamson, Jr.

DECEMBER 1971

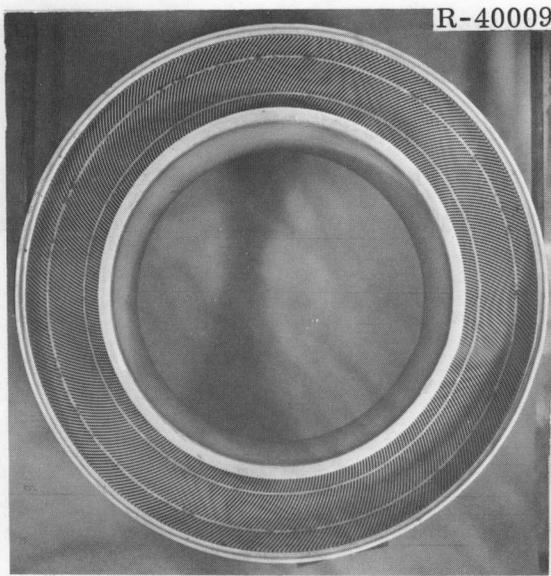
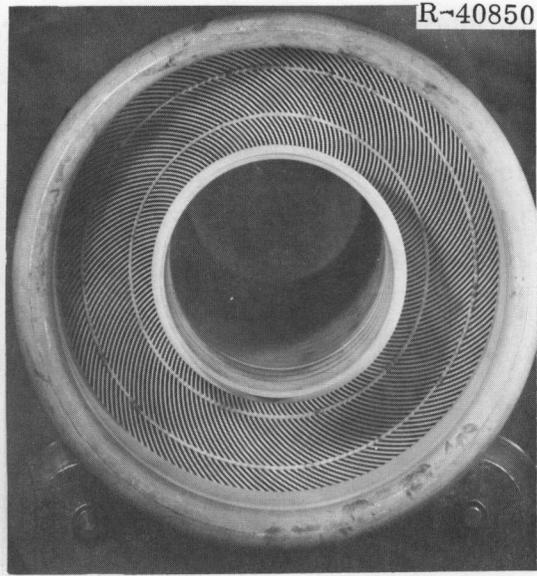
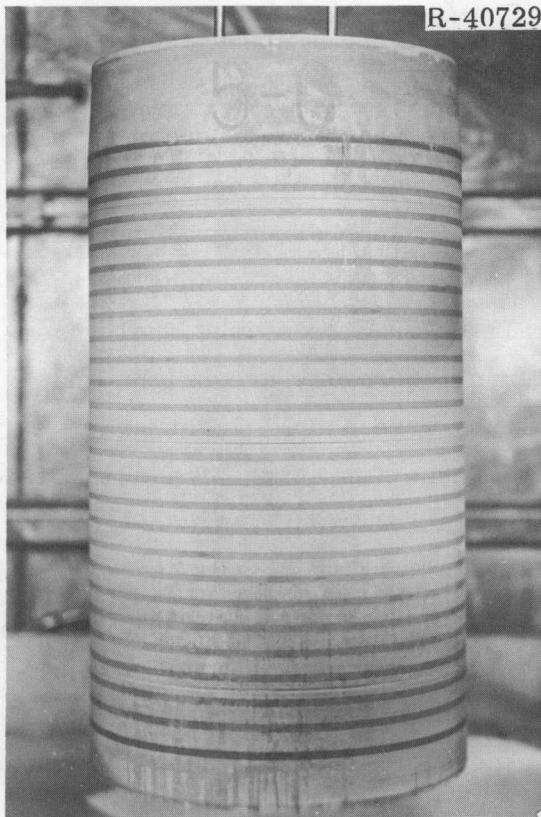
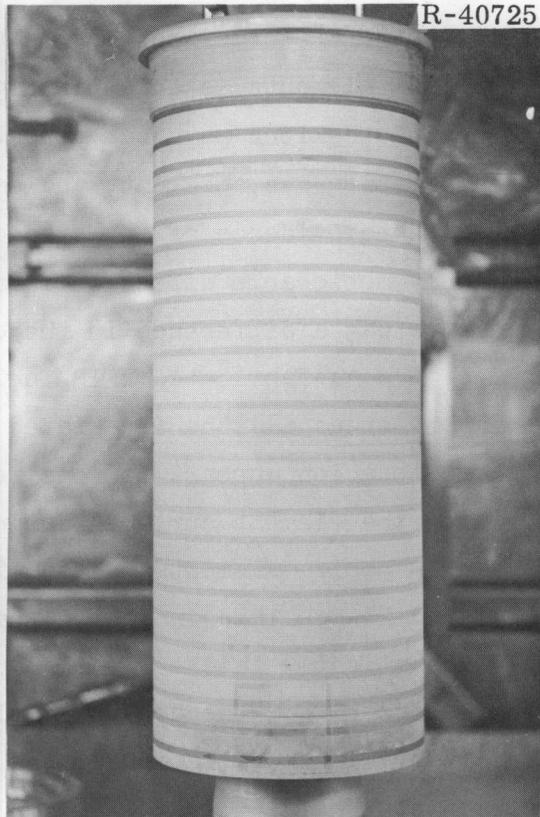
Shortly after unloading the irradiated fuel elements from the shipping cask, we examined the spent fuel assemblies visually through the hot cell windows and with the in-cell periscope system at magnifications up to 4X for evidence of damage. The overall appearance of the four fuel elements is shown in Figs. 9 and 10. In general, all appeared to be in excellent physical condition; no indications of gross warpage or distortion was apparent, and careful inspection of the surfaces revealed no evidence of any type of mechanical or structural damage. The only noticeable effect of irradiation upon the appearance of the elements was a difference in the overall coloration of the fuel assemblies; the as-fabricated HFIR fuel elements normally are bright and shiny, whereas all the irradiated elements were a dull light gray. This coloration appears to be a result of the formation of a thin oxide film on the element surfaces during irradiation or during storage in the HFIR pool. Elements 5-I and 5-0 were slightly darker than elements 49-I and 21-0. This indicates that the oxide film on elements 5-I and 5-0 was slightly thicker. All four elements were slightly darker at the bottom (i.e., the coolant outlet end). This also appears to be a result of slight variation in the thickness of the oxide film along the elements.

Fig. 9. Fuel Elements 5-I and 5-0 after 2046 MWd of Operation and One Year Storage in the Reactor Pool.

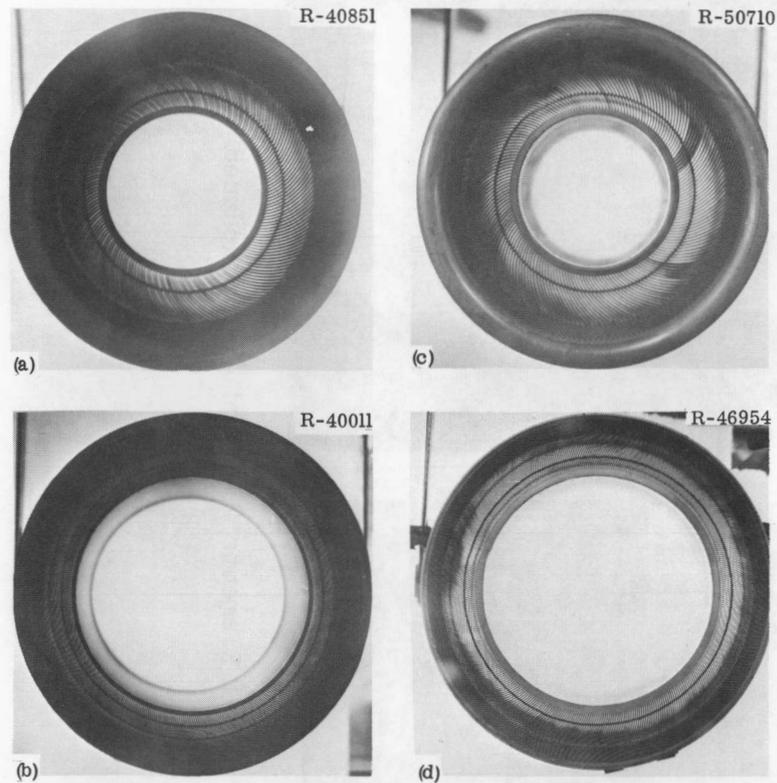
The coolant channels of all four elements were also examined visually for evidence of fuel plate warpage or blockage. As shown in Fig. 11, no significant change in coolant channel spacing was apparent; and, except for element 5-I, all channels were free of any blockage or obstructions. As shown in Fig. 12, a soft, white deposit partially

Fig. 11. Backlighted Views Through the Coolant Channels of HFIR Fuel Elements. (a) 5-I, (b) 5-0, (c) 49-I, and (d) 21-0. Reduced 32%.

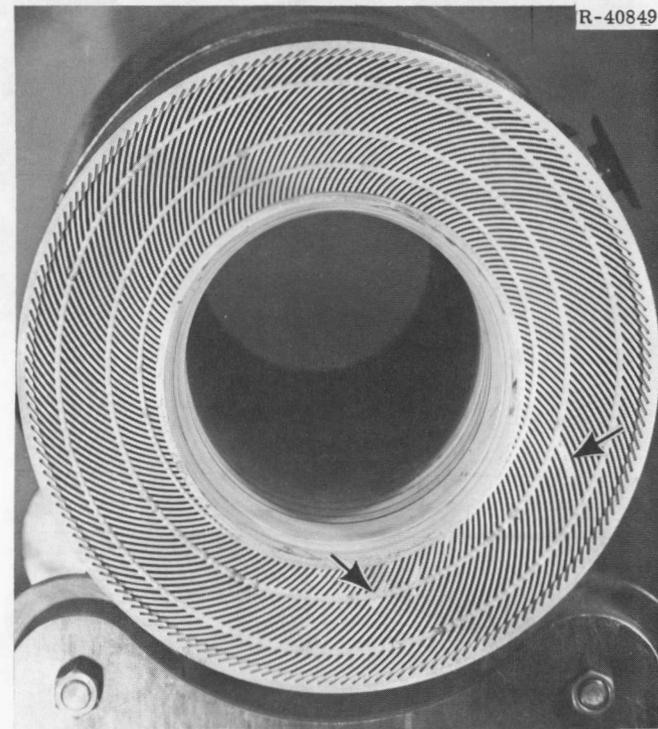
Fig. 12. Bottom View of HFIR Fuel Element 5-I. Arrows show whitish deposit, which partially blocked some of the coolant channels of this element. Reduced 33.5%.

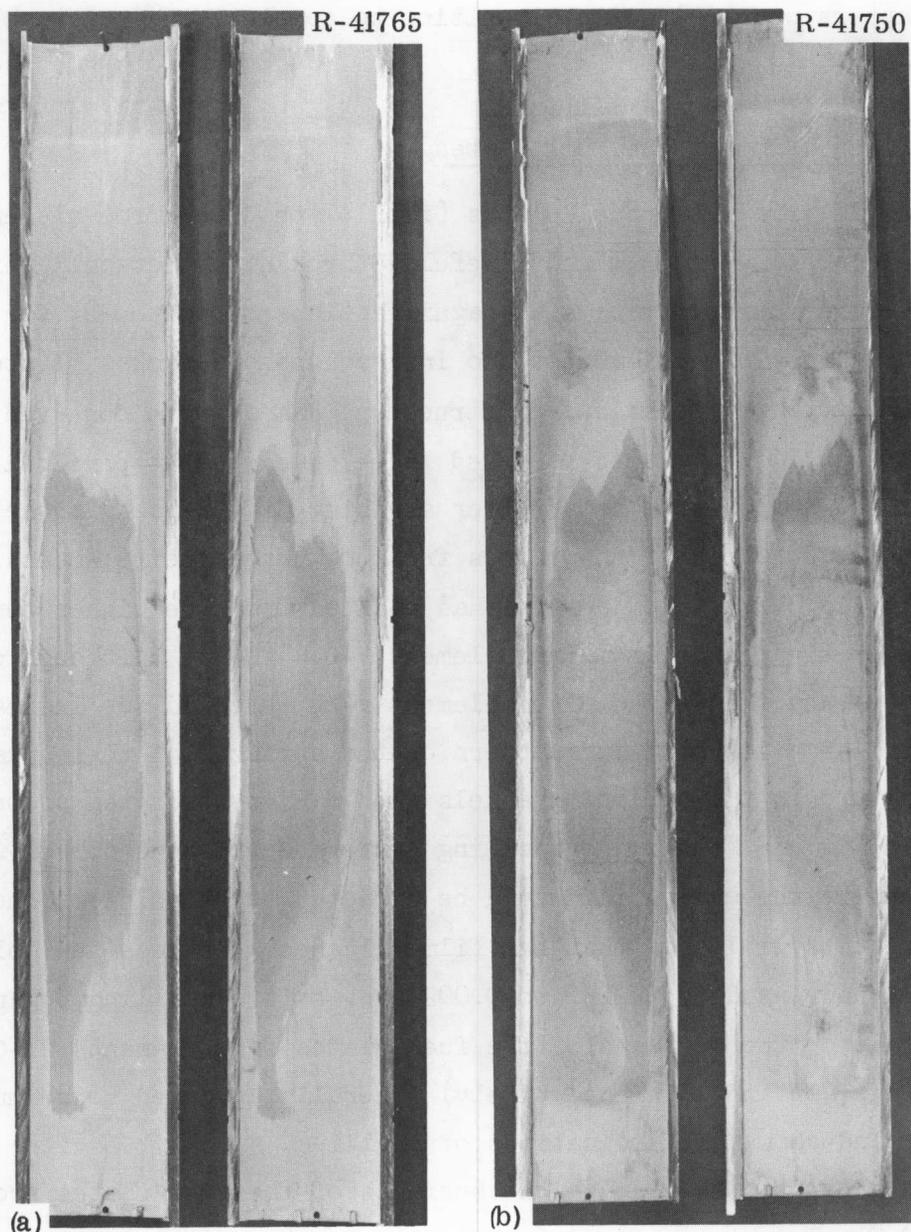
The 12 irradiated fuel plates (four plates each from elements 5-0, 21-0, and 49-I) were examined carefully through the hot-cell periscope and stereomicroscope systems at magnifications of up to 20X for evidence of irradiation-induced damage. No indications of cracks, blisters, or any other type of mechanical or structural damage were observed; and, in general all 12 fuel plates appeared to be in excellent physical condition. However, we did observe some rather striking differences in the oxide film on the surfaces of the plates from the three fuel elements. As shown in Fig. 13, the oxide film had spalled from the higher temperature regions of the plates from fuel element 5-0. (Note: Although we did not remove any fuel plates from element 5-I, we could see indications of a similar oxide-spalling pattern on the surfaces of these plates by looking through the coolant channels with a high-power telescope.) As shown in Fig. 14, the oxide-spalling pattern corresponded well with the region where the oxide film would be expected to be thickest; however, later results will show that the film thickness on these fuel plates actually increased to 0.0015 to 0.0020 in. before spalling began. The oxide film on the surfaces of the fuel plates from elements 21-0 and 49-I (Figs. 15 and 16, respectively) generally appeared to be much thinner and showed no indications of spalling.

Fig. 13. Typical Appearance of Fuel Plates from HFIR Fuel Element 5-0. Regions where the oxide film had spalled from plate surfaces are clearly delineated by the large dark irregularly shaped areas. Approximately one-fourth actual size. Coolant flow is downward. (a) Concave surfaces, inner edge of plates at left. (b) Convex surfaces, inner edge of plates at right.

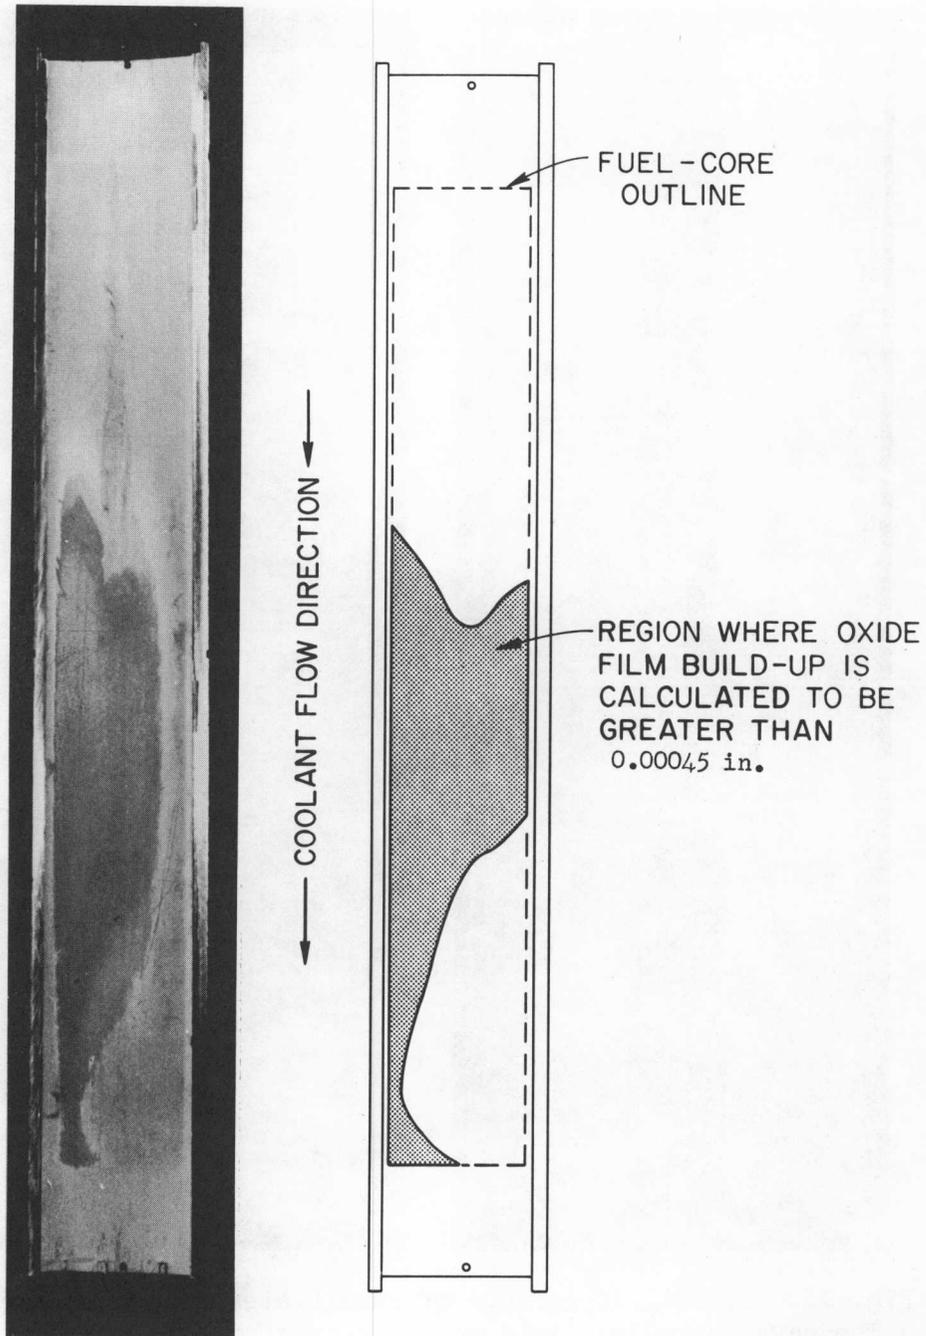
Fig. 14. Comparison Between Oxide Spalling Patterns on Fuel Plates from Element 5-0 with the Predicted Oxide Thickness Pattern for an Outer Annulus HFIR Fuel Plate.

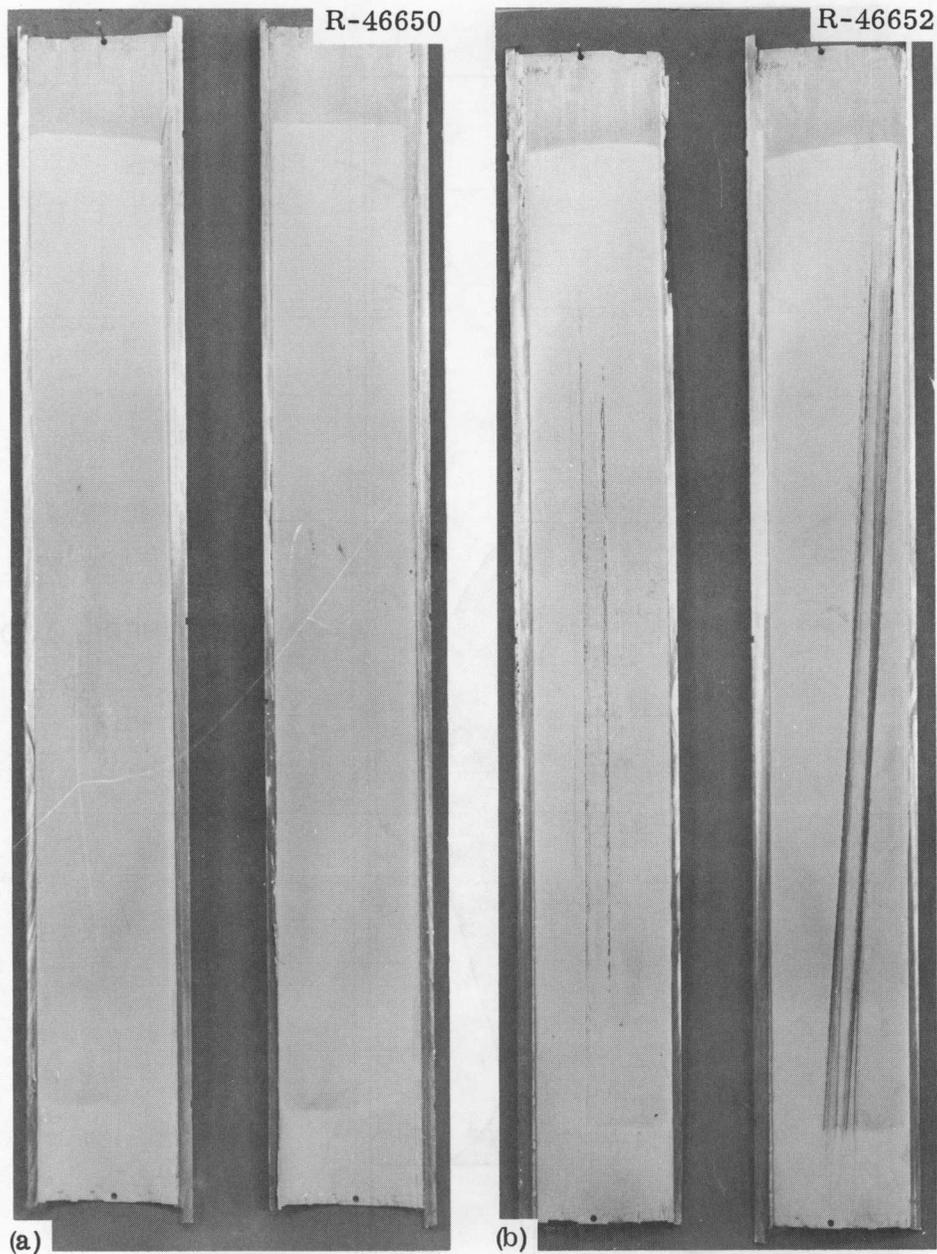
Fig. 15. Typical Appearance of Fuel Plates from HFIR Fuel Element 21-0. The dark, parallel lines on the convex surfaces of these fuel plates are rust stains from sections of a steel tape used as position indicators during disassembly of this fuel element and not an irradiation effect. Approximately one-fourth actual size. Coolant flow is downward. (a) Concave surfaces, inner edge of plates at left. (b) Convex surfaces, inner edge of plates at right.

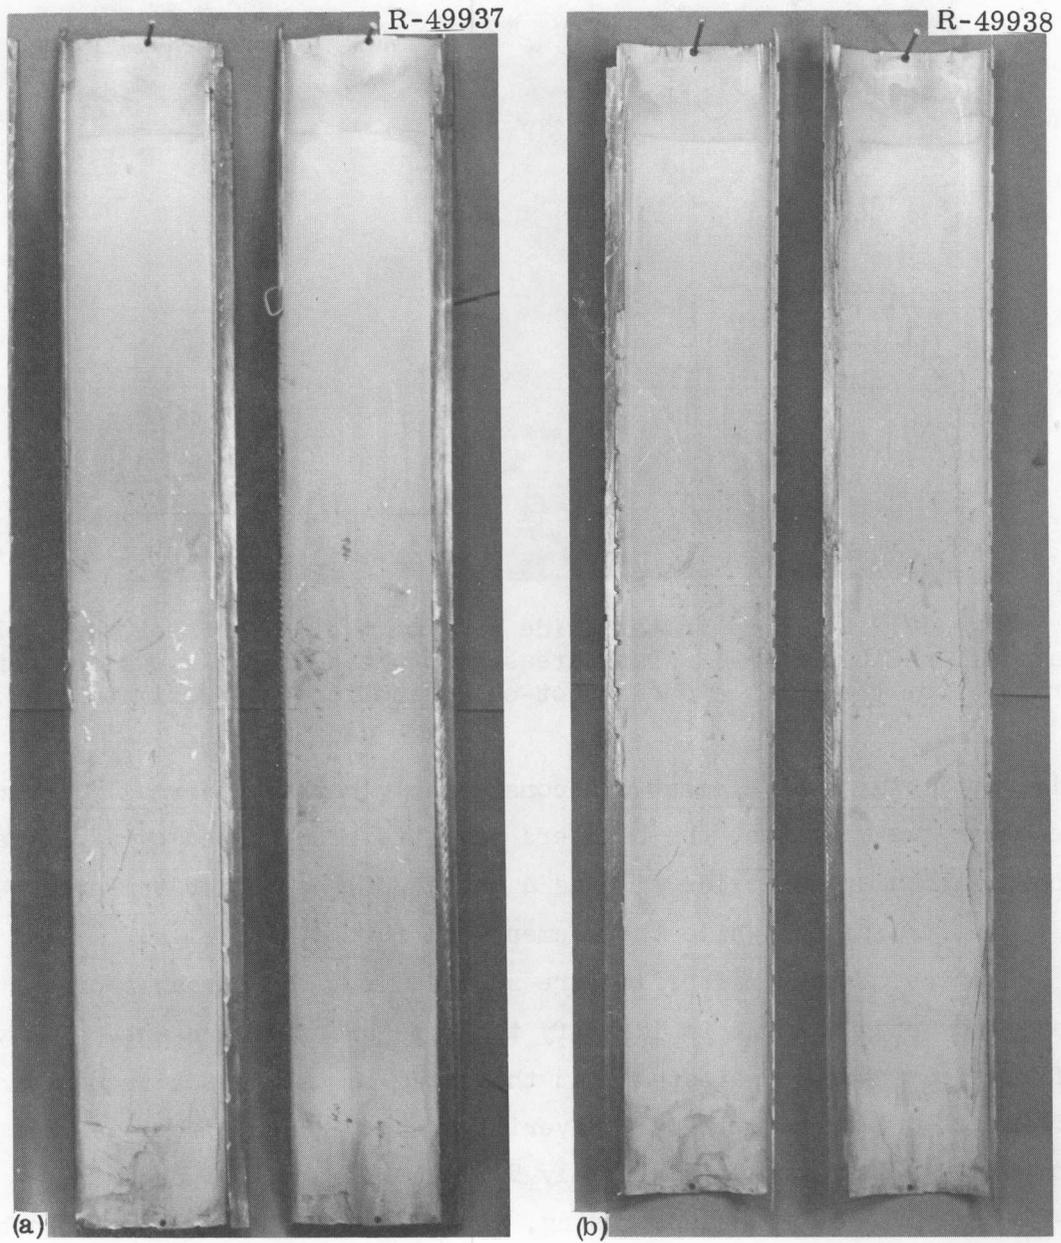
Fig. 16. Typical Appearance of Fuel Plates from HFIR Fuel Element 49-I. Approximately one-fourth actual size. (a) Convex surfaces, inner edge of plates at left. (b) Concave surfaces, inner edge of plates at right.

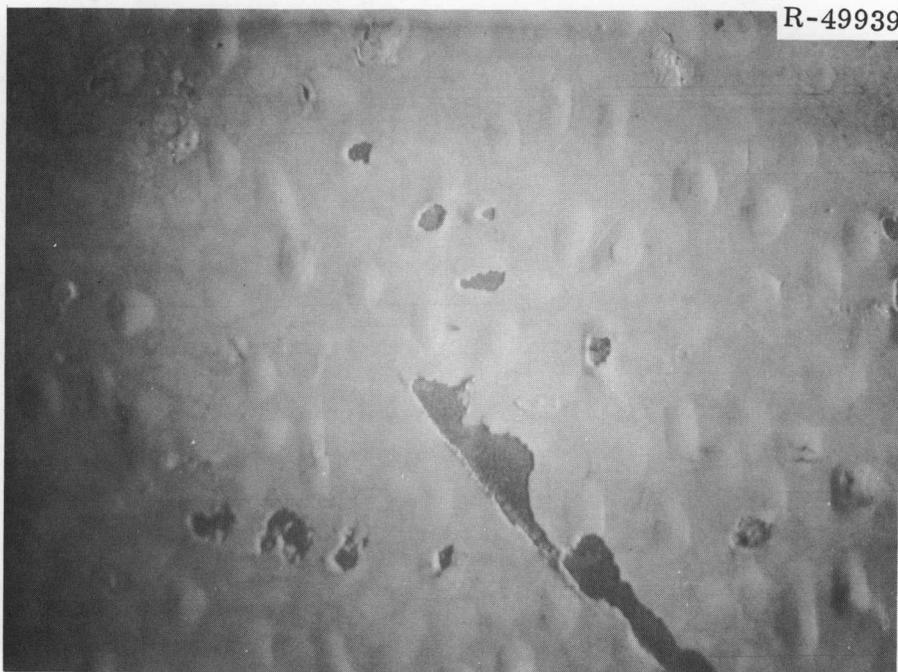
In general, the film on the surfaces of the fuel plates from all three fuel elements appeared to be quite smooth and virtually featureless. However, as shown in Fig. 17, numerous small blisters were observed over the higher performance regions of the fuel plates from element 49-I and confined to the corrosion product film. These blisters were not apparent when this particular fuel element was first examined in the hot cells (i.e., during inspection of the coolant channels); thus, they probably formed sometime later in the examination program. Since

Fig. 17. Blisters in the Oxide Film on the Surfaces of the Fuel Plates from Element 49-I. Dark areas show where the film was accidentally scraped from the surface during hot-cell handling. Approximately 5X.

this particular fuel element was considerably hotter (thermally) than the other two elements, the blisters may have been caused by a partial decomposition of the oxide film as a result of the higher temperatures of these fuel plates while the element was in the hot cells.

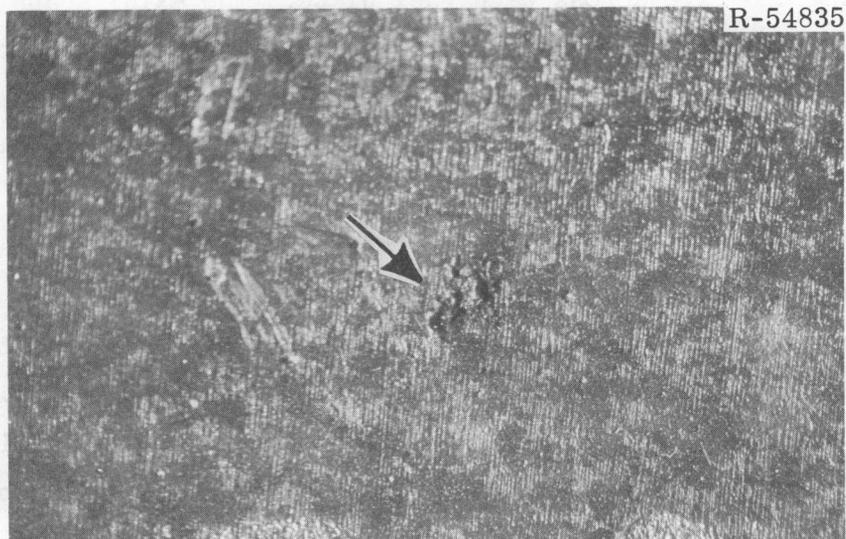
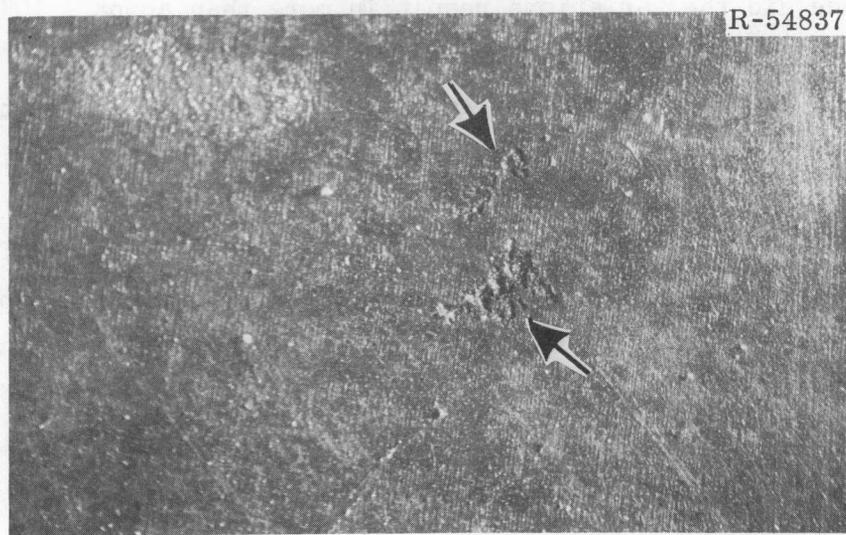
When the oxide films were chemically stripped from the surfaces of some of the fuel plates, we found numerous pits in their cladding (Fig. 18). Although these pits were not deep enough to be cause for alarm, it is perhaps important to note that they were not apparent until the oxide film was removed from the plate surfaces. Thus, pitting of these fuel plates might not have been discovered if the plates had not been chemically defilmed.

Fig. 18. Typical Appearance of Pits Found in the Cladding of the HFIR Fuel Plates after Removal of the Corrosion Product Films. Approximately 20X.

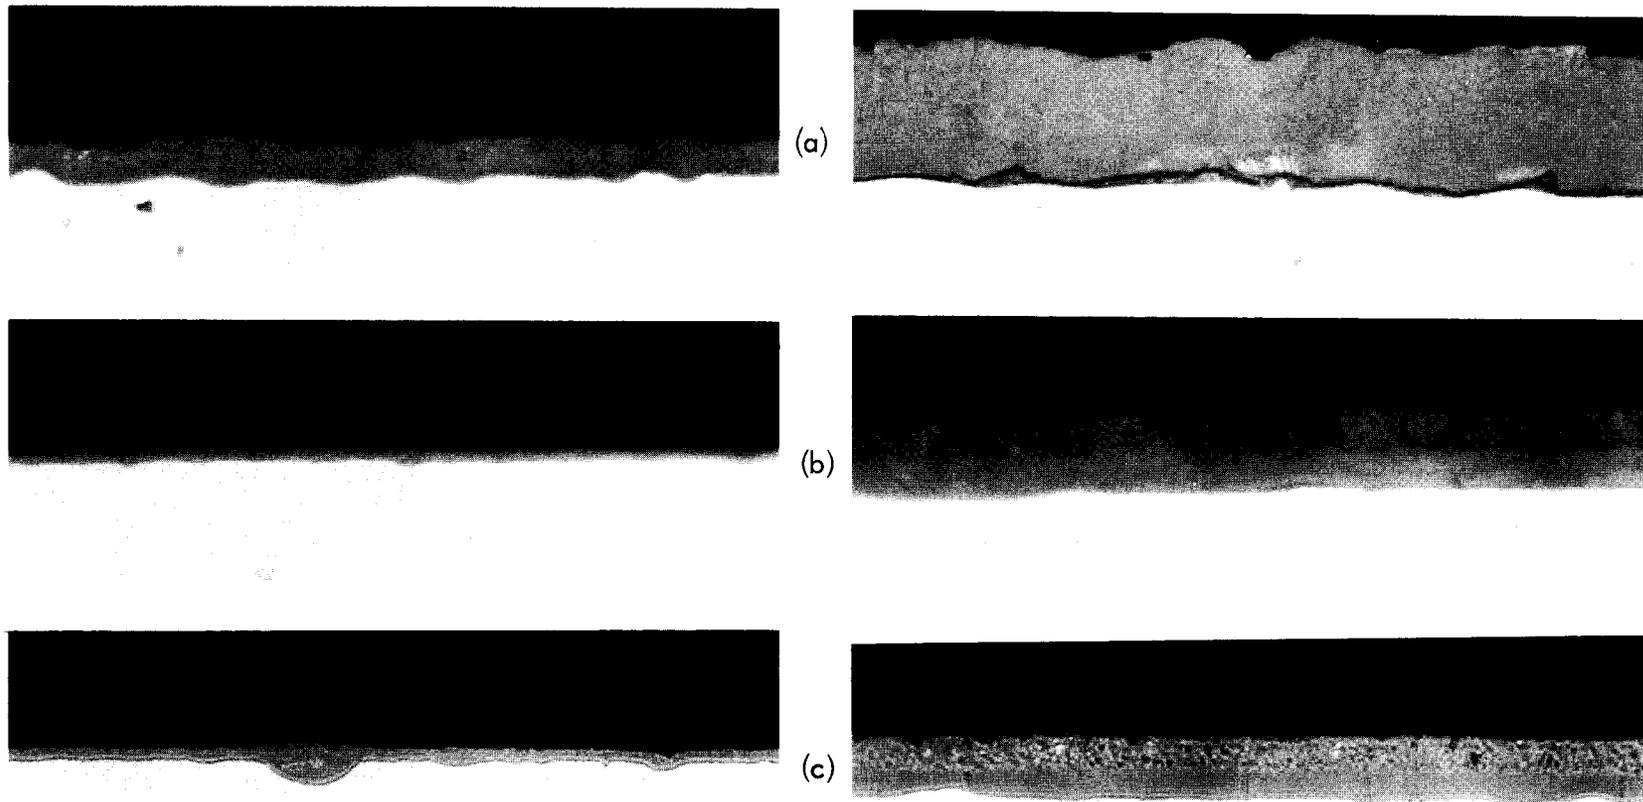
Fig. 28. Comparison of Oxide Films on the Surfaces of the Fuel Plates from HFIR Fuel Elements (a) 5-0, (b) 21-0, and (c) 49-I. These photomicrographs generally show the thinnest (left) and thickest (right) films found in the metallographic examination of a fuel plate from each element. 500X. As polished.

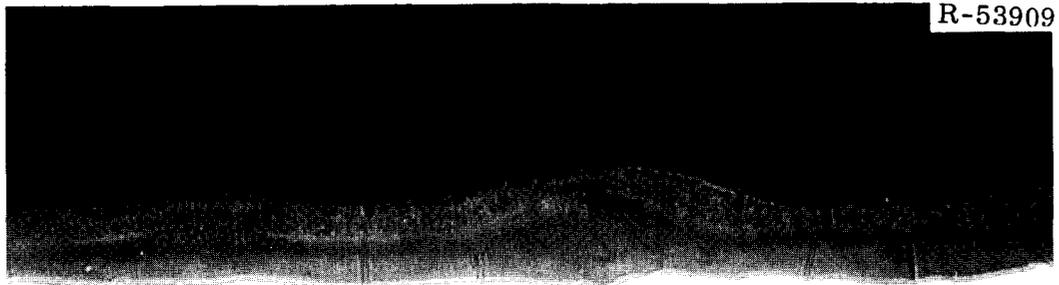
Fig. 29. Typical Blister Found in the Oxide Film on Fuel Plates from HFIR Fuel Element 49-I. 500X. As polished.

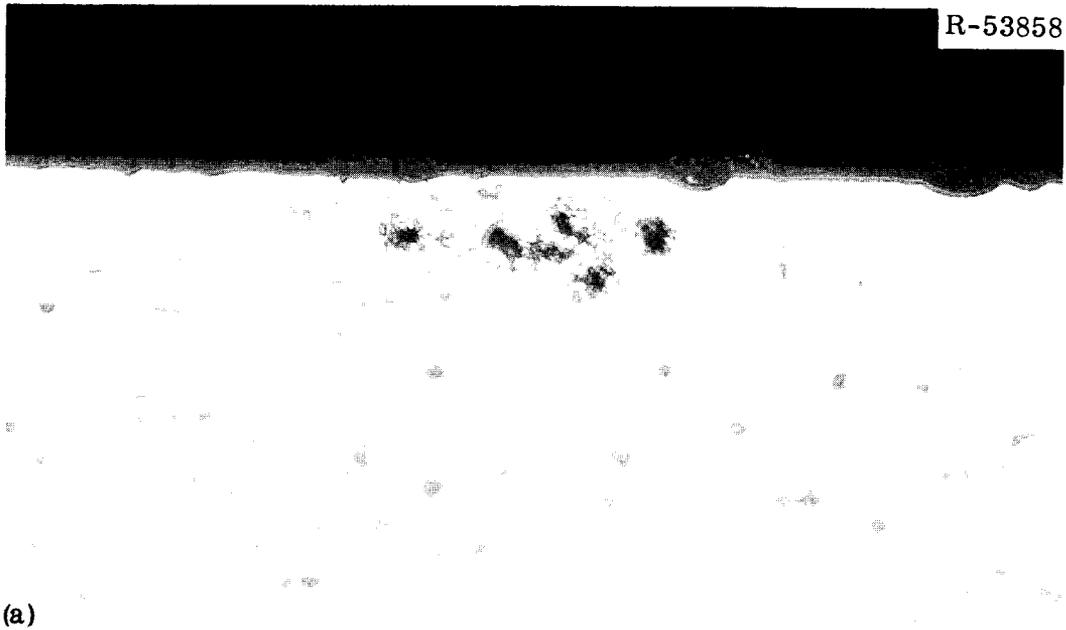
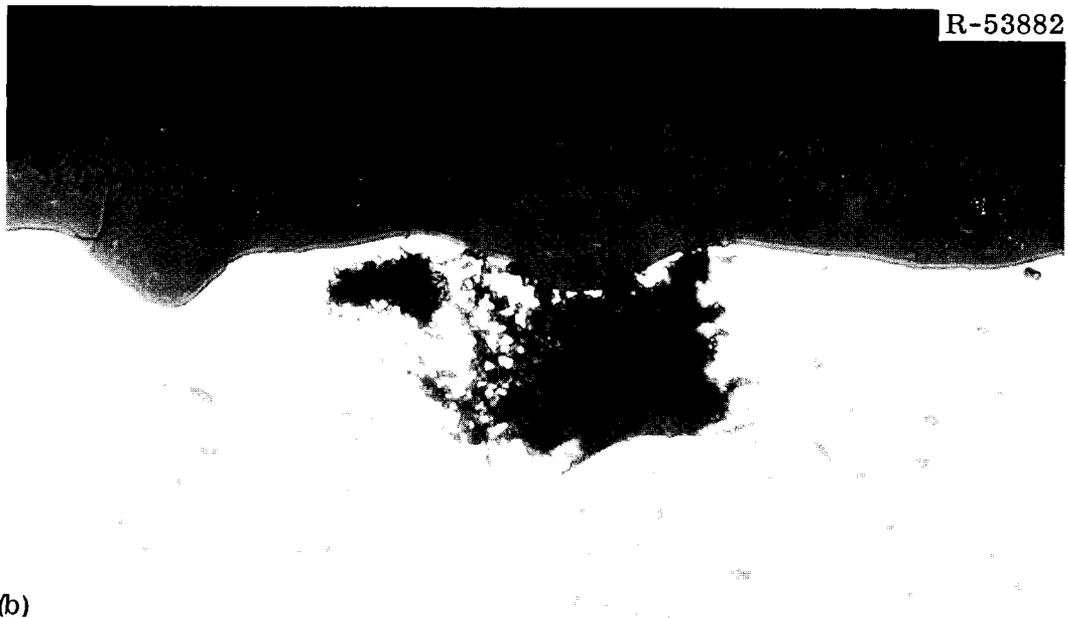
Fig. 30. Microstructural Appearance of Pits Found in the Cladding of the Irradiated HFIR Fuel Plates. 500X. As polished. (a) An early stage of pitting, and (b) fully developed pit.

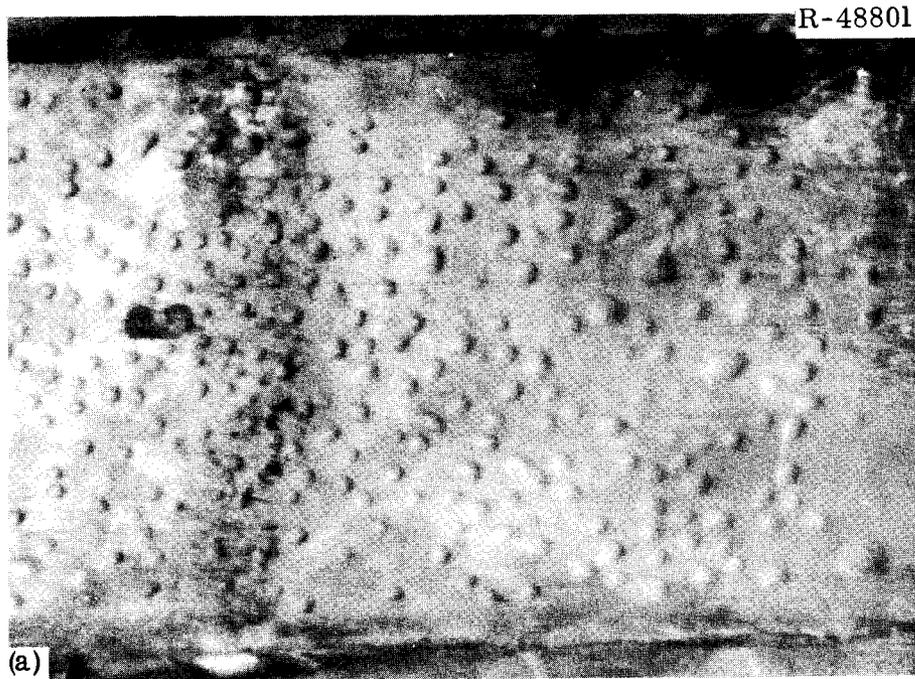
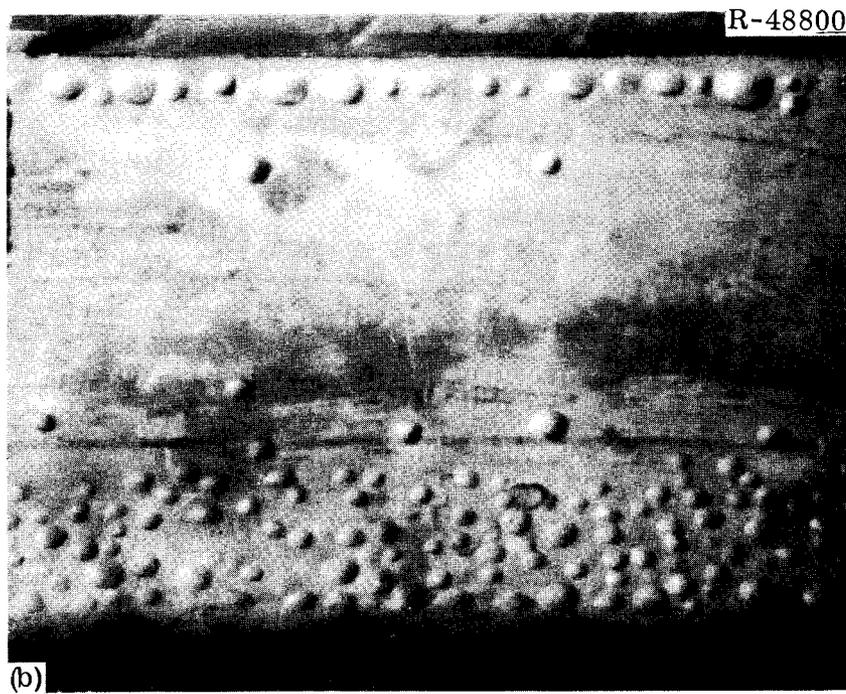
Fig. 36. Sections of an Irradiated HFIR Fuel Plate from Element 21-0 after Heat Treatment for 1 hr at 600°C. (a) Section from upper end of fuel plate. (b) Section from reactor midplane. Approximately actual size.
