ORNL/TM-12033

**ENERGY EFFICIENCY EVALUATION OF THE
HOUSING COMMUNITY PLAN DEVELOPED FOR
SHAW AIR FORCE BASE**

May 1992

Prepared for the
Civil Engineering Squadron
Shaw Air Force Base, South Carolina

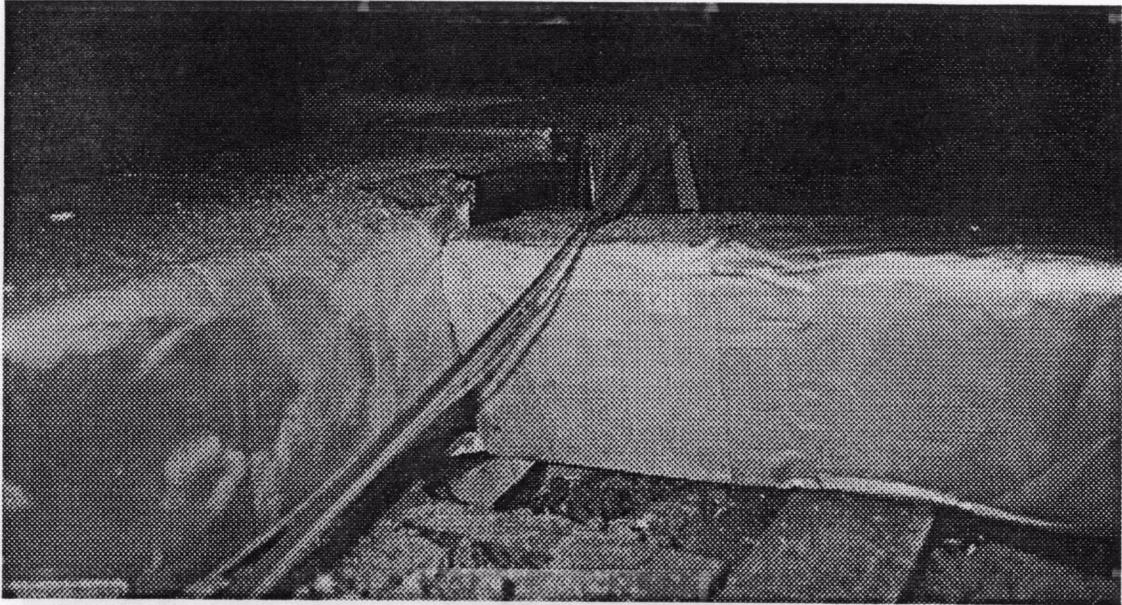
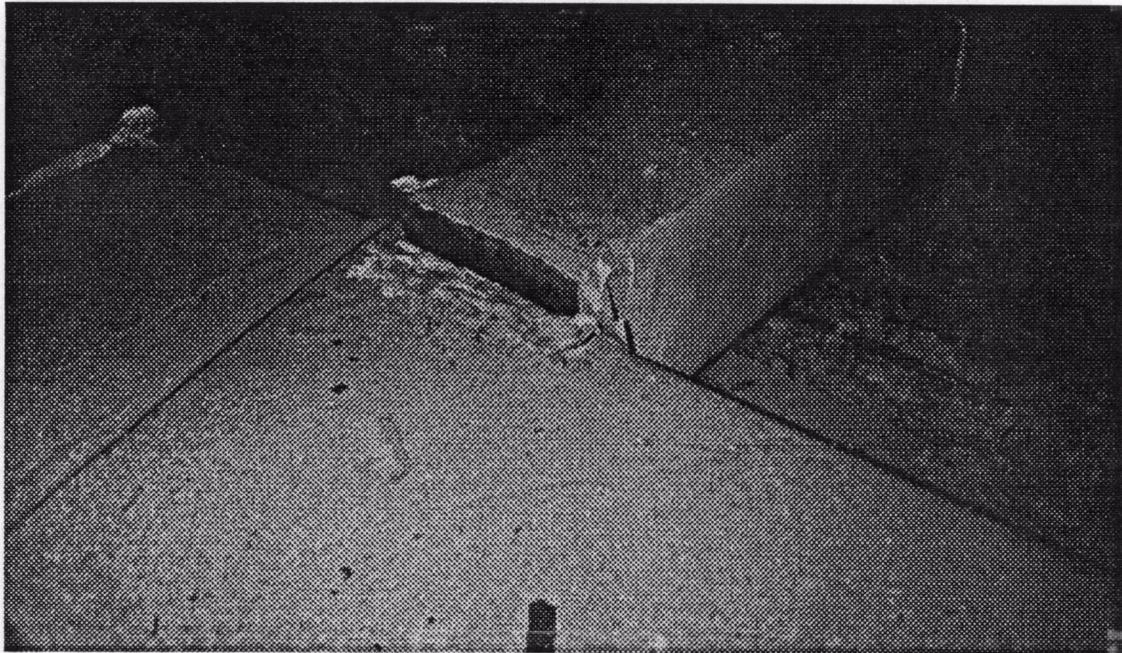
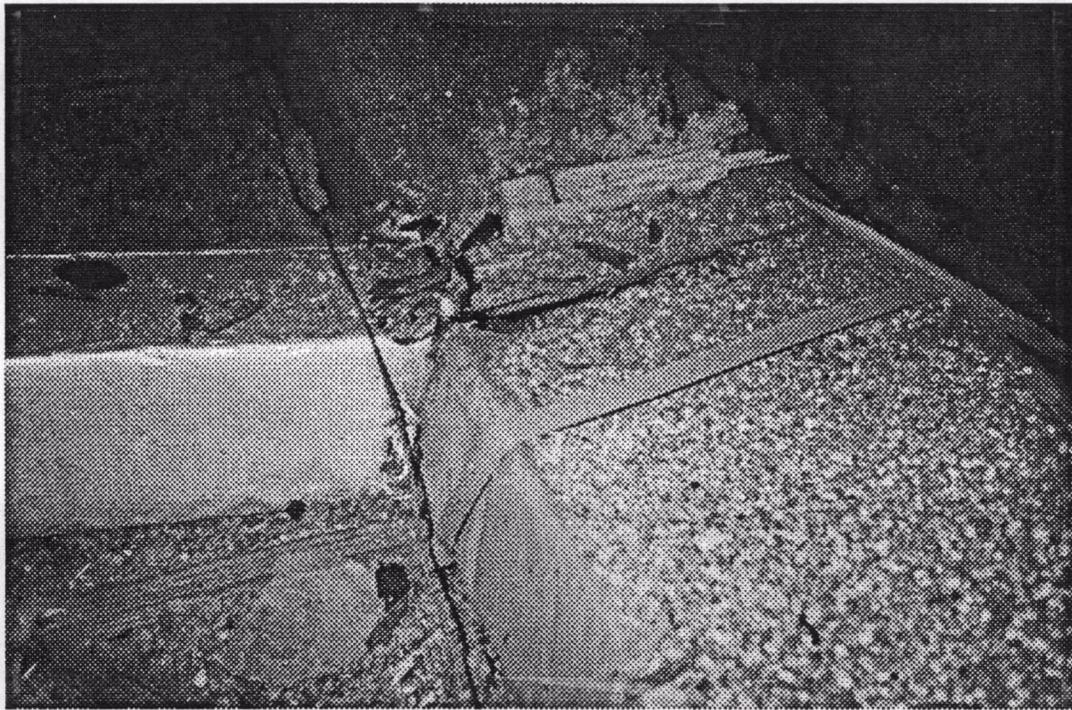
Fig. 2.1. Disconnected supply ducts as found in the attic of unit 4055A.

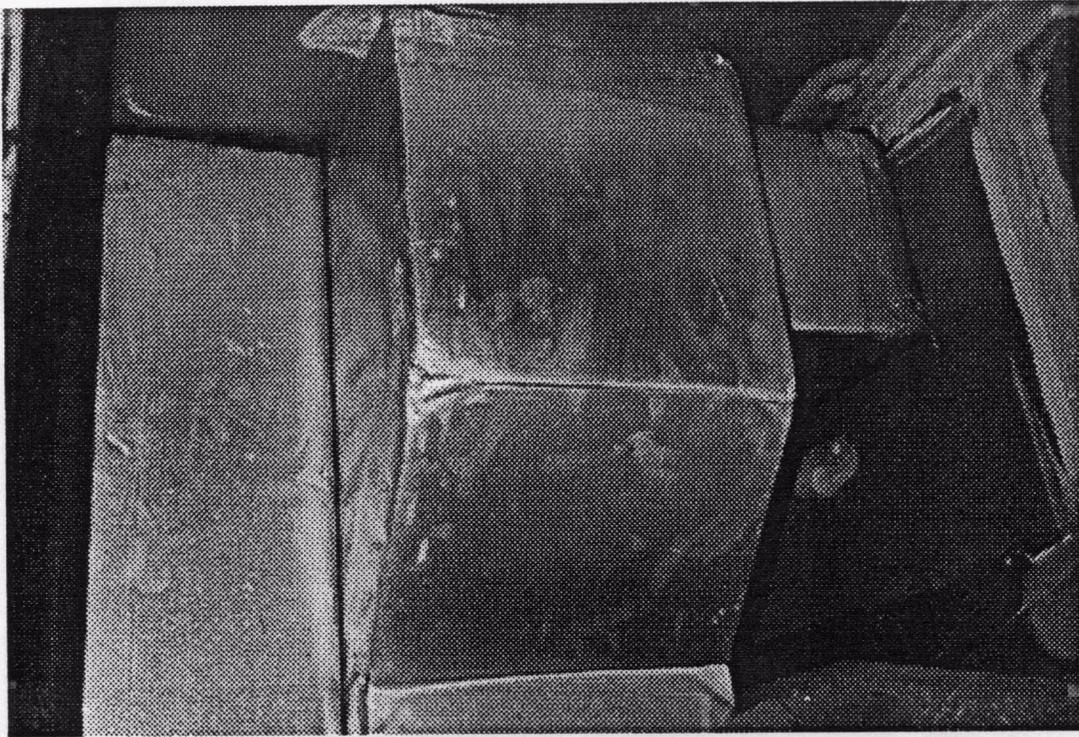
In unit 4073B (the two-story unit), leaks in the supply and return ducts located in the outdoor equipment room were readily apparent using a smoke pencil and with the distribution fan running (see Fig. 2.2). The return leaks caused unconditioned air from the equipment room to be drawn into the distribution system. Because the gas furnace and gas water heater were located in this room, the return leaks could cause flue gases to backdraft and enter the unit. The supply leaks were located in the housing unit, causing air to be blown out the crack around the supply duct where it penetrated the building shell. As shown in Fig. 2.3, duct tape sealing a joint in the supply duct located in the attic was beginning to peel away, creating a supply leak.

Fig. 2.2. Supply and return ducts as found in the outdoor equipment room of unit 4073B. The return duct was located on the left and leaked where the duct butted up to the ceiling of the room. The supply duct entered the housing unit through the wall on the right. With the distribution fan on, air was forced out the cracks around the duct where it penetrated the wall.

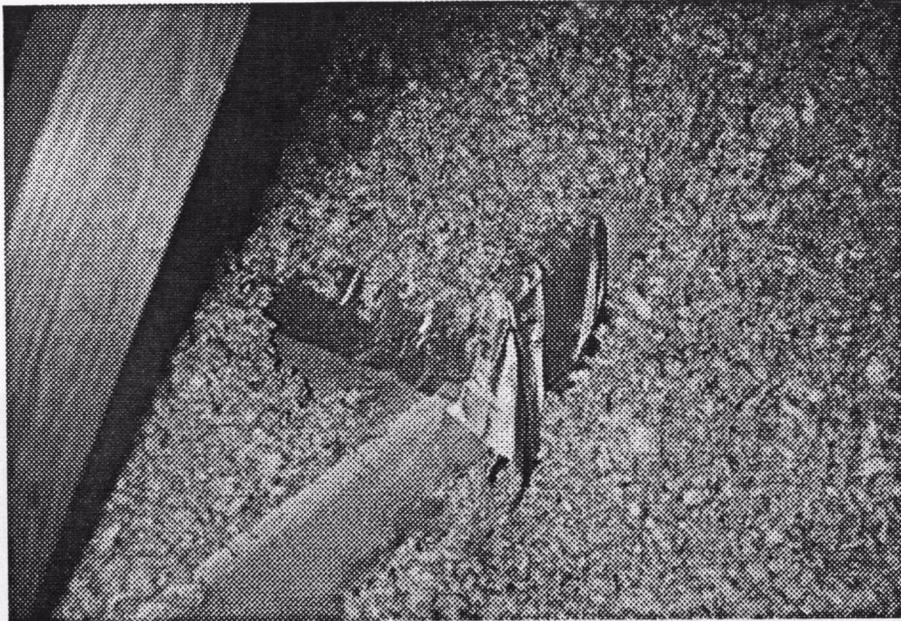
Fig. 2.3. Duct tape sealing a joint in the supply duct located in the attic of unit 4073B was beginning to peel away, creating a supply leak.

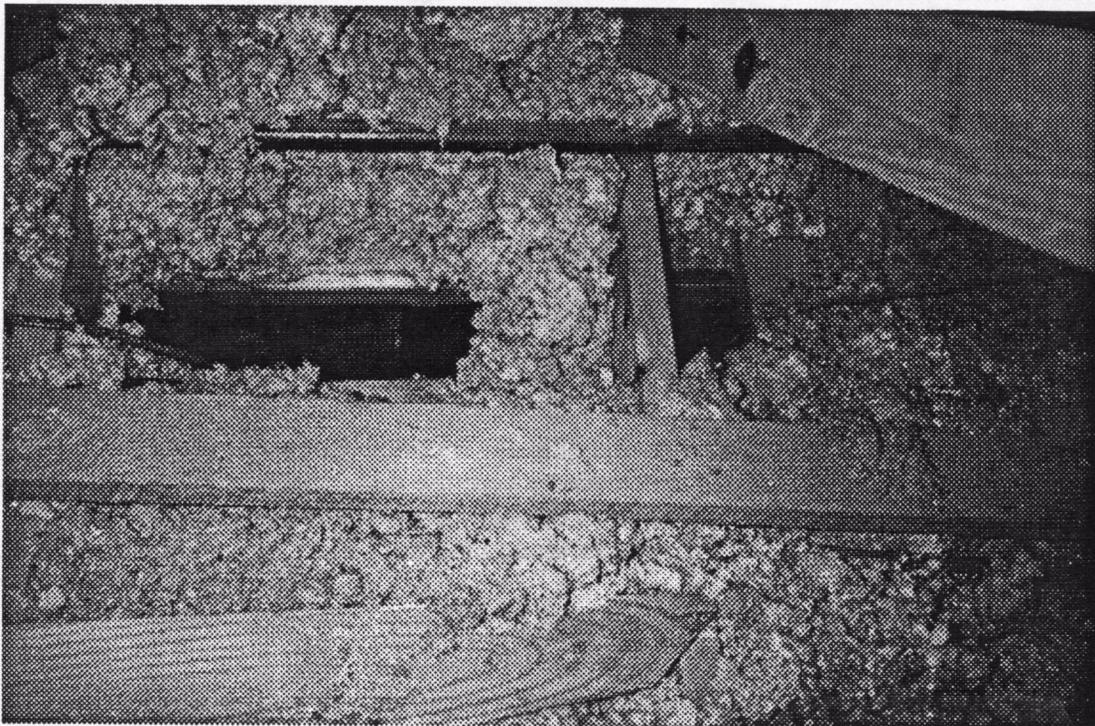
Fig. 2.4. The top of an interior wall in unit 4055A was open to the attic.

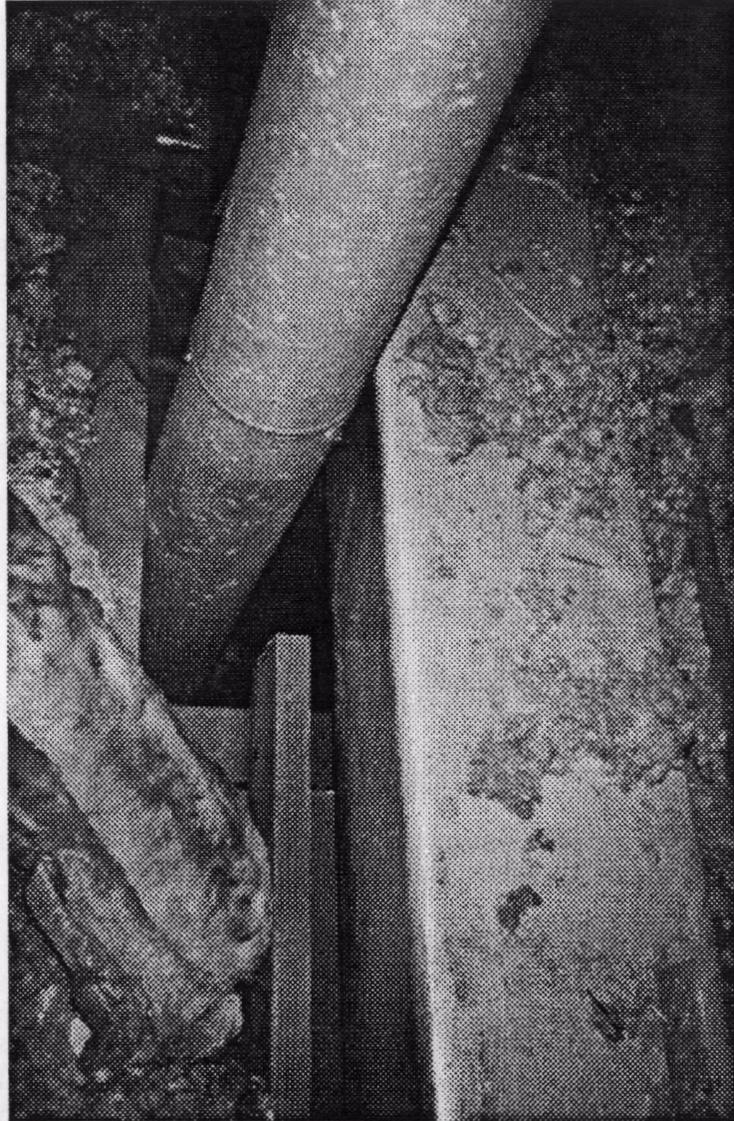
- A passageway (Fig. 2.5), built to allow the supply duct and kitchen exhaust to run from the space between floors to the attic, was not sealed at the attic. This effectively coupled the inside of the unit to the attic, increasing the natural

Fig. 2.5. A passageway built into unit 4073B to allow the supply duct and kitchen exhaust to run from the space between floors to the attic was not sealed.

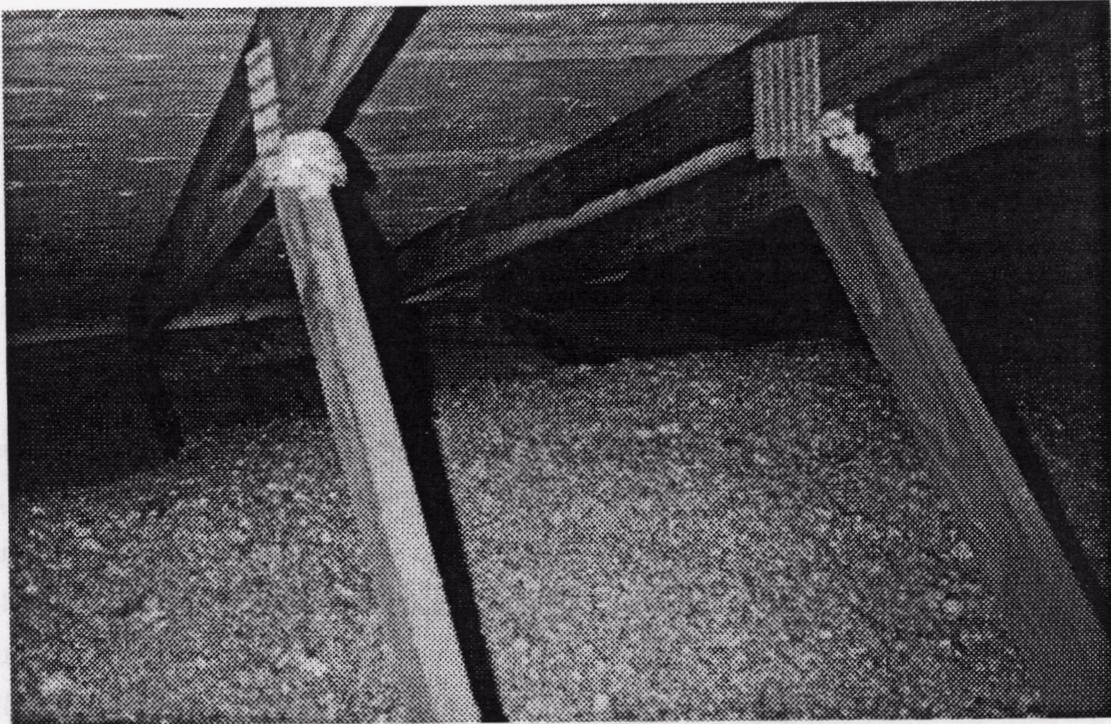
Several problems with the insulation installed in unit 4073B were found. As shown in Fig. 2.6, loose fill attic insulation had been blown into the middle of the attic, leaving the attic floor six feet from the front of the unit uninsulated. This may have occurred due to high winds generated from hurricane Hugo. Both the front and rear second-story overhangs had no floor insulation; these floors were directly exposed to ambient conditions and were likely leaky. The attic floor under and around the attic supply ducts was not always insulated. The insulating blanket installed on the water heater was falling off, rendering it ineffective (Fig. 2.7).

Fig. 2.6. Loose fill insulation in the attic of unit 4073B had been blown away from the edge, leaving a portion of the attic floor uninsulated.

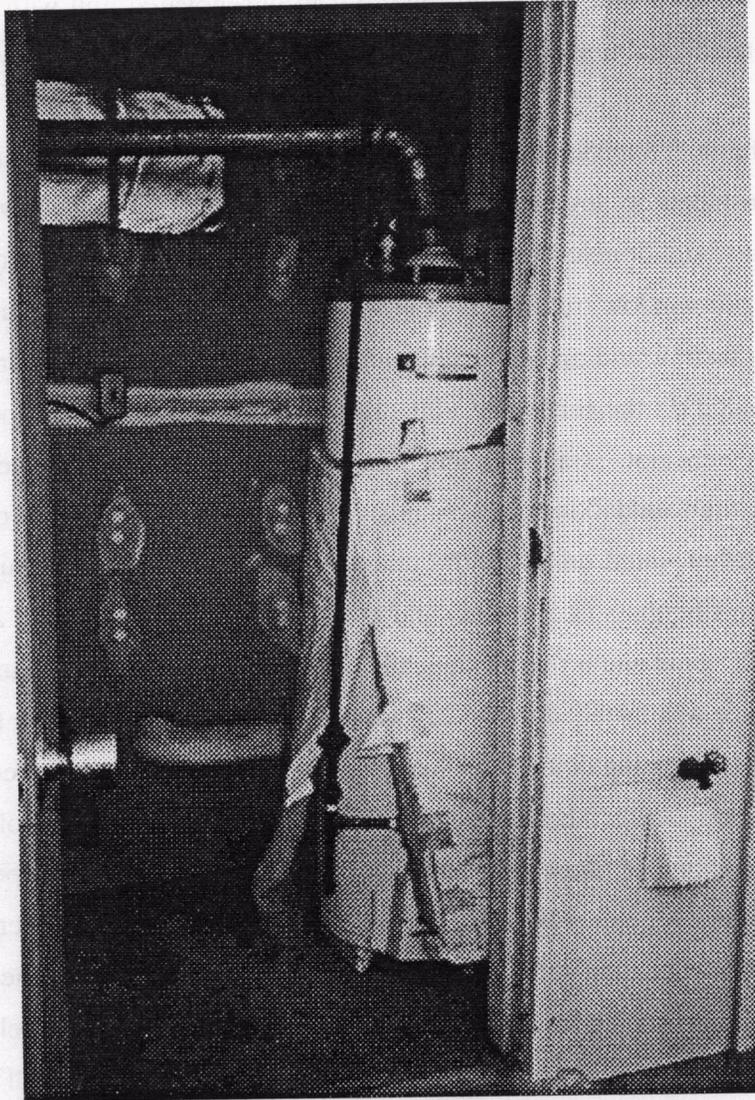
Fig. 2.7. The insulating blanket installed on the water heater of unit 4073B was falling off.

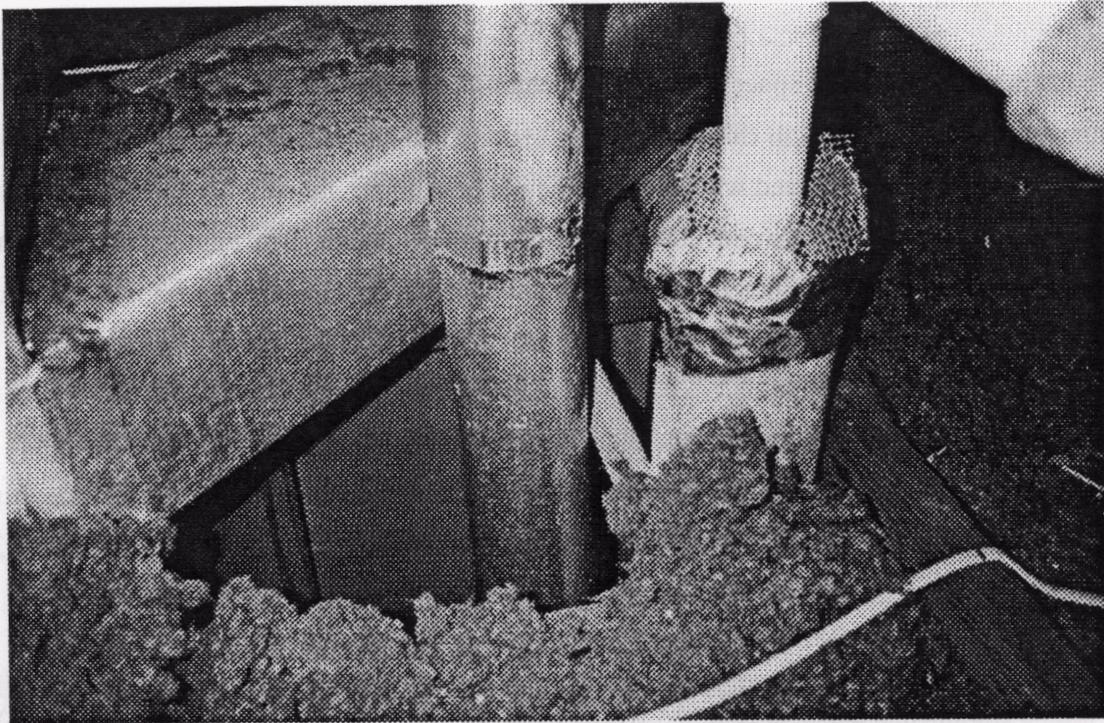
- A passageway (Fig. 2.8) allowed the gas furnace flue, combustion-air pipes, and supply duct to extend through the second story of the unit to the attic. This passageway was not sealed at the attic. A similar bypass was also found in unit 5429B.
- With the installation of the condensing furnace, a plastic flue pipe (with about a 2.5-inch diameter) was installed. The new flue was run inside the previous flue pipe (with about a 6-inch diameter) to the attic and out the roof, but the space between pipes was not sealed at either end (see Figs. 2.8 and 2.9).
- A pipe (with about a 6-inch diameter) was installed between the attic and interior equipment room to provide combustion air to the gas furnace (see Fig. 2.9). As discussed in Sect. 2.2, this pipe served as an attic bypass when the furnace was not operating.

Fig. 2.8. A passageway built into units 5174B and 5425A allowed the gas furnace flue, combustion-air pipe, and supply duct to extend from the first floor to the attic. This passageway was not sealed at the attic. A new plastic flue pipe was run inside the old flue pipe to the attic. A screen was placed over the annulus area to prevent insects from entering the house, but the opening was not sealed.

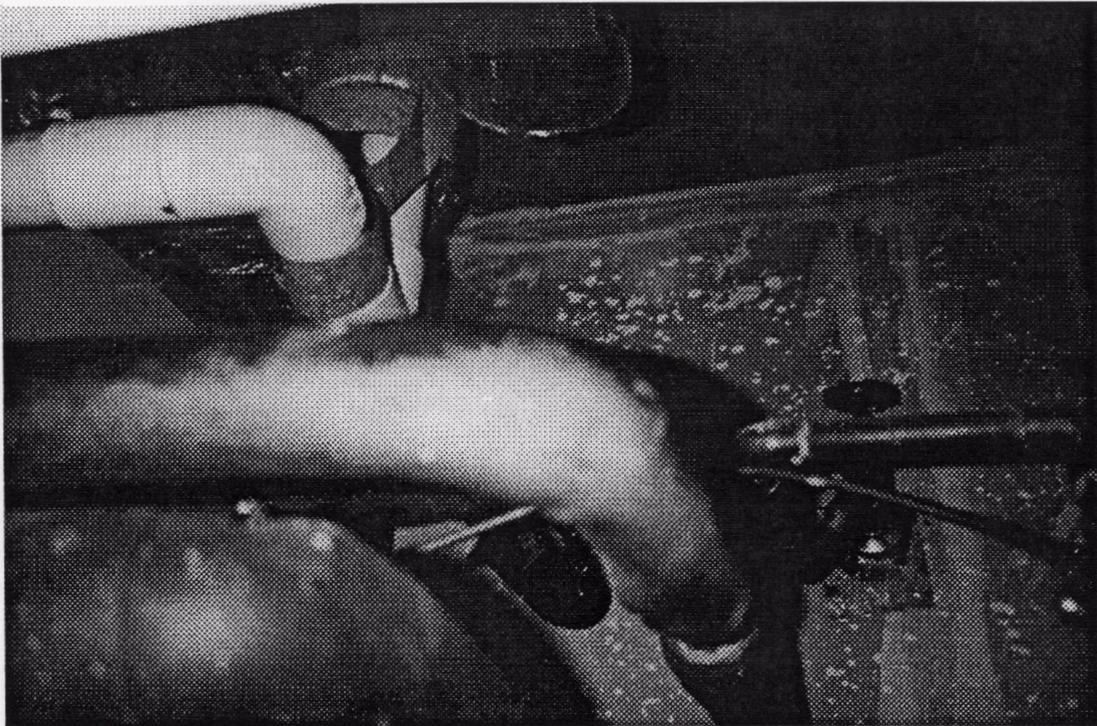
Fig. 2.9. In units 5174B and 5425A, a plastic flue pipe was run inside the old flue pipe (seen in the upper portion of the figure). A combustion-air pipe was also present (next to the plastic flue pipe).

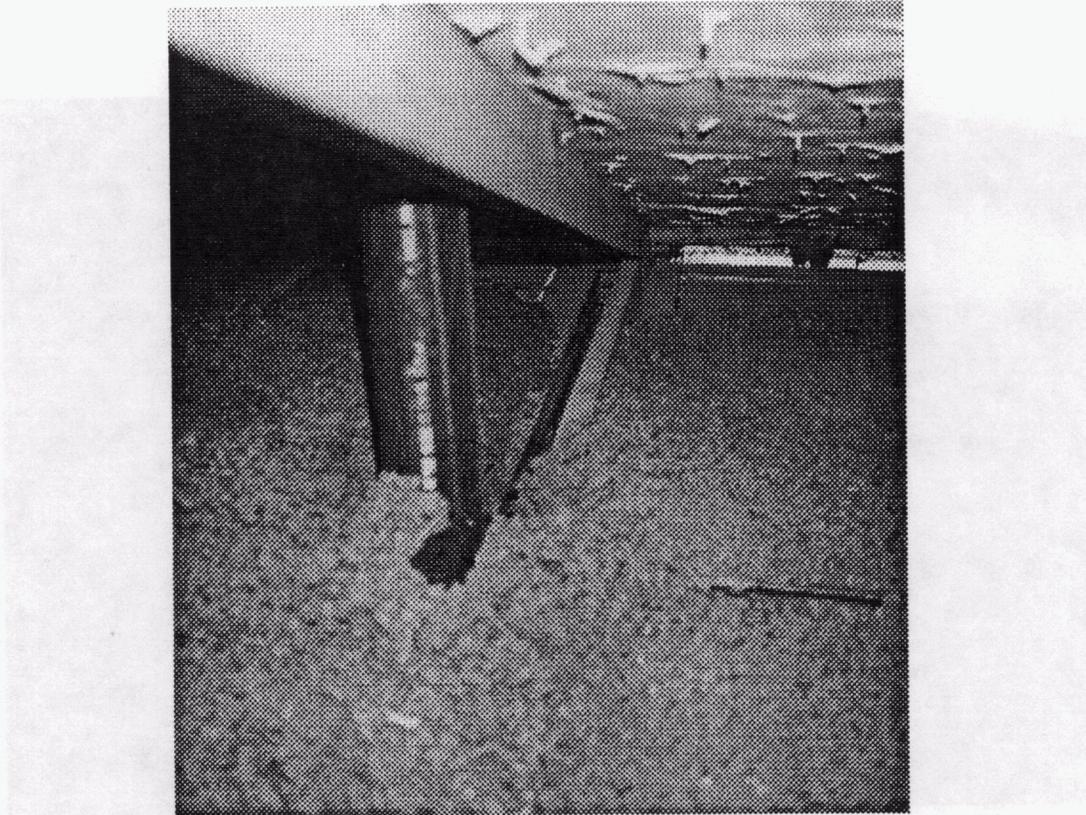
Fig. 2.10. In units 5174B and 5425A, a second floor interior wall was open to the attic and a plumbing vent rose through this space.

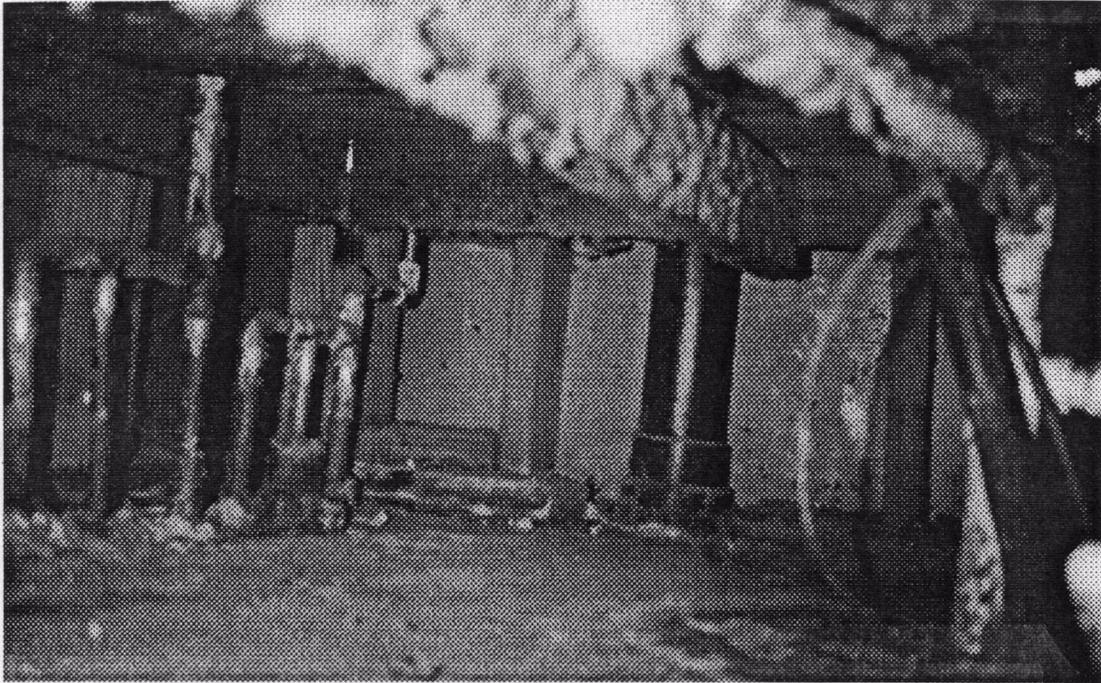
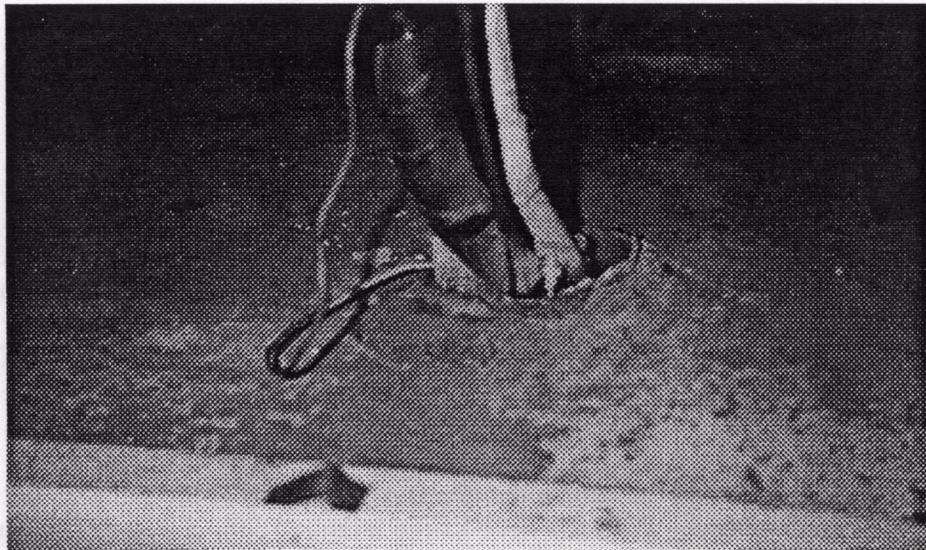
- The return plenum of each unit was connected to the attic and/or outside by the interior walls used to form the plenum, gaps around plumbing running through the plenum, and a pipe used to run refrigerant and condensate lines outside to the condensing unit (see Figs. 2.11a-b). Operation of the distribution fan (which

Fig. 2.11. The return plenum of units 5174B and 5425A was connected to the attic and/or outside by the interior walls used to form the plenum (no dry wall was installed on the plenum side of the studs as shown in Fig. 2.11a), gaps around plumbing running through the plenum, and a pipe used to run refrigerant and condensate lines outside (Fig. 2.11b).

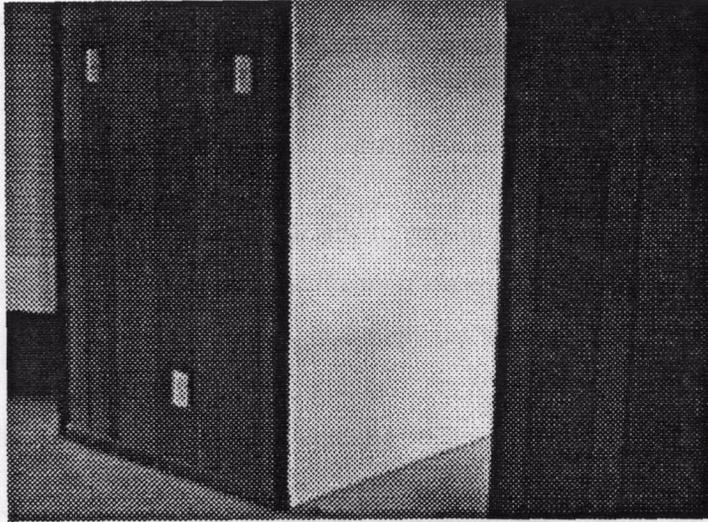
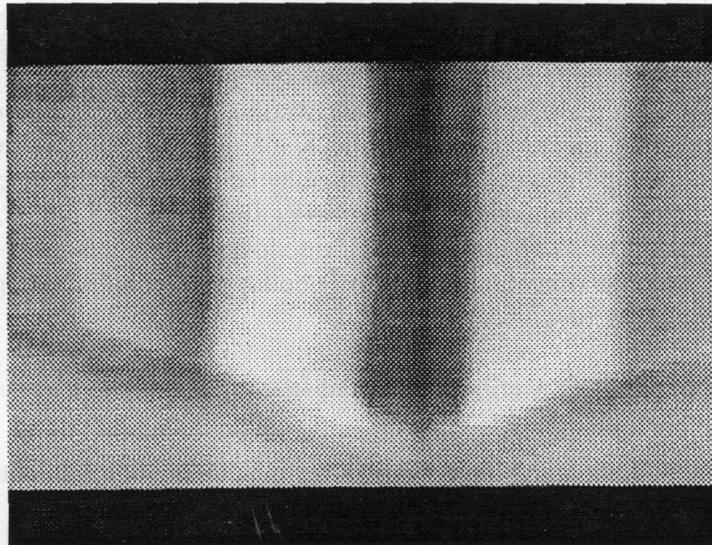
- Conditioned air recirculated directly back to the return plenum in the two units because of the open wall cavities described above. The condensing furnace was an upflow model with an A-coil installed on top. Conditioned air exiting the A-coil directly entered a small supply plenum above it. Ducts then directed conditioned air from the supply plenum to outlet registers. The supply plenum was formed using two of the same interior walls as the return plenum. One cavity in each of these walls was open in the supply plenum (there was no drywall on the plenum side of the wall studs), allowing air to circulate from the supply plenum, down the wall cavity, and into the return plenum. Photographs taken with an infrared camera demonstrate this in Fig. 2.12.
- Air filters in both units were very dirty.

Fig. 2.12. The interior equipment room is behind the two walls shown in Fig. 2.12a. A supply plenum was at the top of the room and a return plenum below. With the system operating in the heating mode, the infrared picture (Fig. 2.12b) shows hot air flowing down a stud cavity in each wall (white indicates a hot surface).
