**MICROSTRUCTURAL EXAMINATION OF V-4Cr-4Ti PRESSURIZED TUBES - D. S. Gelles, M. L. Hamilton, and R. J. Kurtz (Pacific Northwest National Laboratory)\***

**SUMMARY**

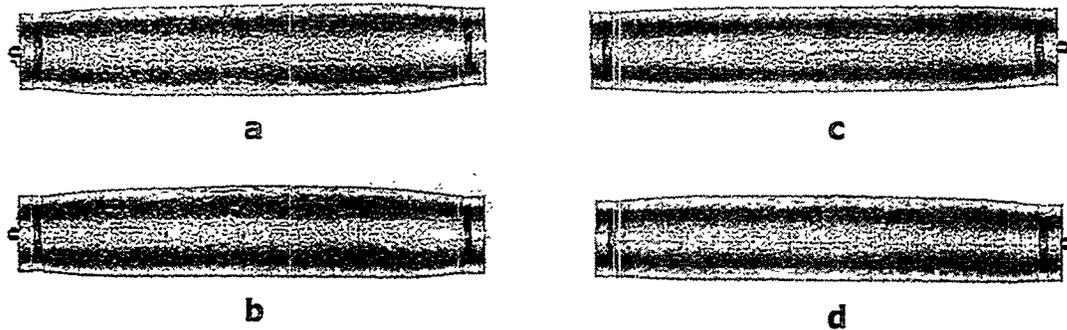
Photographs of tubes AR18 and AR19 using OM are shown in Figures 1a, and b, and c, and d, respectively. The tubes have been oriented to show the likely failure sites in the center of the tube in a) and c) and at the top of the tube in b) and d). Tubes are 27.4 mm in length. In both cases failure appears to be due to formation of a longitudinal crack.

Figure 1. Failed pressurized tubes AR18 in a) and b) and AR19 in c) and d) shown with the likely failure site face-on at the top and rotated towards the top at the bottom.

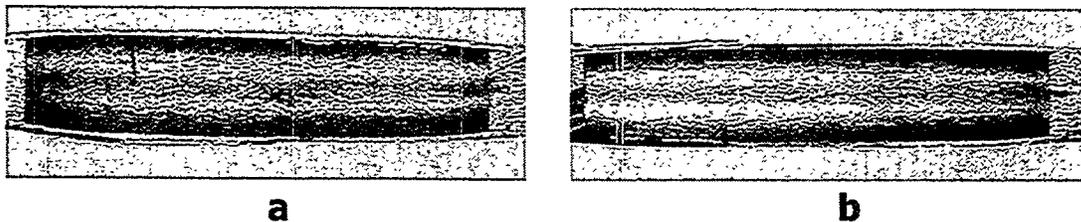
The tubes were then sectioned in order to examine the failure sites from the inside of the tube. Photographs of the inner surfaces of the same specimens are provided in Figure 2, further illustrating the longitudinal failure.

Figure 2. Failed pressurized tubes AR18 and AR19 showing the inner wall in the vicinity of the likely failure site for AR18 in a) and for AR19 in b).

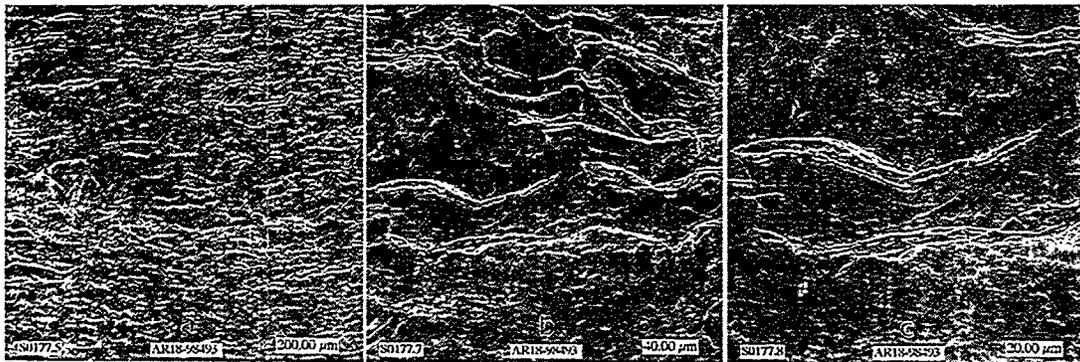
SEM examination failed to conclusively identify the failure sites. The inner surfaces of specimens AR18 and AR19 were examined, and selected images are provided in Figures 3 and 4 that correspond to the photographs in Figure 2. From the low magnification examples in Figures 3 and 4, a number of fine longitudinal cracks can be identified. In each figure sequence, an area within the low magnification image has been enlarged in order to show surface features in greater detail. However, it cannot be demonstrated that these are through-thickness cracks.

Figure 3. Surface features found on specimen AR18 at the failure location

Creep measurements using pressurized tube techniques are inevitably limited by the quality of the tubing used. Figures 3 and 4 reveal a number of small longitudinal defects and figure 5 indicates that where large strains have occurred, strain can be very non-uniform, showing that surface defects probably played a role in strain localization. SEM investigations also revealed larger inner surface defects such as radial scratches or gouges, but those examples are not included in this report because they apparently did not play a role in failure. It is therefore possible that failure to observe steady state creep response during biaxial thermal creep testing of V-4Cr-4Ti could be a consequence of internal surface defects. Also, rupture times can be expected to be underestimates for bulk material. Nonetheless, the quality of the tubing used is demonstrably adequate to provide good estimates for bulk thermal creep properties.

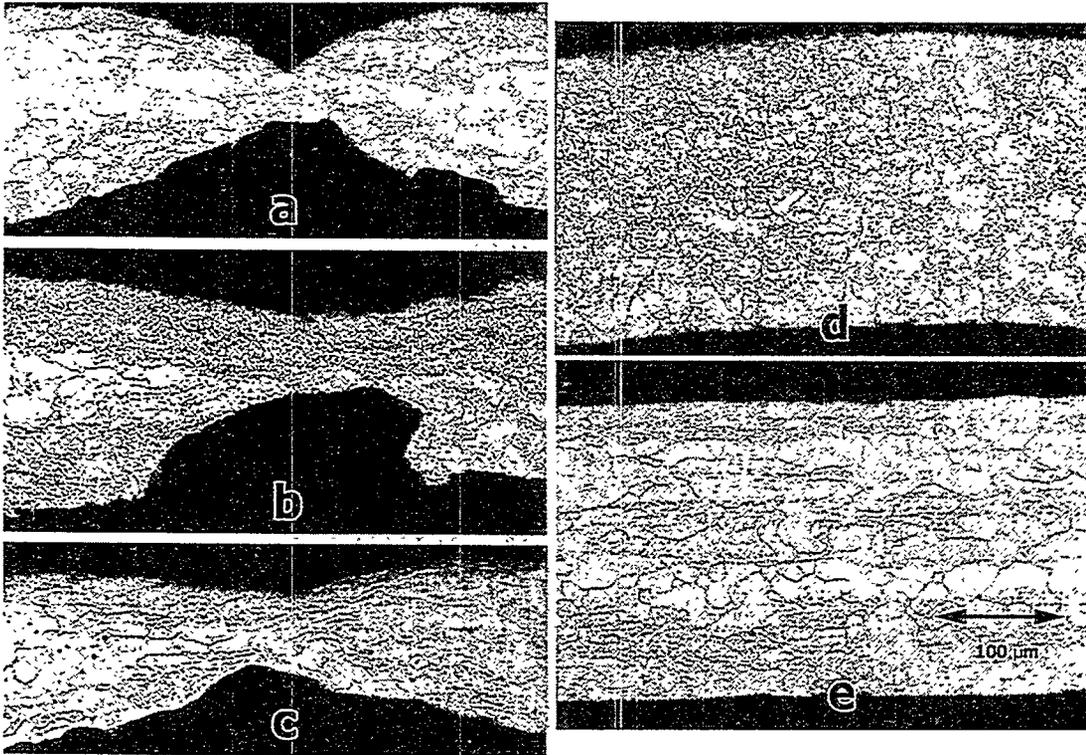
Metallographic sections were then prepared in order to locate through-thickness cracks. Examples are provided in Figure 5 showing regions in specimens AR15, AR17 and AR19 that contain areas that have been reduced in wall thickness between 60 and 75%. Figure 5 also includes transverse and longitudinal examples of unthinned sections of specimen AR17. From Figure 5, examples of grain elongation can be identified in each of the thinned sections, indicating that strain within grains reached high levels in comparison to grains in unthinned regions. Figure 5e) illustrates the bimodal distribution in grain size present in the tubing, i.e., the existence of a group of large grains interspersed with smaller grains.

Figure 5. Optical metallographic examples of thinned sections of specimens AR15, AR17 and AR19 with unthinned transverse and longitudinal sections of specimen AR17 provided for comparison.

Figures 5 b) and e) can be interpreted to indicate that oxidation occurred on the outer surface of specimen AR17 during testing. Unfortunately, the dark banding on one side of the tube is believed due to staining, a metallographic artifact. This can be corroborated based on oxygen content measurements. An unpressurized control specimen in the 800°C furnace beside the pressurized tubes contained 59.8 wppm N and 733 wppm O. Therefore, the increase in the oxygen content was on the order of 30% over the levels after fabrication of 560 wppm.<sup>2</sup> Also, calculations indicated that oxygen penetration for the relevant time and temperature should be on the order of 2000  $\mu\text{m}$ , approximately ten times the thickness of the stain.

The microstructures found following thermal creep indicate that strain is controlled by dislocation climb. This is confirmed by the elongated grain structure shown in figures 5 a), b) and c) and in
