CONDENSATION IN FLAT ROOF SPACES: TWO CASE HISTORIES

J.W. Warren

CASE HISTORY I

CASE HISTORY II

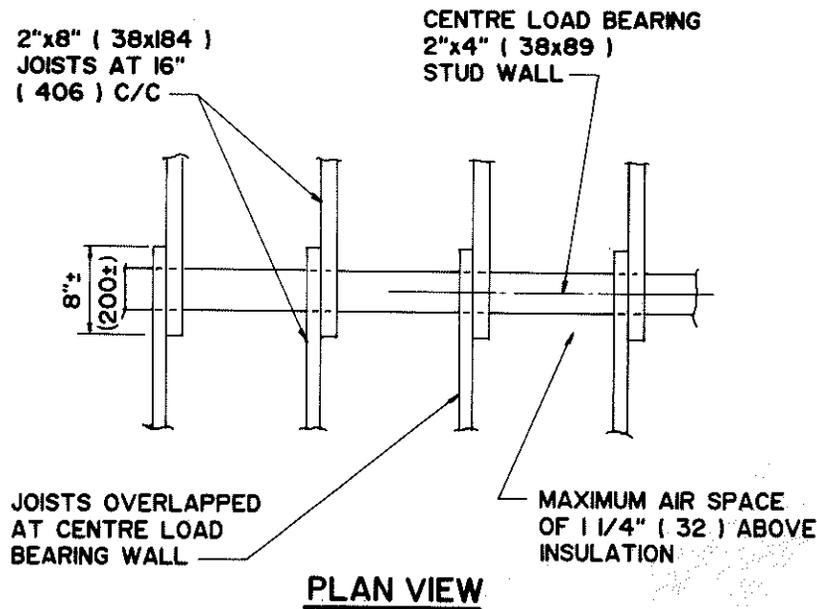
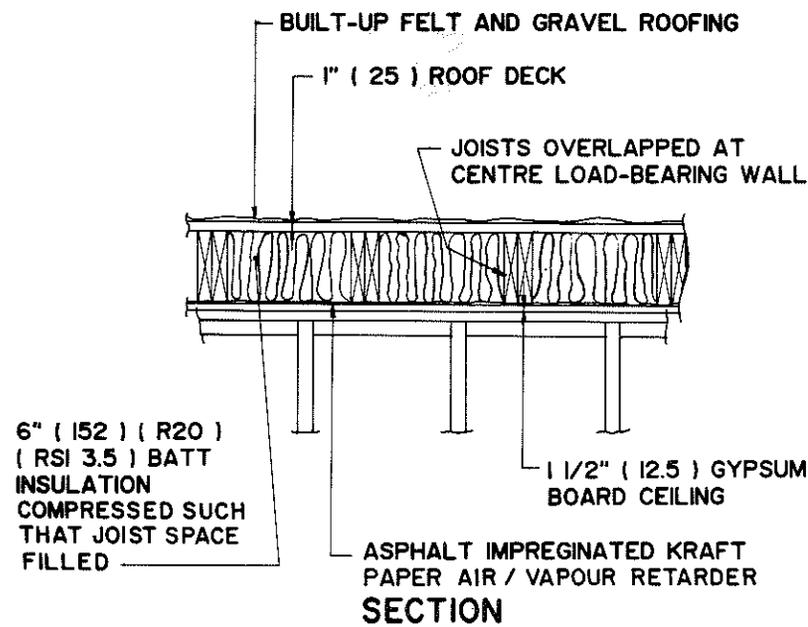
Figure 1. Condition at center load-bearing wall

All units are flat roofed with a cedar shake mansard extending approximately half-way down the top floor at all exterior walls. The original wood roof structure consisted of built-up felt and gravel roofing over 1 in (25 mm) decking; the decking was in turn supported by 2 x 8 (38 mm x 184 mm) joists spaced at 16 in (406 mm), which ran between each unit's exterior and center load-bearing walls. Suspended from the joists' soffit was a 1/2 in (12 mm) gypsum board ceiling. Above this ceiling and wedged between the joists was 6 in (150 mm) fiberglass insulation to provide the required R-20 (RSI-3.5) insulation value. The air/vapor retarder was an asphalt-impregnated kraft paper bonded to the underside of the batts. This air/vapor retarder was overlapped and stapled to the underside of the joists. No vents were provided on the roof. The roof structure's configuration and the condition at the center load-bearing wall is shown diagrammatically on Figure 1.

7. The air gap between the insulation and the roof deck was blocked at all center load-bearing walls. This had resulted from the 14½ in (370 mm) wide insulation being squeezed into a 13 in (330 mm) width since the roof joists are lapped at this location. This condition effectively blocks the ventilation of the entire roof structure, notwithstanding the fact that the mansard vents are also inadequate.

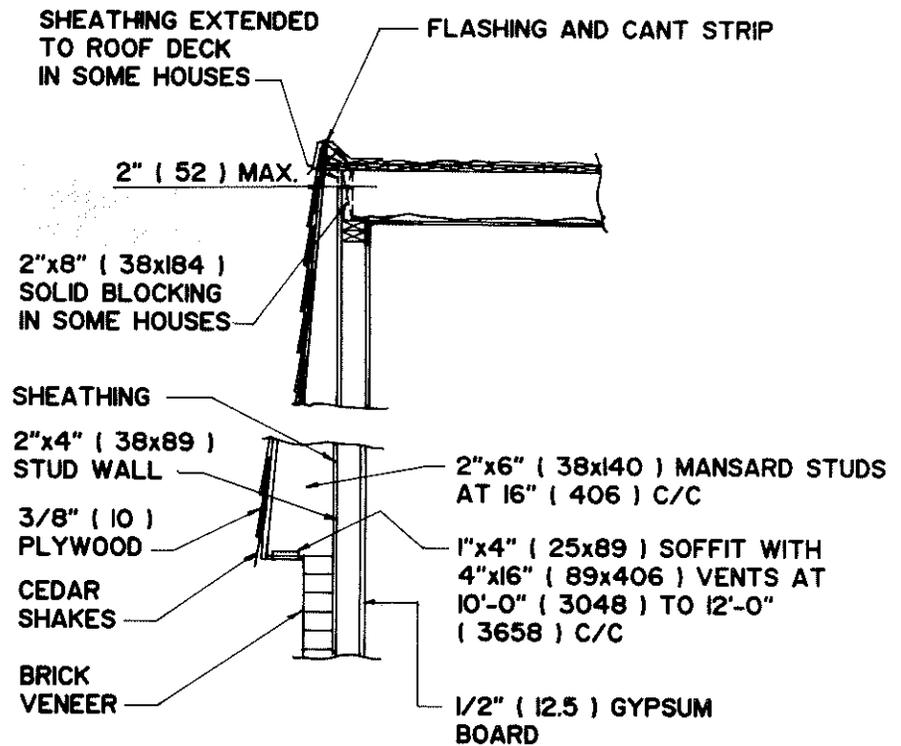
Figure 2. Condition at eave

Venting of the above roof structure was supposedly accomplished through connection front and rear with the mansards. The mansard itself consisted of shaped and tapered 2 x 6 (38 mm x 140 mm) studs spaced at 16 in (406 mm). At the bottom of the mansard, the studs were the full 5 1/2 in (140 mm) in depth and rested atop the brick veneer. At the top the studs were only approximately 1 in (25 mm) in depth. The mansard face was finished with cedar shakes over 3/8 in (10 mm) plywood attached to the studs. Along the bottom of the mansard, a 1 x 4 (20 mm x 89 mm) soffit board was installed with 4 in x 16 in (102 mm x 406 mm) vents placed therein at approximately every 10 to 12 ft (3 to 3.7 m) along the building's length. Nominally these vents would have provided a venting ratio of approximately 1 in 500 had they been effective. In most units the mansard was interrupted front and rear by third floor windows. Between the windows there were short unvented portions of the mansard. The configuration at the eave and at the soffit is shown in Figure 2.

8. Where accessible for inspection, the air gap at the eaves between the insulation and the roof deck and between the insulation and the mansard sheathing was found to be open and unblocked.

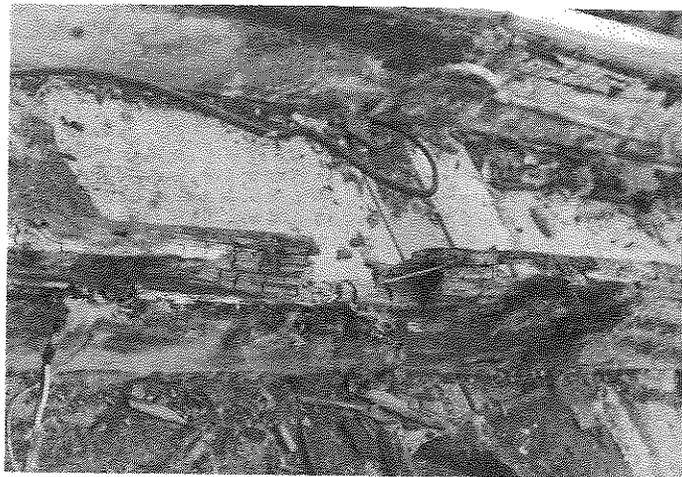
Figure 4. Severely decayed roof joist

Examples of the deterioration found during execution of the subsequent repairs are shown in Figures 4 and 5.

A total of 283 new joists were installed. This represents about 10% of the total number of existing joists. Approximately 8% of the total roof insulation was replaced. Wherever deterioration had occurred, the roof boards were always more severely decayed than the roof joists. Further, the decay in the joists began near the top of the members and worked down toward their soffits.

Of the two-fold intent of this repair philosophy, the assurance of structural integrity was the easier to achieve. In brief, wherever roof joists' capacity had been wholly or partially lost through decay, then that lost capacity was restored by provision of additional joists. (A similar approach was adopted for assurance of the repaired house's thermal insulating capacities). Since the provision of adequate ventilation was also part of the repair philosophy, removal of decayed joists was not necessary. Ventilation would reduce the moisture content of the wood below the 15% to 20% required for continuing fungal attack. As this required inspection and evaluation of all joists and the entire area of insulation, it was obvious that complete removal and replacement of either the ceiling or the roof deck would be necessary. To prevent damage to the units' interior, because headroom restrictions prevented a lowering of the ceiling, and because major portions of the roof deck were known to be decayed, the upper surface emerged as the candidate for total replacement.

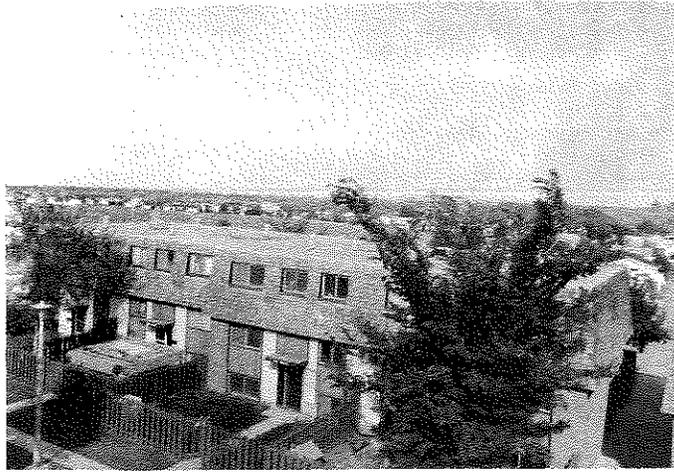
Figure 9. Typical elevation and roof after retrofit

This residential complex, as shown in Figure 9, is approximately 20 years old, is located in Alberta, and consists of 32 two-story townhouse units in four buildings. Each building is approximately 36 feet (11.0 m) wide by 110 feet (33.5 m) long. Each building consists of eight units with a flat mansard roof, and each unit has party walls on each of either two or three sides. The grounds consist of a car park, sidewalks, and landscaped areas. On-site observations confirmed that the originally constructed roof structure consists of a gypsum board ceiling, 2 x 8 (38 mm x 184 mm) timber joists, 1 x 6 (20 mm x 140 mm) roof deck boards, 3/4 in (20 mm) extruded polystyrene and four ply builtup roofing (BUR). There is no air/vapor retarder. Exterior walls consist of lower story brick masonry end walls with a combination of brick, stucco, glazing, and timber infill panels on the side walls. The upper story consists of a cedar shake mansard on all four sides with windows on side elevations only.

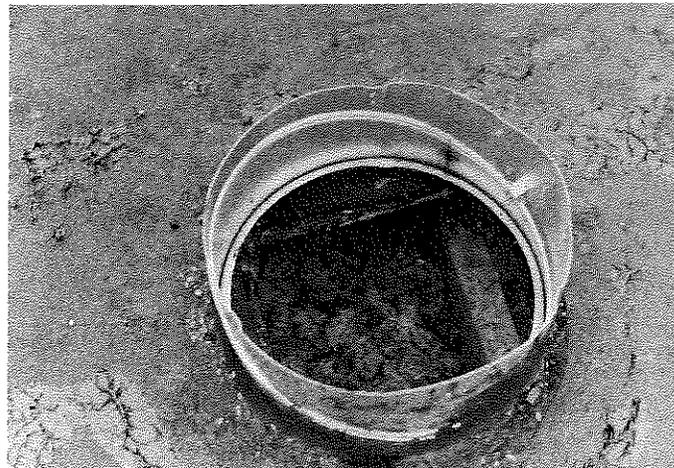
Figure 11. Typical view of joist space through ventilation stack

- 2 in x 8 in (38 mm x 184 mm) wood joists with loose, blown, mineral wool insulation filling the spaces between these
 - gypsum board ceiling
5. No evidence of polyethylene or any other kind of air/vapor retarder was found in the construction, either above or below the roof joists. However, the condition of the existing timber comprising the roof joists and roof deck was very good and did not exhibit any significant structural deterioration or decay. A typical view within the joist space is shown in Figure 11.

Given that the cost of providing effective ventilation was prohibitive, the engineering consultant recommended to the owner that the mineral wool insulation in the joist space and the ventilators be removed to restore the roofs to their original configuration.

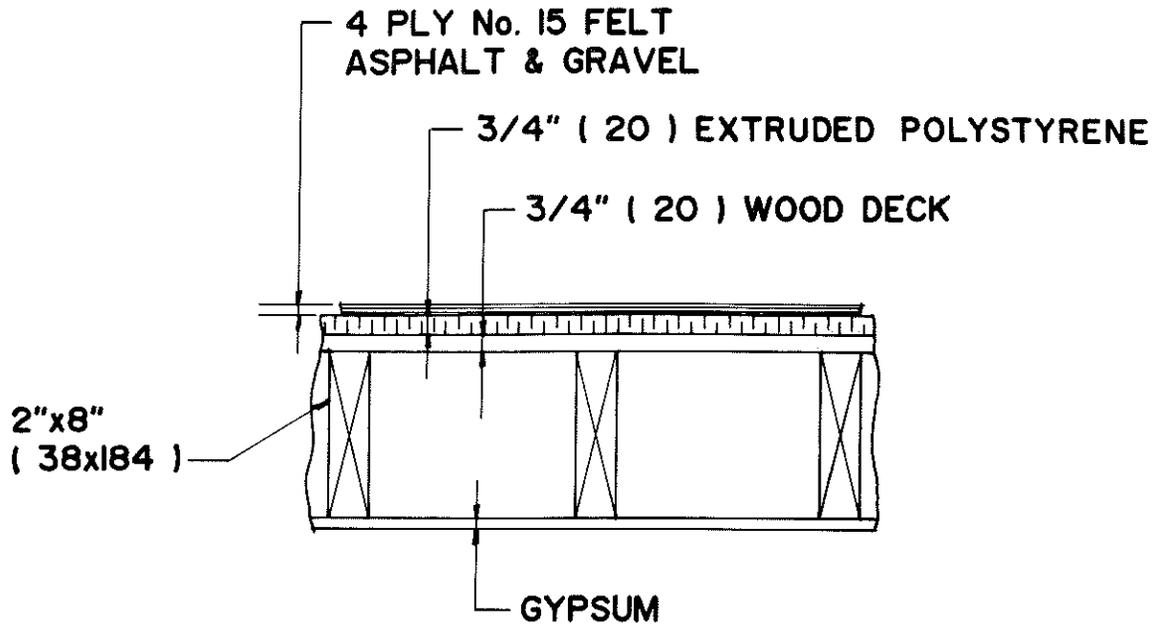
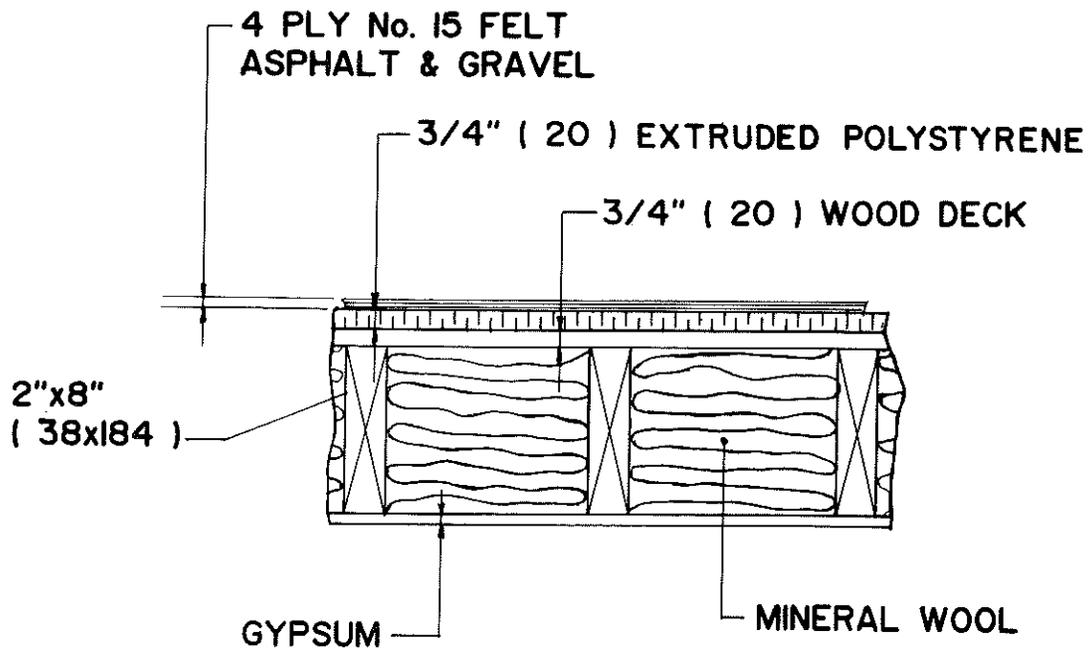
Figure 12. Roof cross section

Figure 12 shows the roof cross sections and Tables 1 and 2 show the temperature gradients before and after retrofit. These demonstrate that the temperature of the lower surface of the timber deck can be expected to be lowered during winter conditions from about 42 °F (6°C) to about -10 °F (-23°C) by the addition of insulation in the joist space. Condensation, particularly in the absence of an effective air/vapor retarder, is inevitable.
