THE SPOKANE WALL INSULATION PROJECT: A FIELD STUDY OF MOISTURE DAMAGE IN WALLS INSULATED WITHOUT A VAPOR BARRIER

G.A. Tsongas, Ph.D., P.E.

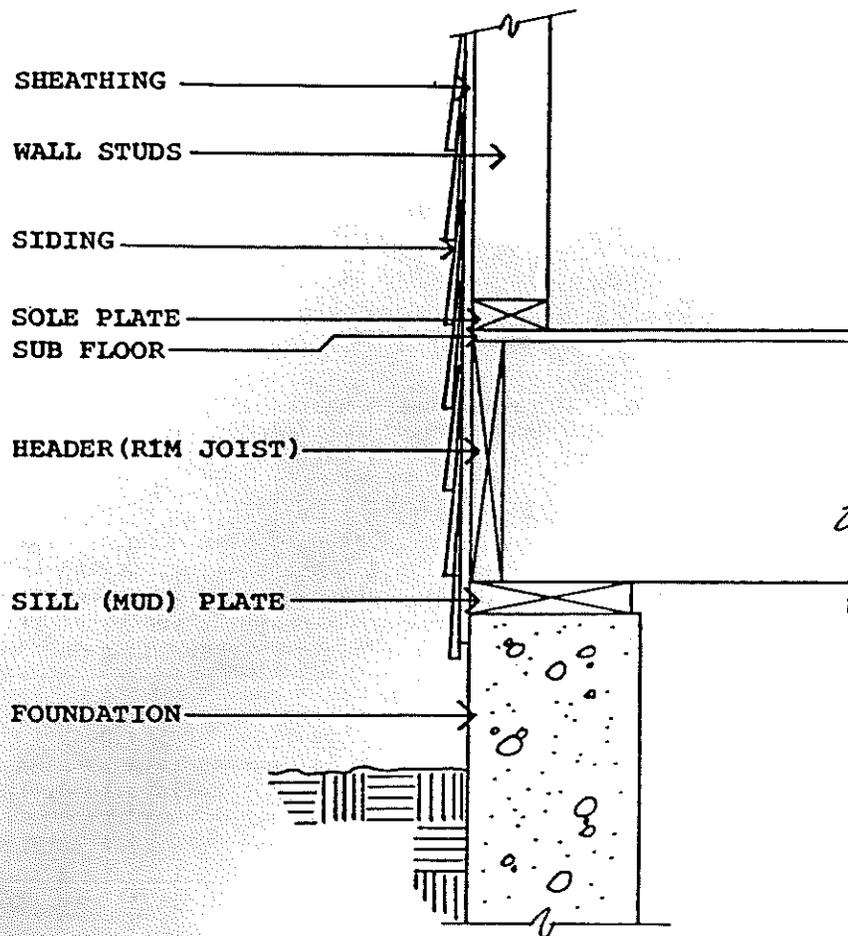
Figure 1. Wall opening wood member
 locations of moisture content
 measurement

In each wall opening the wood moisture content was then measured whenever possible at seven locations, both on the surface and in the interior of the wood member (about 0.75 in (19 mm) deep), using a resistivity type of moisture meter with two insulated pins. The seven measurement locations in each hole are: right stud, left stud, sole plate, sheathing (warm side), subflooring, header (rim joist), and sill (mud) plate. They are illustrated in Figure 1. The moisture content of the sole plate and studs was measured about 1/4 in (6 mm) in from the exterior surface edge, whereas all other measurements were made at the exposed exterior surface. Readings were recorded to the nearest one-half percent within the meter's range of 6% to 30%. For the sheathing, a number of measurements were made at various locations on the part of the surface exposed to the insulation or the uninsulated cavity, and the highest reading was recorded. It should be noted that since for the Portland study (Tsongas 1980) the corrected meter readings were essentially the same as the moisture contents obtained by laboratory gravimetric analysis of wood samples taken from the same locations, it was decided to forego taking any wood samples for such a check in this study.
