# DESIGNING THE ENVELOPE: GUIDELINES FOR BUILDERS

## ABSTRACT

Envelope design and construction variables affecting the energy performance of more than one-hundred Minnesota houses have been investigated. The houses were built as part of a 1981 energy efficient housing demonstration project. Field data gathered on 25 houses using an infrared camera showed common design and construction errors. Performance was evaluated from weekly and monthly energy use measurements.

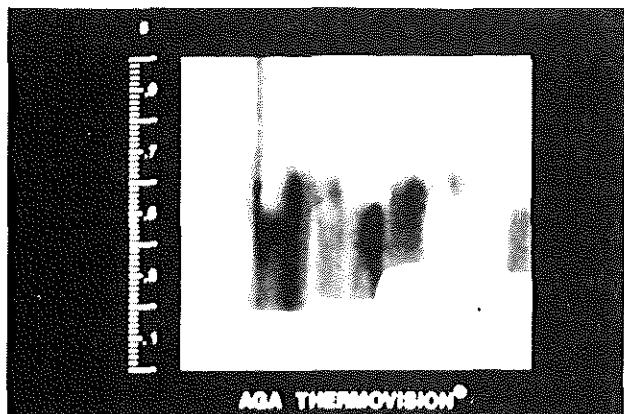
Photographs in the first two figures illustrate the above problem. They show each side of a wall that separates the second and third levels of a split-level home. The ceiling of the second level intersects this wall at about mid-height, so that there is an attic on the back side of the top half of the wall and heated space on the back side of the bottom. Figure 1 is a thermogram of the wall taken with the house depressurized. Note that the bottom part of the wall (with heated space on the back side) is the cold part. This is due to cold air being drawn into and down the wall from the attic. The photograph in Figure 2 was taken from the attic on the back side of the wall. The insulation at the bottom of the photo is above the ceiling of the second level. Some of the insulation for the ceiling of the second level has been removed for inspection, showing the polyethlyene vapor barrier. The open top of the heated wall cavity shows between the fiberglass batts. The interior wall cavity is also exposed just to the left of the black plumbing vent. Water staining was evident on the gypsum board above and to the left of the plumbing vent and on some of the wood in this area. This staining is at the level of the top of the blown fiberglass and was probably caused by condensation from warm, moist air leaking out of the house through the fiberglass insulation.

Unless the space between studs is carefully sealed where the ceiling of the lower level intersects this wall, the stud cavities form chaseways connecting heated space to the attic. Since these walls generally contain major plumbing, wiring, and duct runs, it is usually easy for heated air to get into the stud spaces of these walls.

*Figure 1. Thermogram of wall taken with house depressurized*

The design of exterior envelopes should specify details for air leakage reduction. During construction these details should be followed, and other possible sources of air leakage sealed.

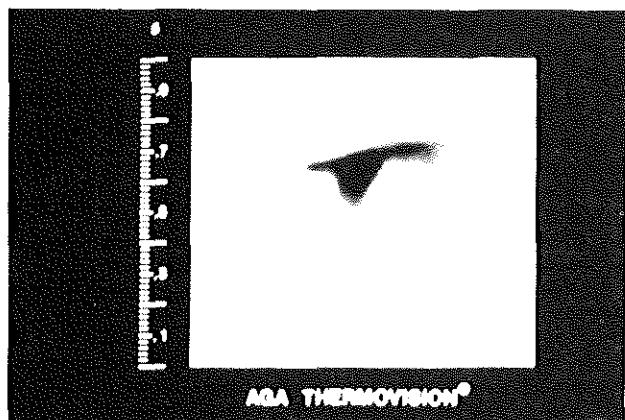
The second example shows that air leaks were also found to be common where interior partition walls intersect the ceiling. The photograph in Figure 3 is a thermogram of the intersection of the wall and ceiling again while the house is being depressurized. The photograph in Figure 4 shows what this area looked like from the attic when the insulation was removed. The hole where the wiring goes through the top plate is a common source of air leakage. A pocket knife blade is seen sticking into a crack approximately 1/32-inch wide between the top plate and the gypsum board of the wall. The dark streak on the fiberglass batt that was covering up the leaks is indication of dirt that was filtered out of the air that leaked from the house.

*Figure 3. Thermogram of intersection of wall and ceiling while house is being depressurized*

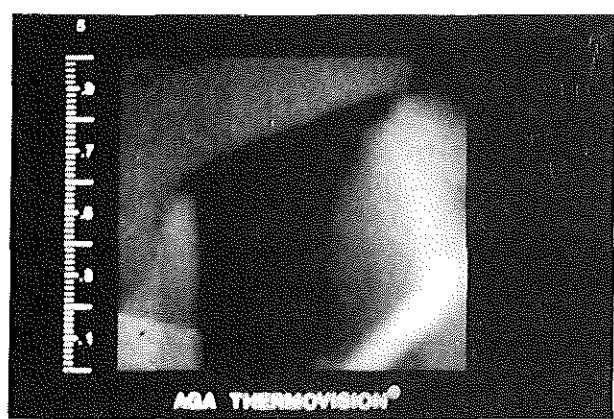
The third example illustrating this guideline shows how complex design features might compromise energy conservation if quality control is omitted. In the house shown in the next two photographs, there is a closet on the other side of the walls that are built out over the stairway. The photograph in Figure 5 is a thermogram of the cathedral ceiling-closet wall intersection taken with the house depressurized. It shows a cold streak coming down from the cathedral ceiling into the partition between the closet and the room where the photos were taken. The photograph in Figure 6 was taken from the attic. A hand could be inserted into the dark area in the middle of the picture into the top of the cold wall cavity that showed up in the thermogram. Two walls, the flat closet ceiling, and the cathedral ceiling all meet at this location, creating some complicated framing details. The cathedral ceiling structure also changes from trusses to solid wood rafters at this point. The plans showed no details of how the air-vapor barrier was to be sealed here.

*Figure 5. Thermogram of cathedral ceiling-closet wall intersection taken with house depressurized*

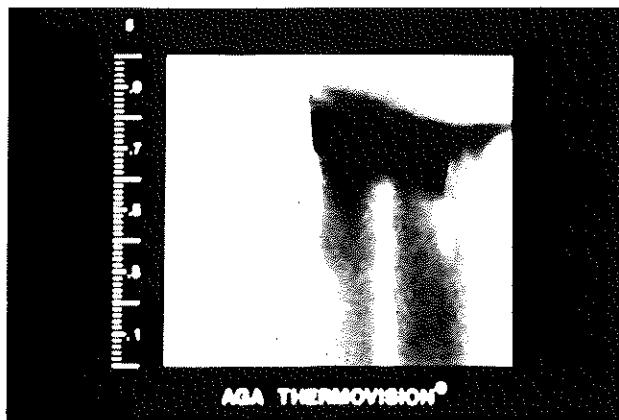
Air leakage and heat loss are increased when the return plenum for a furnace is open into an attic. The photograph in Figure 7 shows a top floor return air grille that connects to two stud spaces that serve as a return duct. The photograph in Figure 8 is a thermogram of this part of the wall, taken with the house depressurized and the furnace fan off. Cold air is apparently being drawn down the return from the attic, and a large amount of cold air was felt coming through the grille. This return plenum was designed to collect warm, solar-heated air from the ceiling of this room, to be blown through a rock-bed under the first level floor. From the above observation, this system appears not only to move warm air out of the living room but to pull cold air from the attic as well.

Figure 8. Thermogram of return air grille with house depressurized and furnace fan off

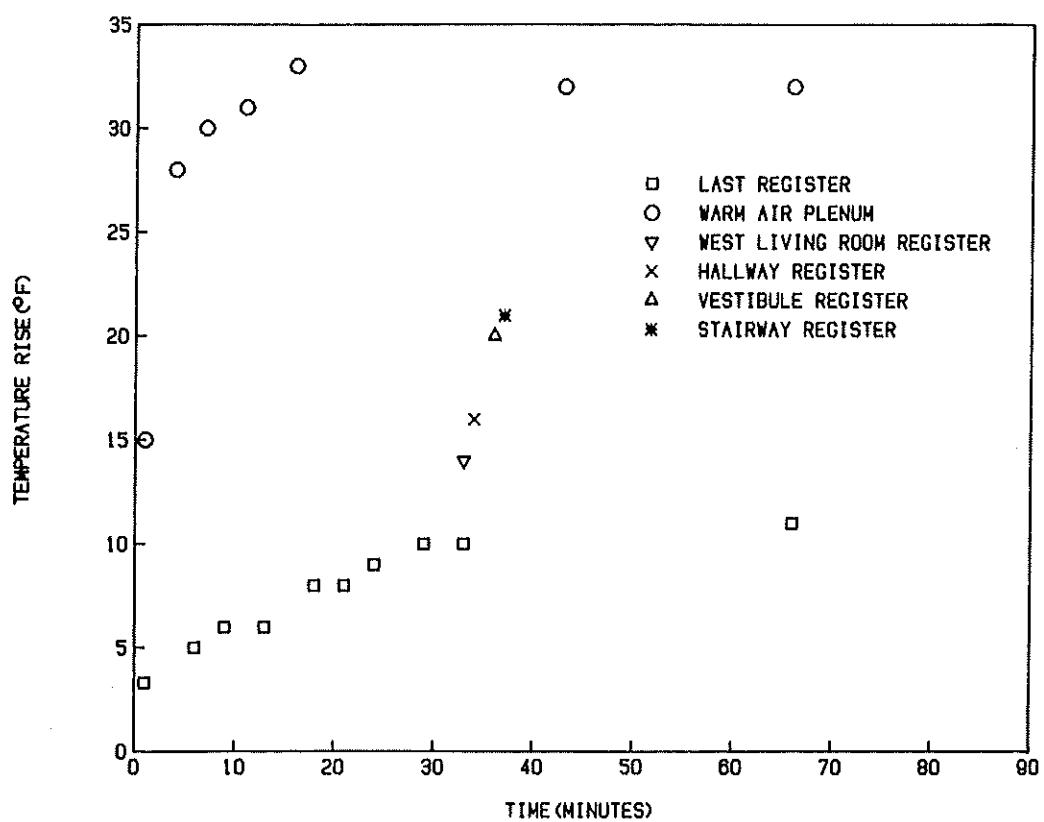
Eleven of the 25 field-inspected houses had forced air heating systems with warm air supply ducts beneath a concrete slab. The plans for these houses all called for some sort of insulation either around or below ducts located close to the exterior edge of a slab. However, thermal bridges may be causing high heat loss in these ducts, especially where there is thermal bridging between the slab and the footings. Two separate analyses showed that these duct systems were responsible for a significant portion of the total house heat loss.

Supply air temperature data on six houses were collected and data for one house is shown in Figure 9. This figure shows the differences between the cold air return temperature and the warm air supply temperatures measured at several locations for about one hour. After the furnace was on for more than an hour, the air coming out of the register farthest from the furnace had lost almost 65% of its energy to the ducts under the slab. Of course, not all of this heat is really lost, since the house will now lose less heat to a slab that is warmer. However, comparing the energy performance of houses with below-slab ducts to those without proves that much of this energy is lost into the ground. In two other units, measurements showed that about 25% was being lost after 25 minutes. In a fourth house, where all the supply air goes below the slab, about 50% of the heat was lost after 30 minutes.

Figure 9. Heat loss in below-slab air distribution systems

There is general agreement of both field observations and statistical analysis that improperly insulated below-slab heat distribution systems increase energy use. Therefore, it is recommended that below-slab heat ducts be properly insulated or avoided.
