INVESTIGATION AND REPAIR OF A TERRA COTTA DOME IN A COLD CLIMATE

Richard Ogle

ABSTRACT

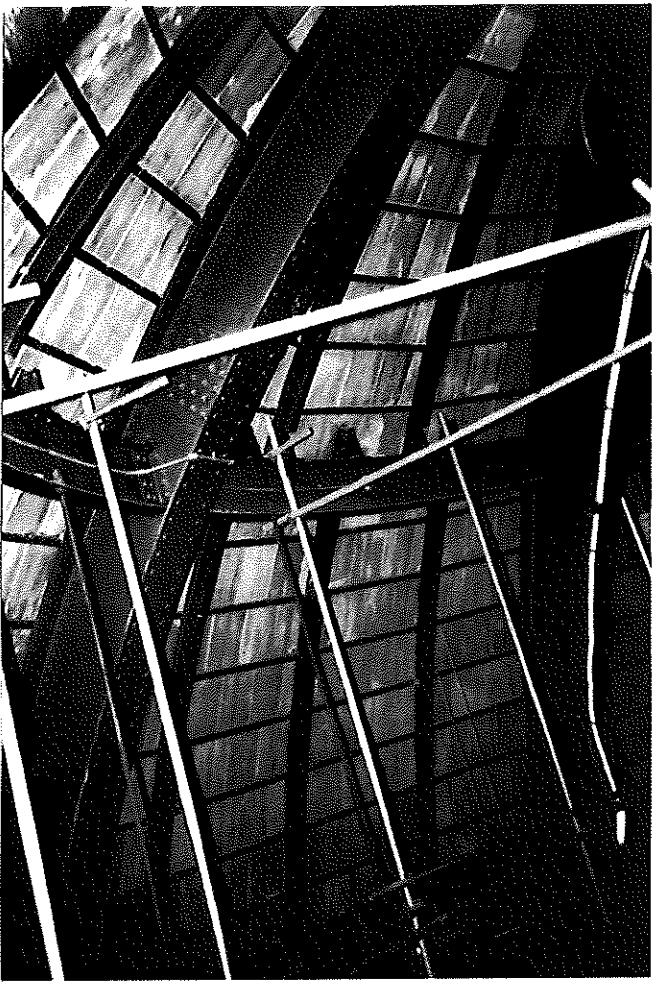
Figure 3 View of a typical dome octant from the interior. Tube shapes in foreground are construction scaffolding.

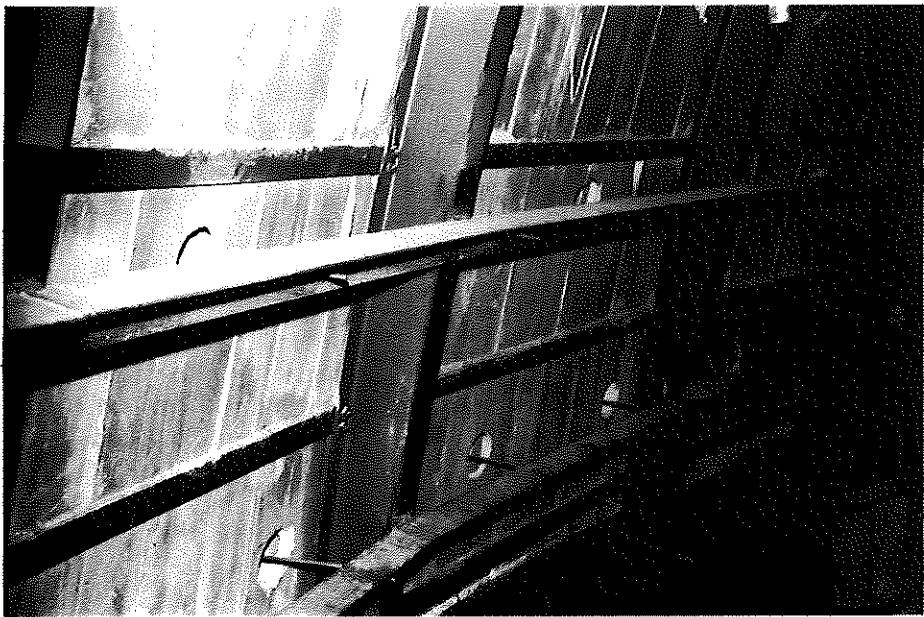
Figure 4 New structural stabilization added to the existing steel framework.

A structural analysis that modeled the outer layer of terra cotta tiles as an unsupported shell indicated that the lower third of the tiles should be stabilized. In this lower zone, a spherical shell structure has a tendency to push outward. Rather than disrupt the dome's appearance by fastening through the outside, it was decided to tie back the outer tiles from the interior using stainless steel rods anchored in the webs of the tiles. The rods were then connected to new angles, which were welded to the existing steel frame as shown in Figures 4 and 5. An analysis of the frame showed that it was adequate to support all loads transmitted from the terra cotta.

To do this work it was first necessary to build a catwalk platform inside the attic around the perimeter of the dome. This was augmented by scaffolding where necessary. Next, 100-mm-diameter cores were made through the inner booktiles corresponding to each exterior tile on every second horizontal row. This resulted in an anchor spacing of approximately 500 mm by 500 mm. A 13-mm-diameter hole was then drilled into a web on the back of each outer tile. The hole did not extend right through the tile, so the exterior surface of the tile was not affected. New 75 by 75 by 6 mm structural steel angles

were then welded to the existing intermediate steel ribs. The hole in the back of each tile was filled with epoxy adhesive and a 10-mm-diameter stainless steel threaded rod was inserted into the hole and fastened to the new angle.

The adhesive anchoring system was selected because of the risk of cracking the tiles with expansion-type anchors. Tests conducted on the site by the adhesive manufacturer showed that the pull-out strength of the rods was more than adequate. The rods were then fastened back to the new steel angles by means of nuts that were tightened sequentially in order to bring the system into a snug position.

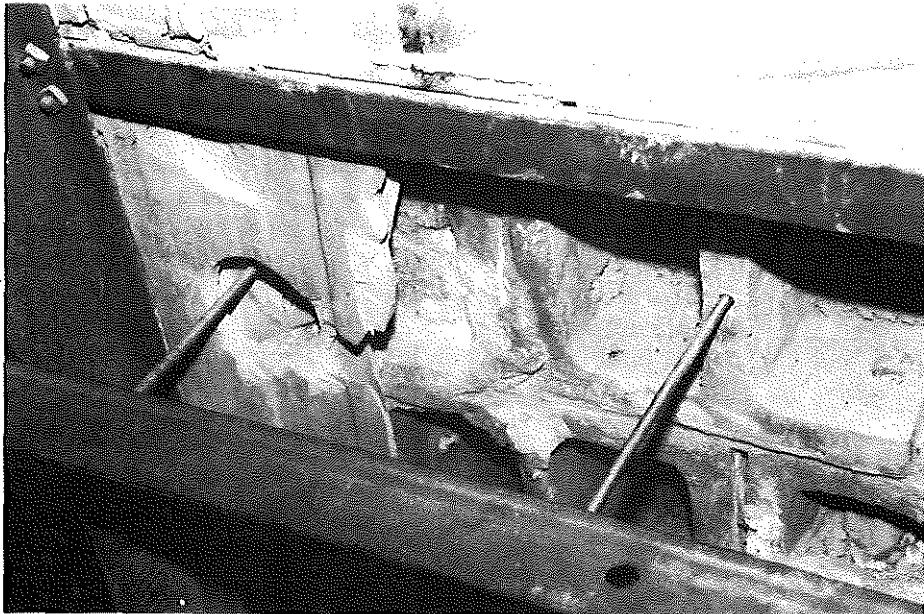
Figure 5 Close-up of the new structure tie-backs. Note inner booktile has been removed to allow viewing of outer terra cotta tile.

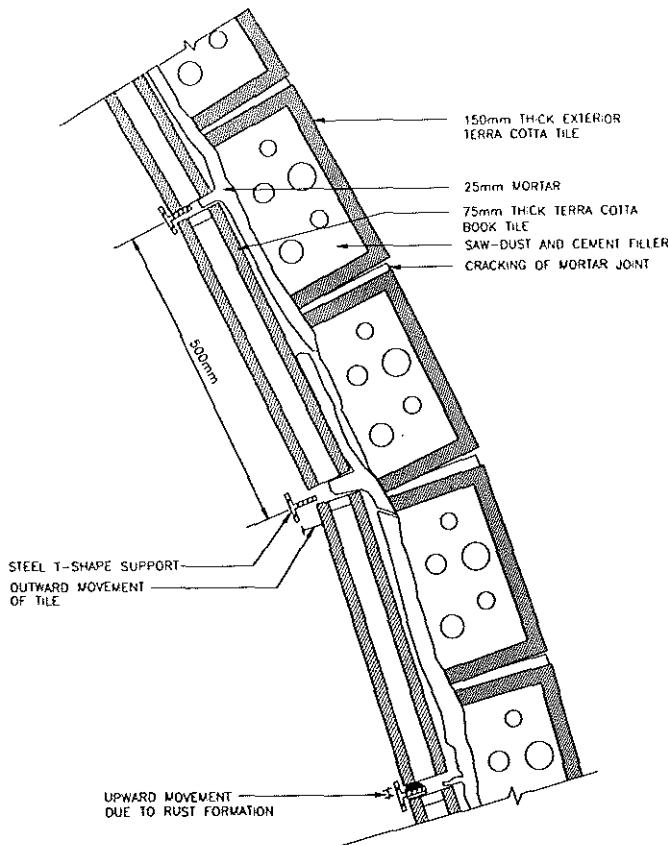
A most disturbing finding was that some of the booktiles were displaced outward as much as 50 mm relative to their supporting T-shapes. The areas most affected by this displacement were the west and south octants. Figure 6 shows an example of the displaced book tile. The book-tile displacement appeared to have increased even during the period of investigation and there were obvious concerns about the stability of the terra cotta.

Figure 6 Original condition of terra cotta tiles at location of maximum displacement.

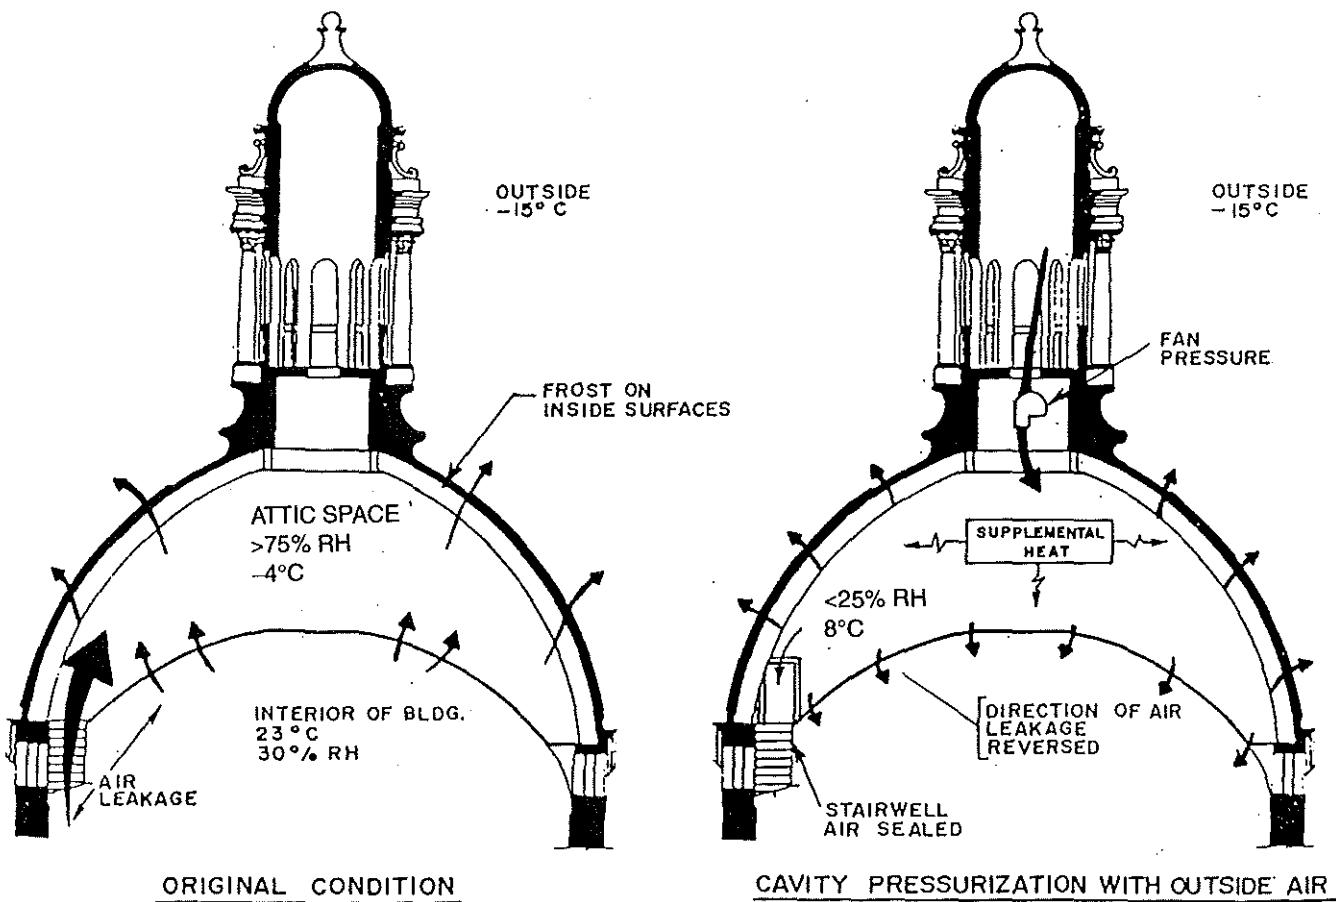
- The frost and ice that accumulated on and between the layers of terra cotta were largely due to the leakage of warm, moist inside air into the cold attic space and subsequent condensation on the cold surfaces. Several large openings through the plaster ceiling that appeared responsible for the leakage were identified. The condensation also contributed to the corrosion of the steel T-shapes.

Figure 7 Typical winter conditions in the dome attic before and after repairs.

Because a substantial amount of the moist interior air was entering the attic space, much of the condensation problem was solved by simply sealing up large leakage holes at the line of the plaster ceiling. However, because it was impractical to locate and seal all air leakage paths, it was decided to artificially pressurize the attic space with outside air and also to provide heat to the space. The pressurization, in effect, reversed the direction of air leakage, which now occurs from the attic to the main building. The outside air used to pressurize the attic

contains little water vapor and, once heated, becomes relatively dry, eliminating the condensation problem and increasing the drying potential from surfaces in the attic. A summary of the concept can be seen in Figure 7.

The new mechanical system consisted of a fan unit with a flow rate of approximately 235 L/s and an outside air intake located in the lantern. Two electric heaters were installed in the attic with a total output of 40 kW, which was the maximum power available to the attic. These heaters were designed to maintain the attic space at a temperature of 5°C when the outside air temperature is -34°C; they are controlled by an interior thermostat. A glycol heat pump was used to augment the heaters. Continuously running circulation fans also were installed within the space to mix the air uniformly.
