FAILURE OF THE BUILDING ENVELOPE: TWO CASE STUDIES

ABSTRACT

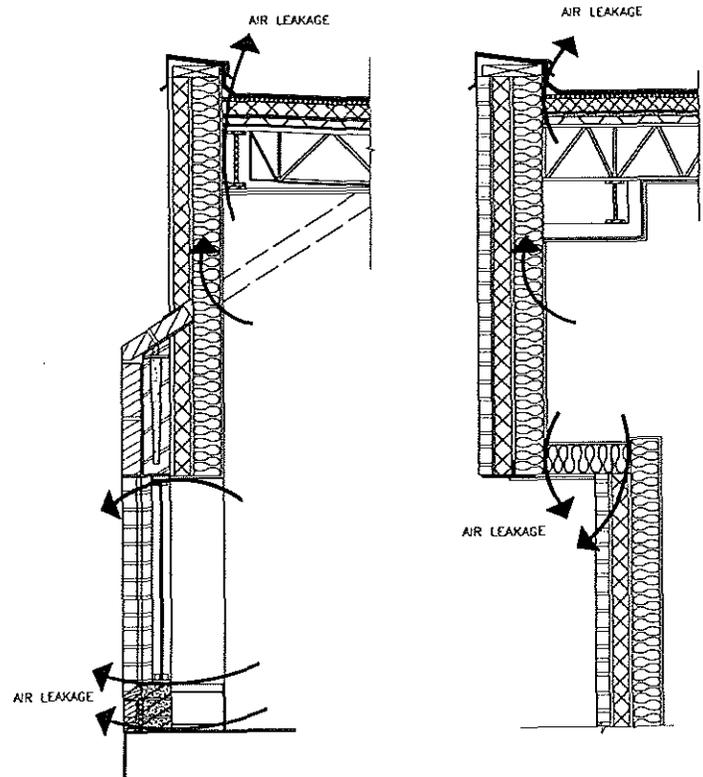
Figure 2 Case study 1, typical air leakage paths.

- Air leakage paths through the building envelope assembly were identified in a number of locations using smoke. These included paths around windows, at the floor-to-wall joint, at the wall-to-roof intersection, and through soffits. In all cases the air appeared to be leaking out of the building at a substantial velocity, suggesting an oversupply of air by the mechanical system. A spot measurement across an exit door indicated a pressure difference of +25 to +30 Pa. Some of the leakage paths corresponded to thermal anomalies identified in an infrared thermography report commissioned earlier by the hospital. Figure 2 illustrates some typical air leakage paths.

The patches of efflorescence observed on various portions of the brick veneer appeared to correlate with areas where air leakage paths had been identified. It is believed that humid interior air leaking through discontinuities in the envelope assembly created condensation on the brick and that this condensate moved through the bricks, leaving visible salt deposits at the surface when it evaporated. The source of the salts was the brick itself, as demonstrated by the efflorescence tests, which showed that this type of brick was susceptible to efflorescence.

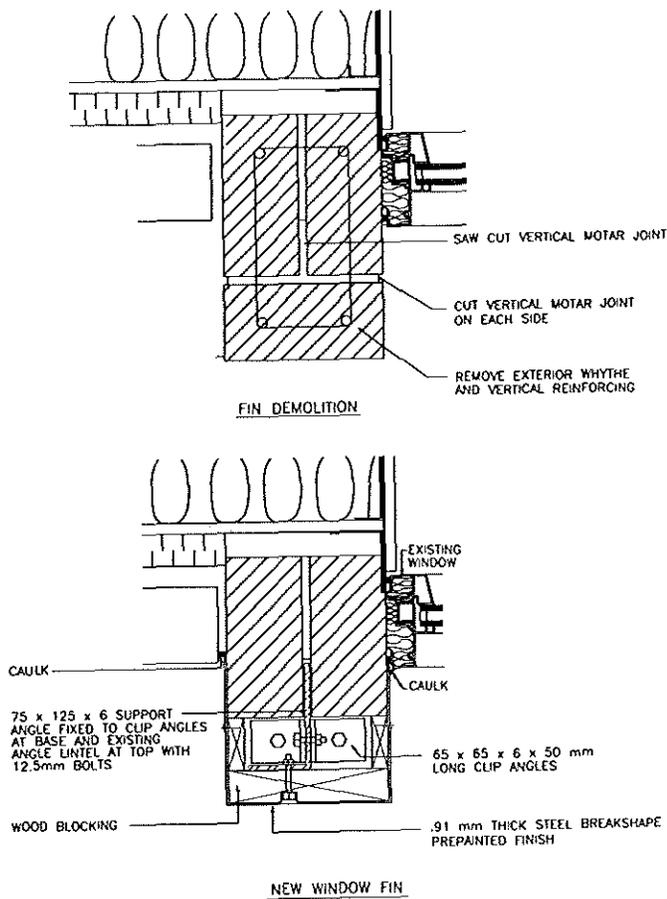
Figure 3 Case study 1, remedial repairs to brick fins.

- A visual survey indicated that cracking in the brick veneer was severe but was confined to the vertical built-out window surrounds or "fins." In the worst cases, the cracks extended over the full 2,400-mm height of the fins and were up to 6 mm in width. The severity of the cracking raised safety concerns about falling brick fragments, particularly from the two-story section.
- Brick fragments that were removed from the fins revealed severely corroded steel reinforcing bars located in the cores of the bricks.
- Twelve mortar samples were removed from the fins and tested for water-soluble chloride ion content. In 10 of the samples, the chloride ion content exceeded the limit of 0.15% by weight of cementitious material stipulated in Canadian Concrete Design Standard

It was concluded that the cracks in the brick veneer were due to corroding reinforcing steel. A similar phenomenon has been studied extensively in reinforced concrete bridge decks and parking structures contaminated by chlorides contained in deicing compounds (Erlin and Hime n.d.). The chlorides depassify the steel, allowing it to corrode in the presence of water and oxygen, thus producing rust, which expands and

splits the surrounding matrix. In this particular building, the source of the soluble chlorides was probably calcium chloride deliberately added to the mortar mix in order to prevent the fresh mortar from freezing during winter construction. It is interesting to note that the contract documents contained a specific clause prohibiting this practice. Rain, melting snow from horizontal surfaces, and condensation from air leakage could all have contributed the moisture required to cause the corrosion.

It was concluded that the brick fins could not be stabilized or repaired due to their advanced state of deterioration and that, in the interest of public safety, the fins would have to be demolished. Due to cost considerations, it was decided not to rebuild the fins out of brick but to replace them with galvanized structural steel columns covered by wood and a sheet-metal cladding. With the careful use of hand tools and shoring it was possible to demolish the fins with a minimum of disturbance to surrounding construction. The new steel columns were bolted to the concrete floor slabs and welded to lintel angles. Wood was used to frame around the columns, and metal cladding was then installed over the wood. Figure 3 shows the implementation of typical remedial repairs.

Since the existing connector spacing did not meet Alberta Building Code requirements, retrofit masonry connectors were installed at a spacing of 600 mm by 800 mm. An engineering analysis showed this was the maximum practical spacing that satisfied strength and deflection criteria. The new connectors were a proprietary product consisting of an adjustable V-shaped rod and L-shaped plate, both made from galvanized steel. In order to place each new connector, a single brick was broken out and the connector was then fastened to the inner wythe, as shown in Figure 4. A new brick and mortar was then installed. Approximately 4,000 connectors were used in the repair.

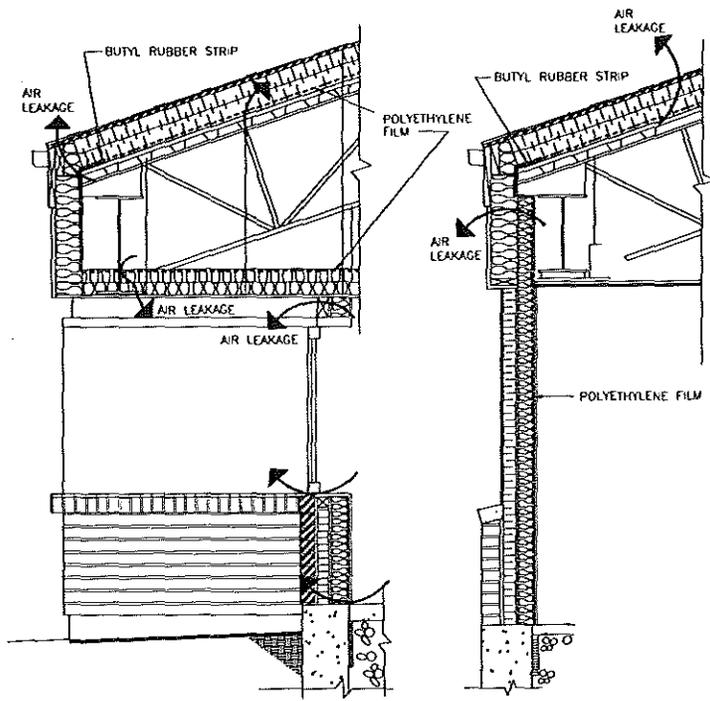
Figure 6 Case study 2, typical existing wall sections.

Figure 6 shows some of the air leakage paths that were identified.

Figure 6 also shows the polyethylene film in a completely unsupported condition on the soffit and at the end wall. In such a condition, the film could not resist even moderate wind loads. In the as-built construction the polyethylene sheets were simply laid loosely over batts of fiberglass insulation and served no air barrier function at all.

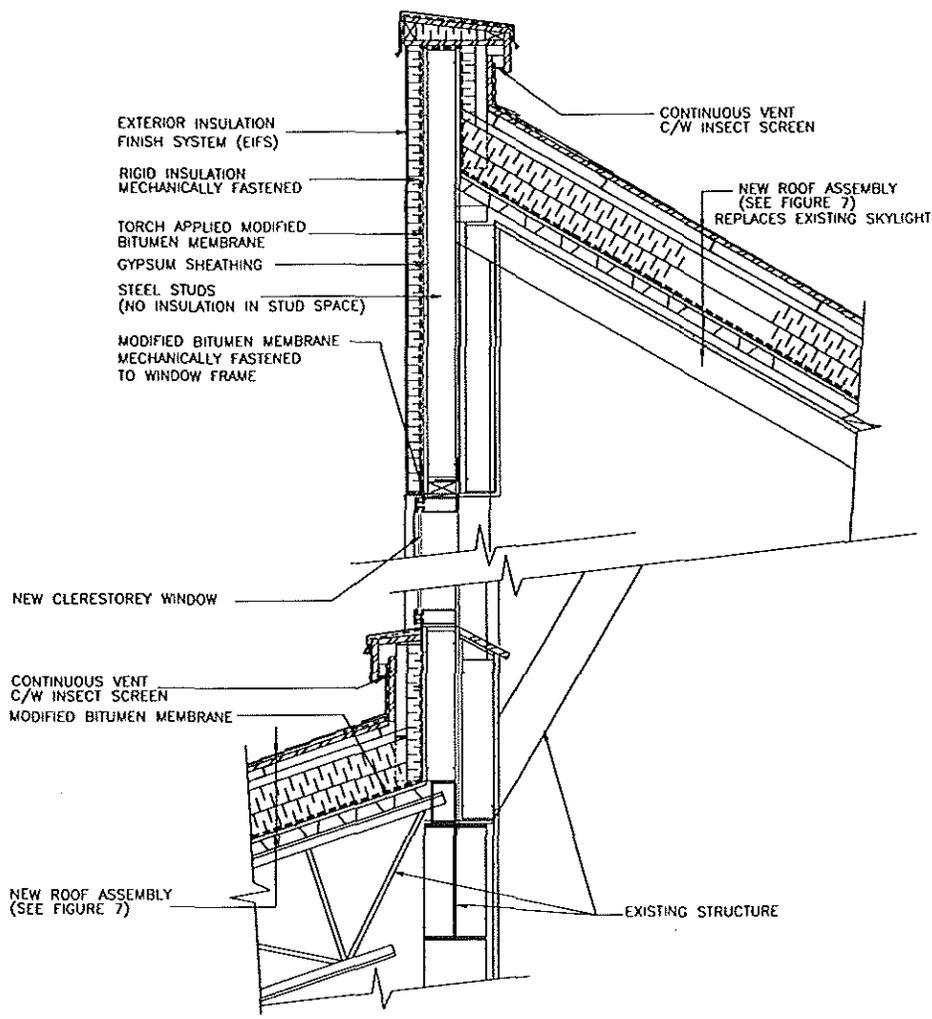
Figure 8 Case study 2, new clerestory windows and sloped roof.

The exact cause of water penetration through the sloped glazing system was not determined. However, previous experience with similar systems suggested that an effective long-term repair would be hard to achieve. Furthermore, the large area of sloped glazing made dealing with the solar heat gain problem difficult. For these reasons it was decided to remove the sloped glazing and replace it with a limited area of clerestory windows. The window system selected was an exterior glazed aluminum box section as shown in Figure 8. These windows are pressure equalized and drained in accordance with the "rainscreen" principle and lend themselves to mechanical attachment of the SBS membrane, thereby

ensuring continuity of the air seal. Such a system has been used with good success by APW many times in the past.
