ENVELOPE DURABILITY PROBLEMS IN HIGH-HUMIDITY BUILDINGS

Mark Lawton, P.Eng.

David Scott

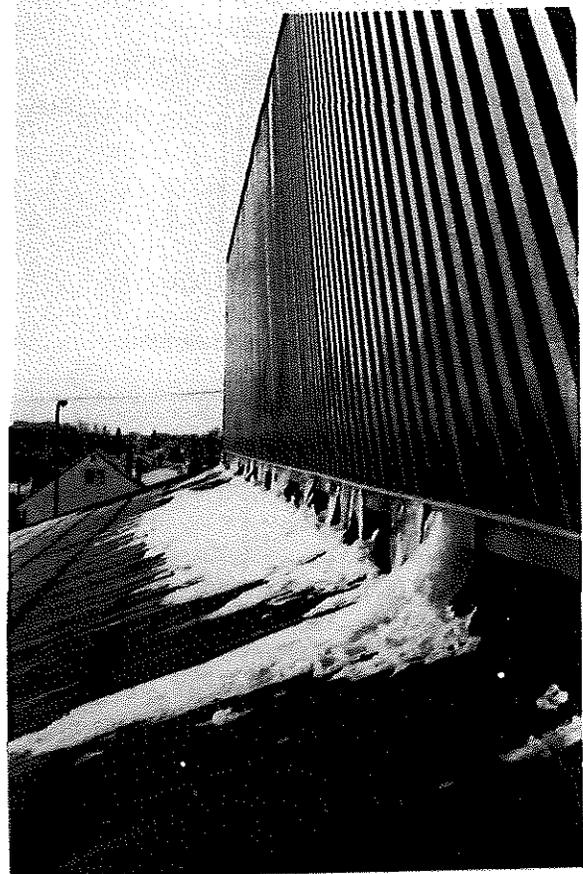
Two of the indications that there were serious envelope problems with this building were the observation of ice formation emanating from the back side of the steel cladding (photo 1), particularly at the base of walls between upper and lower roofs, and water dripping into a visitor's gallery at a location in line with clear-story glazing above. Figure 1 shows a schematic of the typical roof wall intersection of parapet and clear-story glazing. A conventional asphalt roof is seen meeting a metal wall system at the parapet.

Photo 1 Ice formation emanating from the back of the steel cladding.

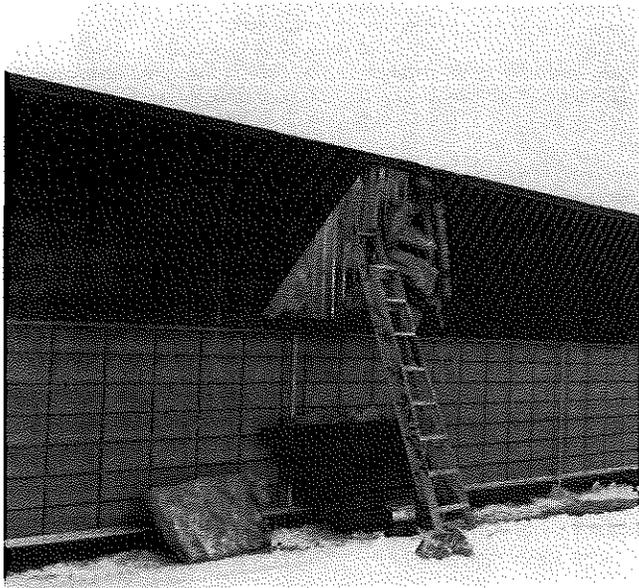
A test opening (photo 2) was conducted, under early winter conditions, to determine the condition of materials within the wall and the parapet.

Inspectors noted that the wall insulation was frozen to the metal cladding. In reviewing the construction of the interior metal liner system (photo 3), the authors found that foam tape had been used in an attempt to seal the joint between the upper channel and the liner and that vertical liner joints were left unsealed. Insulation over the joints was blackened by dirt filtered out of

Photo 2 Test opening above spectators gallery.

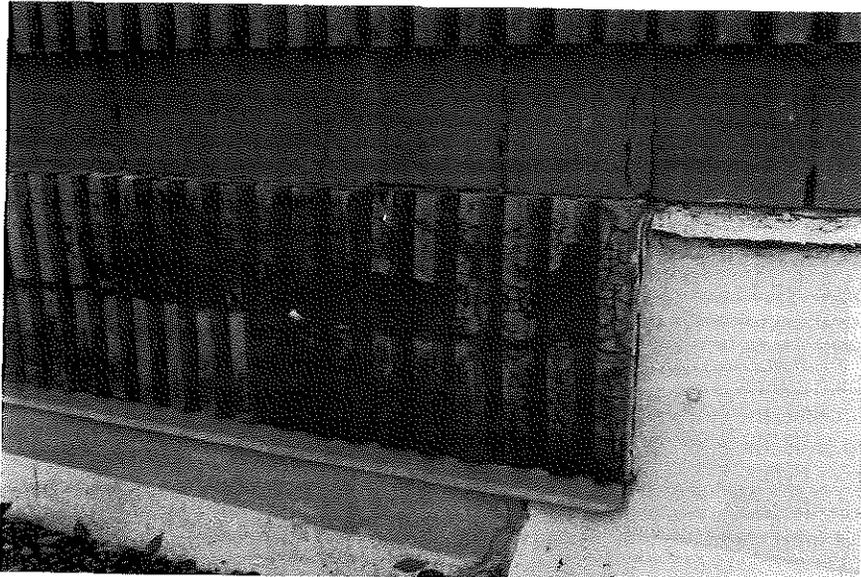
visibly wet, fractured, and approaching an unstable condition in some areas (photo 7).

Block and mortar damage observed in this building can be attributed to air leakage, condensation collection, and subsequent freeze/thaw damage. The deterioration is so great that structural failure of the facade is very likely. Certain design features intended to protect the envelope from high humidity were included in the original design (such as mastic-type vapor barriers and metal deck closures) but they have proven to be ineffective. The degree of air leakage at the roof/wall interfaces was significant at all test opening locations and appears to be the primary source of moist air in the cavity. Diffuse air leakage and vapor transmission through

Photo 7 Badly fractured concrete block cladding.

Because the exterior cladding has deteriorated to the point of failure, remedial plans include its removal and the installation of a complete air barrier on the outer surface of the structural block wall. The roof membranes can be directly connected to the new air barrier to make this connection continuous.

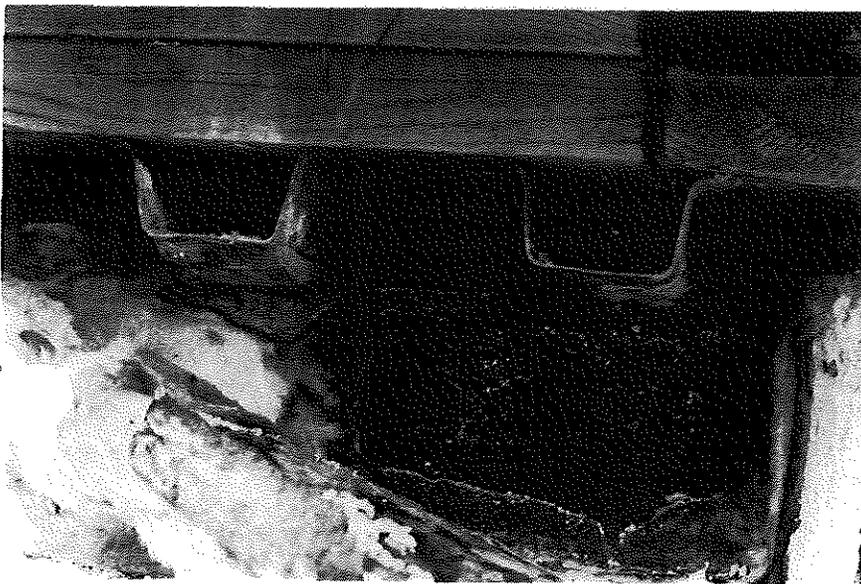
Some attempt had been made to seal the roof/wall interface. Neoprene flute closures were observed in the lower flutes of the metal roof deck. Where the flutes were oriented parallel to the exterior walls, a mastic-type sealing strip was placed along the flute above the inner surface of the wall. Both these air-sealing elements were in line with the inner face of the block rather than the exterior surface, which was the surface treated to be an air barrier. There was no attempt to seal the upper flute openings above the deck. The authors found large quantities of warm air leaking out of the wall-to-deck interface (photo 8). The fiberglass insulation and wood elements of the parapet detail were wet. It was also noted that the coverage of the asphaltic and mastic air/vapor barriers was thin and incomplete.

Photo 8 Roof wall connection.

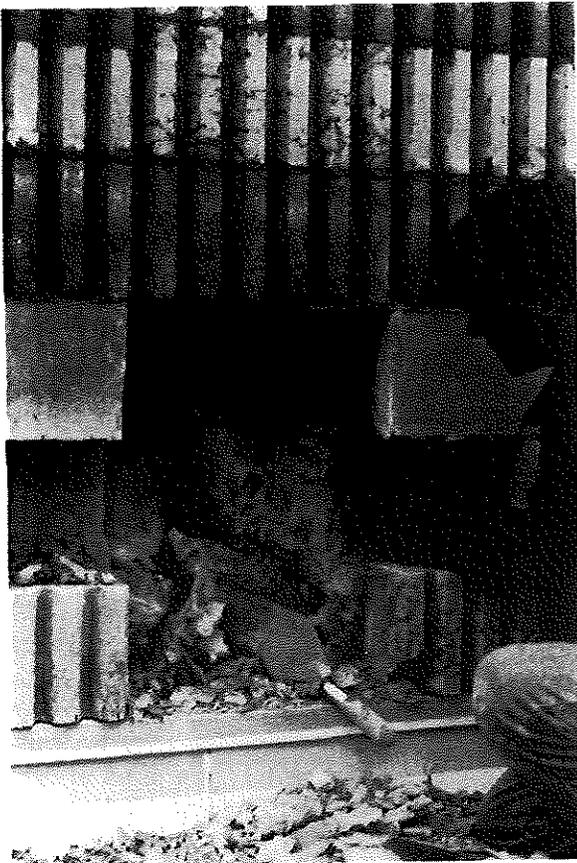
Another test opening was conducted at the intersection of the lower administration and service area roof and the wall above (photo 9). At this location, mortar had no consolidation, the concrete block was fragmented, and the insulation was wet. In addition to air leakage at the roof-wall junction above, the authors found air leaking from behind the through-wall flashing, which was not sealed to the inner block wall. When the construction was reviewed from within the ceiling space of the administration area below, we found the heated space below was connected to the wall cavity above via a layer of fiberglass insulation (photo 10 and Figure 2).

Photo 9 Showing poor condition of masonry and air leakage from top of flashing.

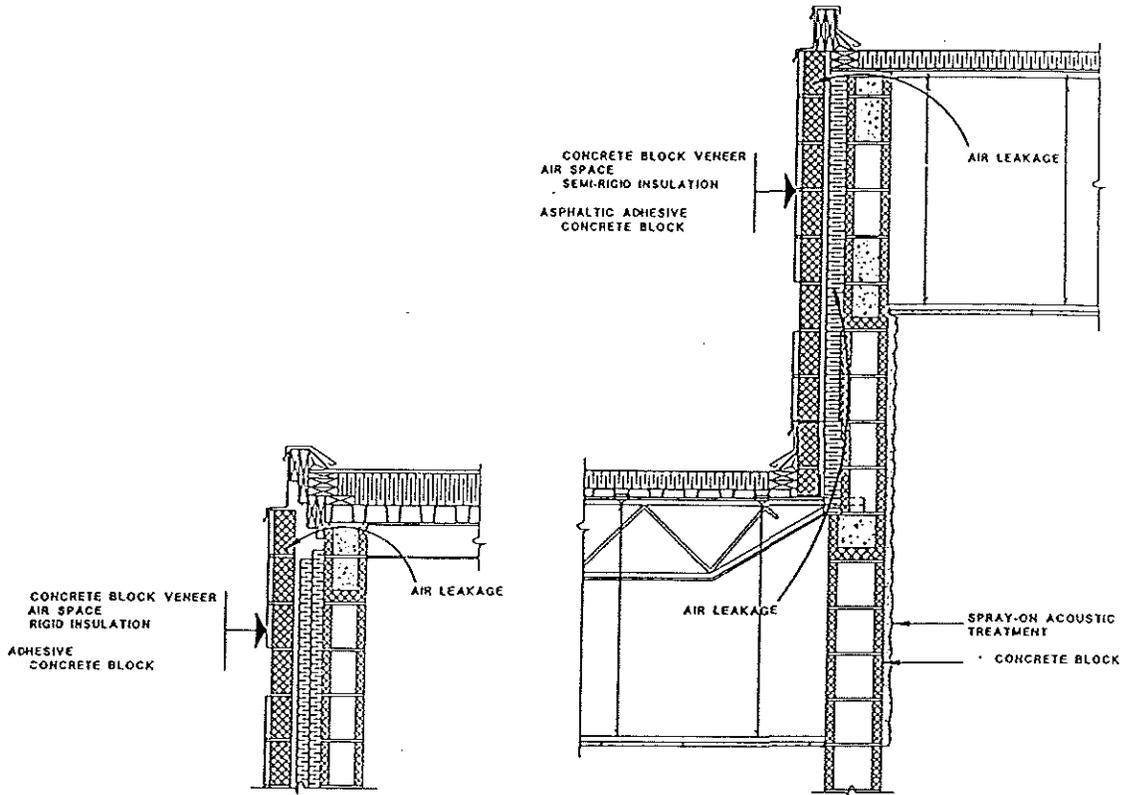
Figure 2 Test opening above spectators gallery.

the block interior walls and an incomplete mastic-type air/vapor barrier is a secondary, but possibly significant, source of moisture (Figure 2).

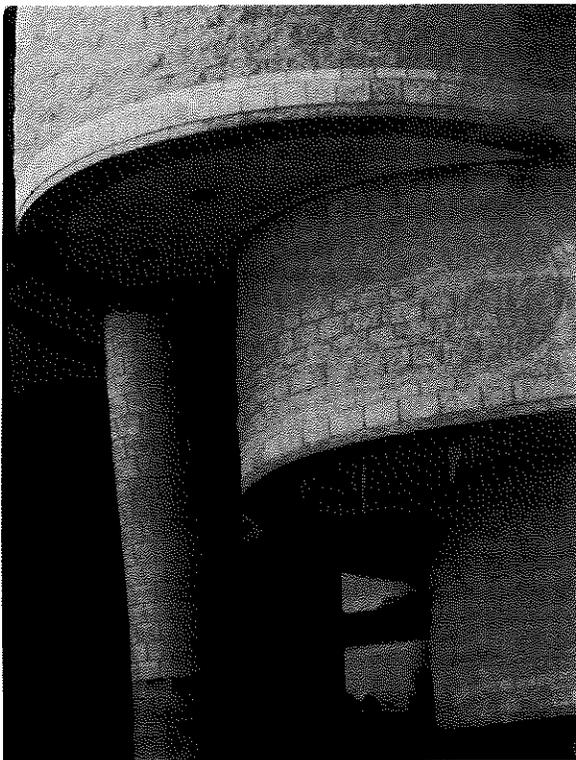
In spite of the attention to providing an air barrier, there have been some areas where moisture collection problems with the building envelope have occurred. One that caused special concern is at a series of overhangs on the front facade of the building. Under winter conditions, icicles were found to be collecting at the inner and outer perimeters of the soffit and at potlight assemblies installed in the soffit (photo 11). The soffits are directly over pedestrian areas, thus raising safety concerns. The museum had to resort to using a worker in a manlift to remove the more significant icicles.

Photo 11 Icicle collection at soffits.

it. Remedial action plans also include removal of the exterior finish and insulation of all affected soffits and sealing all identified leakage points.

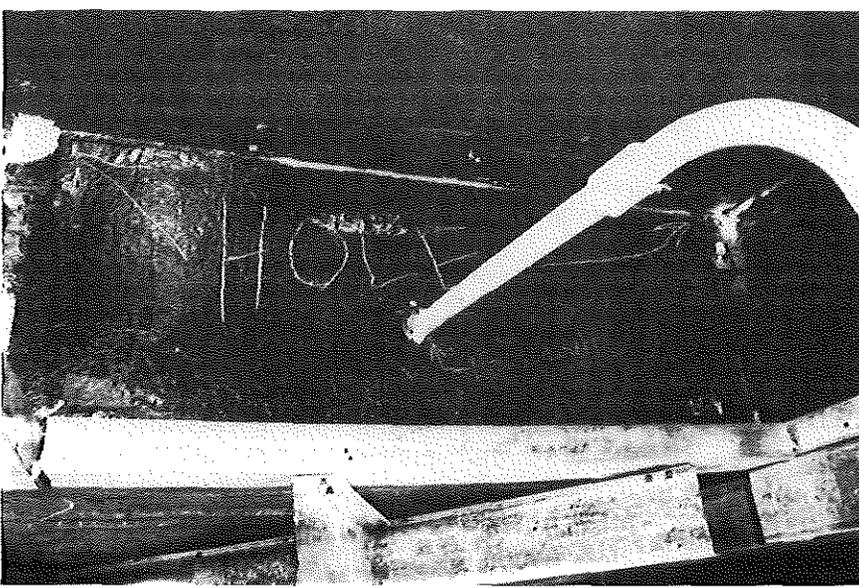
- At corners of the potlight housing assemblies (photo 12).
- Through and around the electrical conduit serving the potlights (photo 12).
- At the head end of the split mullions of the strip windows on the inner perimeter of the overhang. It was found that the membrane used to seal between the mullion sections was located on the inside of the mullion and no provision was made to transfer the plane of airtightness to outside the structure, where the wall and soffit air barriers were located.
- At unsealed screw holes, which appeared to have been drilled from above during construction to identify attachment locations for Z-girts supporting the exterior soffit finish (photo 13).
- Some poor seals at laps between adjacent sheets of air-seal membrane. In the test opening areas these did not appear to be major air leakage points but they could have been a problem in other locations.

Photo 12 Opening in air barrier membrane at corners of potlight housing. Note that there is no seal at the PVC conduit penetrating the air barrier membrane.

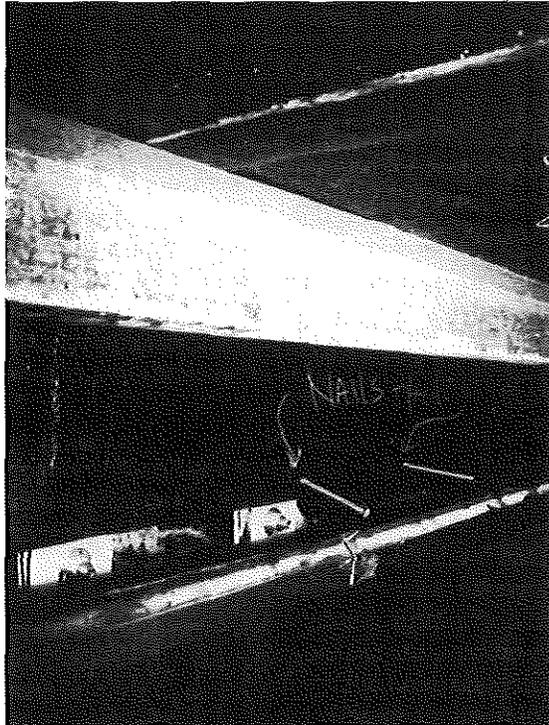
Photo 13 Air barrier leakage points included open screw holes and leakage from window vertical mullions and corners at potlight housing.
