TRI STATE HOMES: A CASE STUDY OF EXTENSIVE DECAY IN THE WALLS OF OLDER MANUFACTURED HOMES WITH AN EXTERIOR VAPOR RETARDER

George Tsongas, Ph.D., P.E.
Member ASHRAE

ABSTRACT

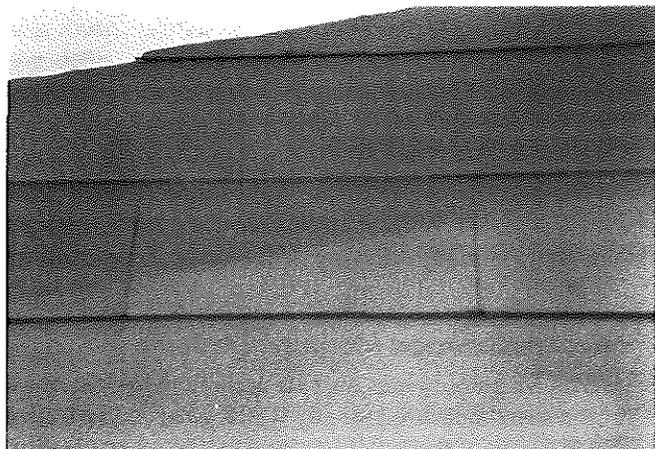
In no case was there any obvious indication of decay present within a wall by observing the wall from outside the siding. There were a few drip marks on the siding from between laps in a few cases (see Figure 3), but they were not always easily observable. However, upon removal of the siding and EVR, the plywood was found to be decayed in 10 of the 11 homes with all or most of the siding removed and 14 out of 15 overall (see Table 1). One

Figure 3 Minor drip marks on siding between laps.

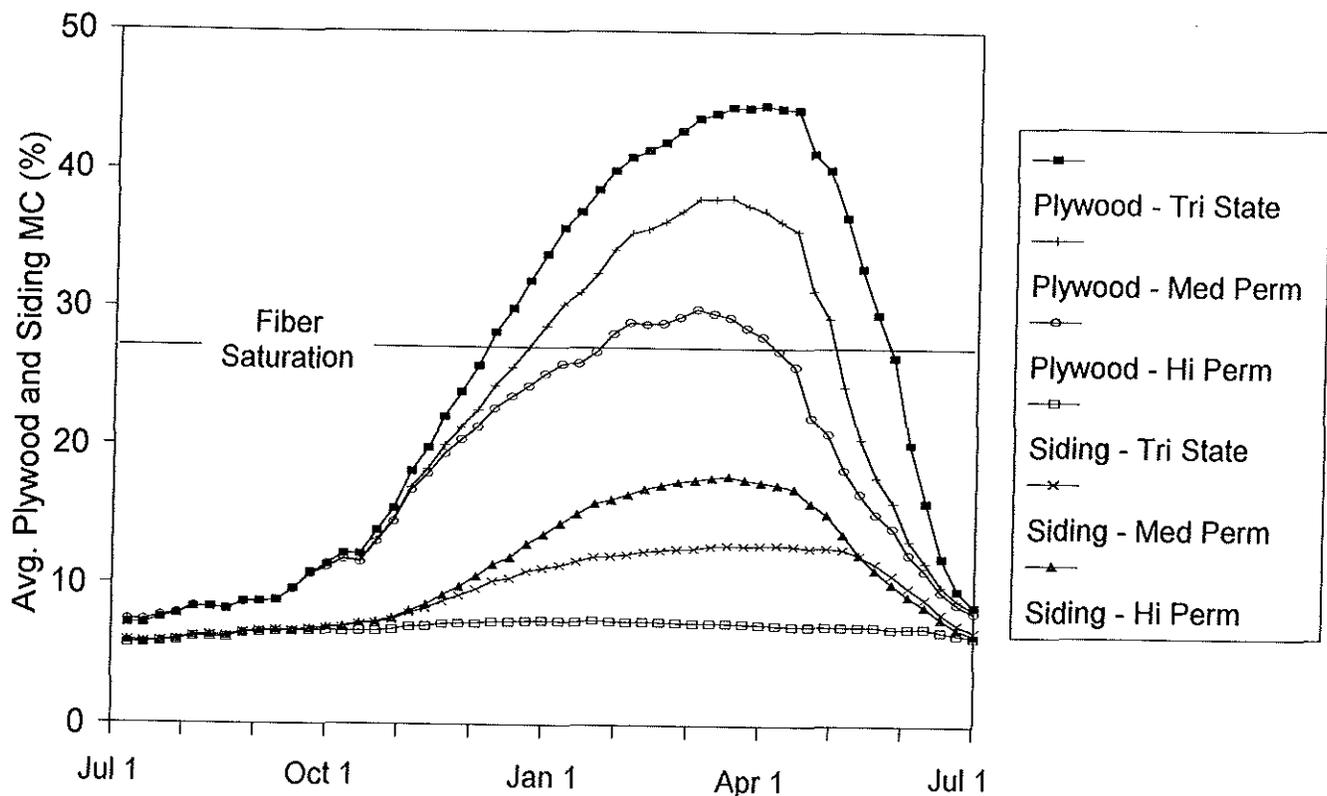
Figure 6 MOIST simulation moisture content predictions for the Tri State wall plywood and siding with building paper of different permeabilities.

ing can get wetter than the fiber saturation condition during winter months when decay cannot occur. Nevertheless, the walls dry out rapidly in the spring so that decay is not possible. The same is true for the case with the very permeable building paper (labeled "Hi Perm"), except the moisture levels are even lower. These computer modeling results are in good agreement with field inspection results—both indicating that wood decay generally does not occur in plywood sheathing in northern heating climates.

However, in the same wall but with a 0.65-perm EVR in place (the actual Tri State wall construction, labeled "Tri State"), the peak winter sheathing moisture content is significantly higher. During the late spring and early summer months, the plywood moisture content with the EVR is about 10% higher than without the EVR, and that is a significant difference. More important, moisture contents above the fiber saturation point persist in the sheathing until late spring and early summer when decay can occur. Thus the sheathing probably got wet enough for some decay to occur. Then, as warm weather continued through the summer, it stopped. This reoccurred for many years until the plywood deteriorated. That is probably why it took more than 10 years for the first decay to be noticed. Incidentally, even without any air leakage, the results were generally the same.
