THE PERFORMANCE OF ENERGY-EFFICIENT RESIDENTIAL BUILDING ENVELOPE SYSTEMS

Gary Proskiw, P.Eng.

ABSTRACT

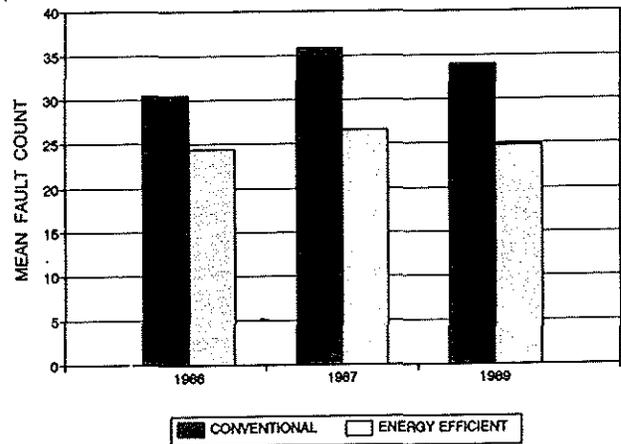
Figure 1 Continuously visible stations.

The thermographic data are summarized in Tables 5 through 8, which show the mean fault count data and severe fault data based on house type and air barrier system. Figures 1 through 4 show the mean fault count data and severe fault data for the continuously visible stations.
