A Qualitative Model for Moisture Balance in Painted Vertical Wood Paneling

Stefan G. Hjort, Ph.D.

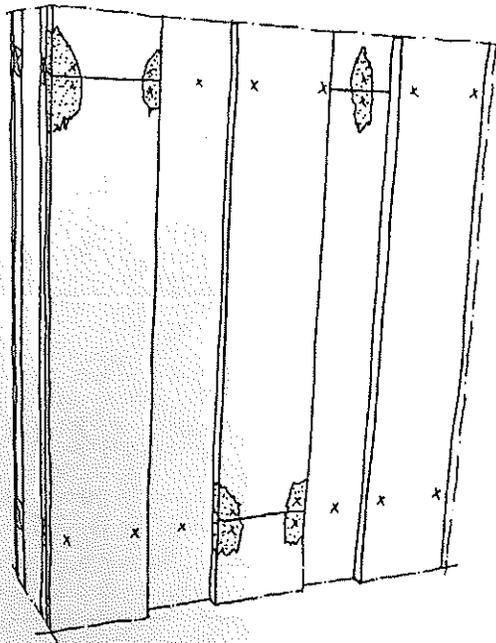
Investigations of a great number of houses damaged by wood rot in the Scandinavian countries have been carried out during the last ten years (Hjort 1989, 1993). The findings have shown a strong correlation between the degree of damage and the orientation of the paneling with respect to driving rain. As much as 90% of the rot was found on the top board. Most problems appear in the neighborhood of the following extremities and in the following order:

1. The joints of the panel boards, especially where the top board overlaps the bottom board.
2. The very end of the paneling, especially where the top board overlaps the bottom board.
3. The nails.

Figure 1 A typical paneling structure damaged by wood rot.

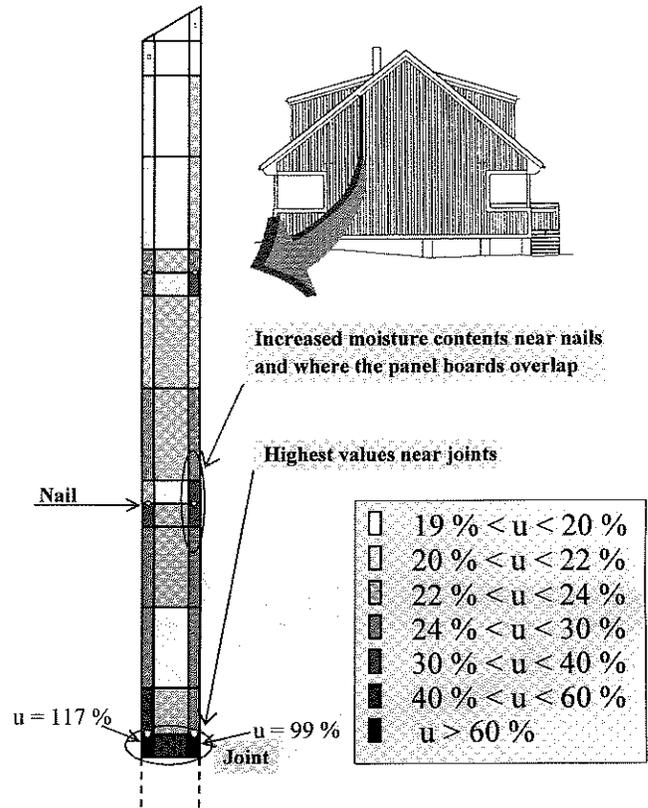
The zone where the top board overlaps the bottom board has higher levels of moisture content than the middle part of the board. It is likely that this depends on the local moisture exposure because panel boards disassembled from damaged houses have had trapped, capillary-transported water in the zone between the bottom and the top board. The moisture content distribution in such a board has been determined (see Figure 2).

The highest value of moisture content ($u = 117\%$) was measured near the butt joint. The theoretical value of complete saturation is approximately 180%. Raised values of moisture content were also found at the overlaps, compared with the middle of the panel board. Another interesting observation is that the values are higher near the nails.

Figure 2 Moisture conditions in a disassembled panel board.

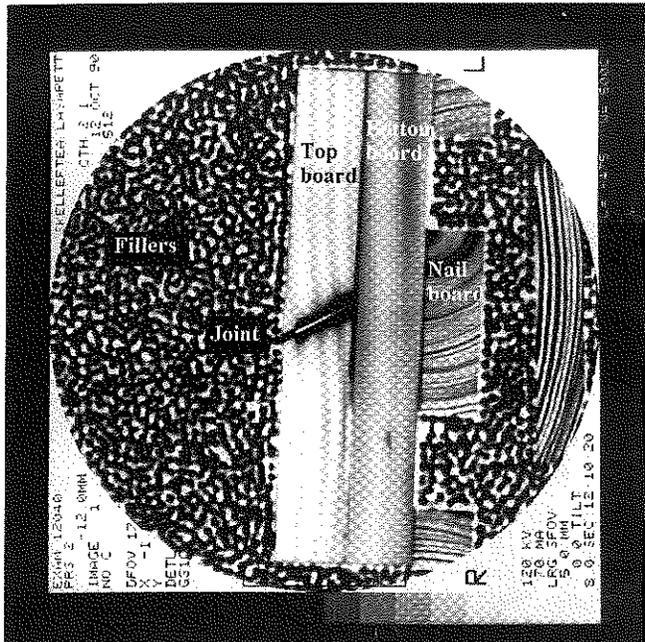
In Figure 4, the results are visualized after a simulated rainfall. Free water is held in the overlap zone and in the joint, which means that water enters the panel not only from the three painted front surfaces but also from the end grain and from the back of the top board.

Figure 4 A section through the specimen. The dark color in the joint and in the overlap between the top and bottom board indicates high levels of moisture content.

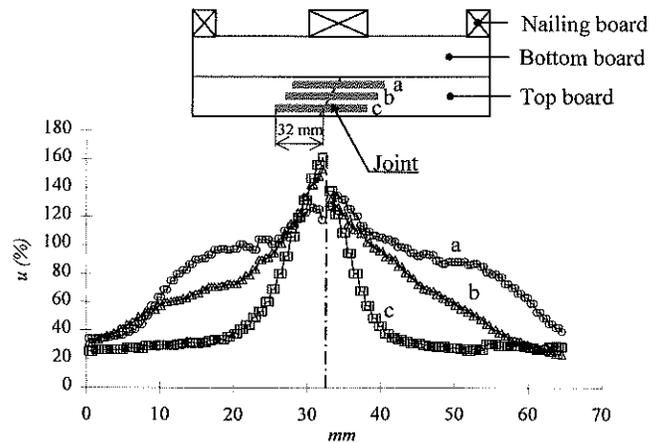
From the CT investigation it is also possible to evaluate the profiles of moisture content in the wood (see Figure 5). During the wetting phase the panelling was oriented vertically. These profiles (after 48 hours) show that the moisture not only enters from the end grain, but they also indicate that the moisture enters from the back of the top board because the

moisture content is of greater magnitude near the back of the panel board than at the front.

Figure 5 Profiles of moisture content in a paneling structure after 48 hours of wetting.

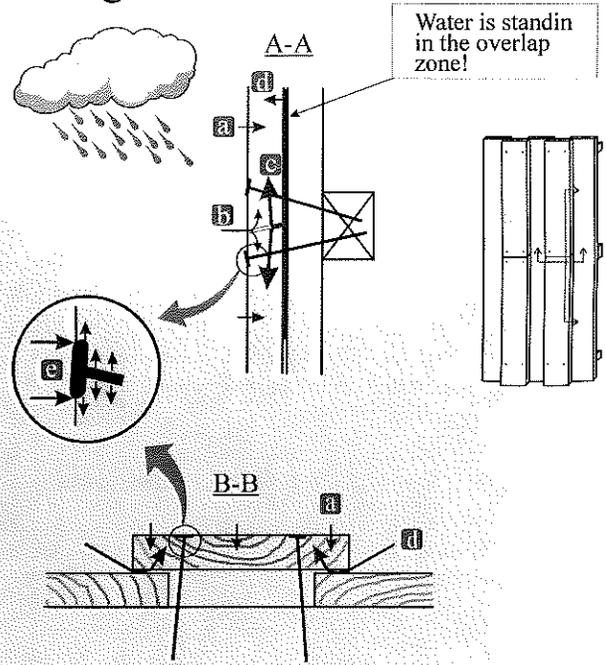
Figure 6 Important paths where water can enter the joint area of painted wood paneling.

- b. *Moisture transport via the joint from the front of the paneling, along the fiber direction.* By capillary suction, water can be transported into the gap between the boards over and under the joint, and once it is there it can be easily transported into the wood. The transport into the wood is a rapid process due to moisture transport parallel to the fiber direction. It will continue as long as there is a feed

- c. *Moisture transport via the joint from the back of the paneling, along the fiber direction.* The water standing in the gap between the top board and the bottom board functions as a reservoir, supplying the end grain at the joint with water. In investigations of houses, free water has been found in the gap several days after it stopped raining. The paint system used on the paneling plays a decisive role; if a hydrophobic paint is used, the risk of capillary suction into the gap will be minimized.

- e. *Moisture transport around the nails.* There is a risk of moisture transport along the nails, with a subsequent moisture transport in the fiber direction. The risk will be pronounced if the nails are driven very far into the board or if cracks appear.

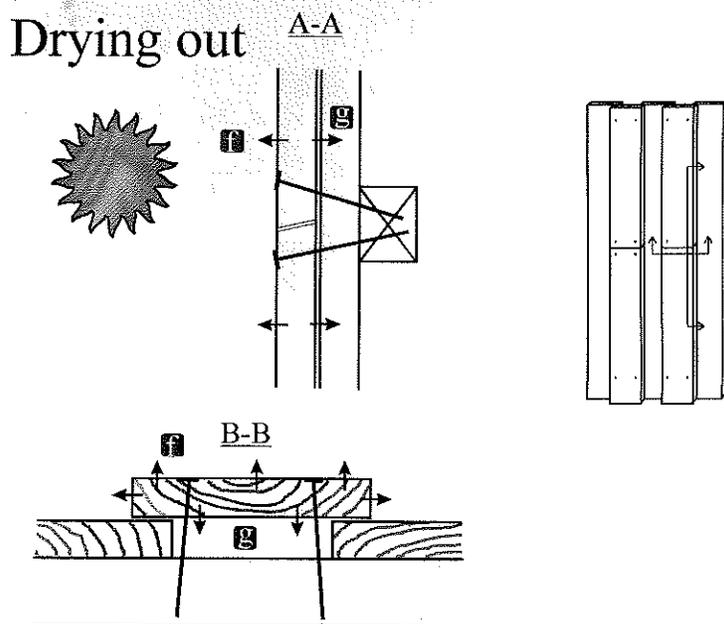
- f. *Moisture transport through the paint film, transverse to the wood fiber direction.* The moisture has to pass through the paint film, which is normally a rather slow process, depending on the paint system used.

- g. *Moisture transport from the back side of the paneling, transverse to the fiber direction.* Normally, there is a ventilated air gap behind the top board that allows the moisture to dry. The lack of paint film makes it possible for the wood to dry out faster, provided that the ventilation is in order.

Figure 7 The most important paths where moisture can exit the joint area of painted wood paneling.
