Temperature and Moisture Performance of Wall Assemblies with Fiberglass and Cellulose Insulation

ABSTRACT

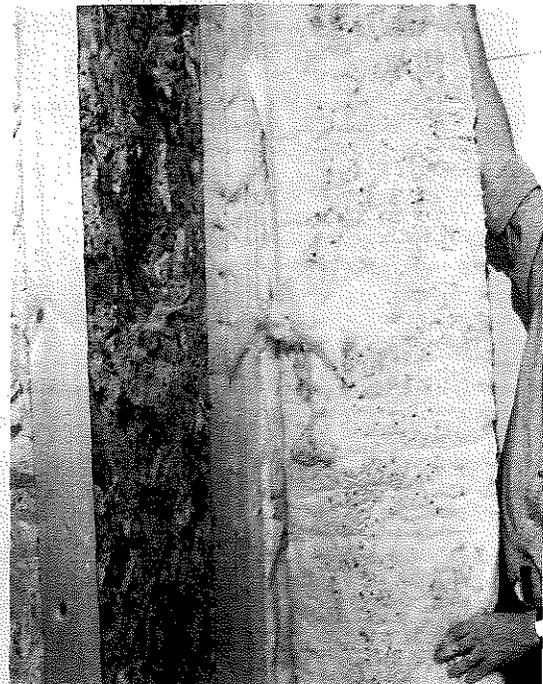
1. The three cavities with no vapor protection—3, 5, and 11—showed mold on the sheathing, uniformly distributed top to bottom and among the three sample cavities. The uniformity of the mold distribution is a strong indication of diffusion/capillary moisture transport and not air leakage in these cavities. Figure 10 shows the worst case of fiberglass without any vapor protection. Figure 11 shows the severe corrosion and mild mold growth in the cellulose-insulated cavity with no vapor protection.

Figure 10 Surface of unfaced R-13 batt insulation showing evenly distributed fungal growth.

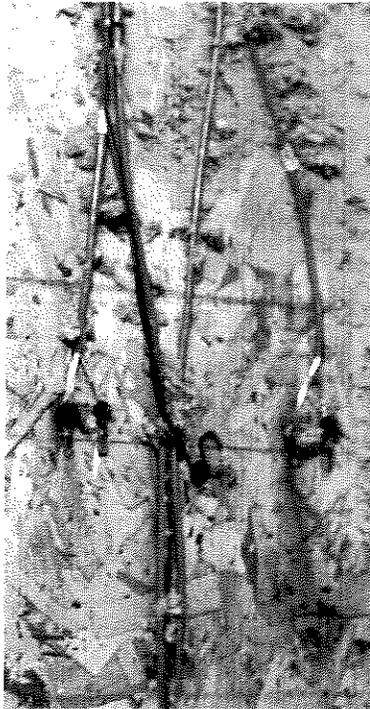
Figure 11 Rust on metal fasteners in cellulose cavity without vapor diffusion protection.

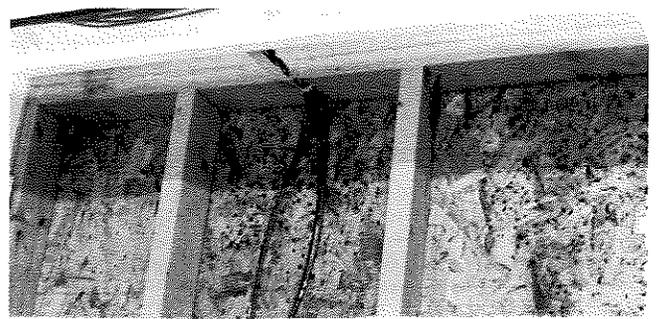
2. The four cavities with polyethylene showed no mold growth at all.
3. All of the fiberglass-insulated cavities with facings showed some mold growth at the tops of the cavities. The mold growth was consistently worse in the middle cavity where the cable penetration would allow moisture entry. However, the adjacent cavities also rather consistently showed some mold growth at the top of the inside of the sheathing. Figure 12 shows mold growth at the top of the cavity, associated with presumed cavity air leakage.

Figure 12 Fungal growth at top of cavity with faced insulation.
