Decision Making on the Indoor Environment and Building Envelope of Canada's Library of Parliament

Stéphane P. Hoffman, P.Eng.

Mark D. Lawton, P.Eng.
Member ASHRAE

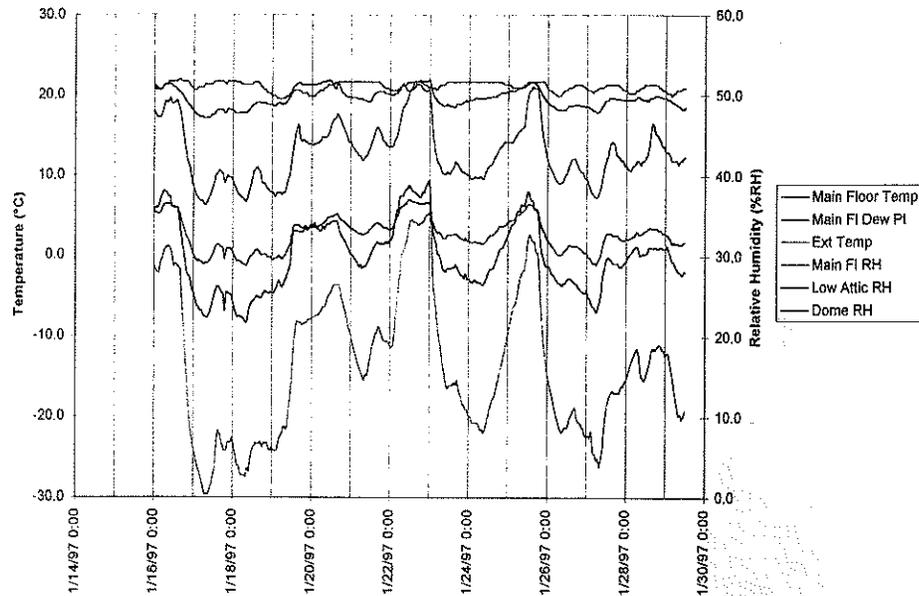
Figure 5 Interior relative humidity during period of January 16 to 29, 1997.

Interior temperature in the main chamber and stacks was relatively stable at 22°C. There was some daily cycling, but this was generally within the desired $\pm 2^\circ\text{C}$ range. Higher variations were noted in the lantern, which could be expected from solar effects through the lantern windows and temperature stratification. Relative humidity and dew point showed considerable cycling related to exterior temperature, especially during the winter months. In winter, when the exterior temperature was above -10°C , the relative humidity in the main chamber was relatively stable at approximately 35%. Below -10°C , the relative humidity in the main chamber fell, and at -20°C , it reached about 25% (Figure 5). Daily cycling

in the main chamber and the perimeter was in the order of $\pm 10\%$, whereas the basement stack areas were within the recommended $\pm 5\%$.

The pattern of variation was characteristic of a building with significant air leakage for which the existing mechanical system could not compensate.

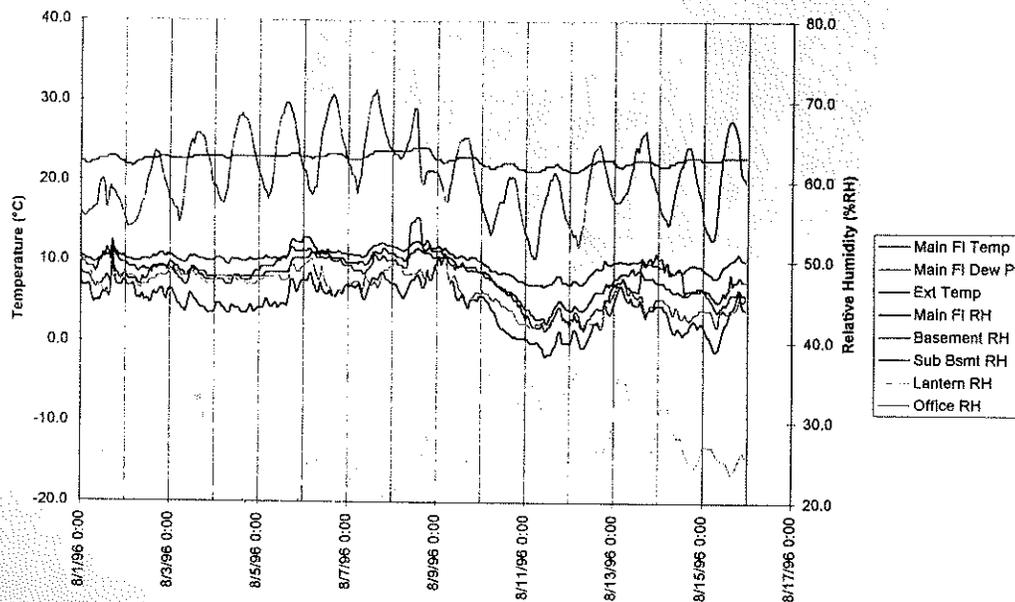
Figure 6 Interior relative humidity during period of August 1 to 15, 1996.

During the summer period, when the exterior dew-point temperature was between 10°C and 20°C , the relative humidity in the main chamber was relatively stable at approximately 45%. Above 20°C outdoor dew point, the relative humidity in the main chamber rose to approximately 50%, and below 10°C , it fell to about 40% (Figure 6). Diurnal cycling of the relative humidity in the central areas of the library and the adjacent perimeter areas directly served by the HVAC system was generally within the recommended $\pm 5\%$.

mer, and the pattern of change was very closely related to the outdoor dew-point temperature. This indicated that indoor conditions were also being driven by the entry of warm moist air in the summer and that the dehumidification systems could not maintain the desired relative humidity level.

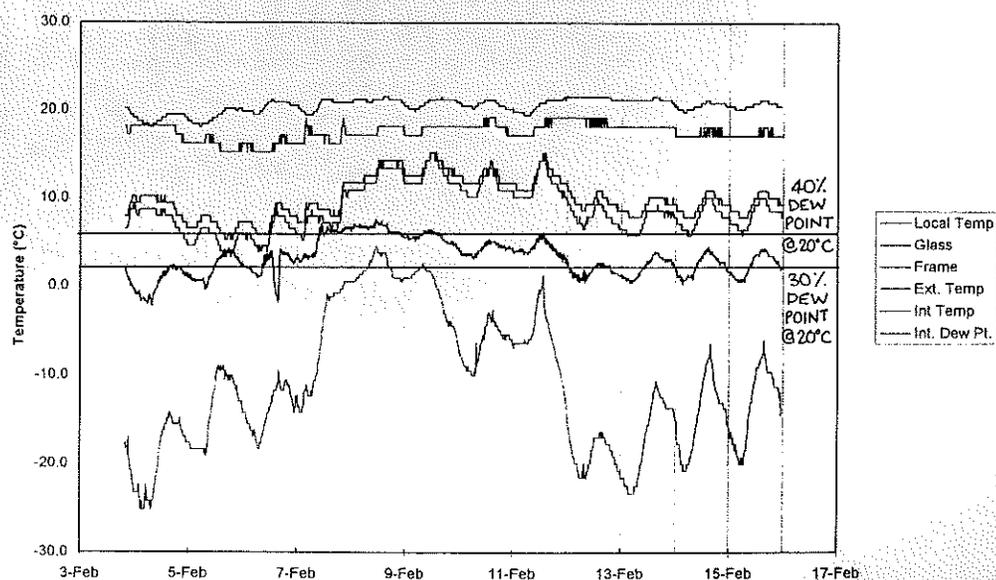
Figure 7 Surface temperature of clerestory windows during period of February 1 to 15, 1996.

The existing glazing systems used for the main clerestory windows and the lantern windows appeared to be performing adequately. The combination of an interior single-pane window and an exterior lead glazed storm window on the

clerestory windows performed as well as the double-glazed insulated units of the lantern windows despite the large air space between the storm unit and the interior glazing. Comparison of the surface temperatures of these windows with the dew-point lines for 30% and 40% relative humidity (Figure 7) showed that these windows could support 30% RH with only occasional periods of condensation but would experience frequent periods of condensation at 40% RH. This was supported by the fact that surface condensation on these units was observed on only one occasion during the winter period, which coincided with a site visit carried out during a period of sustained cold weather.

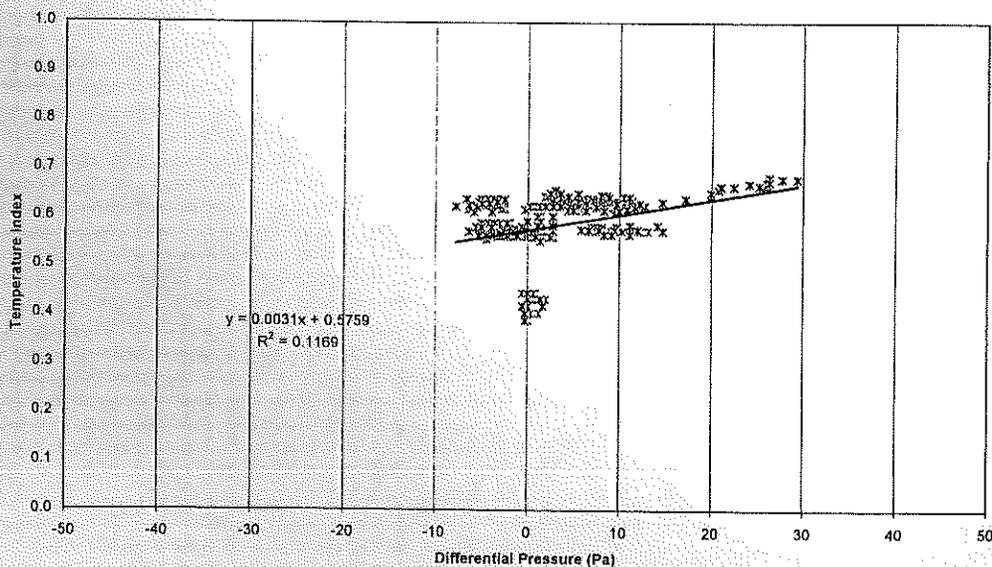
Figure 8 Nightly temperature index as a function of pressure differential across the low attic roof assembly during period of February 16 to 27, 1996.

The cavities in the main roof, low attic roof, and lantern wall assemblies were also instrumented. The cavity temperature and dew-point temperature in both the main roof and low attic roof assemblies were generally very close to the ambient interior air temperature. The calculated temperature index of the main and low attic roof cavity, a normalized ratio of the cavity temperature and the interior and exterior temperatures, showed a gradual rise with respect to the pressure differential across the envelope, as illustrated in Figure 8. This can be interpreted as an indication of air leakage across these assemblies. The cavity temperature is raised by exfiltration of warm indoor air across the envelope. Furthermore, judging from the slope of the trend line, the amount of air leakage was substantial.

There was visual evidence of damage caused by condensation in the envelope assemblies containing cavities. Ice formation was observed in the insulation of the roof and lantern wall assemblies. The bases of the main and low roofs are areas of noted stone deterioration, which could be attributed to wetting from water exiting the roof assemblies. Localized moisture damage was also observed in the interior fireproofing of the peak attic and dome space, where condensation runoff from the roof assemblies had found its way through perforations in the steel deck.

- Undertaking measures to control or reduce air leakage through the roof and lantern wall assemblies or, at a minimum, carefully review the design and existing condition of the waterproofing and flashing details in the roof assemblies to ensure condensation runoff from the roof assembly is drained away from the top of the masonry ringwalls and the numerous projections such as buttresses and pinnacles. While some reduction of air leakage and condensation in the roofs could be achieved by sealing interior surfaces, elimination of condensation will probably require removal of the copper roof and installation of a membrane at the roof deck plane.
