# Building Material Problems Caused by Condensation at an Enclosed Swimming Pool and an Enclosed Ice Rink

Martha G. VanGeem, P.E.  
Member ASHRAE

## ENCLOSED SWIMMING POOL

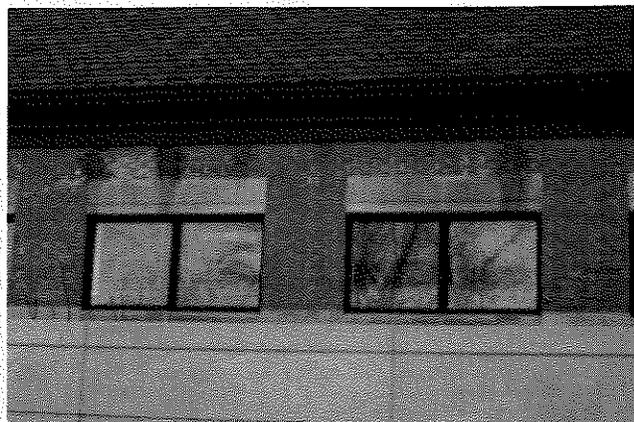
Laboratory testing of the brown-stained water samples taken at pool area roof eaves indicated that the source of the brown-colored material was the OSB of the ventilated deck boards.

**Figure 1** Stains on brick masonry below pool area roof eaves.

Visual review of the building exterior confirmed the presence of several brown stains on the brick masonry immediately below the pool area roof eaves (Figure 1). These stains were not limited to the areas below the skylights and appeared uniformly distributed. It appears that the staining was caused by condensed water that formed on the outside surfaces of the ventilated deck boards. This condensed water would dissolve brown, water-soluble compounds within the OSB and would flow down the roof deck, discharging at the eaves.

In general, the roof and walls were constructed in accordance with design plans. The reported leaks in the skylights in the pool area were attributed to condensation in the roof assembly. The brown stains at the exterior walls were also attributed to this condensation. As water condensed on the ventilated deck boards, it either leaked to the interior at the skylight openings or ran down over the surfaces of the OSB and discharged at the eaves. Condensation at the skylights was further exacerbated by the presence of steel support angles around the perimeter of the skylights. These steel angles caused thermal bridging that resulted in their low surface temperatures. The warmer, humid inside air condensed as it came in contact with the cooler steel surfaces.

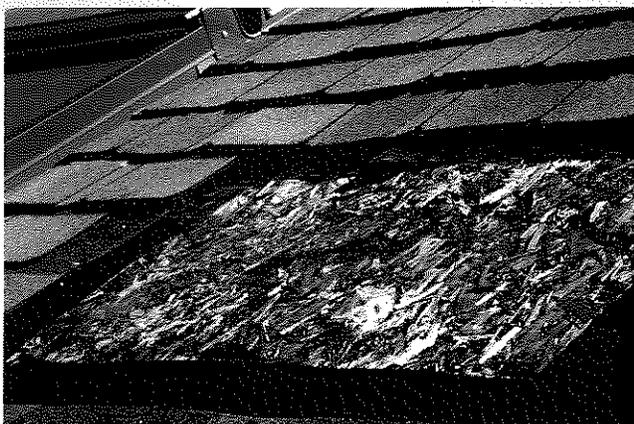
Observations within exploratory openings into the exterior roof surface revealed water damage to the OSB boards in all cases. The water damage was accompanied with mildew in areas adjacent to the skylight (Figure 2). This condition was attributed to the presence of the ice and water protection membrane placed over the outer OSB board in those areas. The presence of this relatively impermeable layer slowed the

**Figure 2** Mildew on OSB board in roof areas adjacent to the skylight.

evaporation of the condensate from the OSB boards and promoted mildew growth. In all exposed areas, the damage caused by the condensation was severe enough to adversely affect the physical characteristics of the OSB boards.

Recommendations for installing a vapor retarder in the roof assembly were to remove all components down to the tongue-and-groove wood deck and to rebuild them. The new roof assembly should contain a ventilated air gap between the top of existing tongue-and-groove decking and a new vapor retarder. Adequate insulation, nailer boards, and roofing materials should then be placed over the vapor retarder.

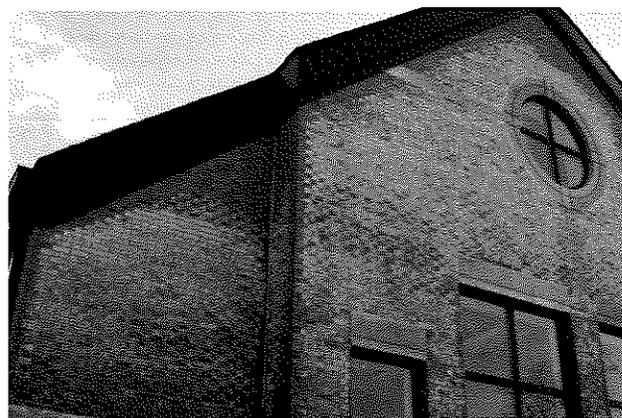
**Figure 3** Efflorescence on exterior masonry surface.

Severe efflorescence was observed on exterior masonry surfaces at the north wall (Figure 3). Efflorescence was also observed on the east and west walls of the pool area, as well as the fireplace chimney on the east elevation. The fireplace was located in a lounge area adjacent to the pool area.

The efflorescence observed on the exterior masonry was also attributed to lack of a vapor retarder. In the absence of an effective vapor retarder, warm, humid air from the pool area penetrated the porous plaster finishes, CMU, and rigid insulation. As it reached the colder surfaces of the exterior brick, it condensed. This condensed moisture was continuously driven toward the outside by higher water vapor pressure on the inside. As it passed through the porous mortar, it dissolved water-soluble salts such as calcium carbonate and brought these salts to the outside surfaces of the brick. Eventual evaporation of the moisture left these salts on the masonry surface in the form of the observed efflorescence.

Recommendations were to provide a continuous vapor retarder in the exterior wall assemblies by installing a vapor retarder over the existing interior surfaces. Rough surfaces should be smoothed to prevent puncturing the vapor retarder. A layer of moisture-resistant wallboard (such as cement board) or cement plaster can then be installed over the vapor retarder. The interior surfaces of the wallboards should be finished and painted with a vapor retarding paint.
