Field Observations and Laboratory Tests of Water Migration in Walls with Shiplap Hardboard Siding

George A. Tsongas, Ph.D., P.E.

CASE STUDY FIELD OBSERVATIONS

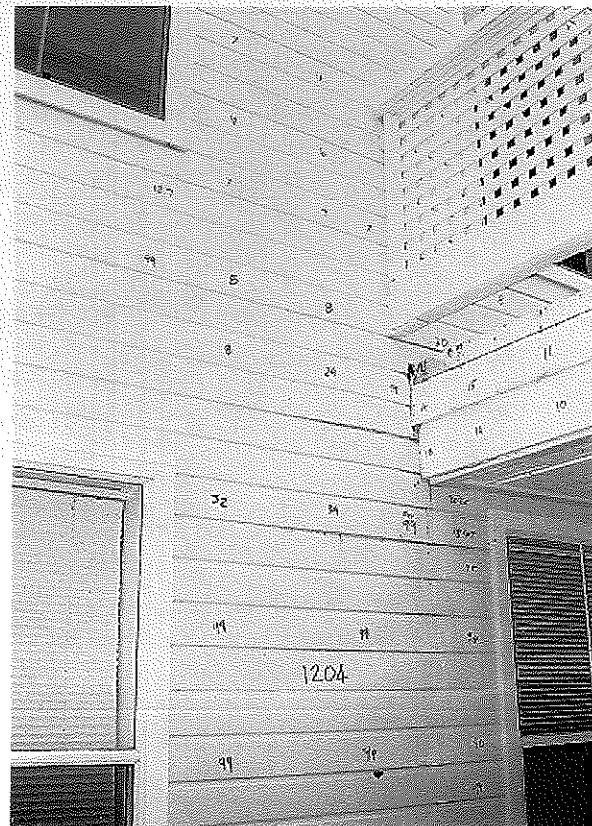
There were a number of causes of the water intrusion, but the main reason was poor flashing details. One main source of water intrusion involved rainwater that collected on many second- and third-story concrete entry landings and readily entered the wall at the wall-landing intersection where flashing was clearly improperly installed. We found many finger- and pencil-sized holes, and we estimated that each would allow entry of many gallons of water into the wall cavities during heavy rains. That resulted in serious deterioration of the siding and the associated wood trim, as well as other wall cavity components such as the building paper and the OSB and gypsum sheathing.

An example is presented in Figure 1 that shows siding that was later removed from three stories of wall in an area where such a point source of water caused swelling and decay below it. The values marked on the siding are its moisture contents measured with a pin-type moisture meter. The readings of 7% to 8% above and to the left of the point leak source indicate the siding is normally dry in those areas, whereas the readings below the leak site are much higher and indicate the siding has been wetted by the water leaking behind the siding (values of 99 written on the siding indicate the moisture content is above the 40% upper limit of the meter). Figure 2 shows the same location after the siding had been removed for inspection. The deterioration noted is directly below the point leak source found where flashing at the intersection of the wall

Figure 1 Front side of hardboard siding near and below third-story point leak source.

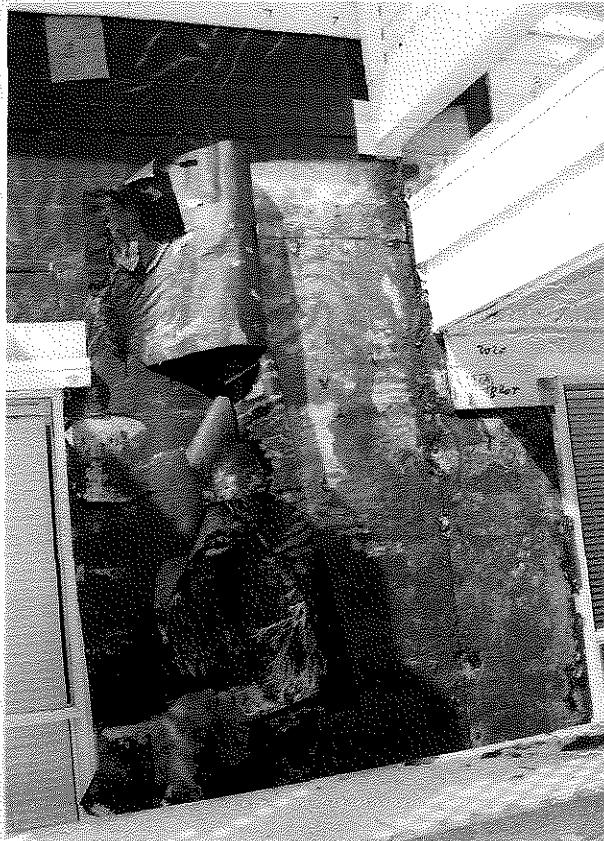
Figure 2 Siding removed from area near and below third-story point leak source.

and the concrete entryway deck was improperly installed. That typical construction condition throughout the apartment complex allowed large amounts of water that collected on the concrete entryway decks to enter the walls and flow behind the siding.

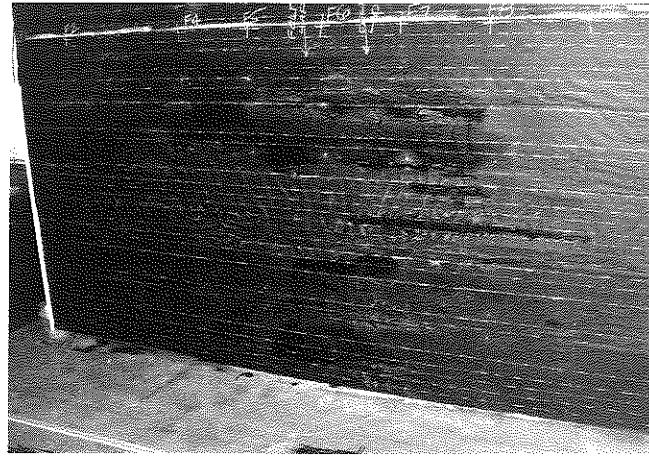
Prior to these tests it had been assumed that water might move laterally primarily along the tight shiplap joints where nailing occurred. That does occur, but it is not the major mechanism for horizontal water migration behind the siding. This test indicated that once the building paper got wet from a leak, the building paper wrinkled with the major wrinkles lying in a horizontal direction such that the water was preferentially channeled horizontally. A photograph of the building paper that was exposed after the siding was removed is shown in Figure 6. While there are some relatively vertical wrinkles in the building paper, there typically were more horizontal ones. It has since been found that when building paper is wetted, it actually expands much more in the direction perpendicular to the length of the roll than in the direction of the roll (Jones and Garden 1966). Thus, the horizontal wrinkles are more than just happenstance. In fact, in examining photos from the field where siding was removed and building paper was exposed, we have noted numerous cases of the same behavior. One such example is shown in Figure 7. In the photograph, the building

Figure 6 Lateral water migration test wall with horizontally wrinkled building paper.

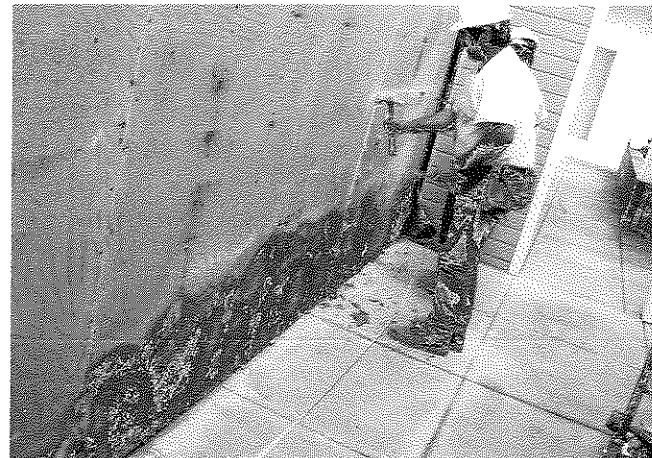
paper has been removed from walls in a breezeway where siding was taken off, but the marks left by the building paper on the gypsum sheathing are clearly distinguishable. Note that the majority of the upper marks are horizontal, although some of the lower ones are more vertical. The wrinkles observed in the field and in the lab test are surprisingly similar. Figure 7 also shows deterioration of the bottom of the OSB sheathing due to wicking of water up into the bottom edge of the gypsum sheathing outside of the OSB.

Figure 7 Wall with horizontally wrinkled building paper marks on OSB sheathing.

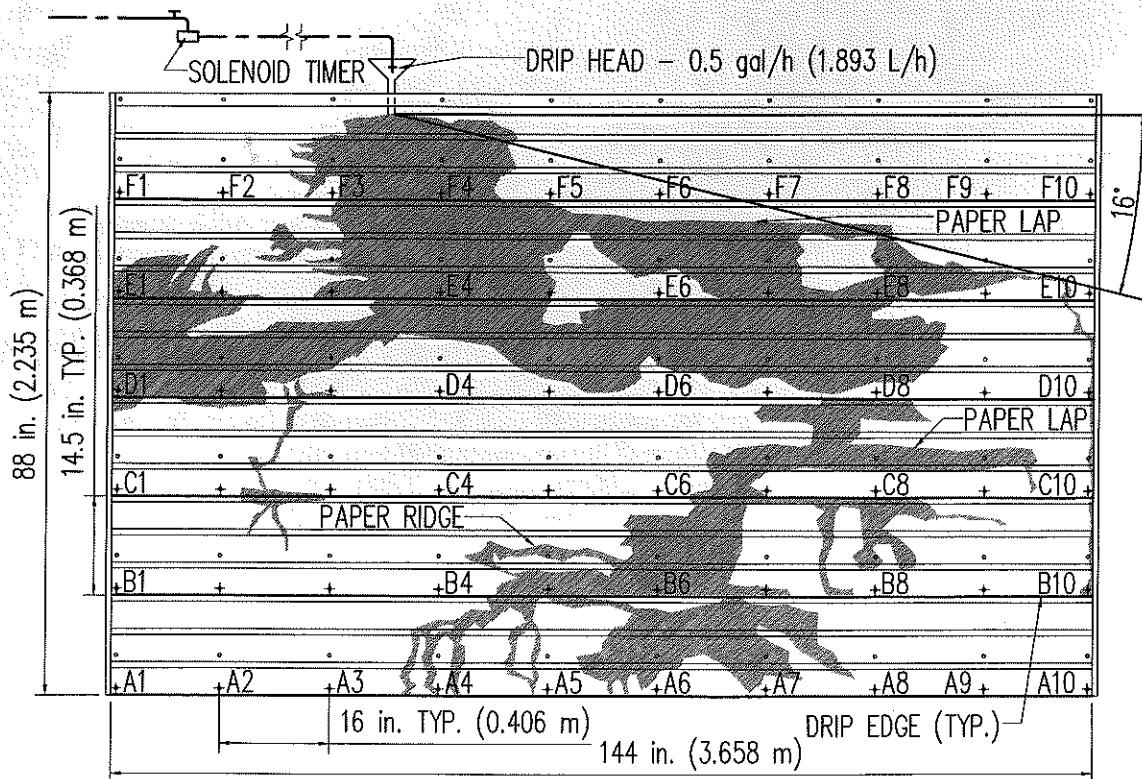
The siding was removed at the end of the four-week test period and set out on the floor to show the water pattern on the backside of the siding. The pattern is shown schematically as the darkened area in Figure 8. It clearly shows how water introduced behind the siding can readily migrate horizontally. Surprisingly similar patterns of horizontal migration of water behind siding have been observed in the field during siding removal for destructive testing.

Figure 8 Water pattern on back of siding at the end of lateral water migration test.

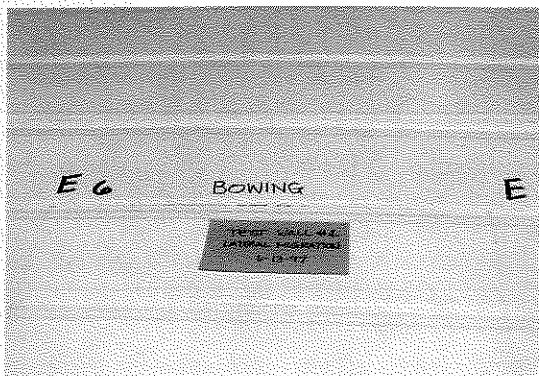
What also is an extremely interesting finding of the lateral migration test is that by the end of the second week of the four-week test, the water absorbed by the siding had caused thickness swelling with consequent micro-cracking of the paint along the length of the bottom edges of the laps. That is identical to what has been noted in the field near leak sites and even away from leak sites. Moreover, after the first two weeks there were indications of the siding swelling such that the siding looked slightly dimpled or puckered at the nail sites and the siding itself became bowed out between the nails that were driven into studs 16 in. (0.41 m) on center both below the point source and horizontally well away from the source. That bowing and dimpling became even more pronounced by the end of the one-month test. Such bowing and dimpling was often seen on site. By the end of the second week, the crack between the boards was noted to open up as a result of the bowing and swelling. A photograph of the bowing and the

Figure 9 Bowing and crack opening observed at end of lateral water migration tests.

resultant crack opening that occurred by the end of the test is shown in Figure 9.

It appears from these tests that such bowing and dimpling noted in the field away from point leak sources was clearly caused by the large amounts of water known to be leaking behind the siding. The horizontal movement mechanism provides an explanation for the cause of many of the cases of isolated siding swelling and bowing well away horizontally from leak sources. Water from a point leak source at the third-story level, as was often found, could easily migrate distances of many tens of feet horizontally and cause siding damage. Unfortunately, the cause of that swelling has often been misdiagnosed in the past during field inspections or destructive testing as being caused by wicking up between the siding laps.

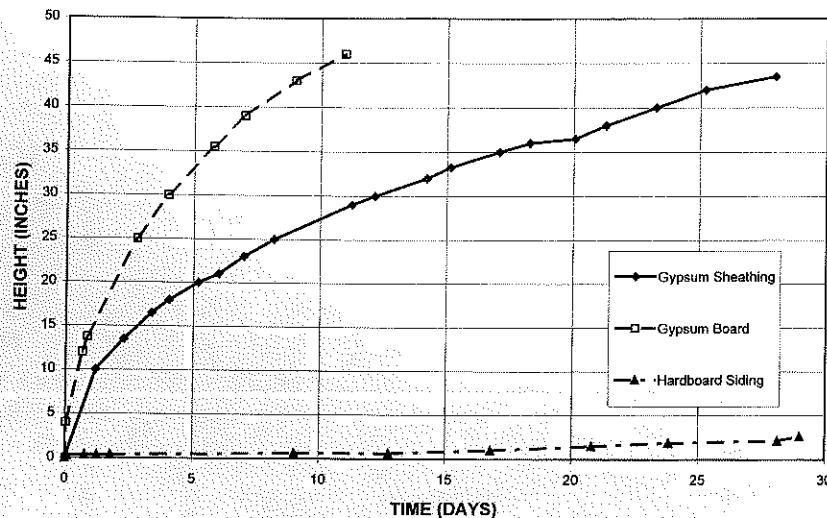
In the first one-day test of the wall with gypsum sheathing, the water wicked up from the bottom of the gypsum sheathing 10 in. to 10.5 in. (0.254 m to 0.267 m) in 24 hours. There was an observable increase in the moisture content of the OSB sheathing and the hardboard siding in that bottom portion of the wall. The only source of the increased moisture content in those materials was the wetted gypsum sheathing.

In the first day of the four-week test of the second wall with gypsum sheathing, the water wicked up 10 in. (0.254 m) just as in the previous test. After that, the water wicked up in ever lesser amounts each day, as shown in Figure 10. Near the end of the test, the water was wicking up the gypsum sheathing at about 1 in. (25.4 mm) per day. At the end of the four weeks, the water had wicked up 43.5 in. (1.10 m). It is notable that the highest wicking in gypsum sheathing observed at the apartment site during destructive testing was 41 in. (1.04 m).

The moisture content of the gypsum sheathing was less than 9% in the area above the line of wicking, whereas it was above 30% (the surface moisture meter limit) in the area below the line of wicking. There was a pronounced effect of the wetted gypsum sheathing on the moisture content of the adjacent OSB sheathing and to a somewhat lesser extent on the hardboard sheathing on the other side of the 15 lb building paper. At the end of the test, when the test wall was disassembled, most of the OSB sheathing was above 30% moisture content, whereas the highest moisture content in the hardboard

Figure 10 Extent and rate of water wicking up gypsum sheathing, gypsum board, and hardboard siding.

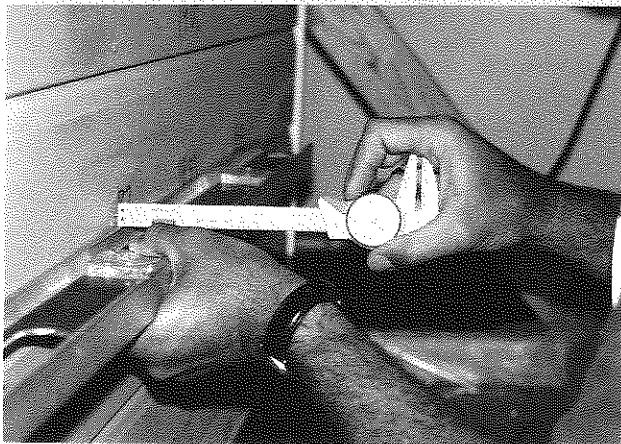
Notably, at the end of the gypsum board test there was bowing and swelling observed on the face of the siding and at the drip edges between nail points. A photograph showing a measurement of the amount of bowing caused by the water introduced behind the siding is presented in Figure 11. The exact same phenomenon was observed in the field where gypsum sheathing and gypsum board had been wetted from the bottom due to rain splashback or ponding. Unfortunately, no check for such bowing and swelling was made after the gypsum sheathing test.

Figure 11 Measurement of bowing between nailheads in gypsum board wicking test.

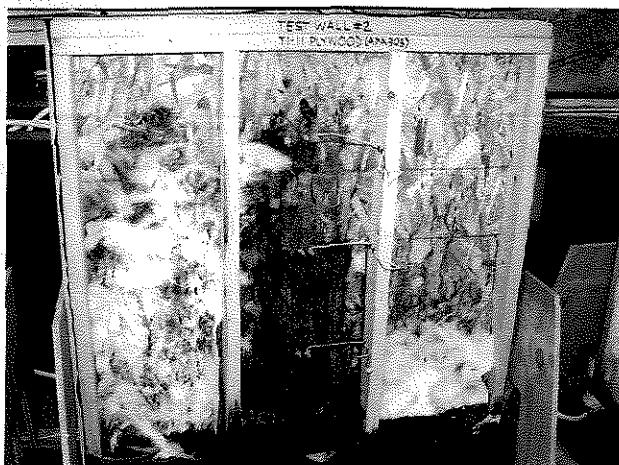
moisture content of about 6% to 8% in both the walls with hardboard siding and the cement siding. However, the sheathing in the walls with the T1-11 plywood siding and OSB siding was above 30% moisture content and thus notably wet and potentially susceptible to decay. That trend continued until the end of the test. At the end of the four-month test, the OSB sheathing in the hardboard and cement siding walls was still dry (6% to 7% for the hardboard wall and 6% to 13% for the cement wall) except right in the vicinity where the water was introduced (7% to 10% for the hardboard wall and 9% to 12% for the cement wall). However, the bulk of the OSB sheathing in the plywood and OSB siding walls was exceedingly wet (over 40% moisture content). This was determined both by using the moisture pins and also by removing the poly and the insulation and exposing the OSB and then surveying its moisture content with an electric resistance pin-type moisture meter.

After removing the poly and the insulation batts in each wall, it was noted that the OSB was clean and largely unstained in the walls with hardboard and cement siding. However, the OSB sheathing in the walls with the plywood and OSB siding was badly stained and darkened and extremely moldy—so much so that the fiberglass insulation batt was stuck to the sheathing and difficult to remove. A photograph of the moldy and wet condition of the OSB sheathing in the wall with T1-11 siding is shown in Figure 12 as an example. The wall with OSB siding had nearly identical deterioration. Such conditions would clearly have been conducive to decay, as was noted in the field where there were leaks into the wall cavity. Given the results of these tests wherein there was little wetting of the OSB sheathing in the wall with hardboard siding, the decay found in the field could only have occurred as the result of significant amounts of water entering the wall cavities as a result of leaks. The degree of wetting in the field certainly led one to believe that the walls were indeed exceedingly wet. The lack of decay in the four-week laboratory tests also indicates that it would take a long period of very wet conditions for decay to occur.

Figure 12 Moldy and wet OSB sheathing in test wall with T1-11 plywood siding.
