# Carbon Monoxide Exposure from a Vehicle in a Garage

Thomas H. Greiner, Ph.D., P.E.  
Member ASHRAE

Charles V. Schwab, Ph.D.

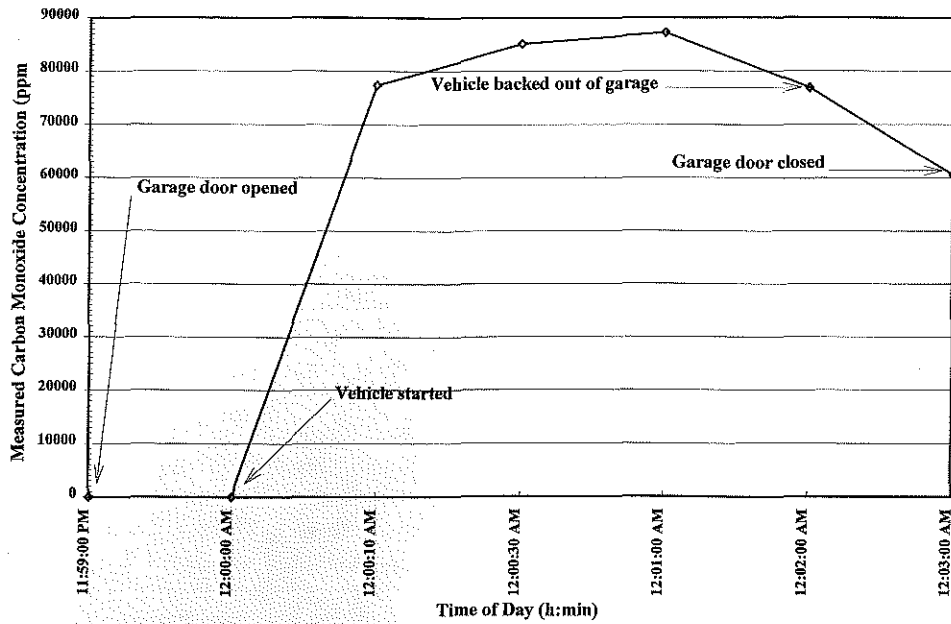
Figure 2 Measurement of CO concentrations in vehicle tailpipe.

Vehicles produce higher carbon monoxide concentrations on a cold start due to cold engine surface, a rich fuel/air mixture, and a cold catalytic converter (ASHRAE 1995). Figure 2 shows the CO tailpipe concentrations. The concentrations reached 87,200 ppm one minute after starting and dropped to 76,900 ppm after two minutes. The tail pipe concentration when the garage door closed was 60,000 ppm. After the vehicle was driven at 20 mph to 30 mph for 15 minutes, tailpipe CO concentrations decreased to 300 ppm.

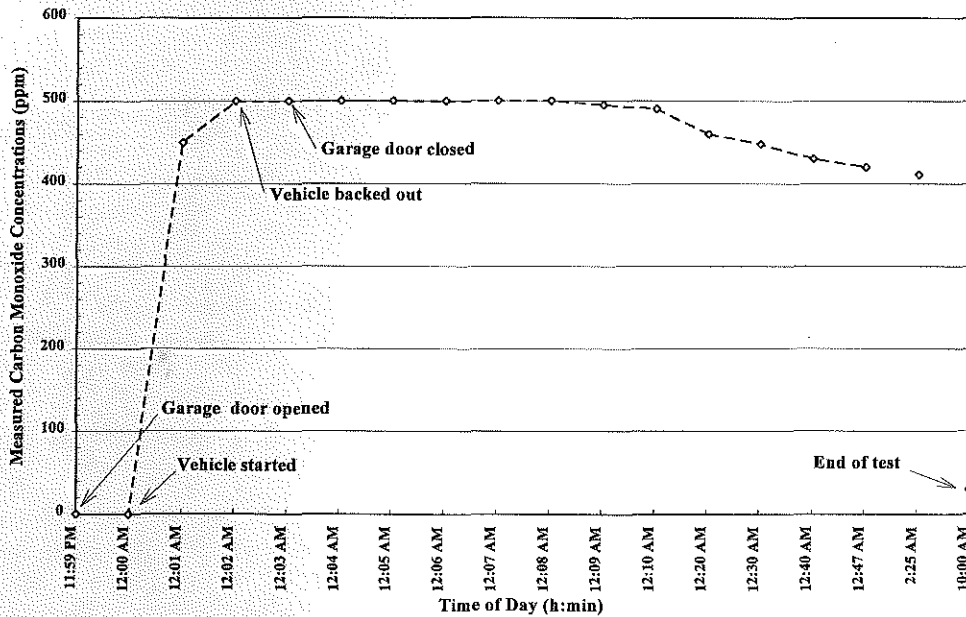
Figure 3 Measured CO concentrations in the garage.

Carbon monoxide concentrations increased rapidly in the garage, even though the overhead garage door was opened (Figure 3). The CO concentrations in the garage increased to 450 ppm after one minute of operation of a cold engine started in the garage. Another minute of operation raised the concentration to 500 ppm. The vehicle was removed from the garage after two minutes and the garage door shut. Carbon monoxide concentrations remained at 500 ppm for six minutes, then began falling to 420 ppm after 47 minutes. Concentrations in the garage remained elevated for several hours after the vehicle was removed from the garage, with 411 ppm after 2 hours, 25 minutes, and 30 ppm after 10 hours. Using a probe from outdoors, no carbon monoxide was detected around the overhead door cracks.

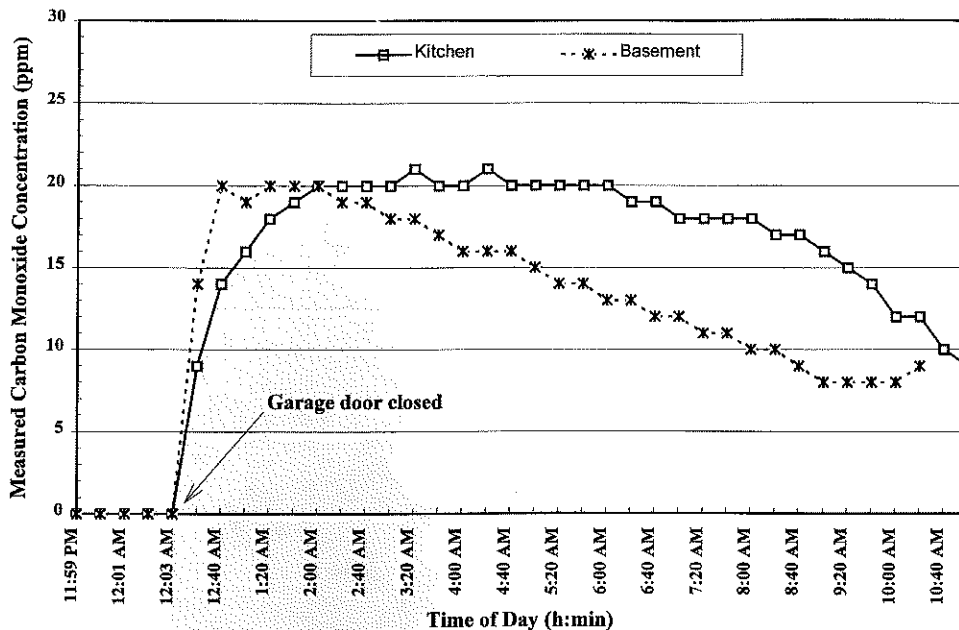
Figure 4 Measured CO concentrations in the kitchen and basement.

Carbon monoxide concentrations in the basement rose to a peak value of 20 ppm after 40 minutes. Figure 4 shows that

concentrations in the kitchen rose more slowly, reaching 14 ppm after 40 minutes. The peak CO concentration for the kitchen was 20 ppm after 117 minutes. Furnace and blower operated as controlled by a thermostat set at 70°F (21°C).

Two hours after first starting the car, concentrations in the kitchen and basement were equal. Concentrations then decreased more quickly in the basement room. At 11 a.m. (11 hours after the car was first started), several doors and windows in the garage and house were opened. Within ten minutes, CO concentrations decreased to an undetectable level.

To avoid future exposures from the garage, an exhaust fan in the garage was designed and installed. The system was sized to slowly remove low-level CO concentrations from the garage and to depressurize the garage relative to the house. Depressurization causes air to flow from the house to the garage, thus preventing garage contaminants from entering the house. An 8 in. (203 mm) diameter, centrifugal in-line duct fan rated at 492 cfm (232 L/s) at 0.125 in. wc (31.3 Pa) static pressure was used. A variable-speed fan controller was installed. Fan speed was increased until the pressure difference between

the garage and house was  $16.0 \times 10^{-3}$  in. wc (4.0 Pa) relative to the house. Flow through the fan was measured at 278 cfm (131 L/s). Operation of the fan effectively reverses flow direction from the garage to the house, as verified using theatrical smoke, pressure measurements, and a tracer gas test. Carbon monoxide, produced by briefly operating a lawn mower in the garage, was used as the tracer gas. Carbon monoxide concentrations in the garage increased to above 600 ppm. After two hours, no carbon monoxide was detected in the house. The garage was then thoroughly aired out by opening outside doors.
