Monitoring Performance of EIFS Clad Dwellings

Eric S. Auman

William F. Egan

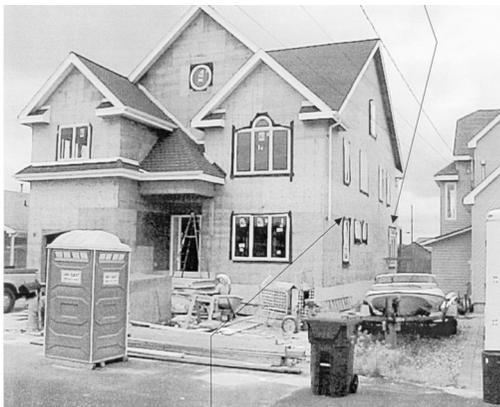
Figure 4 Residence #2, Bricktown, N.J., elevation with logger locations.

Background Information. In the spring of 2000, construction started on a new, three-story wood-frame home with wood-based (plywood) sheathing to be clad with a drainage type EIFS (Figure 4). The home is located on an inlet along the east coast of New Jersey. The data logger system leads were installed over the substrate in July of 2000. Figures 5 and 6 show approximate locations of the data logger leads. All leads except for #1 of logger 1 were located at window mullions or jamb/sill intersections since these were areas of windows that have been subject to water infiltration in the past. Loggers were installed only on this elevation (west) due to logistics of the project. The weather-resistive barrier was installed in August 2000, followed by the drainage type EIFS in the fall of 2000.

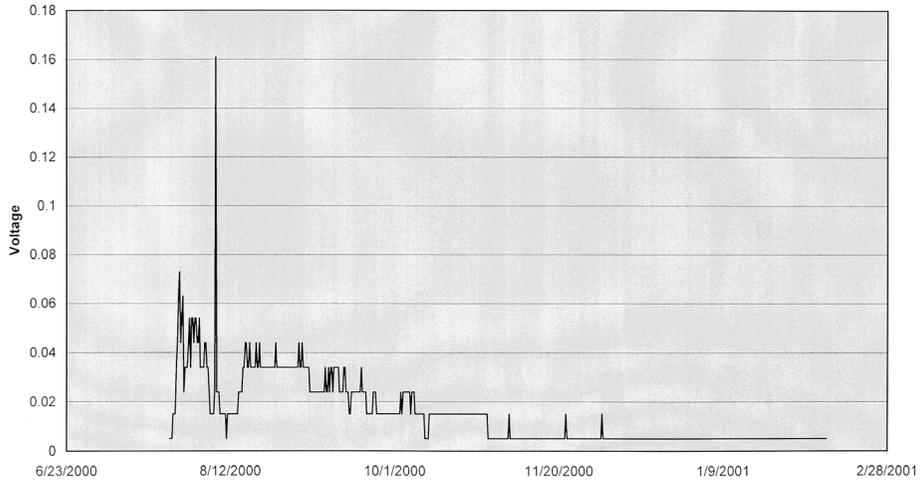
Findings. Figures 7 through 9 are graphs of data from logger 1. For logger #1, data have been recorded from mid-July 2000 through early February 2001. After the early part of September, the three channels in use showed essentially flat line graphs, which indicates little or no change in moisture content of the underlying substrate. The maximum voltage drop was less than 0.05 volts, which, based on the trendlines

Figure 7 Residence #2, Bricktown, N.J., Logger 1—Channel 1.

for plywood sheathing (Figure 2), correlates to percent moisture contents that are significantly less than 20%, which is not a concern for wood decay. Channel 4 of logger #1 was not needed and, consequently, not used. With respect to the spikes on the graph that occurred in August 2000, these are attributable to a time of heavy rainfall when the loggers were directly exposed to the weather prior to the installation of the weather barrier, cladding, flashings, sealants, etc. Although high moisture readings were evident at the time, an item to note is the drop in moisture content after the installation of the cladding, which indicates drying of the underlying substrate.

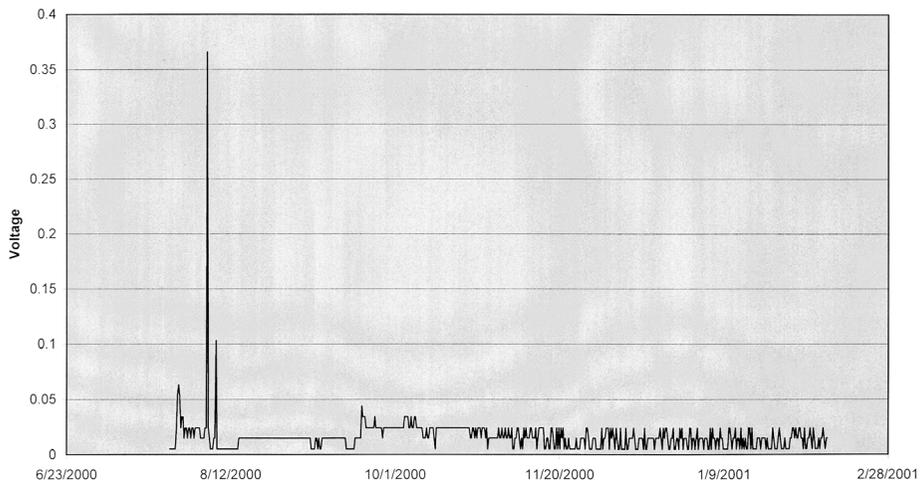
Figure 8 Residence #2, Bricktown, N.J., Logger 1—Channel 2.

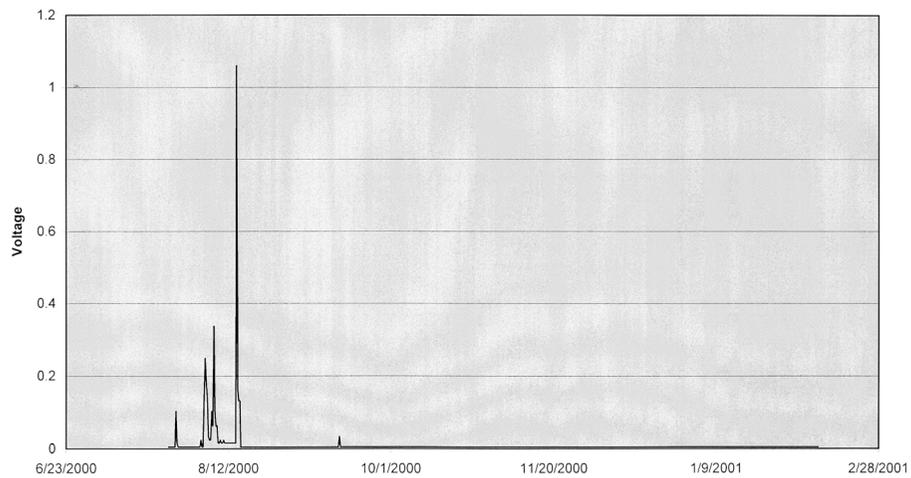
Figure 9 Residence #2, Bricktown, N.J., Logger 1—Channel 3.
