Lessons to be Learned from Performance Failures of Framed Walls in High-Rise Buildings

Mark Lawton, P.Eng.

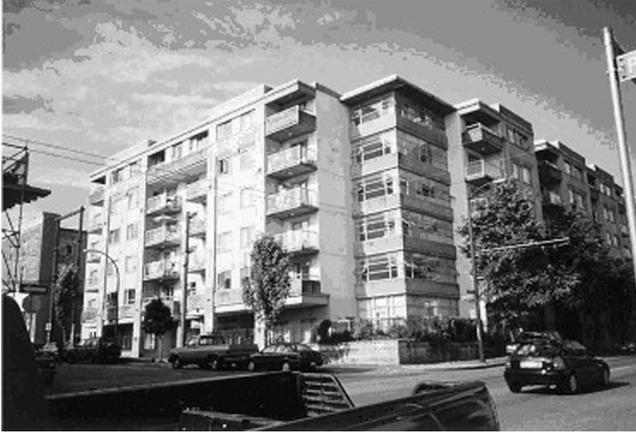
Figure 2 General view of building in Case Study 1.

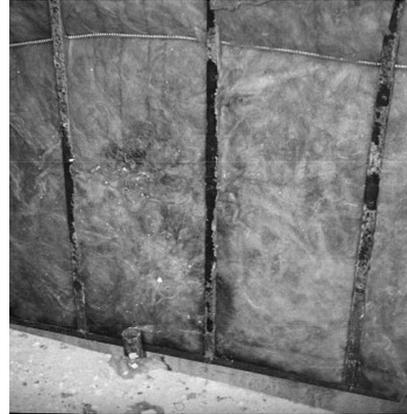
Figure 3 Wall with exterior sheathing removed showing relatively light corrosion on exterior flange of studs.

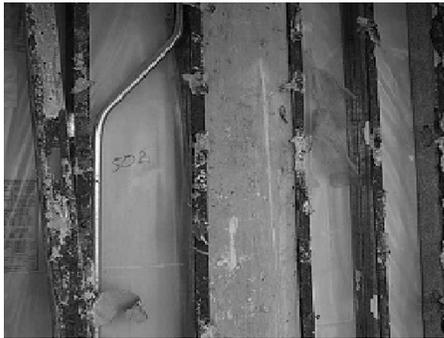
Figure 4 Wall with exterior sheathing removed. Note heavy corrosion of studs and the interior gypsum, inside of polyethylene vapor barrier, is in good condition.

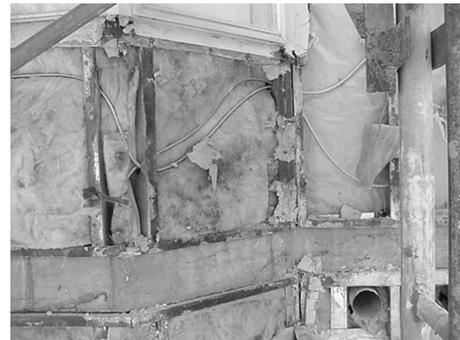
With the bottom track, there is typically the same pattern of corrosion on the outer flange, but often one can also discern a pattern of corrosion indicative of water pooling in the track.

Figure 5 Showing corrosion on top and bottom tracks as well as studs.

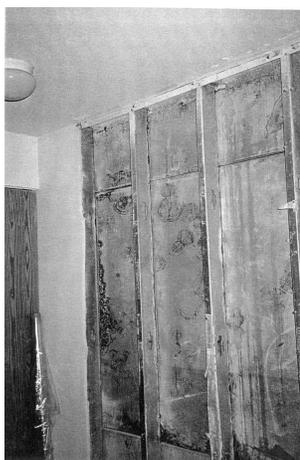
Figure 6 Opening from inside showing degradation of inside face of exterior sheathing.

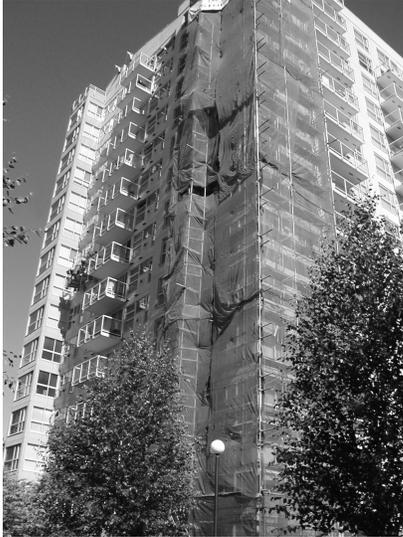
Figure 7 Southeast corner of building (Case 2) where damage was most intense.

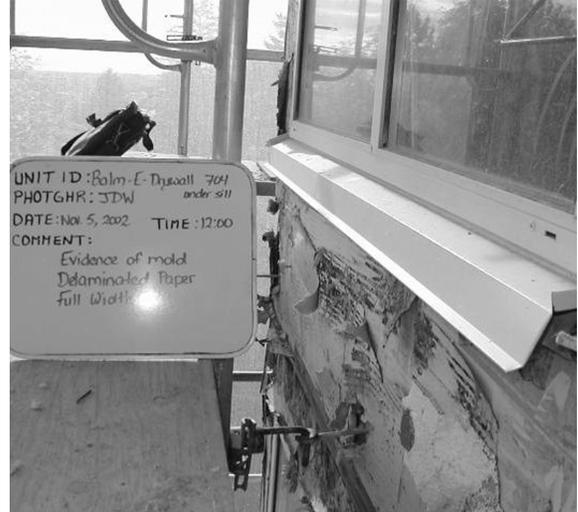
Figure 8 After EIFS removal. Note mold and paper delamination.

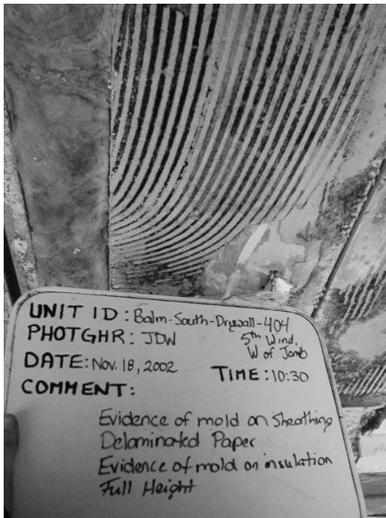
Figure 9 Mold growth on exterior face of sheathing.

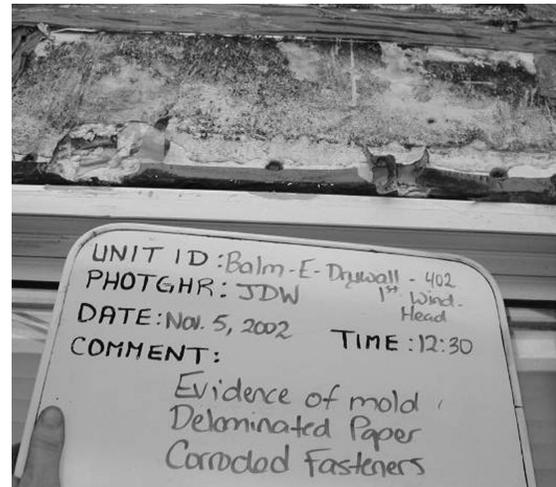
Figure 10 Water damage on exterior face of sheathing.

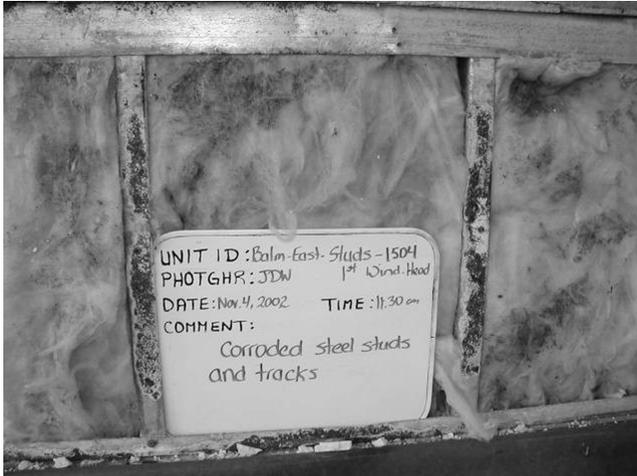
Figure 11 Stud corrosion below window (Case 2).

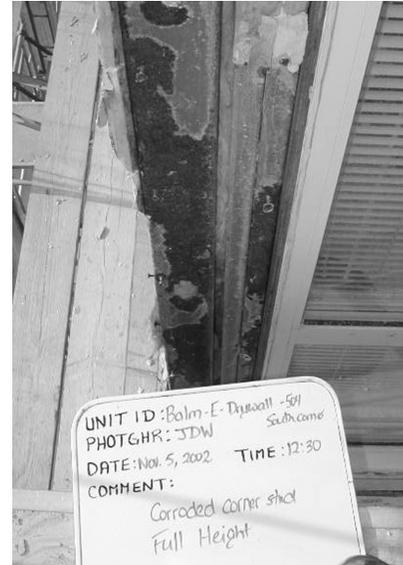
Figure 12 Stud corrosion at SW corner.

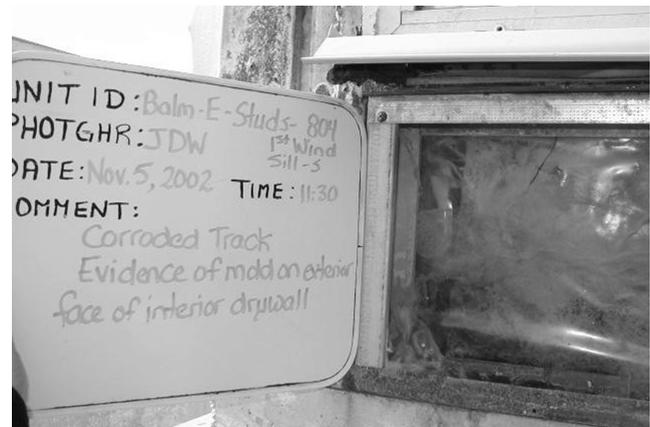
Figure 13 Showing one of limited locations with mold on interior gypsum board.

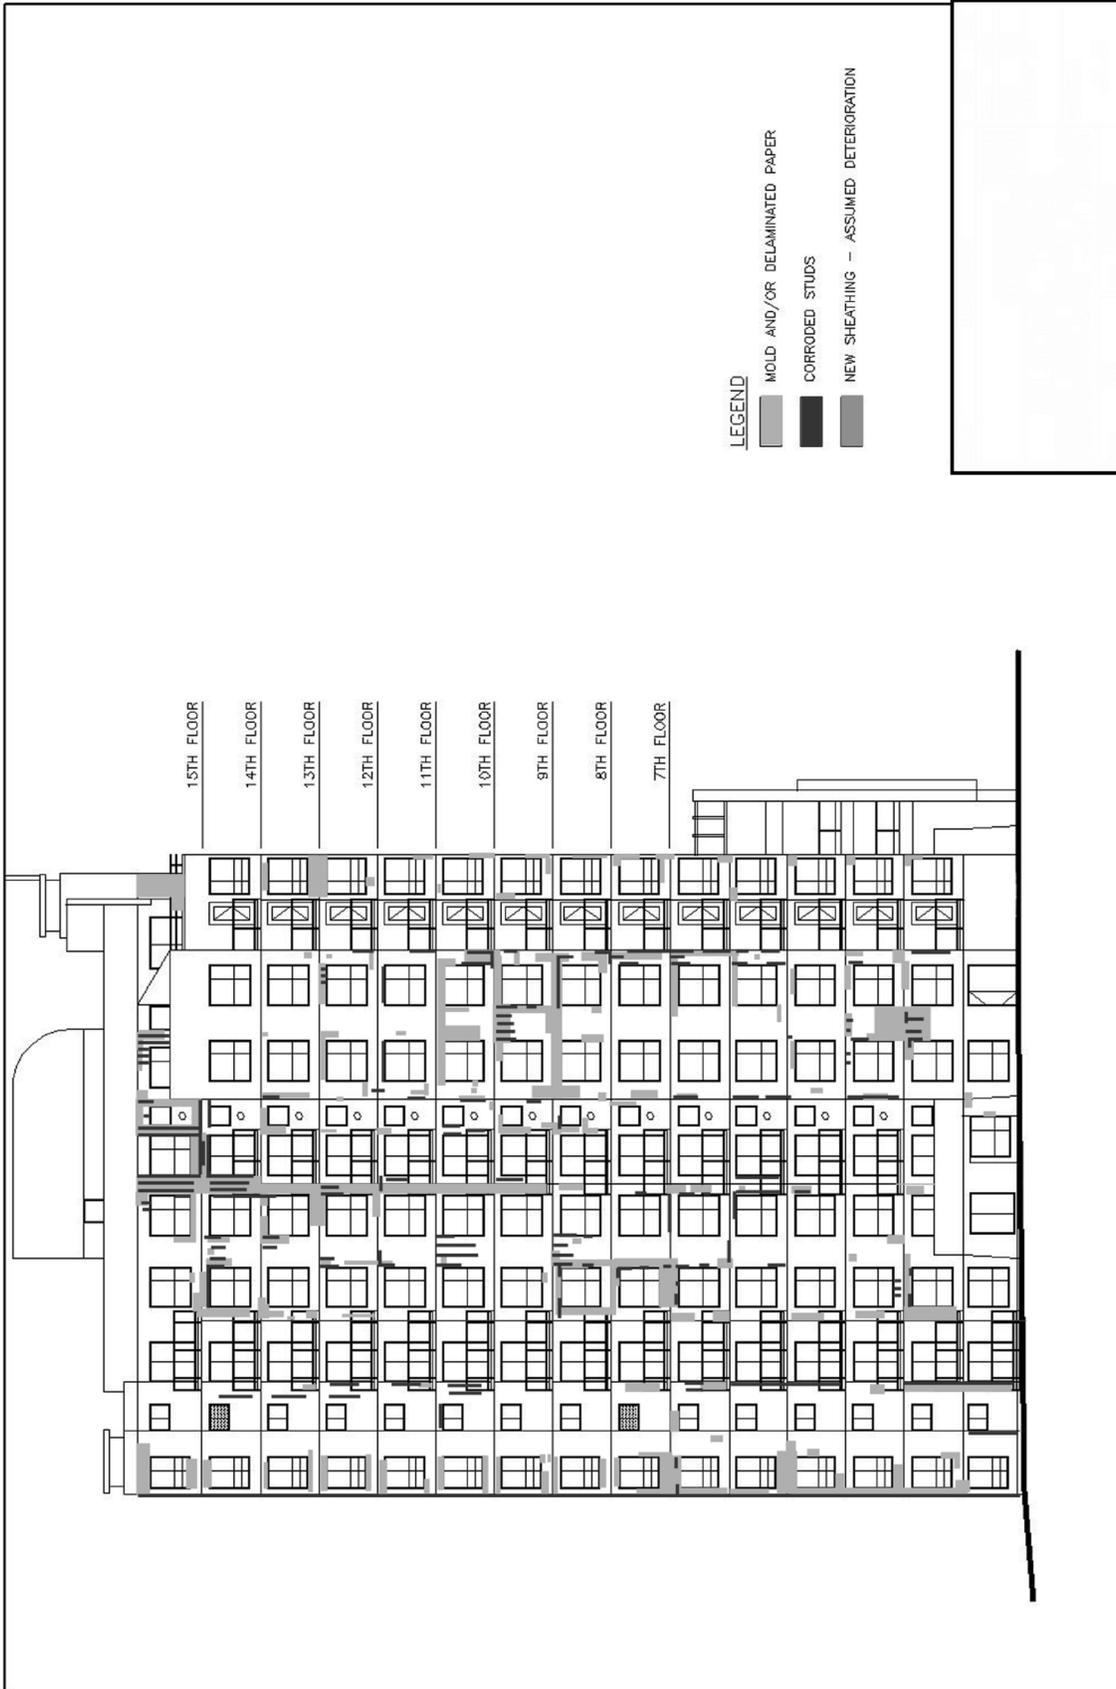
Figure 14 shows one elevation of a building (Case 2) where the original face-sealed EIFS cladding was removed and replaced with an alternate cladding system. The pattern of damage found has been identified on the drawing. The type of

damage includes areas of mold growth on the exterior face of the sheathing, delamination of the paper face from the gypsum core of the sheathing, and corrosion of the framing detected once the exterior sheathing was removed. From an engineering perspective, it is important to note the following:

- The pattern of damage was strongly associated with areas of known risk of rain penetration, notably windows, parapets, balconies, vent hood penetrations, and sealant joints.
- The damage was the worst on the south and east façades of the building. This is the direction of wind coincident with rain in the Vancouver area.
- There were areas of framing corrosion outside of the areas where there was significant observable degradation of the exterior sheathing.
- In this building, there were very limited areas where there was mold growth on the outside face of the interior sheathing. This can be explained, in part, because the sheathing is kept warm, and because it was protected from exposure to exterior source moisture by a polyethylene vapor barrier.

Figure 14 East elevation of Case 2, showing found water damage.

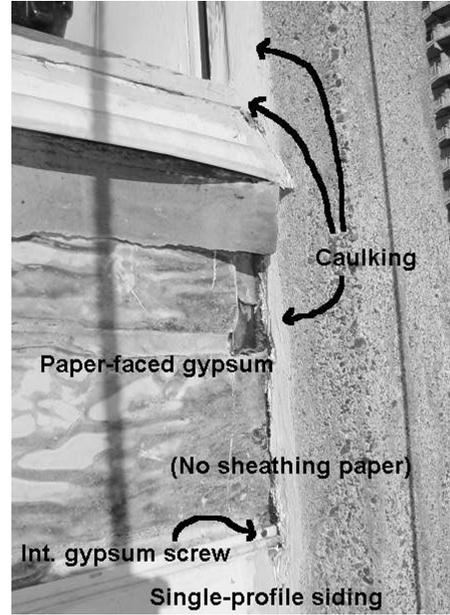
Figure 16 Test opening showing cladding. Note lack of weather-resistant barrier under metal siding.

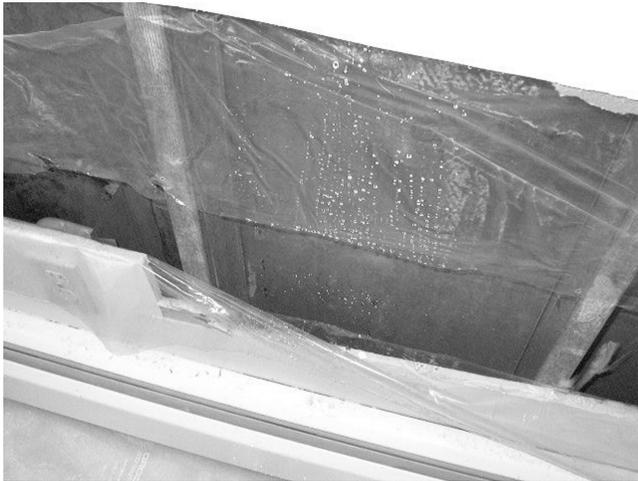
Figure 17 Showing water in frame wall after ASTM E1105 water leakage test.

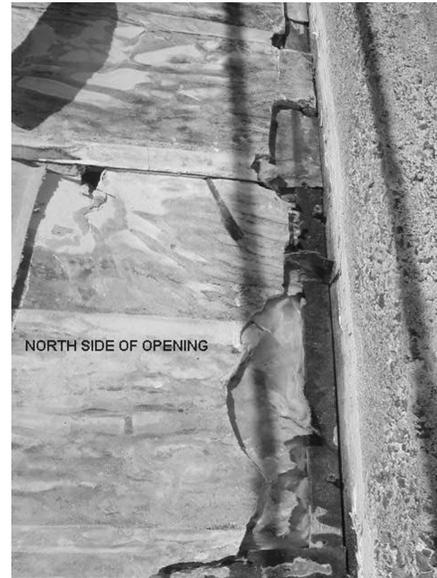
Figure 18 Showing corrosion of framing at test opening.

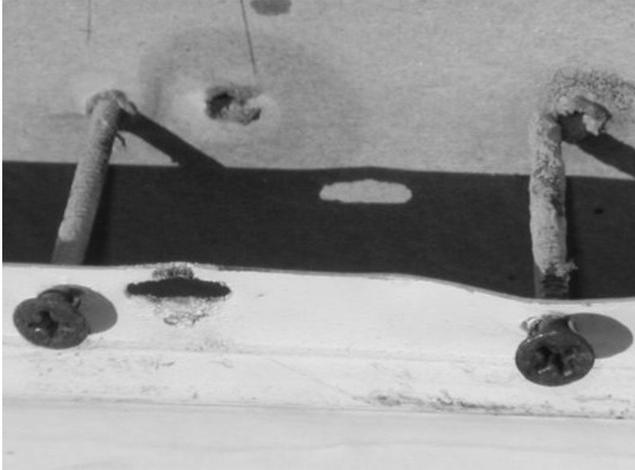
Figure 19 Rusted fasteners that had little pullout resistance (Case 3).

sheathing and metal cladding had been installed with drywall screws. These had limited corrosion resistance and they were corroded to the point that resistance to lateral loads was compromised. These findings prompted the decision to re-clad the walls in conjunction with window replacement.

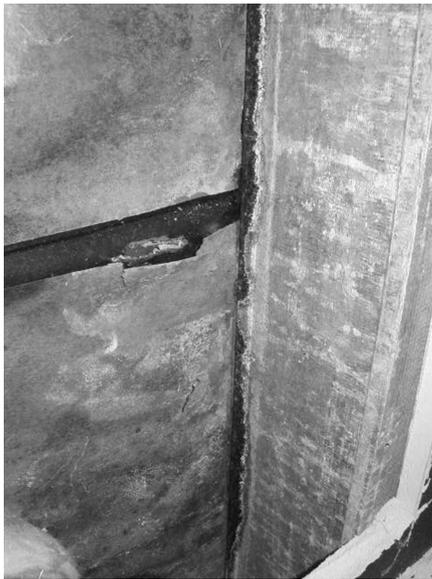
Figure 21 Stud at shear wall. Note corrosion on outer flange.

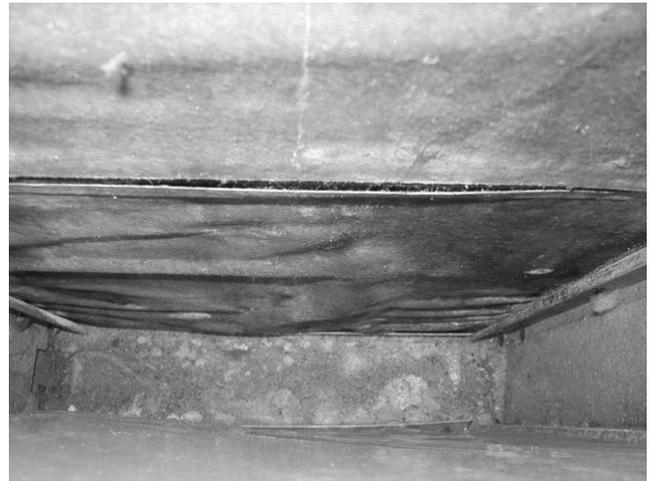
Figure 22 Water damage on interior face of exterior sheathing.
