# Ice Damming: Case Studies in Diagnosis and Remediation

**Mark Lucuik, P.Eng.**

**William C. Brown, P.Eng.**

*This paper will discuss the factors that contribute to ice damming through detailed case studies on three low-rise condominium complexes in Ottawa, Ontario, Canada. Each complex has suffered severe ice damming since its construction. To develop a remediation strategy, we performed a systematic diagnosis of the cause of the ice damming and the implementation of trial repairs at each site. These trial repairs were monitored (temperature and visual indicators), and it was found that the suggested repairs had some benefit on two sites and little benefit on the third.*

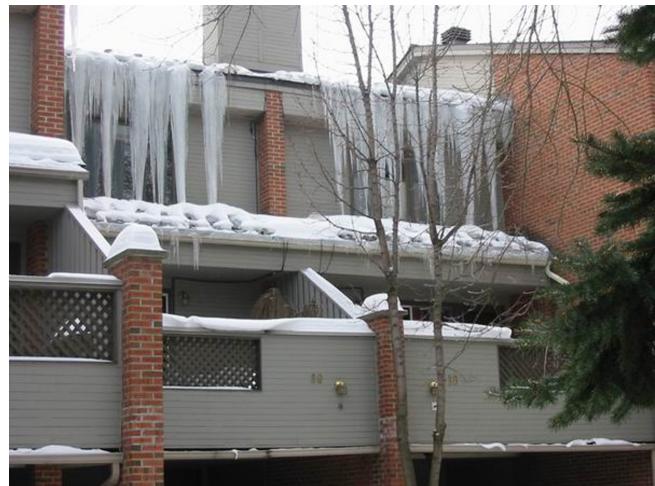
**Figure 1** Site 1, ice formation on non-repaired unit.

Site 1 is a wood-framed townhouse complex constructed in 1984 (Figure 1). The buildings have been experiencing severe ice damming problems since occupancy. The problems have been well documented with reports and photographs. Approximately 85% of the units have experienced ice dam-related roof leaks within the last nine years. Seven consultants

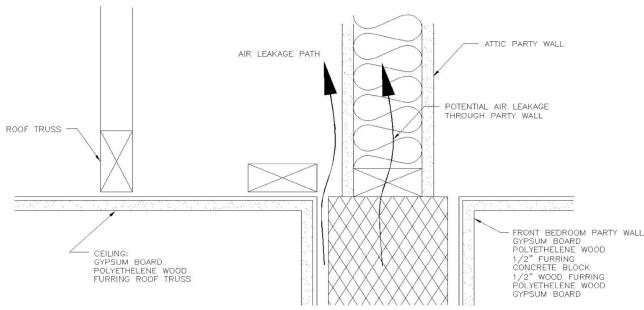
**Figure 2** Air leakage path at party wall.

- We observed a 16 mm gap between the concrete block party wall and the gypsum wallboard below the attic, as shown in Figure 2. This gap was created by the furring between the concrete block wall and the gypsum wallboard. This gap could be a potential air leakage path between the interior conditioned space and the attic.

The remedial solutions developed for each site included air sealing of all of the potential air leakage paths noted above and installing new weatherstripping on attic hatch doors. All repairs were performed under our direction by a contractor familiar with air sealing repairs.

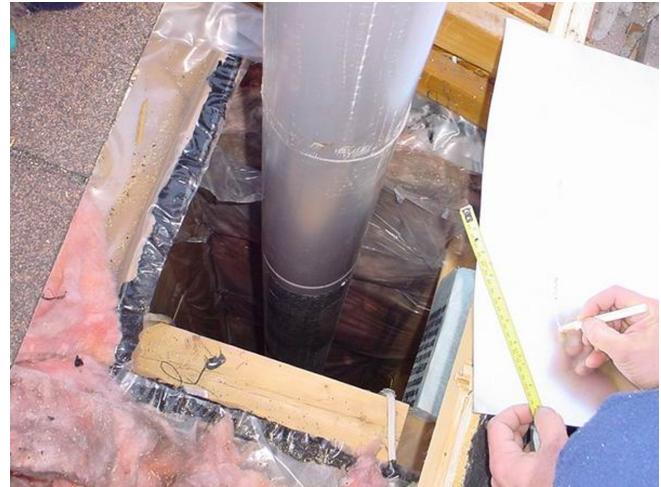
**Figure 3** Site 1, air leakage path at furnace flue in cathedral ceiling.

- The fireplace chimney chase was not sealed as the chimney passed into the attic. A sheet metal baffle was present, but it fit loosely in the chase.
- The furnace chimney (B vent) was not sealed as it passed through the cathedral ceiling (Figure 3).

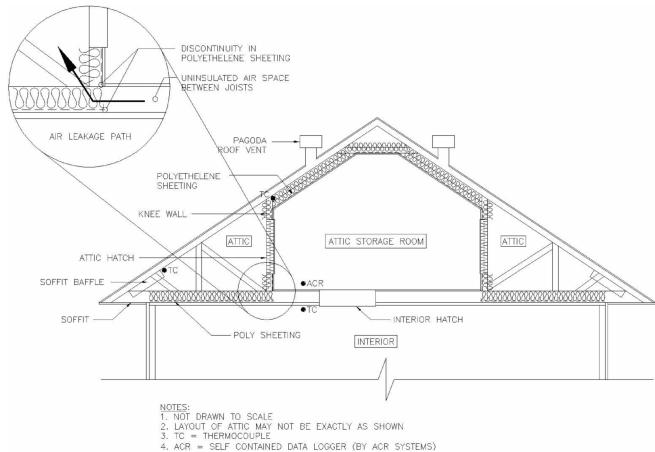
**Figure 4** Site 3, building cross section displaying major air leakage path.

We noted that the units have unconventional floor plans and framing designs (see Figure 4). The units had several half-floors with short series of stairs connecting them. The roofs had an 8/12 pitch and were protected with asphalt shingles on oriented strand board (OSB) sheathing. The attics utilized unconventional engineered wood trusses creating a storage room at the center of the attic. Roof access was not available, and we are not certain what material, if any, had been utilized for ice and water protection at the roof eaves below the shingles. Concrete block party walls were present between the attics of adjacent units.

- We noted that the floor framing that extended past the line of the attic storage room knee wall into the attic spaces was not sealed to prevent air leakage. Effectively, this created a 200 mm (8 in.) deep hole that ran the entire length of the each knee wall through which air could freely enter the attic space (as shown in Figure 4).

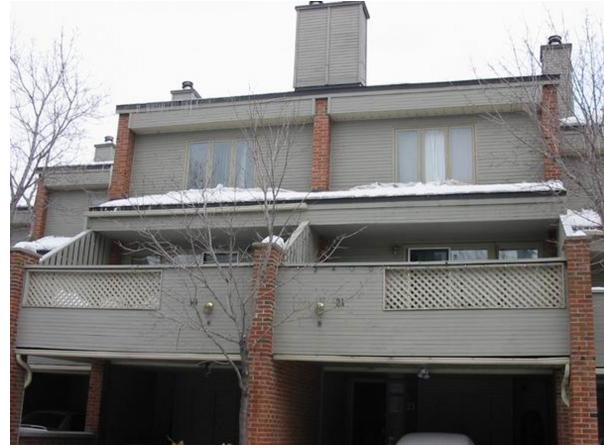
**Figure 5** Site 1, ice formation on repaired units.

Visual reviews at site 1 noted a significant reduction in ice formation during the winter of 2003/04 as shown in Figures 5 and 6. Visual reviews at sites 2 and 3 generally revealed little ice formation and no appreciable difference in the amount of snow or ice buildup between the repaired and unrepairs units.

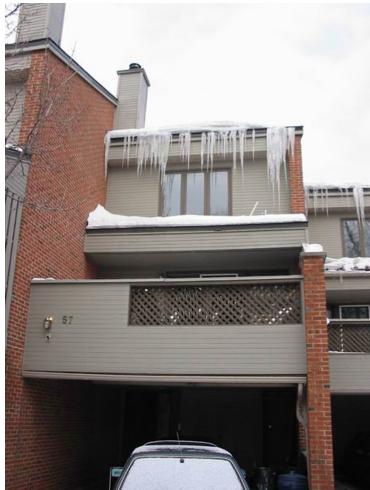
**Figure 6** Site 1, ice formation on unrepairs units.

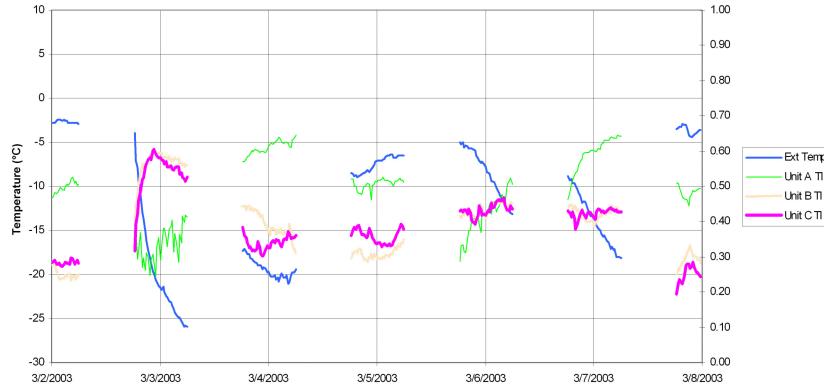
**Figure 7** Site 1, pre-repair, temperature index comparison —night data only.

- **Site 1:** After the repair, the temperature indices of unit B were an average of 0.18 lower (35%) than those of unit A. Prior to the repair, the temperature indices of unit B were 0.10 lower (20%) than those for unit A.
- **Site 2:** After the repair, the temperature indices of unit B were an average of 0.11 higher (37%) than those from unit A. Prior to the repair, the temperature indices of unit B were 0.06 higher (38%) than those for unit A.

At first glance, the post-repair temperature index difference at site 1 appears to indicate that the air sealing may have resulted in a small benefit with respect to the propensity for ice dam formation. However, the temperature index for unit A increased over the period, while the temperature index for unit B decreased. Accordingly, the apparent temperature index decrease for units B and C may be a conservative representation of the benefit of the repairs. This indicates the repairs had some effect on the attic temperatures and propensity for ice damming formation at site 1.

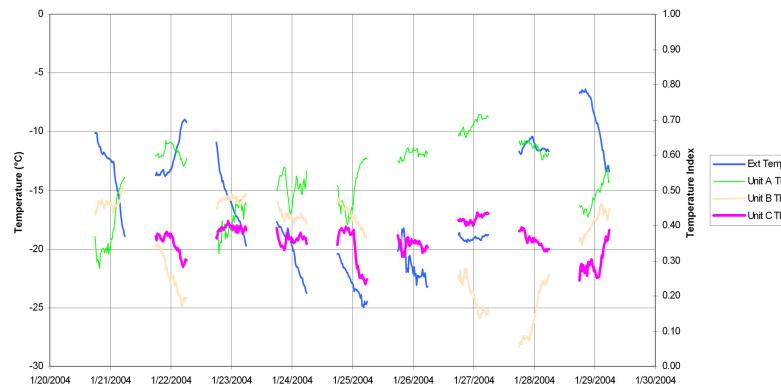
**Figure 8** Site 1, post-repair, temperature index comparison —night data only.

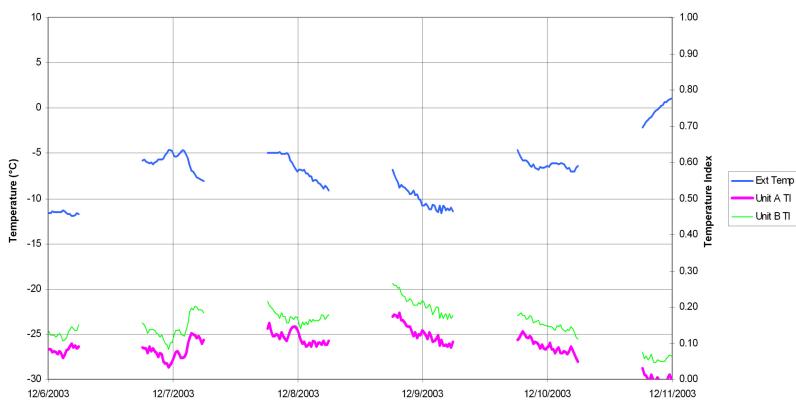
**Figure 9** Site 2, pre-repair, temperature index comparison—night data only.

For sites 2 and 3, the temperature index differences between the repaired and unrepaired units appear to indicate that the air sealing was counterproductive with respect to propensity for ice dam formation. This is counterintuitive and unlikely to be true—air sealing repairs within an attic cannot possibly be the reason for a rise in temperature index. Air sealing repairs only serve to block paths of potential air leakage, so at worst they would have no effect on attic temperatures related to ice dam formation. Accordingly, some other factors must be present that result in this apparent effect. Other factors potentially affecting ice dam formation are discussed later in this paper.

In our analysis, we also noted that the difference in temperature indices at site 2 before and after the repair is similar for both Units A and B. This method of analysis indicates that the repairs had little effect on the attic temperatures and propensity for ice dam formation at this site.

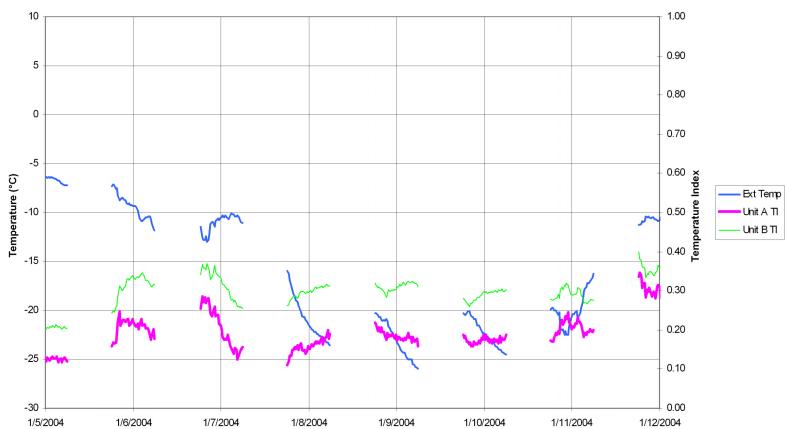
**Figure 10** Site 2, post-repair, temperature index comparison—night data only.

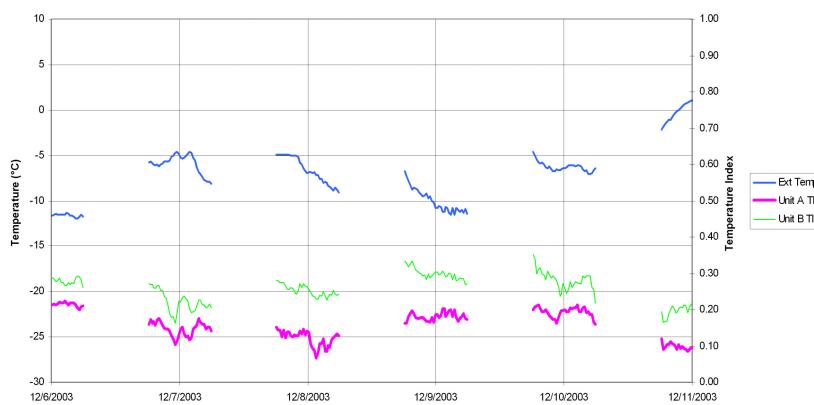
**Figure 11** Site 3, pre-repair, temperature index comparison—night data only.

- **Site 3:** After the repair, the temperature indices of unit B were an average of 0.07 higher (25%) than those from unit A. Prior to the repair, the temperature indices of unit B were 0.11 higher (44%) than those for unit A.

We also observed that the pre- and post-repair temperature index difference for unit A is larger than for unit B at site 3. This indicates that the repairs may have had some effect on

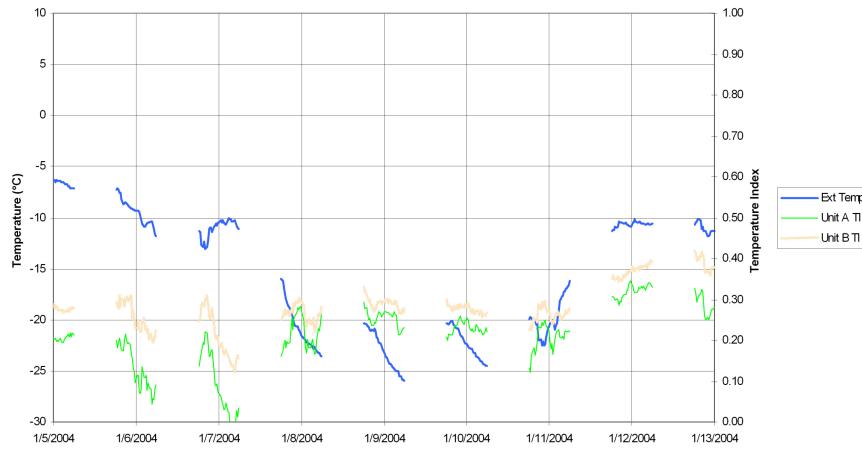
**Figure 12** Site 3, post-repair, temperature index comparison—night data only.
