Moisture Performance of a Contemporary Wood-Frame House Operated at Design Indoor Humidity Levels

ABSTRACT

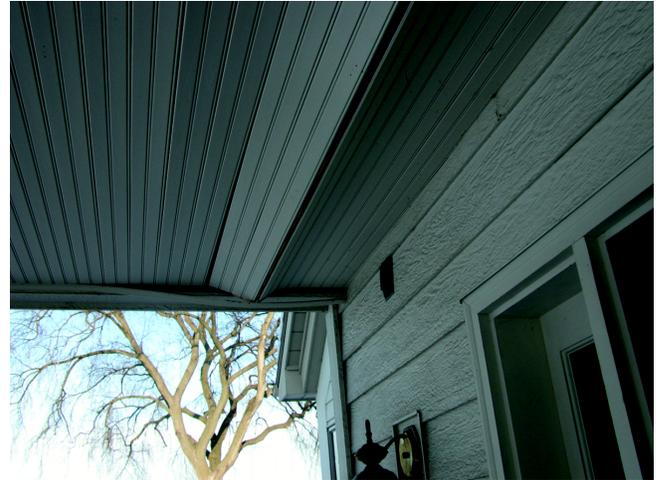
rior porch ceiling was however seasonally wetted, causing buckling and permanent distortion (Figure 4). The pattern lumber was not back-primed. It was nailed to the lower flanges of wood I-joists that cantilevered beyond first story walls; the I-joists supported a second-story bedroom floor that cantilevered beyond the first-story walls. There was no blocking between I-joists where they rested on the top plate of the first-story wall. Outside of the first-story walls and below the second-story bedroom floor, the spaces between I-joists had been packed full of dry-blown cellulose insulation, (using netting to hold the insulation in place). The porch ceiling extended outward beyond the second story bedroom floor to a ventilated soffit. Buckling was restricted to that portion of the ceiling below the bedroom floor (the portion packed with insulation — and not ventilated). Buckling was most extreme near the first story wall. The buckled lumber was of pine sapwood, which has limited mold resistance, but it showed no mold or mildew growth, suggesting that moisture accumulated during the winter was dissipated by the time temperature conditions were conducive to fungal growth¹¹.

Figure 4 Buckled flat-grain pine pattern lumber on porch ceiling in late December of 2005. In contrast to lumber on ceiling, OSB lap siding on adjacent wall is not buckled. Buckled lumber is not defaced by mold or mildew.
