Case Studies of Moisture Problems in Buildings

G. Proskiw, PEng

ABSTRACT

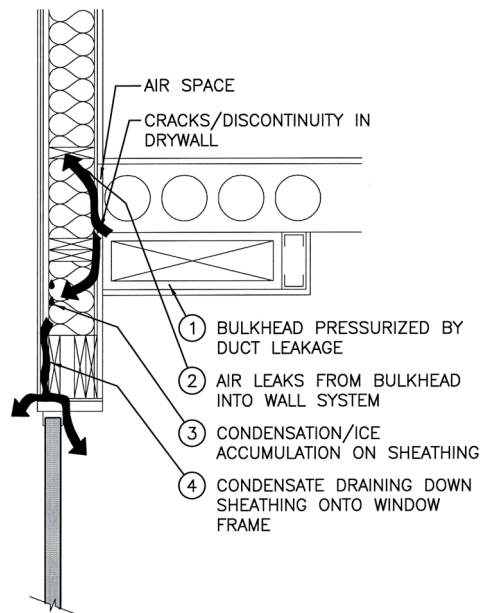
Diagnosis. The pressure diagnostics revealed that when the furnace fan was operating, the pressure differential between the inside of the bulkheads and the outdoors increased from approximately zero to a maximum of +10 Pascals (Pa) as the result of duct leakage. Any leakage paths in the exterior wall air barrier behind the bulkheads would have been subject to a moderately strong driving force which would cause air exfiltration and moisture deposition, as shown in Figure 1.

Figure 1 Mechanically induced air exfiltration into exterior wall system.

Remedial Action. The ultimate solution would have been to repair the cracks behind the bulkheads; however, this would have involved considerable cost and disruption to the occupants. Instead, a series of pressure-relief grilles were installed in the bulkheads of each suite, giving a total relief area of approximately 400 cm² (62 in²) per suite. Selected to have the same appearance as the heating registers, these grilles reduced the bulkhead-to-outdoor pressure differential to near zero, thereby significantly reducing the driving force for air leakage and moisture deposition. At a cost of less than \$100 per suite, this technically sub-optimal solution was selected as the most practical solution to the problem.

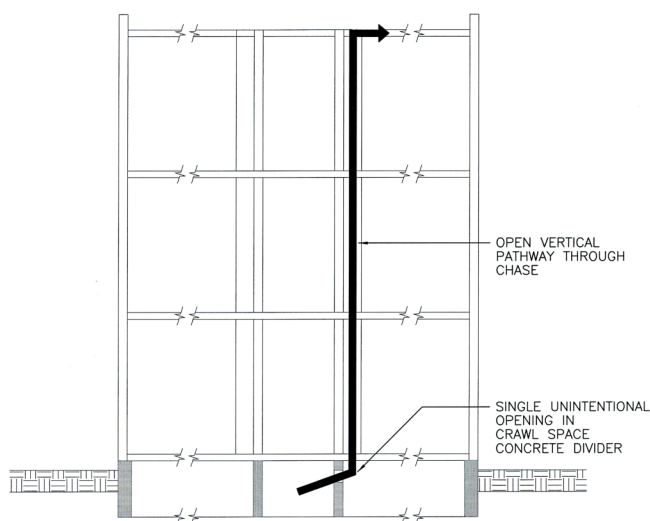
Examination of the crawl space revealed two large holes in the wall of the concrete crawl space wall which separated the crawl space corridor from the crawl space suite space directly below the main floor suite described above. These had been added after the building was completed and were used to route new electrical and gas lines. No other such access holes could be found. This permitted water vapor from the main part of the crawl space to enter the enclosed space (two floors) below the problem suite. But how was it getting to the third floor while bypassing the two intermediate floors? Further examination revealed that a small plumbing chase started in the crawl space and ran vertically to the underside of the roof on the third floor with no openings on the main or second floors, as shown in Figure 2. The underside of the chase was open to the crawl space. Thus, air leakage was able to take place from the wet crawl space (two floors) below the problem suite courtesy of the two utility holes, into the bottom of the plumbing chase where it rose via stack effect into the enclosed roof cavity. Since the roof had little insulation, the roof space was comparatively cool, which permitted condensation to occur. Since the utility holes occurred in only one location, only the problem suite was affected.

Figure 2 Moisture transport from crawlspace to roof system.

Remedial Action. The solution to this problem was almost too easy: seal the top and bottom of the plumbing chase along with the two access holes made in the concrete walls in the crawl space. This stopped any air movement and prevented the transport of water vapor from the crawl space into the roof space on the third floor. Using a can of one-component polyurethane foam, the building's maintenance man was able to repair the problem for a total expenditure of about \$10,

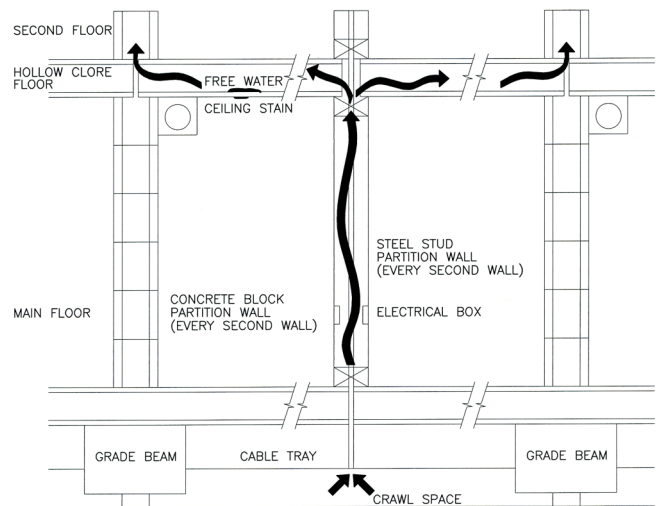
Diagnosis. The wet spots were caused by a bizarre example of interzonal air movement within the building. As shown in Figure 3, humid crawl space air was able to leak into the open ends of the conduits due to stack effect. The conduits then entered various junction boxes on the main floor. Since the boxes were not airtight, the air leaked into the hollow steel stud partition wall housing the conduits. Next, the air moved up the partition wall into the oversized holes cut for the conduits in the floor slabs. Some of this air then entered the open end of the hollow core slab. The air then migrated laterally through the hollow cores parallel to the exterior wall, across the room, to the concrete block partition wall (which functioned as a fire wall). This lateral movement occurred because the steel stud walls were capped at the top of the third floor whereas the concrete block wall penetrated through the ceiling line of the third floor since it formed a fire separation.

However, as the air passed through the hollow core slab, just before it reached the concrete block partition wall, it was (with the correct ambient conditions) cooled from the under-

side by air infiltrating from the outdoors through the metal exhaust duct running between the bathroom and the outdoors. Under the appropriate conditions, some of this air in the hollow core was cooled sufficiently that moisture condensed out of the air stream. This was aggravated by the fact that birds had built nests in some of these exhaust ducts, thus jamming the backdraft dampers open (although the dampers were very loose in any event) and consequently eliminating any significant resistance to air flow. This also explained why the ceiling wetting was only observed on the ceiling of the first floor. Since the bathroom exhaust ducts on the first floor were located below the building's neutral pressure plane (which was estimated to be situated at about the ceiling level of the second floor), the first floor exhaust hoods on the exterior wall would normally have been exposed to negative pressure differentials during the winter. Since the dampers were loose fitting, the exhaust ducts functioned as air inlets whenever the fans were off (which, based on data from other buildings, was about 95% of the time). In contrast, the exhaust hoods on the second and third floors would have normally been exposed to positive pressure differentials, which meant that air would have moved in the opposite direction (indoors to outdoors), thus precluding any cooling of the ducts and preventing any condensation of moisture from the air in the hollow cores immediately above the ducts. The water condensed in the floor system then flowed horizontally to the low spot in the hollow core slab. If it encountered a micro-crack or other discontinuity, it was able to leak through the crack and stain the underside of the ceiling on the first floor.

Figure 3 Moisture transport from crawlspace to floor system.

Remedial Action. The ceiling staining problem was solved by carefully sealing the ends of the conduits in the crawl space using urethane foam, thereby preventing air from entering the conduits and creating the scenario described above. In addition, the backdraft dampers were repaired and

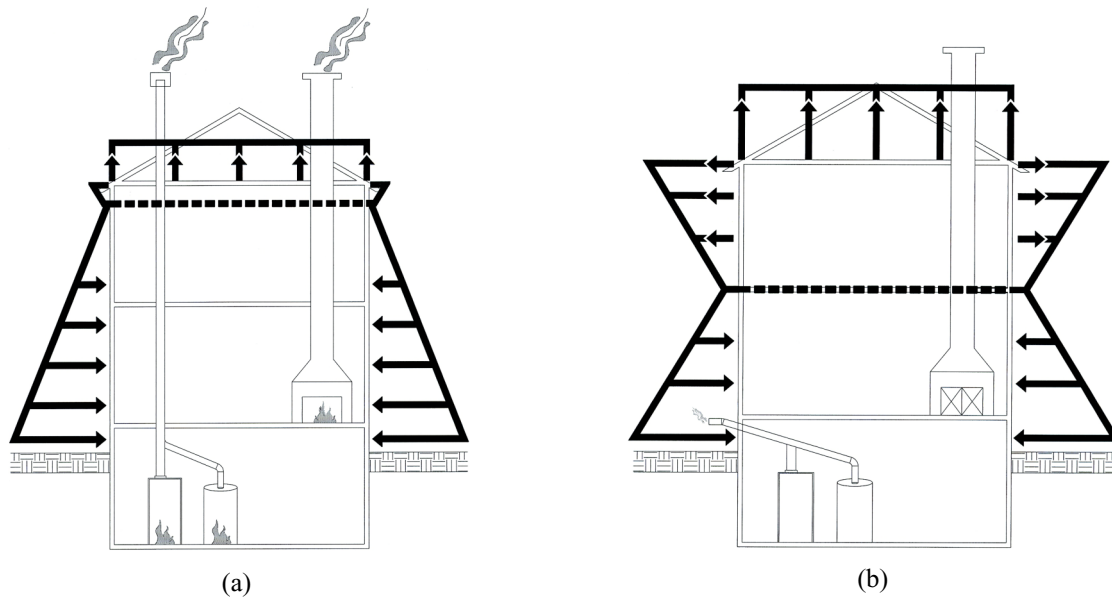
Diagnosis. The problems experienced by these buildings were classic examples of the house-as-a-system philosophy. As shown in Figure 4, the moisture problems were caused by increased air exfiltration into the attic and other portions of the upper building envelope as the result of the recent replacement of the original, naturally aspirated furnace. These types of devices require large amounts of combustion and dilution air which is drawn from the zone in which the furnace is situated. Effectively, this means that the furnace depressurizes the building with the result that the neutral pressure plane is located just below the ceiling. As a result, air exfiltration from

Figure 4 Stack-induced envelope pressure differentials with (a) combustion appliances and (b) no combustion appliances.

However, when the naturally aspirated furnace was replaced with a direct vent unit (which draws its air directly from the outdoors), two effects occurred. First, the neutral pressure plane was lowered significantly – typically to about mid-building height, which significantly increased the positive pressure differential across the ceiling and upper portions of the envelope and dramatically increased air exfiltration into the attic. Second, since the houses' overall air change rate was reduced, interior humidity levels rose, often by significant amounts. As a result, the average moisture content of the air exfiltrating into the envelope was much higher than had previously been the case. The net effect was a large increase in the amount of moisture being transported into the upper parts of the envelope.

Remedial Action. A couple of strategies were recommended to deal with this problem. First, it was proposed that winter humidity levels be maintained at the lowest levels consistent with good indoor air quality. Second, it was recommended that all air leakage pathways on the upper portions of the envelope should be sealed. This included all attic penetrations such as plumbing and electrical lines, access hatches, the tops of partition walls, chimney and vent penetrations, etc. It could also include major pathways such as the floor joists on the top floors of 1 1/2- and 2 1/2-story houses since these can provide an unimpeded pathway for air leakage from the house interior to the spaces behind the kneewalls.
