# Case Study: Performance of a House Built on a Treated Wood Foundation System in a Cold Climate

Charles G. Carll

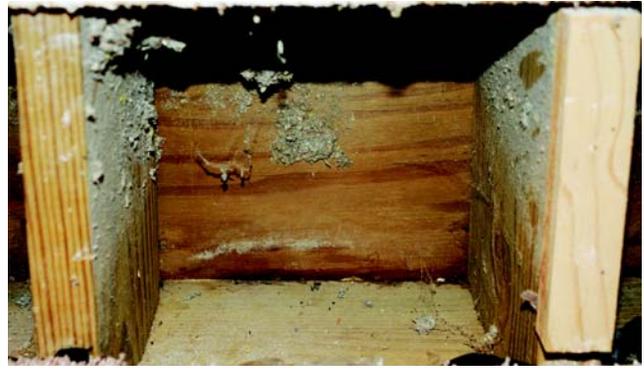
**Figure 2** Section of foundation wall bottom plate, showing the interface between bottom plate and plywood sheathing. Foundation wall studs are to left and right of picture. Plywood and bottom plate are visibly wet at their interface. Gray material containing red and white flecks (adhered to plywood and to left stud) is cellulose insulation. White rime above wet area is composed primarily of mycelia of a mold fungus. Bottom plate and plywood, although at moisture contents near fiber saturation, show no obvious mold growth.

During intrusive investigation, we only observed limited patches of mold growth in foundation walls. These were located at the base of the wall on the uphill side of the building (see Figure 2) and on the back surface of interior gypsum board near the top of the foundation wall (on the opposite side of the building). These patches of mold growth quite likely occurred during construction. As indicated in Carll et al. (2007), wall bases underwent substantial and obvious wetting before roof gutters were installed and the site was graded. In addition, the spatial distribution of mold on the back of gypsum drywall (near the top edge, where the drywall contacted double top plates that were dry in service) was consistent with the occurrence during construction of rainwater penetration at the rim joist. As indicated in footnote 5, the spun-bonded polyolefin house wrap that covered first-story walls and the rim joist was initially reverse-lapped with the
