Building Science in the Restoration of a Heritage Building

Mark Lawton, PEng
Member ASHRAE

The Hotel Georgia is a Vancouver landmark. The 12-story building opened in 1927 and since then has hosted royalty and scoundrels—and a host of famous entertainers. The hotel is registered as a protected heritage property by the City of Vancouver. It is currently undergoing a major renovation with the intent of reopening as a five-star hotel.

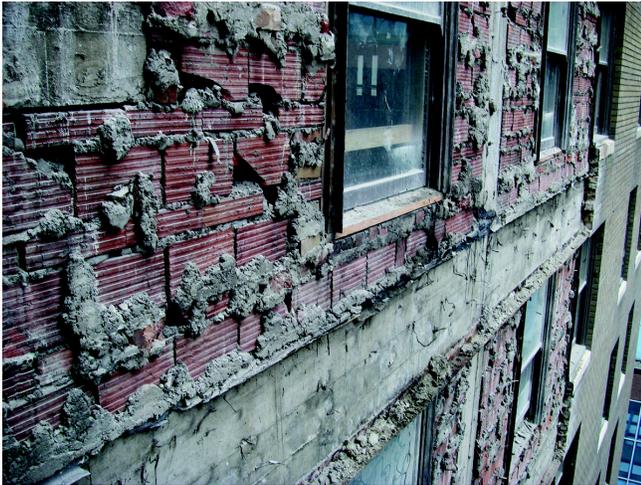
The terra-cotta block in areas that were exposed proved to be relatively roughly laid with chipped blocks and open joints on the outer face. It certainly was not watertight. There were tarred felt flashings at the base of the terra-cotta (visible in Photo 3).

Photo 3 Wall with face brick removed.

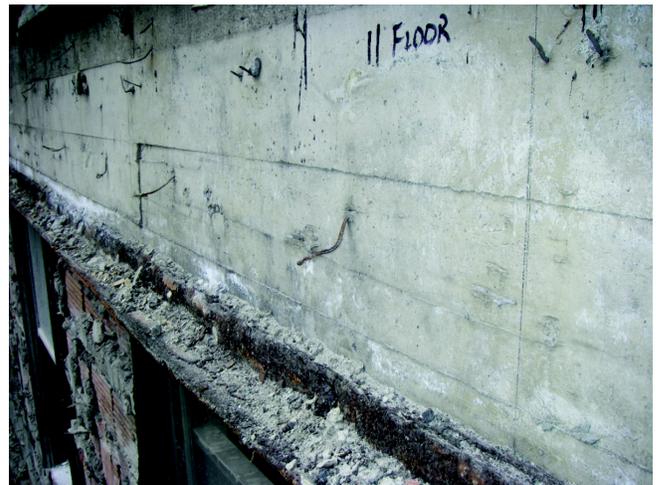
that were probably originally used as form ties (see Photo 4). Considering that the terra-cotta is too brittle to assume it would remain in place under seismic forces and displacements, the structural engineer was of the opinion that upgrading retention of the brick against lateral forces was necessary for a high seismic zone such as Vancouver.

Photo 4 Wire “ties” found at perimeter beam.

the brick was outside the perimeter beam or concrete backup walls, commercially available retrofit expansion ties were installed from the exterior, through the mortar joints of the brick and into the concrete backup.

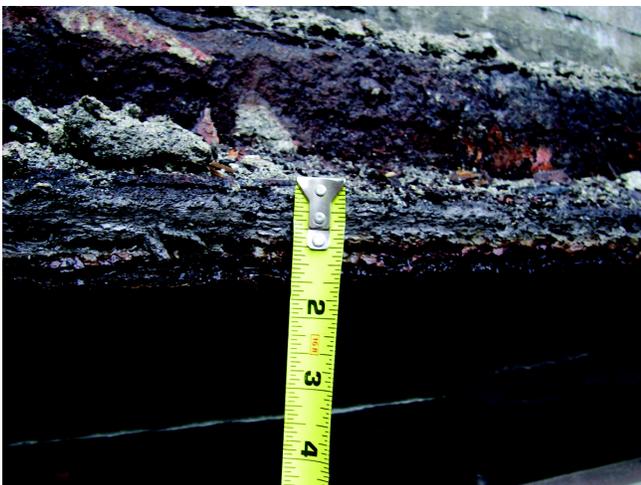
At upper floors there was masonry damage and displacement of the brick and cast stone elements due to corrosion of the shelf angles. This was generally limited to the tenth, eleventh, and twelfth floors and the elevator machinery penthouse. We found some upper-floor panels of brick “bowing” outwards due to shelf angle corrosion jacking. The extent of displace-

ment due to corrosion jacking was remarkable in places on upper floors (see Photos 5 and 6). At lower floors, the shelf angles still had the original paint. We attribute the variations primarily to dramatic differences in time and extent of wetting of the brick due to rain impact that results from wind-driven rain patterns around tall buildings (Inculet and Surry 1995). Moisture accumulation due to exfiltration of indoor air during cold conditions may also have played a role. We note that the latter mechanism could be minimized during the renovation but the former was an environmental condition that could not be changed.

Photo 5 Shelf angle corrosion, horizontal leg.

Replacement of the corroded, steel shelf angles with new galvanized steel angles was required on the top three floors, at the penthouse, and at limited locations at lower levels; thus, some brick removal was involved in sections. In general this was limited to two to three courses of brick by installing the shelf angle in sections and anchoring the sections back to the concrete perimeter beams using drilled-in expansion anchors. At locations where the shelf angles were replaced, a liquid urethane waterproofing membrane was installed to direct any incidental moisture away to the exterior (see Photo 15). The exterior masonry repair included replacement of damaged, cast stone window sills and all the spindles of the parapet balustrade. Repointing was carried out where necessary.

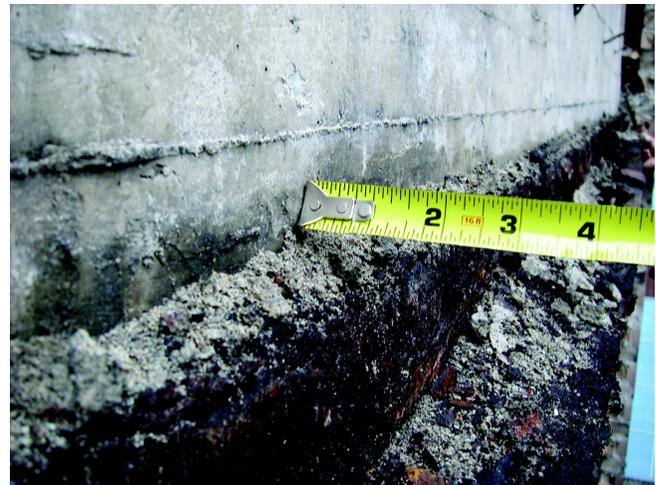
Photo 6 Shelf angle corrosion, vertical leg.

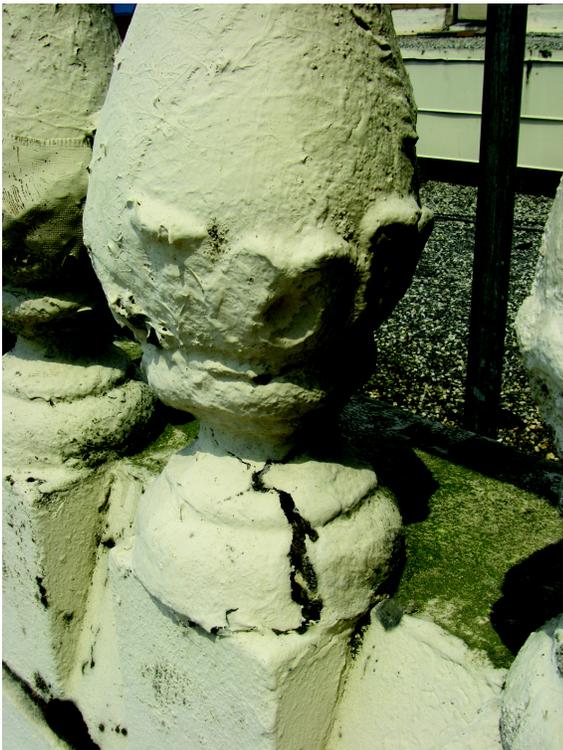
The cast stone elements at the lower floors were in good condition but required some localized repairs. More repair was required at the upper floors, where the cast stone has cracked due to corrosion of reinforcing steel. This was particularly problematic at the parapet. Many of the spindles of the parapet railing were cracked and damaged (see Photo 7). The finials required cleaning, some relatively minor repairs, and seismic restraints. Again, the pattern of degradation matched typical wetting patterns. Many of the cast stone window sills and some jambs were cracked, with their reinforcing steel corroding and expanding (see Photo 8). Our window survey indicated that approximately 18% of the concrete sills required replacement and approximately 48% required refinishing of the concrete sill coating.

Photo 7 Degraded cast stone spindle of parapet wall.

Since most of the parapet spindles were in disrepair, it was decided that all spindles would be removed and replaced. A waterproofing detail (liquid urethane membrane) similar to that of the parapet wall was implemented at the spindle locations.

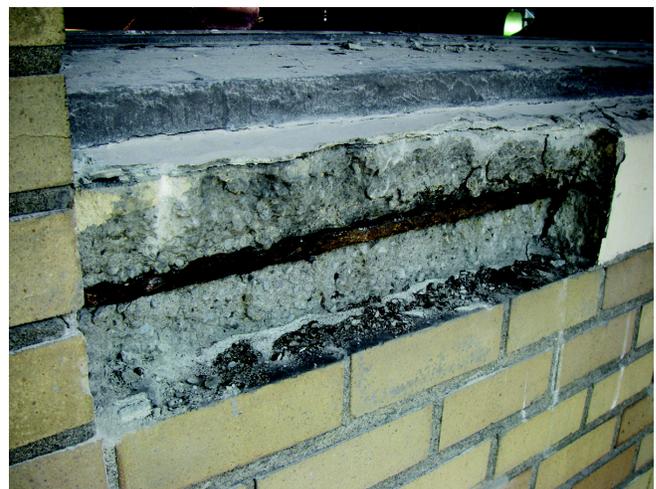
Photo 8 Failure of cast stone window sill due to corrosion at reinforcing.

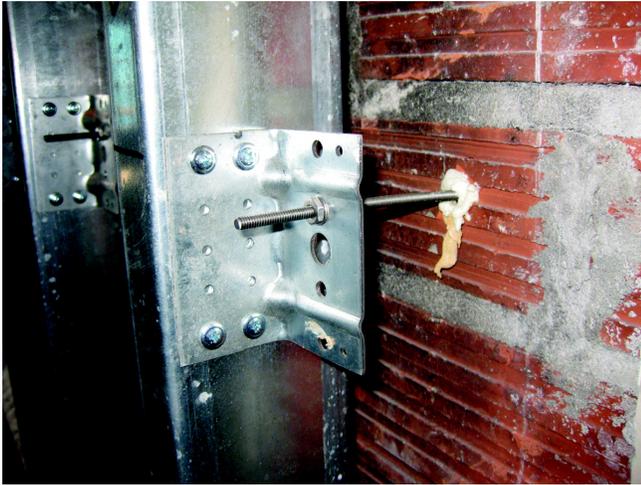
Photo 9 Brick tie installed through terra-cotta backup wall.

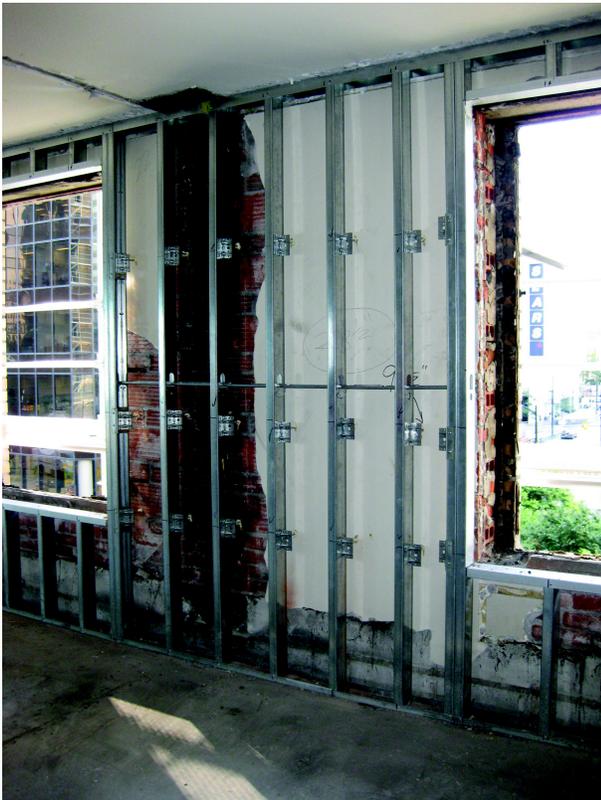
Photo 10 Structural frame supporting brick ties.

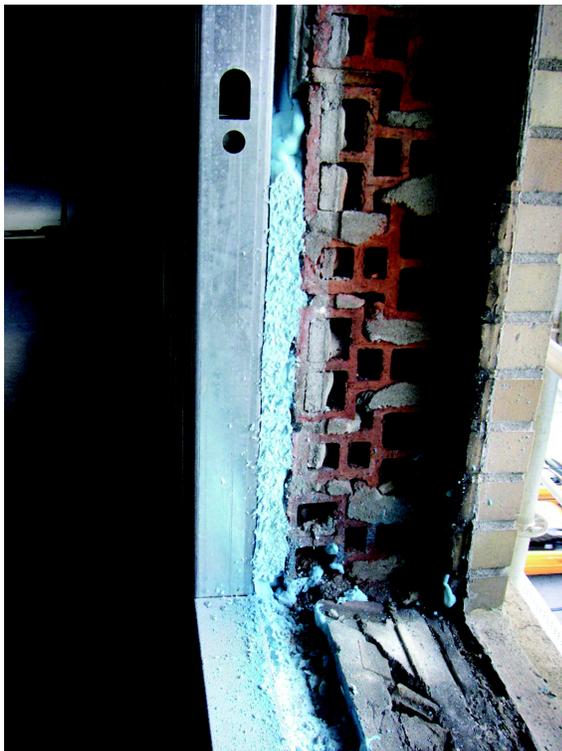
Significant attention was paid to preparing the openings for the new windows. The original windows were mortared in, so they were probably installed concurrently with the brick and terra-cotta block. As can be seen in Photo 12, the masonry around the window was rough and open. The windows were located in a plane that bridged the terra-cotta block and the brick. Any water that leaked through the window frame or at the wall/window joint was generally restricted to these moisture-tolerant materials. The new windows were installed in the same plane, but we decided that all reasonable measures should be taken to minimize water entry as far inboard as the terra-cotta, particularly considering that the insulation would reduce the drying capacity of the masonry elements. The installation detail also had to address the fact that without weight pockets, the new window assemblies were narrower than the historic windows.

Photo 12 Condition of window rough opening prior to purging.

The rough openings of the windows were prepared by parging the sills and jambs on the openings to fill the cavities in the terra-cotta. At the sill, the parge coat was formed with a slope to the outside. The sill was waterproofed with a liquid-applied urethane waterproofing that extended approximately 6 in. up the jambs. The window was installed in the opening

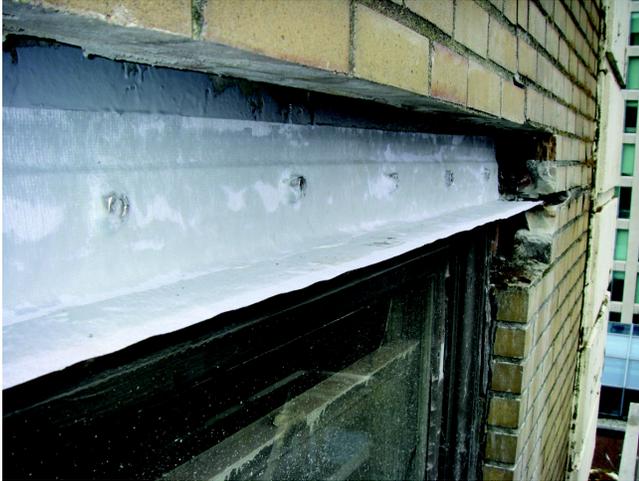
Photo 15 New shelf angle with liquid applied "flashing."
