# Innovative Structurally Glazed Curtain Wall at the New Vancouver Convention Centre: Design and Construction Challenges

Anik Teasdale-St-Hilaire, PEng, PhD

*The Vancouver Convention Centre and Expansion Project (VCCEP) was a project undertaken to more than triple the size of the existing Vancouver Convention and Exhibition Centre. The new VCCEP building is located in downtown Vancouver and is built over land and water, overlooking the Burrard Inlet. It is approximately 102,000 m<sup>2</sup> (1.1 million ft<sup>2</sup>), and its construction started in the fall of 2004 and took almost five years to complete.*

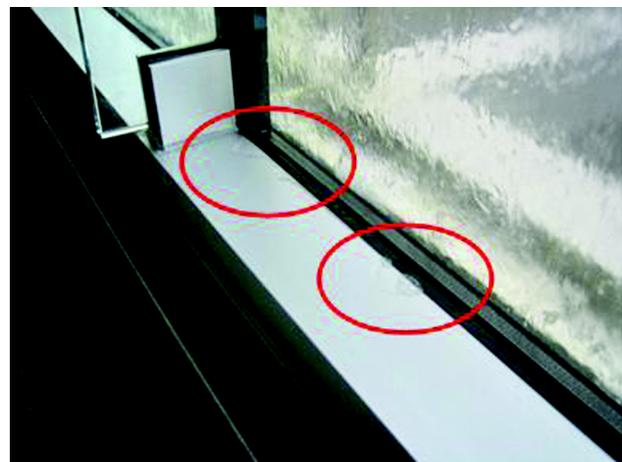
1. Water was noted on the sill of horizontal mullions (Figure 11). The testing team traced the water ingress to defects where the sill heel bead connected to the vertical butt glazing bead. The location and geometry of this connection made it a challenge to seal and/or visually detect a defect. This occurred at three locations in the first mock-up and at two in the second mock-up.
2. Water was noted at the head of the glazing where the field-applied glazing seal ran around the “shoe” that support the glass mullion.
3. Water was noted at a small defect in the factory-applied structural silicone butt seal between the IGU and the glass mullion on a corner of the first mock-up.

*Figure 11 Water ingress observed during laboratory static water penetration resistance testing.*

Repairs of the sealant at the various locations, followed by successful static and dynamic water penetration resistance testing, demonstrated that the leaks could be corrected in the field.

The location and geometry of the factory-sealed transition between the heel bead on the horizontal joint and the vertical butt glazed joints (failure 1 from the laboratory testing) rendered it difficult to seal the transition and to visually detect a defect. Because a visual review would not likely be sufficient to demonstrate success, the testing team recommended that quality control procedures in the fabrication plant include a simple panel or joint test that could demonstrate air- and watertightness. The fact that the curtain wall was a unitized system permitted such a test. The recommendation included the following testing:

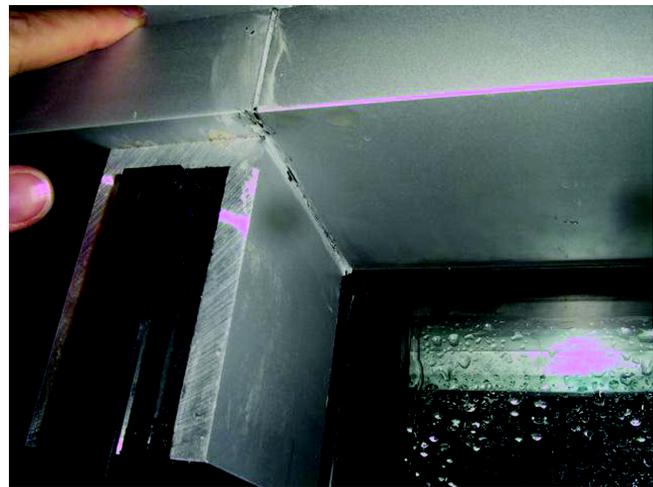
The first water penetration test (test 4) conducted on the system supported by an exterior truss failed. Water ingress was noted at the underside of the horizontal mullion butt joint (Figure 12). Given the high air pressure difference applied and the small amount of water ingress, the water was suspected to have been trapped within the system during construction. To test this theory, the test was repeated (test 4a), this time without applying any water, and the test failed again. The glazing contractor then dried out the system by depressurizing the interior chamber until no water ingress was observed. However, upon another retest (test 4b), it failed again at the same location, indicating that “construction moisture” was not the sole moisture source. We observed water migrating through a pinhole in the sealant applied on the interior face of the horizontal mullion’s butt joint. This observation prompted a recommendation to remove or cut this sealant prior to performing the next tests, since this sealant was purely aesthetic and its presence prevented visualization of water migration past the line of watertightness. The structural silicone sealant at the butt joint was repaired from the exterior, and a retest was conducted (test 4c). A few drops of water ingress were noted once again, at the same location. The glazing contractor suspected residual moisture from the previous test. He dried out the system once again and conducted a smoke test to verify the airtightness of the system. Upon completion of these checks, testing was repeated (test 4d) and passed.

**Figure 12** Sealed butt joint in the horizontal mullion from which water penetration was noted during field testing.

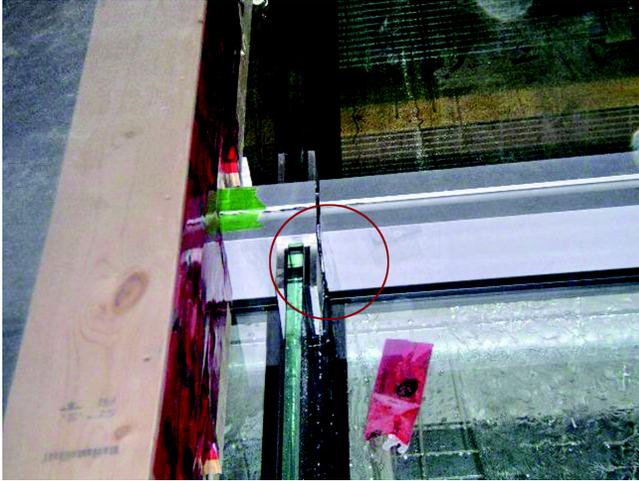
The same curtain wall system was tested at a different location (test 5). Upon application of the water spray, leaks occurred at the curtain-wall-head-to-truss connection on

either side of the test chamber (Figure 13). However, no water ingress was noted at the same joint located within the test chamber. We noted that the horizontal mullion joint between the two panels had no interior caulked seal at the leak locations but that the seal was complete at the joint within the chamber. When the testing team reviewed the location of the leak from outside using a scissor lift, a breach in the air/moisture seal

**Figure 13** *Unexpected water ingress at a butt joint in the horizontal mullion located adjacent to the test chamber.*

was noted. Calling this test a failure was arguable. While the failures did not occur within the test area, the leaks were unexpected, as they occurred at areas where the moisture seal was expected to be complete. The glazing contractor investigated the leaks and conducted the repairs. The contractor suggested that the interior gasket at the sill of the curtain wall be removed at the jamb connection and silicone sealant be injected. The repairs complete, the curtain wall was retested (test 5b) and passed. It was agreed that the failure of test 5 was likely a systemic problem for the SGCW with exterior truss and that the contractor would need to apply the same repair method to all similar joints.

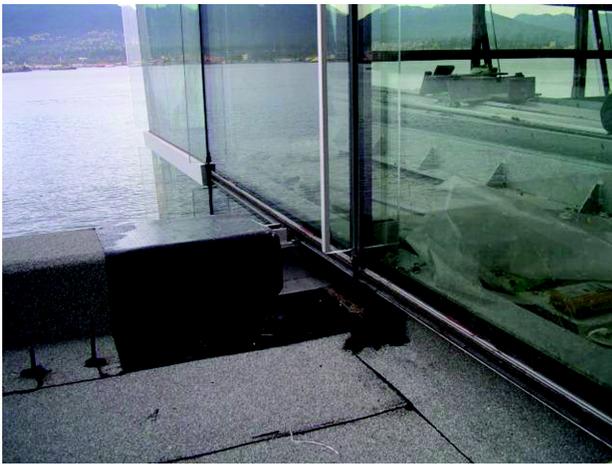
Another SGWC construction issue arose at the second-level north terrace, where the sill of the SGWC interfaced with the terrace's parapet. These two meet at a 90° angle. The detail is complicated by the fact that the top surface of the parapet, which covers the head of the SGWC below, was higher than the curtain wall sill (Figure 14). The parapet was redesigned and rebuilt to reduce its height by cutting back the curtain wall head's extrusion. However, the curtain wall head's height could not be sufficiently reduced to permit the tie-in of the parapet's modified bitumen waterproofing membrane to the SGWC sill's shoulder. The roofing contractor proceeded to

**Figure 14** Terrace parapet connection to the SGWC sill during construction. Note the SGWC head extrusion at the parapet, which prevented a proper tie-in to the SGWC sill.

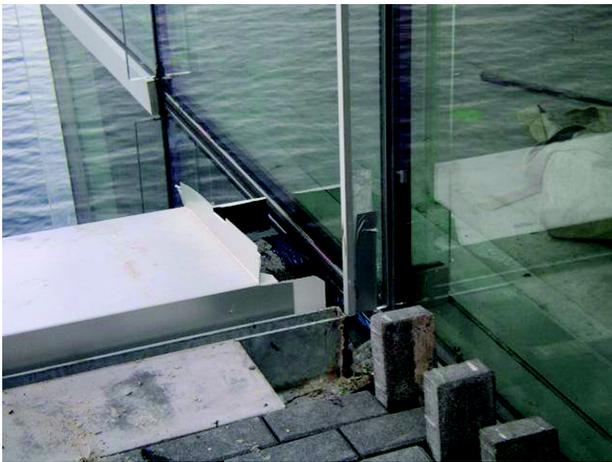
**Figure 15** Once the SGWC head extrusion was cut back, the parapet construction was completed and continuity of the waterproofing was achieved.

seal the parapet's membrane to the SGWC sill's PVC watershed (Figure 15). However, the compatibility of the membrane and the watershed was an issue: we noted lack of adhesion between these two during a field review. The roofing contractor subsequently cut back the modified bitumen membrane and attempted to tie in the PVC and the modified bitumen membrane with a proprietary liquid-applied polyurethane membrane compatible with the modified bitumen membrane, but he encountered a similar adhesion issue with the watershed. Different options were considered, including cutting back the PVC watershed at the parapet and adhering the modified bitumen membrane to the exposed aluminum extrusion beneath the watershed; however, the glazing contractor was reluctant to pursue this option as it created a risk of moisture ingress at the butt joints in the horizontal mullion. In the end, after successful on-site qualitative adhesion testing, hot rubberized asphalt was successfully applied as a transition membrane between the modified bitumen and the PVC watershed, as shown in Figure 15.

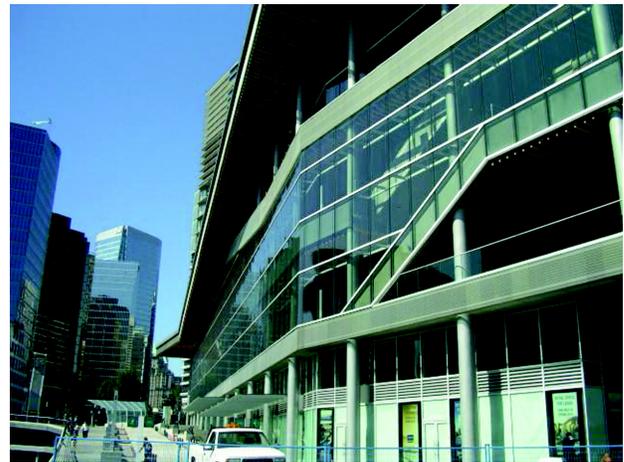
At the building's east elevation, there is a bulkhead located beneath an escalator that serves as an environmental separation (Figure 16). Where the bulkhead meets the sill of the SGWC, the construction challenge lay in the need to provide a transition that allowed continuity of the air, moisture, and vapor barrier systems; allowed access to the inside face of the IGUs for cleaning purposes; and was aesthetically pleasing. At the same time, the transition was complicated by the structural steel supporting the SGWC sill and the aluminum bar grating beneath the bulkhead.

**Figure 16** Bulkhead serving as an environmental separator below the escalator required a tie-in to the SGWC sill for envelope integrity.

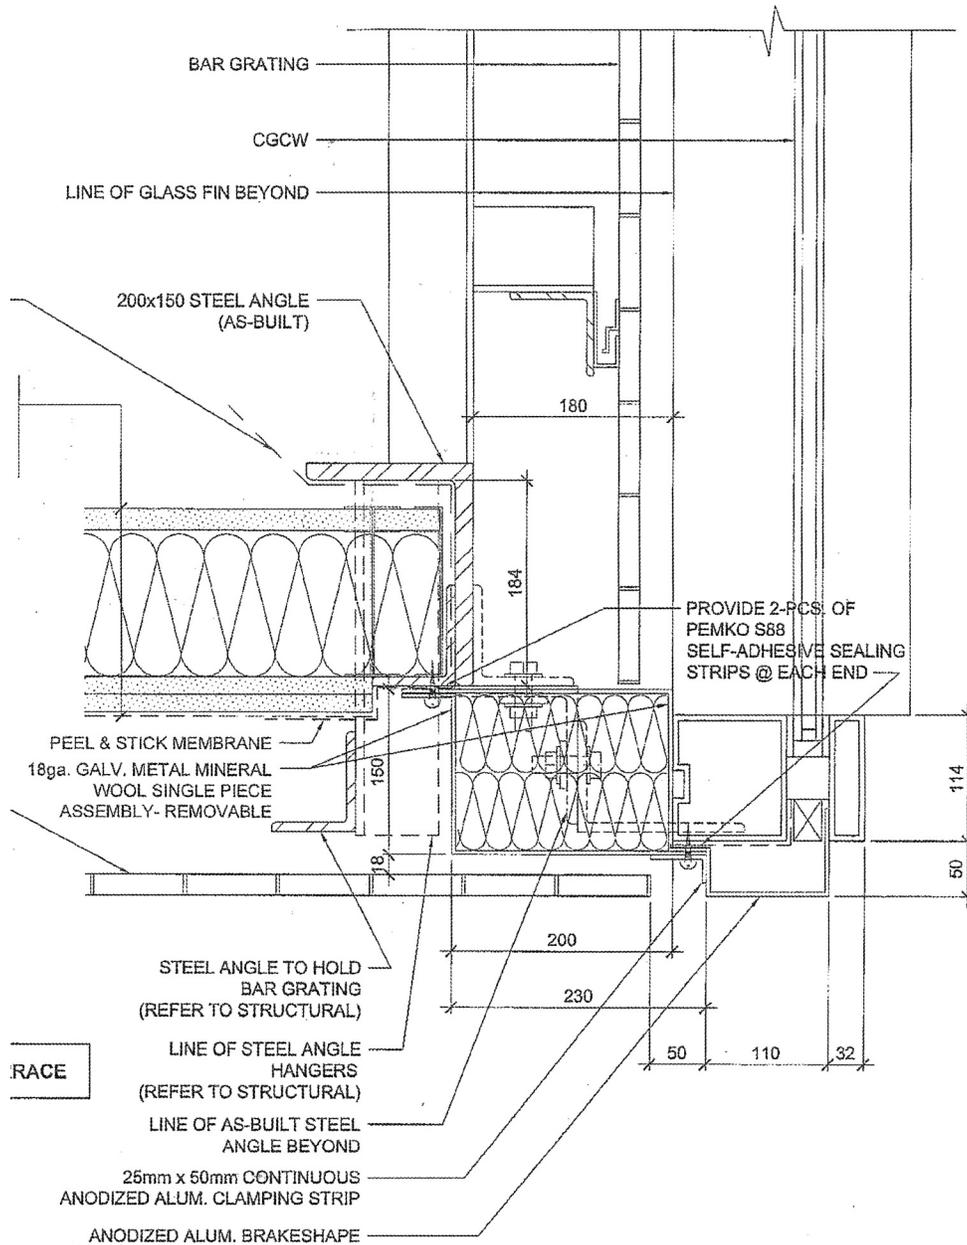
The construction team dismissed the original design detail (see Figure 17) because the presence of the steel

supporting the SGCW sill, and the as-built position of the steel supporting the bar grating, interfered with the 18 gauge galvanized metal breakshapes serving to bridge the SGCW sill and the bulkhead. The final design consisted of replacing the inner breakshape with a strip of EPDM membrane sealed and mechanically fixed to the bulkhead with a termination bar; at the mullion, the EPDM membrane is sealed with a gasket and covered with a breakshape, which doubles as a termination bar (Figure 18). The use of a gasket at the mullion connection permits removal of the EPDM membrane. Note that the configuration of the removable black breakshapes was modified by the contractor during construction.

**Figure 17** Original architectural detail showing the use of metal breakshapes to tie in the bulkhead to the SGCW sill.

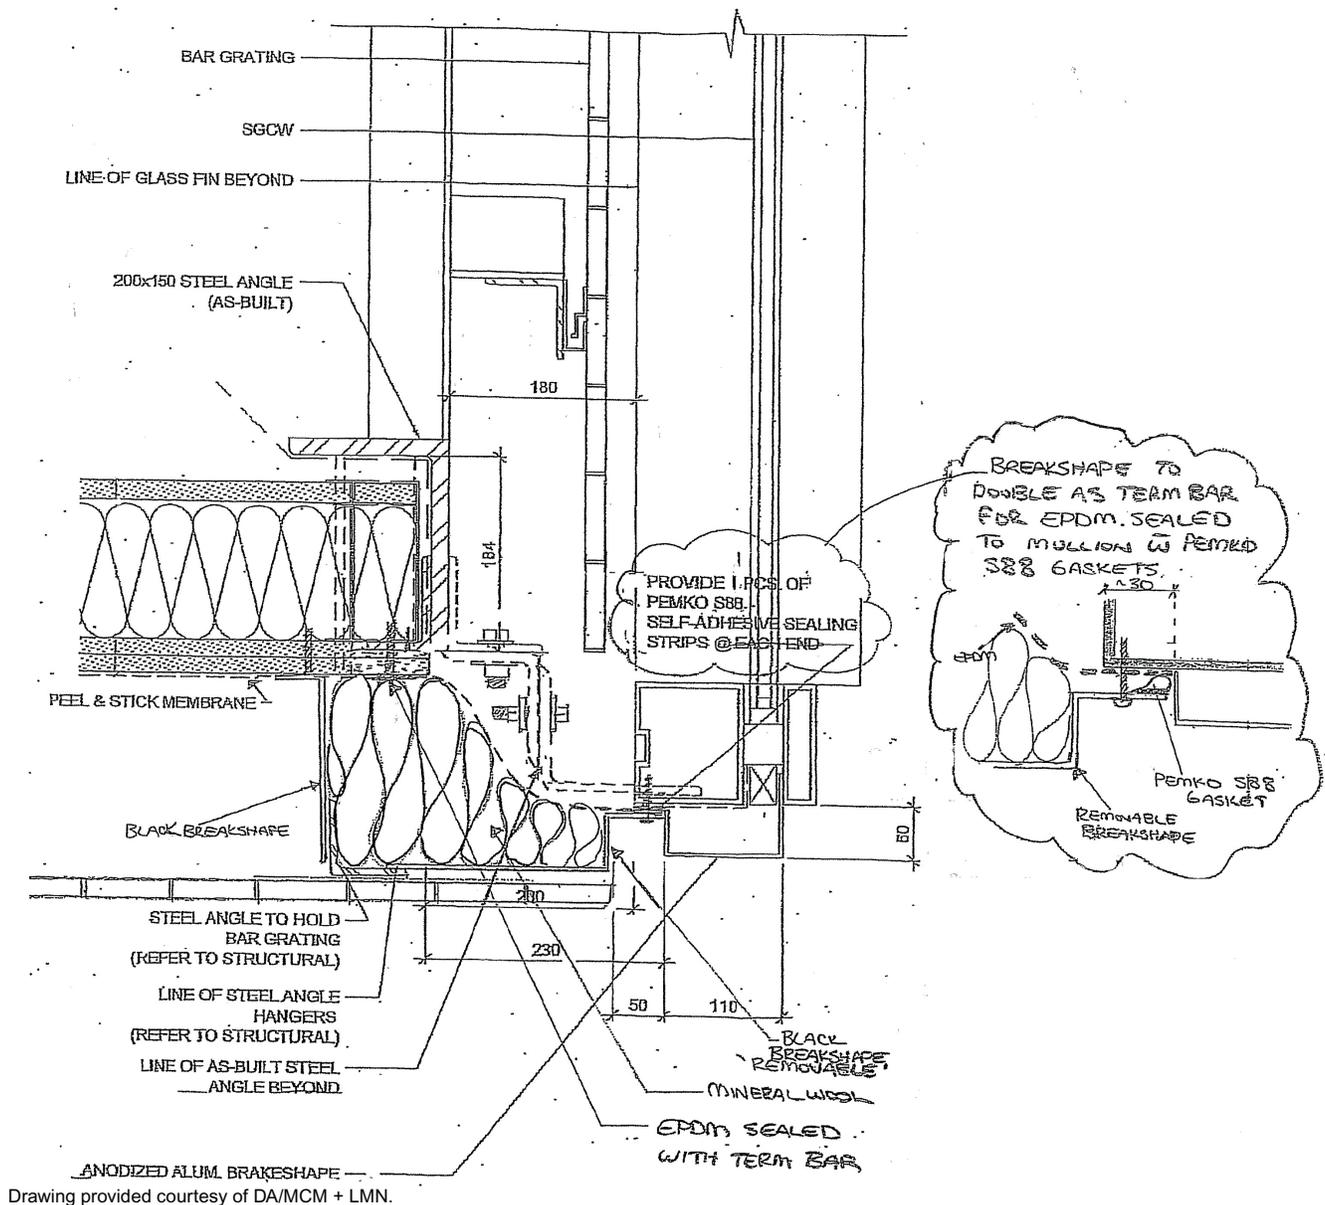
**Figure 18** Revised architectural detail showing the as-built location of the bar-grating structural support, and the use of a flexible EPDM membrane for envelope continuity.
