Timber-Frame Walls: Feasible with a Damaged Vapor Barrier?

ABSTRACT

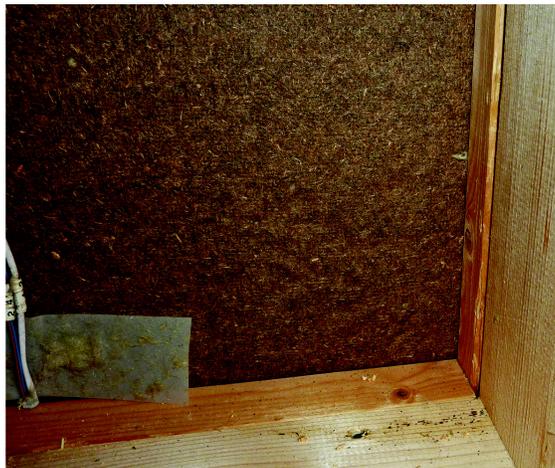
In general, inspection of elements with an intact vapor barrier showed a moisture content behind or in the wind barrier below the critical level, although the moisture content in the

Figure 9 Inner side of the wind barrier after four years of exposure: element 14, facing north (vertical weatherboard, no cavity, wind barrier: asphalt-impregnated wood fiberboard).

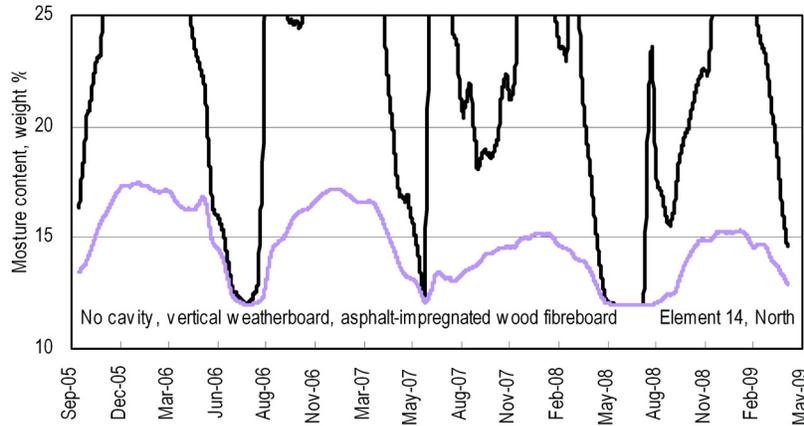
Figure 10 Moisture content (weight %) in element 14, facing north, in the cladding (black), and behind the wind barrier (violet).

cladding was sometimes quite high (see Figure 10). In some cases, this might lead to problems (e.g., in combination with freeze/thaw). In element 8, however, the moisture content in the wind barrier and in the timber studs was very high (see Figures 11 and 12). Element 8 was placed at the corner of the test building, and the moisture was explained by poor workmanship on the outer part of the element, which in combination with a leaky drainpipe made it possible for moisture to enter from the side of the element (Figure 13).

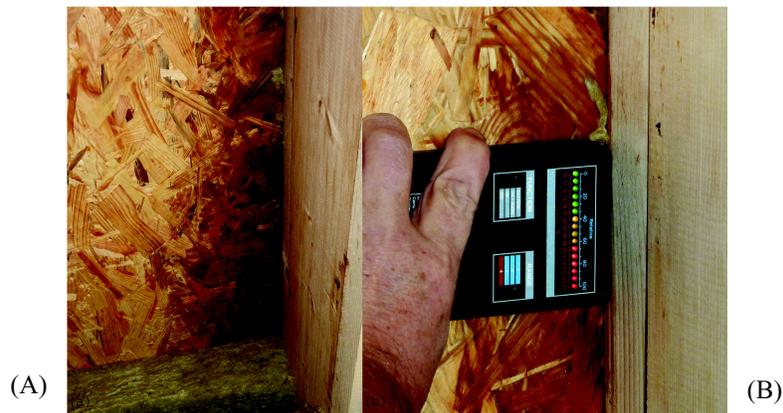
Figure 11 Element 8 facing north (horizontal weatherboard, nonventilated cavity, oriented strand board as wind barrier). (A) Wet part of the wind barrier seen from inside and (B) display on the handheld moisture meter indicating critical moisture content (i.e., all indicator lamps are on, including the red ones).

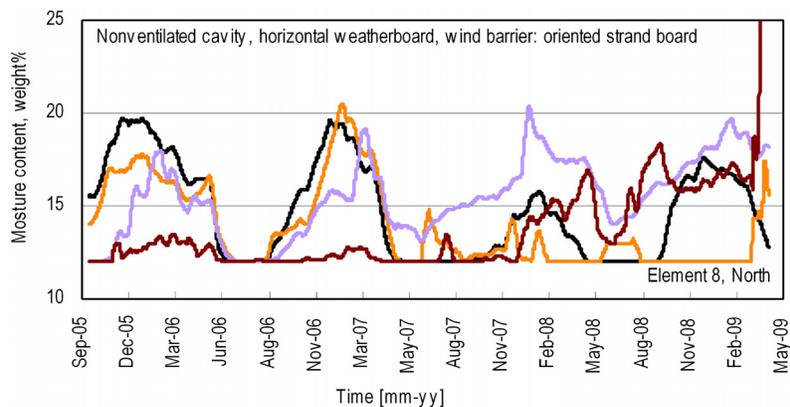
Figure 12 Moisture content (weight %) in element 8 facing north. Moisture content in cladding (black), in the cavity (orange), behind the wind barrier (violet), and in the timber studs (brown). Note the sharp increase of moisture content in the timber studs at the end of the period.

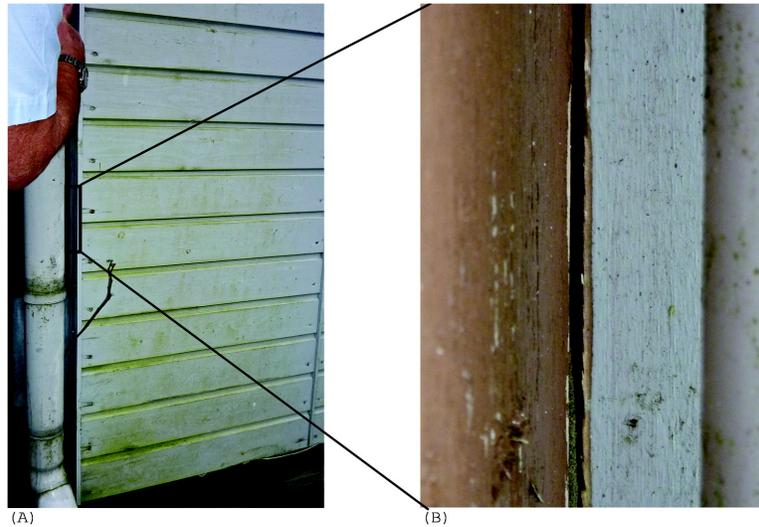
Figure 13 (A) Detail of northeastern corner of the test building with element 8 and its adjacent leaky drainpipe. (B) Close-up of the assembly between the test building and element 8, seen from the side. November 2009 after four years of exposure.

Note the amount of algae on the cladding and compare with the condition five months earlier (Figure 14). This is a clear example of how fast the appearance of the surface can change. It also demonstrates how vulnerable this kind of construction is to poor detailing and workmanship, even when the element includes a cavity.

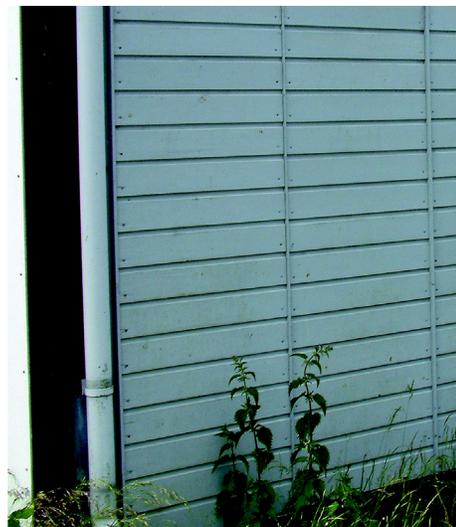
Figure 14 Section of north façade of test building, June 2009. Element 8 is to the left, next to the drainpipe. Algae are not visible on the cladding.
