ORNL-2217 *cy. 6-A*
C-84 - Reactors - Special Features
of Aircraft Reactors

METALLURGY DIVISION
SEMIANNUAL PROGRESS REPORT
FOR PERIOD ENDING OCTOBER 10, 1956

OAK RIDGE NATIONAL LABORATORY

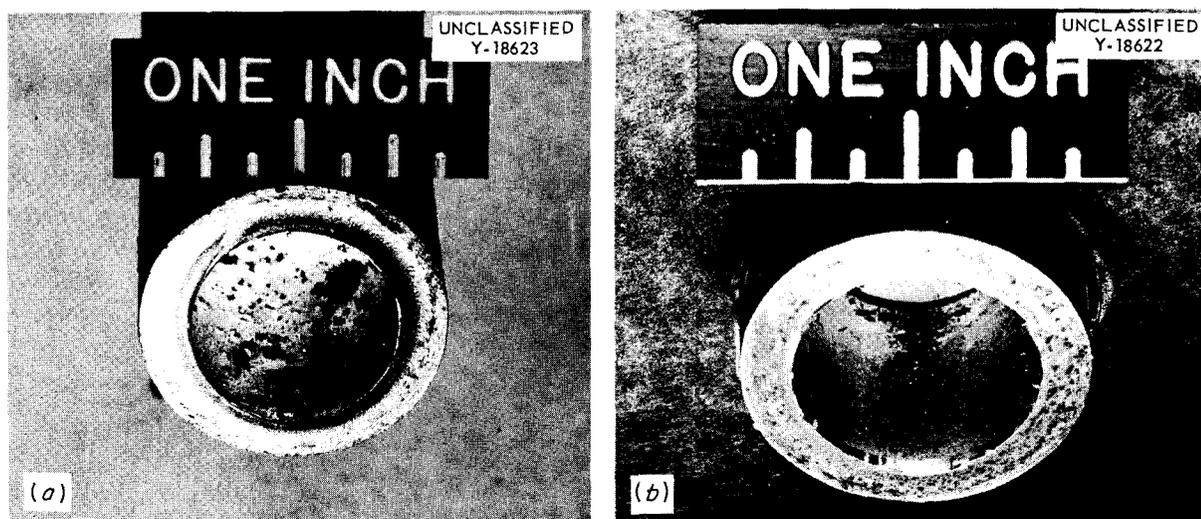
Fig. 6. Mass Transfer in Inconel-Sodium Thermal-Convection Loop Tests. (a) Cold-zone section of loop which had no diffusion cold trap (loop 29). (b) Cold-zone section of loop which had a diffusion cold trap (loop 28).

Two Inconel-sodium thermal-convection-loop tests have been conducted to determine the effect of a diffusion cold trap on the amount of mass transfer observed in the cold leg of the loop. Corrosion and mass transfer were found to be less in the loop with the diffusion cold trap than in a standard loop with no trap.

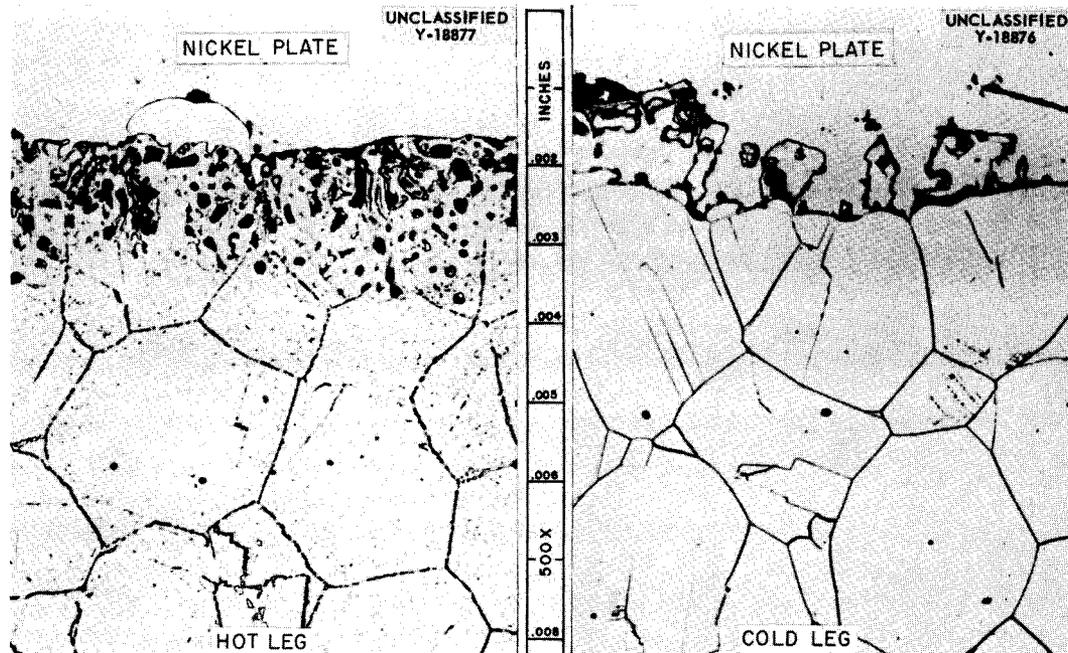
Fig. 12. Hot- and Cold-Leg Surfaces of Loop 16 – Type 316 Stainless Steel (See Fig. 10). Crystal on hot-leg surface is chromium carbide. Note mass-transfer crystals on cold-leg surface. Specimen nickel-plated following test. Etchant: glyceria regia. 500X. Reduced 5%.

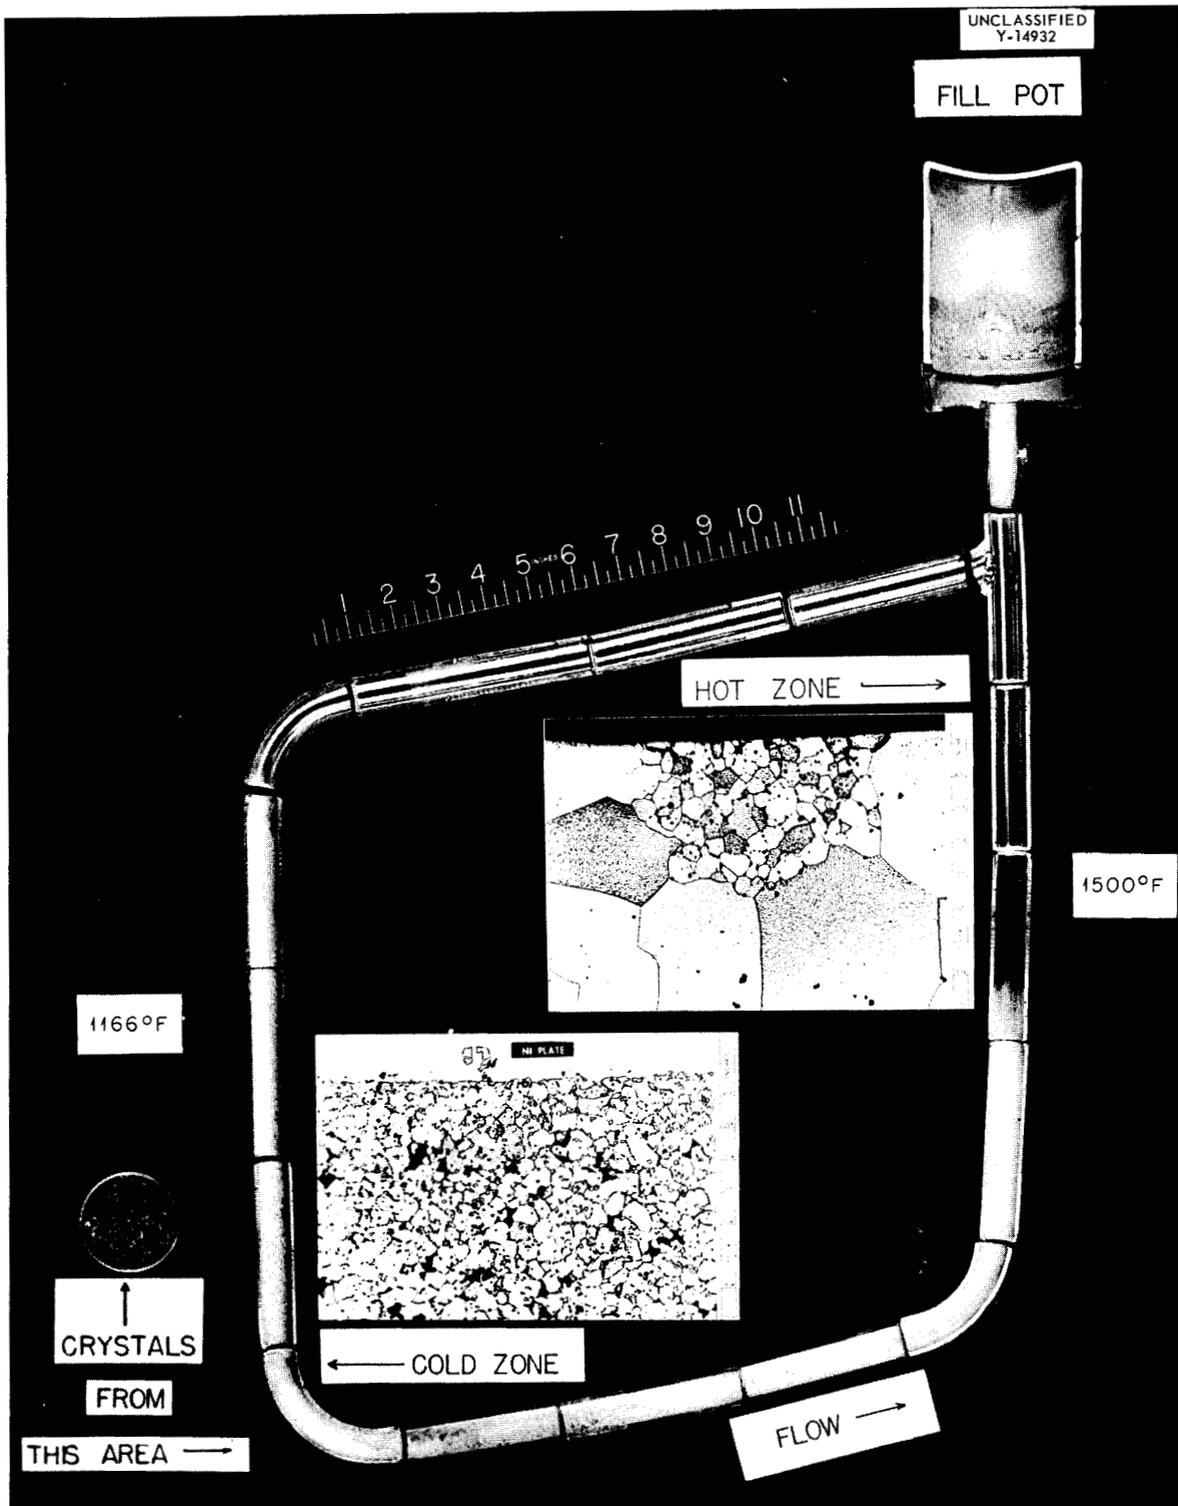
Fig. 14. Type 446 Stainless Steel Thermal-Convection Loop in Which Lithium Was Circulated for 864 hr.

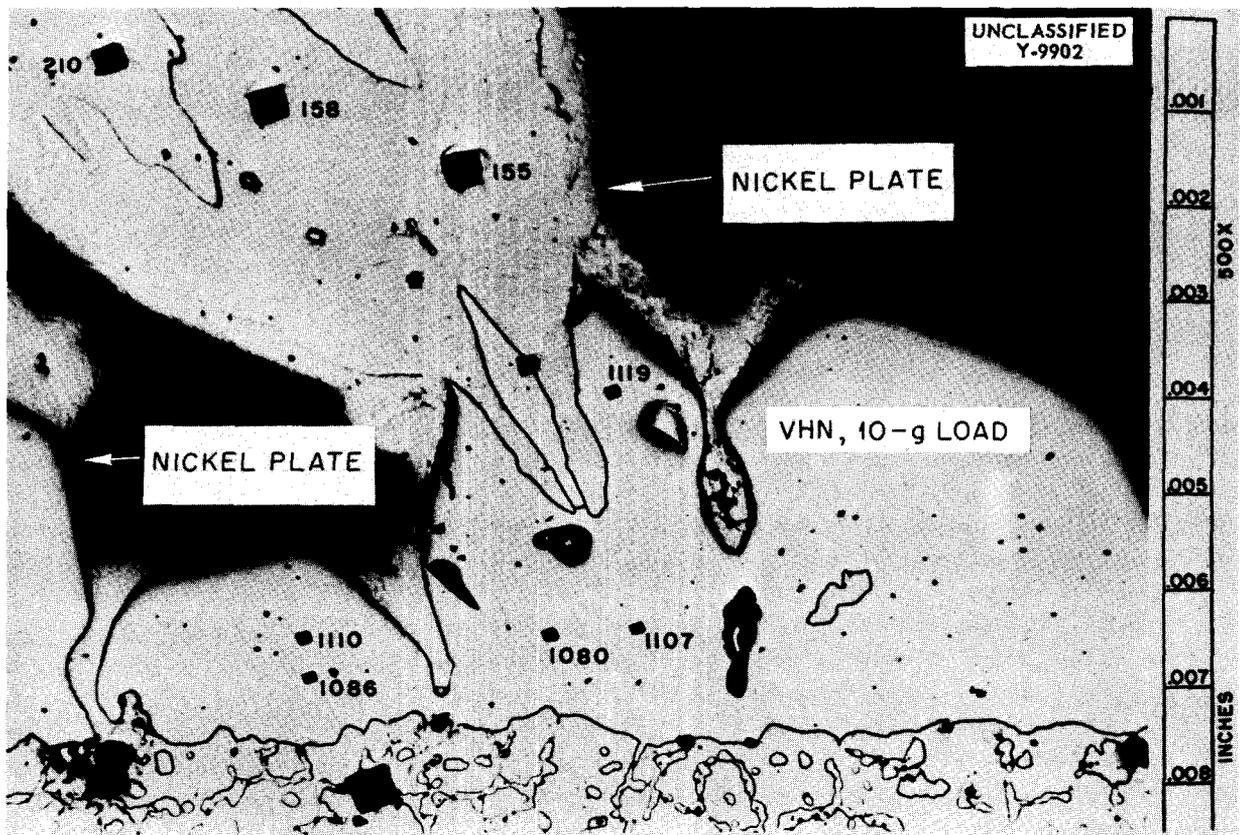
Fig. 15. Cold-Leg Wall of Type 446 Stainless Steel Loop Following Exposure to Lithium (See Fig. 13). Very hard phase (VHN ~ 1100) is Cr_{23}C_6 , while soft crystal attached to it is a ferrite crystal of $\text{Fe}_{90}\text{Cr}_6$. Specimen was nickel-plated (VHN 210) following test. Etchant: glyceria regia.

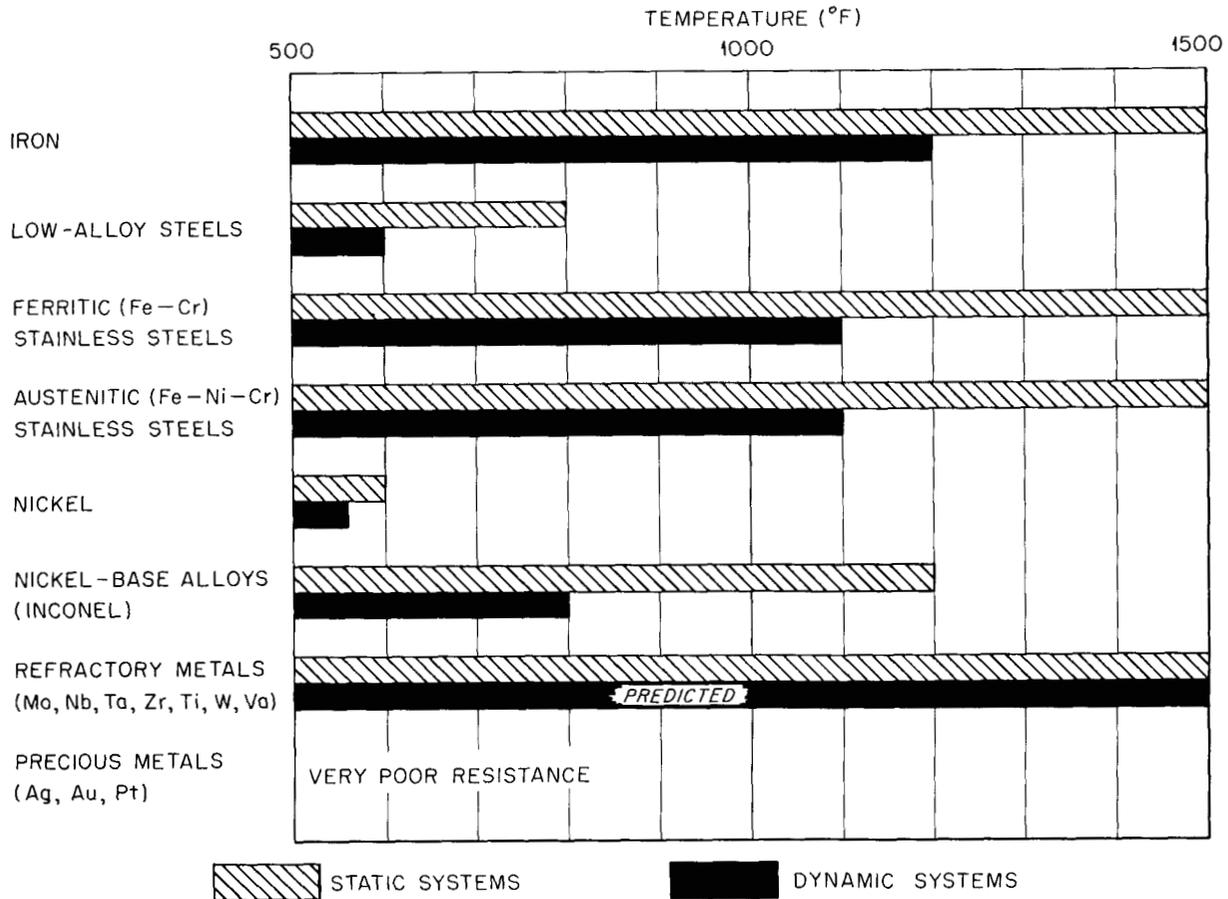
Fig. 16. Corrosion Resistance of Various Metals and Alloys in Lithium. Bars indicate approximate temperatures below which a system might be operated for 1000 hr with less than 0.005 in. of attack or container surface removal. (Confidential with caption)

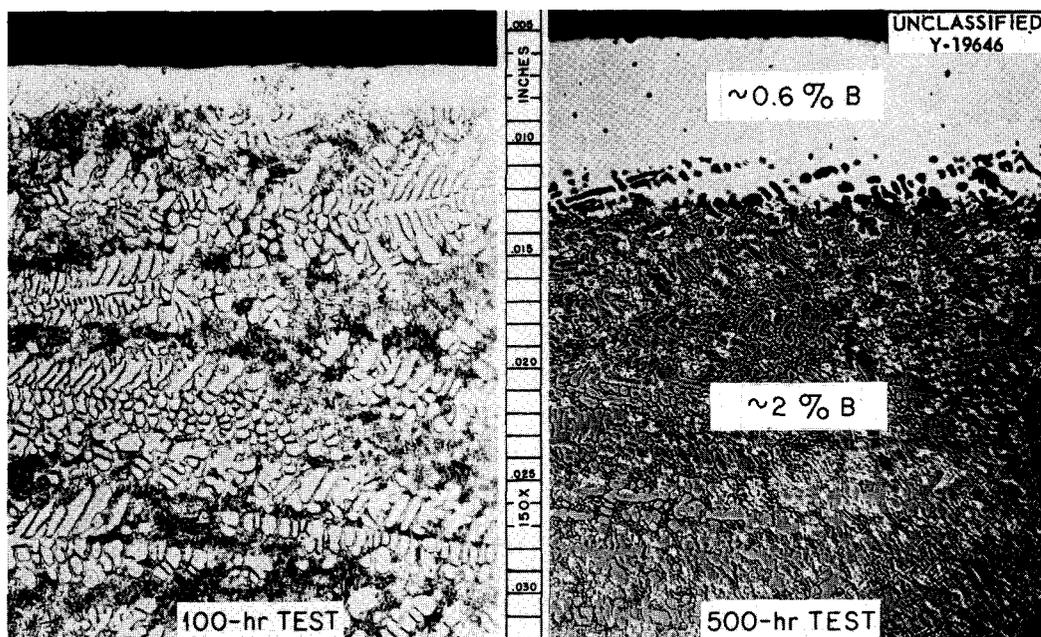
Fig. 17. Coast Metals No. 52 Alloy After Seesaw Testing in NaF-ZrF₄-UF₄ (53.5-40.0-6.5 mole %) for 100 and 500 hr. The leached-out region was 2.3 mils deep on the 100-hr test and was 6 mils deep on the 500-hr test. (Secret with caption)

Corrosion tests in seesaw apparatus have been conducted on a series of Coast Metals No. 52 (89% Ni-5% Si-4% B-2% Fe) buttons to obtain some information on the depleted region found at the edge of this alloy after exposure to liquid metal or fuel salts. It was found that the depth of the depleted region is time-dependent and that boron is leached out of this area when tested in the fuel bath. Similar tests were conducted on Coast Metals No. 53 (81% Ni-8% Cr-4% Si-4% B-3% Fe) with the expectation that the high chromium content would tie up the boron and prevent it from being leached into the fuel bath.

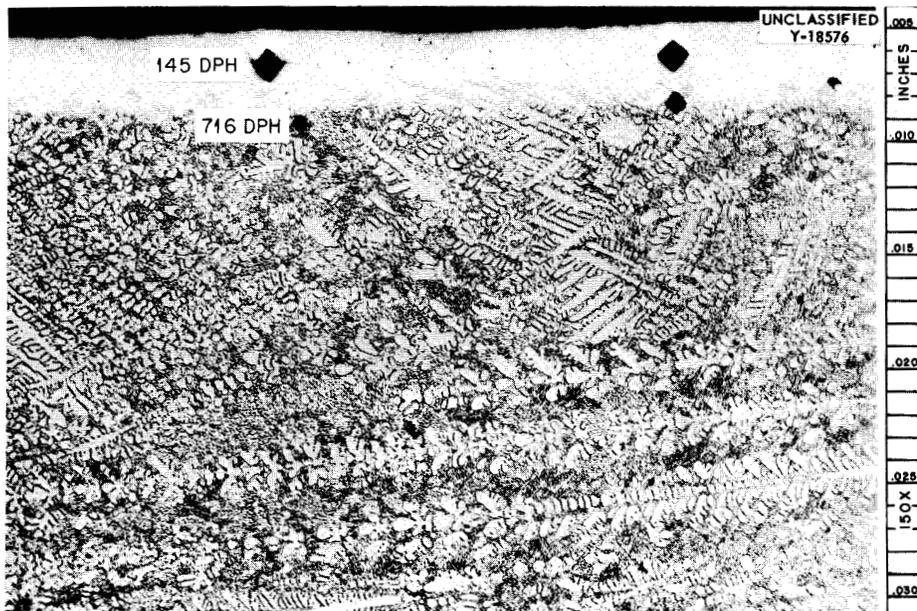
Fig. 18. Coast Metals No. 52 Alloy Button Tested in NaK for 350 hr. Note the difference in hardness. Etchant: 10% oxalic acid. Reduced 21.5%.

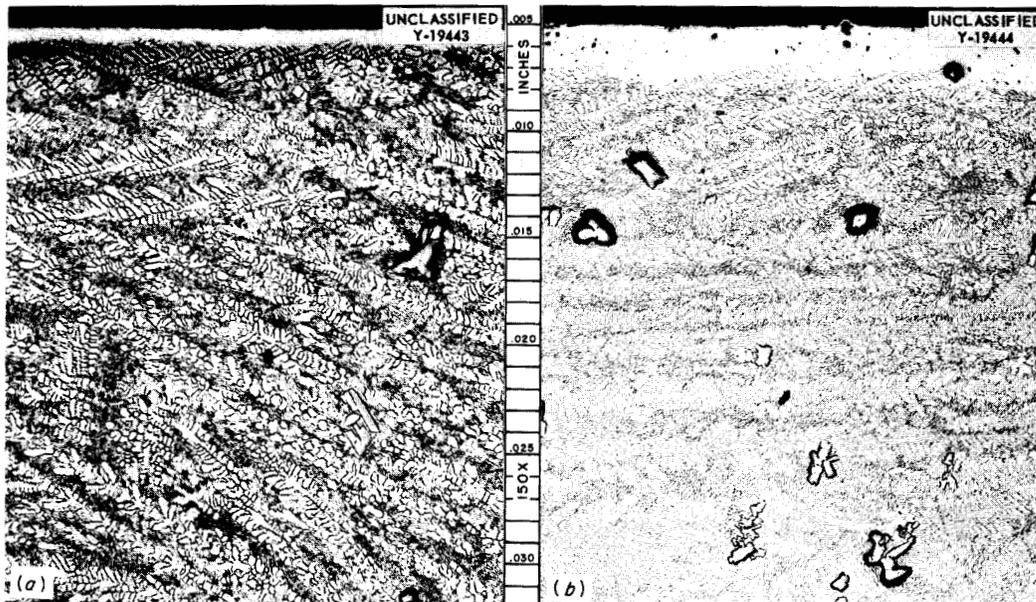
Fig. 19. Coast Metals No. 53 Alloy Seesaw Corrosion-Tested in NaK (56-44 wt %) for 100 hr at (a) 1400°F and (b) 1500°F. The constituent removal is greater at the higher temperature. Etchant: 10% oxalic acid. 50X. Reduced 24%.

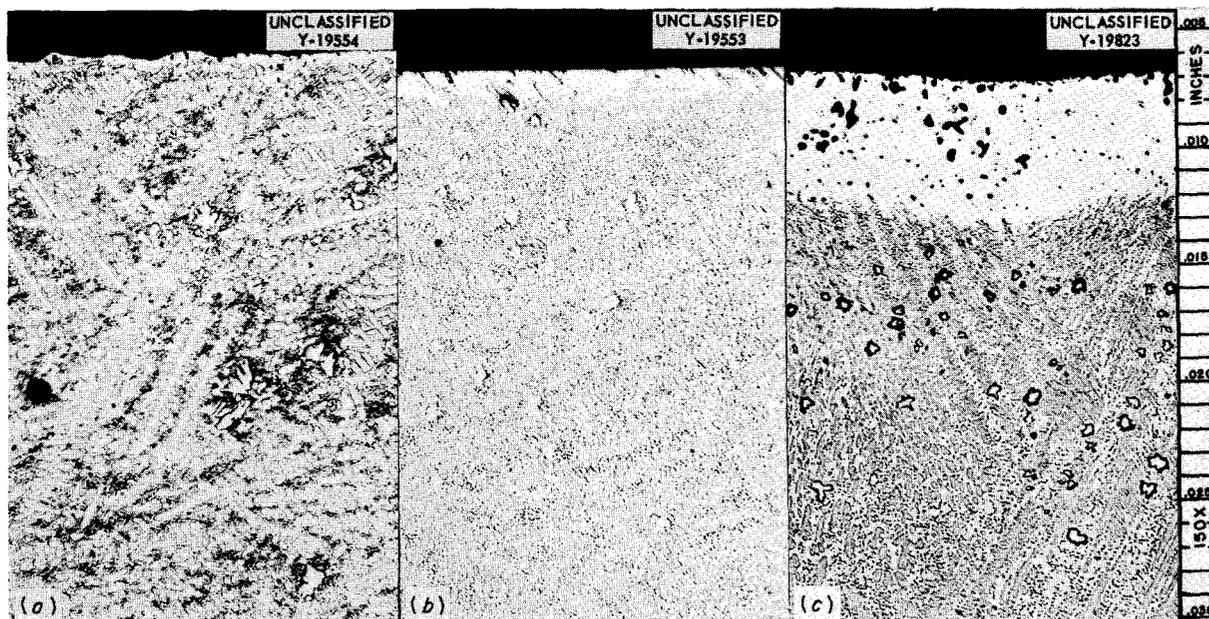
Fig. 20. Coast Metals No. 53 (81 Ni-8 Cr-4 Si-4 B-3 Fe) Alloy Seesaw Corrosion-Tested in $\text{NaF-ZrF}_4\text{-UF}_4$ (53.5-40.0-6.5 mole %) at (a) 1400°F for 100 hr, (b) 1500°F for 100 hr, and (c) 1500°F for 500 hr. Etchant: 10% oxalic acid. 50X. Reduced 17%. (Secret with caption)

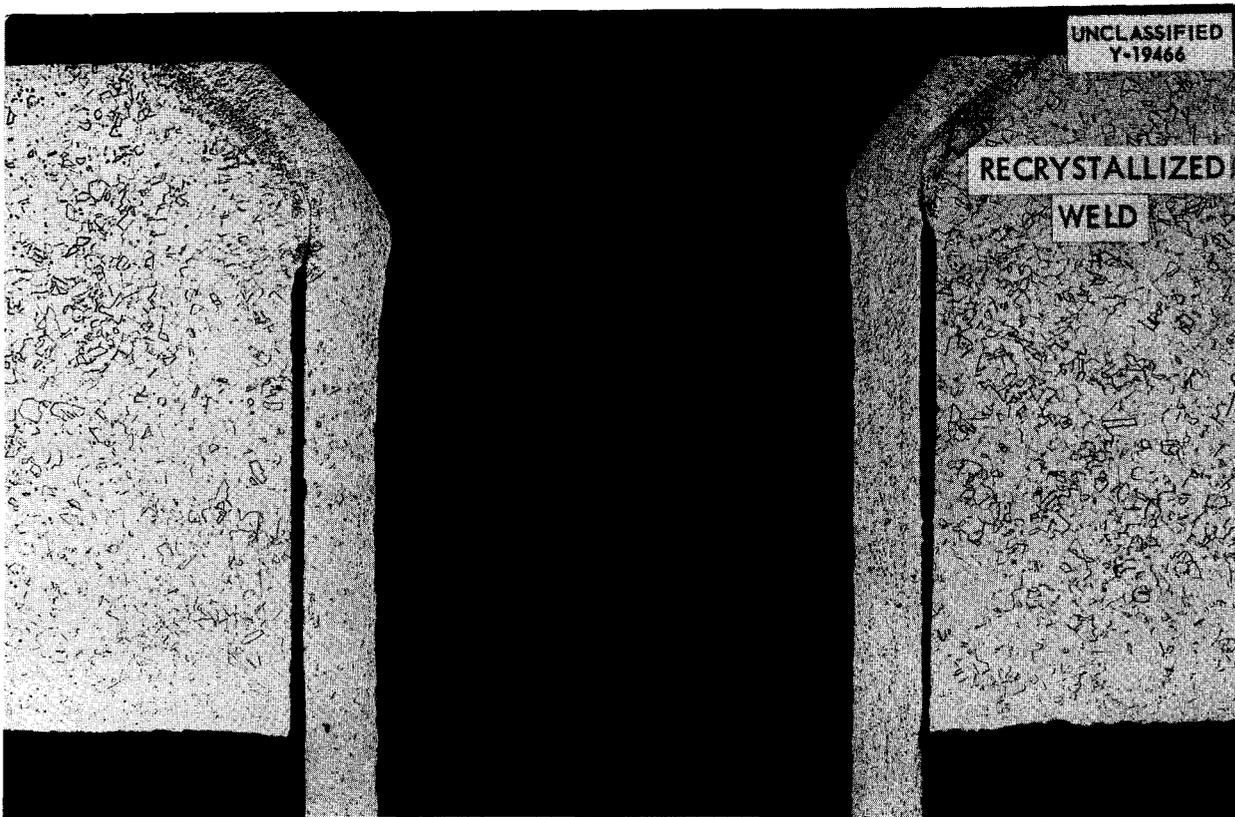
Fig. 21. As-received Tube-to-Header Joint Welded by the "Flange-During-Welding Method." The recrystallization weld and worked portion of the tube can be seen at the top of the header plate. Etchant: glyceria regia. 15X.

Recrystallized tube-to-header joints welded and supplied by The Glenn L. Martin Co. show good resistance to the $\text{NaF-ZrF}_4\text{-UF}_4$ (50-46-4 mole %) and NaK (56-44 wt %) baths during corrosion tests at 1500°F for 100 hr. The welds are made by forging a preflared tube into a drilled header plate; the edge of the header hole is heated to a plastic

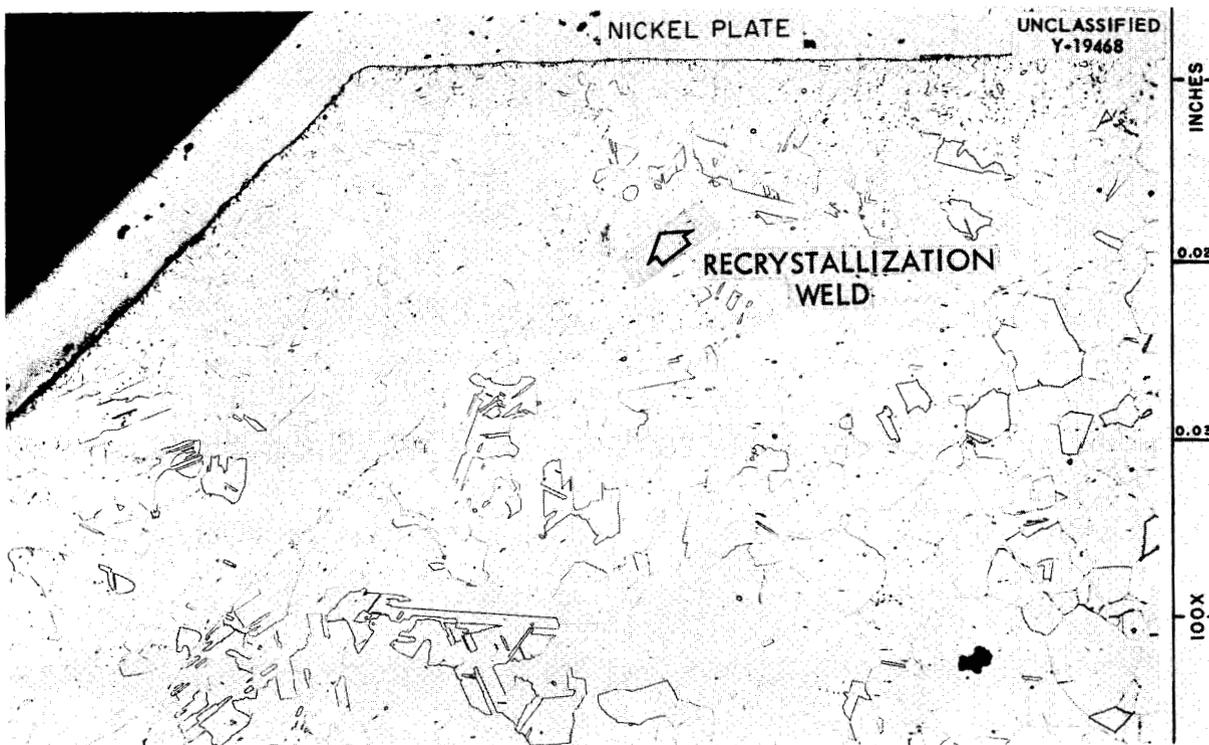
Fig. 23. Recrystallization Weld of Tube-to-Header Joint Seesaw Corrosion-Tested in NaK (56-44 wt%) for 100 hr at 1500°F. Etchant: glyceria regia. 100X. Reduced 3%.

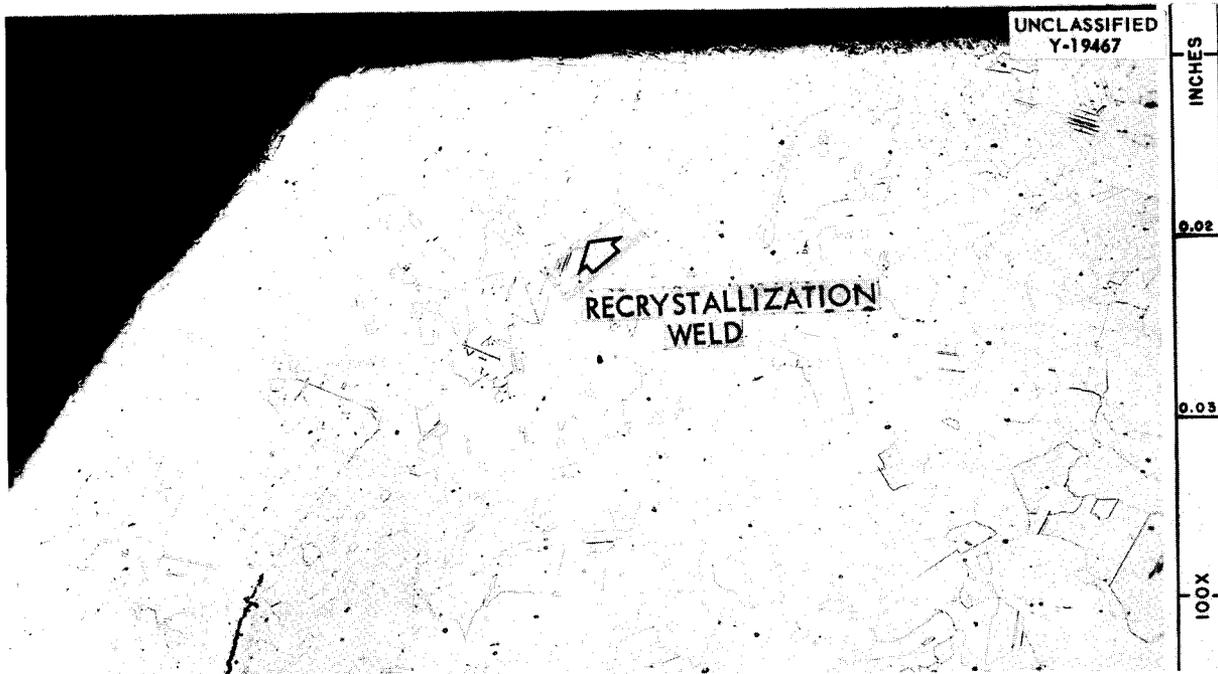
Fig. 24. Recrystallization Weld of Inconel Tube-to-Header Joint Seesaw Corrosion-Tested in NaF-ZrF₄-UF₄ (50.0-46.0-4.0 mole %) for 100 hr at 1500°F. Etchant: glyceria regia. 100X. Reduced 4%. (Secret with caption)

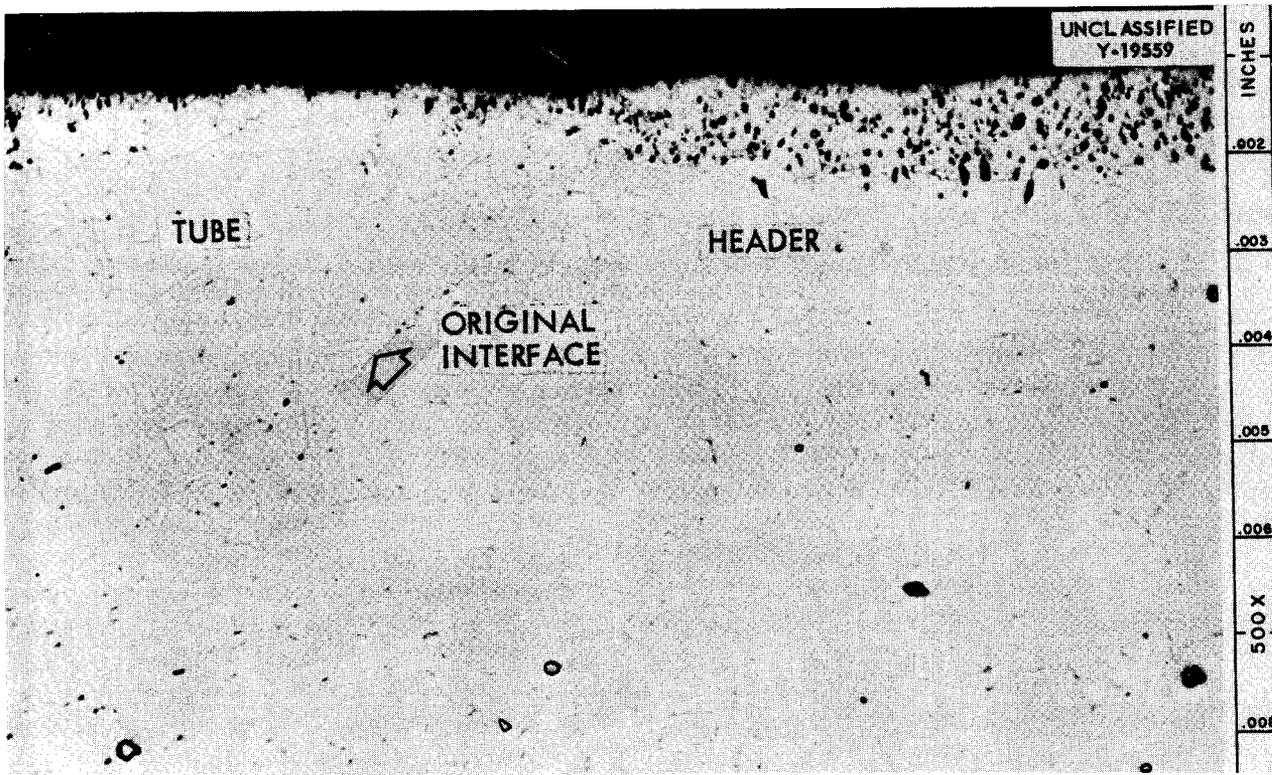
Fig. 25. Enlarged View of Recrystallization Weld Shown in Fig. 24. Note how attack by the NaF-ZrF₄-UF₄ (50.0-46.0-4.0 mole %) bath decreases in the worked tube area. Etchant: glyceria regia. (Secret with caption)

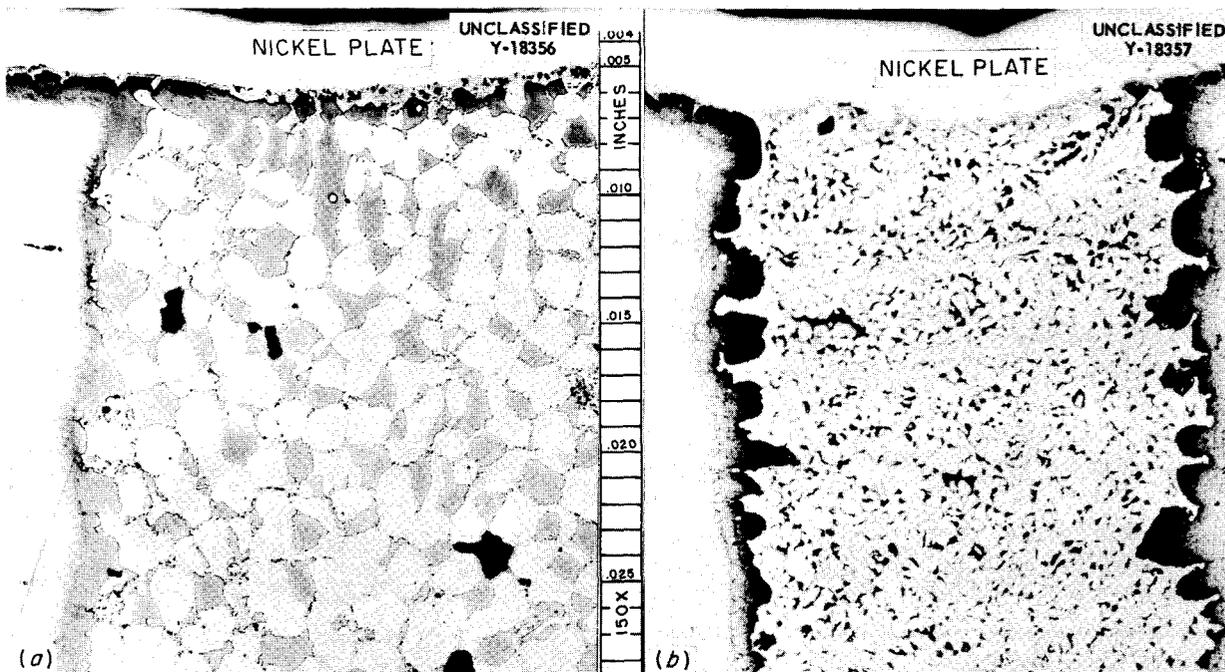
Fig. 26. Brazed Joints 2 (a) and 6 (b) of Inconel-NaK Thermal-Convection Loop Showing a Slight Attack on Brazing Alloy. These two samples were the only ones examined in which a large crack in the brazing alloy was not found. Specimens were nickel-plated to preserve edge during polishing. Etchant: 10% oxalic acid. 50X. Reduced 11%.

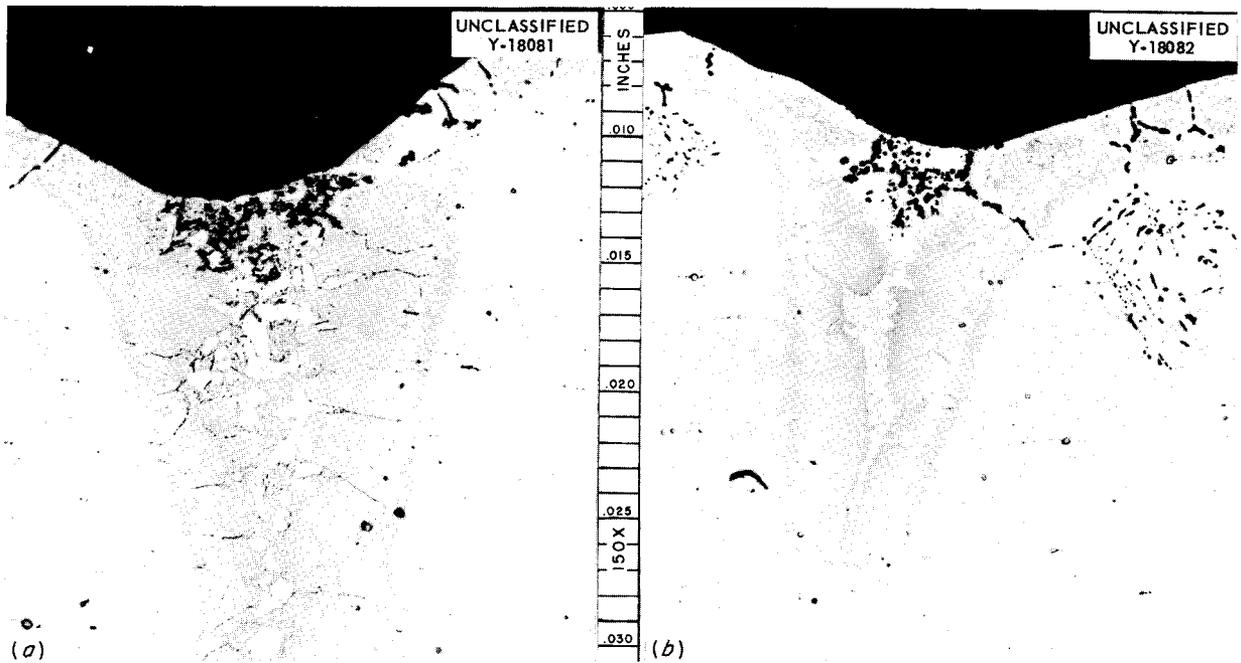
Fig. 28. Brazed Joints Located in (a) Cool Section, 1450°F, and (b) Hottest Section, 1500°F, of Hot Leg in Inconel-NaF-ZrF₄-UF₄ (50-46-4 mole %) Thermal-Convection Loop. Etchant: 10% oxalic acid. 50X. Reduced 11%. (Secret with caption)

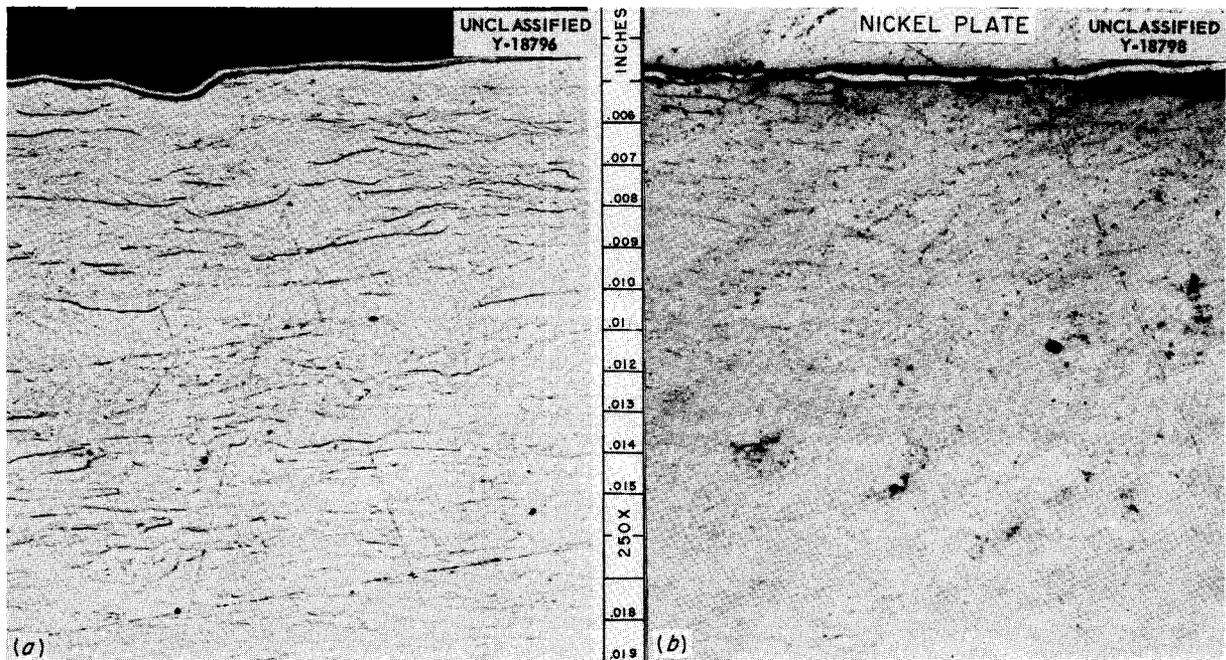
Fig. 29. Niobium Specimens Tested in Liquid Sodium for 1000 hr in (a) Inconel and (b) Type 304 Stainless Steel Containers. Specimen nickel-plated to preserve edge during polishing. Etchant: 25% HF, 25% H₂SO₄, 50% H₂O. 250X. Reduced 12%.

Pure niobium has been static tested in sodium for 1000 hr at 1500°F in Inconel and type 304 stainless steel capsules. A small amount of surface roughening and weight loss was found on the specimens after the test.

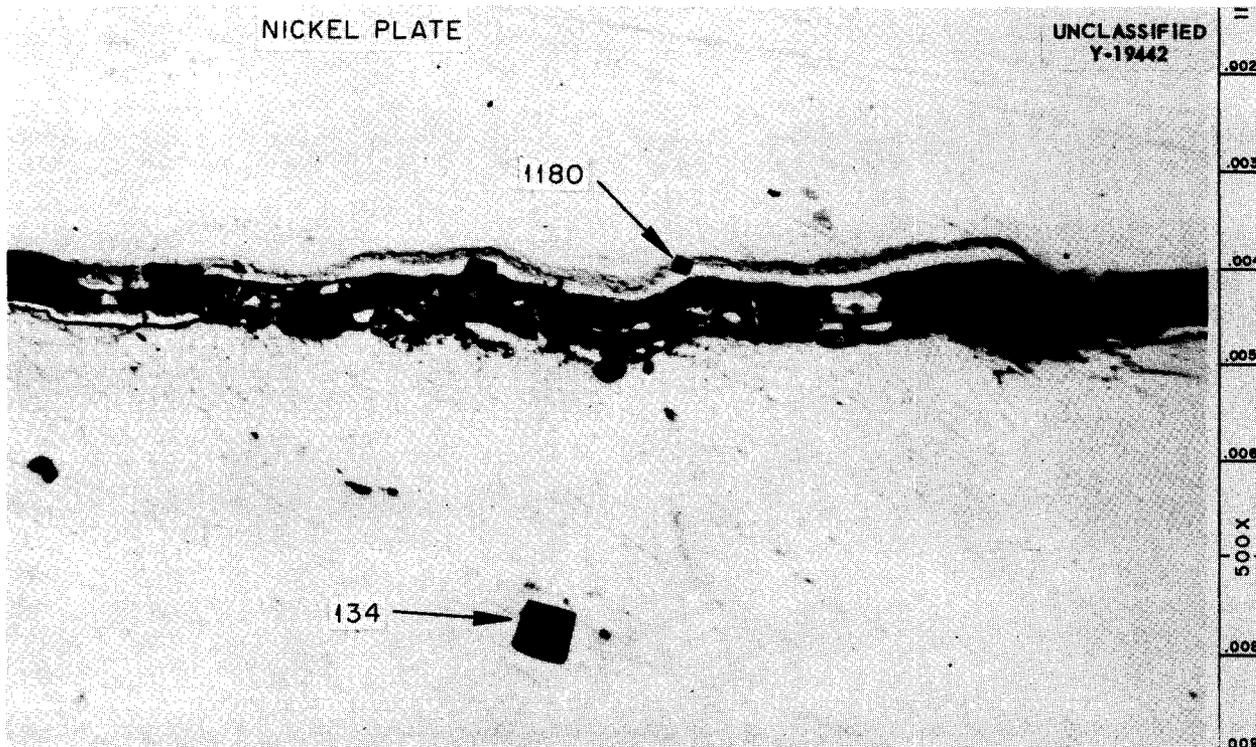
Fig. 30. Niobium Specimen Tested in Static Sodium in Type 304 Stainless Steel Container at 1500°F for 1000 hr Showing Comparative Hardness of Layer Formed on Surface and on the Niobium Specimen. The value 1180 VHN is approximate. Etchant: 25% HF, 25% H₂SO₄, 50% H₂O.

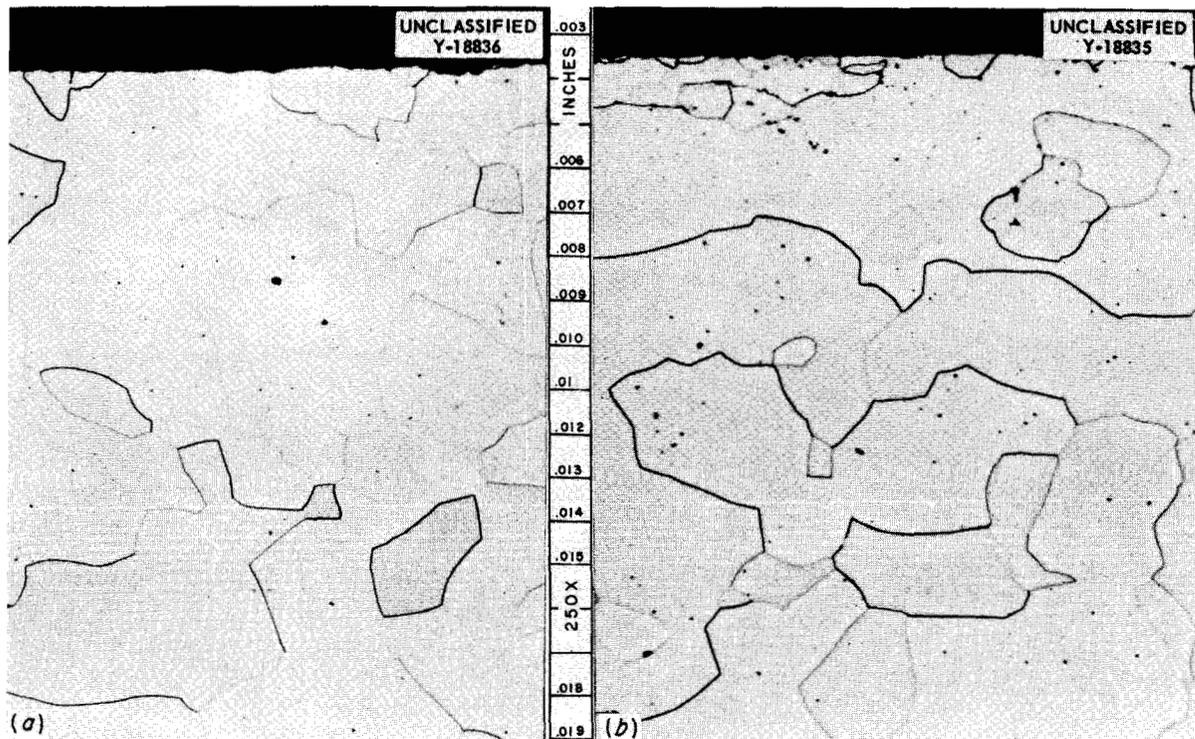
Fig. 31. As-tested Thermenol (82 Fe-15 Al-3 Mo) Specimens After Exposure to Static Sodium at 1500°F for 100 hr in (a) Type 430 Stainless Steel and (b) AISI 1035 Steel Capsules. Etchant: aqua regia. 250X. Reduced 7%.

Some Thermenol (82% Fe-15% Al-3% Mo) samples have been statically tested in sodium for 100 hr at 1500°F using 1035 steel and type 430 stainless steel capsules. A small weight and thickness loss was found on the tested specimens.

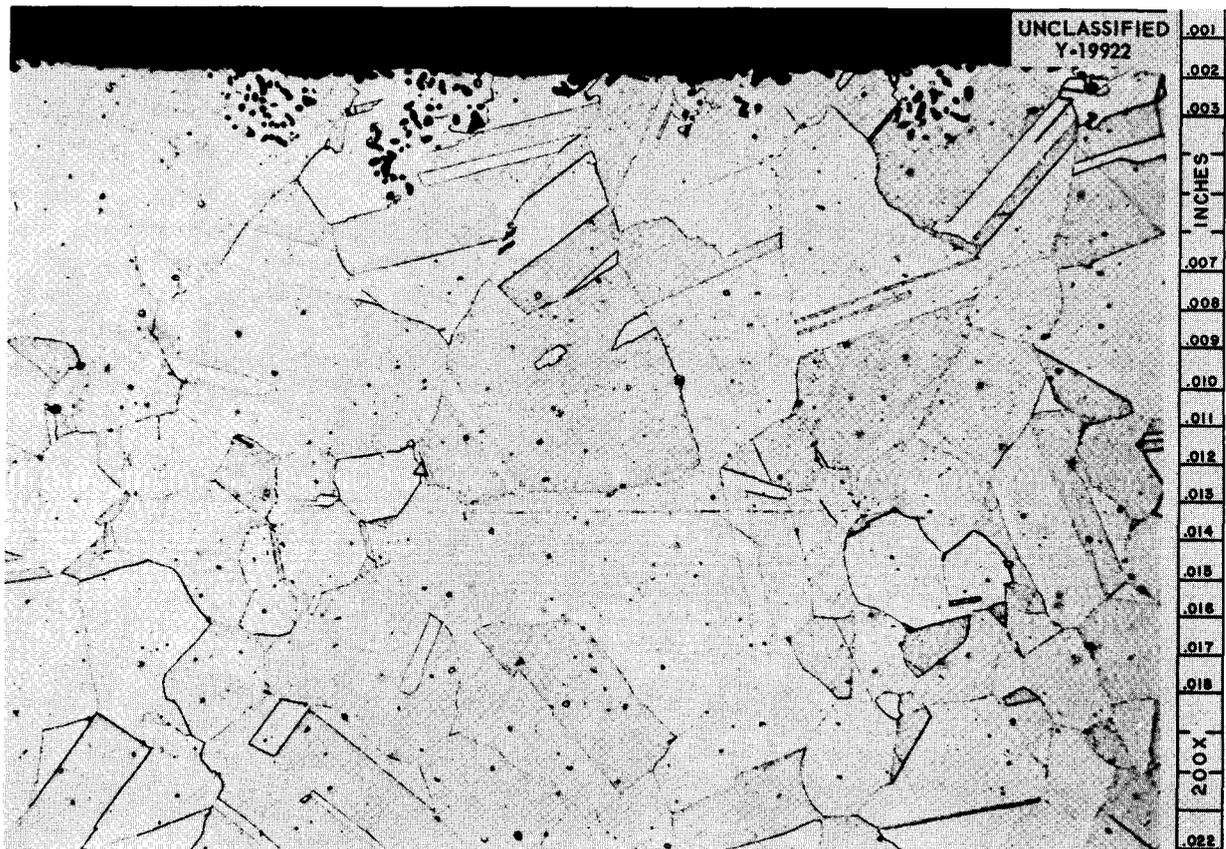
Fig. 34. Hot Zone from Inconel Capsule Subjected to NaCl-MgCl₂-UCl₃ (50.0-33.3-16.7 mole %) Bath for 500 hr at 1350°F. A spotty subsurface void attack to a maximum depth of 4 mils can be seen. Etchant: copper regia. (Secret with caption)

Screening corrosion tests on nickel and Inconel by using an $\text{NaCl-MgCl}_2\text{-UCl}_3$ (50.0-33.3-16.7 mole %) bath show that nickel mass-transfers quite readily in this bath at 1800°F during a 100-hr test. Inconel showed trace amounts of mass transfer under the same conditions and a 2-mil subsurface type attack in a 500-hr test at 1350°F in the same bath.

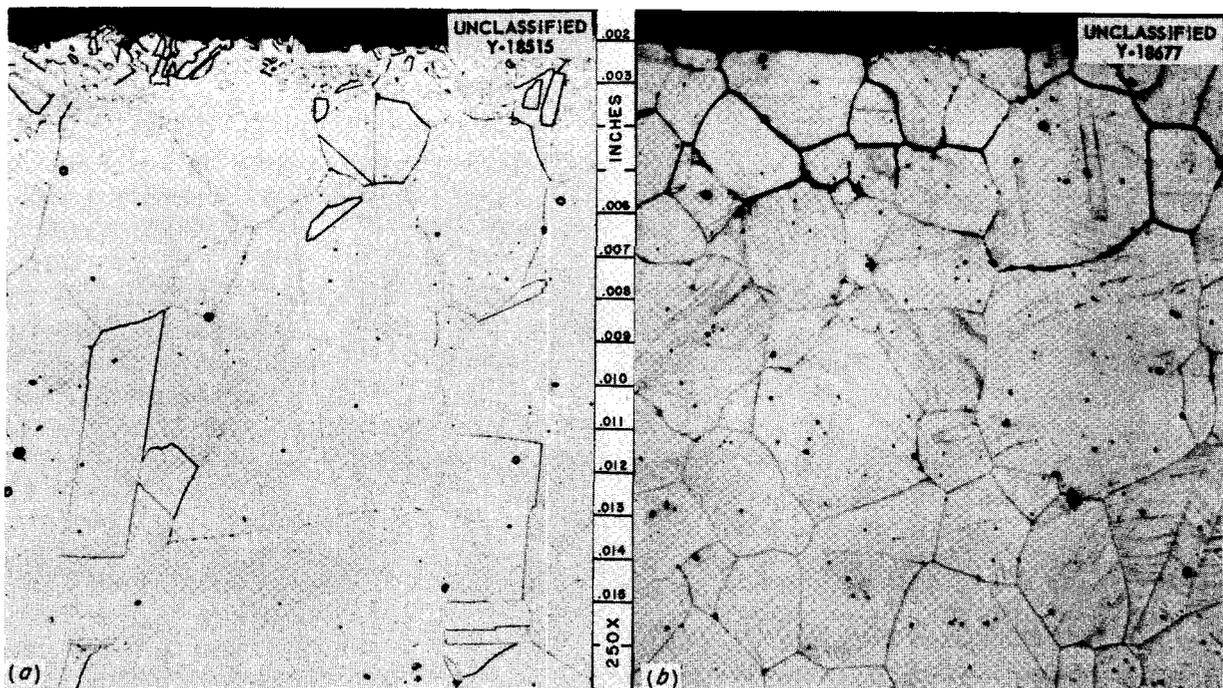
Fig. 37. Cold Legs of (a) Inconel and of (b) Type 316 Stainless Steel Thermal-Convection Loops Operated for 1000 hr at 1500°F with NaK + 5 wt % Li as Circulating Medium. Etchant: aqua regia. 250X. Reduced 10%. (Secret with caption)

conducted for 1000 hr at 1500°F with a 5% lithium addition revealed no change in attack on the Inconel, but the stainless steel was attacked to a depth of 6 mils in the cold leg.

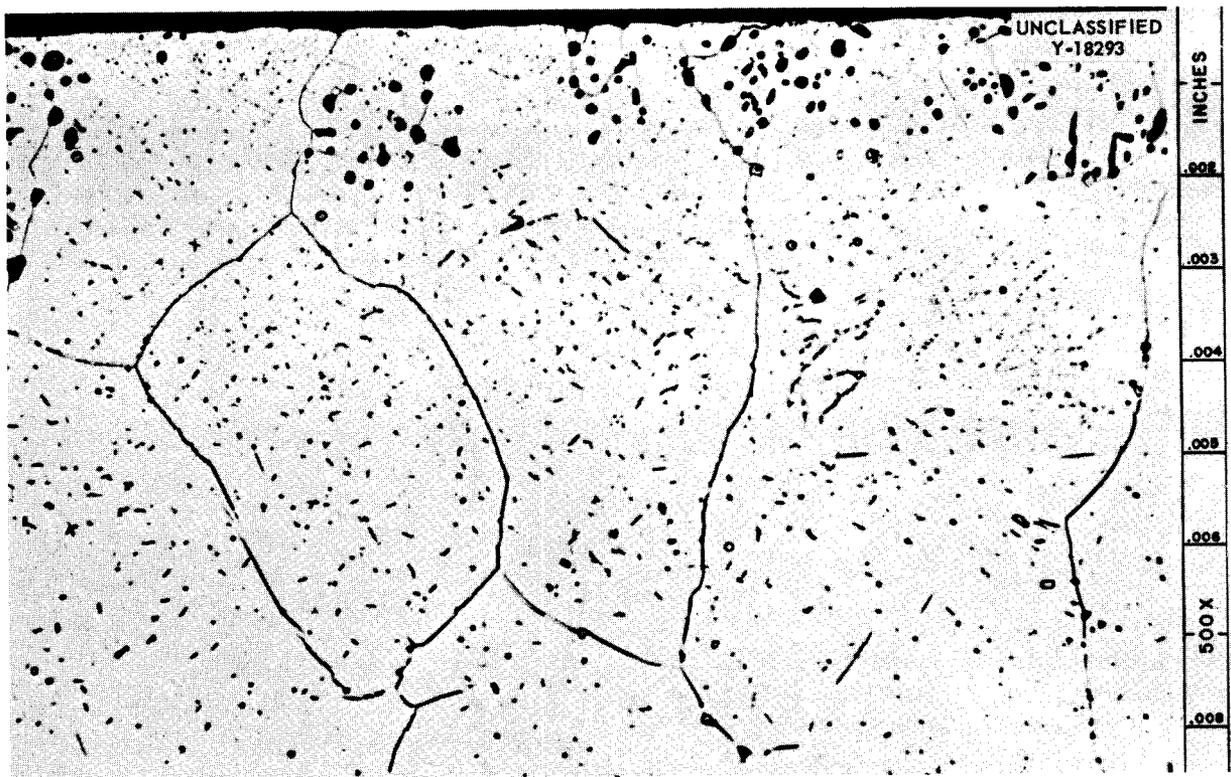
Fig. 39. Bath Zone of Inconel Capsule Following Exposure to $\text{NaF-ZrF}_4\text{-UF}_4$ (53.5-40-6.5 mole %) for 1000 hr at 1600°F. Etchant: 10% oxalic acid. 500X. Reduced 2%. (Secret with caption)

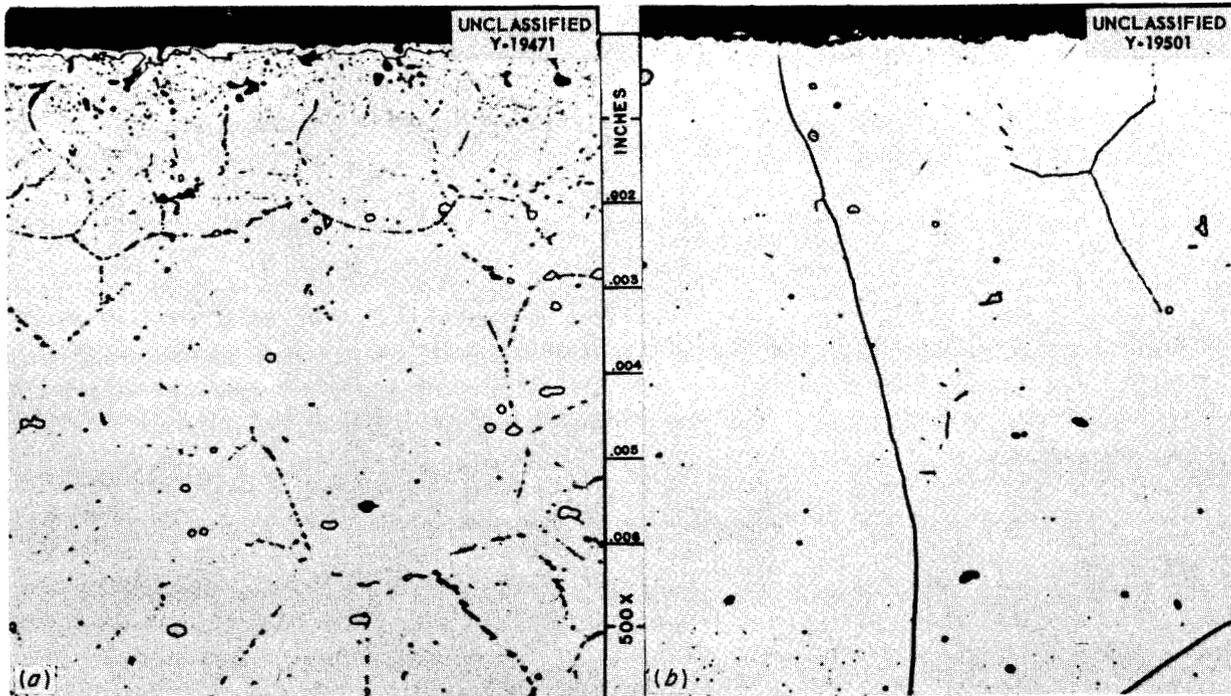
Fig. 41. (a) Hastelloy B and (b) Inconel Containers, Both of Which Contained Niobium, After Exposure to Sodium for 100 hr at 1535°F. Note dissimilar-metal mass-transfer layers on the surfaces of the Hastelloy B and the Inconel. Etchant: (a) 20 cc 10% chromic acid-30 cc HCl, (b) 10% oxalic acid. 500X. Reduced 10%. (Secret with caption)

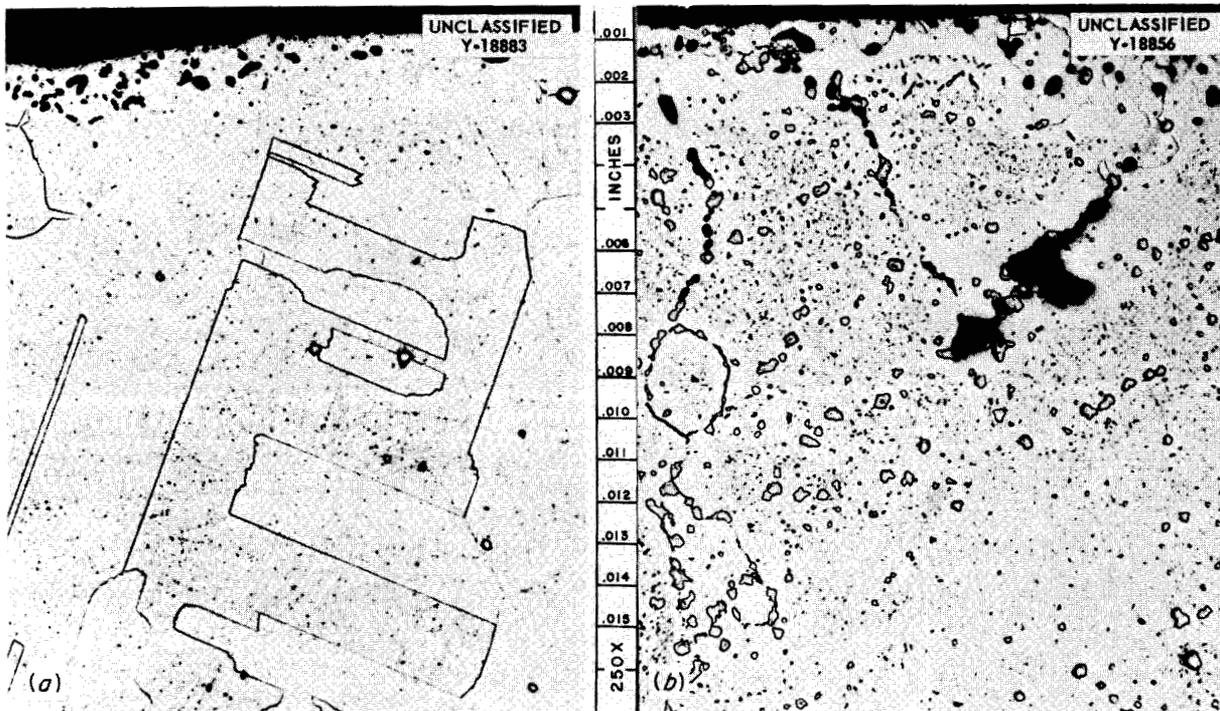
Fig. 43. (a) Bath Zone of Wrought Inconel Capsule and (b) Cast Inconel Specimen No. 321 Tested Staticly in NaF-ZrF₄-UF₄ (50-46-4 mole %) for 1000 hr at 1500° F. Etchant: aqua regia. 250X. Reduced 11%. (Secret with caption)
