ORNL-2217 *cy. 6-A*
C-84 - Reactors - Special Features
of Aircraft Reactors

METALLURGY DIVISION
SEMIANNUAL PROGRESS REPORT
FOR PERIOD ENDING OCTOBER 10, 1956

OAK RIDGE NATIONAL LABORATORY

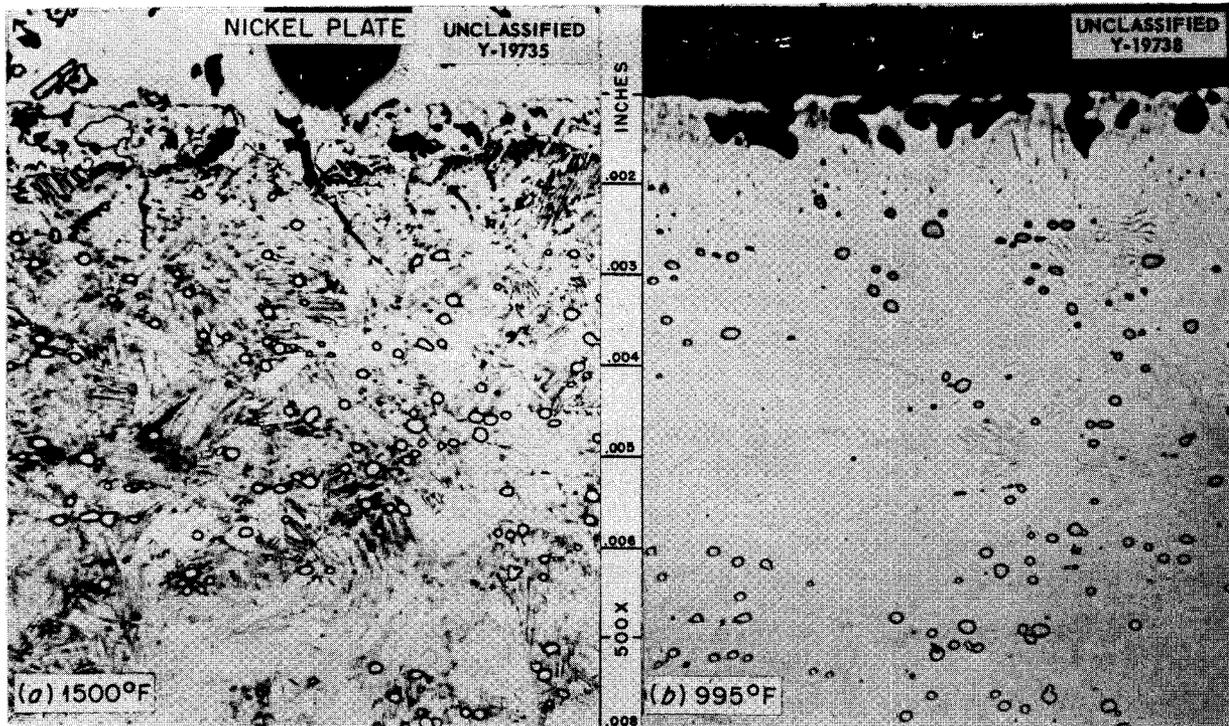
Fig. 44. (a) Bath Zone and (b) Vapor Zone of Hastelloy B Standpipe Test No. 2 After Exposure to Rubidium for 500 hr. Etchant: 80 cc H_2O_2 -20 cc H_3PO_4 . 500X. Reduced 4%. (Secret with caption)

Rubidium standpipe and corrosion tests by seesaw apparatus in Hastelloy B and in molybdenum capsules which were performed for 500 hr at various temperatures produced no mass transfer and little attack of the two materials.

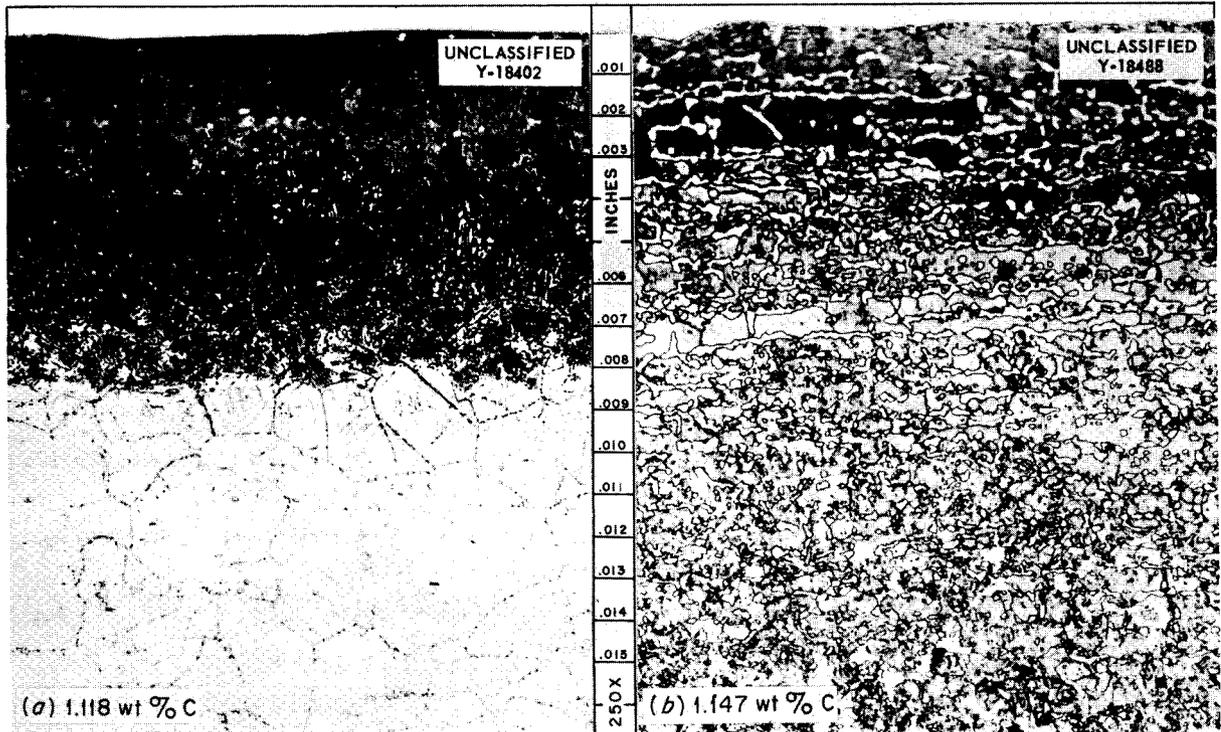
Fig. 47. (a) Hastelloy B and (b) Type 430 Stainless Steel After Exposure to Sodium + 10 wt % Graphite for 100 hr at 1500°F. Etchant: (a) phosphoric acid-H₂O₂ and (b) glyceria regia. 250X. Reduced 11%.

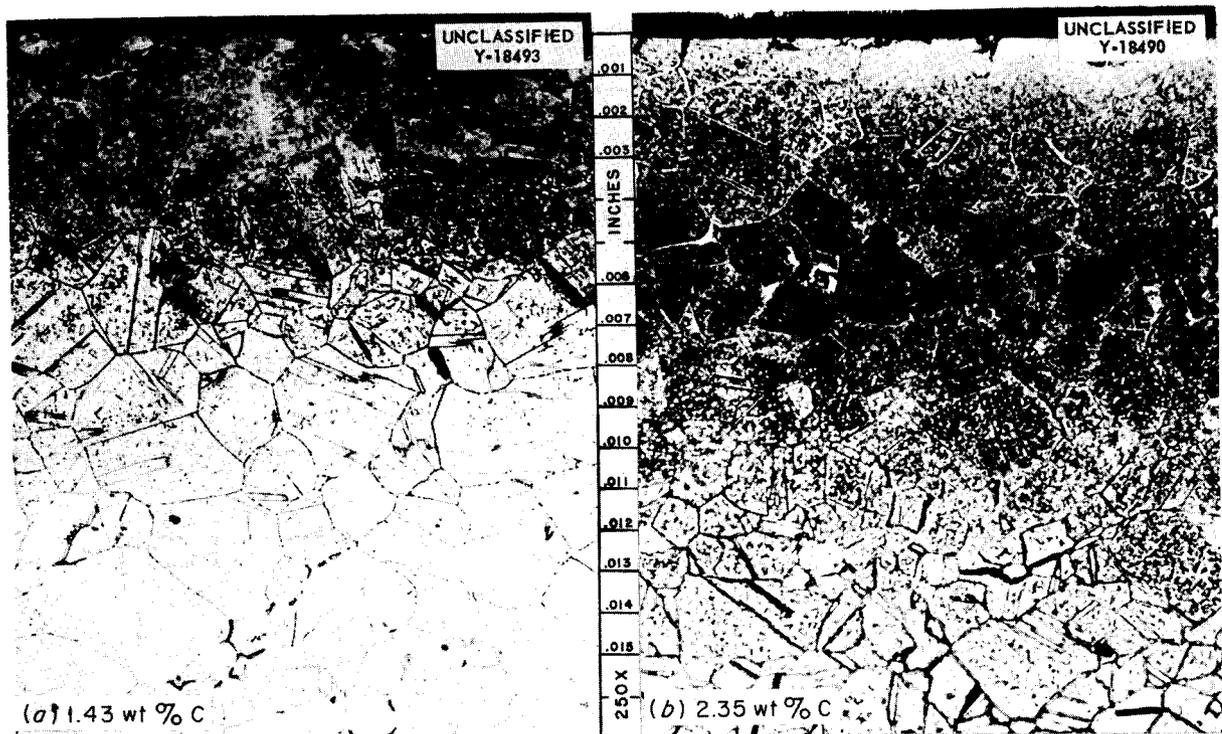
Fig. 48. (a) Type 310 and (b) Type 316 Stainless Steel After Exposure to Sodium + 10 wt % Graphite for 100 hr at 1500°F. Etchant: glyceria regia. 250X. Reduced 11%.

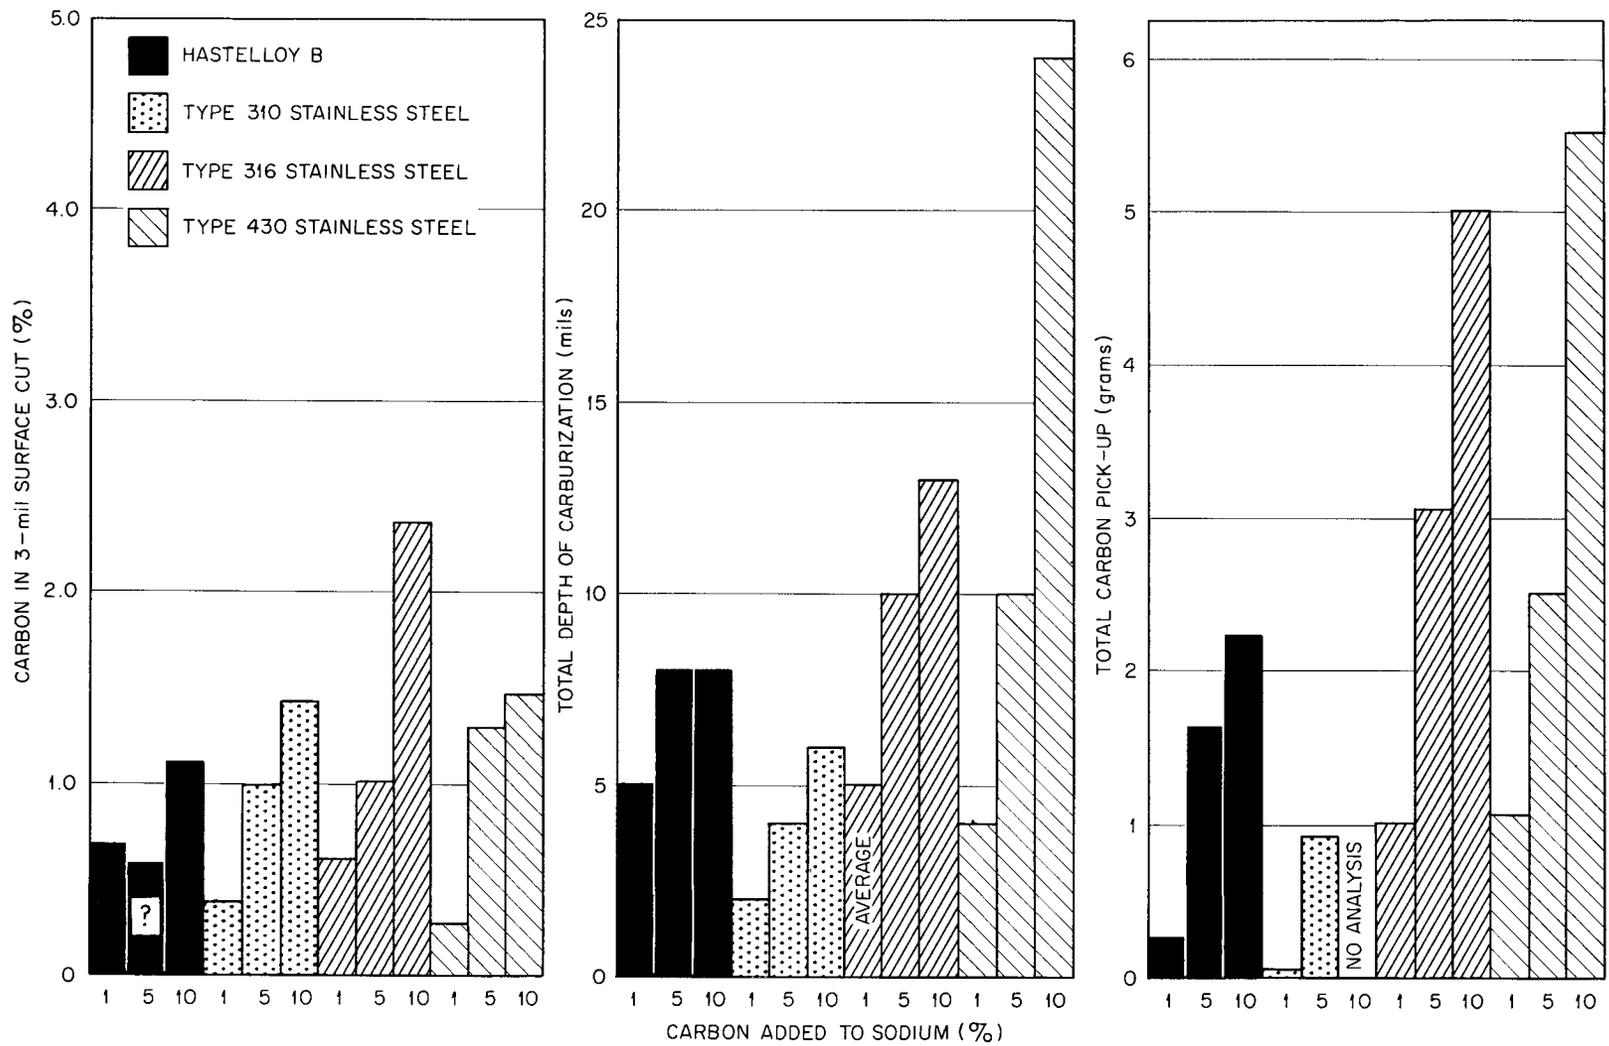
Fig. 49. Carburization of Various Alloys as a Function of the Per Cent Carbon Added to the Sodium.

Of the four materials subjected to carburization by sodium with varying graphite additions, the heaviest amount of carburization and deepest carbon penetration occurred, in descending order, in type 430 stainless steel, type 316 stainless steel, Hastelloy B, and type 310 stainless steel.

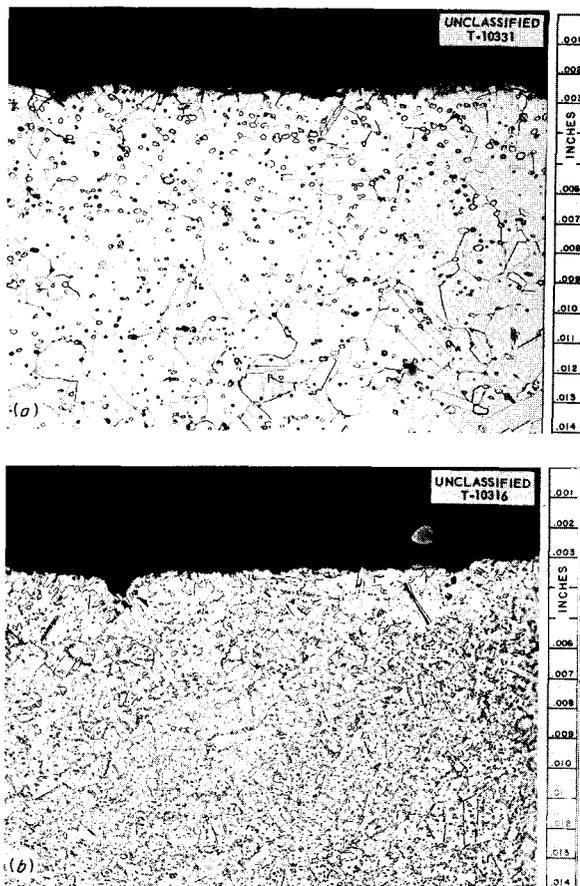
Fig. 54. Hastelloy B As-received Tubing (a) and Hot-Leg Sample (b) from Loop 7425-13 After Exposure to Fuel 107 for 1000 hr. Note increased amount of second phase resulting from aging at 1500°F. 250X. Reduced 35.5%. (Secret with caption)

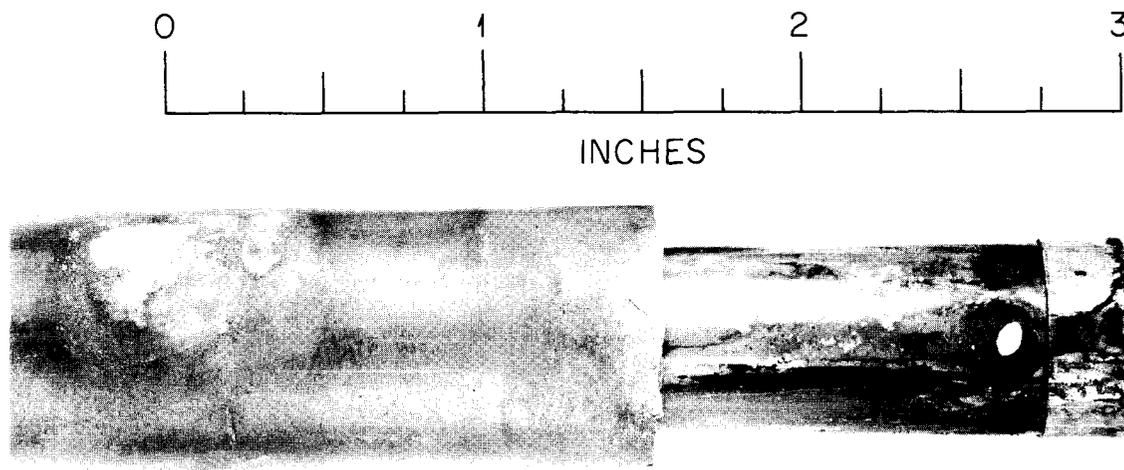
Fig. 65. Deposit on Beryllium Insert After Operation in Inconel Loop 913, Which Circulated Sodium 1000/hr at 1250°F.

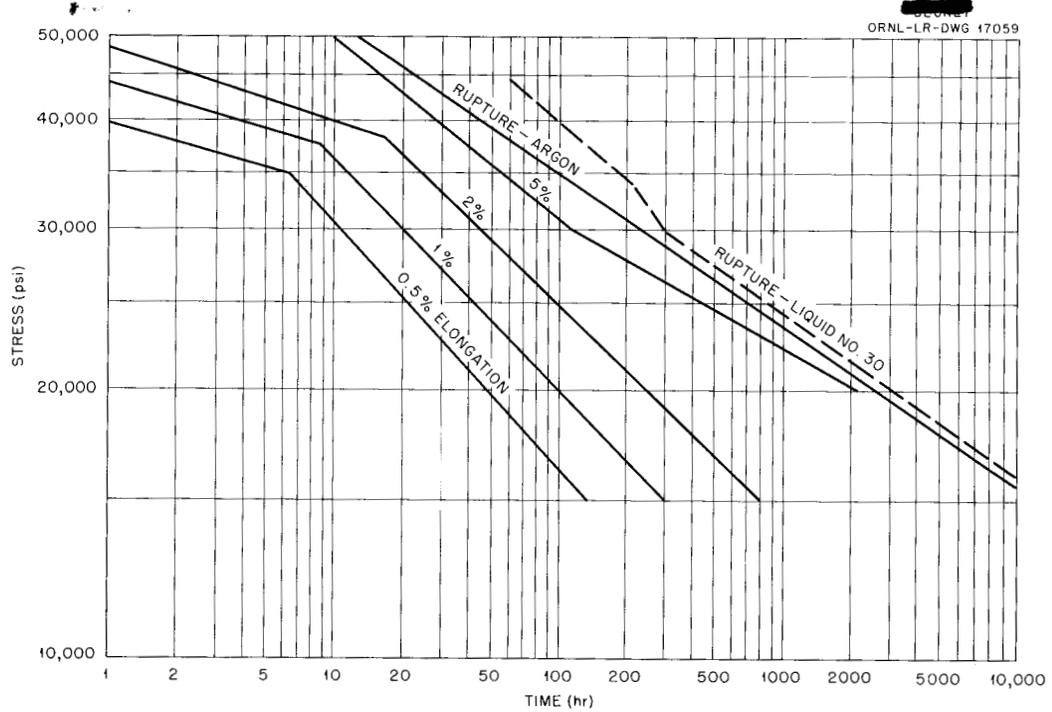
Fig. 70. Design Curve for Solution-annealed Hastelloy B Sheet Tested in Argon and Liquid No. 30 at 1300°F.

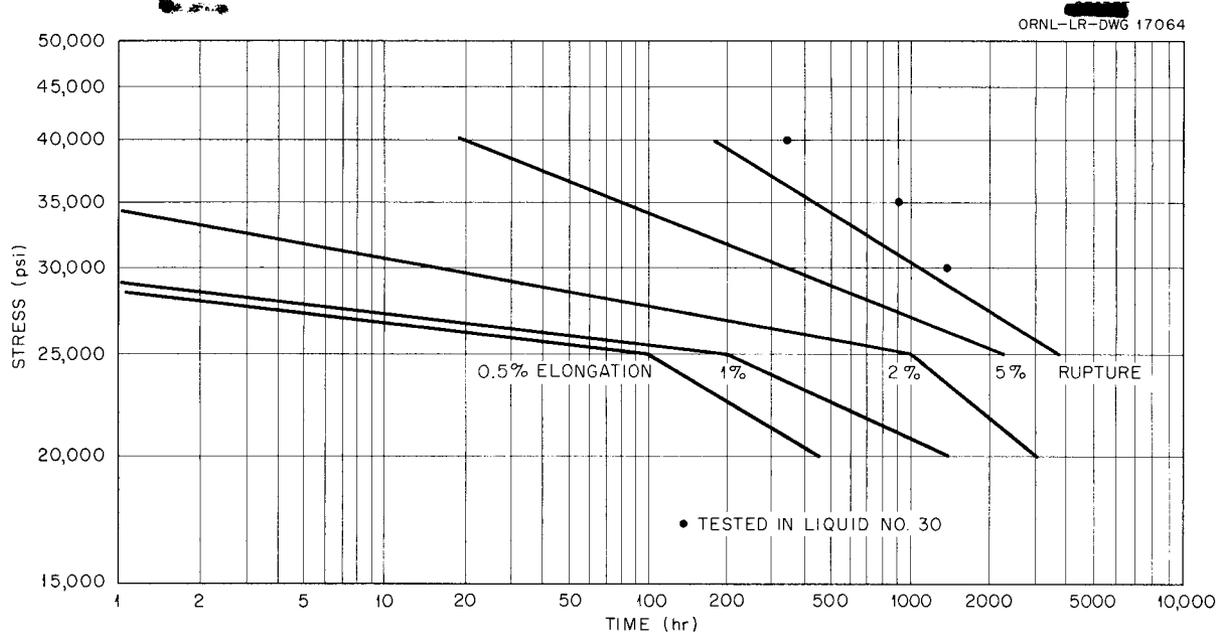
Fig. 76. Design Curve for Solution-annealed Hastelloy W Sheet Tested in Argon at 1300°F.

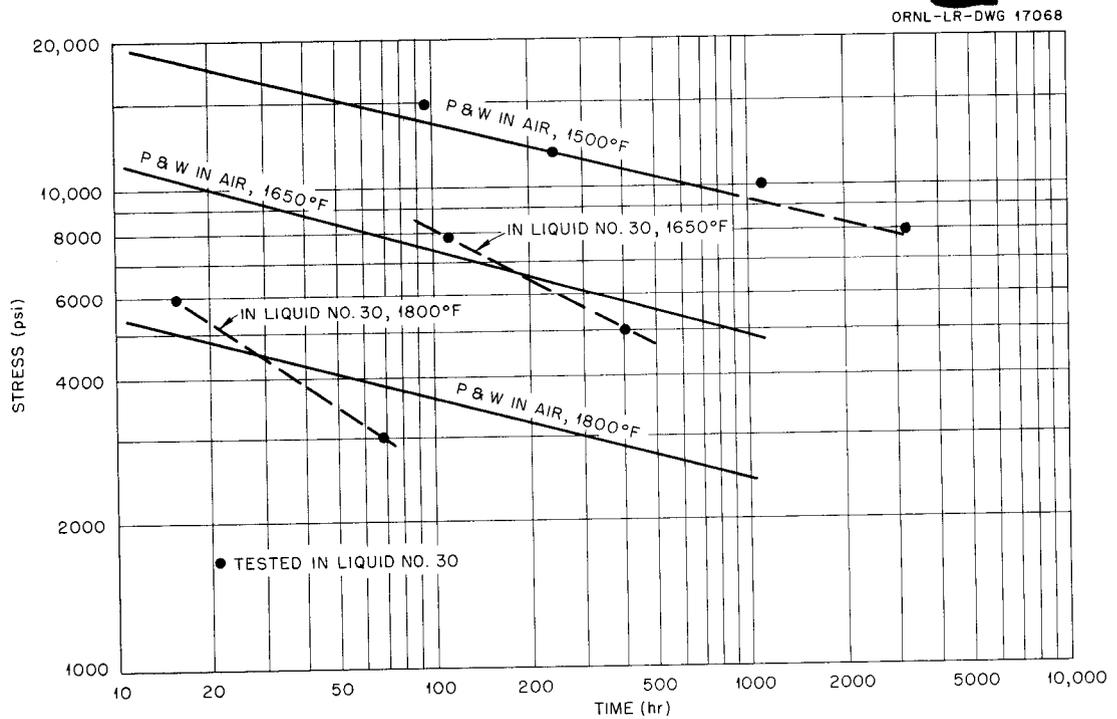
Fig. 81. Comparison of Stress-Rupture Properties of Hastelloy X in Air and in Liquid No. 30 at 1500, 1650, and 1800°F.

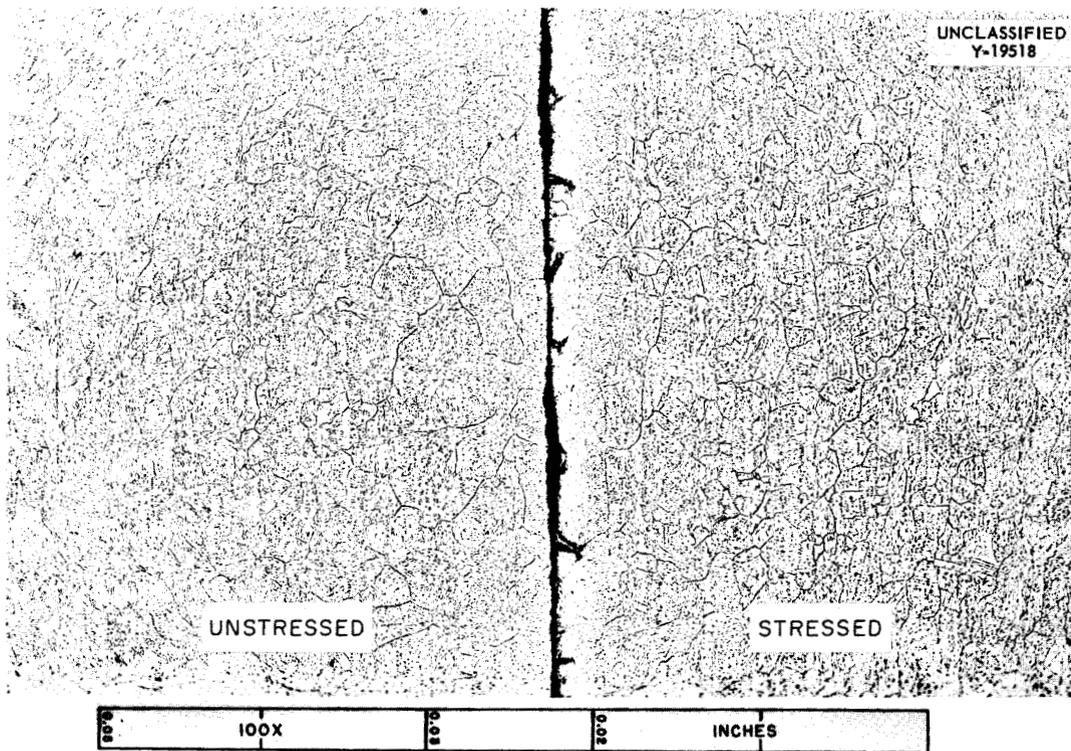
Fig. 82. Surface of the Stressed and Unstressed Portion of a Hastelloy X Specimen After Creep-Rupture Testing in Liquid No. 30 at 1500°F. Reduced 13%. (Secret with caption)

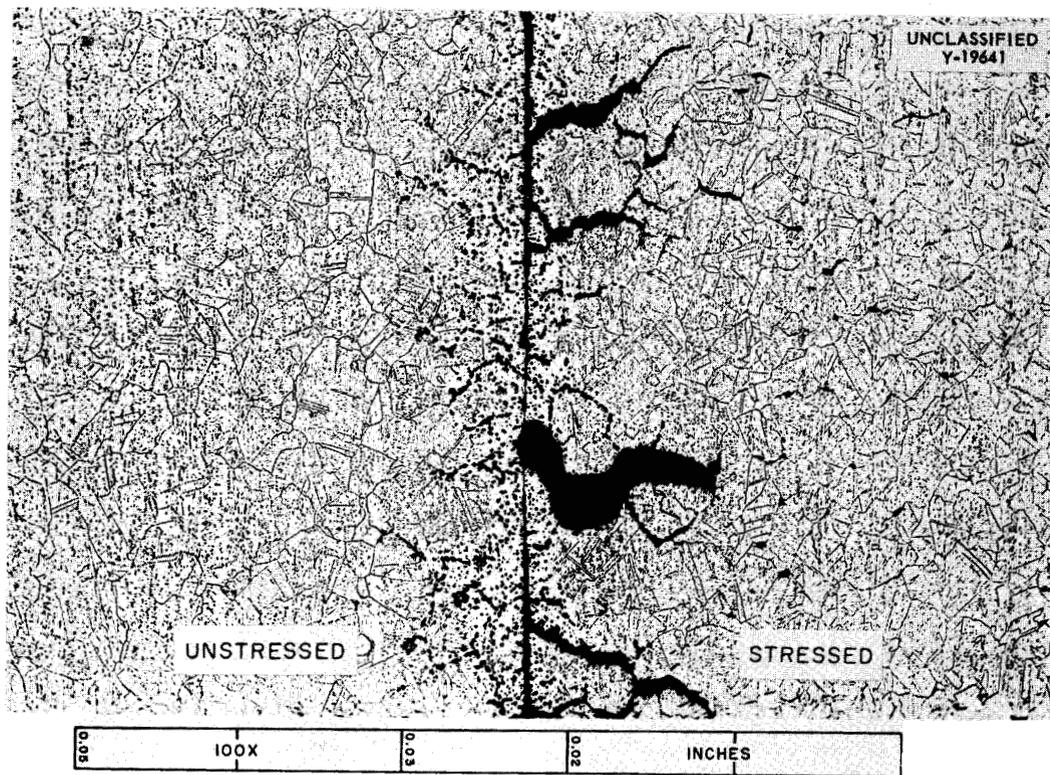
Fig. 83. Surface of the Stressed and Unstressed Portion of a Hastelloy X Specimen After Creep-Rupture Testing in Liquid No. 30 at 1650°F. Reduced 14%. (Secret with caption)

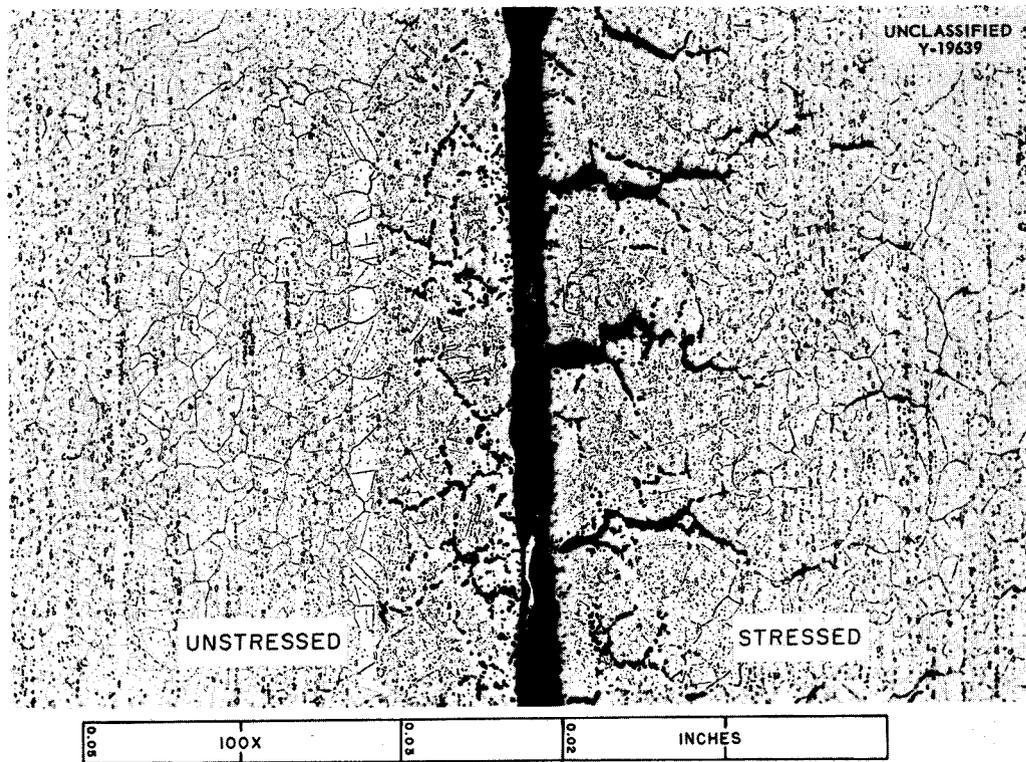
Fig. 84. Surface of the Stressed and Unstressed Portion of a Hastelloy X Specimen After Creep-Rupture Testing in Liquid No. 30 at 1800°F. Reduced 11%. (Secret with caption)

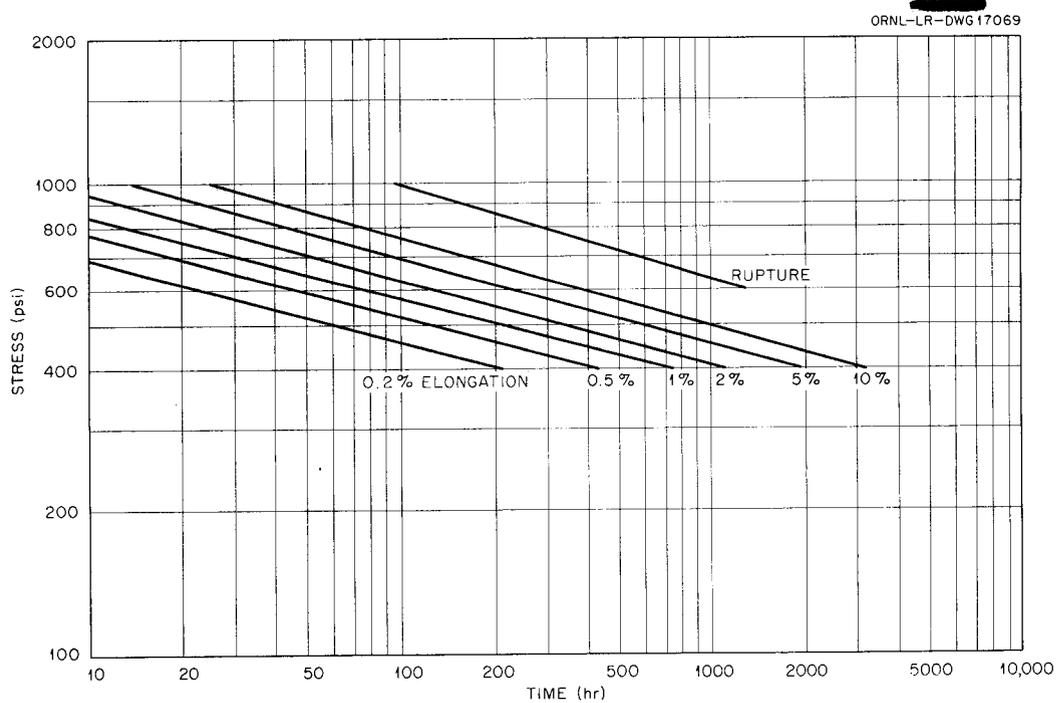
Fig. 85. Creep-Rupture Summary Graph for the Surface-treated Magnesium-Lithium Alloy Tested at 200°F in Air.

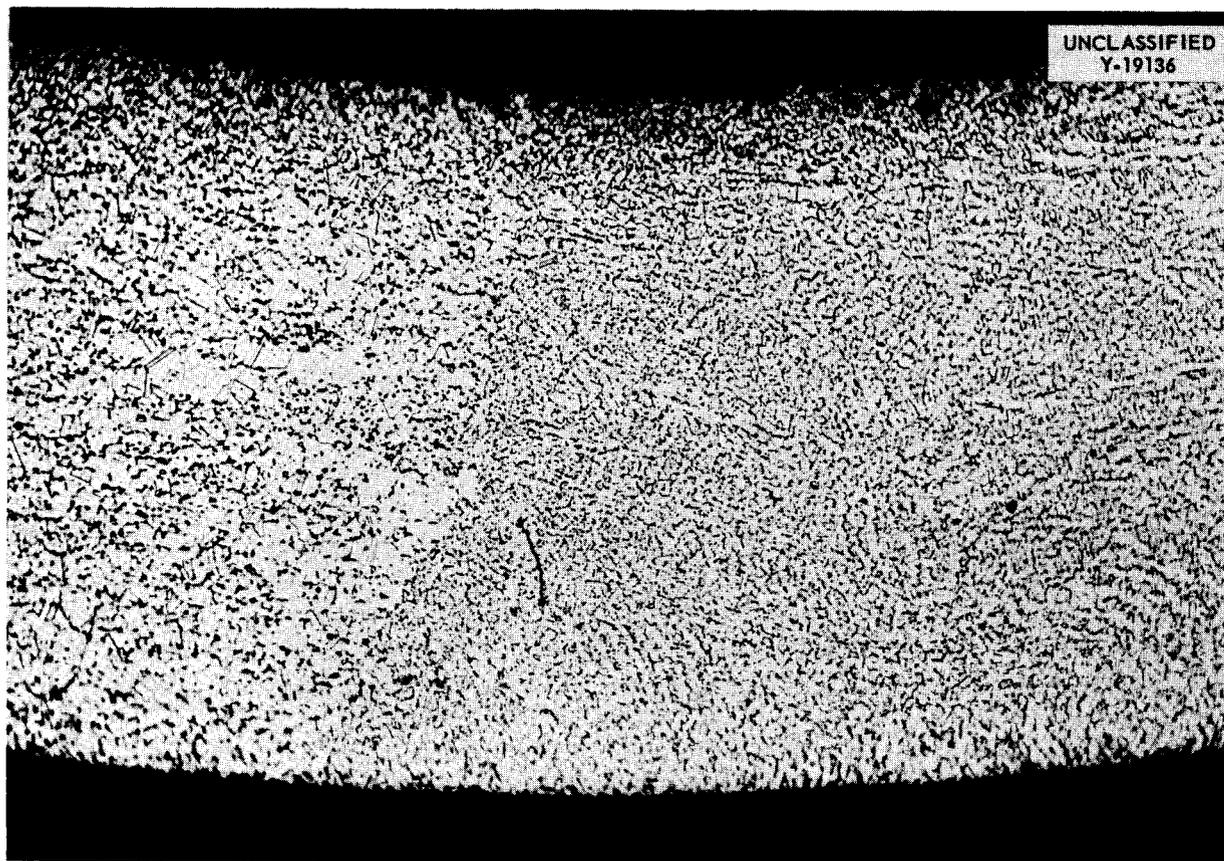
Fig. 88. Internal Crack in the Weld Bead of $\frac{3}{8}$ -in.-OD \times 0.035-in.-wall Hastelloy C Tube. Etched with chrome regia. 100X.

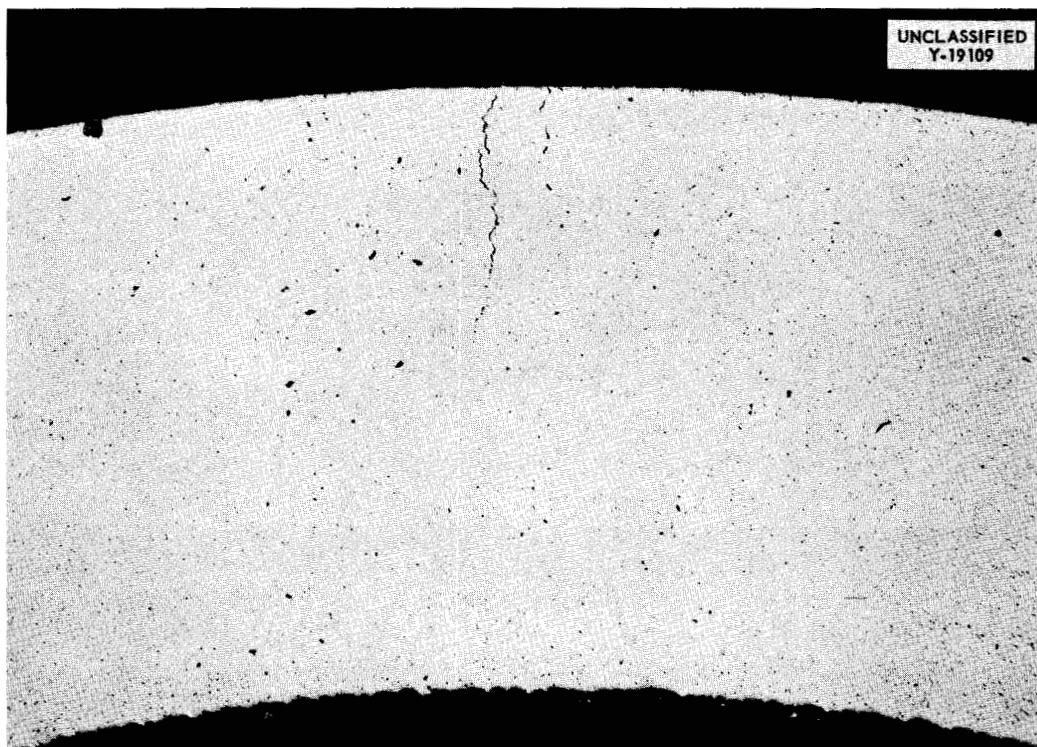
Fig. 89. Intergranular Cracking in Hastelloy C Tube. Not etched. 100X. Reduced 11%.

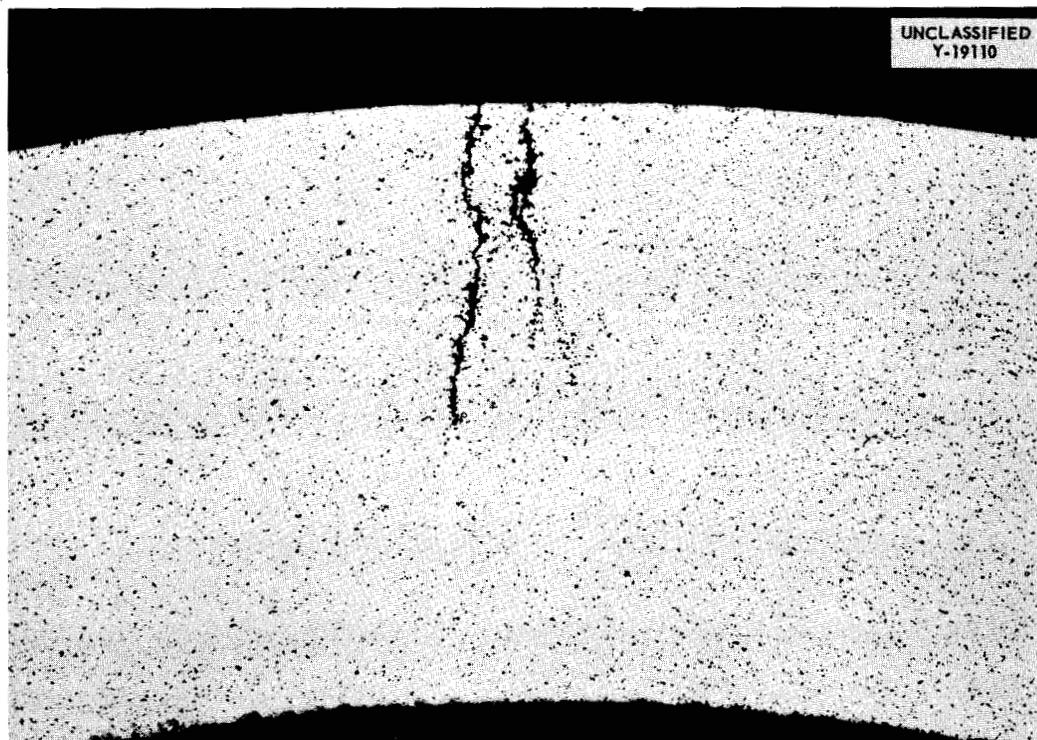
Fig. 90. Intergranular Cracking in Hastelloy C Tube. Etched with chrome regia. 100X. Reduced 11%.

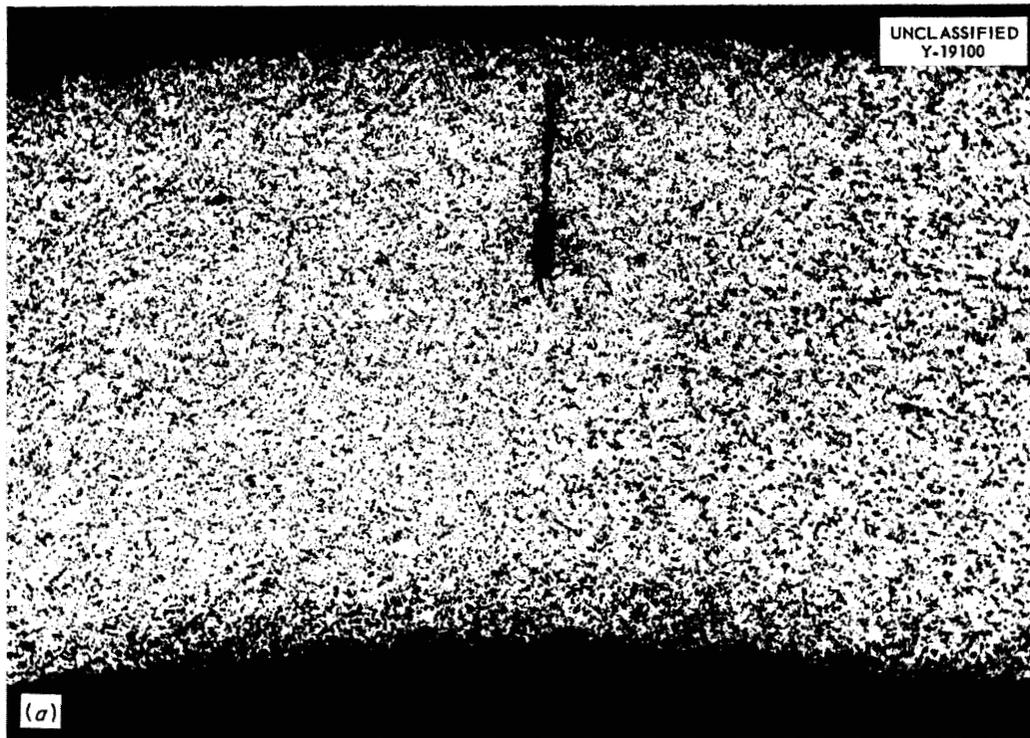
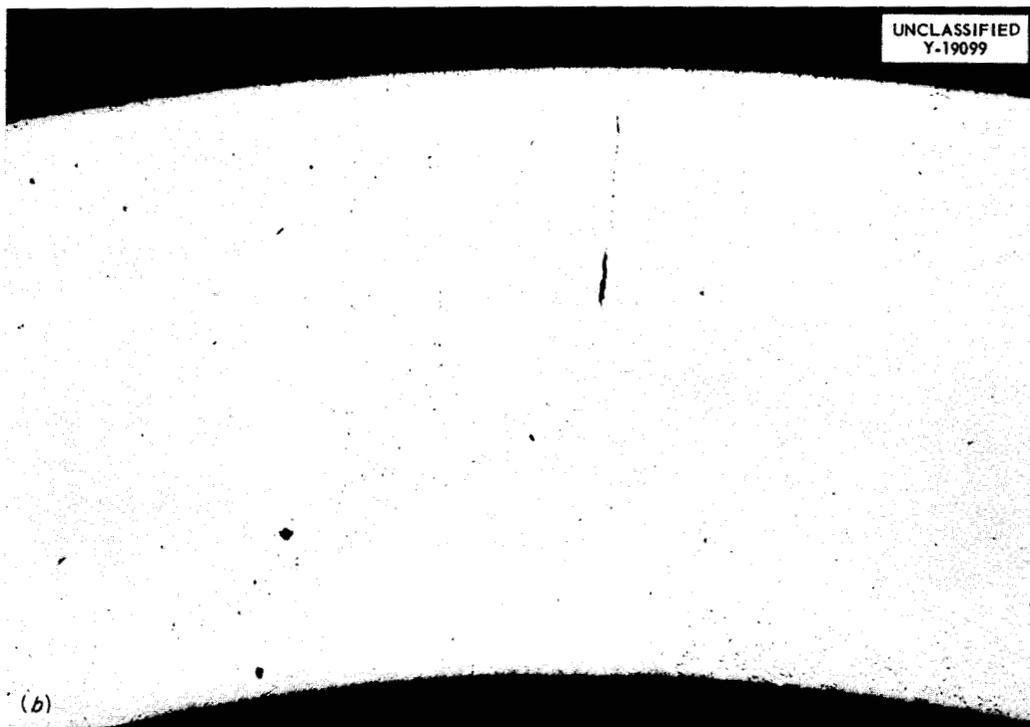
Fig. 91. Cracking in Hastelloy C Tubing. (a) Etched with chrome regia. (b) Unetched. 100X. Reduced 13.5%.

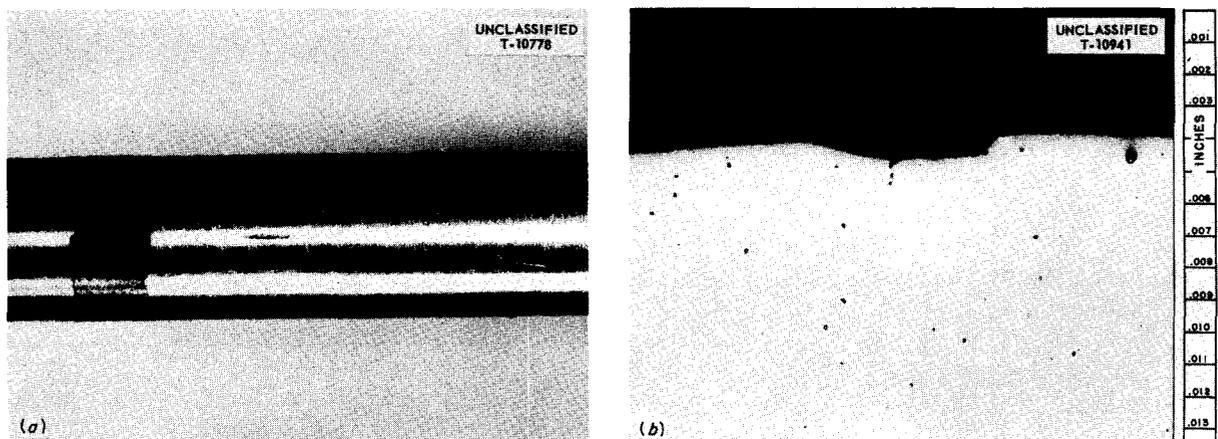
Fig. 95. Typical Defect Rejected on Visual Examination. (a) Macrograph, 3X. (b) Micrograph, 250X. Reduced 30.5%.

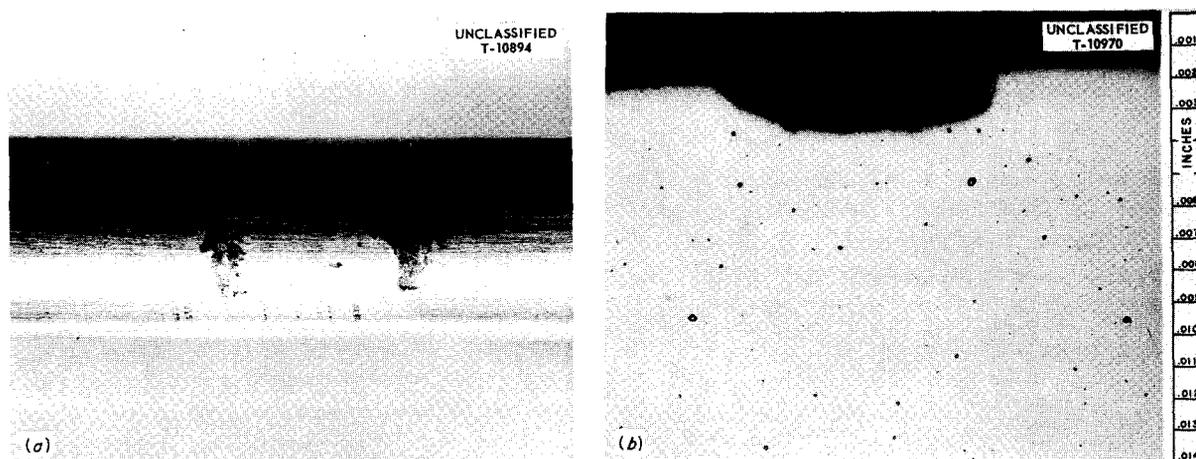
Fig. 97. Typical Defect Rejected on Pentrex Penetrant Examination. (a) Macrograph. 8X. (b) Micrograph. 250X. Reduced 31%.

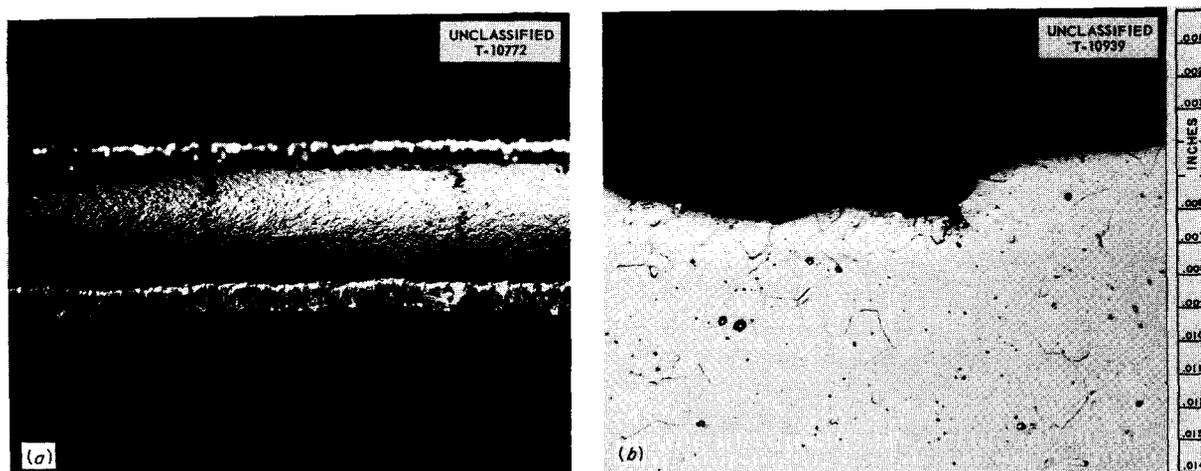
Fig. 98. Typical Defect Rejected on Radiographic Inspection. (a) Macrograph. 8X. (b) Micrograph. 250X. Reduced 28%.

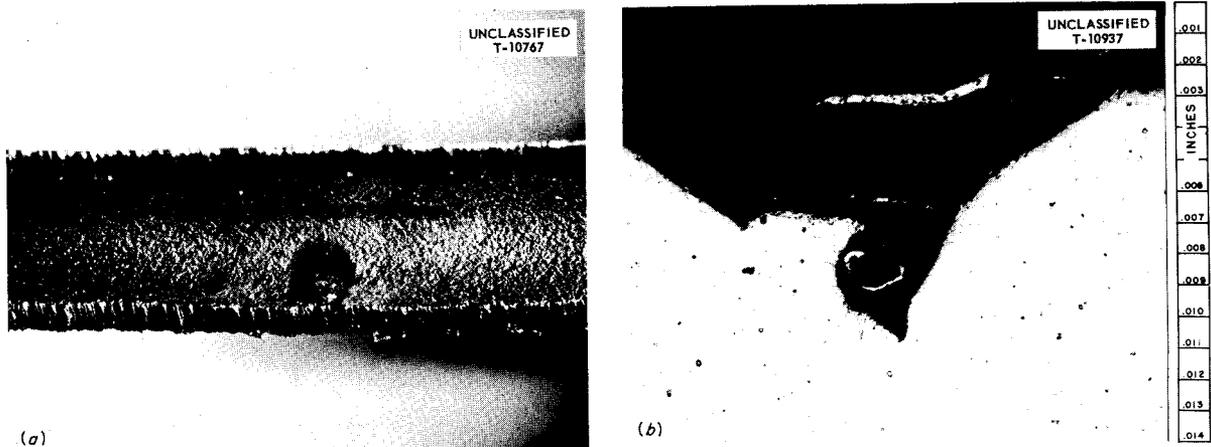
Fig. 100. Typical Defect Rejected on Radiographic Inspection. (a) Macrograph. 8X. (b) Micrograph. 250X. Reduced 31%.

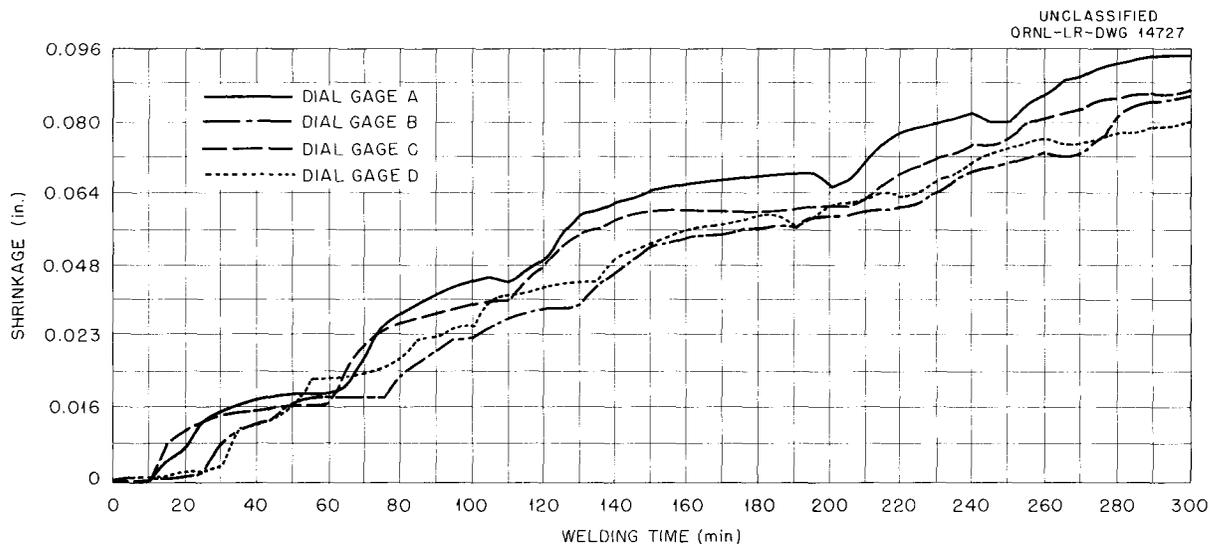
Fig. 107. Plot of Dial-Gage Readings for Hoop Test No. 1.

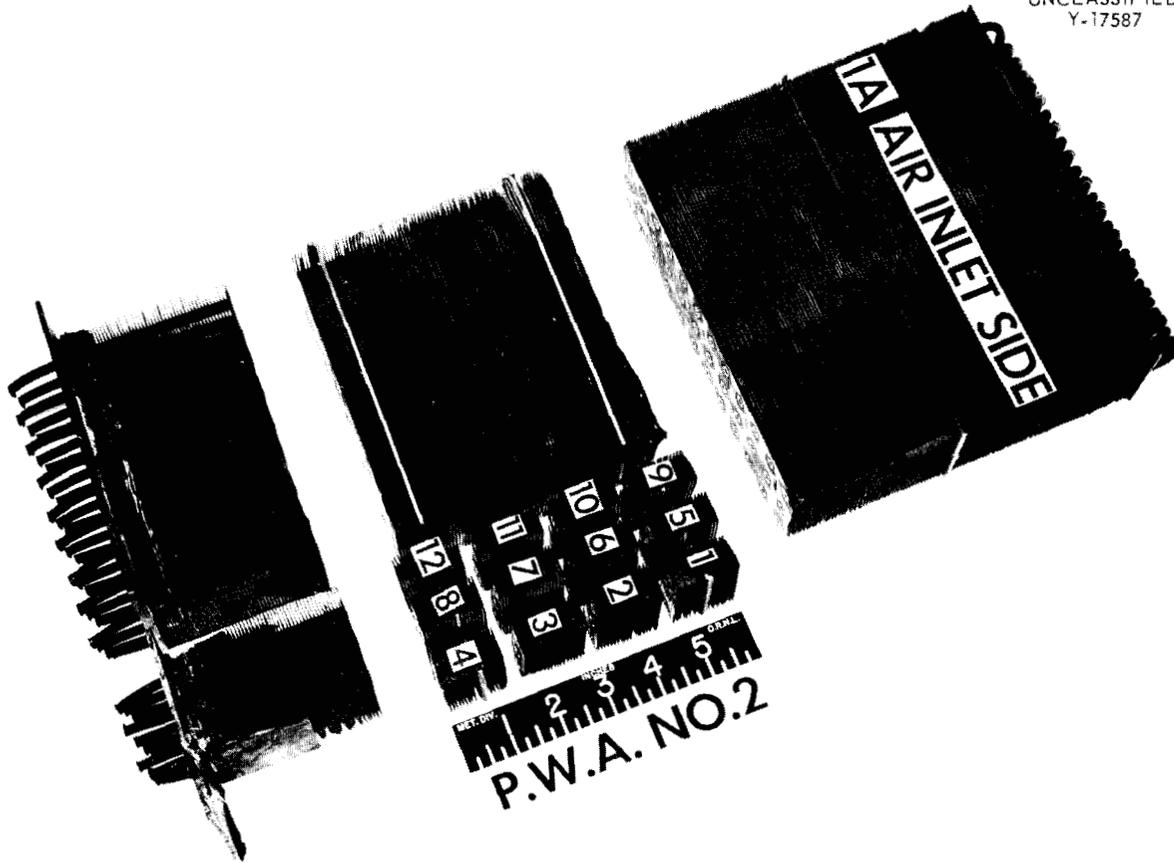
Fig. 116. PWA No. 2 Section A with Failed Tubes C-1 and Adjacent Tubes C-2 and C-3.

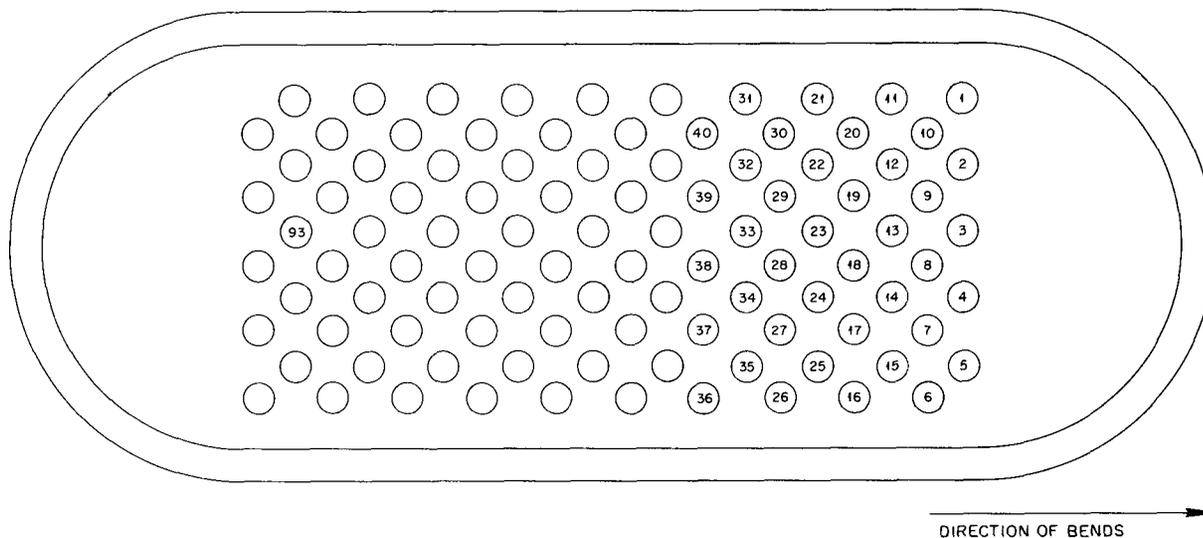
Fig. 131. Tube-Sheet Configuration and Dissection Nomenclature. IHE No. 3 failure.

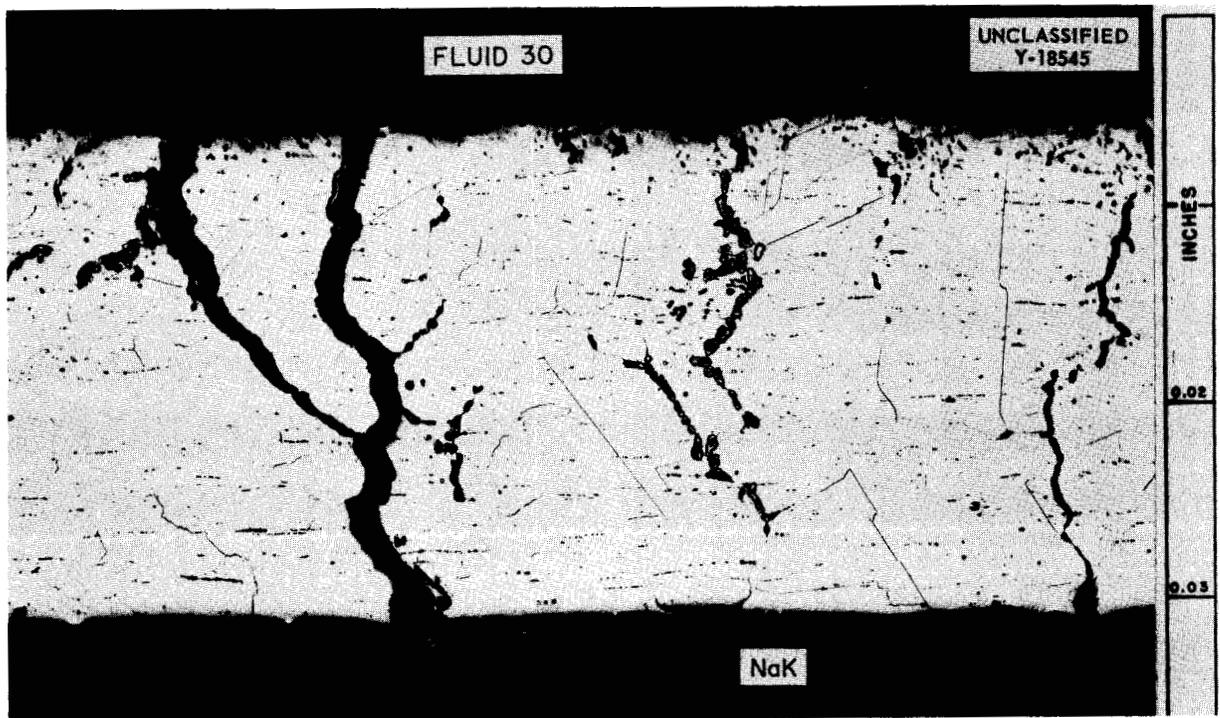
Fig. 134. Cracks in Tension Side of Tube 3. Etchant: electrolytic oxalic acid. 100X.

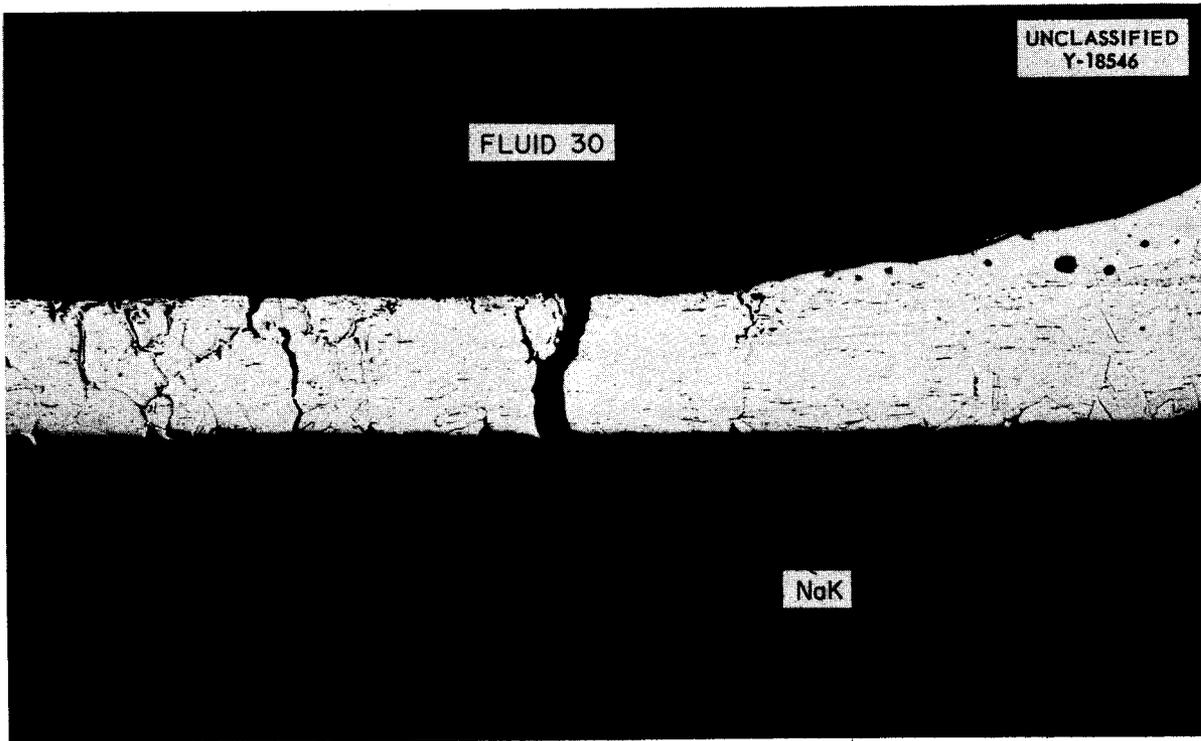
Fig. 135. Panorama of Tension Side of Tube No. 17 Showing Gross Cracking and Corrosion. Etchant: electrolytic oxalic acid. 33X.

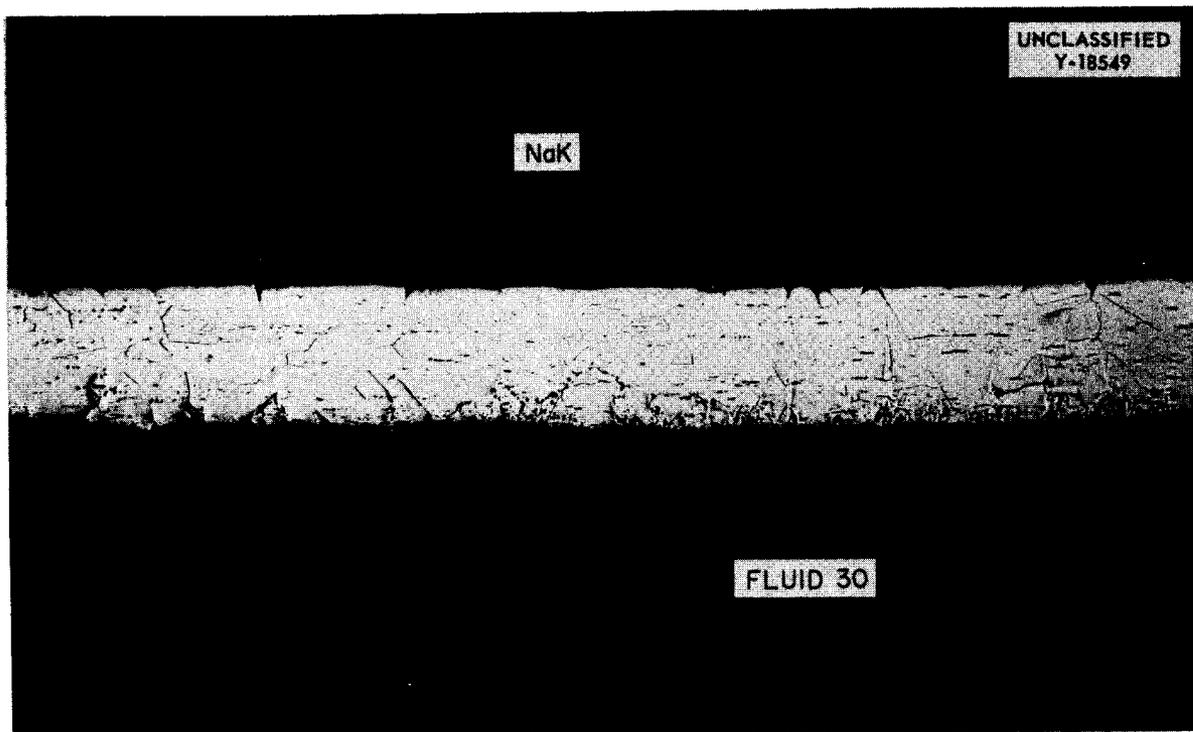
Fig. 136. Panorama of Compression Side of Tube No. 17 Showing Corrosion and Occasional Cracking. Etchant: electrolytic oxalic acid. 33X.
