ORNL-2217 *cy. 6-A*
C-84 - Reactors - Special Features
of Aircraft Reactors

METALLURGY DIVISION
SEMIANNUAL PROGRESS REPORT
FOR PERIOD ENDING OCTOBER 10, 1956

OAK RIDGE NATIONAL LABORATORY

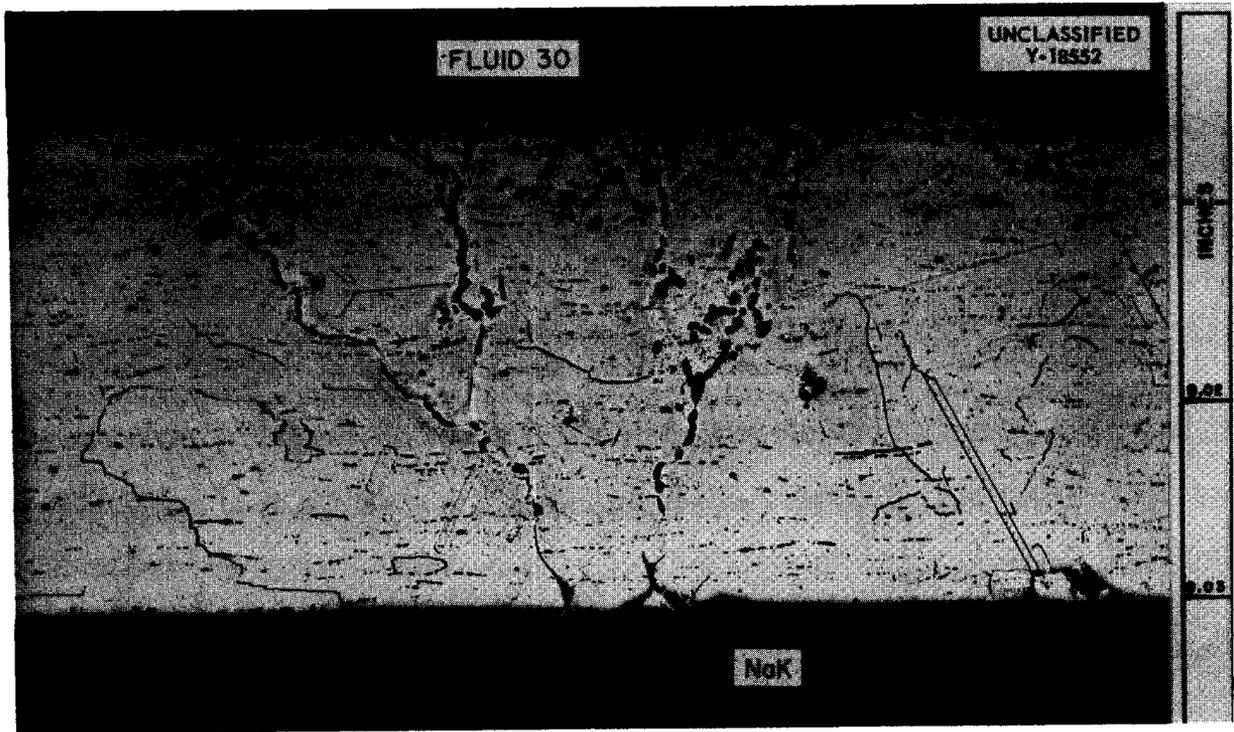
Fig. 137. Photomicrograph Showing Severe Corrosion on Tension Side of Tube 93. Etchant: electrolytic oxalic acid. 100X.

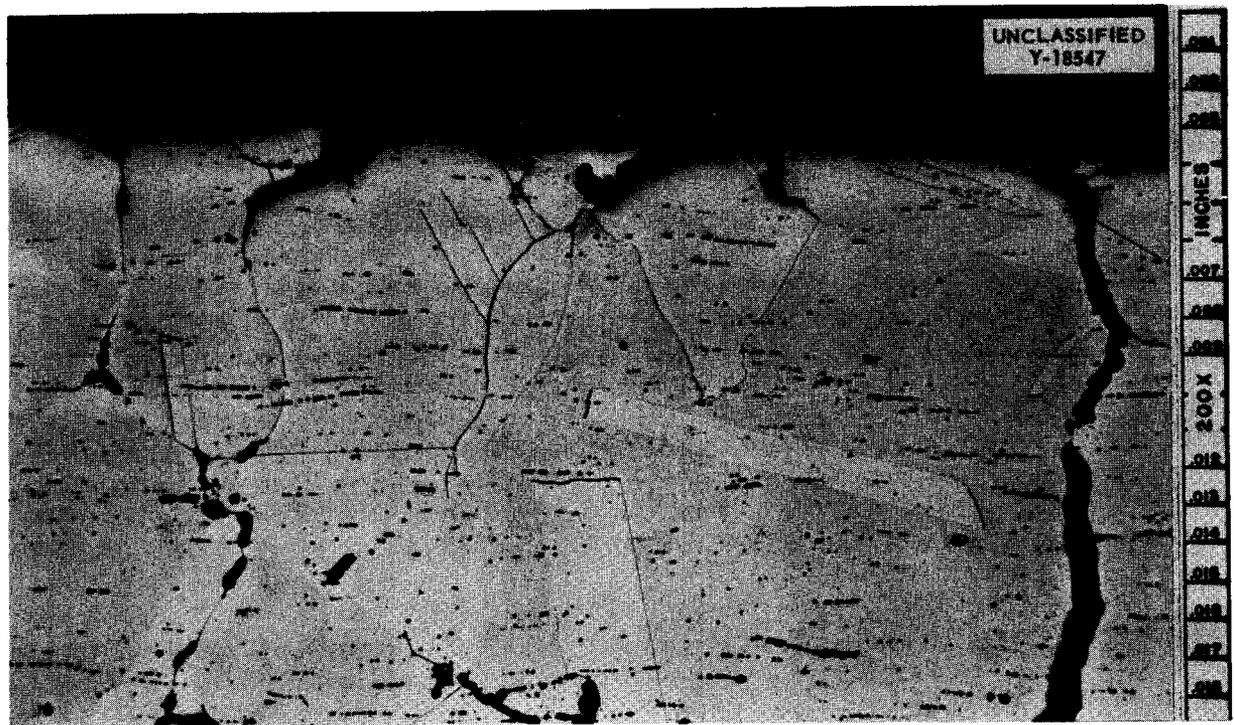
Fig. 138. Inner Surface of Tube 17. Cracking and corrosion from the outer surface are evident. Etchant: electrolytic oxalic acid.

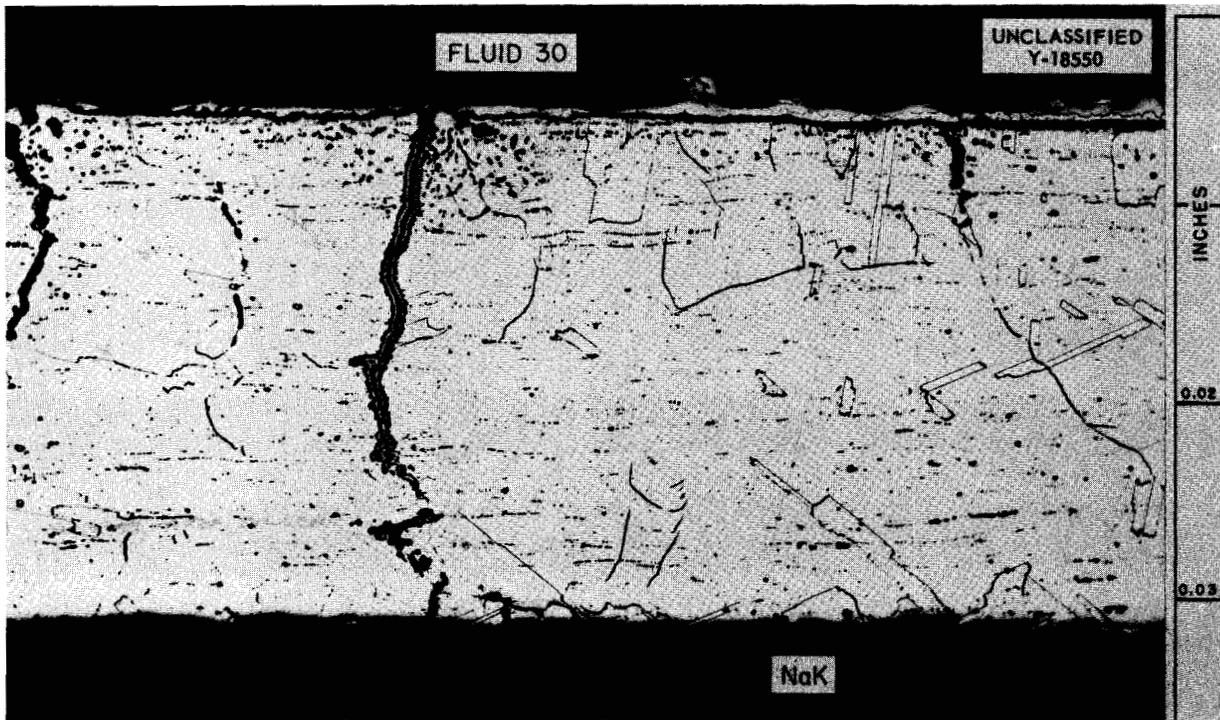
Fig. 139. Crack and Deposit in Tension Side of Tube 19. Etchant: electrolytic oxalic acid. 100X.

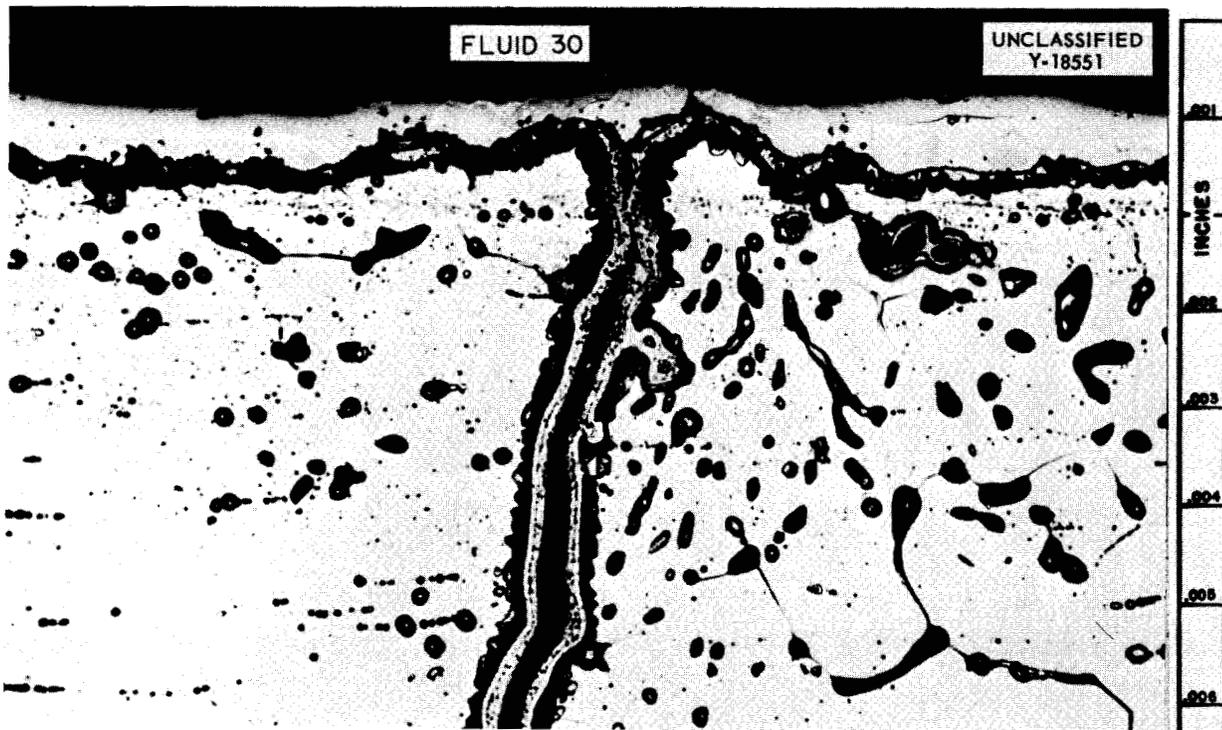
Fig. 140. High-Magnification View of Crack and Deposit. Etchant: electrolytic oxalic acid. 500X.

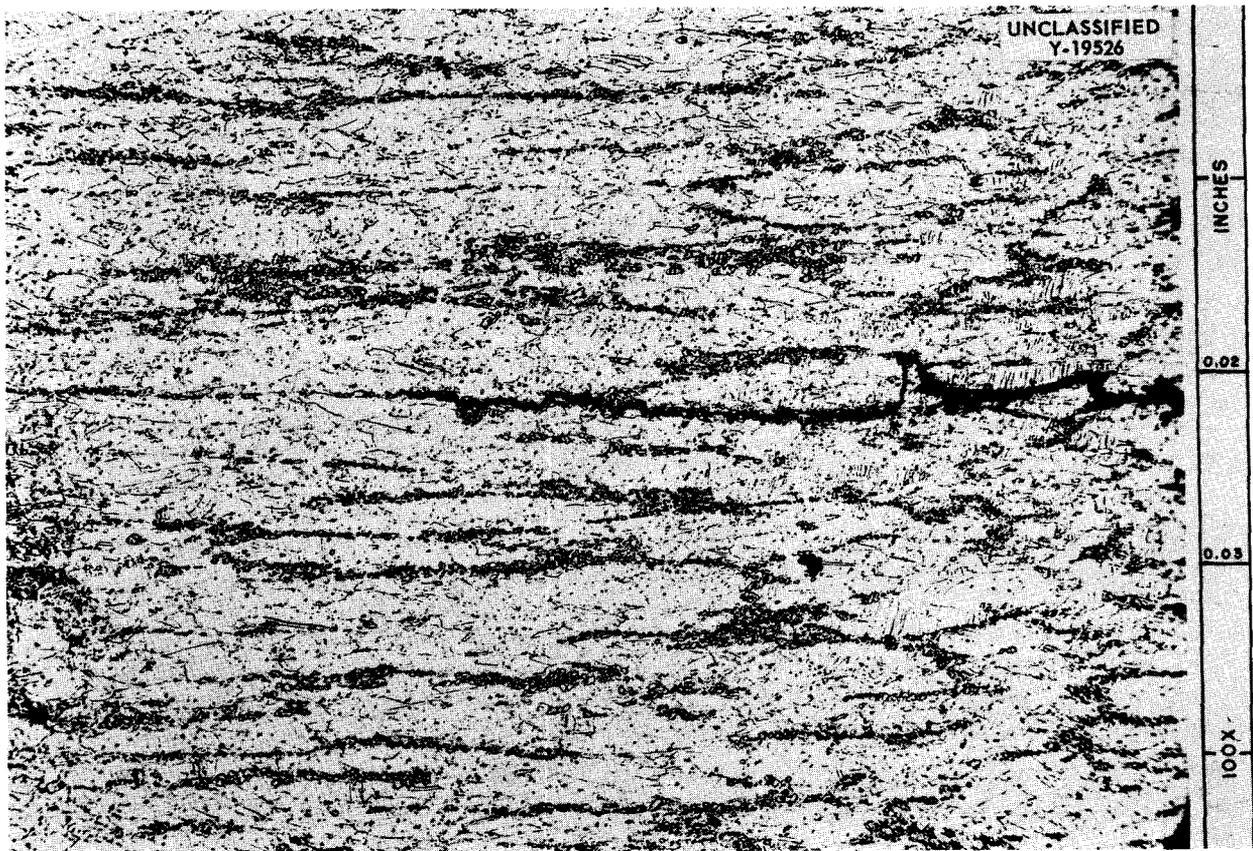
Fig. 158. Longitudinal Section of Tube Blank of Alloy 2898 Showing Crack Propagation Along Carbide Stringers. Etchant: chrome regia.

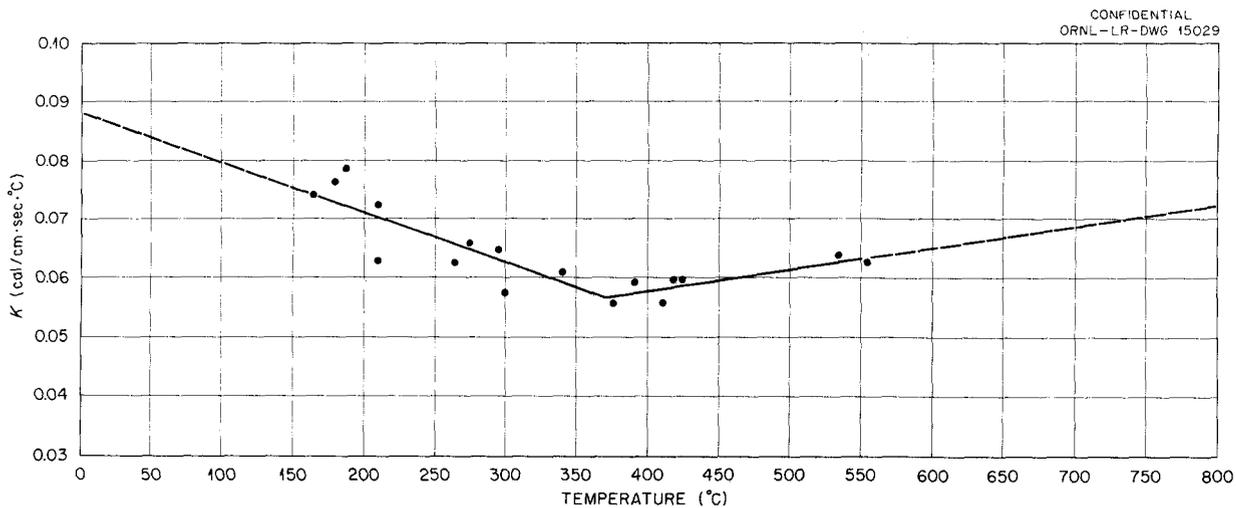
Fig. 159. Thermal Conductivity of 70% Nickel-30% Lindsay Oxide Specimen.

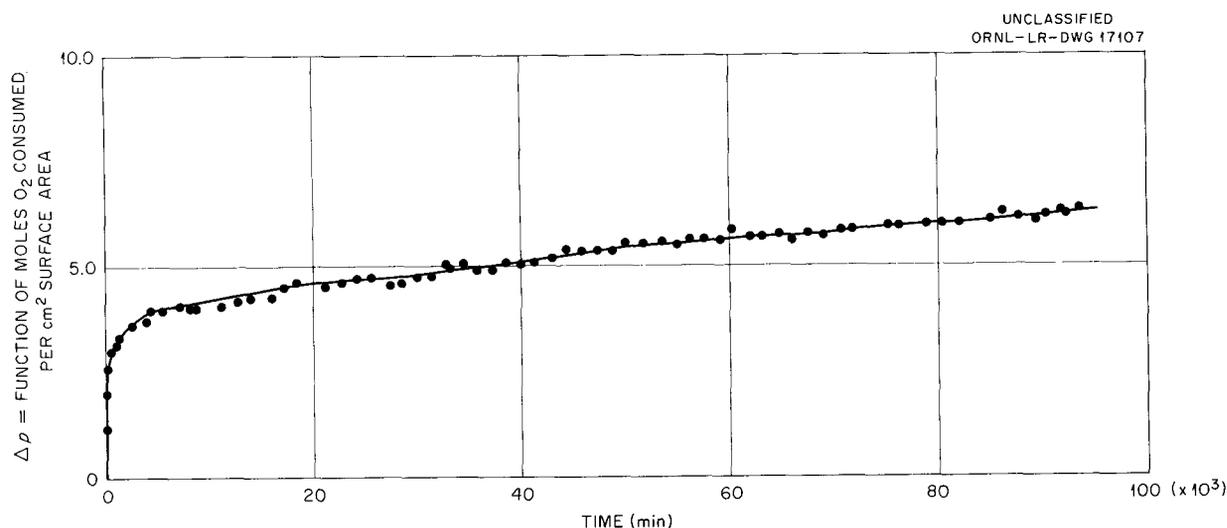
Fig. 160. Oxidation of Potassium at -50°C , Showing Protective Film Formation.

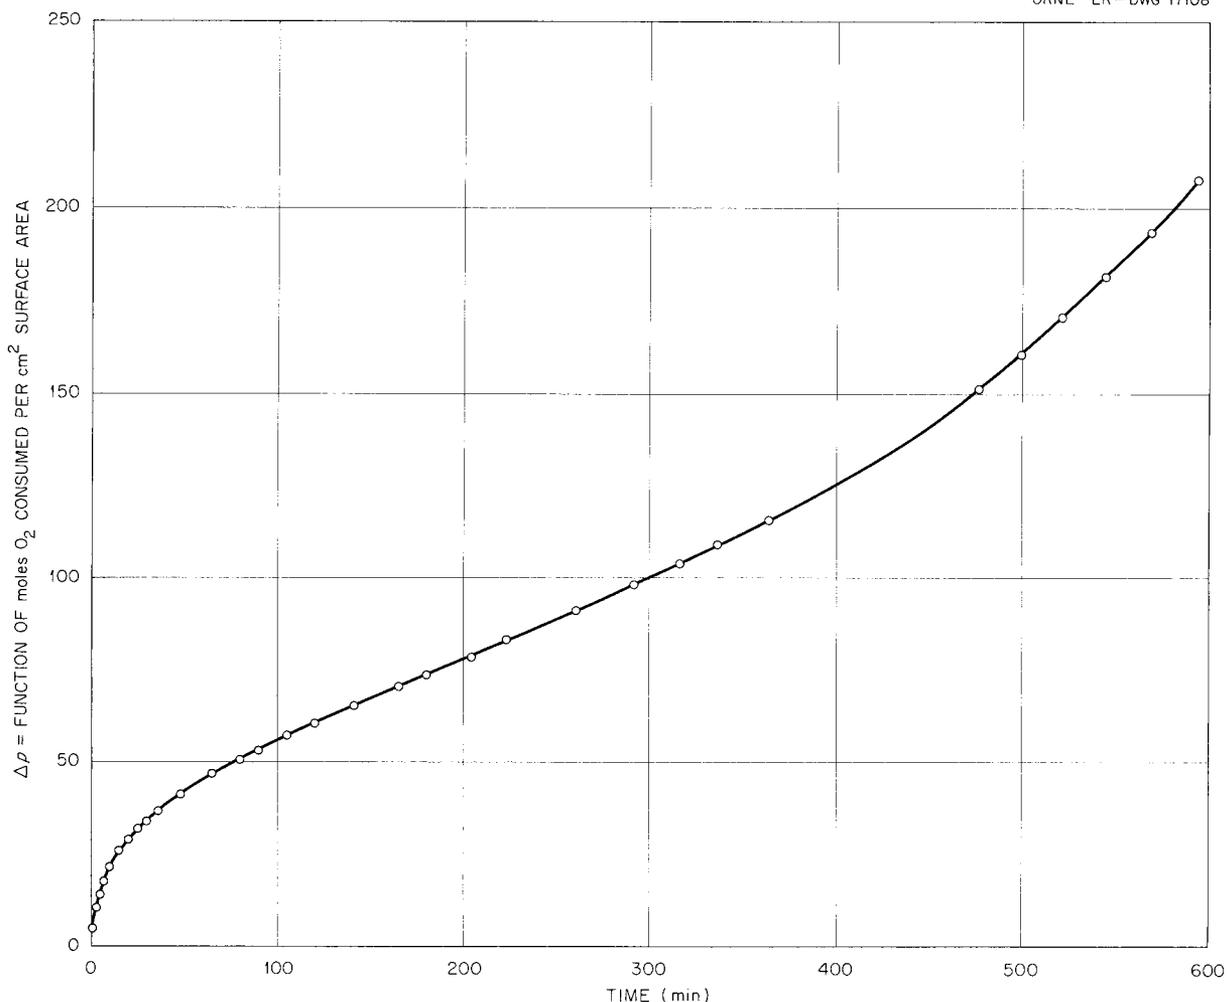
Fig. 161. Oxidation of Potassium at -20°C , Showing the Transition from Protective to Nonprotective Films.

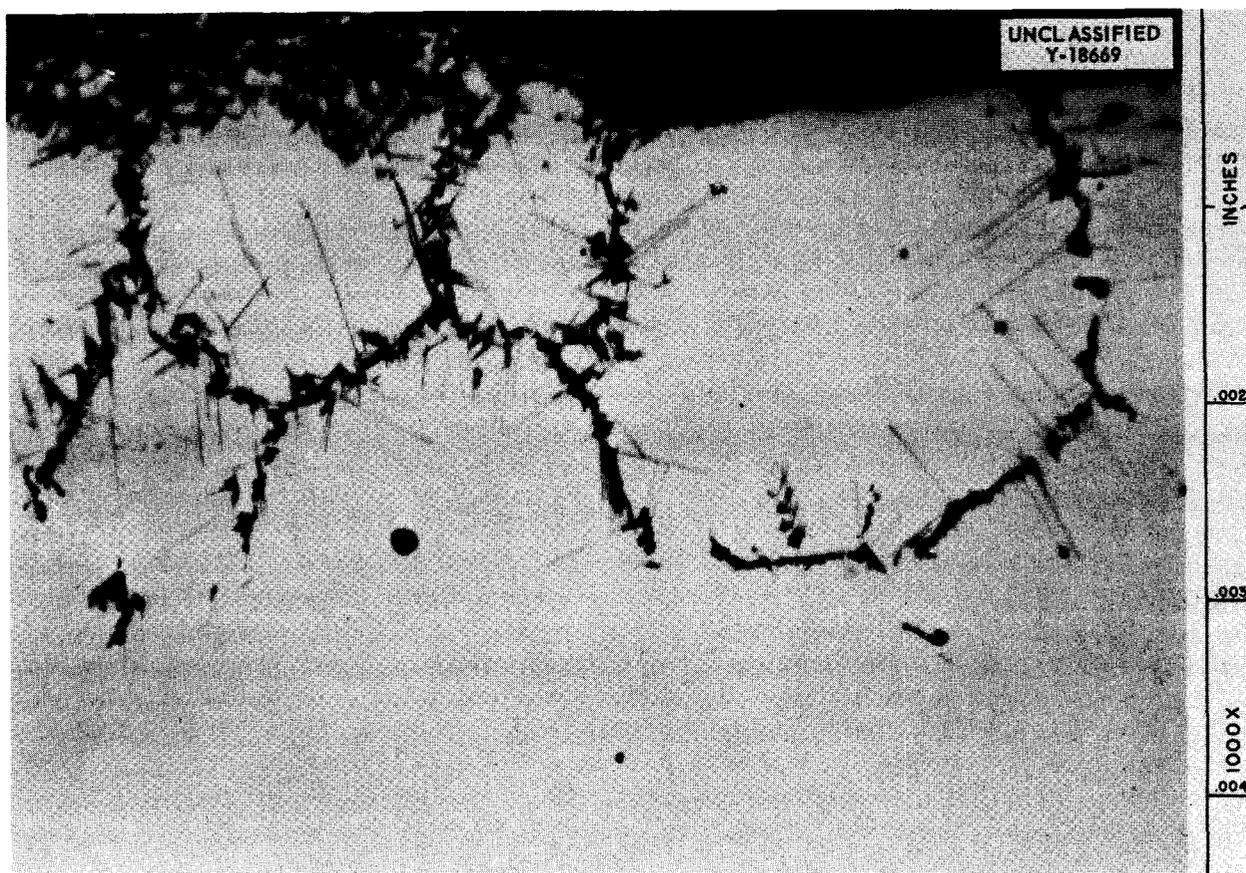
Fig. 162. Corrosion-Product Network Formed in Inconel After Exposure to a Sodium Hydroxide Melt for 100 hr at 600°C.

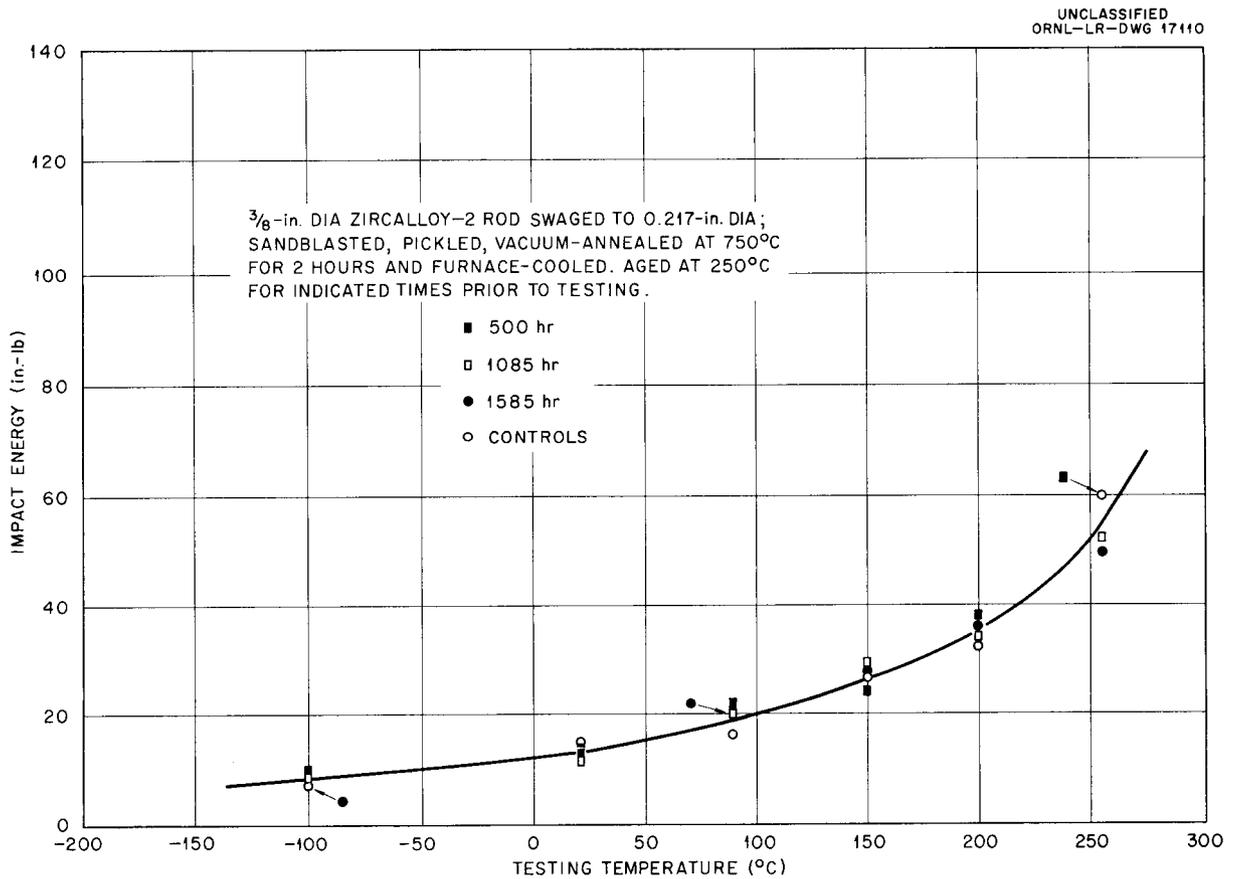
Fig. 171. Impact Energy vs Testing Temperature for Zircalloy-2 Aged at 250°C for Various Times.

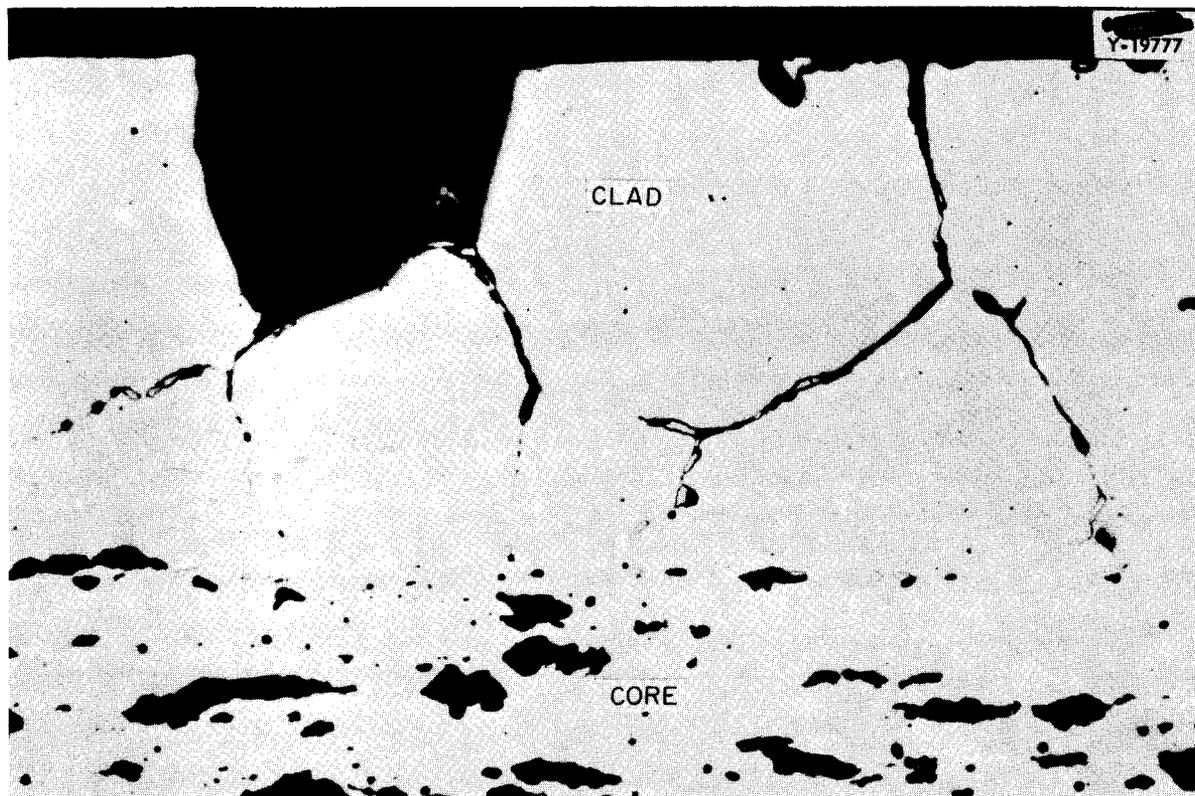
Fig. 178. Cross Section of APPR-1 Fuel Plate in Which the Stainless Steel Cladding Had Become Carbonized and Sensitized, Showing Severe Intergranular Attack After Treatment in 15% HNO_3 -5% HF Aqueous Solution.

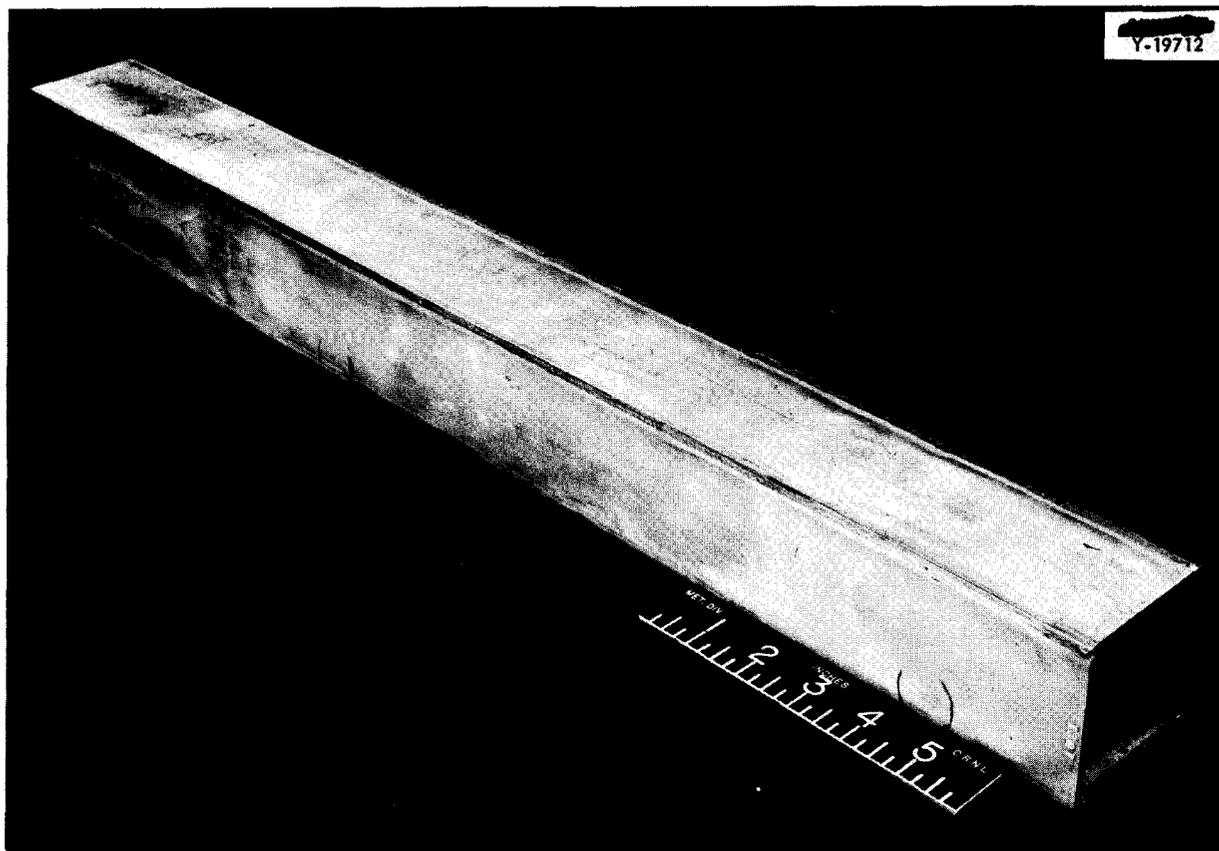
Fig. 179. APPR-1 Welded Absorber Section.

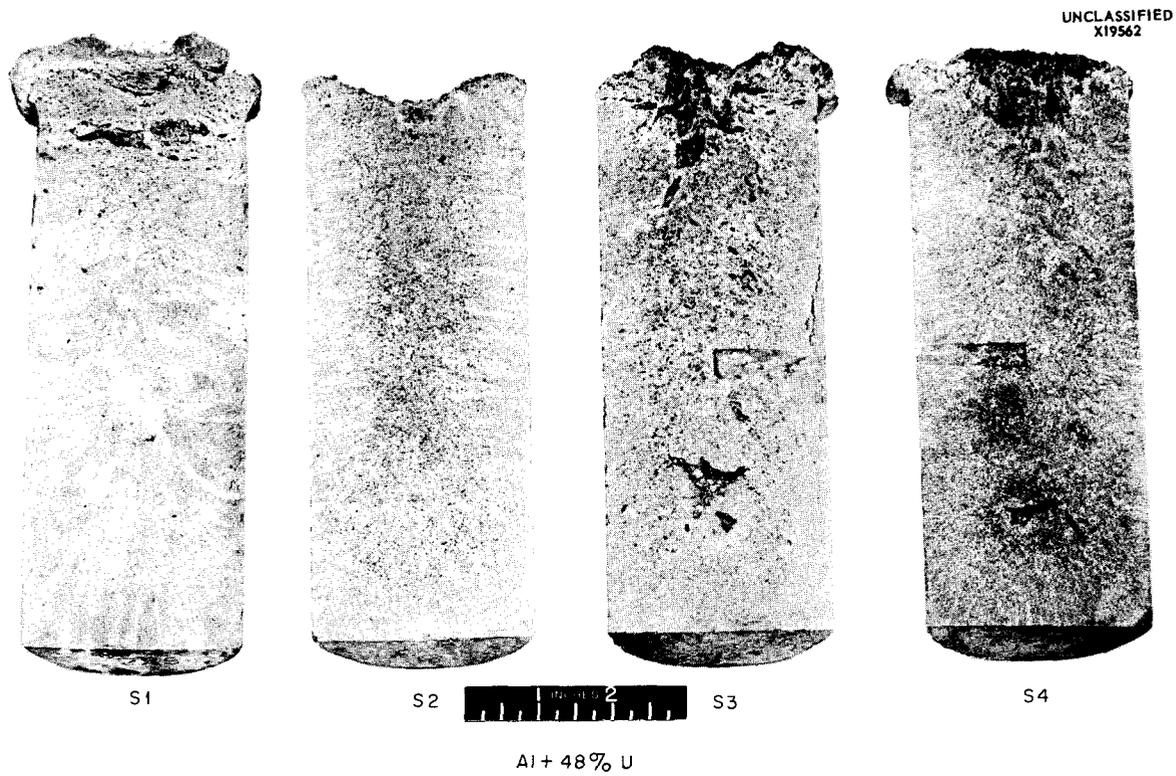
Fig. 180. Microstructures of Sectional Cylinders Produced in Molds of Dimensions as Given in Table 72.

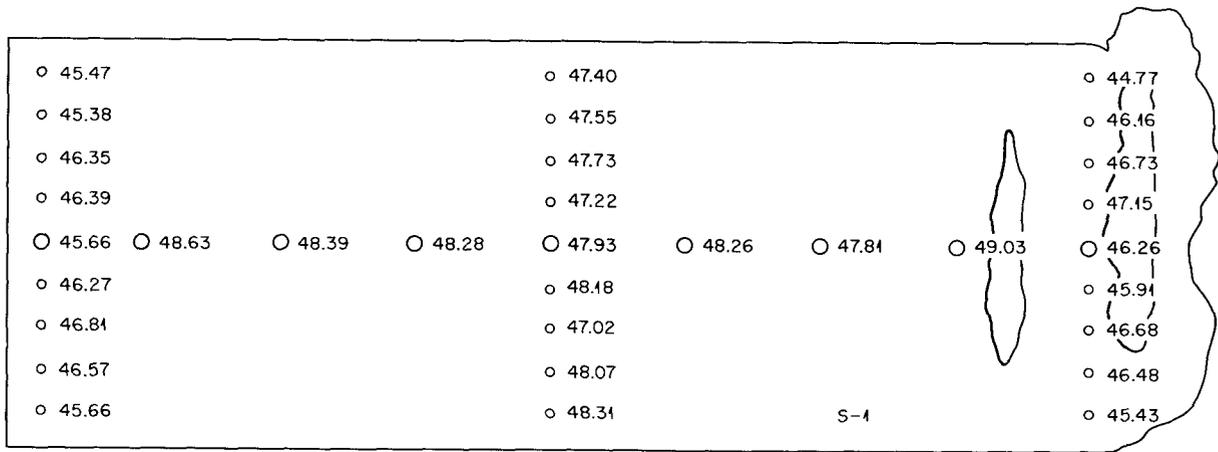
Fig. 181. Drilling Pattern and Uranium Contents of Sectional Cylinders S-1 and S-2, Produced in Molds Having Dimensions as Given in Table 72.

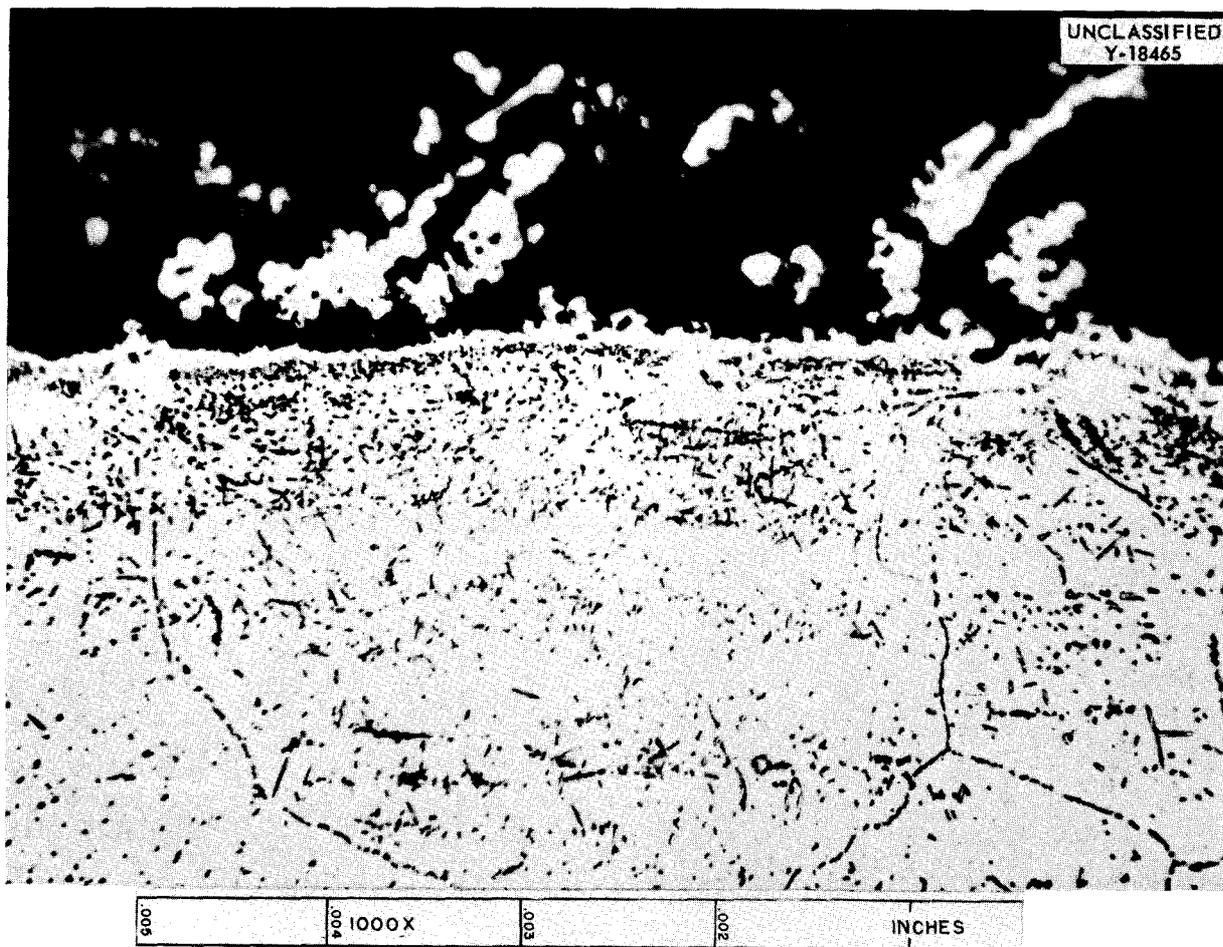
Fig. 201. Outer Bend, Area D, Similar to NaK Side Shown in Fig. 199. (Confidential with caption)

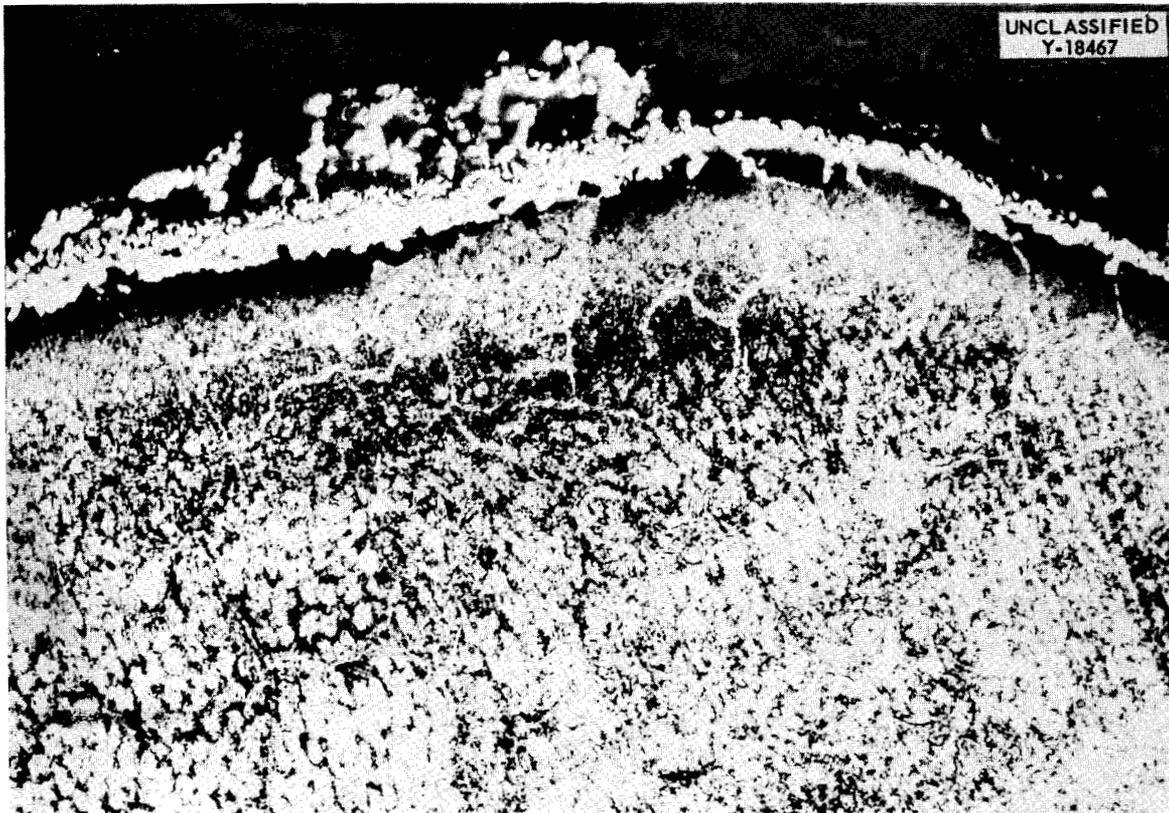
Fig. 204. Same as Fig. 203 but at Higher Magnification. Note deposit on NaK surface. 250X. (Confidential with caption)

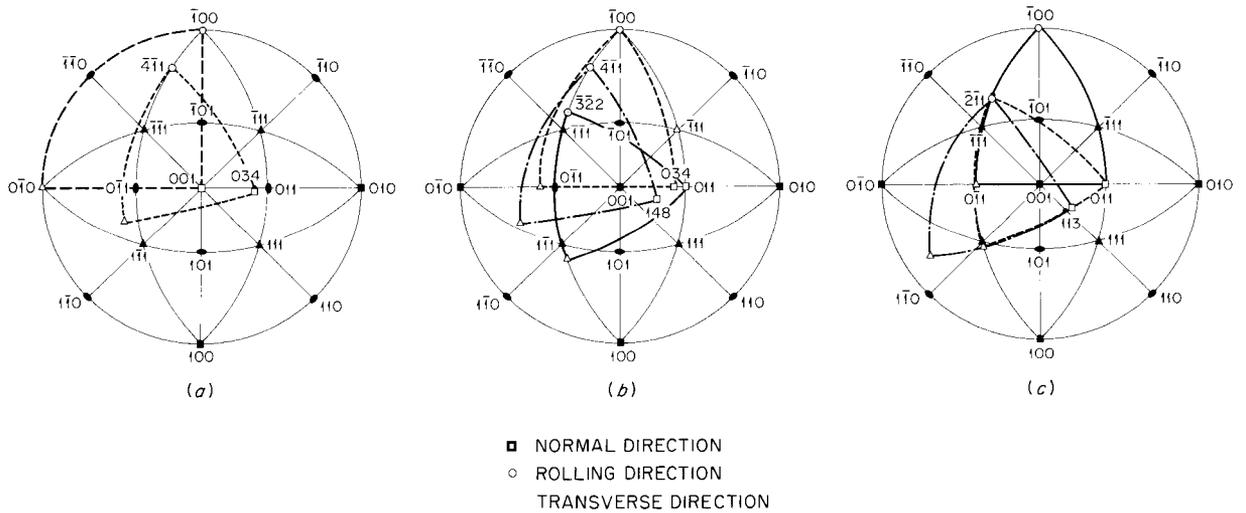
Fig. 224. Standard Stereographic Projection Illustrating the Components of the Sheet Textures of Thorium. (a) As-extruded 1 x 2 in. bar, near {034} $\langle \bar{4}\bar{1}1 \rangle$, {001} $\langle \bar{1}\bar{0}0 \rangle$. (b) Cold-rolled 75%, {011} $\langle \bar{3}\bar{2}2 \rangle$, {034} $\langle \bar{1}\bar{0}0 \rangle$, {148} $\langle \bar{4}\bar{1}1 \rangle$. (c) Cold-rolled 95%, {011} $\langle \bar{1}\bar{0}0 \rangle$, near {113} $\langle \bar{2}\bar{1}1 \rangle$, near {011} $\langle \bar{2}\bar{1}1 \rangle$.

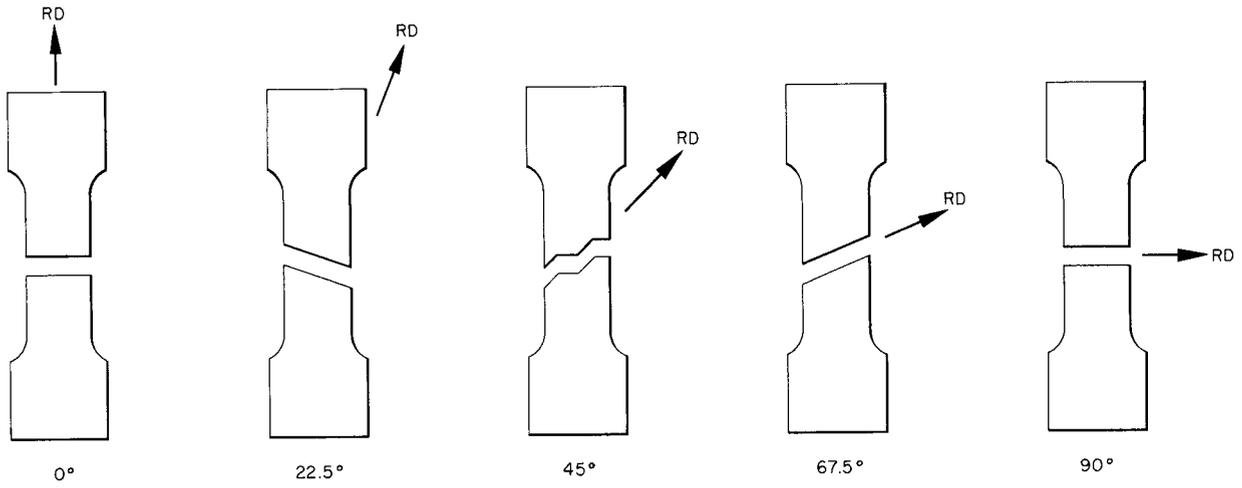
Fig. 232. Relationship Between Rolling Direction and Fracture in Tensile Specimens of Annealed Thorium Sheet. The arrow denotes the rolling direction, and the angle between rolling direction and tension axis is noted beneath each specimen.
