OAK RIDGE NATIONAL LABORATORY

58-8-33

DATE: August 13, 1958
SUBJECT: Screening Tests of Mechanical Pipe Joints
for a Fused Salt Reactor System
TO: Distribution
FROM: W. B. McDonald, E. Storto, A. S. Olson

ABSTRACT

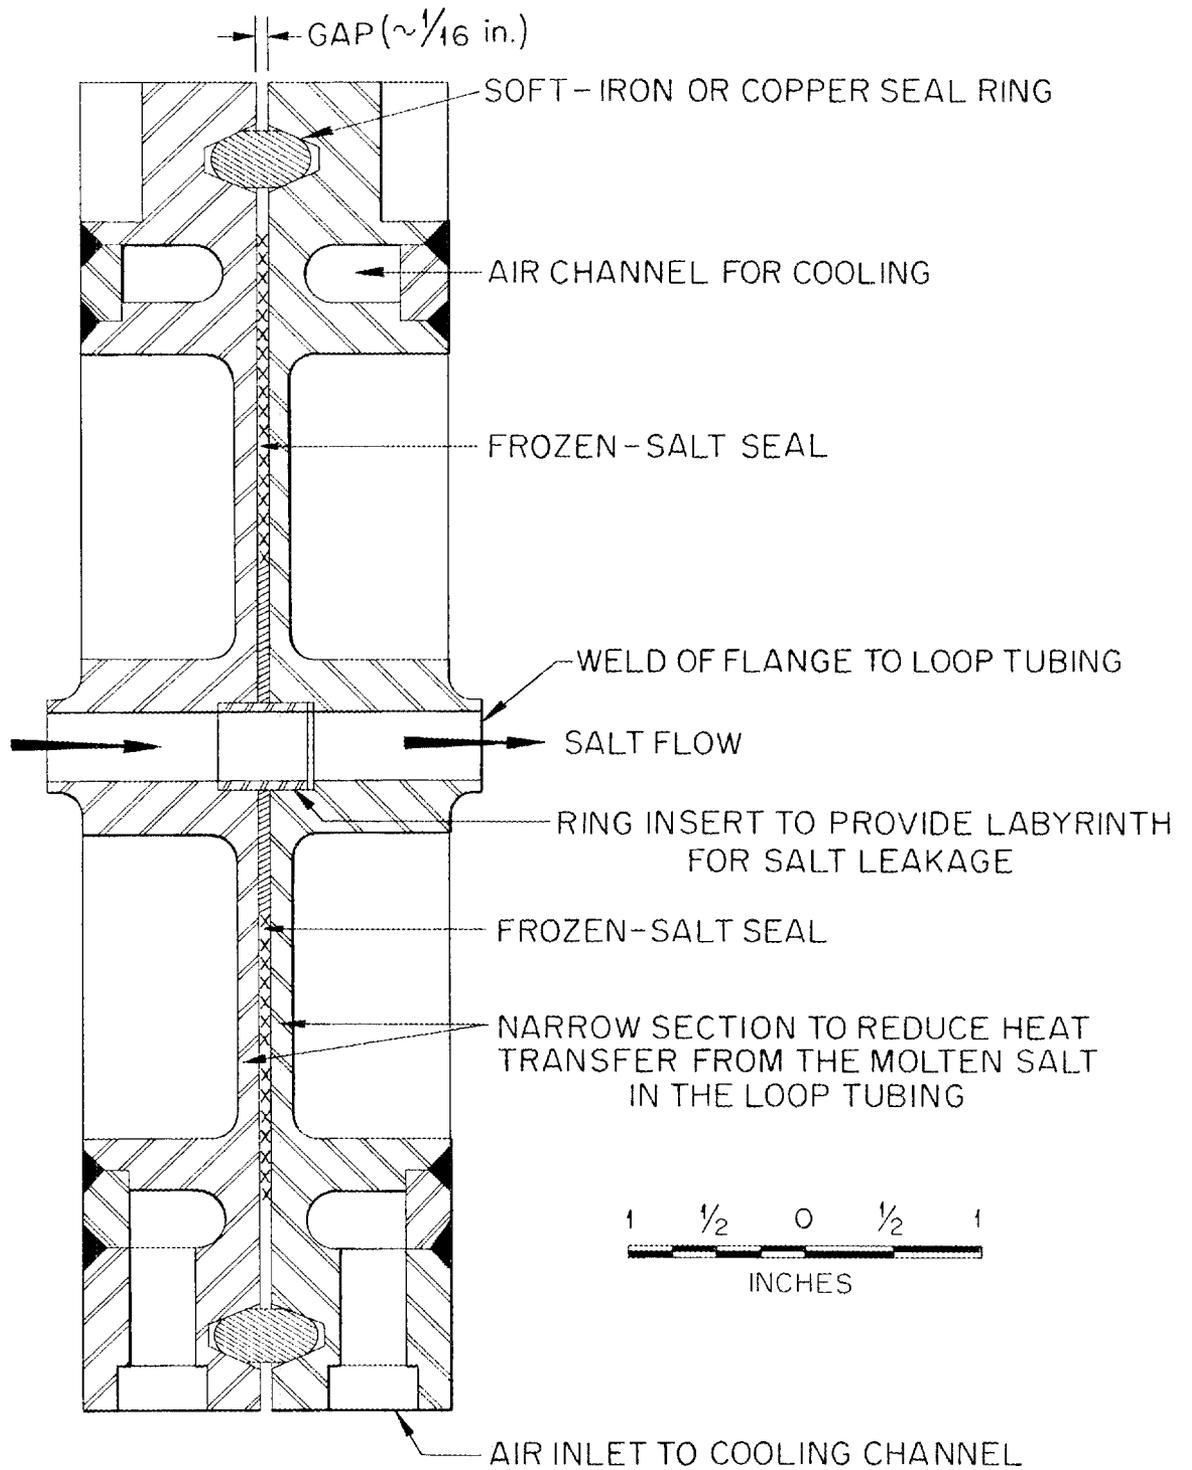
Fig.1. Cross Section of Freeze Flange Joint.

The principle of the frozen seal mechanical joint, or freeze flange, is illustrated in Fig. 1. The frozen salt seal is formed in the gap between the flange faces. The ring insert provides a labyrinth restriction to the passage of salt into the gap. The labyrinth is important only when the test loop was filled with salt, before the frozen seal was formed. After the frozen seal is formed, it retains the molten salt in the process stream. The metal seal ring provides a gas-tight seal, which retains fission gases. For an effective gas seal, it was found necessary to manufacture the seal ring to close tolerances. The O. D. and I. D. of the ring were within 0.004 inches on a diameter of seven inches, and concentric within 0.001 inches. The finish required was sixteen microinches. The same tolerances were required in making the seal ring groove in the flange faces.

The flange has a thin cross section between the flange hub, which is welded to the loop tubing, and the seal ring, near the outer edge of the flange. This was designed to present a small cross sectional area for radial heat conduction. Four webs add strength to the flange and reduce warping.

XXXX BETWEEN FLANGE FACES INDICATE REGION OF FROZEN-SALT SEAL; // INDICATES REGION OF TRANSITION FROM LIQUID TO SOLID SALT

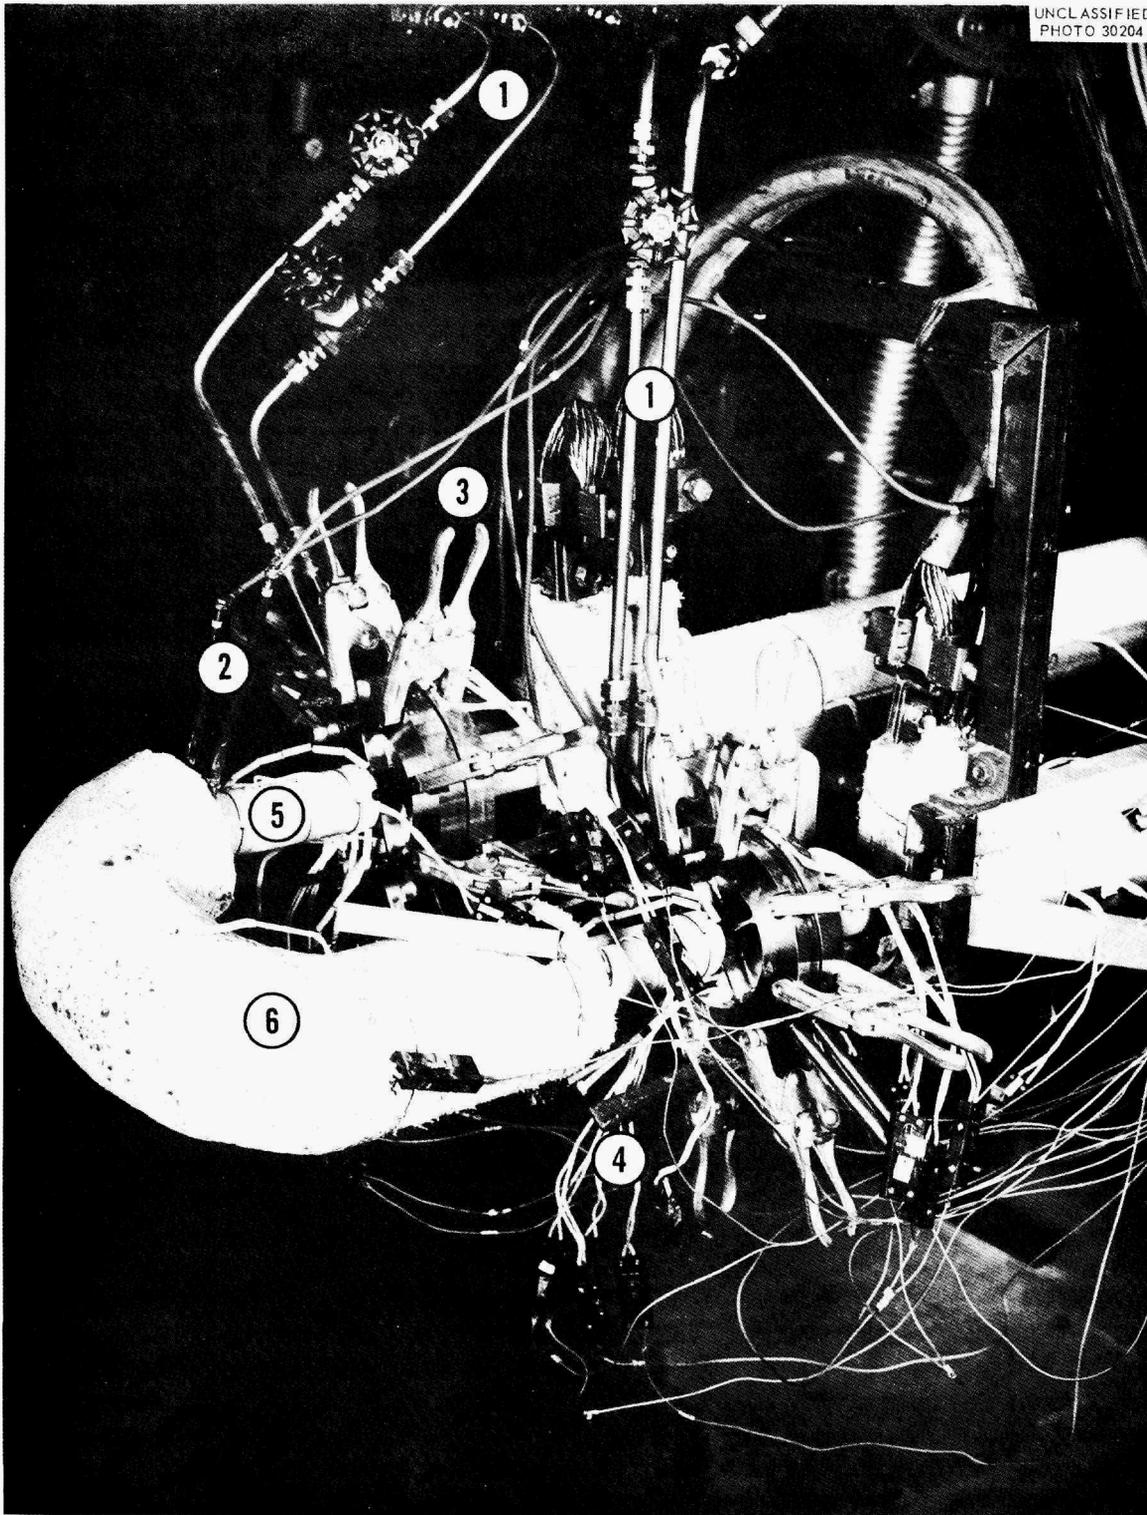
On the test installation, eight quick-opening toggle clamps were used on each flange assembly, as shown in Fig. 2, to provide the necessary

Fig. 2. Freeze Flanges Installed in Inconel Test Loop.
(1) Air Cooling Lines (2 places); (2) Calrod Heaters (1 place); (3) Toggle Clamp (1 place);
(4) Support for Flange (1 place); (5) Clam Shell Heater (1 place); (6) Hy-Temp Insulation (1 place)

Two sets of flanges were assembled with seal rings prior to installation in the loop. Each flange assembly was then leak tested using a helium leak detector. To leak test, the tubing from one end of a flange assembly was plugged and the other end connected to a vacuum pump. A plastic bag was then placed around the flange assembly and kept filled with helium during the leak test. Helium leak rate tests were made on both flange assemblies prior to installation in the loop for Tests 3 and 4. This work was done by the Instrument Department and is described in detail in their report No. 58-1-20. Both flange assemblies were then welded into one end of the loop as shown in Figs. 2 and 9.

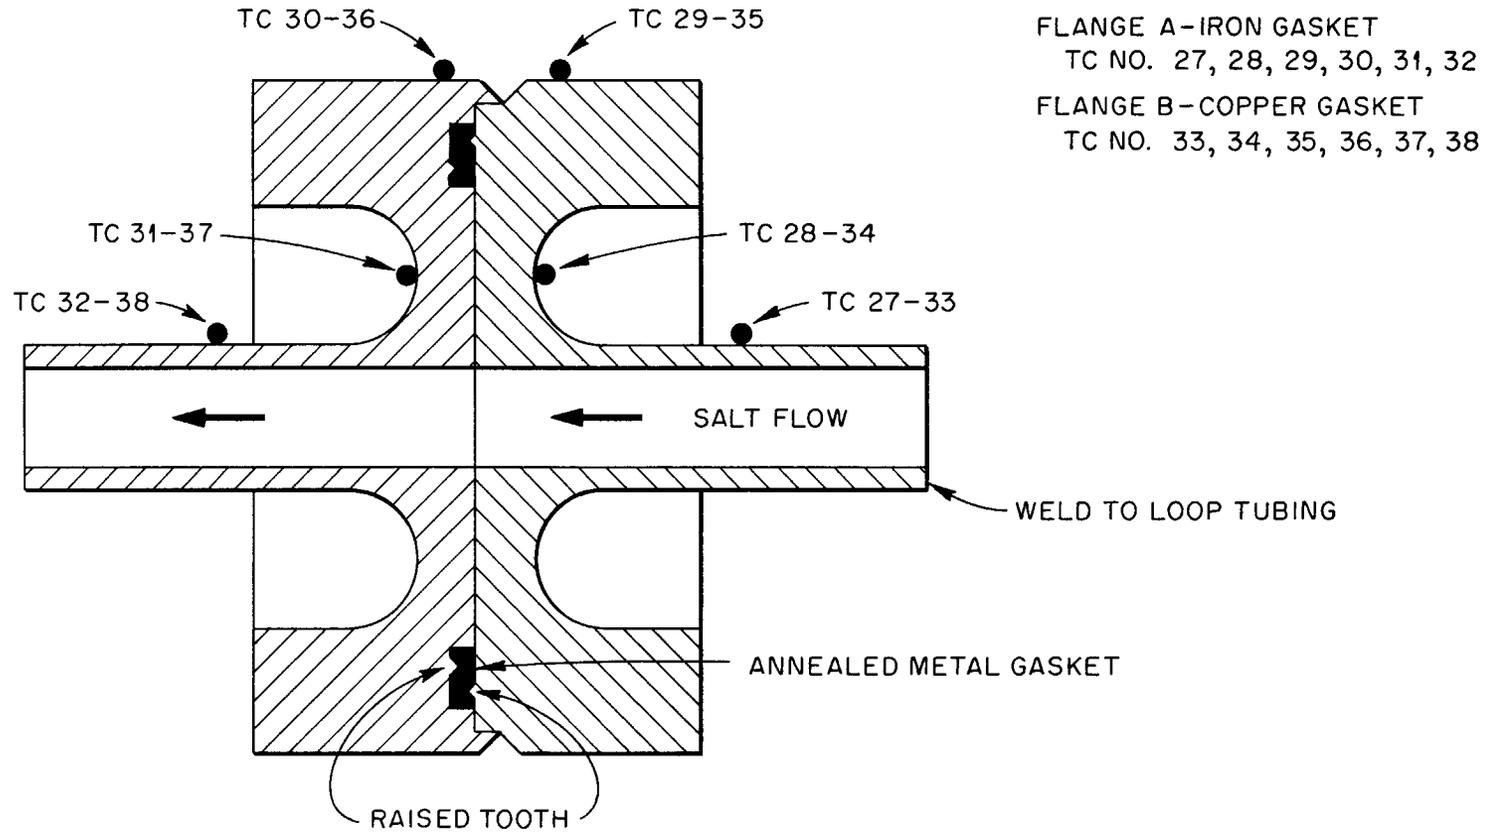
Fig. 3. Schematic Drawing of Indented Seal Mechanical Joint.

INDENTATION SEAL FLANGE TEST NO. 1. THERMOCOUPLE LOCATIONS

The loop was then placed in operation for thermal cycle testing as described in Section 4.1. During Test No. 1 temperatures were measured at the points indicated in Fig. 3. Fluoride salt, Fuel No. 30, was circulated in the loop at a flow rate of 2 gpm. The salt temperature was cycled 50 times between 1100°F and 1300°F. The average cycle time was 60 minutes.

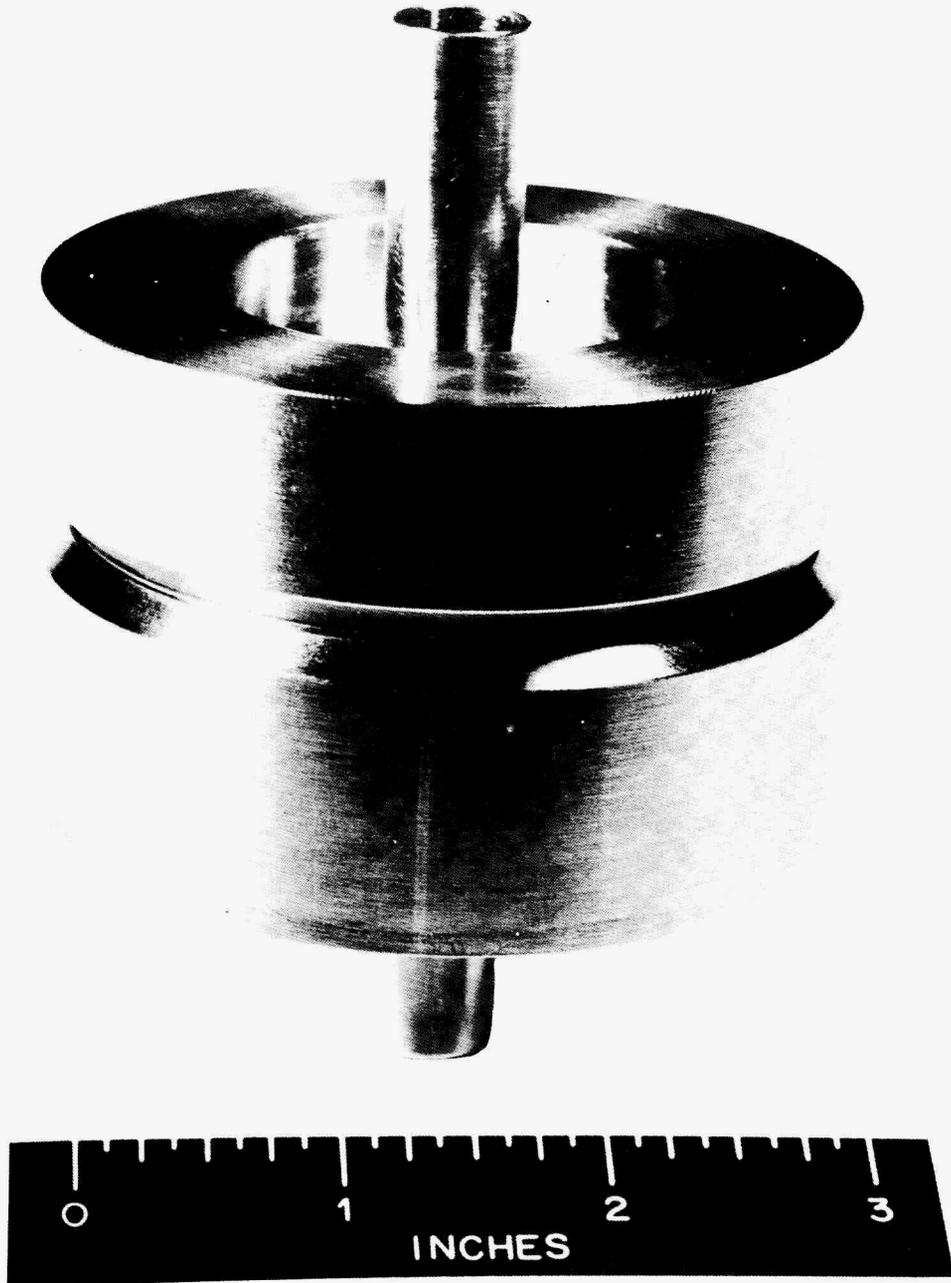
Fig. 4. Assembly of Indented Seal Flange Before Testing.

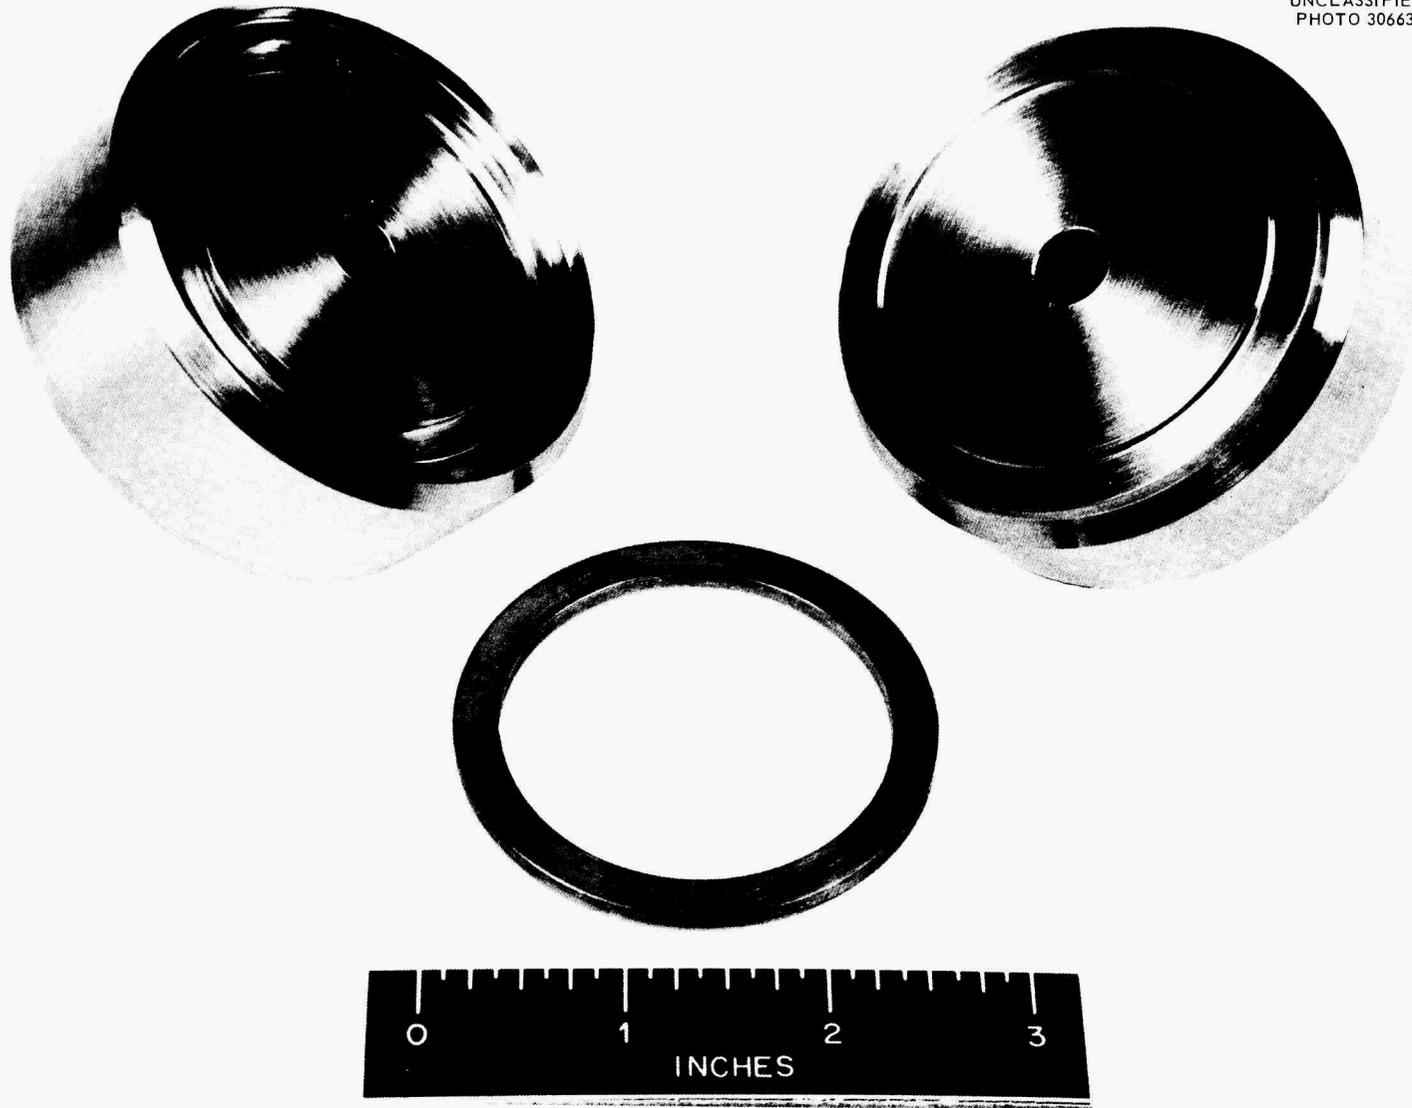
Fig. 5. Parts of Indented Seal Flange Before Testing.

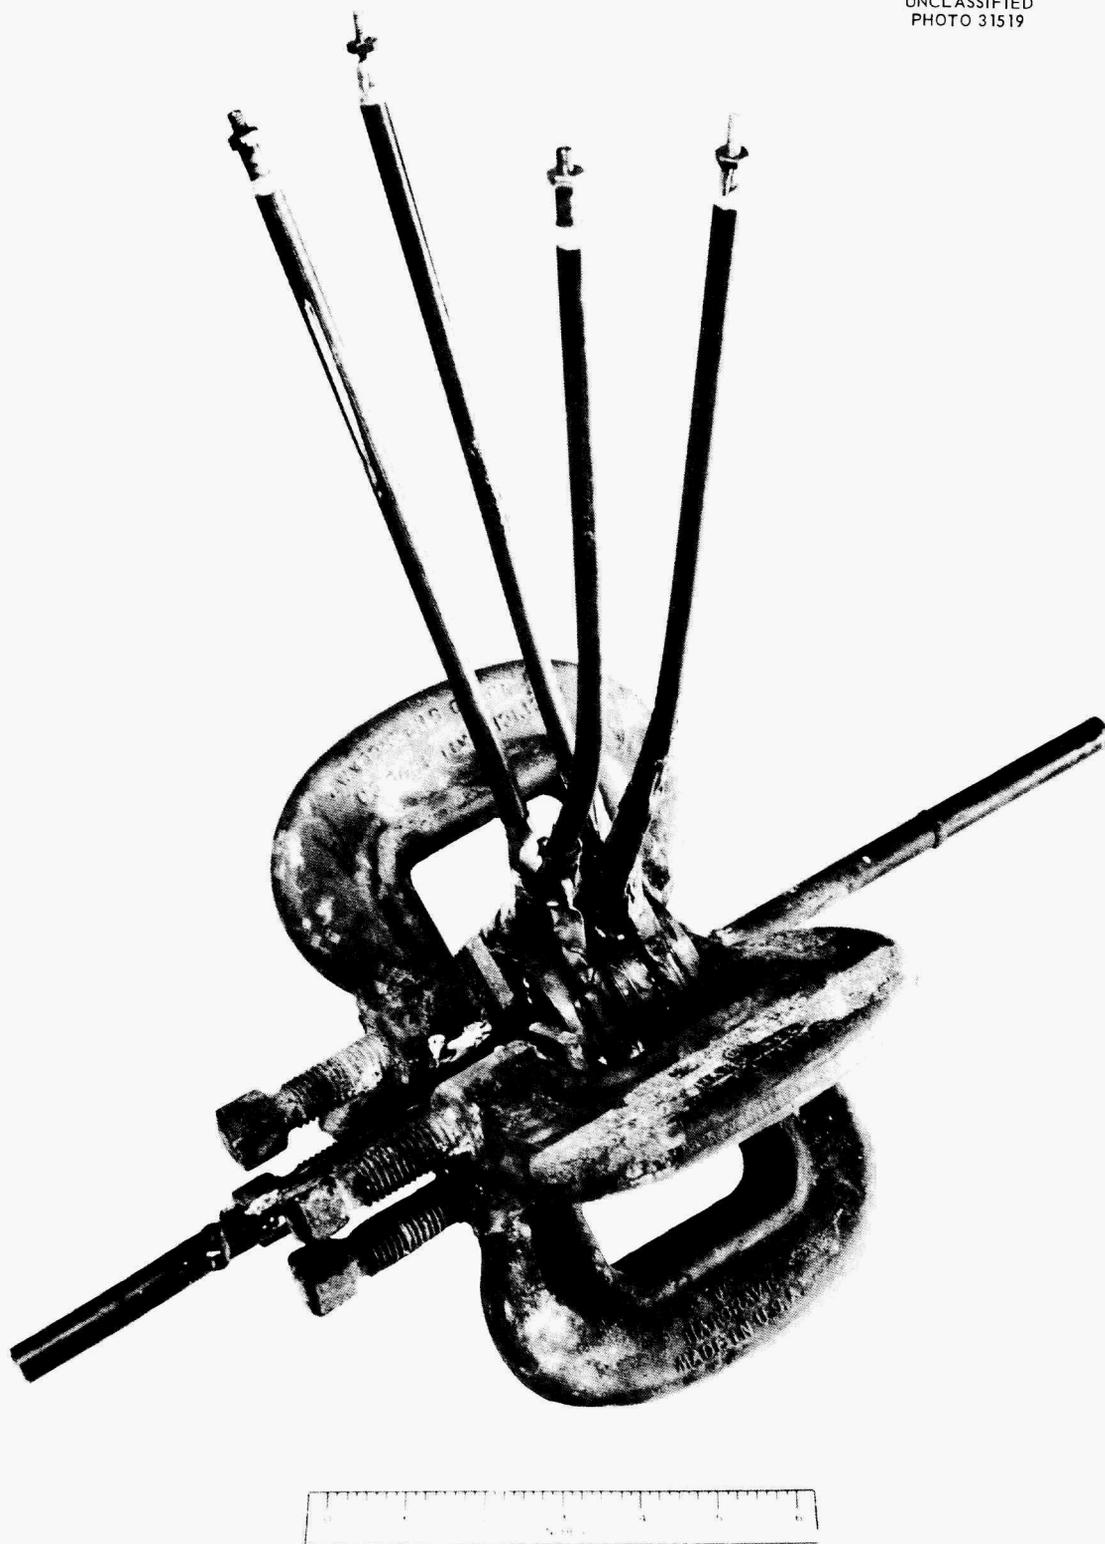
On the test installation, four standard design "C" clamps were used on each flange assembly to provide the force necessary to indent the gasket and maintain a gas leakage rate below the maximum allowed. Fig. 6 shows an assembly with clamps.

Fig. 6. Indented Seal Flange Shown Assembled with "C" Clamps.

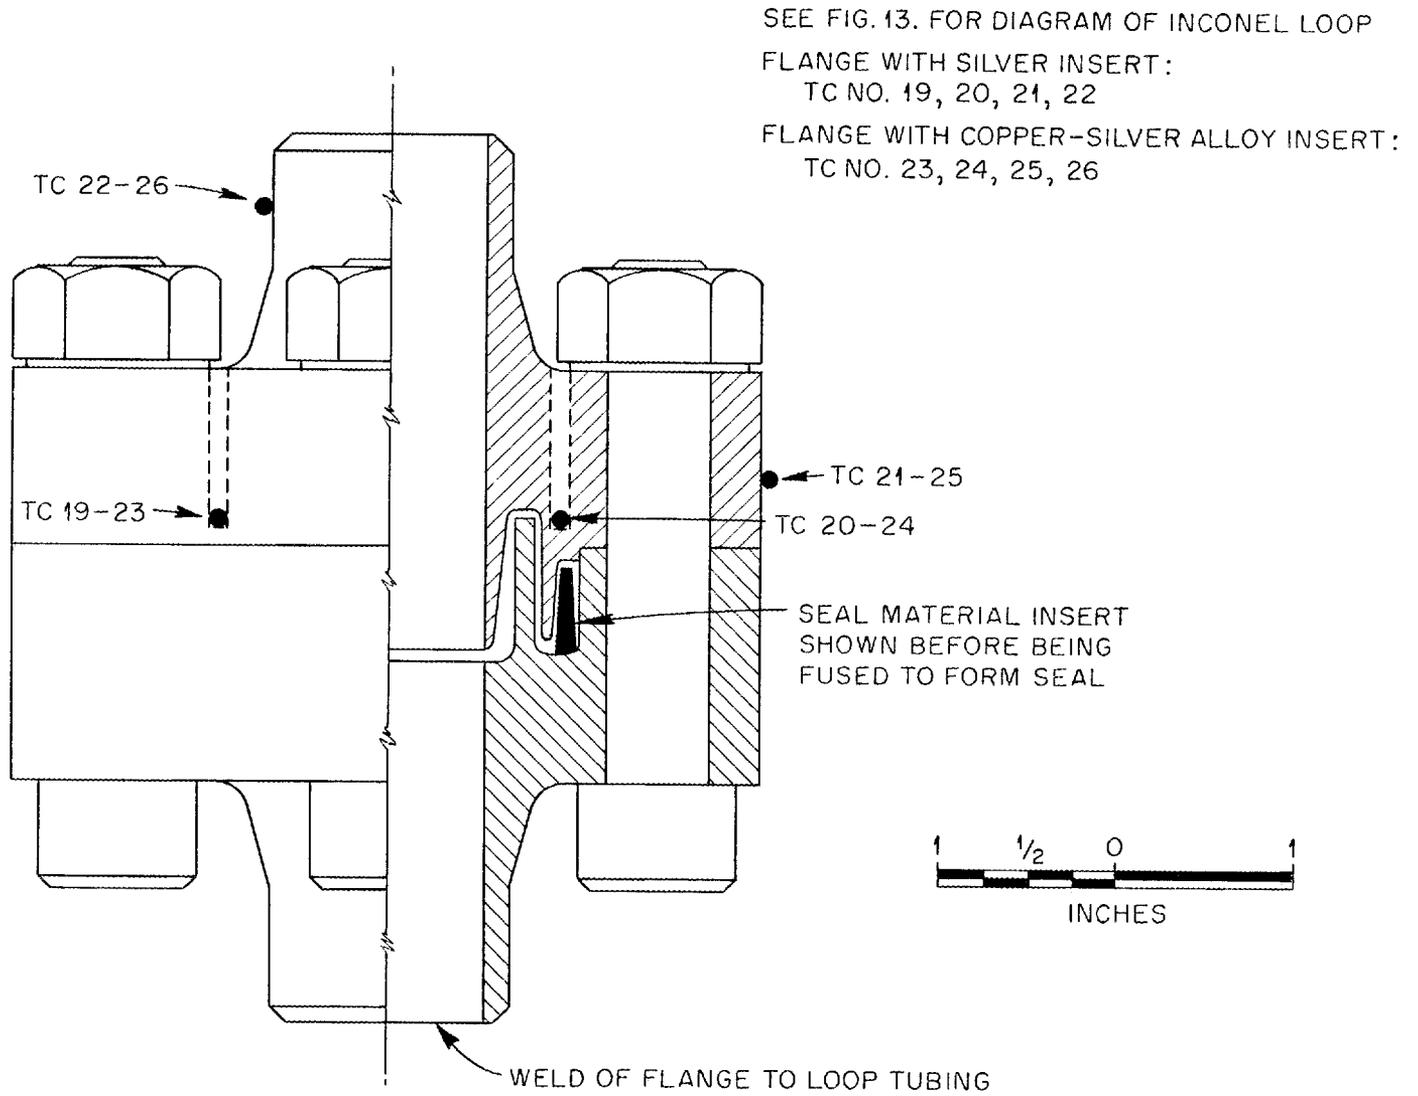
A cross section of this mechanical joint is shown in Fig. 7. Four stainless steel bolts provide the mechanical strength for the joint. A metal insert, shown in the figure before being fused, is used to provide a salt and gas seal. The metal insert is fused between the flange faces before the test loop is filled with salt. The seal whose melting point is above that of the fuel salt, is in the solid state during operation of the test loop.

Fig. 7. Cast Seal Flange Showing a Cross Section View and Thermocouple Locations.

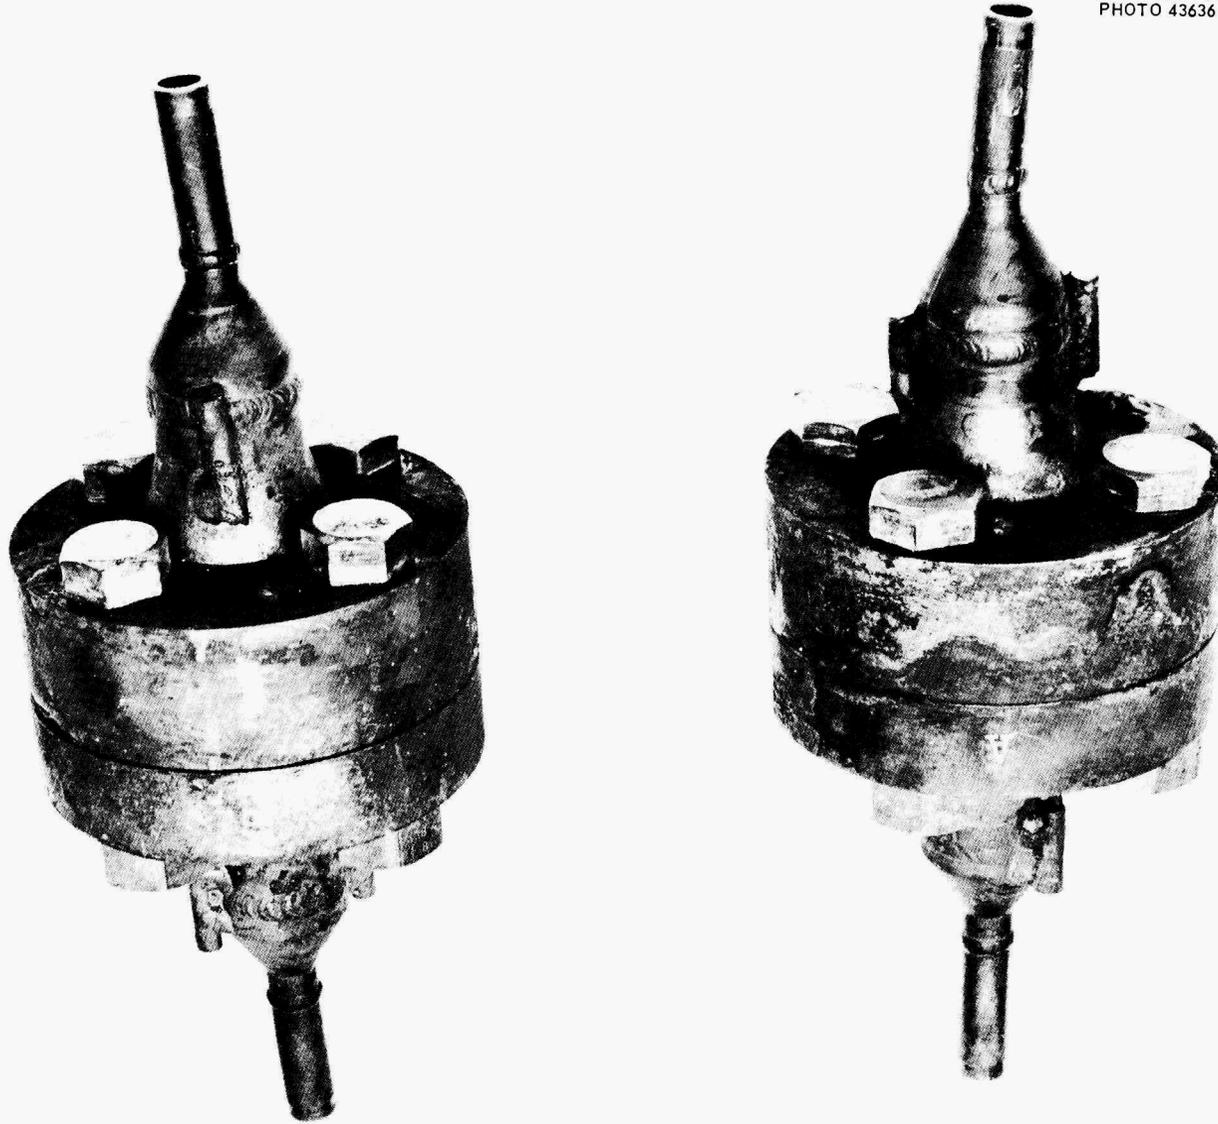
Fig. 8. Assembly of Cast Seal Flanges.

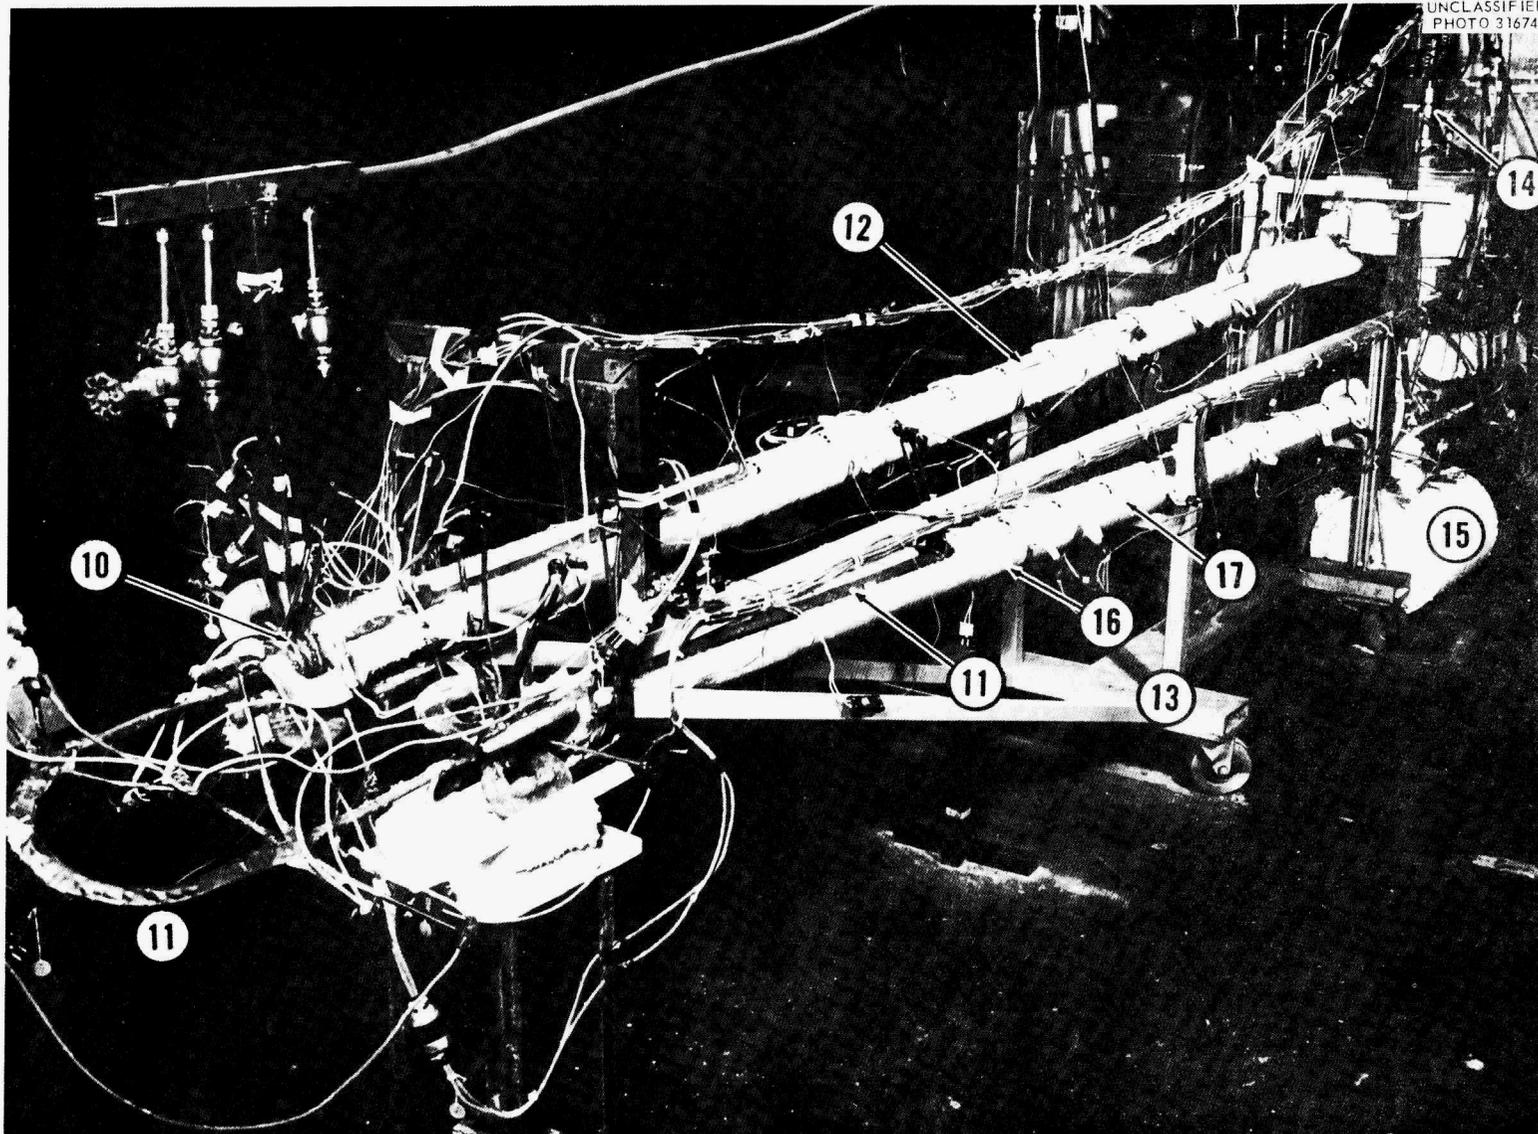
The test loop consisted of 25 feet of one-half inch O. D., 0.045 inch wall thickness, Inconel tubing arranged as shown in Fig. 9. The various parts are identified as follows: (10) Location of flanges under test, (11) Calrod heaters wrapped with stainless steel strip, (12) Clam

Fig. 9. Inconel Test Loop.

- (10) Indented Seal Flange (1 place); (11) Calrod Heaters Wrapped with Stainless Steel Strip (2 places); (12) Clam Shell Heaters (1 place); (13) Unistrut Frame (1 place); (14) LFB Pump (1 place); (15) Salt Sump (1 place); (16) Metal Trough Support (1 place); (17) Hy-Temp Insulation (1 place)

Two sets of flanges were assembled with metal gaskets prior to installation in the loop. Four "C" clamps were used on each flange assembly. The clamps were each tightened with a torque of 80 - 90 foot pounds. The load on each gasket was approximately 12,000 pounds per inch of gasket circumference. Each flange assembly was leak tested using a helium leak detector. Both assemblies were then welded into one end of the loop as shown in Figs. 9 and 17.

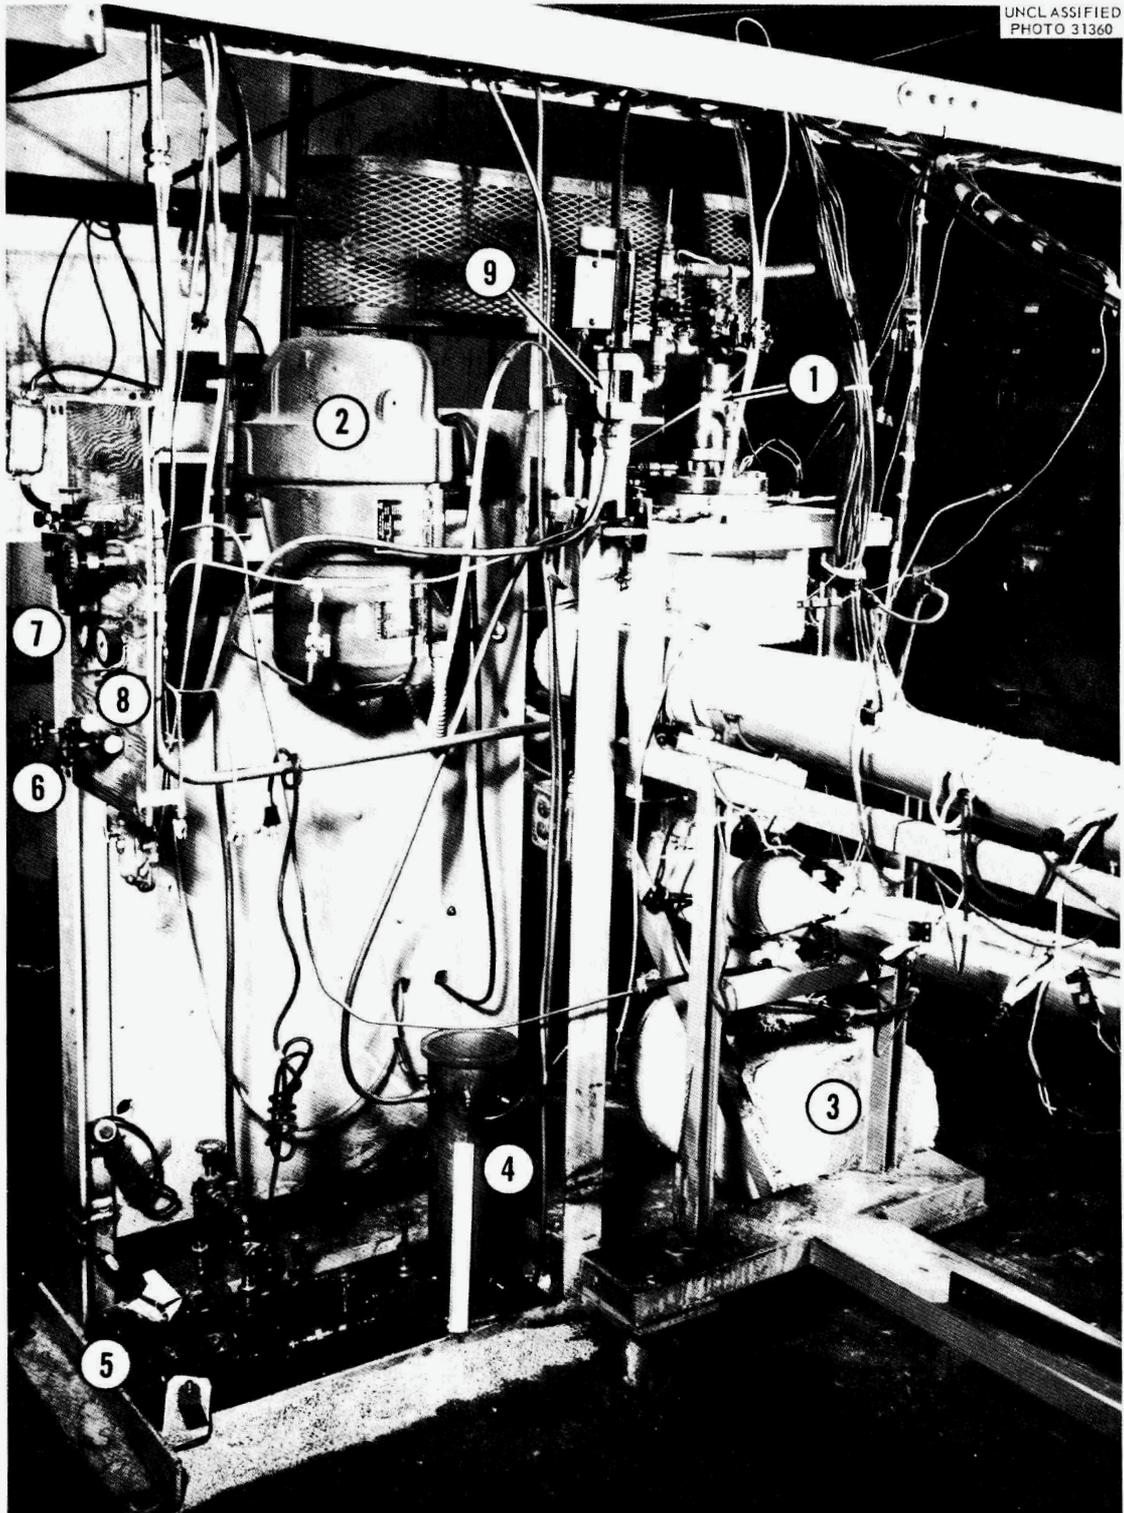
A sump tank, connected to the point of lowest elevation in the loop, was used to fill and drain the loop of molten salt. The LFB pump, installed at the highest point in the loop also served as a surge tank. The pump was supplied with an oil lubricating system. A helium supply was connected to the loop for initial purging of air before heating. It was also used to pressurize the sump for filling the loop with molten salt. The various components at the pump end of the loop are shown in Fig. 10 and are identified as follows: (1) LFB pump, (2) Pump motor and clutch, (3) Salt sump, (4) Water cooled oil storage tank, (5) Lubricating oil pumps, (6) Helium supply regulators, (7) Helium bubbler, (8) Helium pressure gauges, (9) Lubricating oil flowmeter.

Salt flow in the loop was controlled by a variable speed magnetic-type clutch and induction motor. V-belts connected the motor and clutch to the LFB pump.

Fig. 10. Inconel Test Loop - Pump End.
(1) LFB Pump (1 place); (2) Pump Motor and Clutch (1 place); (3) Salt Sump (1 place); (4) Water Cooled Oil Storage Tank (1 place); (5) Lube Oil Pumps (1 place); (6) He Supply Regulator (1 place); (7) He Bubbler (1 place); (8) He Pressure Gages (1 place); (9) Lube Oil Flowmeter (1 place).

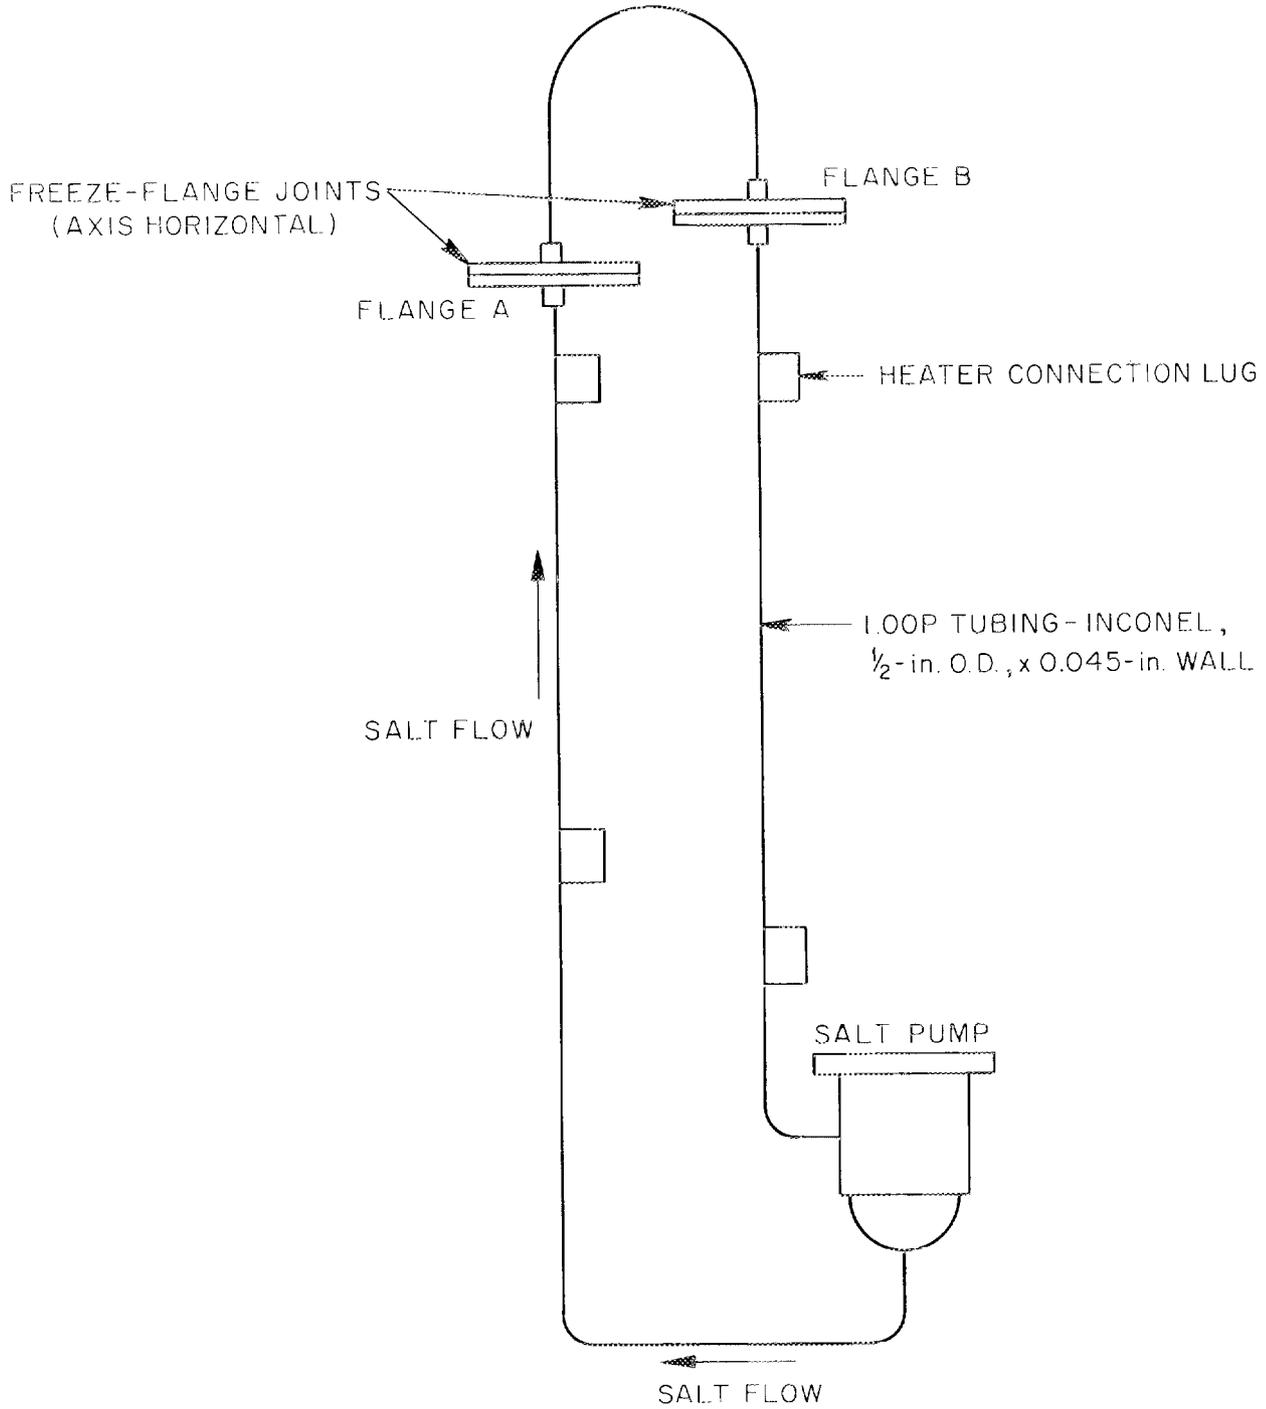
UNCLASSIFIED
ORNL-LR-DWG 27897R

Fig. 11. Schematic Drawing of Test Loop for Freeze Flange Tests 1 and 2.

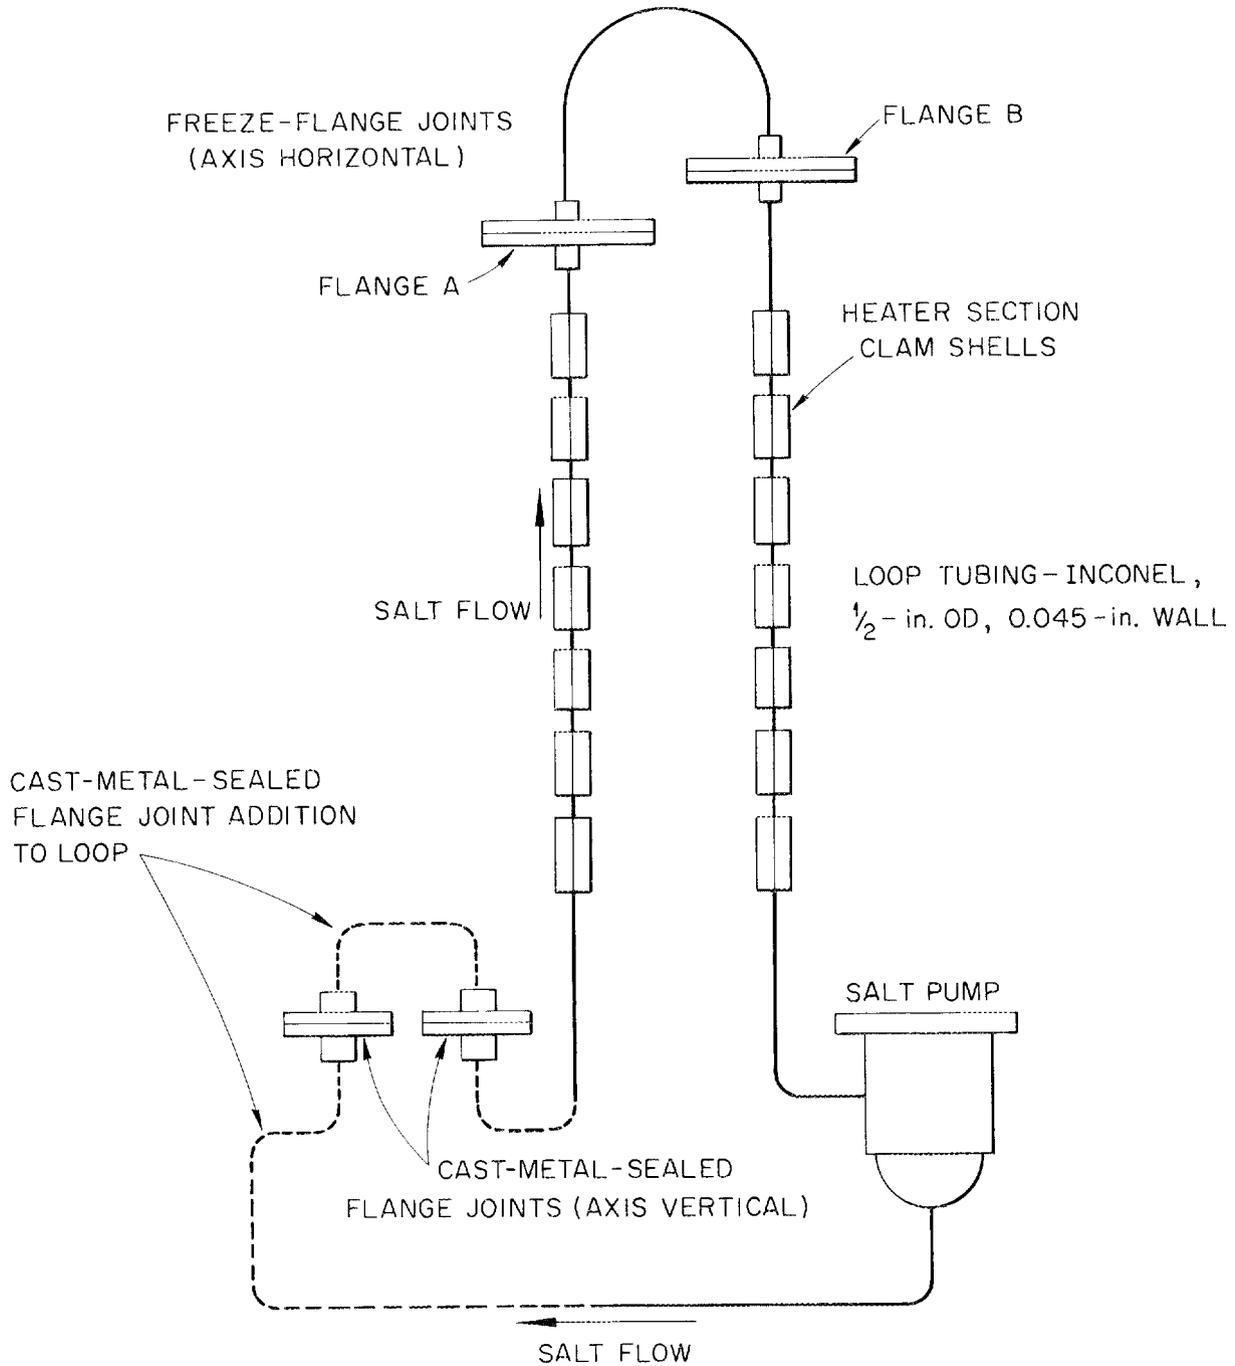
UNCLASSIFIED
ORNL-LR-DWG 31975

Fig.13. Schematic Drawing of Test Loop for Freeze Flange Tests 3 and 4 and Cast Seal Flange Tests 1 and 2 .

flange assemblies were then welded into one end of the loop in the location shown in Fig. 13.

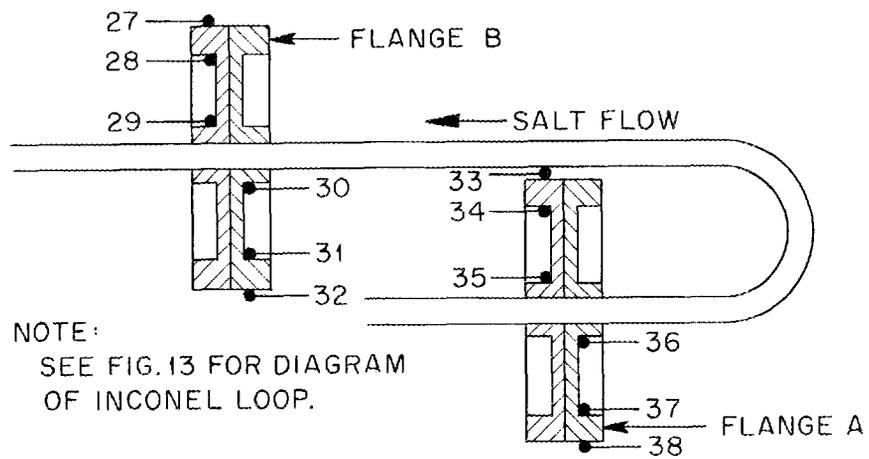
Fig. 14. Schematic Drawing of Thermocouple Locations on the Freeze Flanges for Tests 3 and 4.

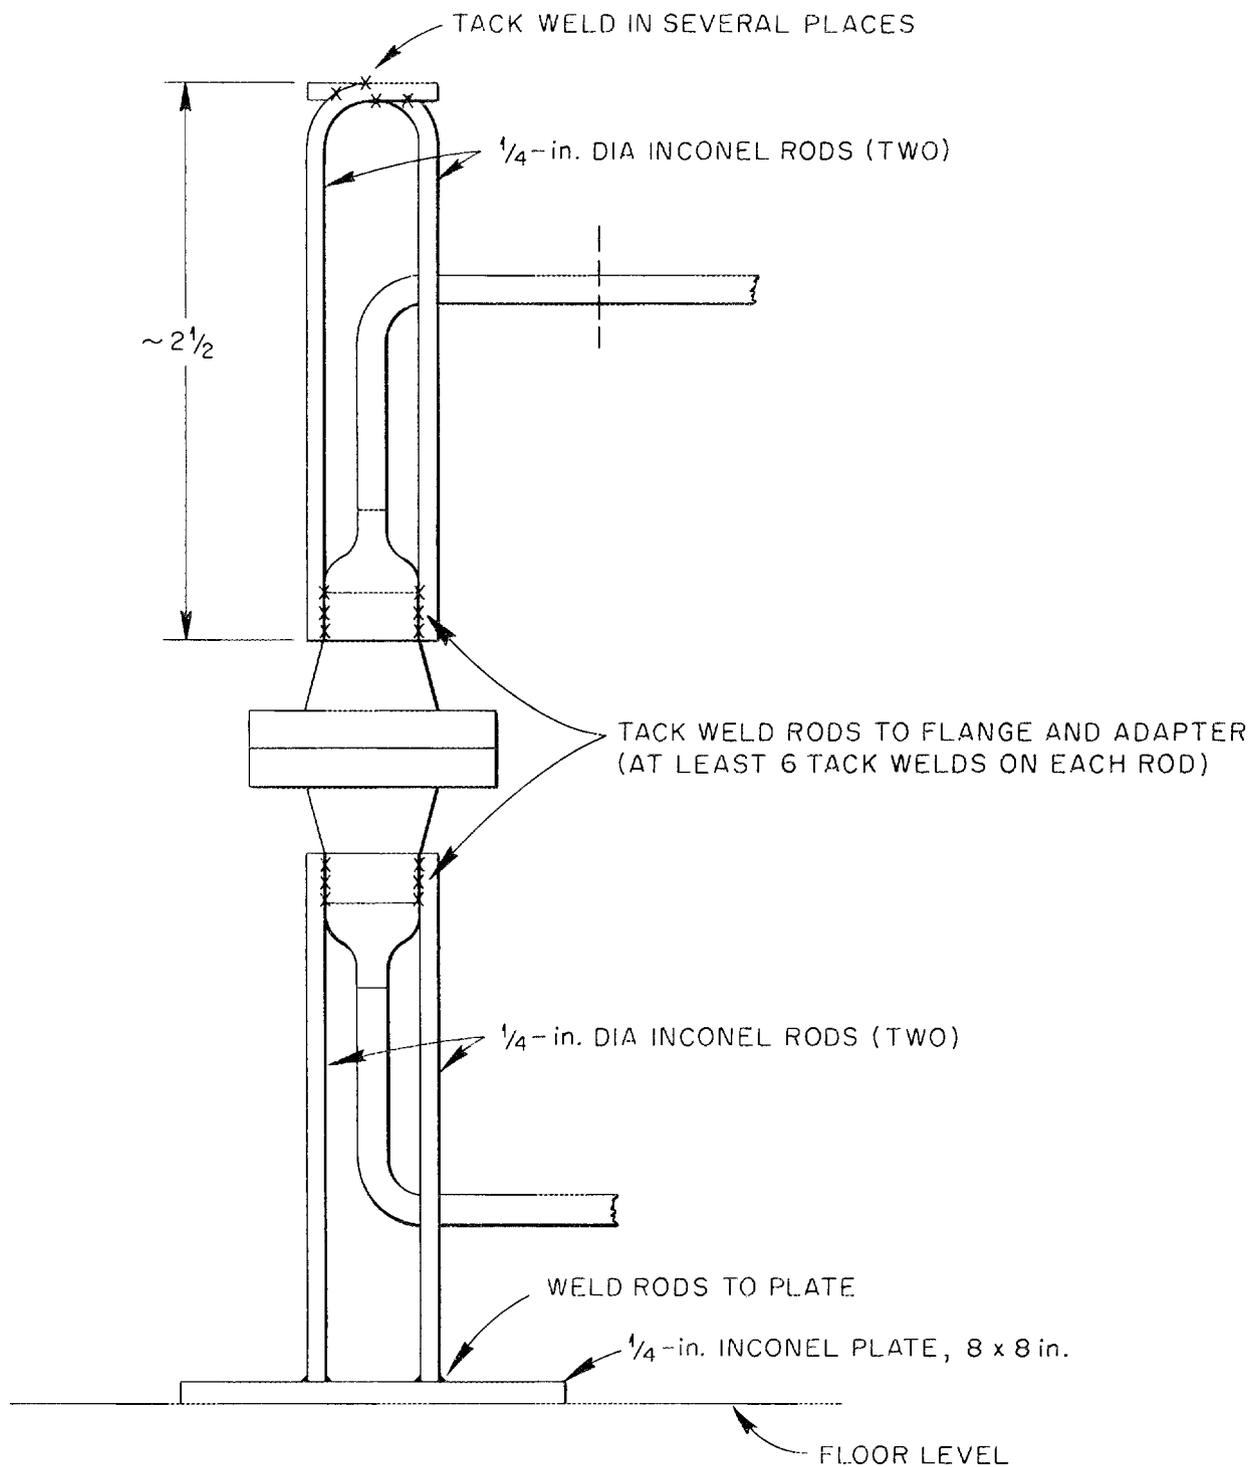
Stainless steel rods were tack welded to the flanges to pull them apart, while the seals were in the molten state. A diagram of this apparatus is shown in Fig. 15.

Fig. 15. Sketch of Extension Rods for Disassembly of Cast Seal Flanges.
