OAK RIDGE NATIONAL LABORATORY

58-8-33

DATE: August 13, 1958
SUBJECT: Screening Tests of Mechanical Pipe Joints
for a Fused Salt Reactor System
TO: Distribution
FROM: W. B. McDonald, E. Storto, A. S. Olson

ABSTRACT

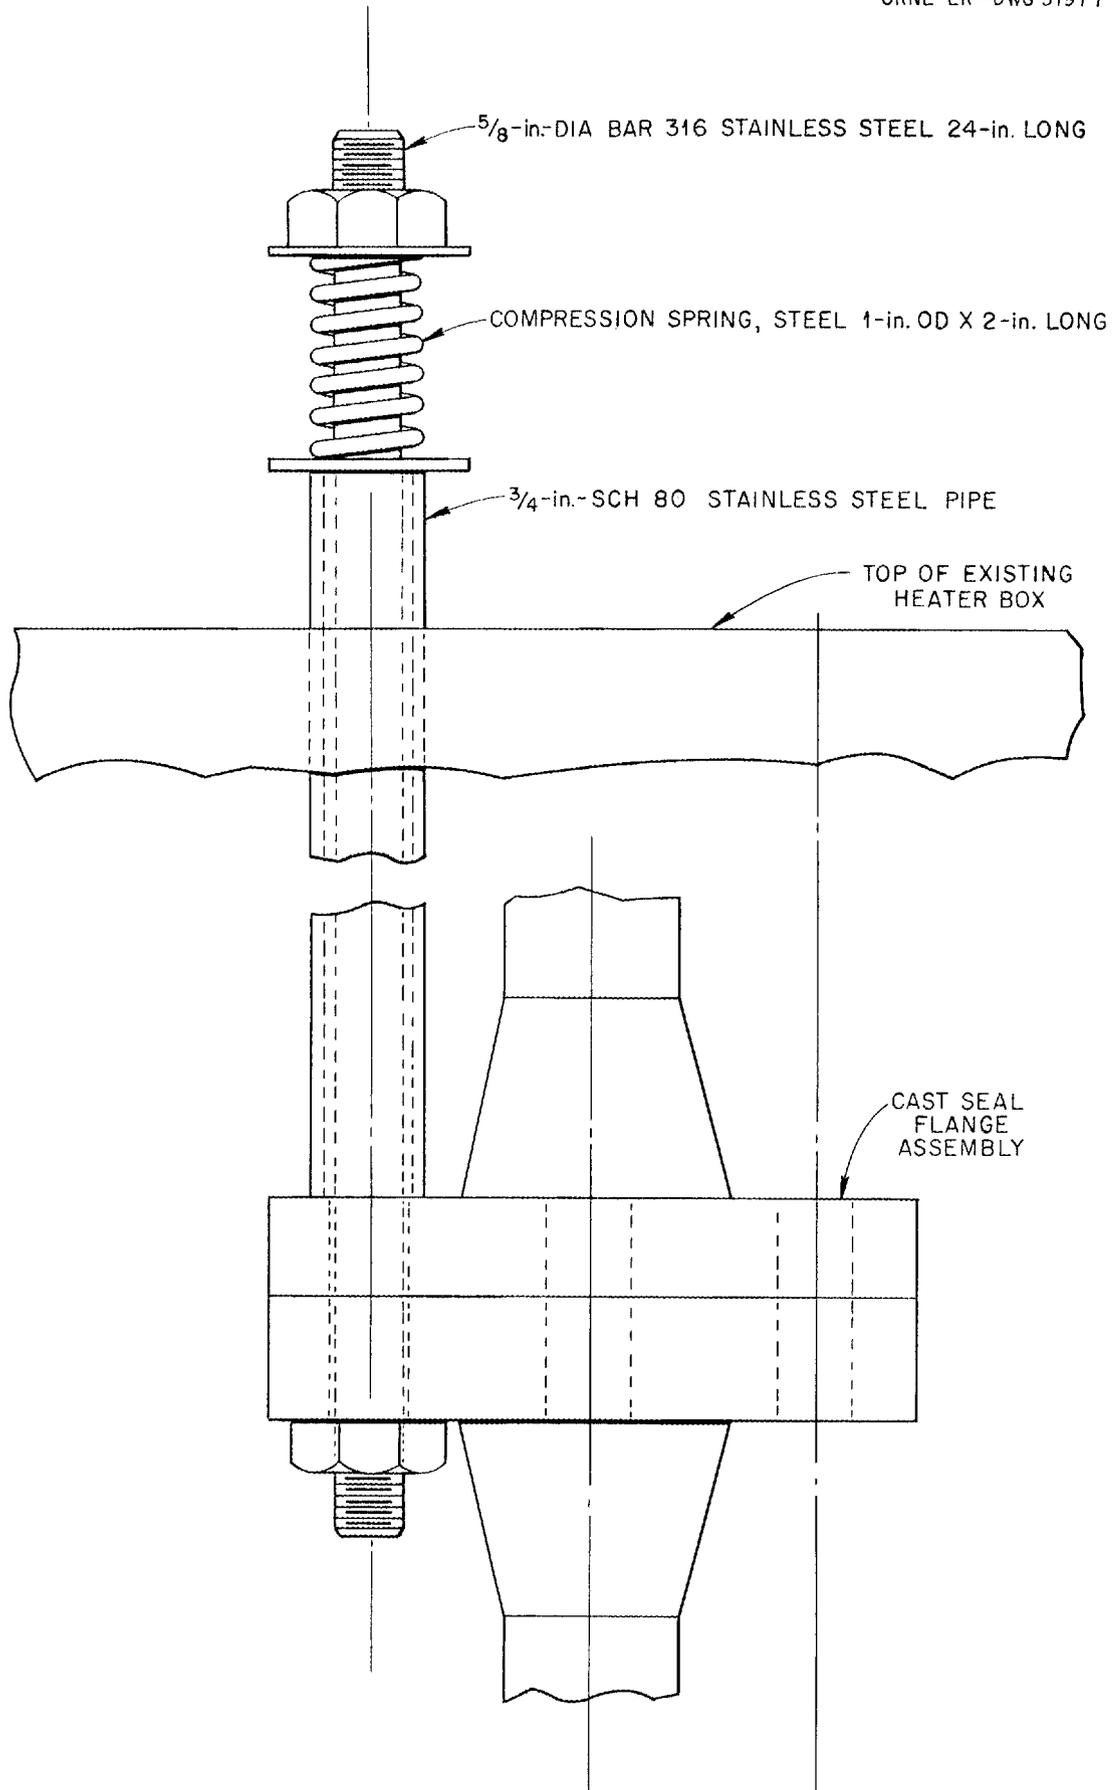
Fig. 16. Sketch of Spring-Loaded Tie Rods for Reassembly of Cast Seal Flanges.

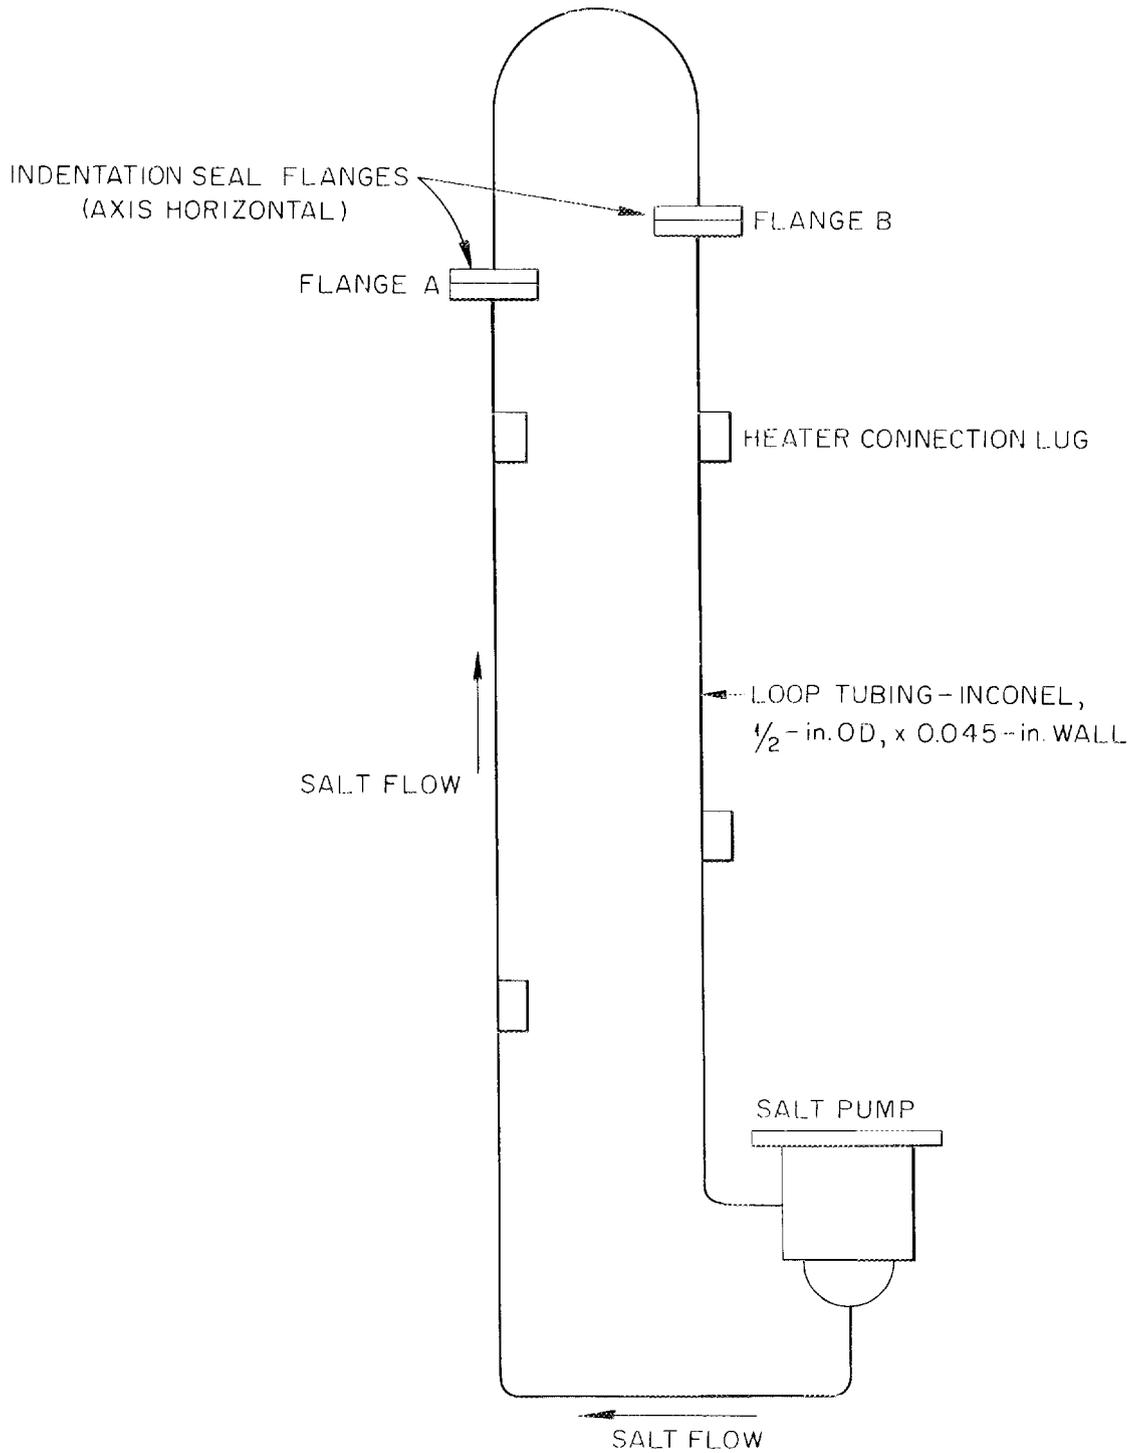
Fig. 17. Schematic Drawing of Test Loop for Indented Seal Flange Tests 1 and 2.

Two sets of flanges were assembled with metal gaskets prior to installation in the loop. Four "C" clamps were used on each flange assembly. The clamps were each tightened with a torque of 80 - 90 foot pounds. The load on each gasket was approximately 12,000 pounds per inch of gasket circumference. Each flange assembly was leak tested using a helium leak detector. Both assemblies were then welded into one end of the loop as shown in Figs. 9 and 17.

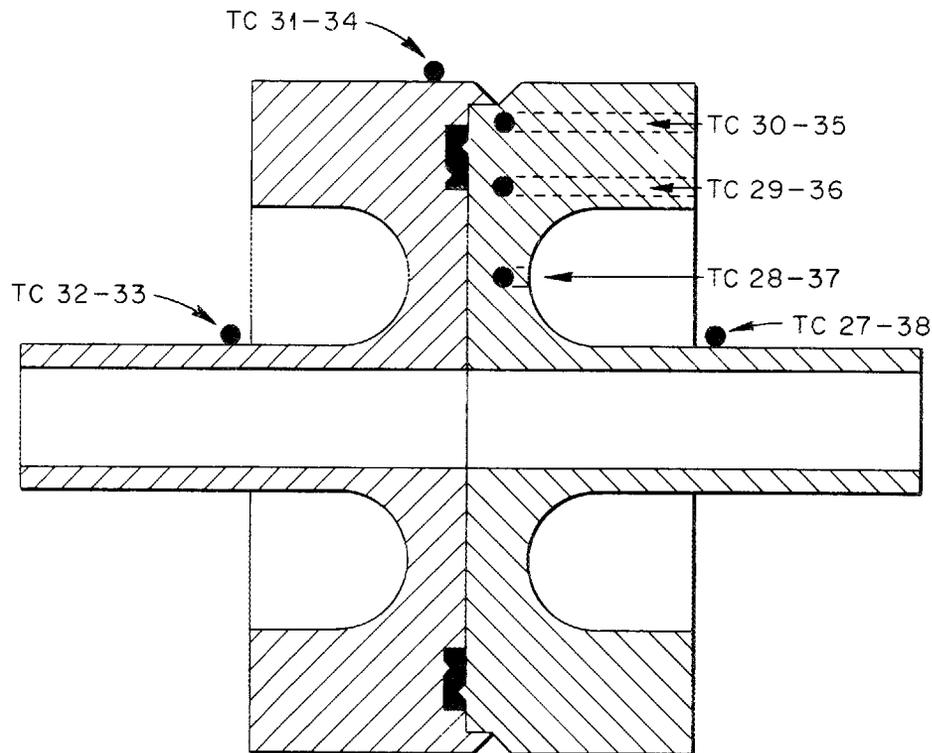
FLANGE A—NICKEL PLATED IRON GASKET
TC NO. 27, 28, 29, 30, 31, 32
FLANGE B—NICKEL GASKET
TC NO. 33, 34, 35, 36, 37, 38

Fig. 18. Schematic Drawing of Thermocouple Locations for Test 2 on Indented Seal Flange.

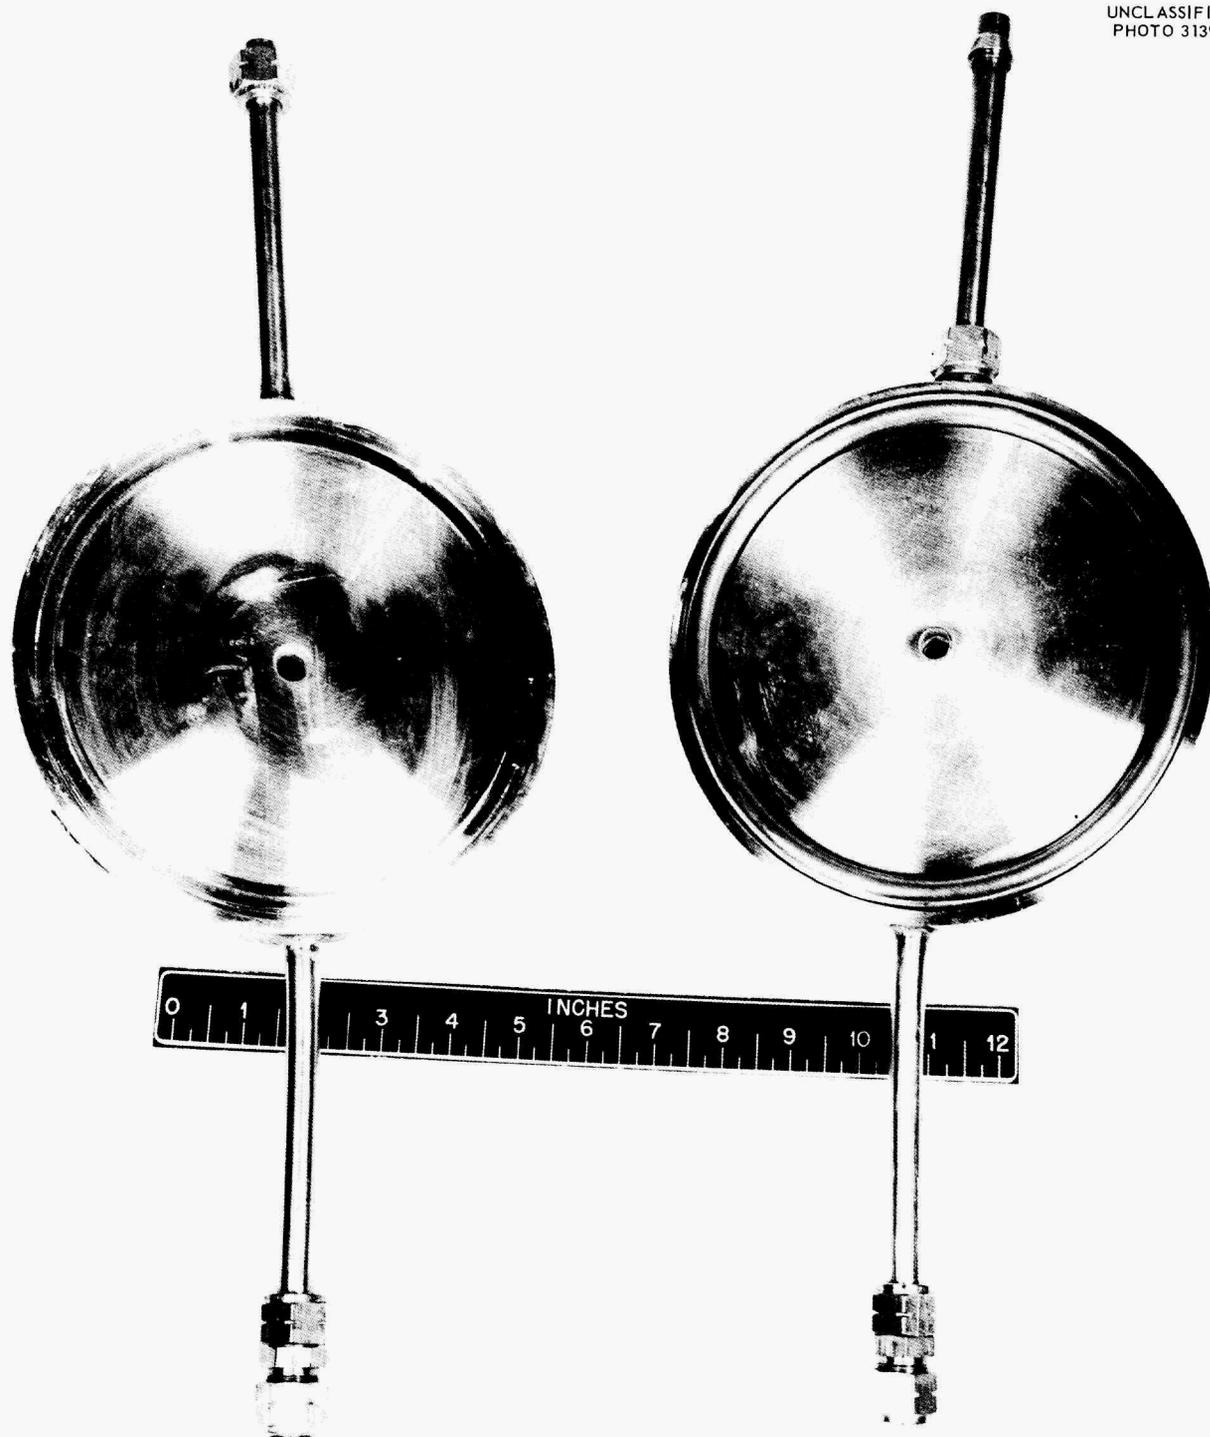
Oxidation of the copper seal rings was negligible. The rings had the same bright appearance after testing as they did originally. The Inconel flanges showed no noticeable salt corrosion. The flanges and seal rings are shown after the completion of Test No. 4 in Figs. 19 and 20.

Fig. 19. Freeze Flange (1/2" Tubing Size) Open with Copper Seal Ring After Cleaning, Following Test 4.

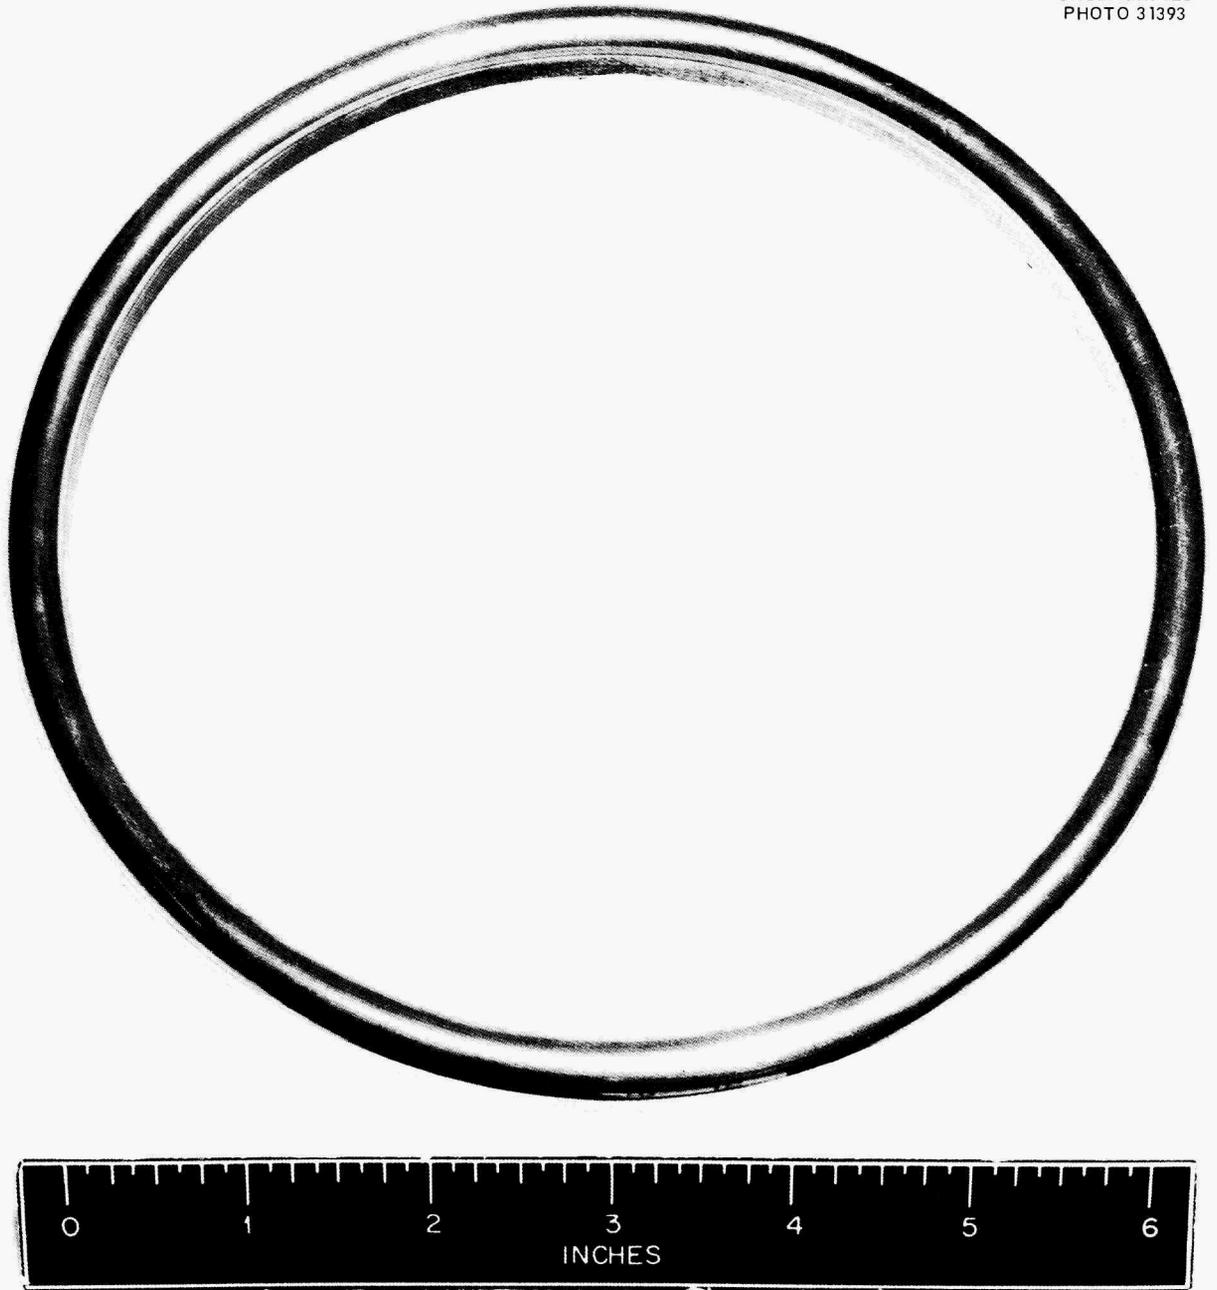
Fig. 20. Copper Seal Ring from Small Freeze Flange After Test 4.

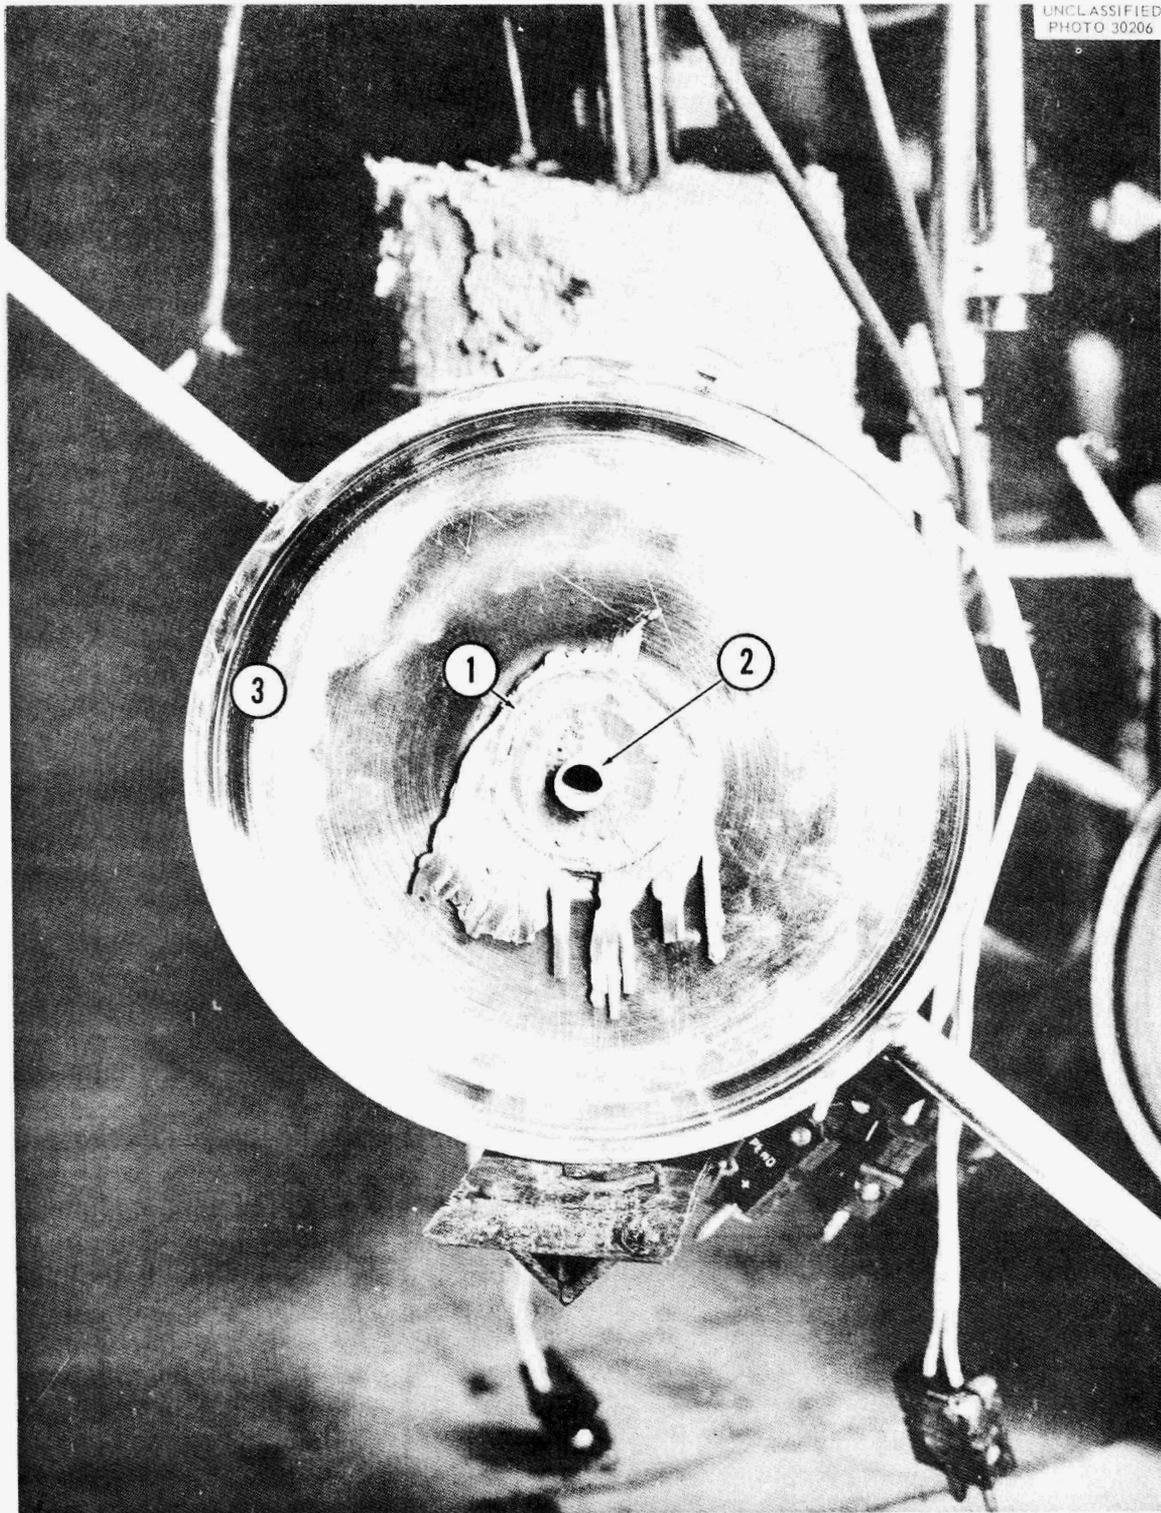
Fig. 21. Freeze Flange Showing Formation of Frozen Salt Seal.

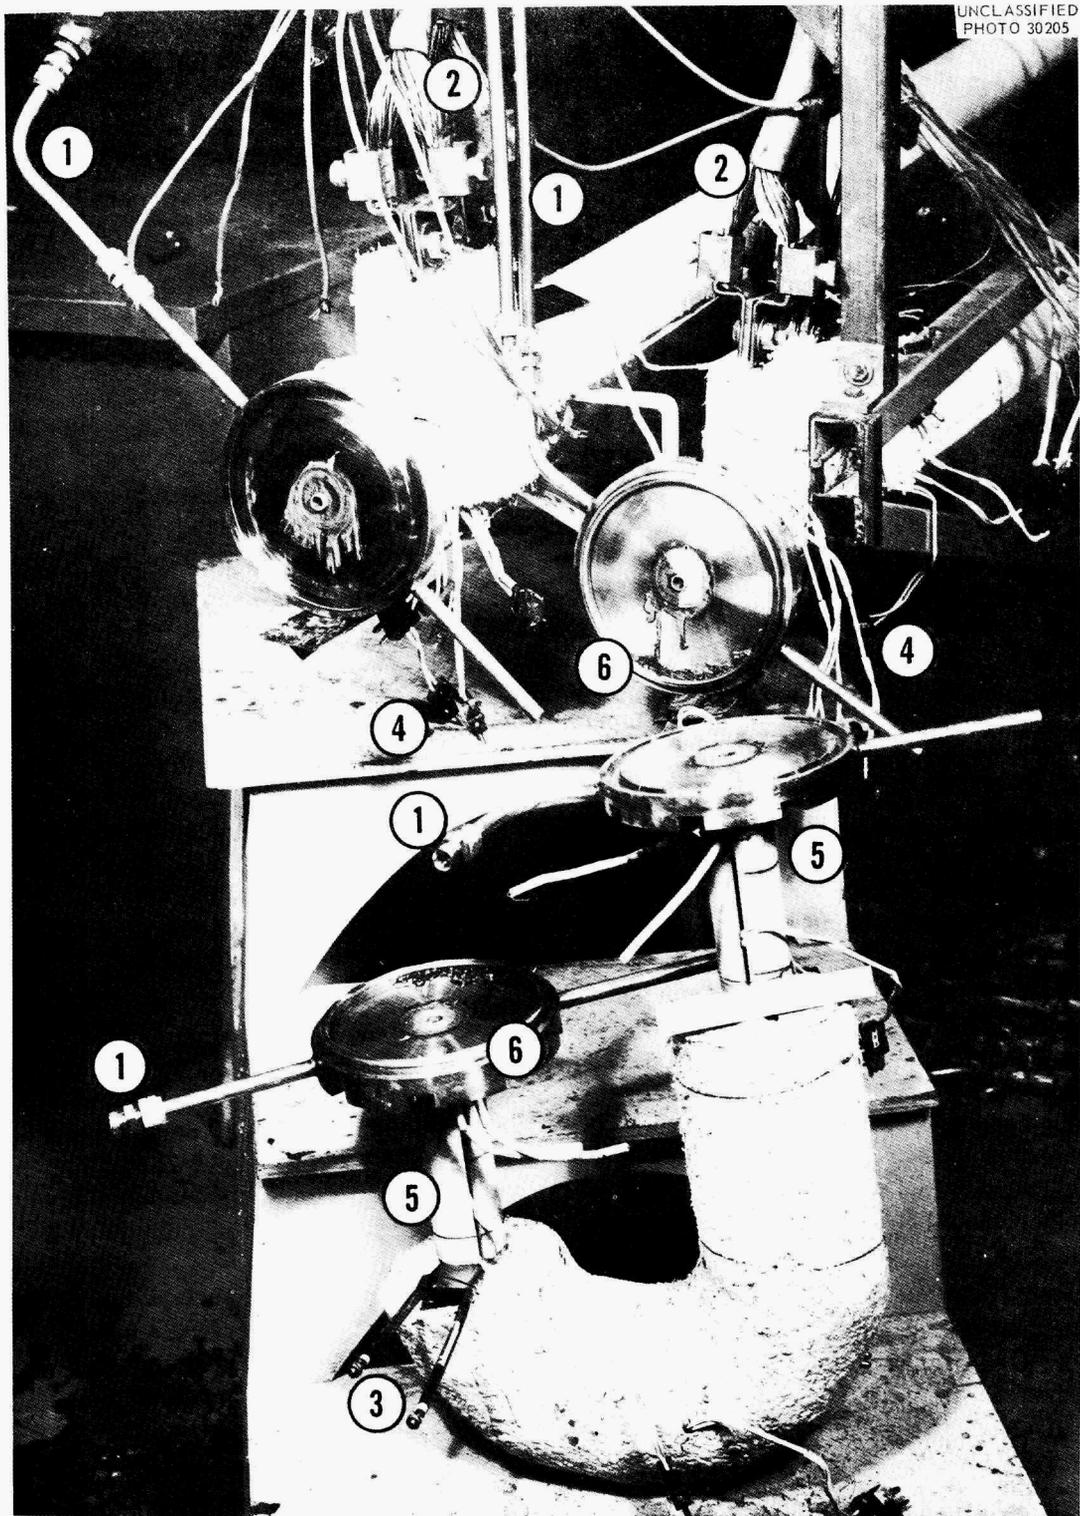
Fig. 22. Freeze Flanges Installed in Test Loop After Disassembly of the Flanges. Photo showing both flanges disassembled.

- (1) Air Cooling Inlet (4 places);
- (2) Resistance Heater Leads (2 places);
- (3) Calrod Heater (1 place);
- (4) Thermocouple Leads (2 places);
- (5) Clam Shell Heaters (2 places)
- (6) Seal Ring (2 places)

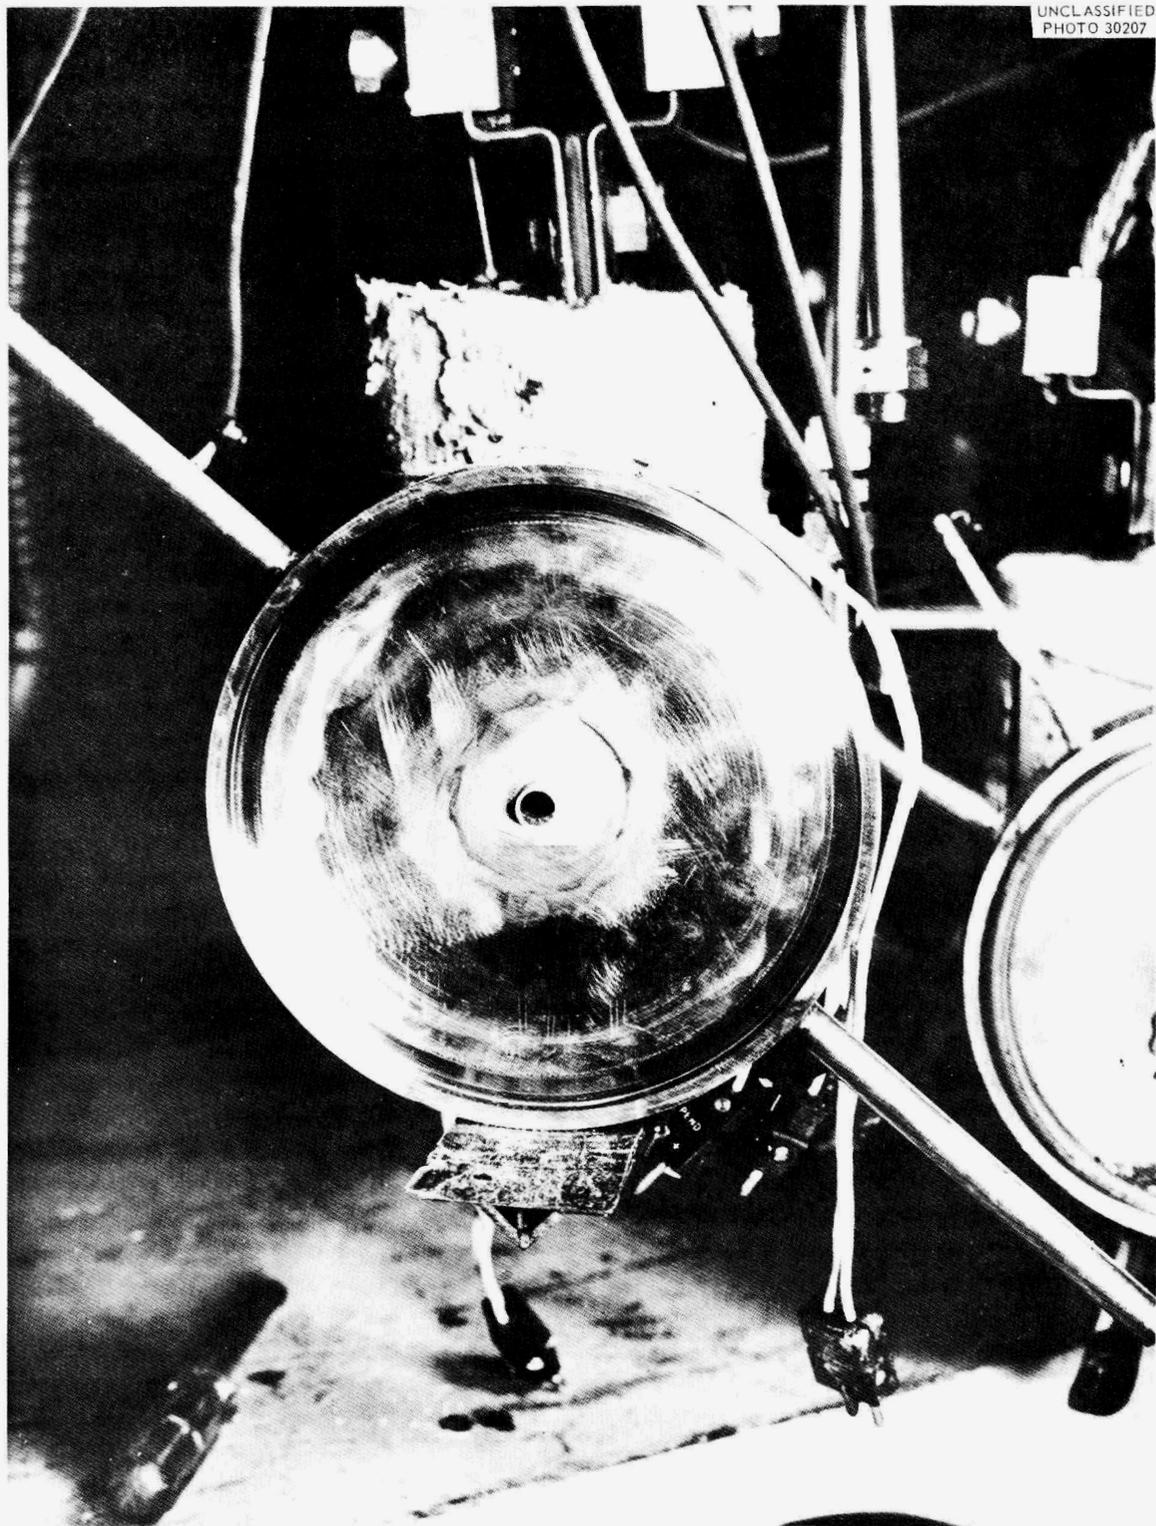
Fig. 23. Freeze Flange After Removal of Salt Seal from Face of Flange.

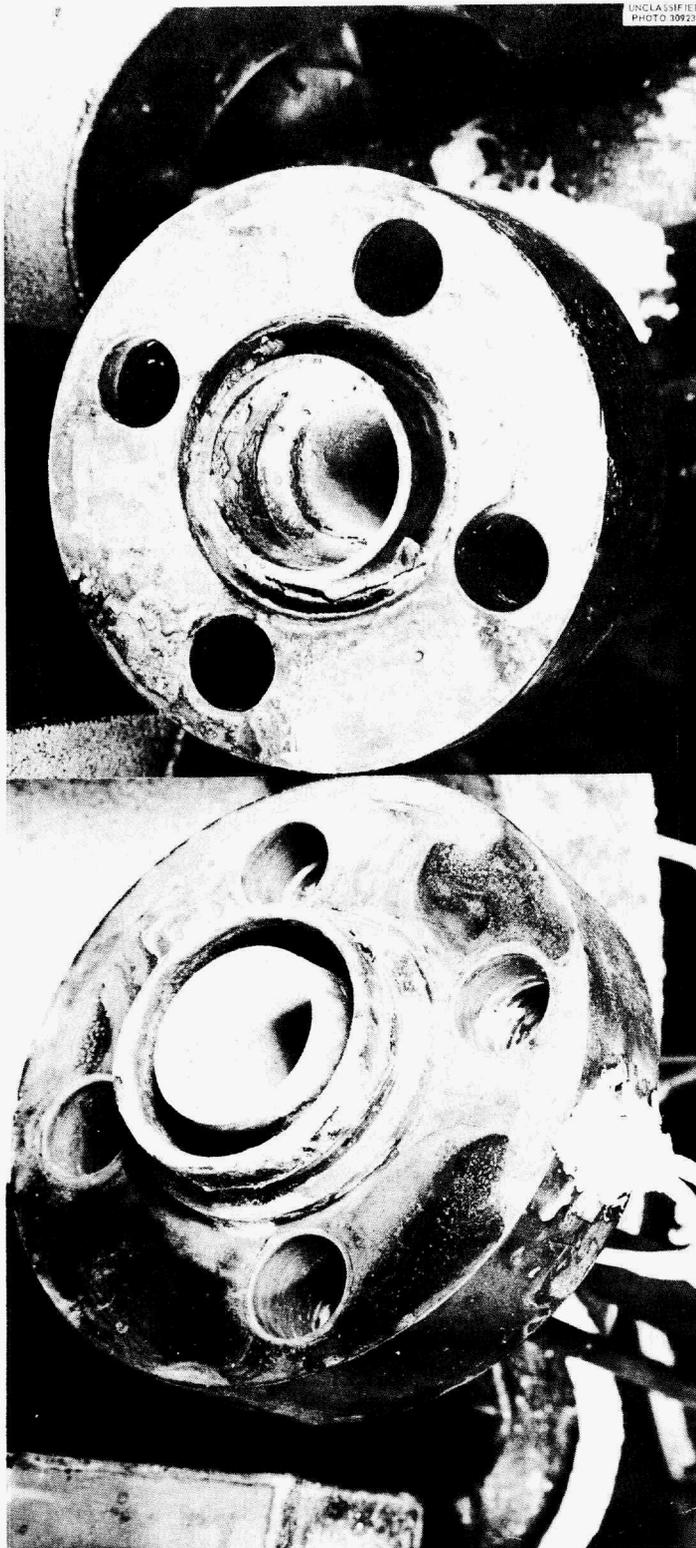
Photographs taken after disassembly of the flanges show that the flanges and sealing alloys were badly oxidized. Fig. 24 shows the flange with the copper-silver alloy seal; Fig. 25 the flange with the silver seal.

Fig. 24. Cast Seal Flange After Disassembly Following Loop Tests - Copper-Silver Alloy Seal.

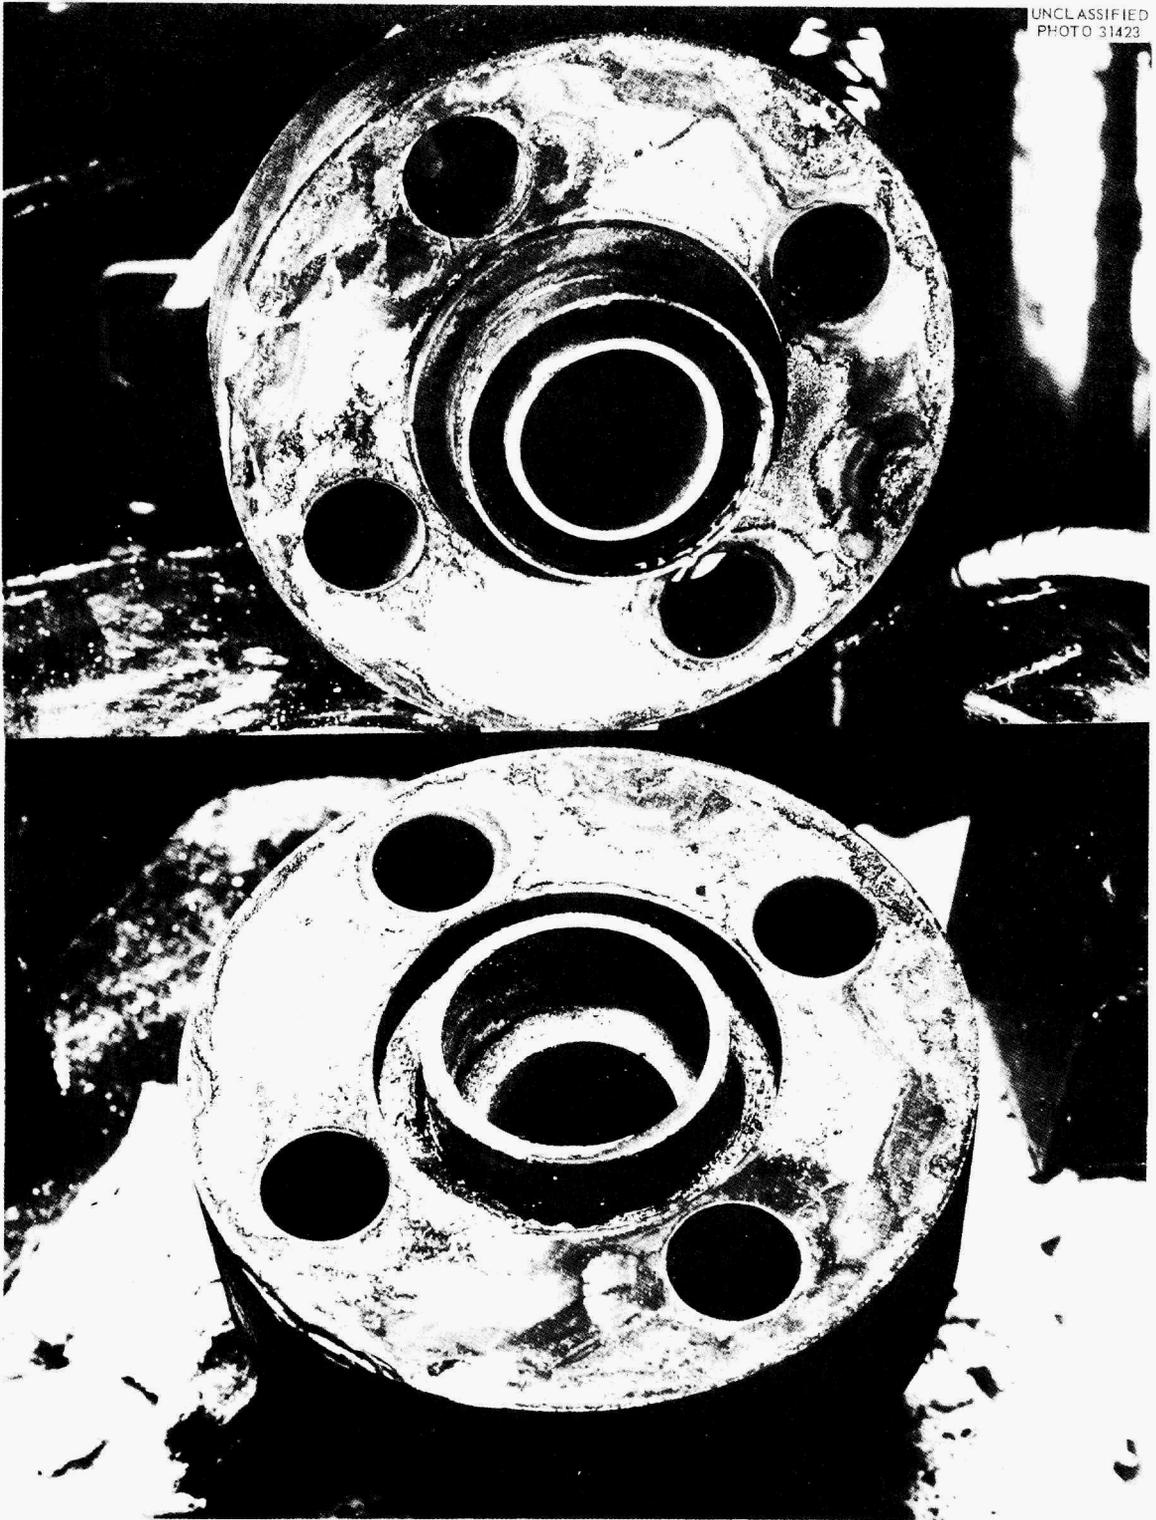
Fig. 25. Cast Seal Flange After Disassembly Following Loop Tests - Silver Seal.

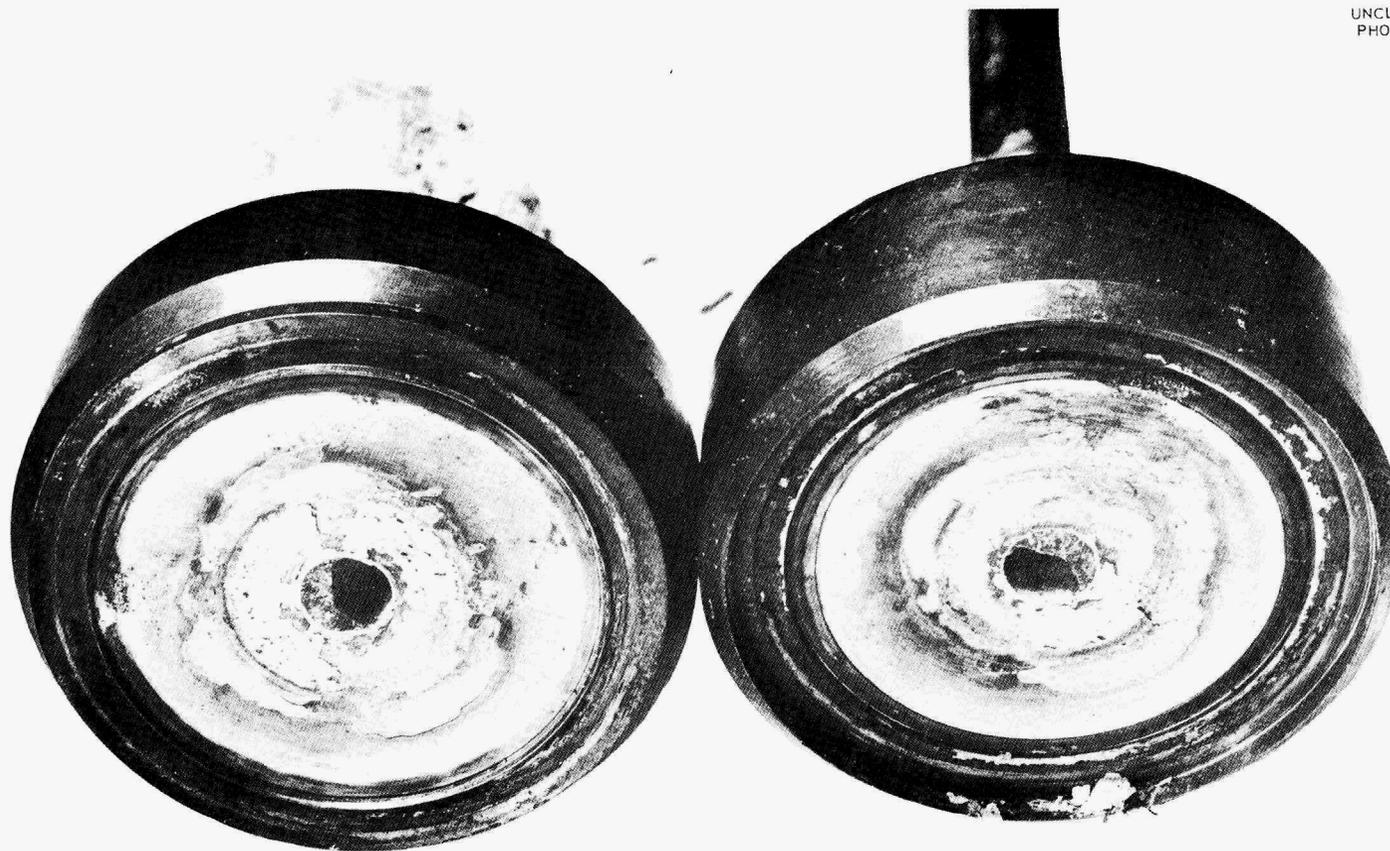
Fig. 26. Indented Seal Flange with Copper Gasket After Testing.

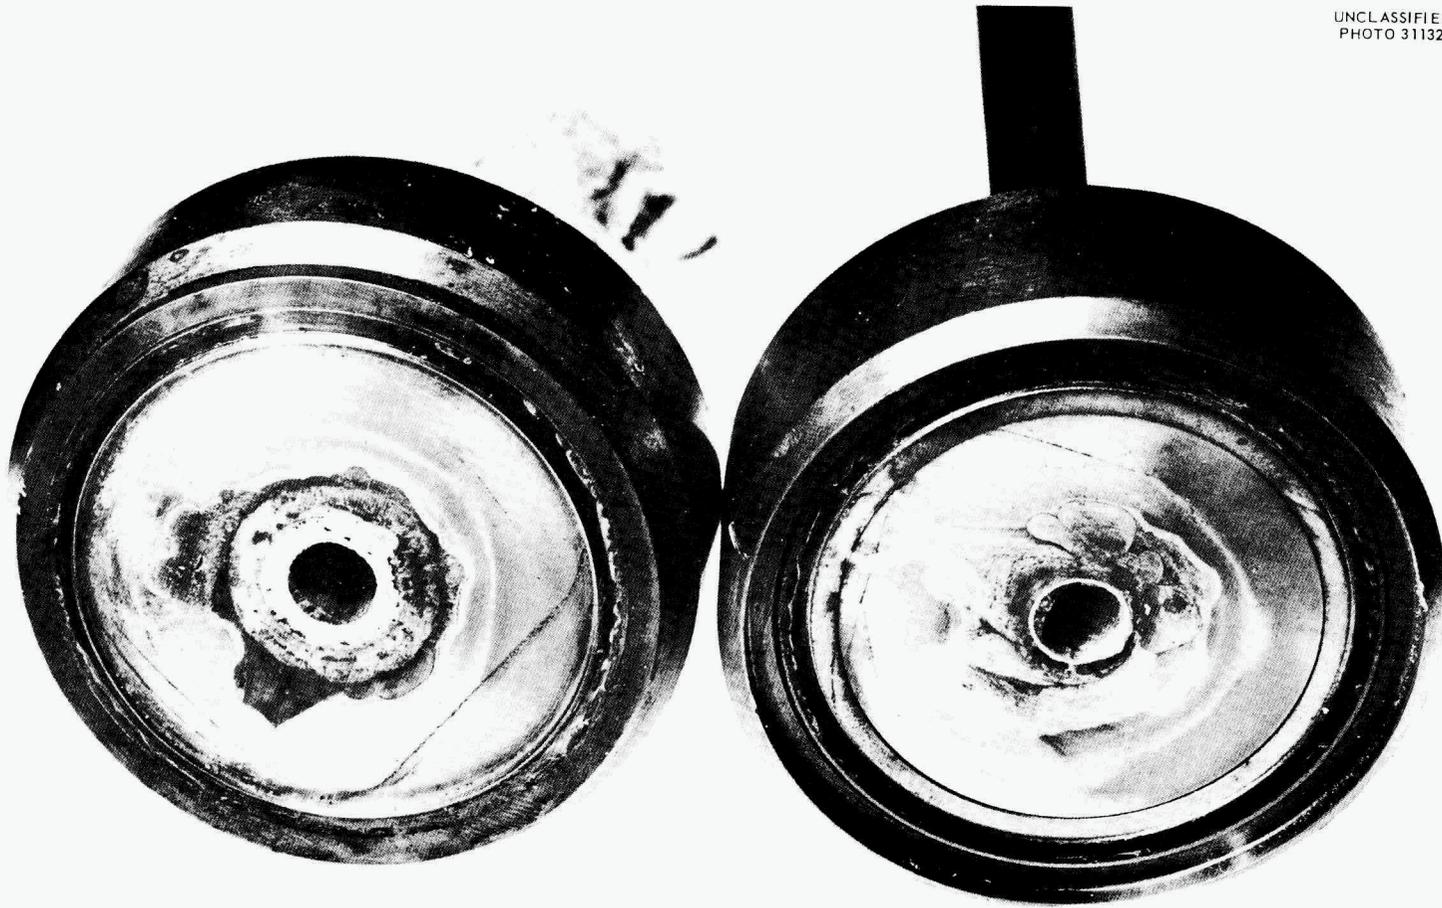
Fig. 27. Indented Seal Flange with Armco Iron Gasket After Testing.

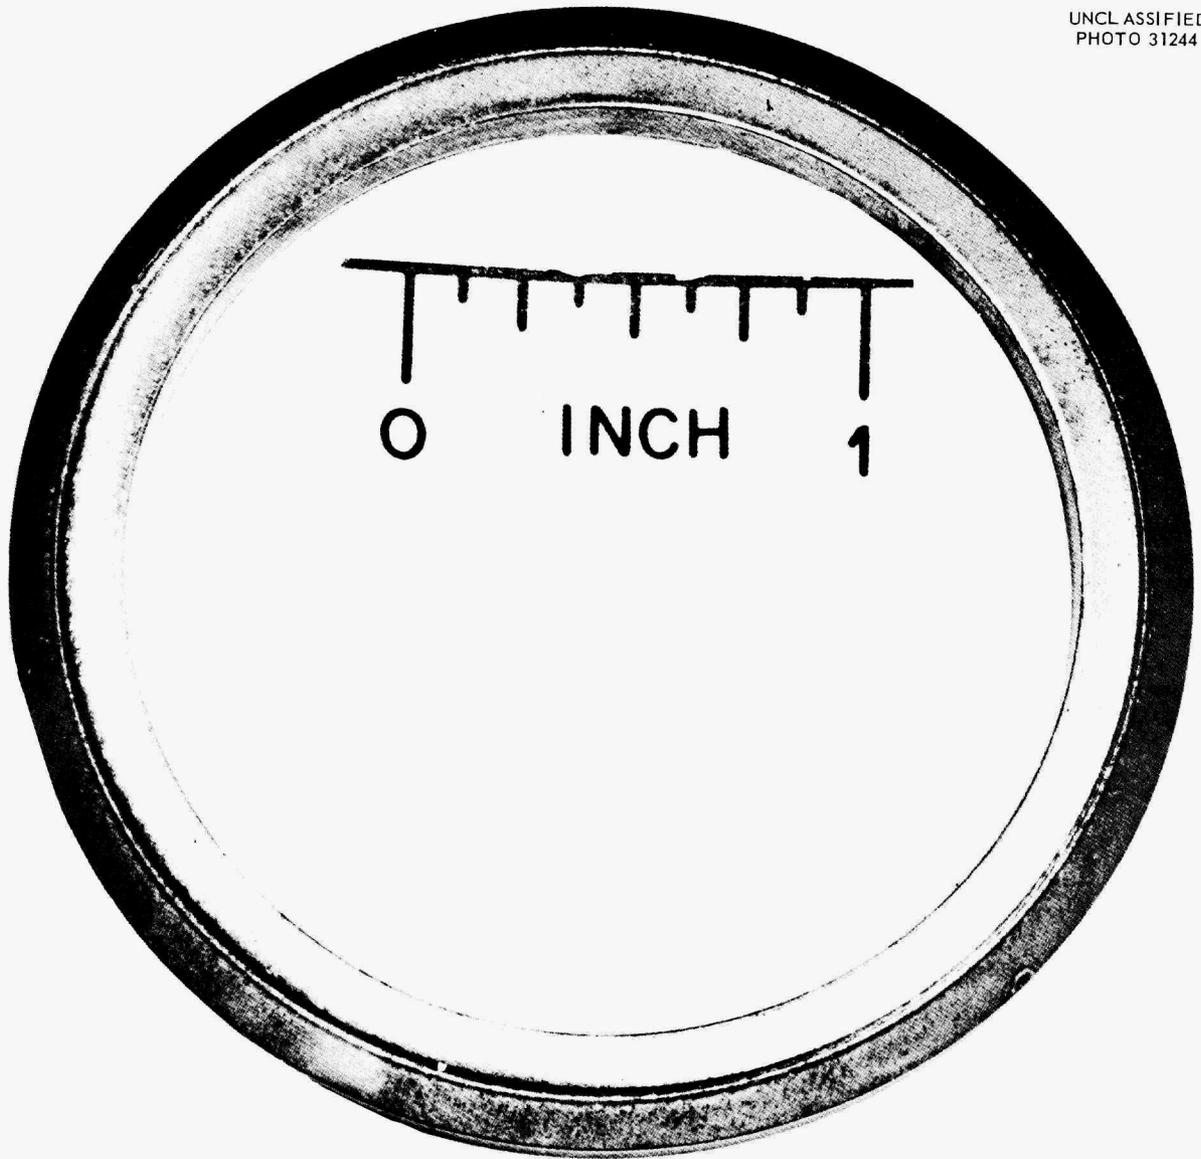
Fig. 28. Armco Iron Gasket After Testing in Indented Seal Flange.

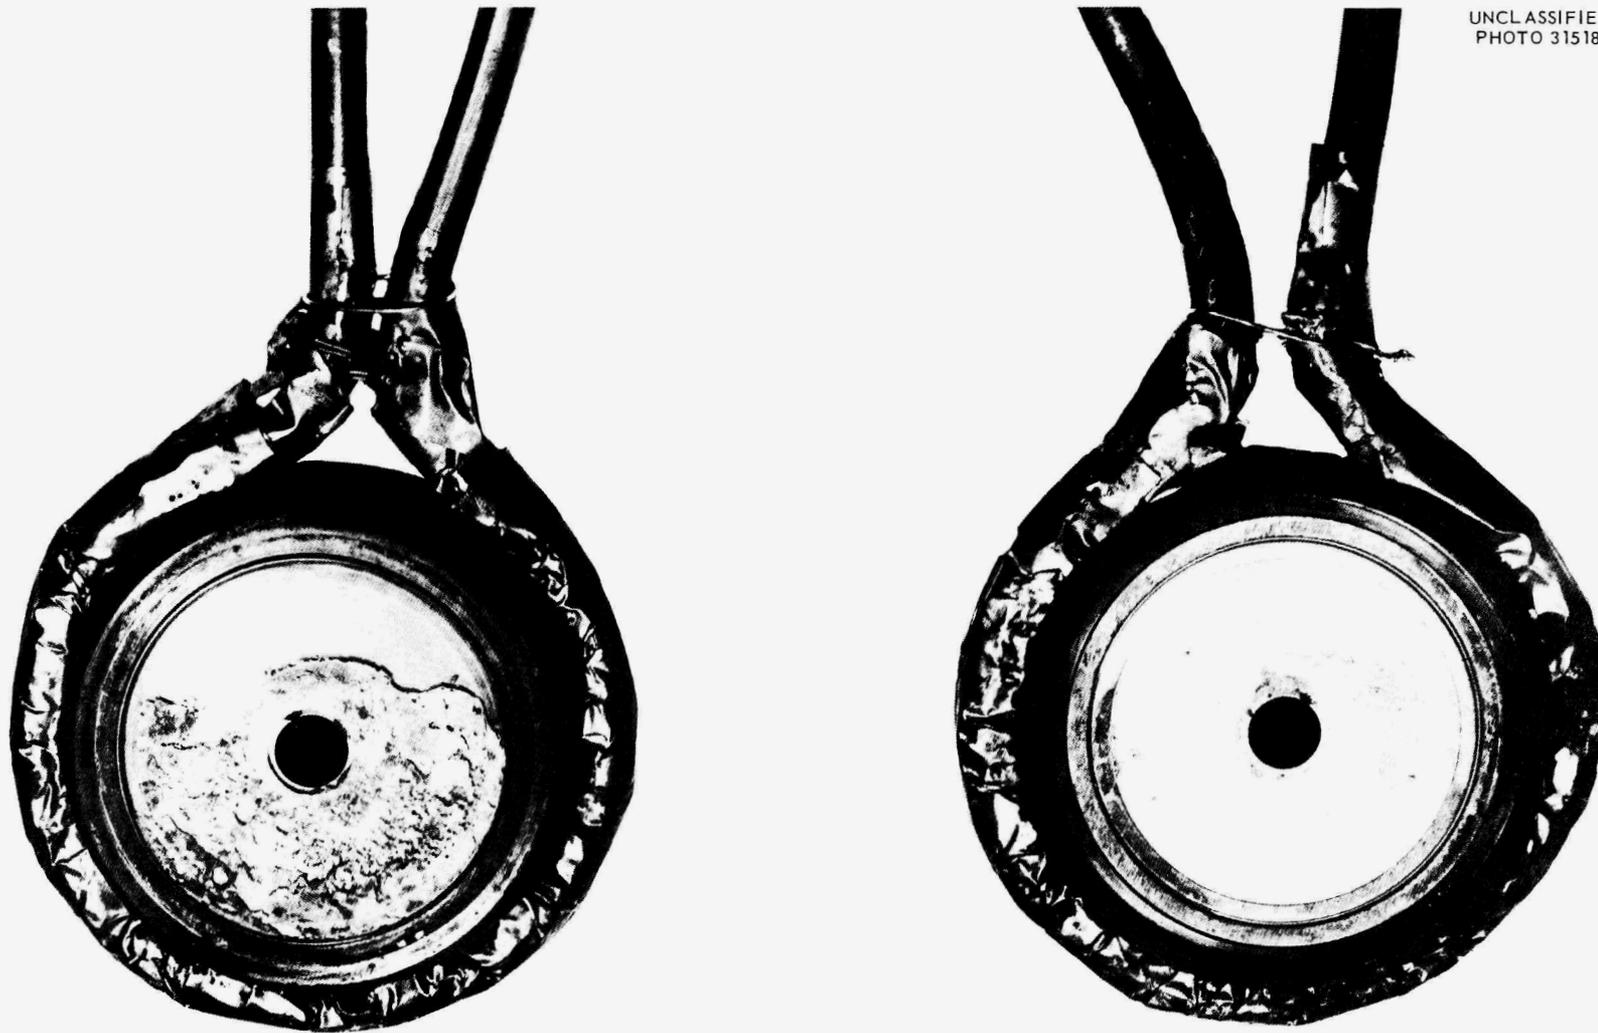
Fig. 29. Indented Seal Flange with Nickel Gasket After Testing.

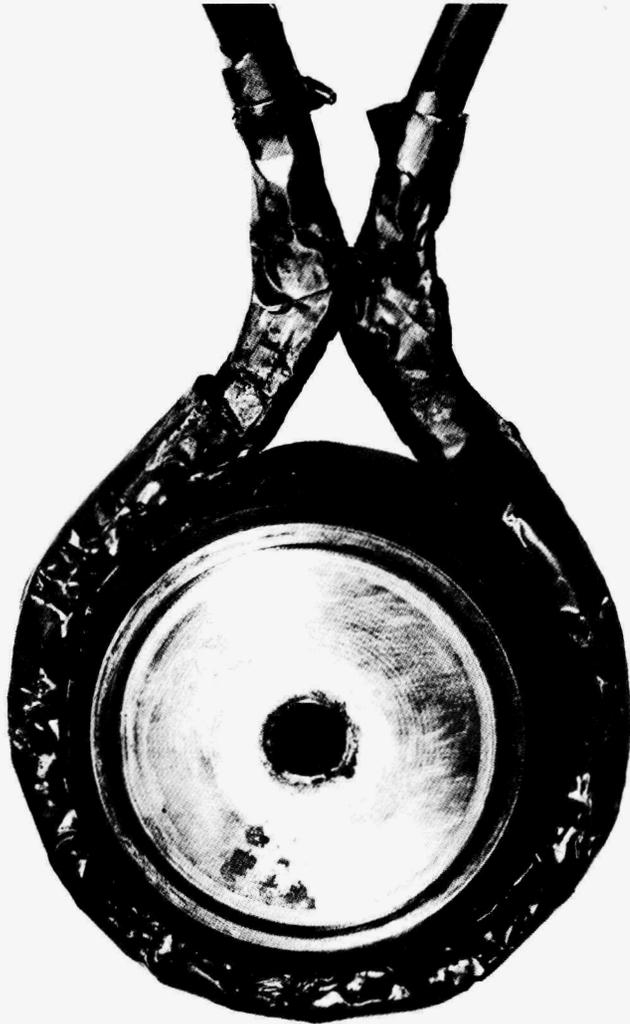
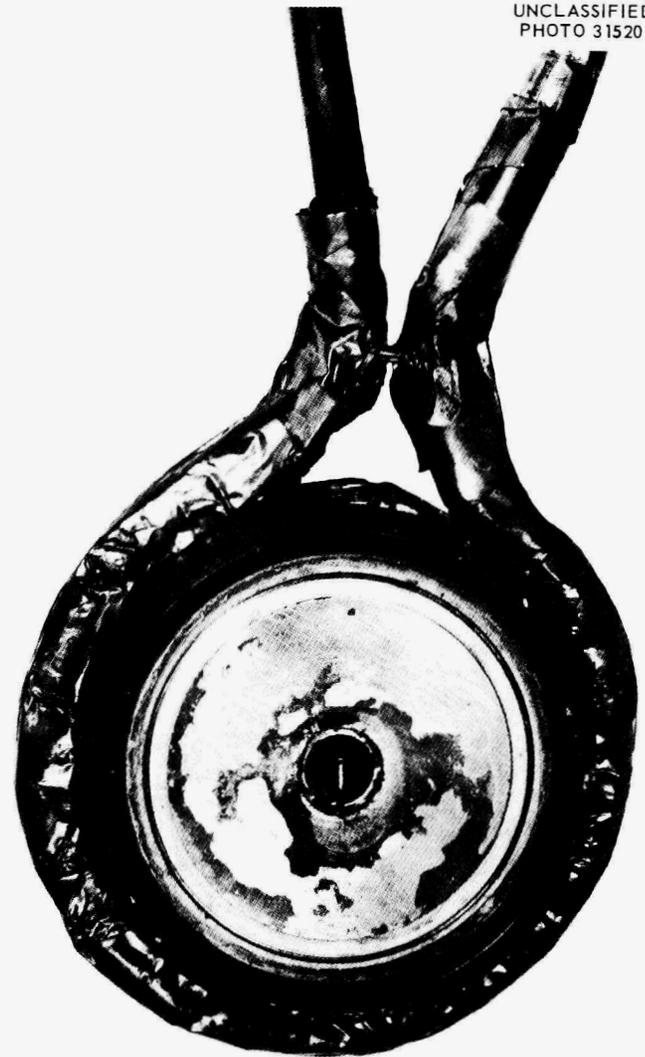
Fig. 30. Indented Seal Flange with Nickel-Plated Armco Iron Gasket After Testing.
