OAK RIDGE NATIONAL LABORATORY

58-8-33

DATE: August 13, 1958
SUBJECT: Screening Tests of Mechanical Pipe Joints
for a Fused Salt Reactor System
TO: Distribution
FROM: W. B. McDonald, E. Storto, A. S. Olson

ABSTRACT

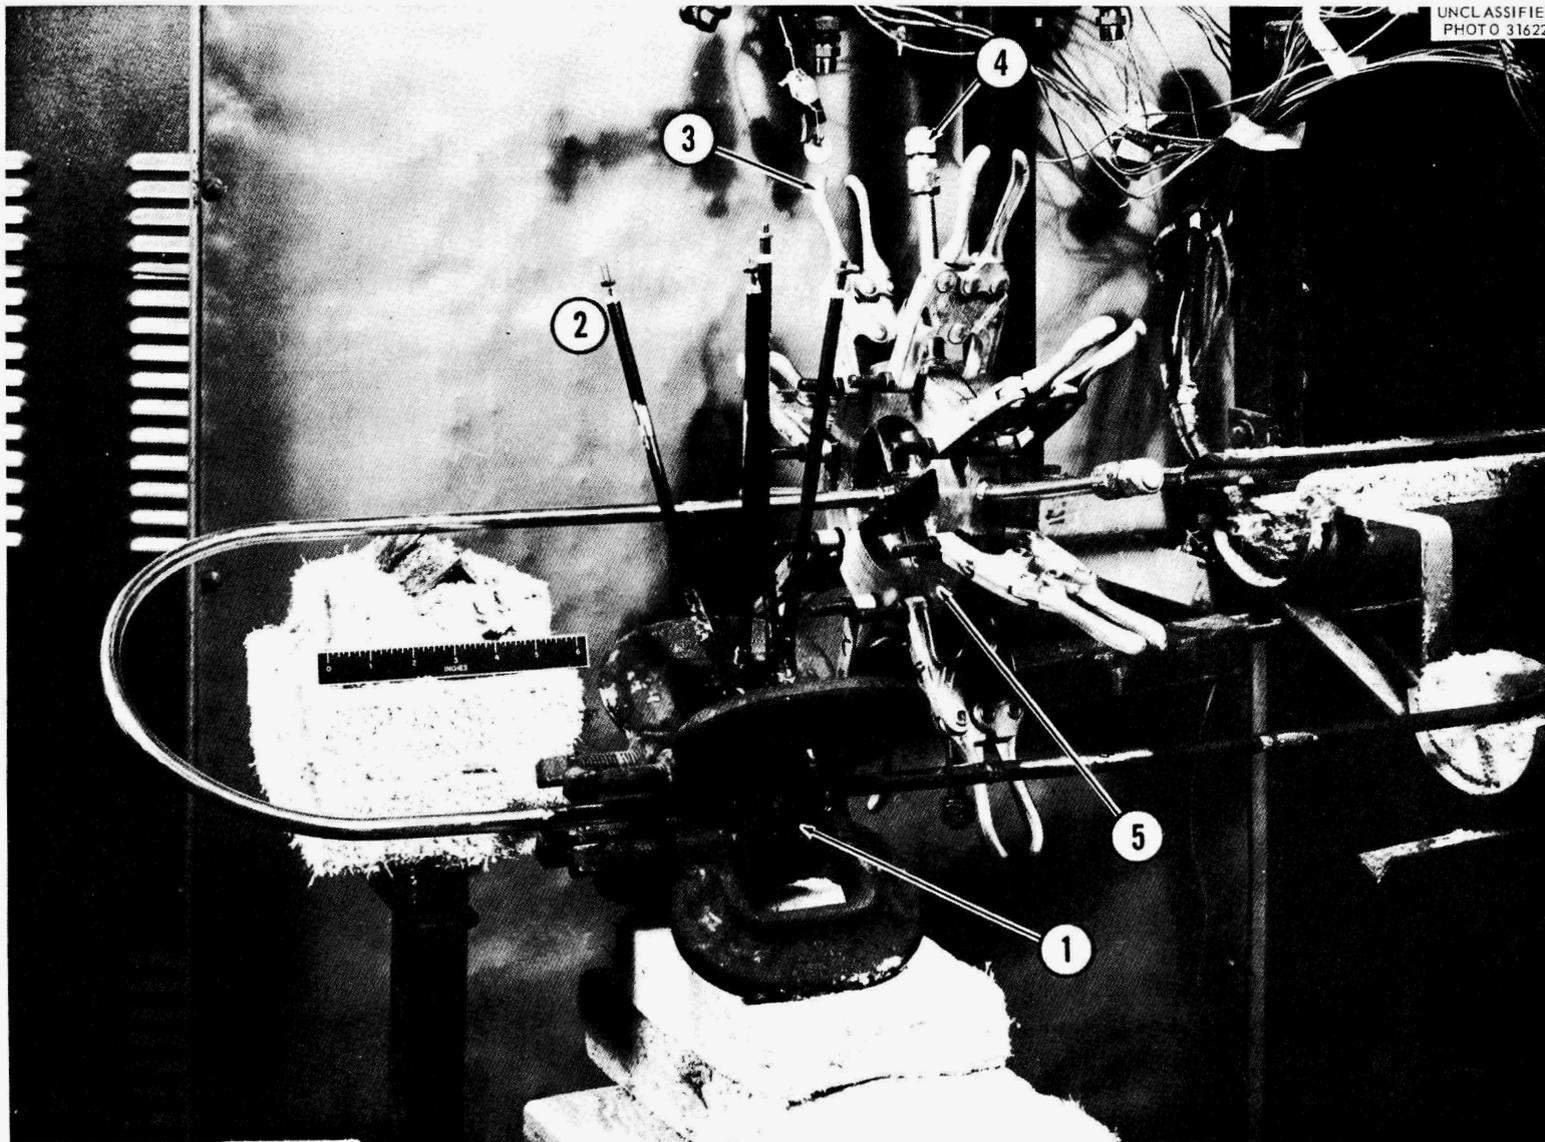
Fig. 31. Freeze Flange and Indented Seal Flange Installed in Test Loop for Cycling Tests with Molten Sodium.
(1) Indented Seal Flange; (2) Calrod Heaters; (3) Toggle Clamp; (4) Air Cooling Inlet; (5) Freeze Flange

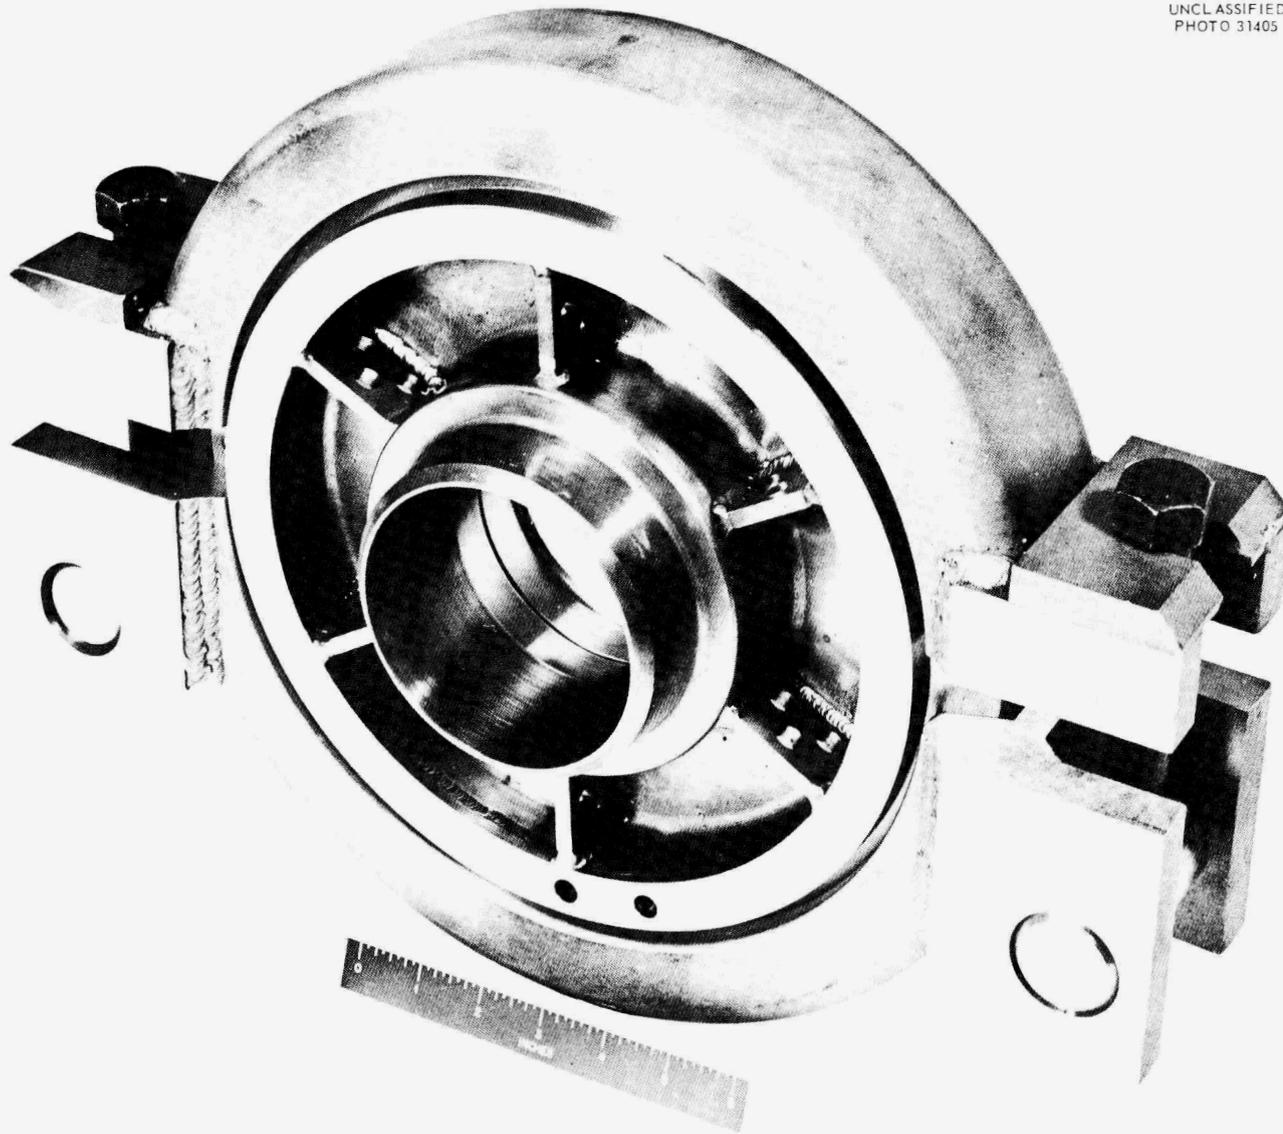
A larger size freeze flange joint has been fabricated. It is shown assembled in Fig. 32. The flange is shown open with the copper seal ring in place in Fig. 33. The principle of operation is identical to the small size flange tested and described above. Provision has been made on the ring seal for monitoring the gas leak rate during operation. Two such flanges have been fabricated for testing with molten salt in a loop, shown schematically in Fig. 34. The welding necks on the flanges will match a 4-inch, schedule 40 pipe. An unusual feature of the large flange is the use of a special clamp, made in two sections, which holds the flanges around their entire circumference. The clamp is shown in the assembly photograph, Fig. 32. Holes were placed in the webs to reduce heat conduction from the salt to the seal ring area. A metal screen will be inserted in the space between the flange faces to reduce the hold-up volume of salt,

Fig. 32. Assembly of Large Freeze Flange.

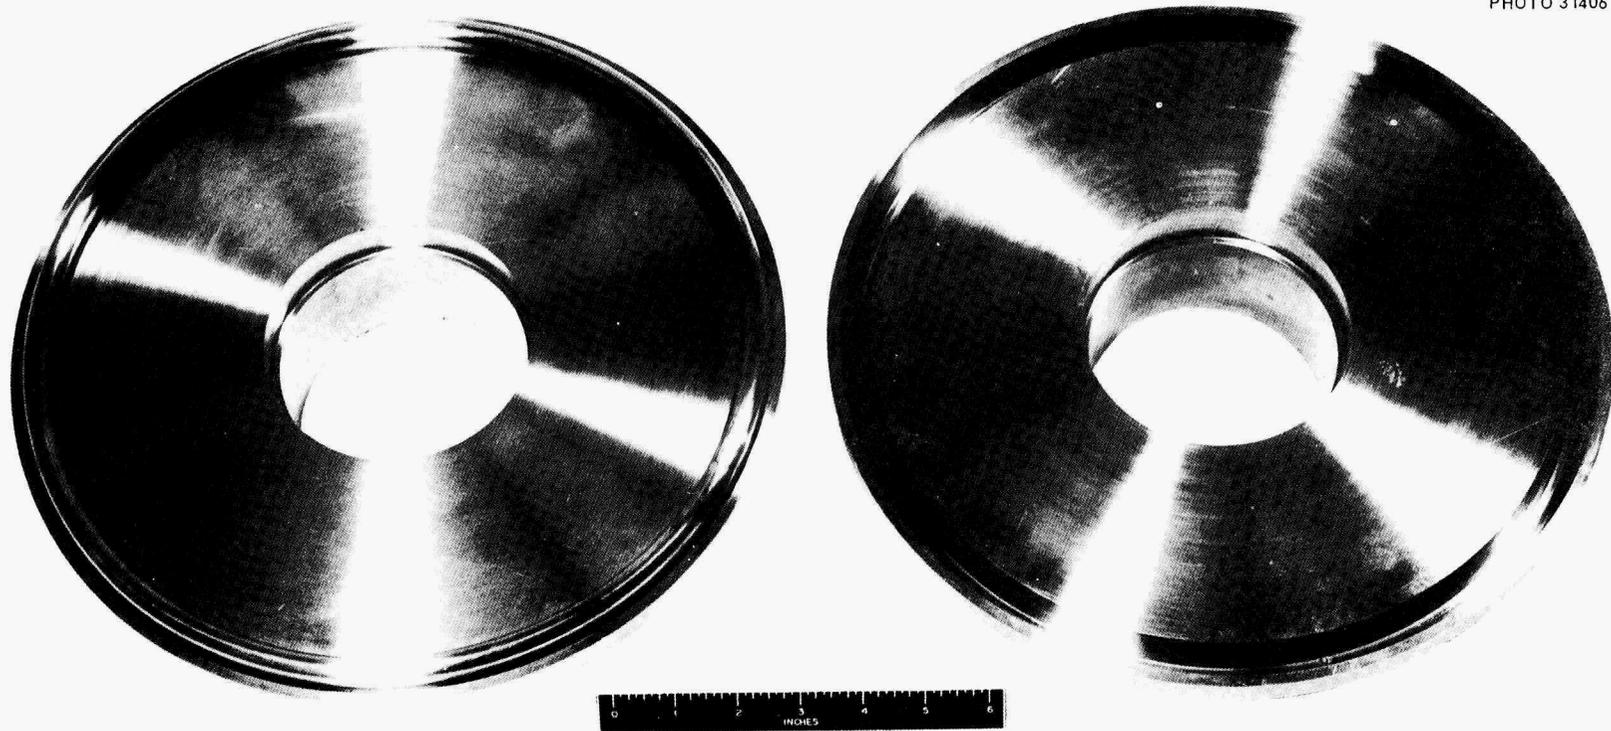
Fig. 33. Large Freeze Flange Shown Open with Copper Seal Ring in Place.

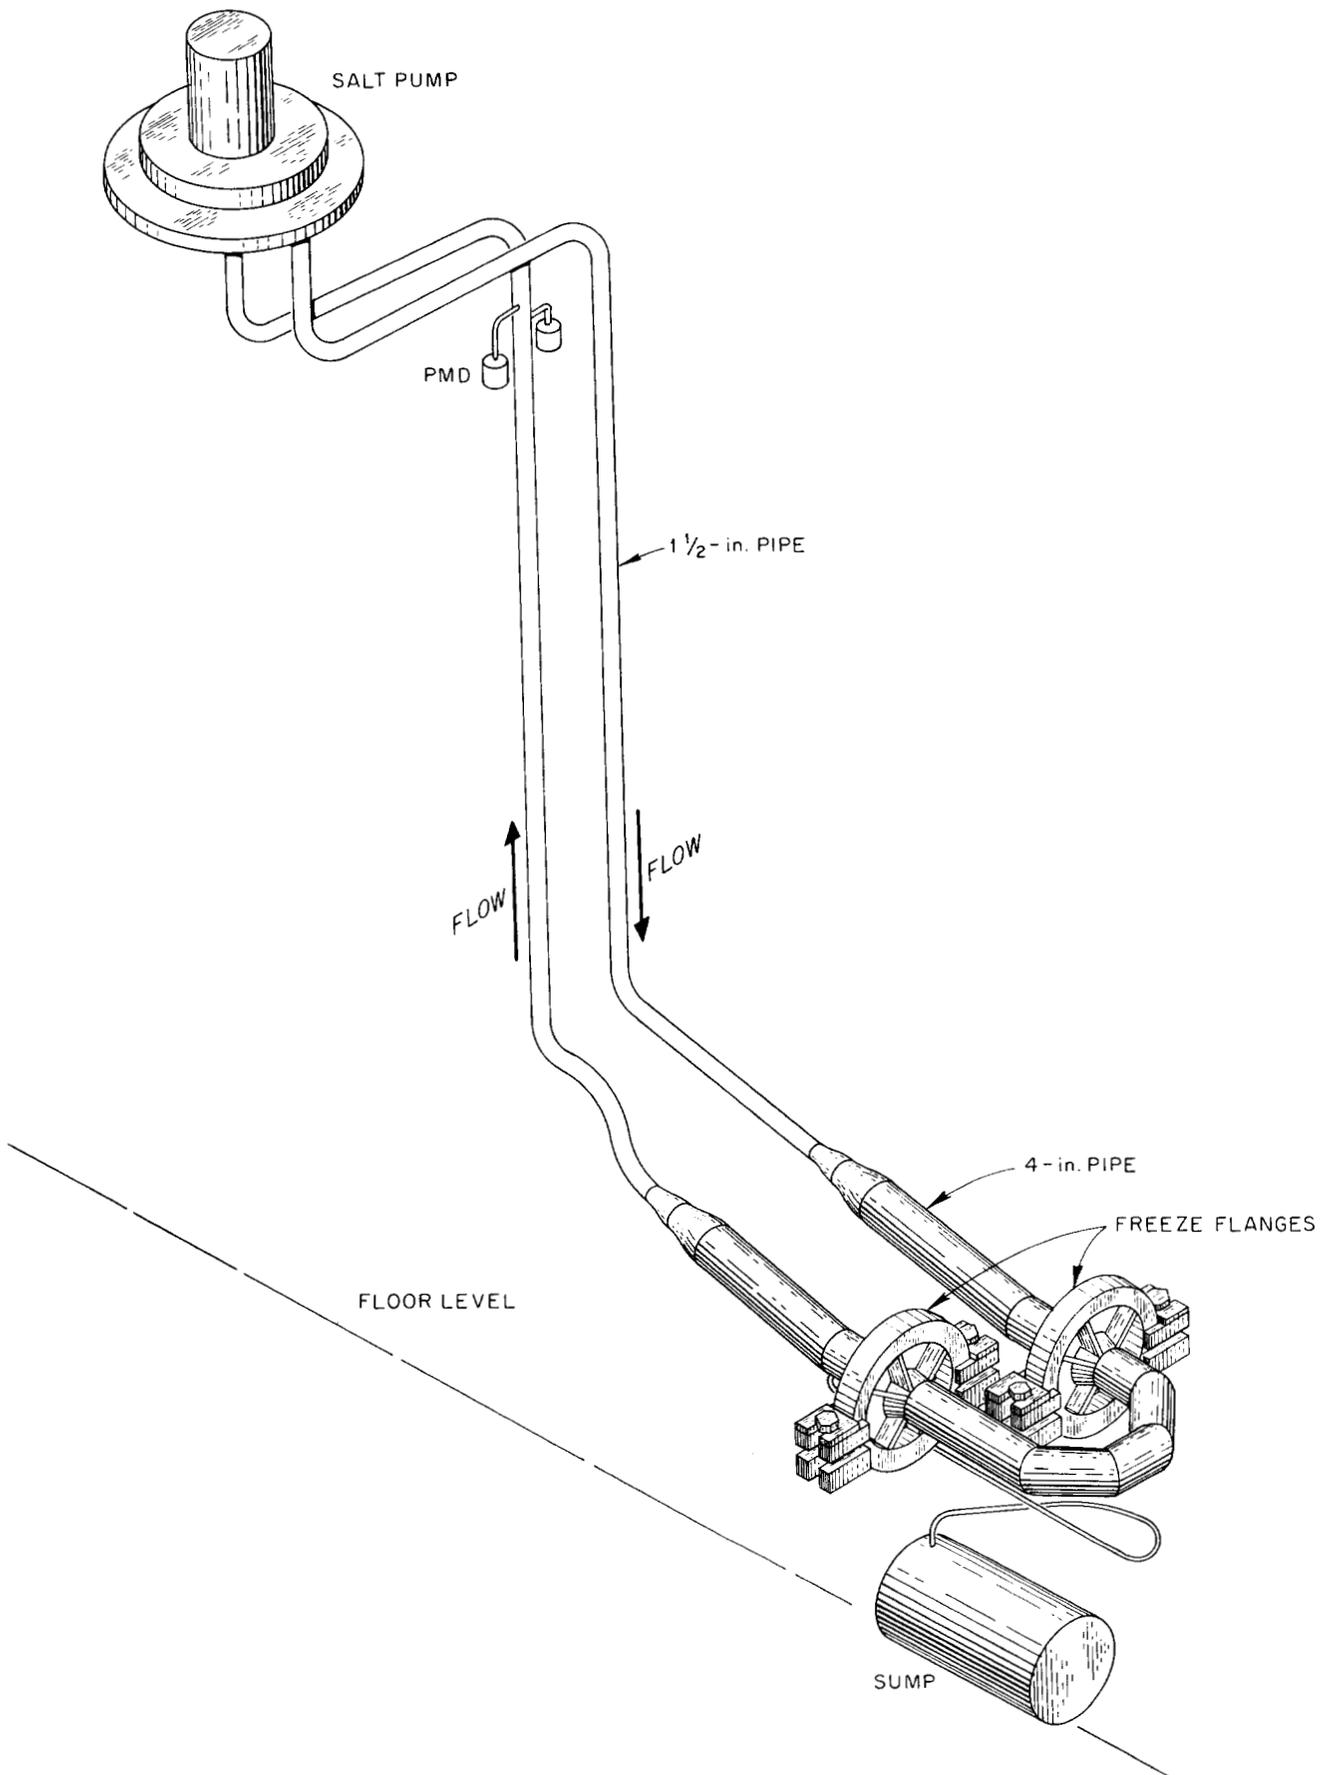
Fig. 34. Schematic Drawing of Test Loop for Large Freeze Flange.

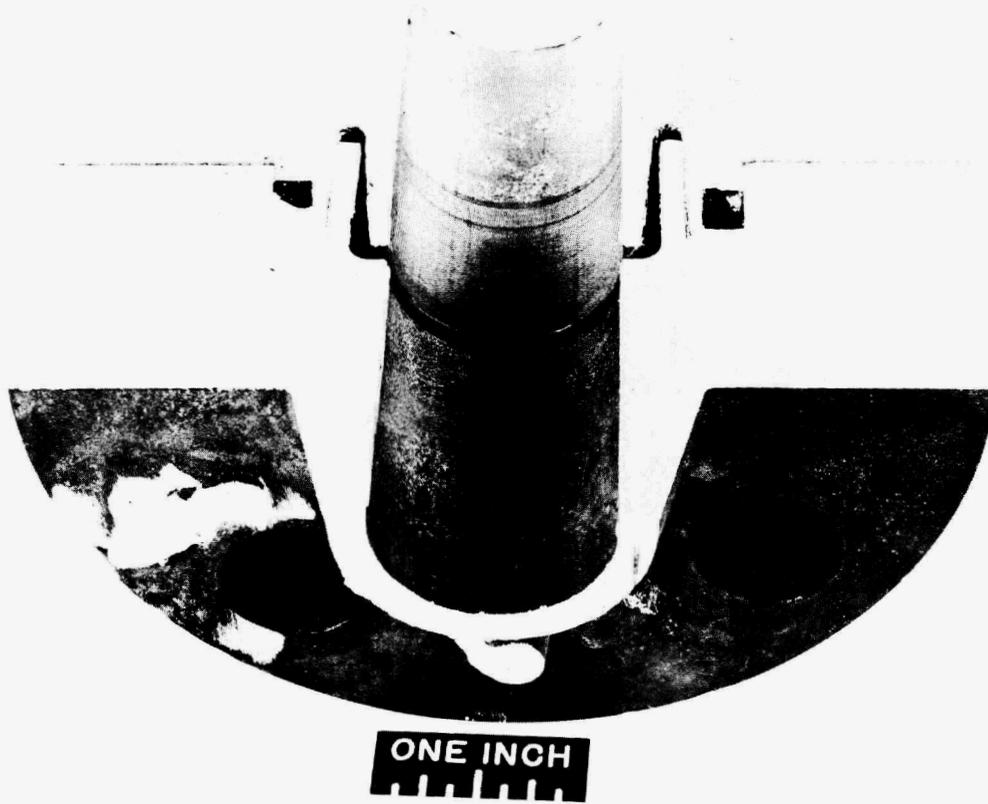
Fig. 35. Cast Seal Flange with Silver Seal, Sectioned.

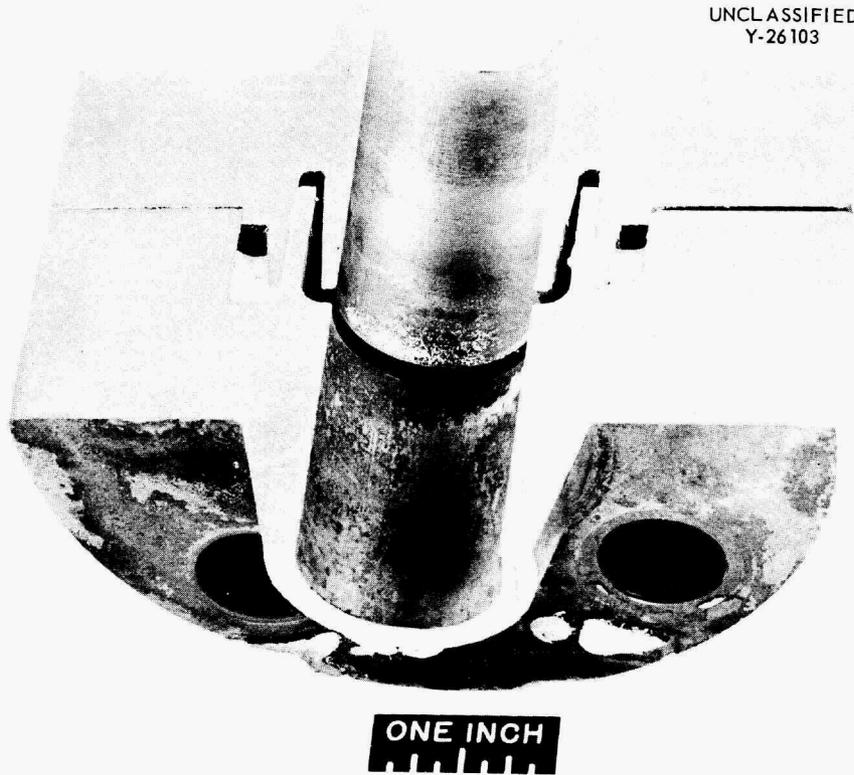
Fig. 36. Cast Seal Flange with Copper-Silver Alloy Seal,
Sectioned.

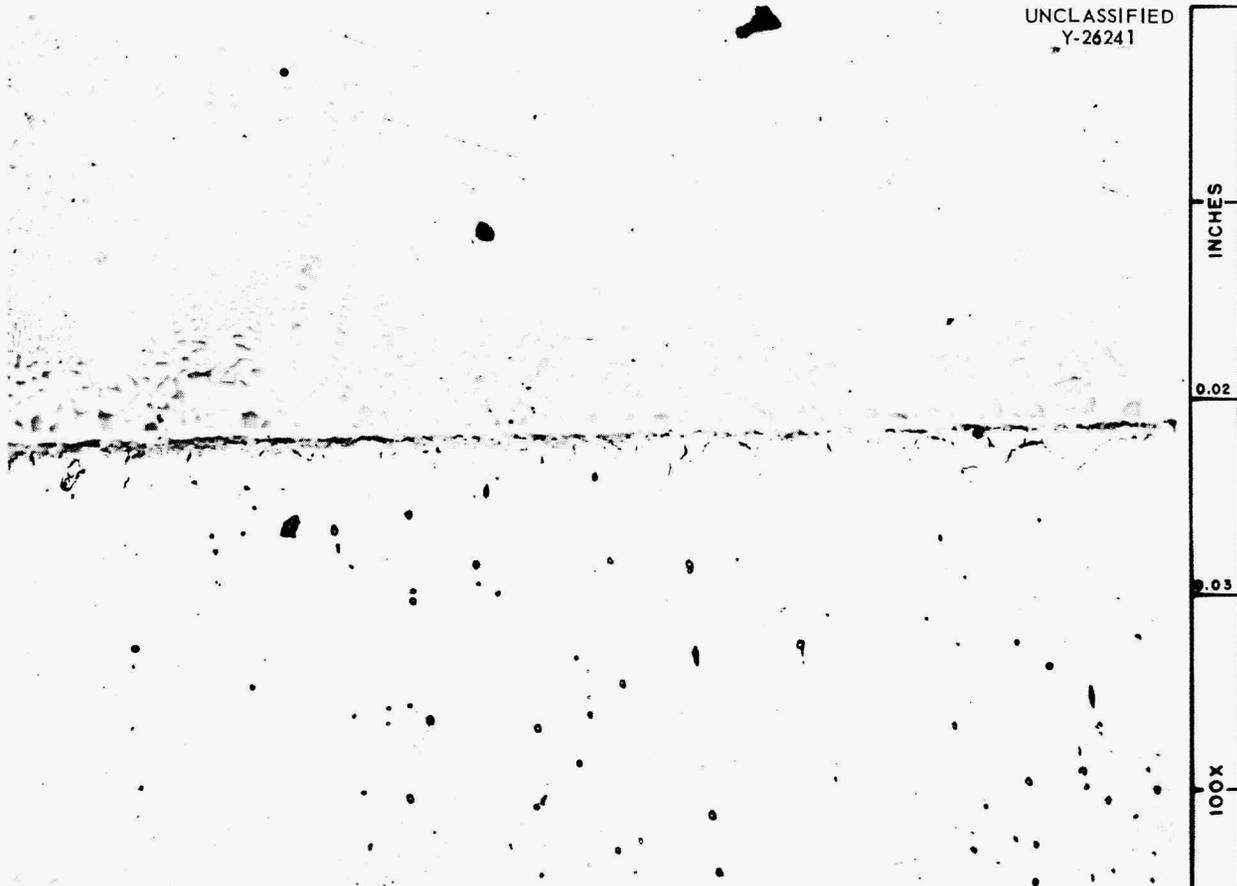
Fig. 37. Cast Seal Flange with Copper-Silver Alloy Seal; Photomicrograph of Interface of Alloy and Inconel Wall.

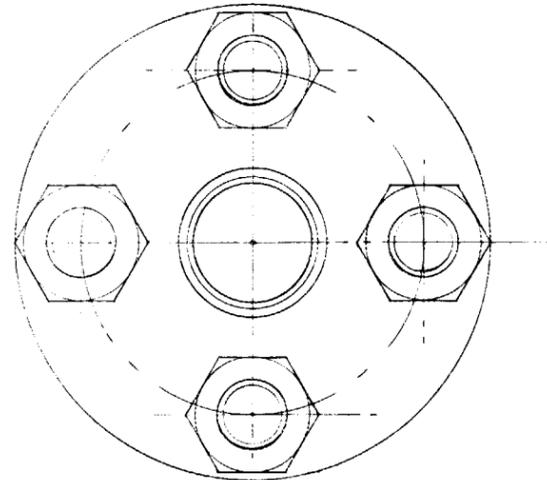
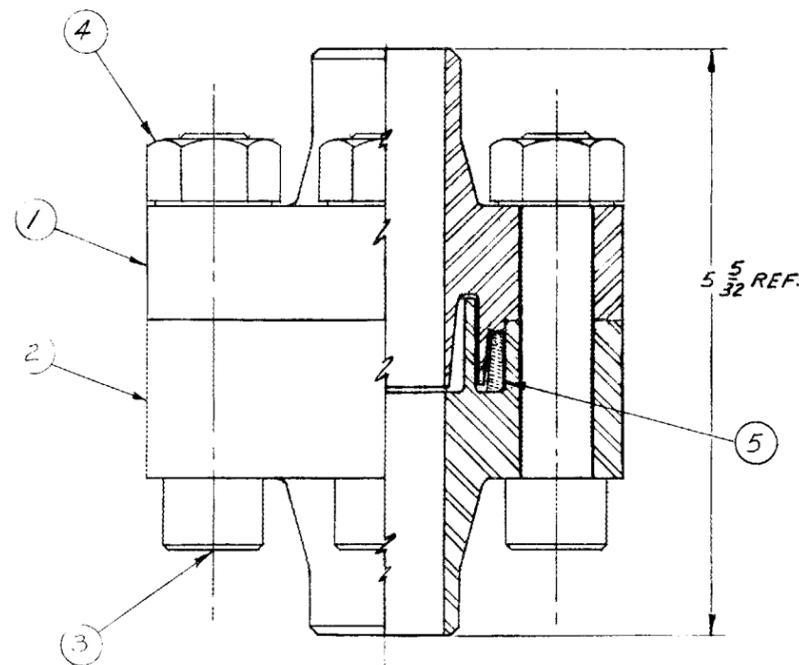
C-2-02-054-6837

SILVER ALLOY RING IS MELTED AFTER JOINT IS ASSEMBLED. JOINT IS SURROUNDED BY ELECTRIC CLAMHELL HEATERS OF QUICK REMOVAL TYPE FOR JOINT REPLACEMENT.
