## PROBLEMS ENCOUNTERED DURING FOUR YEARS OF ORR OPERATION

PROBLEMS ENCOUNTERED DURING FOUR YEARS OF ORR OPERATION

Paper presented at Conference on  
Light-Water-Moderated Research Reactors  
June 11-14, 1962  
Gatlinburg, Tennessee

The over-all design and operation is reviewed in the light of four years of operating experience. Items discussed consist of the reactor components and instrumentation, reactor and pool cooling systems (including system cleanup), the emergency systems for electric power and reactor cooling, the waste-disposal systems (liquid, gaseous, and solid), and the building, itself.

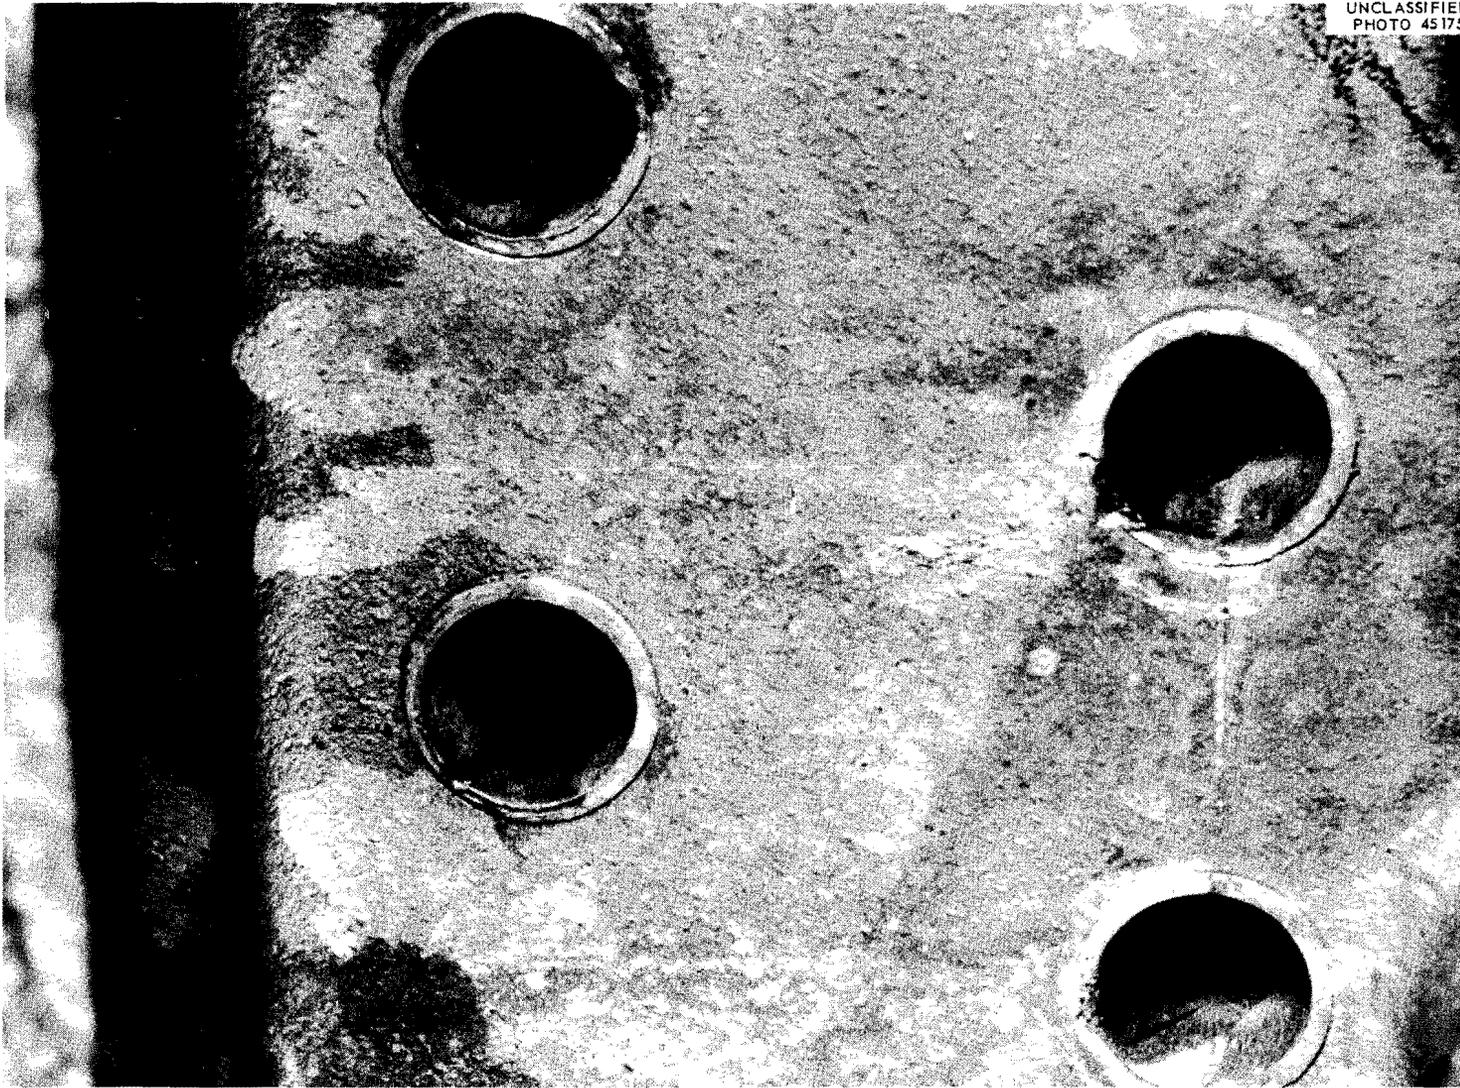
Figure 22. Tube Damage in Heat Exchangers.

Shortly after full power operation (20 Mw) was attained, it became obvious that the air-cooled heat exchangers did not meet performance specifications. In addition, a serious wear problem, illustrated in Figure 22, developed in the heat exchangers due to vibrating turbulators in the tubes. A turbulator is a long, spiraled, metal plate and is used in this application to effect a larger heat-transfer area. An attempt, as illustrated by Figure 23, by the manufacturer to correct the performance deficiency proved unsuccessful; however, the wear problem was minimized by changing the method of securing the turbulators in the tubes. As a result of the cooling deficiency, a reduction in operating power to 16 Mw was required during the summer months, while cool weather permitted 20-Mw operation. The reactor was operated under these conditions until July, 1960.
