ORNL-TM-1179

PROCUREMENT AND QUALITY EVALUATION OF Nb-1% Zr STOCK
FOR BOILING ALKALI METAL CORROSION STUDIES

METALS AND CERAMICS DIVISION

AUGUST 1965

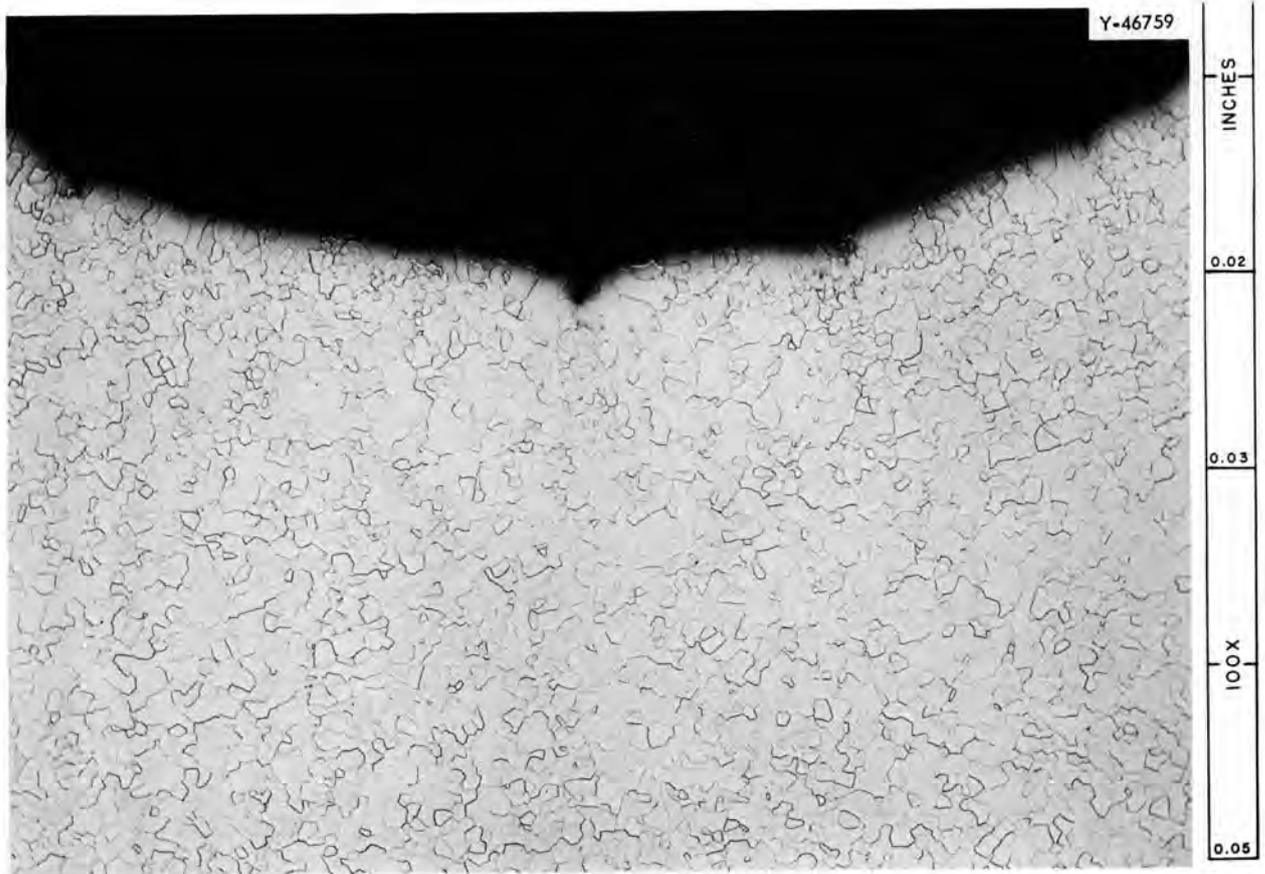
Metallographic examination of a transverse section of this tubing showed the longitudinal striations on the inside diameter to penetrate the wall to a depth of 0.001 to 0.003 in. This measurement was made in an area that was shown not to have defects > 5% of the wall thickness by ultrasonic inspection. Striations of this nature are believed to be the result of scoring upon removal of the mandrel following tube drawing operations. The tubing had a recrystallized grain size of ASTM 6 to 8. The microstructure and inside-diameter defects are shown in Fig. 1.

Fig. 1. Inside Diameter Defects on As-Received 0.250-in. OD \times 0.065-in. Wall Nb-1% Zr Tubing from Vendor A. Transverse section.

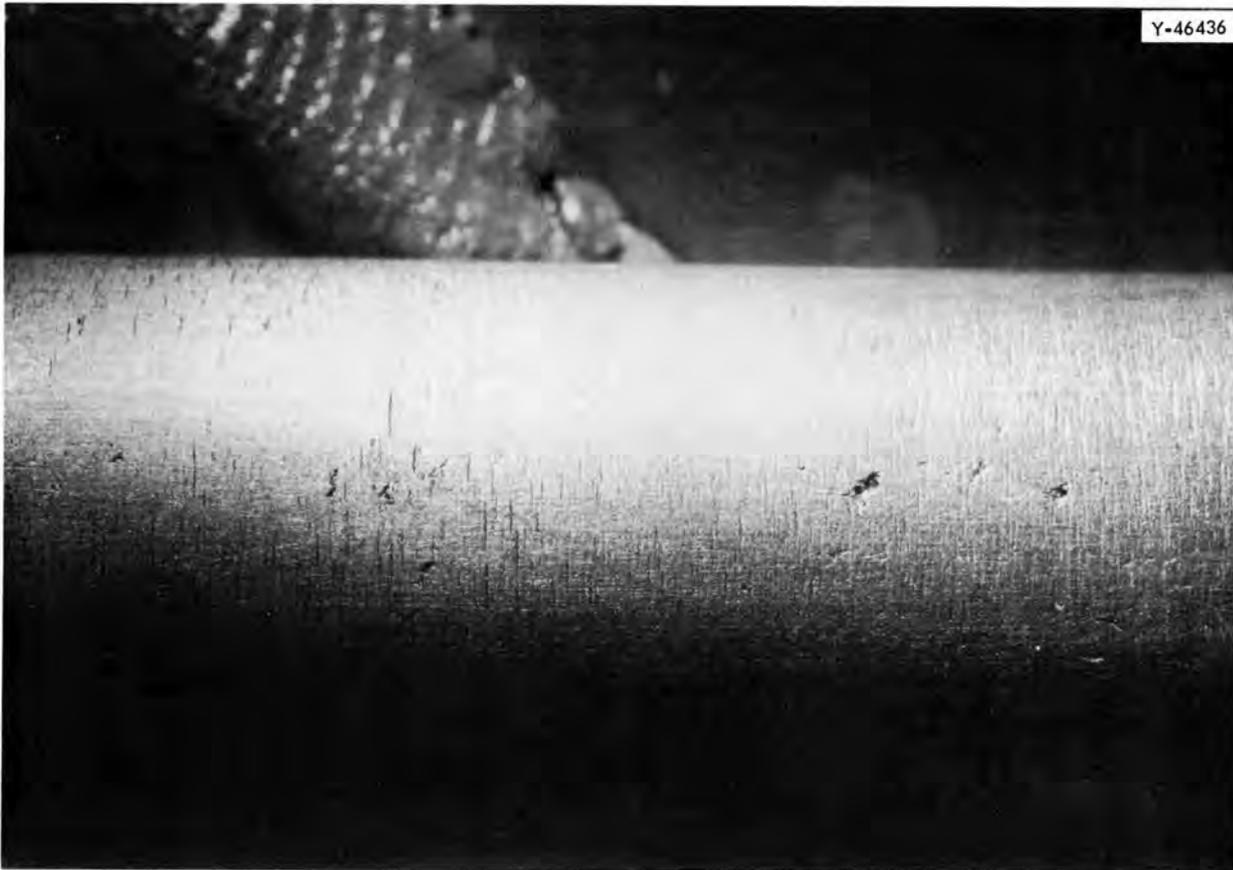
Visual inspection at ORNL disclosed grinding marks, pits, and gouges on the outside diameter. Liquid penetrant inspection by the vendor showed this tubing to be acceptable with no visible defects, while this same inspection at ORNL revealed numerous indications on the outside diameter resulting from the visually observed defects. Radiographic inspection at ORNL on only one piece of tubing disclosed longitudinal striations on the inside diameter; and the response to ultrasonic inspection at ORNL was high background signals.

The grinding marks, pits, and gouges observed visually on the outer diameter of this tubing are shown in Fig. 2. The most severe gouges observed were estimated to be $> 10\%$ of the wall in depth. The transverse

Fig. 2. Outside Diameter Defects on As-Received 0.375-in. OD \times 0.065-in. Wall Nb-1% Zr Tubing from Vendor A. Tubing returned to vendor for replacement. Approximately 9 \times .

grinding and polishing marks on the outside diameter could not be detected in a longitudinal metallographic sample; hence, their depth was considered to be no more than 0.002 in., which is approximately equivalent to the depth obscured through the rounding of the metallographic sample edge during preparation. Inside diameter cracks and folds measuring up to 0.007 in., as shown in Fig. 3, were present in a transverse section through an area with longitudinal inside-diameter striations. These flaws opened up (or were already present) to a maximum depth of 0.013 in. when a half section of the tubing was bent flat. The recrystallized grain size of this tubing was ASTM 4 to 7.

Surface conditioning experiments were performed at ORNL. It appeared that most of the outside diameter flaws could be removed, as it was possible to centerless grind a specimen from 0.379-in. OD to 0.366-in. OD

Because of the poor quality of this lot of tubing, approximately 75 ft of the tubing was returned to the vendor for replacement.

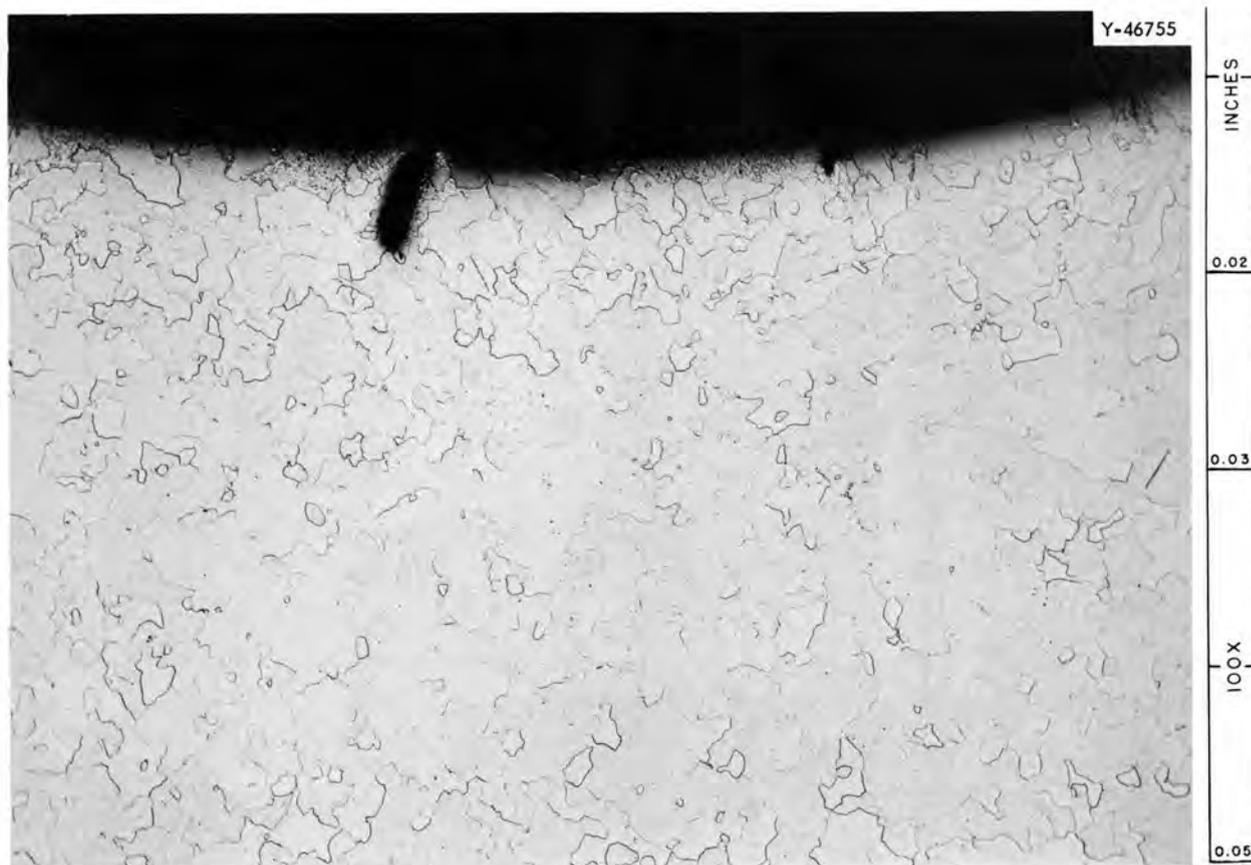
Fig. 3. Inside-Diameter Defects on As-Received 0.375-in. OD \times 0.065-in. 0.065-in. Wall Nb-1% Zr Tubing from Vendor A. Tubing returned to vendor for replacement. Transverse section.

with a 200-grit wheel and obtain a smooth-appearing surface. Also, an attempt was made to acid etch the inside diameter with a solution of 70 parts HNO_3 and 30 parts HF for the purpose of surface improvement. However, after removing 0.009 in. from the wall on the inner-diameter side, images of the striations were still visible.

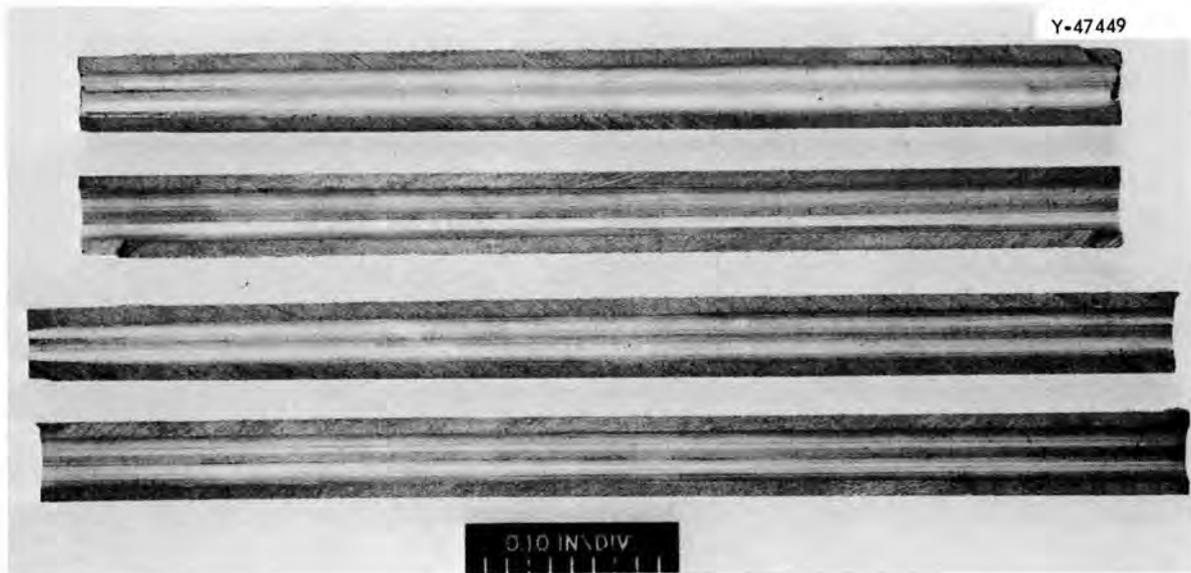
On visual inspection at ORNL, shallow-appearing striations on the inside diameter were noted. Liquid penetrant inspection by the vendor revealed no visible defects. Ultrasonic inspection was performed by the vendor, and on four of the eight pieces of tubing indications greater than those from a 0.004-in.-deep notch were detected, affecting a total length of 82 in. The second ultrasonic inspection at ORNL disclosed no indications $> 5\%$ of the wall thickness in any of the tubing of this lot, but defects < 0.003 in. deep, associated with the inside diameter, were detected. The areas marked as defective by the vendor had the highest defect level. The vendor reported inside-diameter defects as deep as 0.005 in. after metallographic examination of a specimen taken from a defective area in the tubing. Two specimens were submitted to ORNL by the vendor. These were sectioned longitudinally and showed longitudinal striations on the inside diameter. This condition was typical for this lot of tubing and is illustrated in Fig. 4. Metallographic examination revealed inside-diameter "scallop" generally 0.0005 to 0.001 in. deep and occasionally 0.002 in. deep. These defects are shown in Fig. 5.

Fig. 4. Inside-Diameter Striations on As-Received 0.375-in.-OD \times 0.065-in.-Wall Nb-1% Zr Tubing from Vendor C. Approximately 1X.

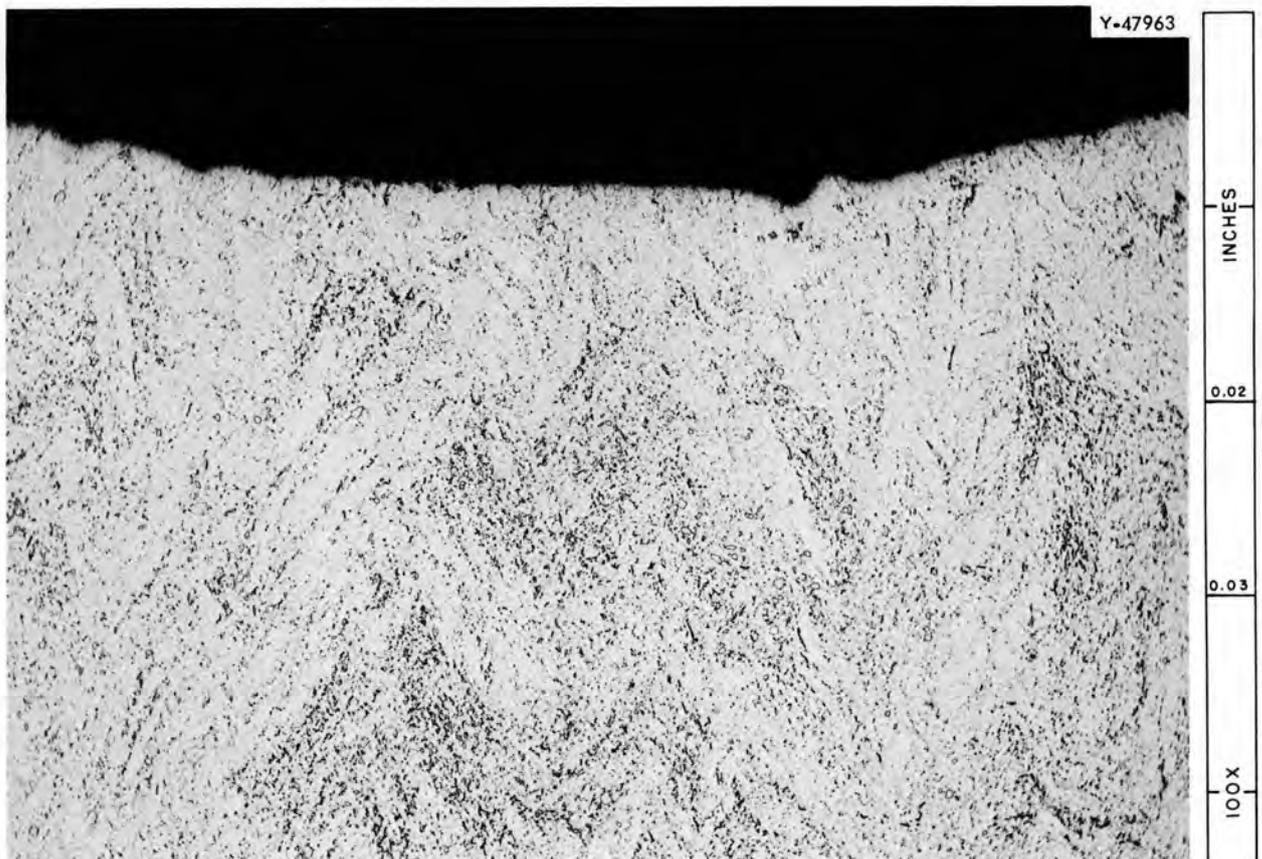
Fig. 5. Inside-Diameter "Scallops" on As-Received 0.375-in.-OD \times 0.065-in.-Wall Nb-1% Zr Tubing from Vendor C. Transverse section.

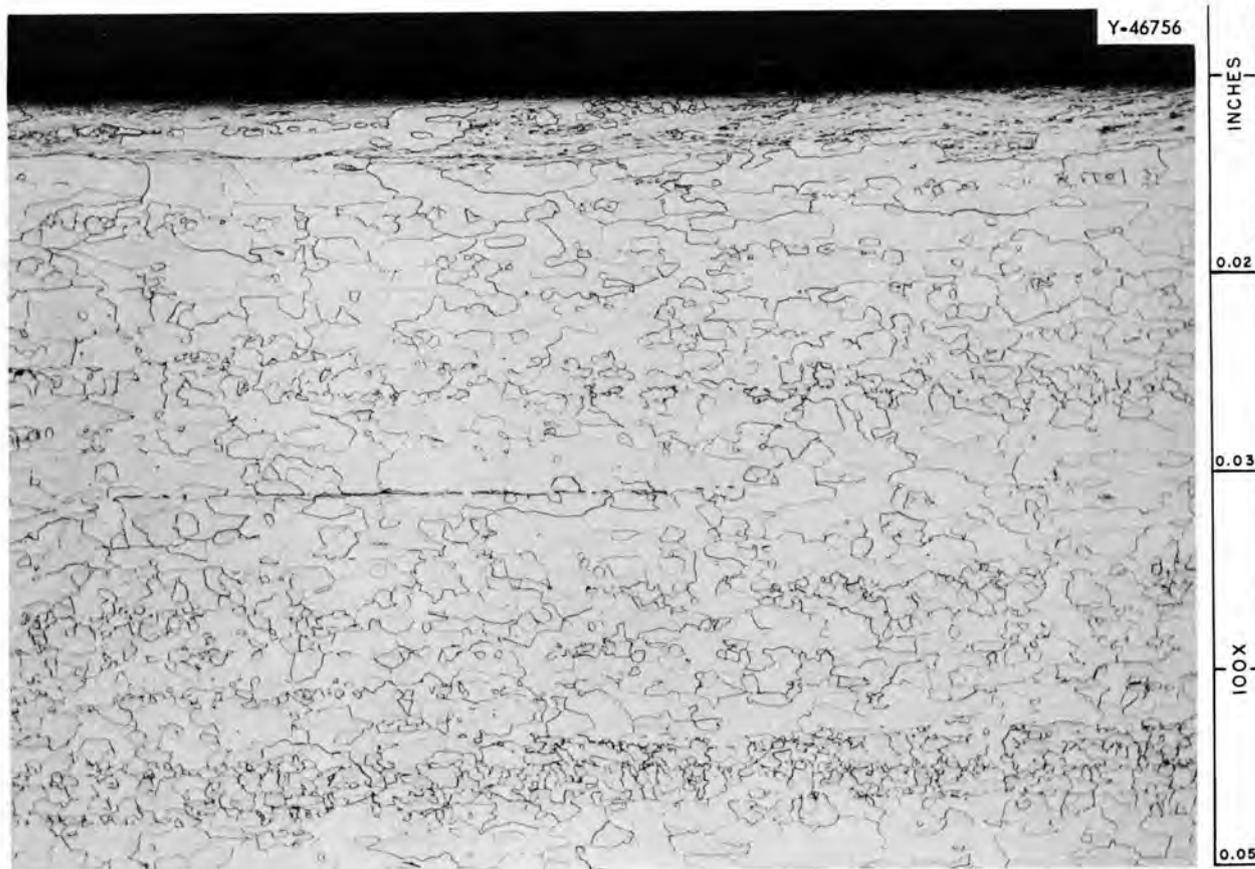
On visual inspection at ORNL, several shallow-appearing flaws on the outside diameter were noted. A spiral marking was observed along the tube length on the inside diameter, probably as a result of a roll-off operation to remove the drawing mandrel or of a tube-straightening operation. Liquid penetrant inspection by the vendor and ORNL showed no visible defects. When the tube was radiographically examined at ORNL, closely spaced transverse markings were apparent on the film, possibly related to polishing marks on the outside diameter. Several questionable areas were also noted. Ultrasonic inspection at ORNL disclosed no indications of discontinuities as great as 5% of the wall thickness. Metallographic examination showed the recrystallized grain size to be ASTM 5 to 8. The microstructure of a sample taken from the end of the tube is shown in Fig. 6. There were on the inside diameter discontinuous areas approximately 0.003-in. deep that did not appear to be completely recrystallized.

Fig. 6. Microstructure of As-Received 1.0-in.-OD \times 0.065-in.-Wall Nb-1% Zr Tubing from Vendor A. Longitudinal section. 100X.
