EXAMINATION OF IRRADIATED URANIUM NITRIDE FUEL CLAD WITH TUNGSTEN-RHENIUM OR T-III ALLOY

METALS AND CERAMICS DIVISION

EXAMINATION OF IRRADIATED URANIUM NITRIDE FUEL
CLAD WITH TUNGSTEN-RHENIUM OR T-111 ALLOY

OCTOBER 1972

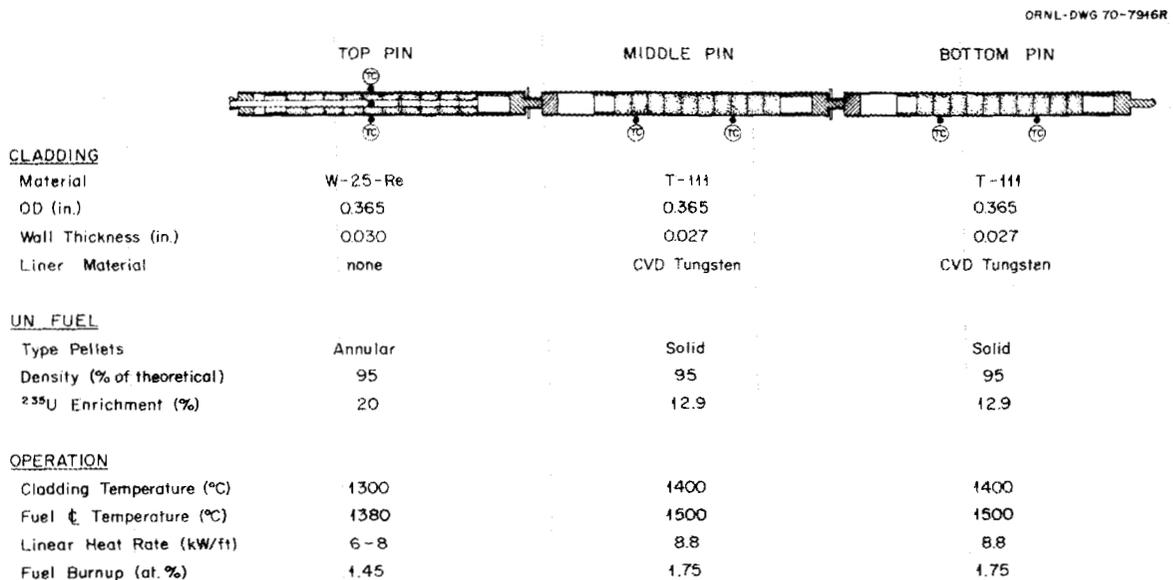
Capsule UN-3 contained three collinear fuel pins as shown in Fig. 1. Each pin was 4.5 in. long and contained ten 0.3-in.-OD UN pellets. The fuel column length was 3 in. in the top fuel pin and 2.6 in. in both the middle and bottom fuel pins. The fuel pellets in the top pin were hollow (0.105-in.-diam hole) to accommodate a thermowell, whereas the pellets in the lower two pins were solid. The two lower pins had 12.9%-enriched ^{235}U , but the fuel in the top pin had 20%-enriched ^{235}U , to partially compensate for the lower neutron flux at the top pin position. A 0.005-in. helium-filled diametral gap existed between the fuel pellets and the cladding when fabricated. A 0.003-in.-thick layer of tungsten was vapor-deposited on the inner surface of the T-111 cladding to separate the UN fuel from the T-111, since these materials are considered not to be compatible at the test conditions.

Fig. 1. Design of Fuel Pins of Capsule UN-3.

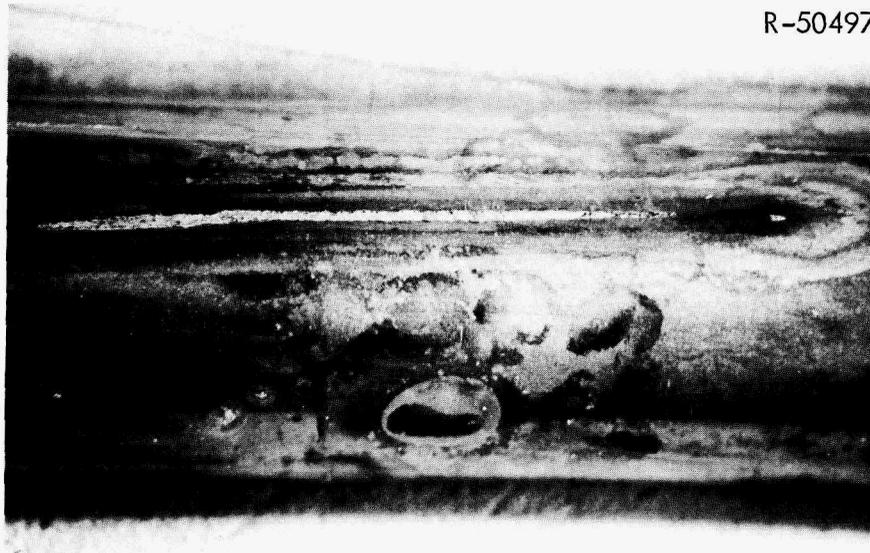
of the bottom fuel pin, and one thermocouple sheath, which terminated at midlength of the top fuel pin, had self-welded to the fuel pin for a distance of about 1.5 in., as shown in Fig. 2. This couple had been pulled loose before removal of the fuel pins from the niobium-zirconium sleeve. When removed from the capsule 30 days after irradiation, the NaK coolant gave a reading of about 10 R/hr, thus confirming earlier indications of a failed fuel pin within the capsule.

Fig. 2. Location of Self-Welding of Thermocouple to Top Fuel Pin Cladding, Capsule UN-3. 5.5x.

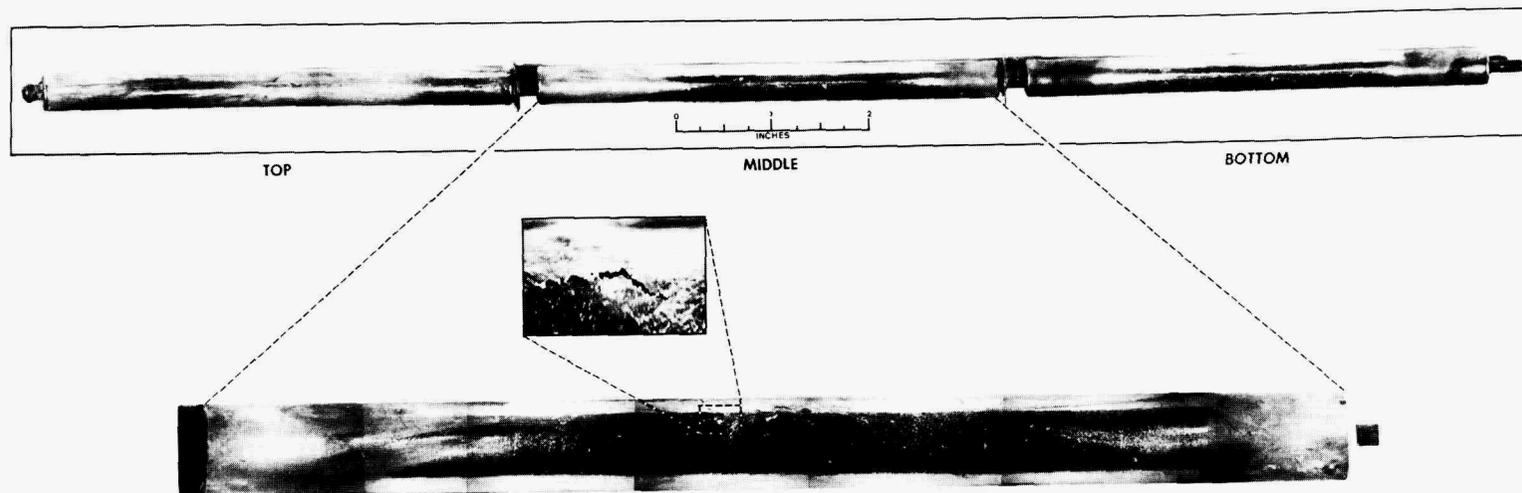
R-52887

Visual examination of the fuel pins revealed several short cracks in the cladding of the middle pin. Generally, these cracks were parallel to the long axis of the pin. Figure 3 shows the three fuel pins with an enlarged view of the middle pin. Figure 4 gives dimensional details regarding crack locations. Locations of the cracks are related to the thermocouple straps in Fig. 5.

Fig. 3. Overall View of the Three Fuel Pins in Capsule UN-3, with an Enlarged View of the Middle Pin and its Major Crack.

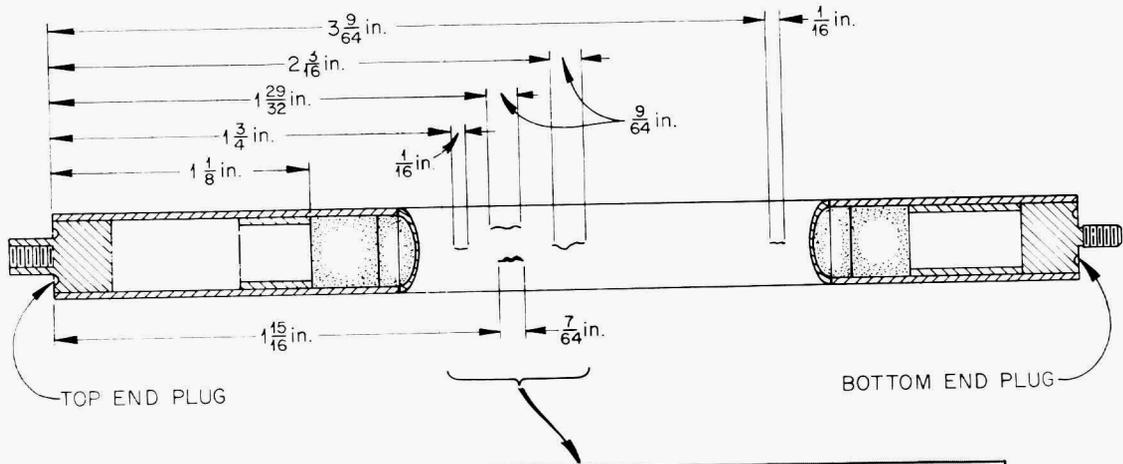
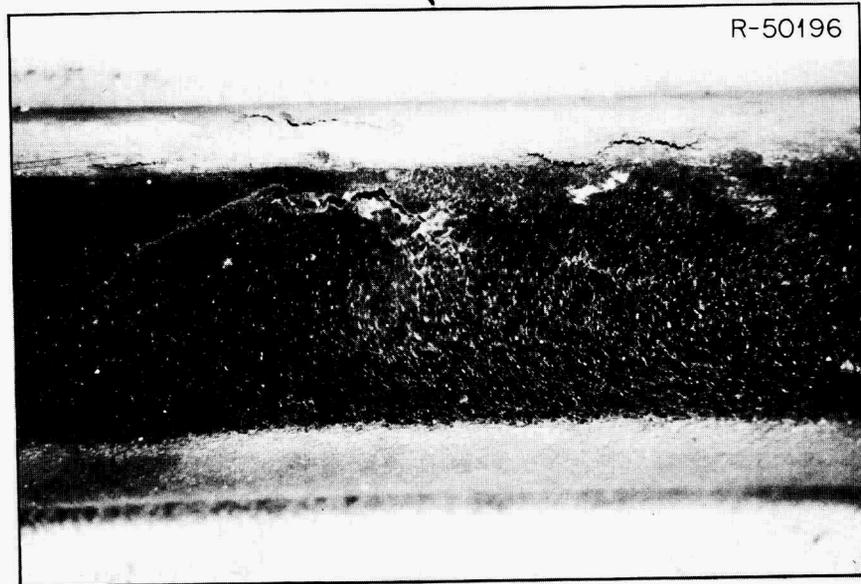
ORNL-DWG 70-519

Fig. 4. Location of Cracks in Cladding of Middle Fuel Pin of Capsule UN-3.

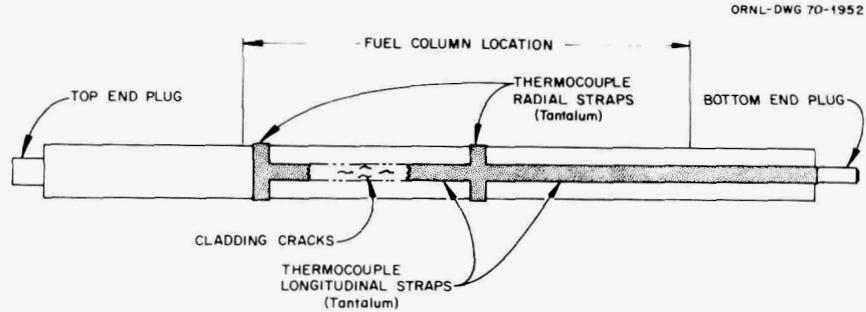
Fig. 5. Location of Cladding Cracks Relative to Thermocouple Straps on Middle Fuel Pin of Capsule UN-3.

Large variations in grain size of the cladding indicate that localized hot spots developed during irradiation. Grain size in the failed region was 6 times that in the gas plenum region, and the failure was located under a thermocouple strap where a gas bubble could form and cause a localized hot spot. We believe this condition determined the

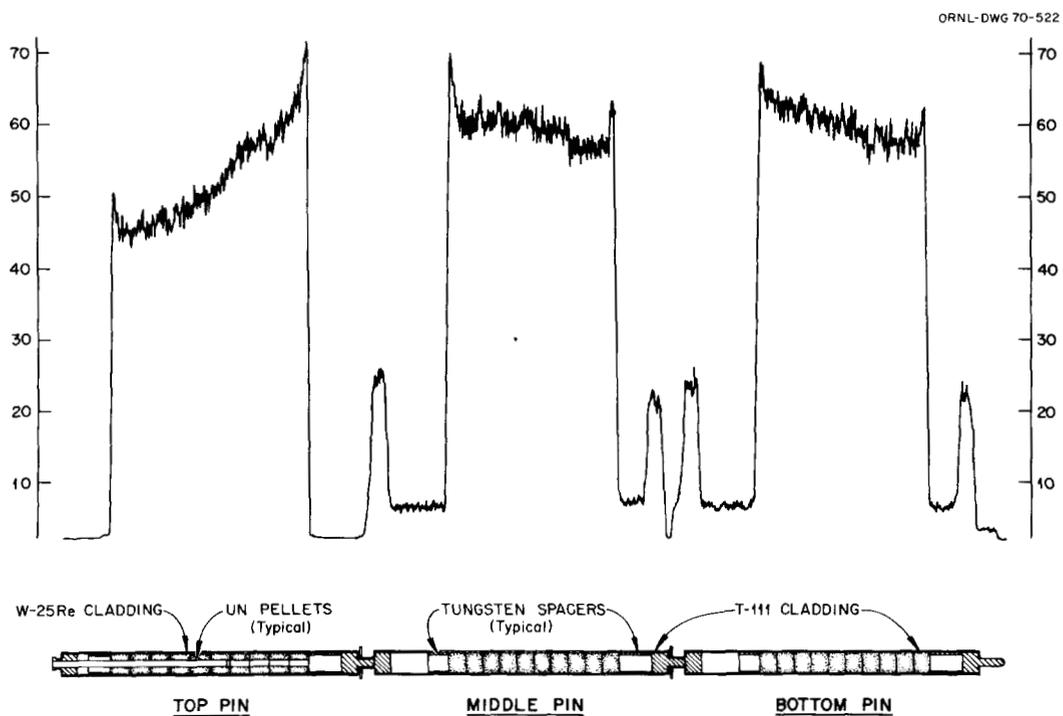
Typical gamma scans along the fuel pins, Fig. 7, showed no unusual characteristics. The top fuel pin scan showed no activity other than from the fueled portion because the tungsten-rhenium cladding and end plugs do not have activation products with sufficient half-lives to be found beyond a short time after removal from the reactor. Activated components of the T-111 cladding and end plugs were clearly defined for the middle and bottom pins. These scans were taken in the energy range 0.75 to 0.85 MeV, which is sensitive particularly to $^{95}\text{Zr-Nb}$. Multi-energy scans were taken in both fueled and unfueled regions of the fuel pins and yielded normal findings.

Fig. 7. Gamma Scan Activity of Fuel Pins in Capsule UN-3 (0.75 to 0.85 MeV).

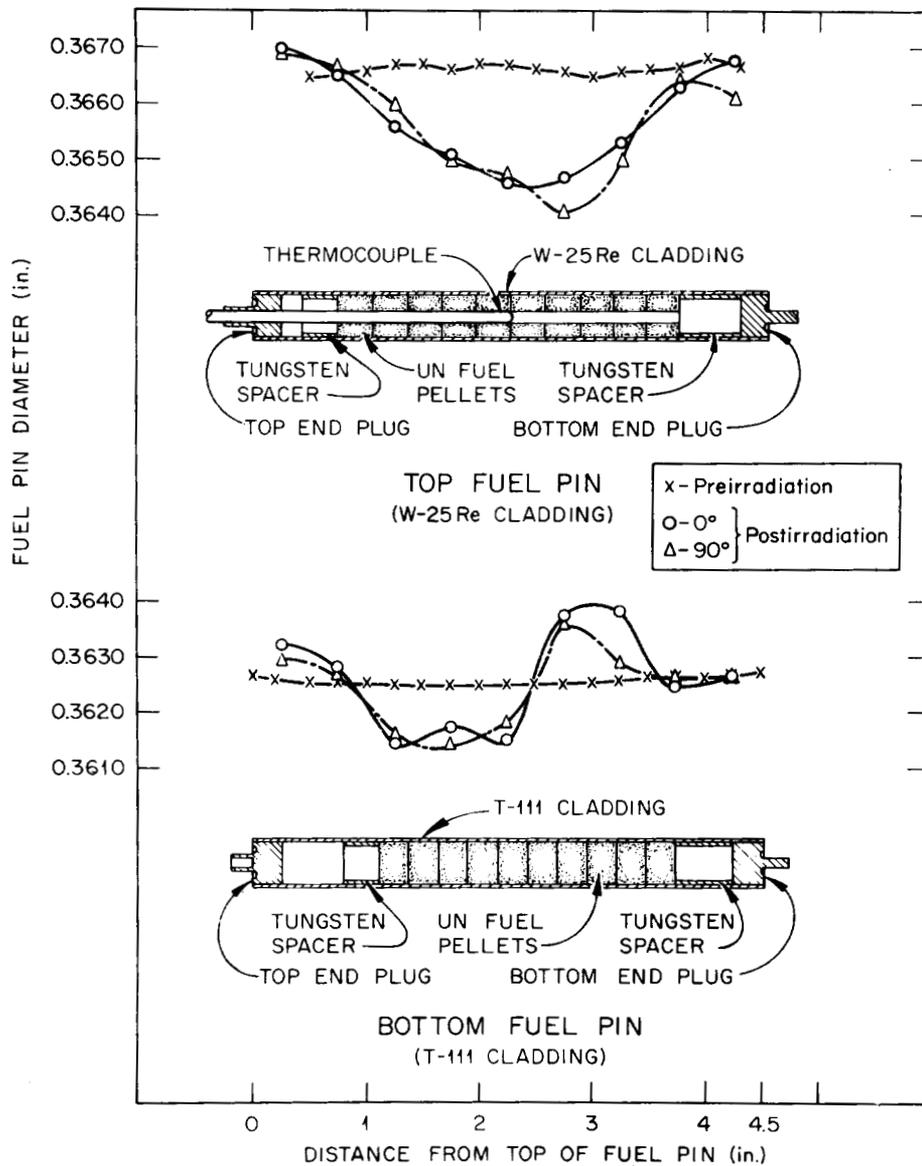
ORNL-DWG 70-258

Measurements of the pin diameters with an opposed-dial-gage profilometer are shown in Figs. 8 and 9 and in Table 1. The agreement between

post- and preirradiation measurements in the regions of the end plugs indicates the absence of significant discrepancies between pre- and post-test measurement techniques. Each of the fuel pins had some reduction in diameter during irradiation. This was most pronounced in the top fuel pin, which had a maximum decrease in diameter of 0.003 in. just below

Fig. 8. Comparison of Diameters of Top and Bottom Fuel Pins of Capsule UN-3 Before and After Irradiation.

the end of the central thermocouple well. The bottom fuel pin had a diameter decrease of about 0.001 in. near the top of the fuel column but an increase of about 0.0015 in. near the bottom of the fuel column. Diameter measurements at 0 and 90° orientations indicated an ovality of less than 0.001 in. in the irradiated pins. In measuring the diameters on the middle (failed) pin, a 0° orientation was selected to obtain the maximum diameter at the largest crack. Therefore, the differences between readings at 0 and 90° orientations do not necessarily indicate ovality, but more likely indicate protrusion of the cladding in the failed region.

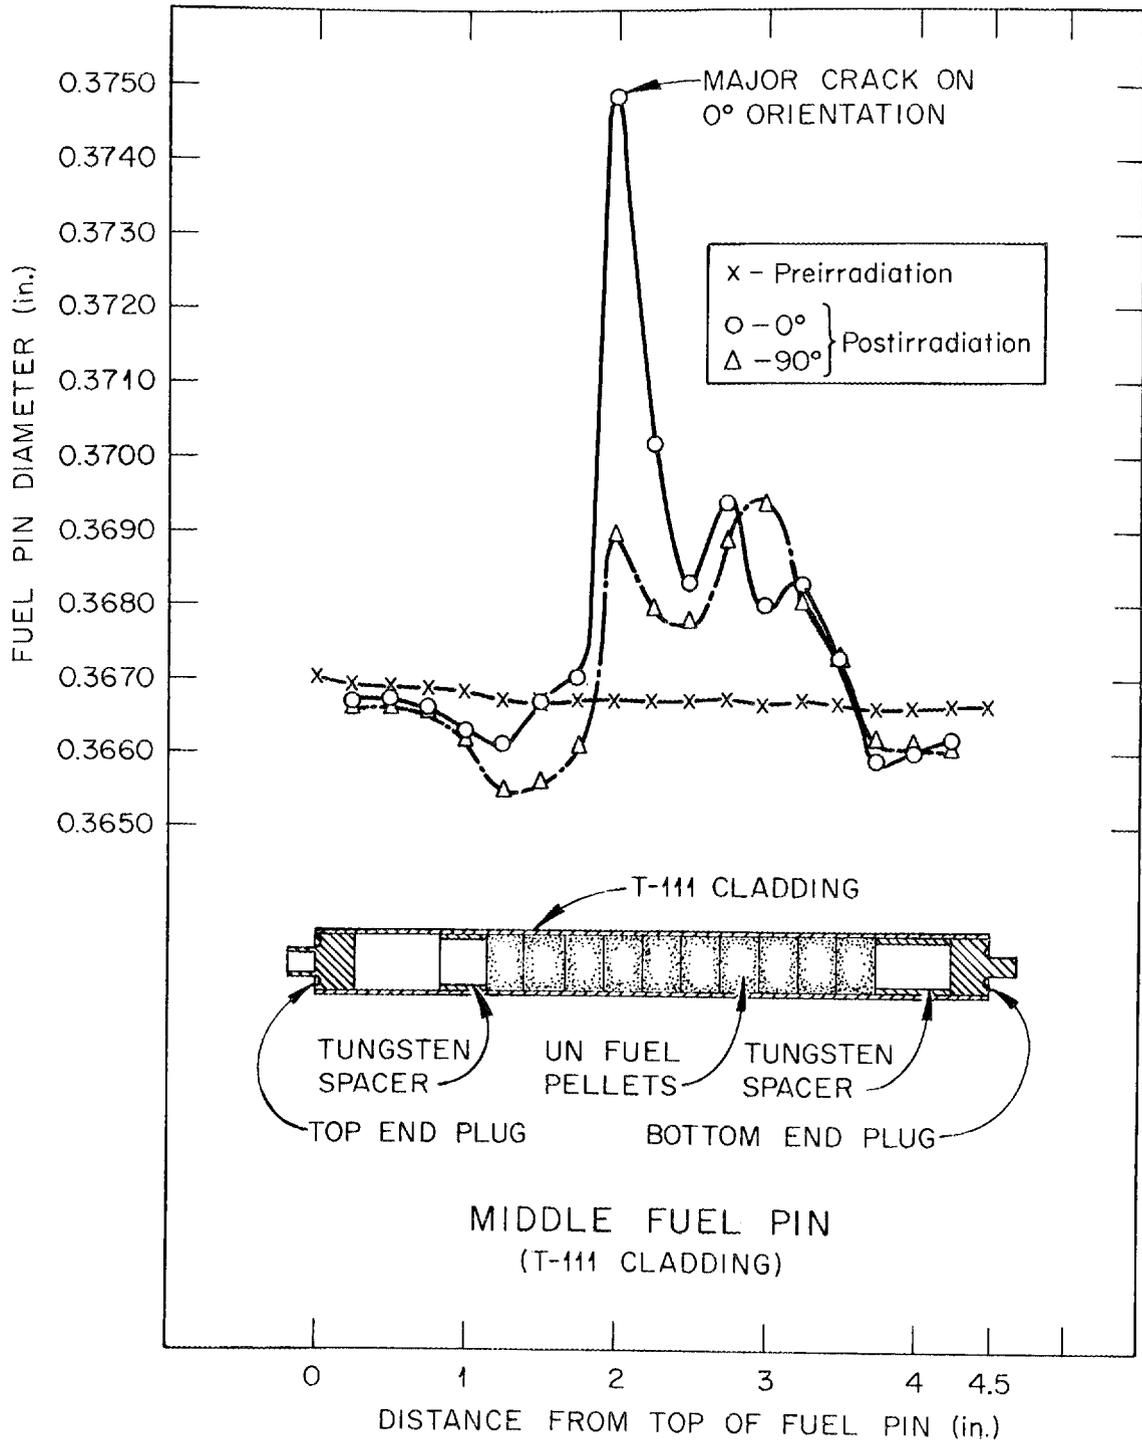
Fig. 9. Comparison of Diameters of Middle Fuel Pin of Capsule UN-3 Before and After Irradiation.

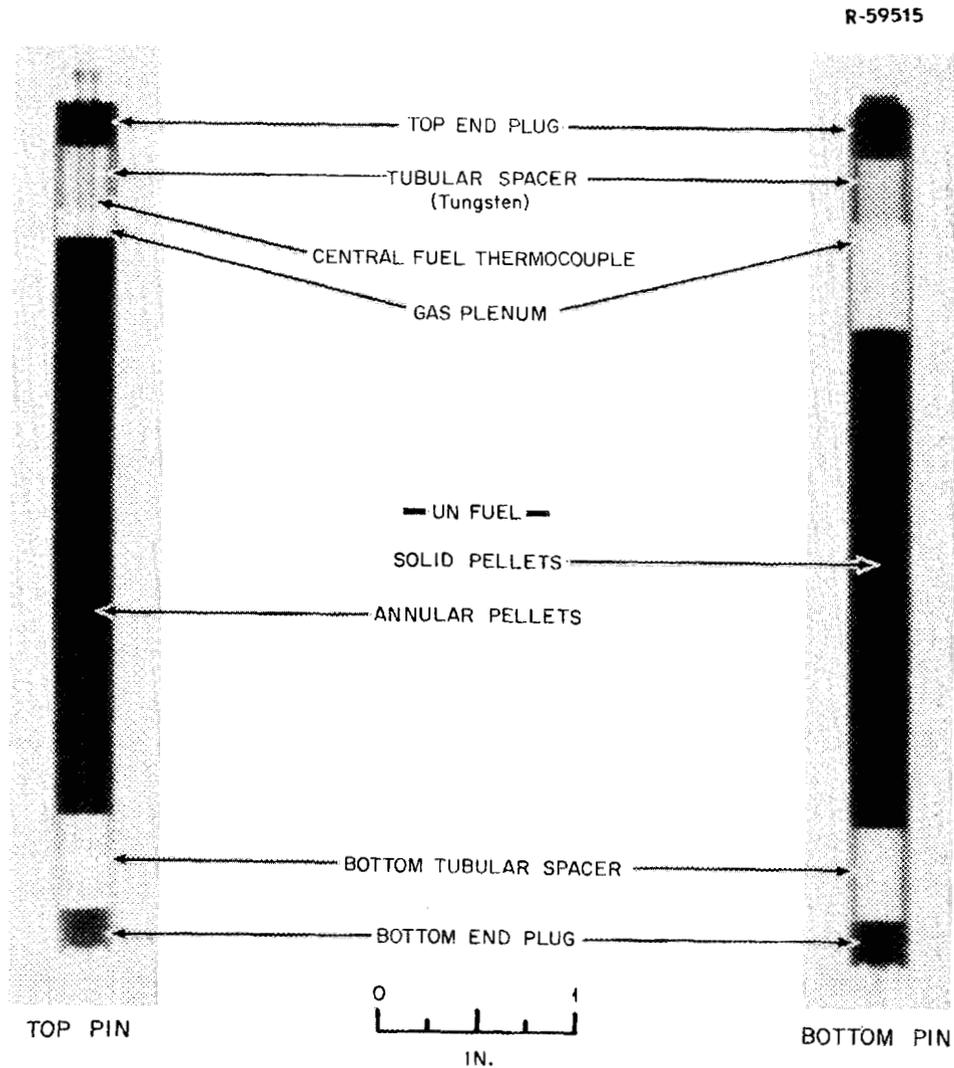
Neutron radiographs of the top and bottom fuel pins obtained from exposures in the ORR facility are shown in Fig. 10. Details of the fuel pin components are evident to various degrees. The thermowell (top pin) and tungsten spacers at each end of the fuel columns are delineated, and pellet interfaces are discernible in the fueled region of the top pin but not in the bottom pin.

Fig. 10. Neutron Radiograph of Two Fuel Pins of Capsule UN-3.

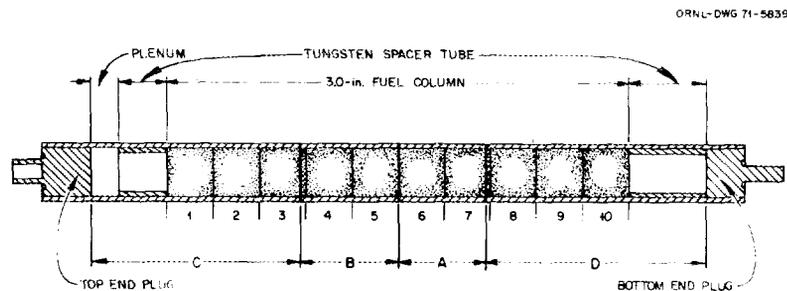
This pin was sectioned as shown in Fig. 11. A longitudinal metallographic specimen was prepared from section A which included parts of pellets 6 and 7 as well as the end of the central thermocouple. Metallographic examination disclosed no deleterious effects from the presence of the central thermowell; an occasional globule of metal about 10 μm in diameter was noted along the inner surface of the annular pellet that

Fig. 11. Sectioning Diagram of Top Fuel Pin from Capsule UN-3.

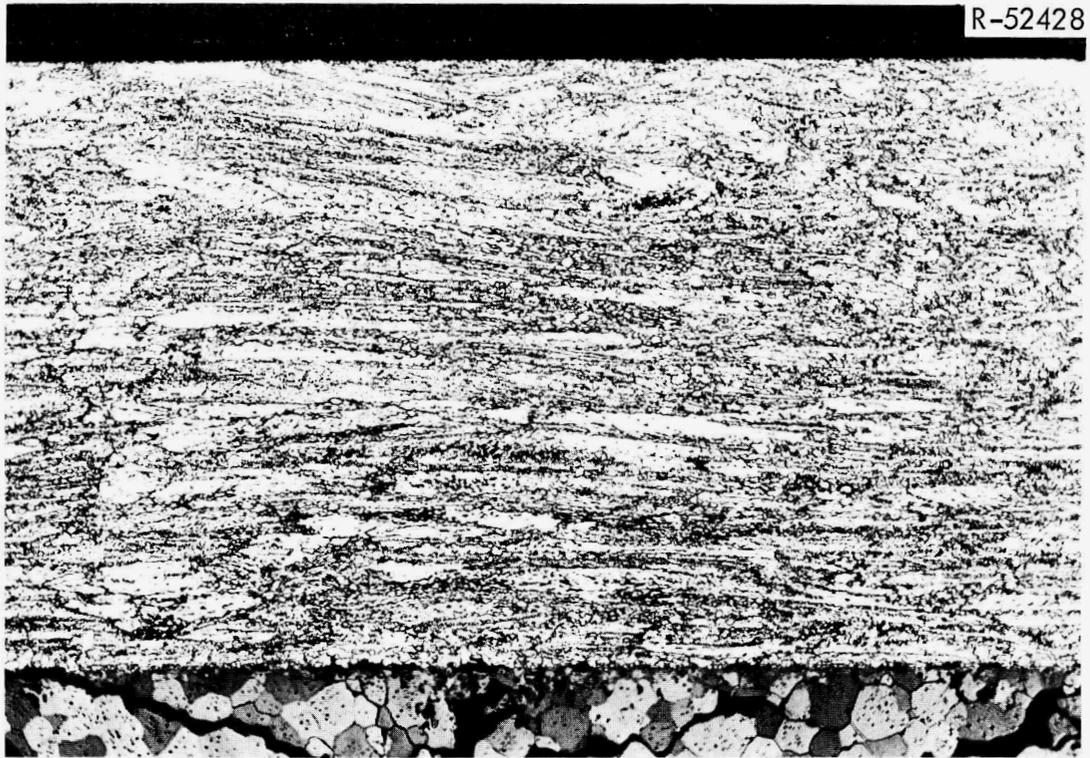
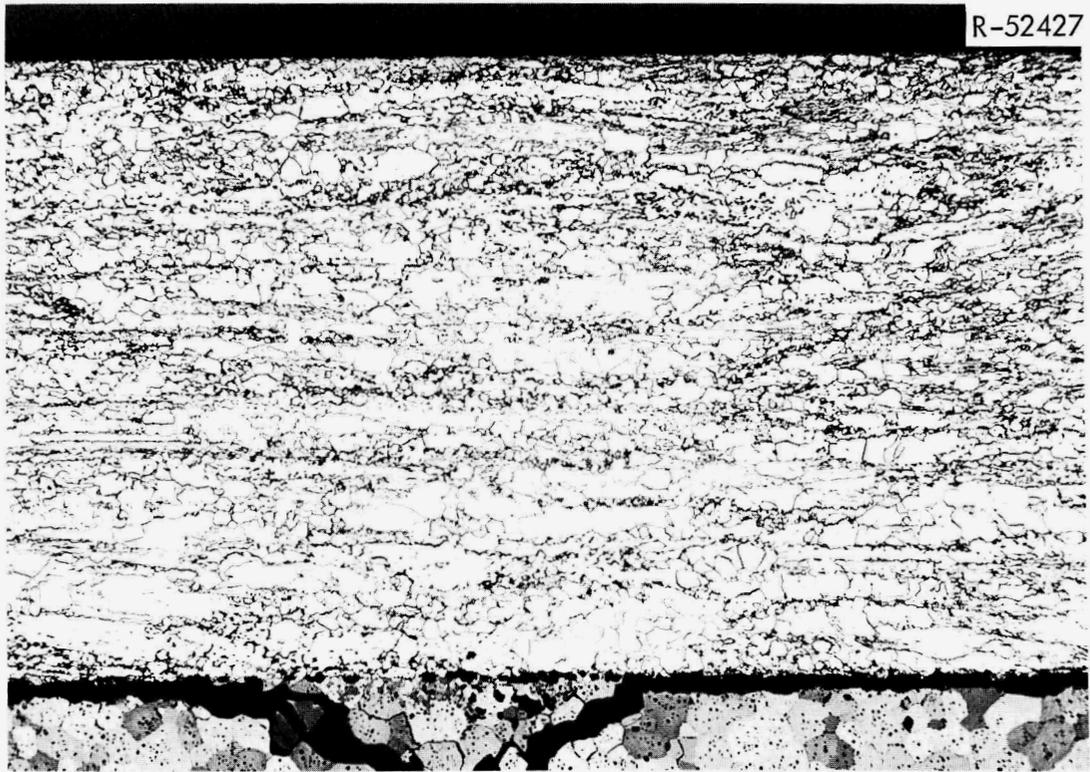
contained the the thermowell. The microstructures of the W-25% Re cladding on opposite sides of the pin are compared in Fig. 12. Apparently, one side of the pin operated at a higher temperature than the other, as evidenced by the comparative degree of recrystallization.

Fig. 12. Appearance of Cladding from Opposite Sides of Top Fuel Pin, Capsule UN-3. Etched. 100x.

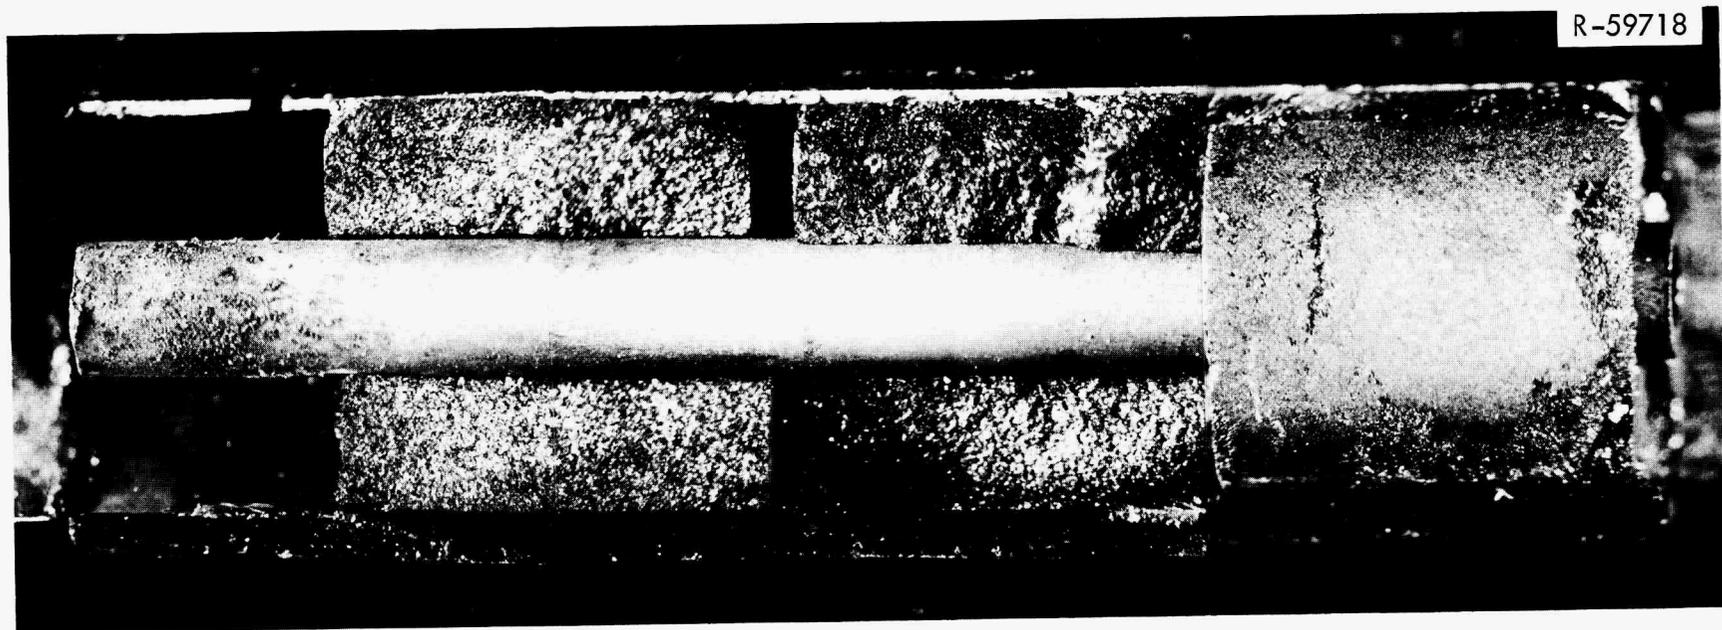
The cladding on the other sections was slit longitudinally to allow recovery of the fuel pellets for various tests. Some of the pellets broke longitudinally during sectioning of the cladding. Figure 13 shows section C after slitting with the central thermowell in place in the pellets. Metallographic examination of the fuel pellets revealed no change in grain size, and the pellets had not sintered together. The microstructure of the fuel at the outside, midradius, and inside regions of the pellets, Fig. 14, shows that the grain size was uniform across the wall of the fuel pellets, and the grain boundaries were decorated with fission gas bubbles. The larger cavities within the grains represent fabrication

Fig. 13. Portions of Pellets 1 and 2 and Intact Pellet 3 with Thermowell in Place, Top Fuel Pin, Capsule UN-3. 7x.

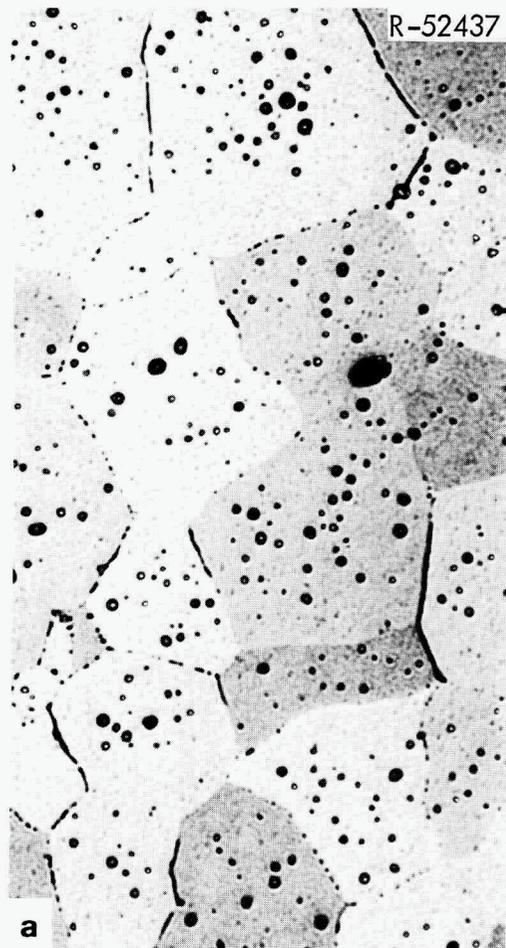
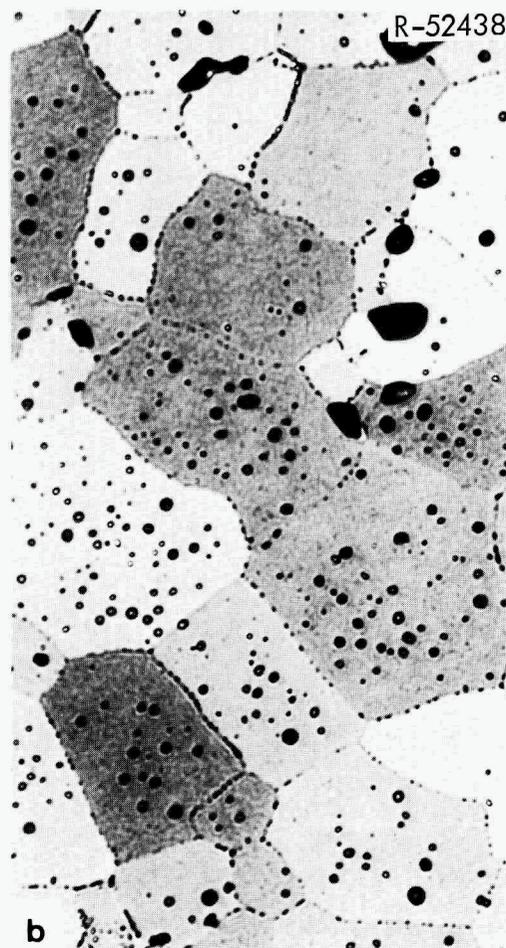
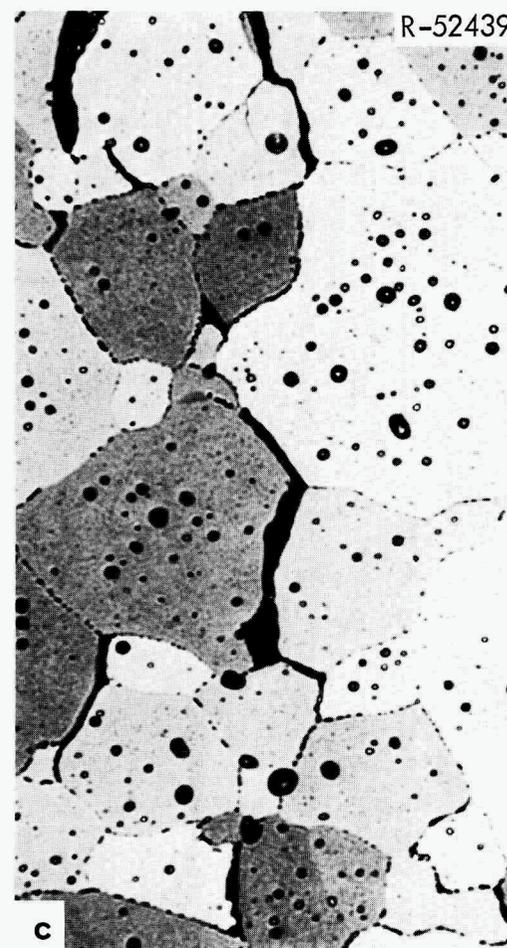
Fig. 14. Appearance of UN Annular Pellets from Top Fuel Pin, Capsule UN-3. Near (a) peripheral region, (b) midradius, and (c) inner surface of fuel pellets. Etched. 500x.

porosity. Although some grain boundary separation was apparent in the outer surface region of the fuel pellet, a rather severe degree of grain boundary separation was noted in the inner surface region. Examination of an unirradiated archive pellet showed that the fuel had a tendency for grain boundary separation, as shown in Fig. 15.

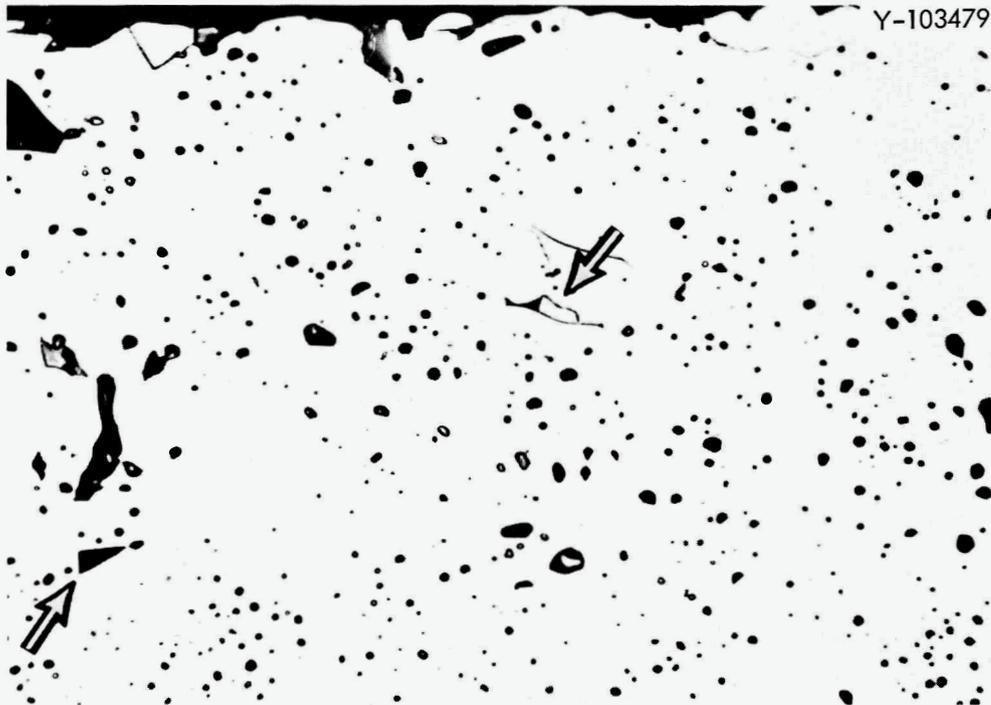
Fig. 15. Appearance of Unirradiated Archive UN Pellet for Top Fuel Pin, Capsule UN-3. This area is at the outer surface of the pellet; note grain boundary separation and occasional missing grain corner (arrows). As polished, 500x. Reduced 12%.

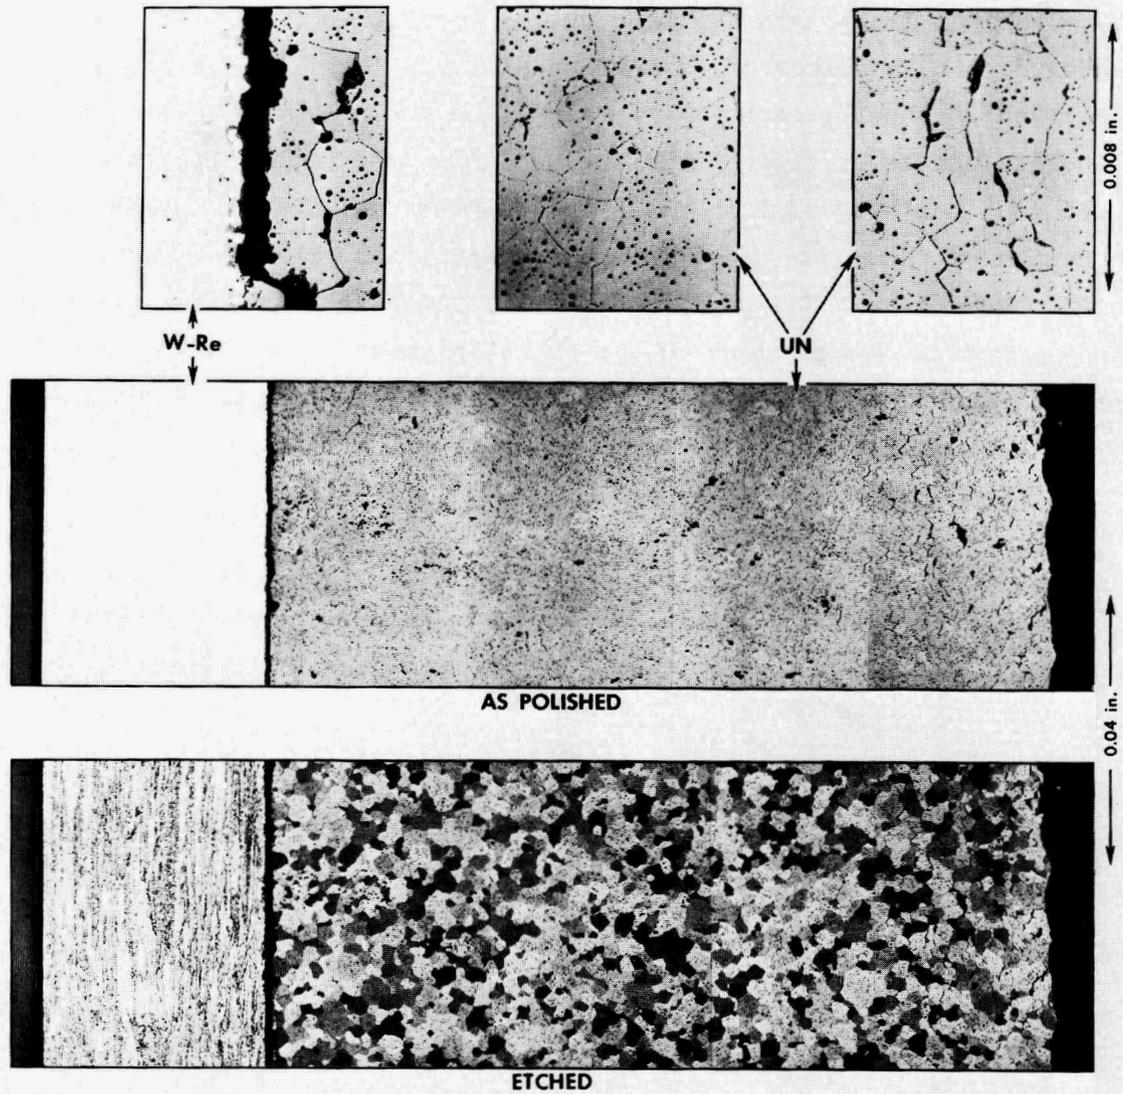
The general metallographic appearance of this fuel pin is summarized in Fig. 16. There was no evidence of any gross chemical incompatibility between the UN fuel and the W-25% Re cladding, although a general intergranular penetration of the cladding occurred to a maximum depth of 20 μm . (See upper left detail of Fig. 16). Examination of the fuel-cladding interface also showed that the fuel was in intimate contact with the cladding during irradiation; several regions were noted where grains of fuel had separated from the periphery of the pellet during cooldown and remained attached to the cladding.

Fig. 16. Typical Microstructural Details from a Longitudinal Section Through the Top Fuel Pin of Capsule UN-3.

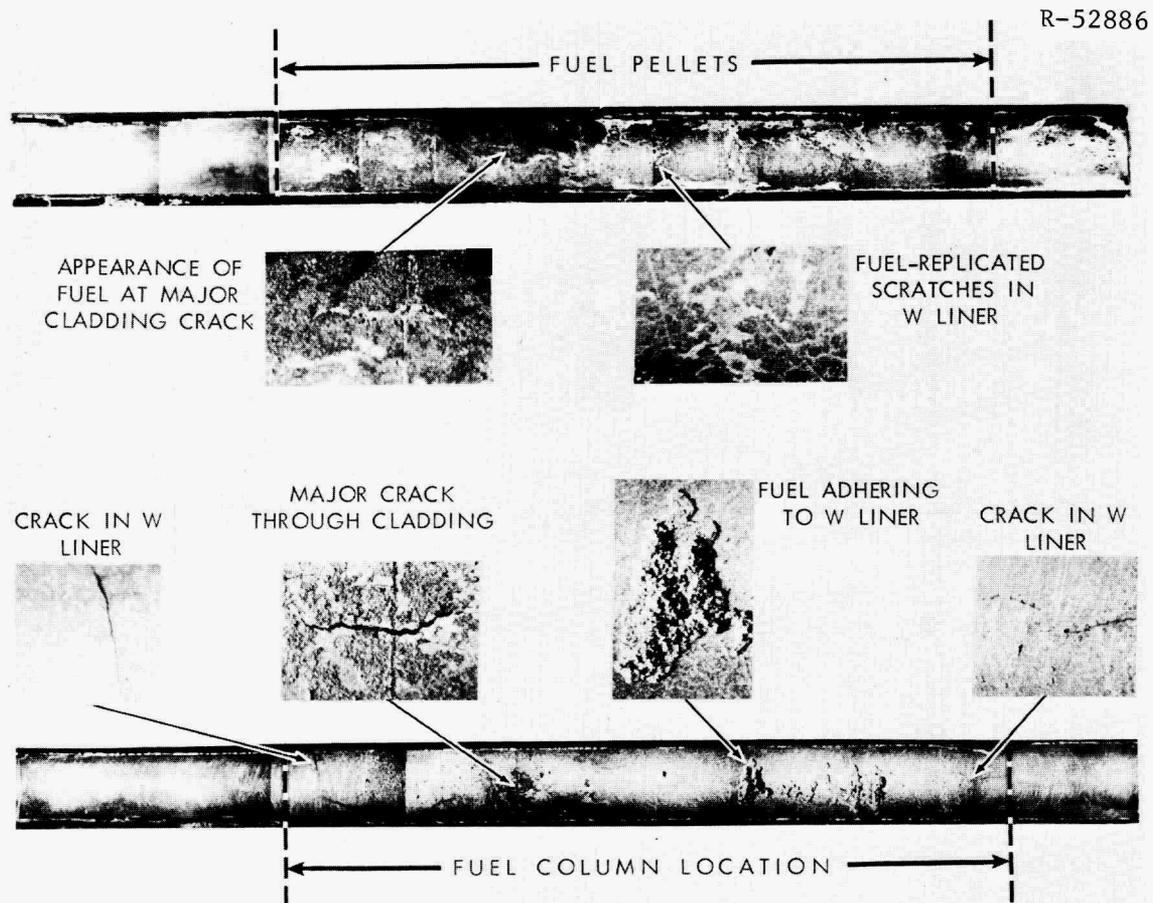
shown in Fig. 17. The lower view shows the interior of the cladding with its tungsten liner. In addition to the major crack that admitted NaK into the pin, a number of circumferential and longitudinal cracks were observed in the tungsten liner. Also, the fuel was bonded to the tungsten liner in the lower half of the fuel column. The upper view shows the ten fuel (UN) pellets still in place in the other half of the cladding. At the location of the major crack in the cladding, the fuel appeared to have been eroded away. The UN expanded to fill available space and replicated honing scratches that were on the tungsten liner of the cladding. Fuel pellet interfaces were easily visible in the top portion of the fuel column but virtually undetectable in the lower portion.

Fig. 17. Middle Fuel Pin of Capsule UN-3 after Longitudinal Slitting of the Cladding and Separation of the Cladding Halves. Top of fuel pin is on left side.

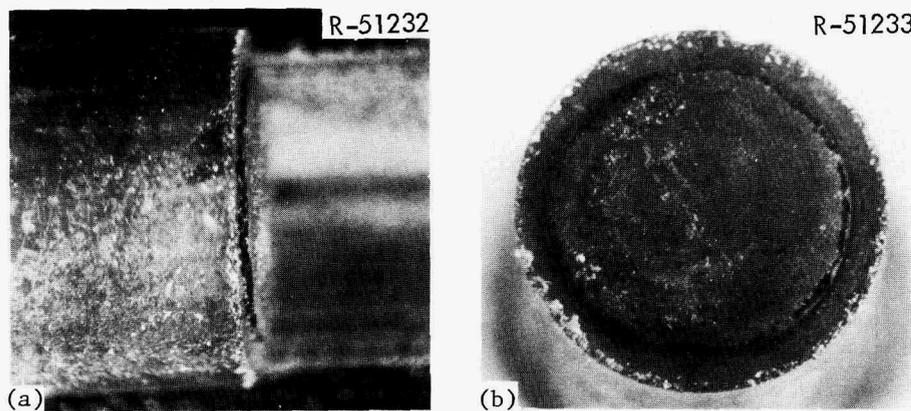
When the UN pellets were removed from the cladding, a shoulder was visible on the bottom pellet as shown in Fig. 18. The thickness of the shoulder is 9 mils, and the diameter is about 240 mils, showing that the UN extruded into the bottom tungsten spacer. Since the tungsten spacer at the top end of the fuel column moved freely when the pin was slit open, we conclude that the UN initially expanded to fit tightly in the cladding in the central region, and subsequent swelling of the UN in the lower portion of the column was accommodated by axial expansion into the bottom tungsten spacer.

Fig. 18. Shoulder on Bottom UN Pellet, Middle Fuel Pin, Capsule UN-3. (a) Side view, (b) end view. 7 \times . Reduced 10.5%.

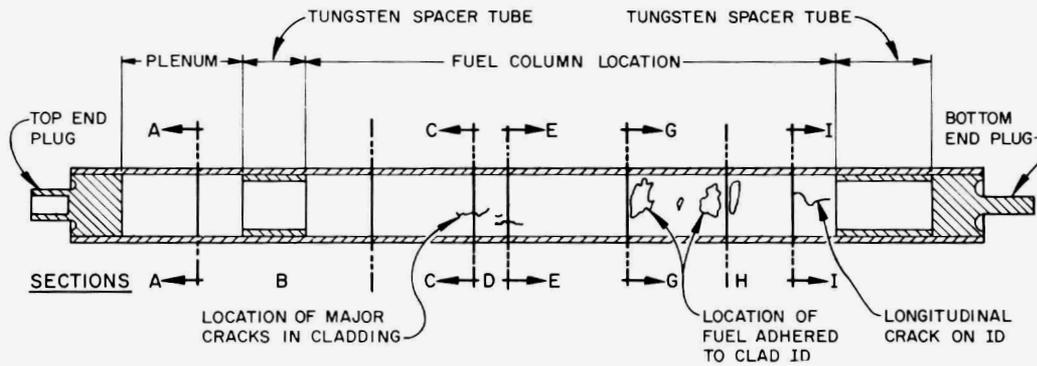
The middle pin cladding was sectioned as shown in Fig. 19. Sections A, C, E, G, and I were used as metallographic specimens. Examination of section A, taken through the gas plenum region, showed no evidence of grain growth nor any significant changes in the microstructure of either the T-111 or tungsten relative to the unirradiated archives. However, a fine intermittent precipitate on grain boundaries and grain corners, revealed only after etching, was noted in the cladding but not in the archives.

Fig. 19. Sectioning Diagram for Cladding of Middle Fuel Pin of Capsule UN-3.

The grain size was 6 times larger in the failed region of the middle fuel pin than in the gas plenum region. There was an average of only seven grains across the cladding in the failed region. The grain diameters were as follows: unirradiated material, 0.022 mm; section A, 0.017 mm; section C, 0.102 mm; section I, 0.022 mm. (See Fig. 19 for location of sections.)

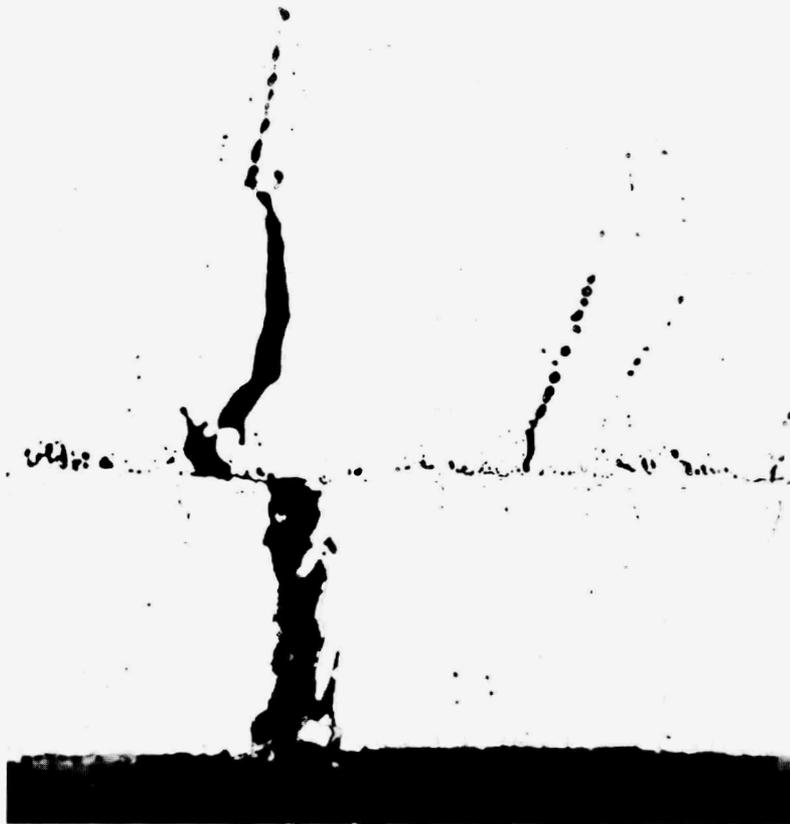
The results of the examination of sections through two failed regions (sections C and E) are shown in Figs. 20 and 21. Fractures in the T-111 cladding were primarily intergranular, but a few short transgranular fractures were noted in a shallow inner surface region of the T-111. The intergranular fractures in both the tungsten and T-111 appear to be preceded by spherical cavities. Cavities were found also at the interface between tungsten and T-111.

Fig. 20. Appearance of an Area from Section C. Note the series of voids that precedes the intergranular separation of the T-111 cladding. As polished. 500 \times . Reduced 29.5%.

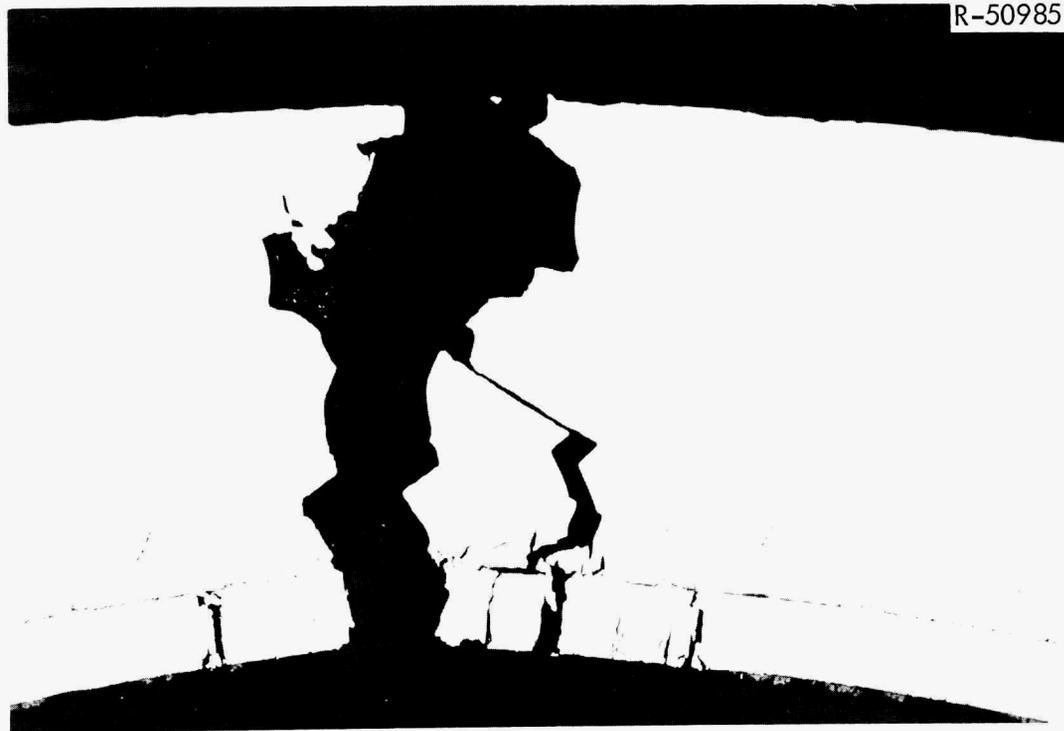
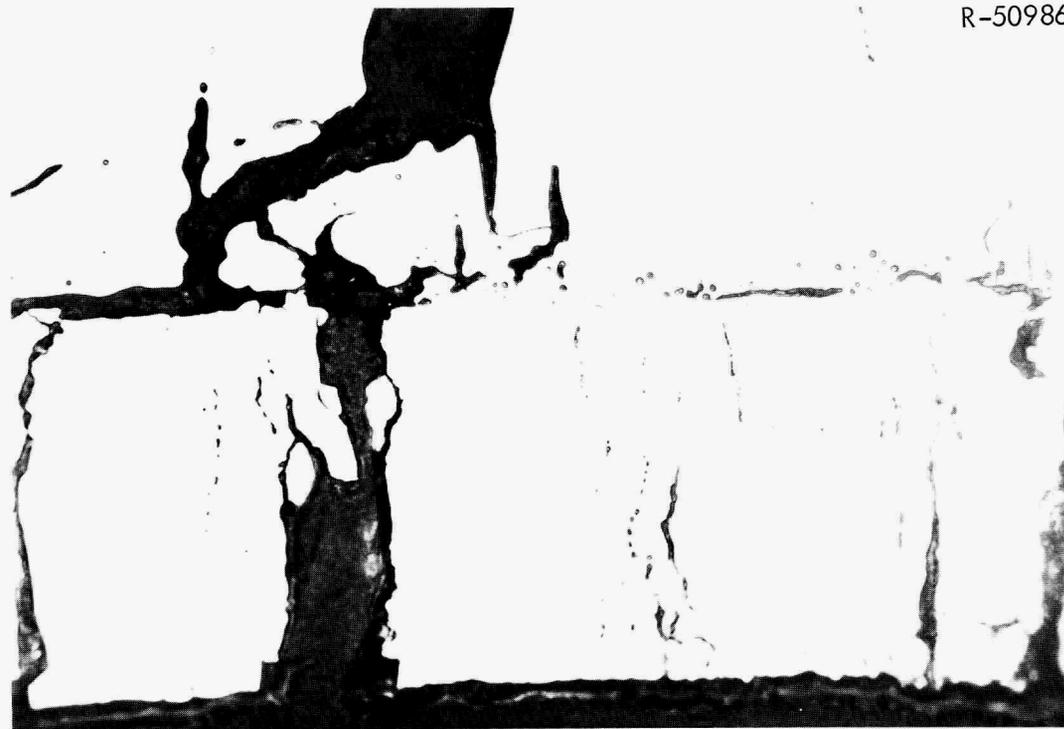
Fig. 21. Appearance of a Failed Region in the T-111 Cladding and Tungsten Liner from Section E of the Middle Pin. (a) Low, 100 \times , and (b) high, 500 \times , magnification. As polished. Reduced 3%.

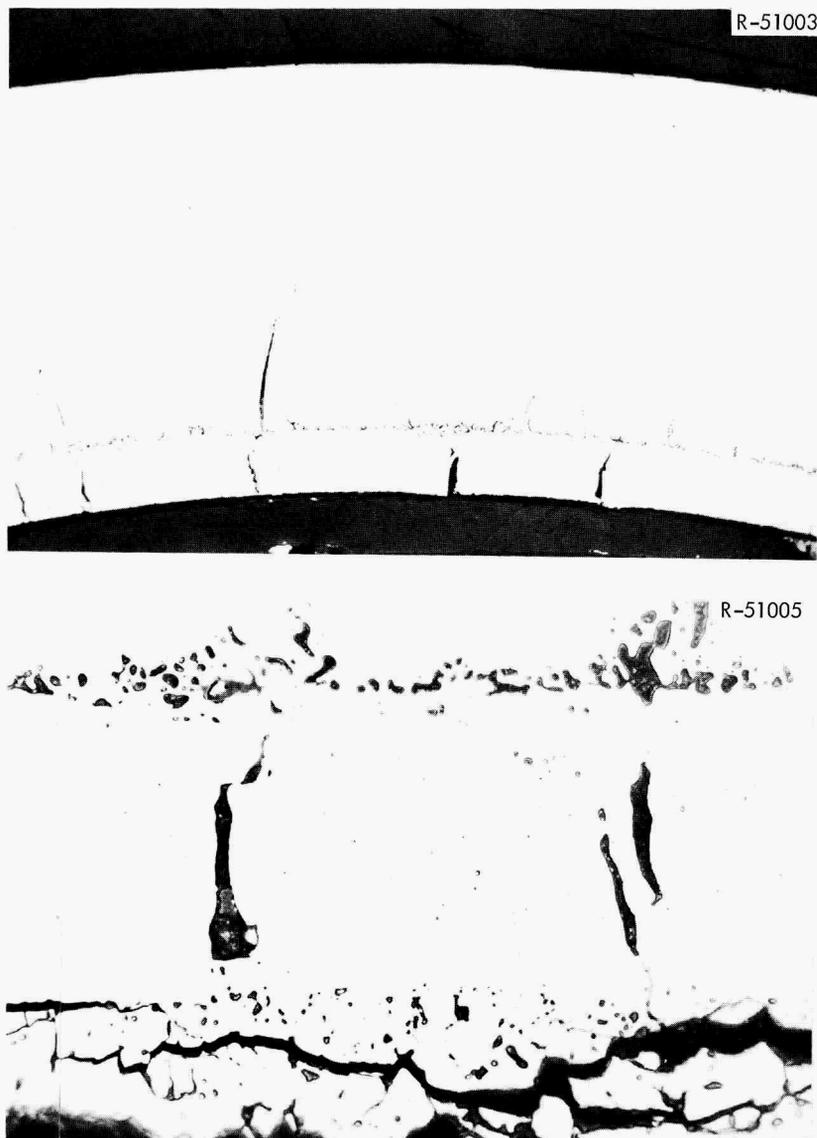
Metallographic examination of a section from an unfailed region (section G) revealed intergranular separations in the T-111 that originated at the inner surface and extended through half the wall thickness, as shown in Fig. 22. Numerous cavities were observed at the interface between tungsten and T-111 and as intergranular cavities in the T-111.

Fig. 22. Appearance of T-111 Cladding and Tungsten Liner from Section G of the Middle Fuel Pin. (a) Low, 100 \times , and (b) high, 500 \times , magnifications. As polished. Reduced 26.5%.

Intergranular separations occurred also in the tungsten liner. A region where the fuel had adhered to the tungsten liner is shown in Fig. 22(b). We noted that not only had the UN bonded with the tungsten, but in some regions the UN had penetrated the tungsten to a depth of about 15 μm . We also noted the occasional presence of a gray phase in some of the grain-boundary separations in the T-111 and in some of the cavities at the interface between tungsten and T-111. This gray phase can be seen also in Fig. 22(b).

Some of the cracks in the T-111 near the tungsten liner and cavities at the cladding-liner interface contained a material of low optical reflectivity, as shown in Fig. 22. Microprobe analysis showed this material to be rich in hafnium. On areas slightly smaller than the electron beam diameter, the hafnium content was 65%; therefore, this figure is to be taken as a lower limit of hafnium concentration. Similar hafnium concentrations were found alongside all cracks in the tungsten liner. Spectral analyses of the hafnium-rich areas failed to detect any additional elements. However, our present detector system does not enable us to analyze for nitrogen. Except where the UN fuel had been extruded into cracks in the tungsten liner, there was no evidence of uranium in the cracks or grain boundaries of the tungsten or T-111. No movement of the tungsten-T-111 interface, as a result of high temperature operation, was detected. Analysis of the interface regions failed to detect the existence of diffusion gradients. Consequently, it is highly unlikely that the cavities in the vicinity of the cladding-liner interface are the result of the Kirkendall effect.
