EXAMINATION OF IRRADIATED URANIUM NITRIDE FUEL CLAD WITH TUNGSTEN-RHENIUM OR T-III ALLOY

METALS AND CERAMICS DIVISION

EXAMINATION OF IRRADIATED URANIUM NITRIDE FUEL
CLAD WITH TUNGSTEN-RHENIUM OR T-111 ALLOY

OCTOBER 1972

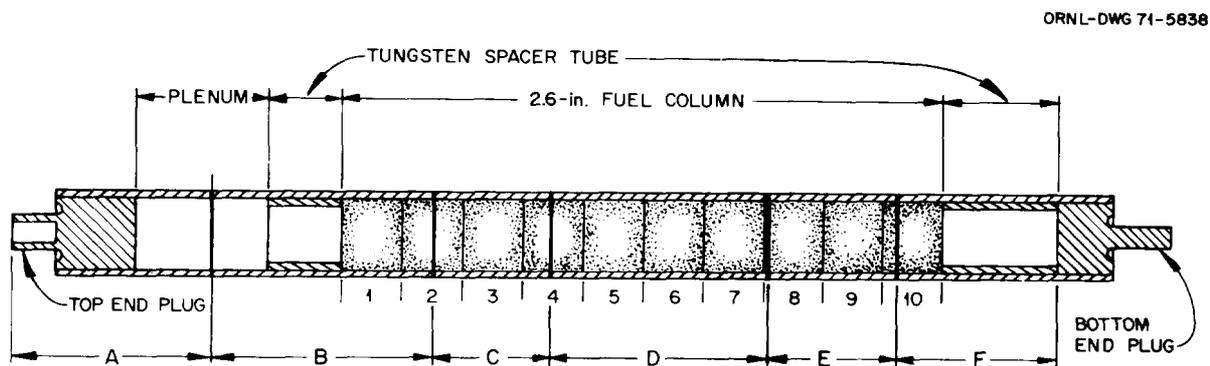
The bottom fuel pin in this experiment was essentially a duplicate of the middle (failed) pin, both in design and operation. The pin was sectioned as shown in Fig. 23. All fuel pellets were intact, and

Fig. 23. Sectioning Diagram for Cladding of Bottom Fuel Pin of Capsule UN-3.

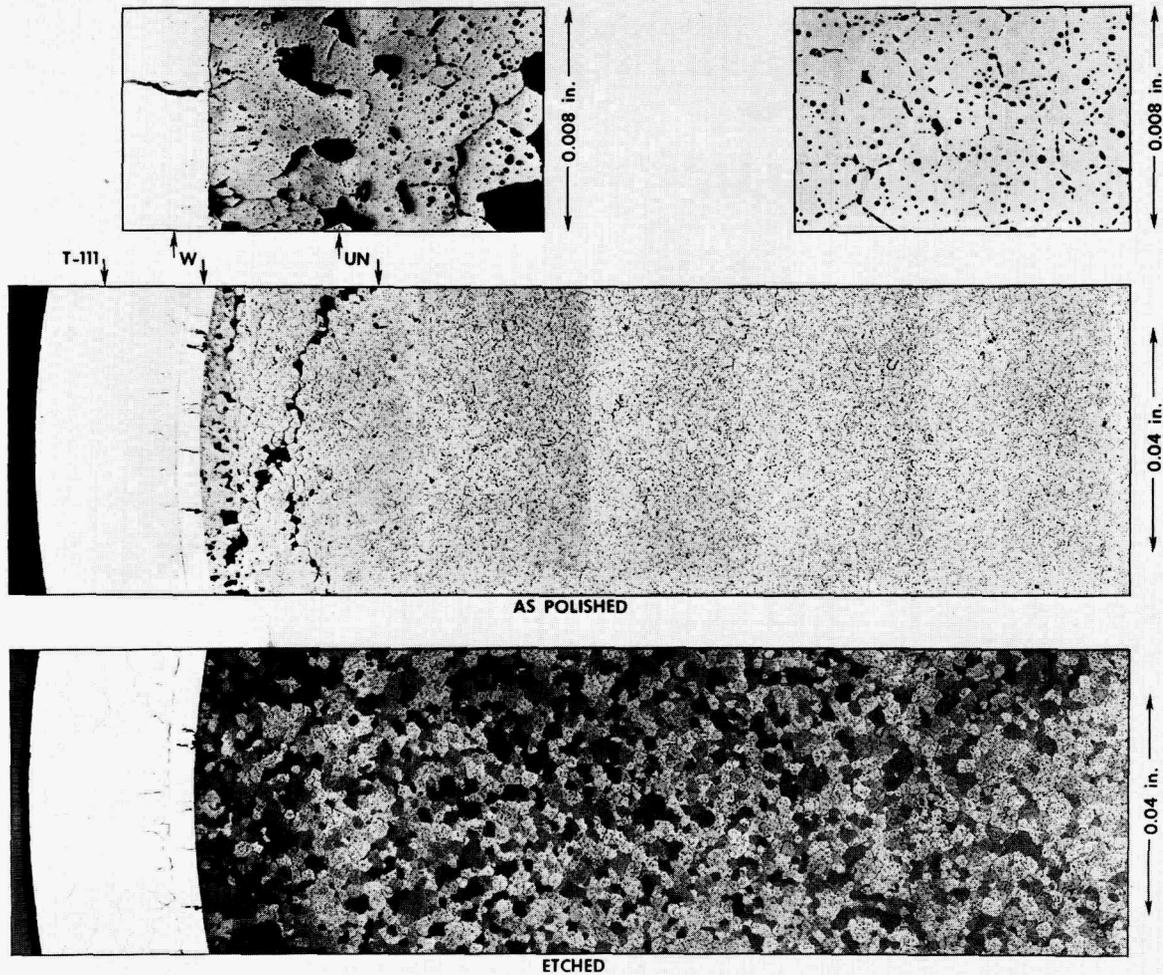
A transverse section is shown in Fig. 24. Cracks and cavities observed in both the tungsten liner and the T-111 cladding were similar to those that led to failure of the middle fuel pin.

Fig. 24. Typical Microstructural Details from a Transverse Section Through the Bottom Fuel Pin of Capsule UN-3.

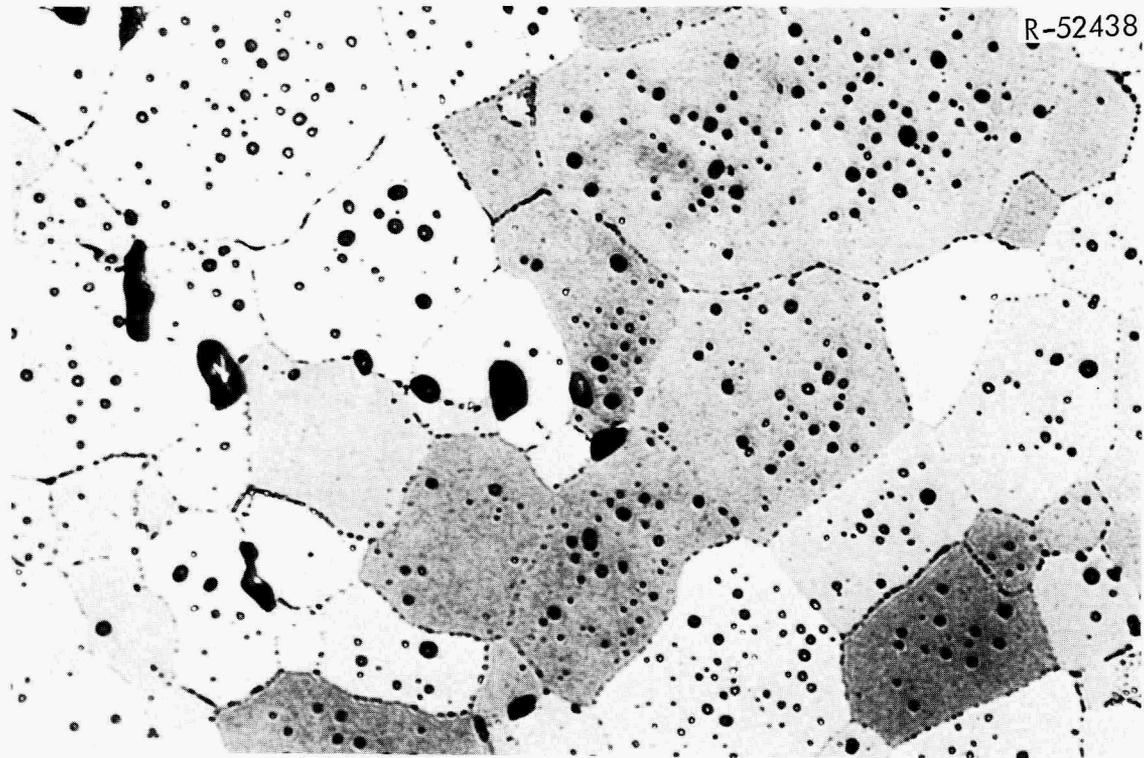
The release of fission gases from the fuel bodies was low (0.1% for the top pin and 7.1% for the bottom pin). Fission gas retention led to swelling by accumulation of fission gas bubbles at the grain boundaries, as seen in Fig. 25. The large cavities within the grains were fabrication porosity. The porosity at the grain boundaries is shown

Fig. 25. Metallographic Appearance of Irradiated UN Fuel from the Bottom Pin of Capsule UN-3. 500X.

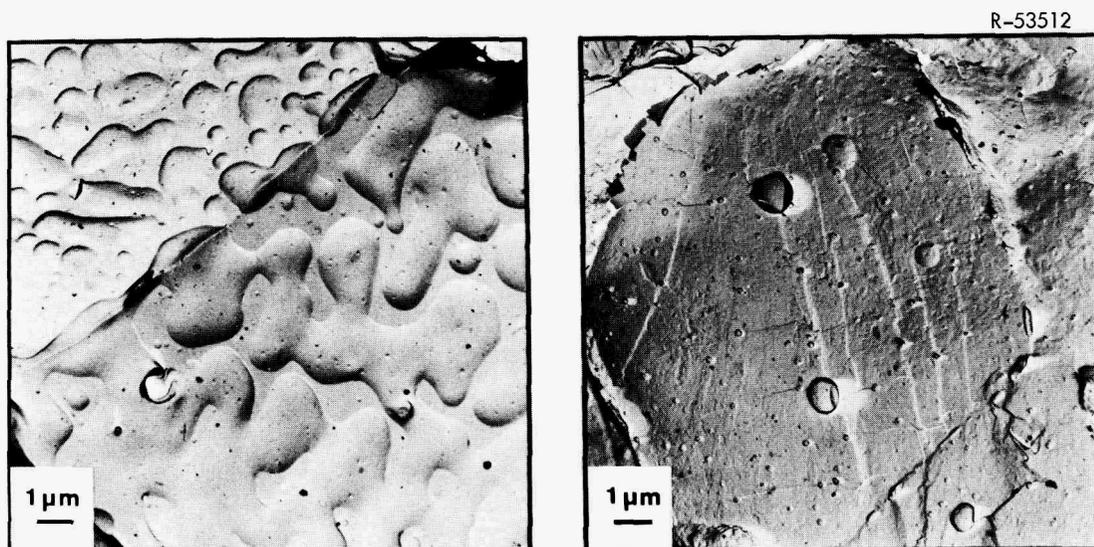
more clearly in Fig. 26 by transmission electron microscopy of replicas of fractured UN surfaces. The intergranular fracture shows coalescence of bubbles of fission gas at grain boundaries. The transgranular fracture shows small bubbles of fission gas in the grain as well as larger cavities that we believe to be fabrication porosity. The coalescence of the fission gases at the grain boundaries forces the grains apart and produces substantial swelling of the fuel, although the fission gases are not released in large quantity from the fuel body. It has been established

Fig. 26. Fractographic Surfaces from the Central Region of a UN Fuel Pellet from Bottom Fuel Pin, Capsule UN-3. (a) Intergranular and (b) transgranular. Carbon replica shadowed with chromium.

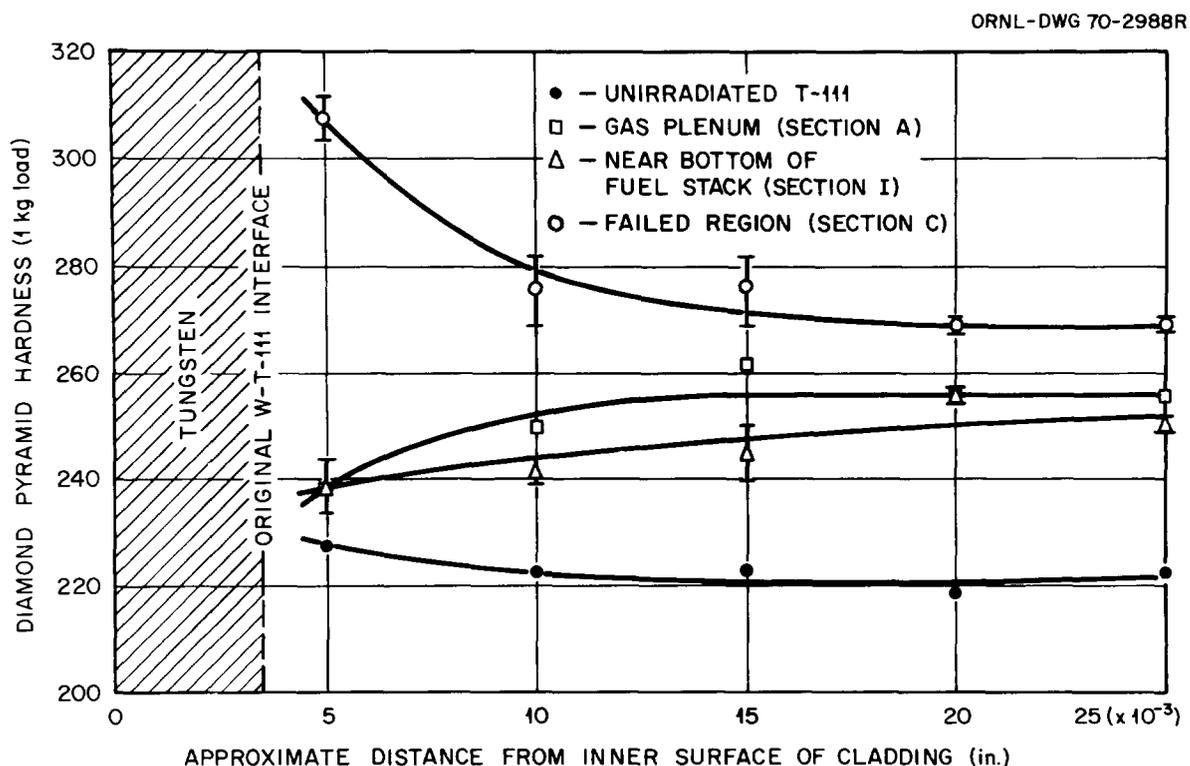
We measured the microhardness across the wall of the T-111 cladding on three sections from the middle (failed) pin and compared these values with an archive sample. The cladding sections came from the gas plenum region, the failed region, and near the bottom of the fuel column; the results are shown in Fig. 27. The sections from both the gas plenum and from near the bottom of the fuel column were harder than the archive and showed an increase in hardness across the wall of the cladding as the

Fig. 27. Microhardness of Cladding of Middle Pin from Capsule UN-3.

outer surface was approached. A marked increase in hardness was measured in the section from the failed region, but in contrast to the other two sections the maximum hardness occurred at the inner surface region.

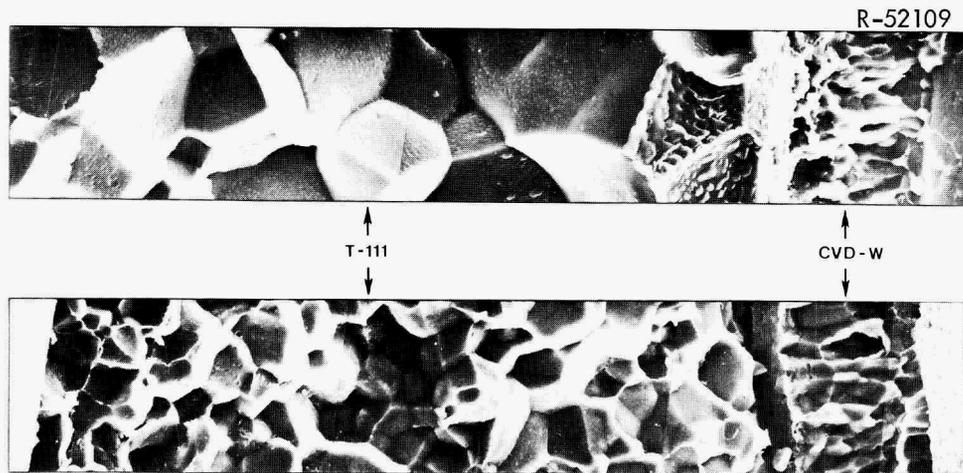
Since the irradiated T-111 cladding from both middle and bottom pins was brittle at room temperature, replicas were readily obtained from fresh fractures. Scanning electron micrographs of a replica taken from cladding fractured longitudinally near the failed region of the middle pin are shown in Fig. 28. The large variation in grain size between

Fig. 28. Scanning Electron Micrographs of Two Fracture Surfaces about 1 cm Apart. The larger grained region (a) was near the failed region of the cladding. Plastic replica, gold shadowed. About 200 \times . Reduced 16%.

regions about 1 cm apart, shown in Fig. 28, indicates that localized hot spots developed in the cladding during irradiation. Large grain boundary cavities in the T-111 near the cladding-liner interface are apparent in Fig. 28(a). Higher magnification micrographs of the finer grained region in Fig. 28(b) also revealed grain boundary cavities. Grain boundary cavities were observed throughout the cladding thickness; the radius of the cavities, in the range of 10^{-5} to 10^{-4} cm, decreased from the inner to outer surface of the cladding. The density of grain boundary cavities was estimated to be about $5 \times 10^6/\text{cm}^2$ of grain boundary area. Numerous grain boundary cavities were present in the tungsten liner, which also fractured intergranularly as shown in Fig. 29.

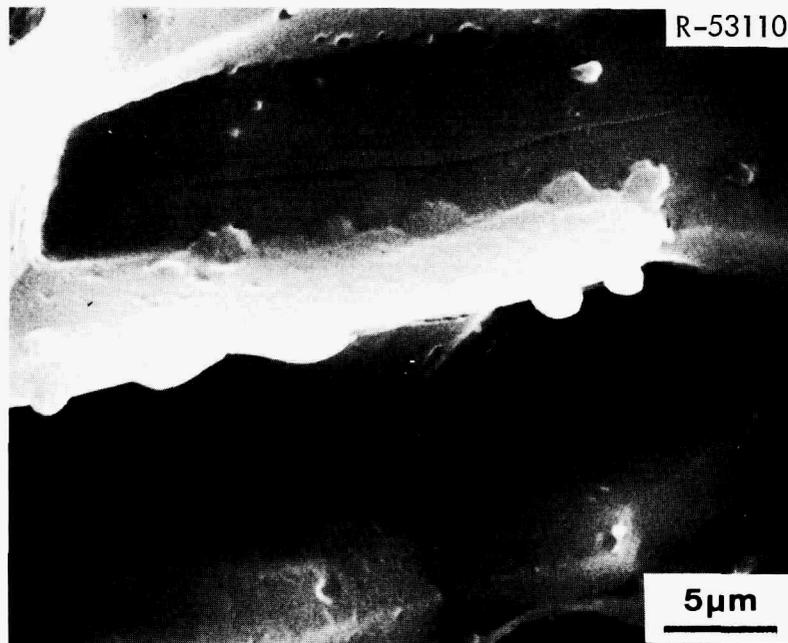
Fig. 29. Grain Boundary Cavities in CVD Tungsten Liner as Revealed by Scanning Electron Microscopy Image of a Plastic Replica of a Fracture Surface. Gold shadowed.
