ORNL-4918

HEAVY-SECTION STEEL TECHNOLOGY PROGRAM
SEMIANNUAL PROGRESS REPORT
FOR PERIOD ENDING FEBRUARY 28, 1973

F. J. Witt, Program Director

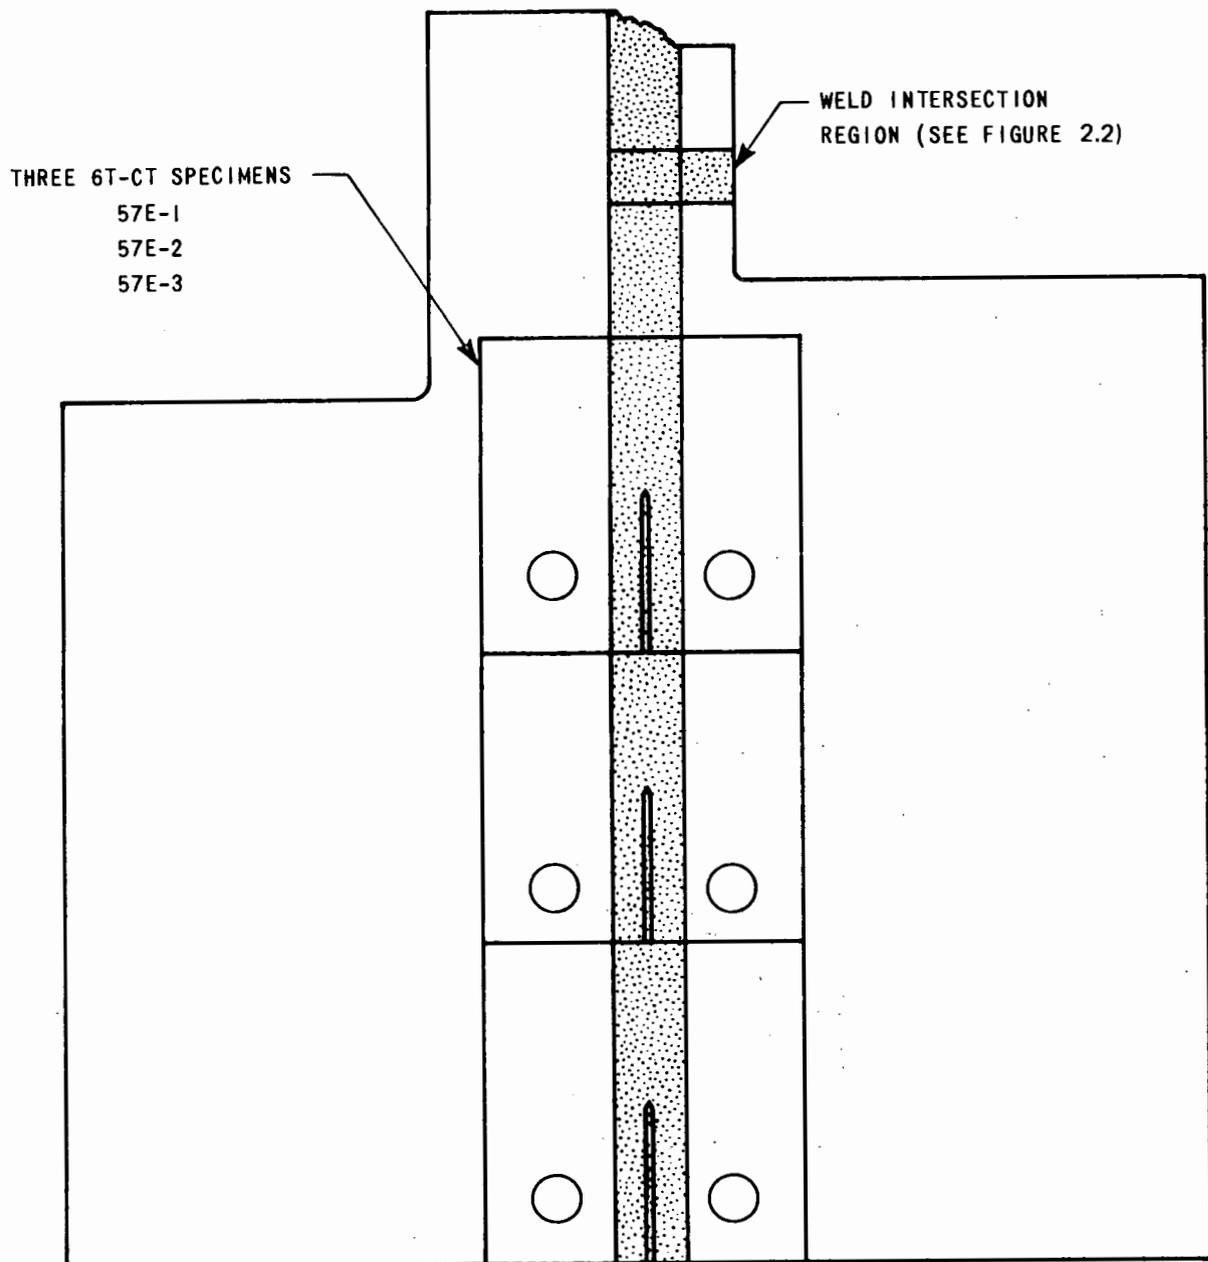
Fig. 2.1. Machining of fracture toughness specimens from HSST weldment 57E.

Nineteen compact-tension (CT) specimens have been fabricated from HSST weldment 57E. These specimens include three 6T CT (6-in.-thick, compact-tension) specimens which were machined from the main weld as shown in Fig. 2.1. The remaining 16 specimens are 1T CT specimens machined from the weld intersection region as shown in Fig. 2.2. Five of these specimens were taken directly from the weld intersection, and eleven were taken from the main weld in the vicinity of that intersection. The five specimens from the intersection were taken in two different orientations to determine the effect of crack orientation on the data.

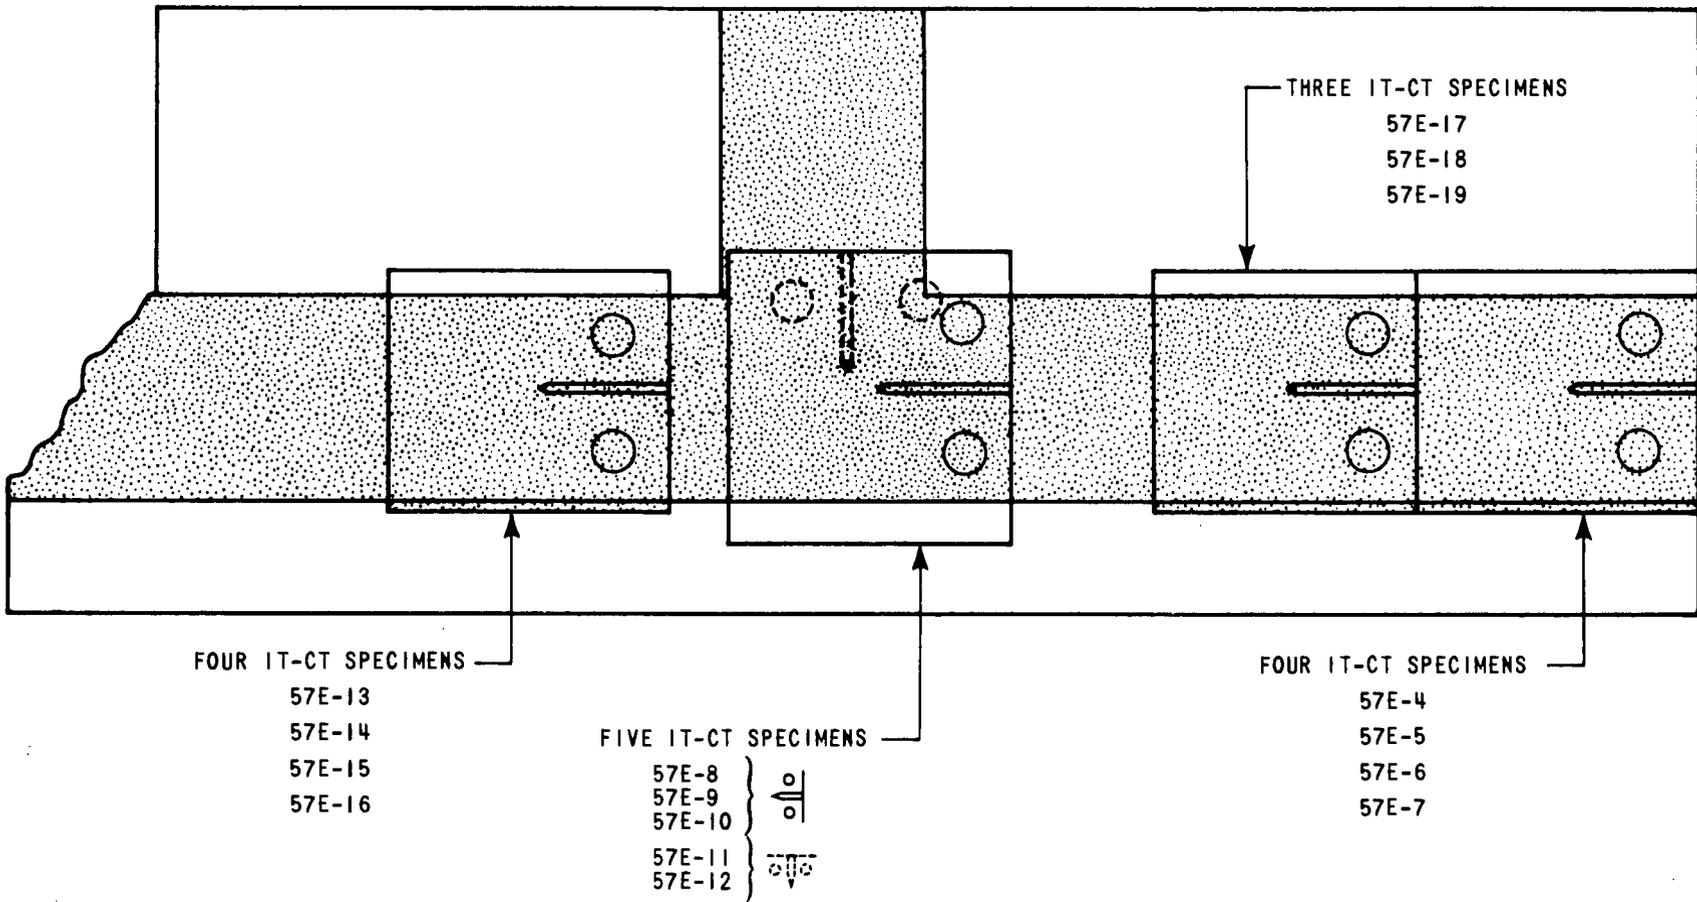
Fig. 2.2. Machining of fracture toughness specimens from weld inter-section region of HSST weldment 57E.

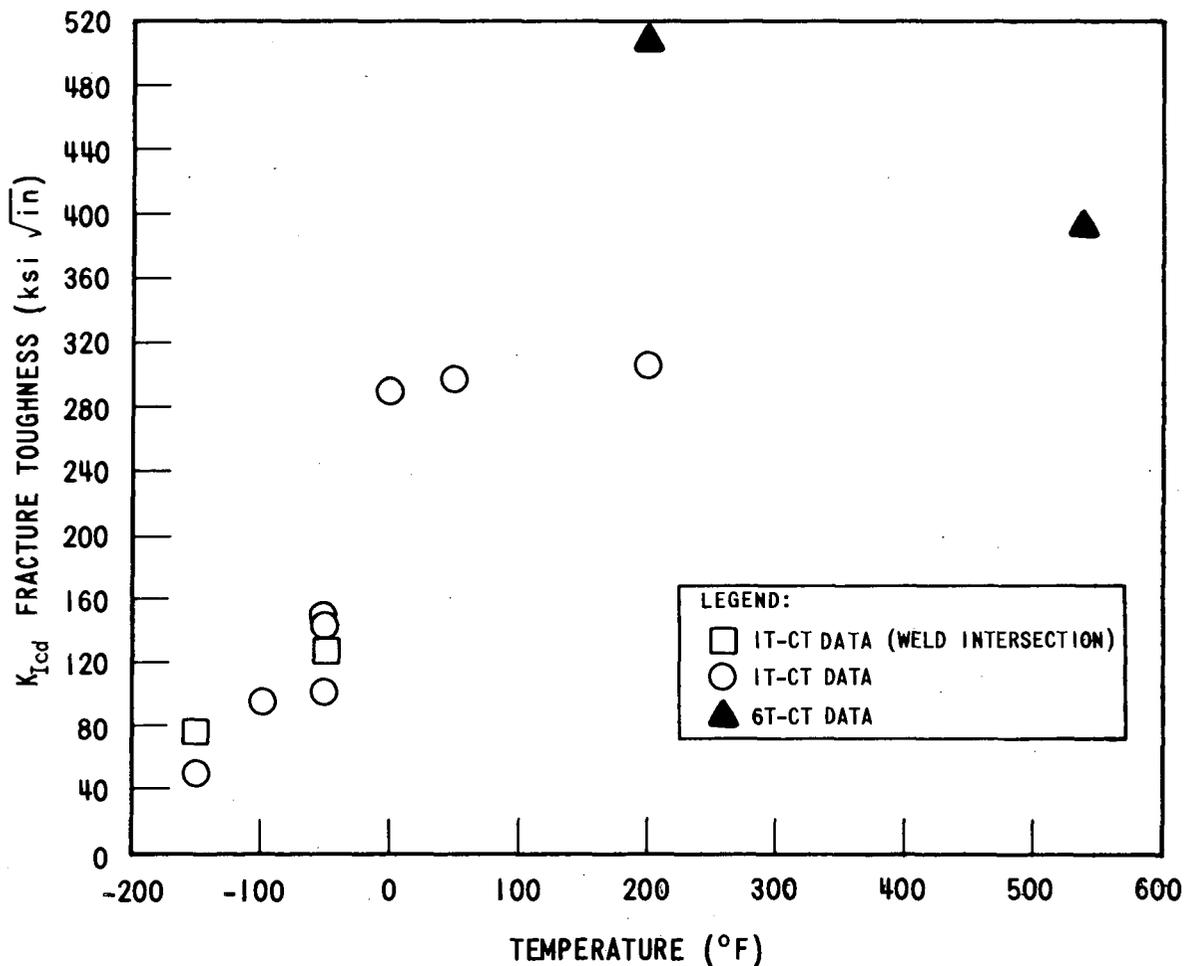
Fig. 2.3. Fracture toughness data for HSST weldment 57E.

The resulting fracture toughness data from these tests are summarized in Table 2.1 and are illustrated graphically in Fig. 2.3. Comparisons of these data with previous fracture toughness data for base metal^{3,4} indicate that this weldment is significantly tougher. Furthermore, these tests indicate that the toughness of the weld intersection is not significantly different than that of the main weld. Temperatures have been chosen for testing the remaining seven specimens to fill in the gaps in the data presented in Fig. 2.3.

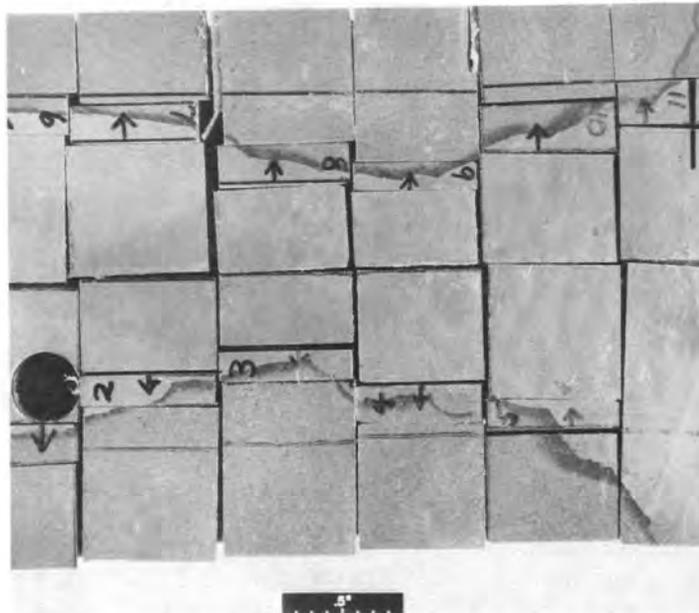
Fig. 2.4. Photograph of a weld section from the prolongation of intermediate test vessel 3. The numbers identify each specimen, which is mounted, polished, and metallographically studied on the surface identified by the arrows.

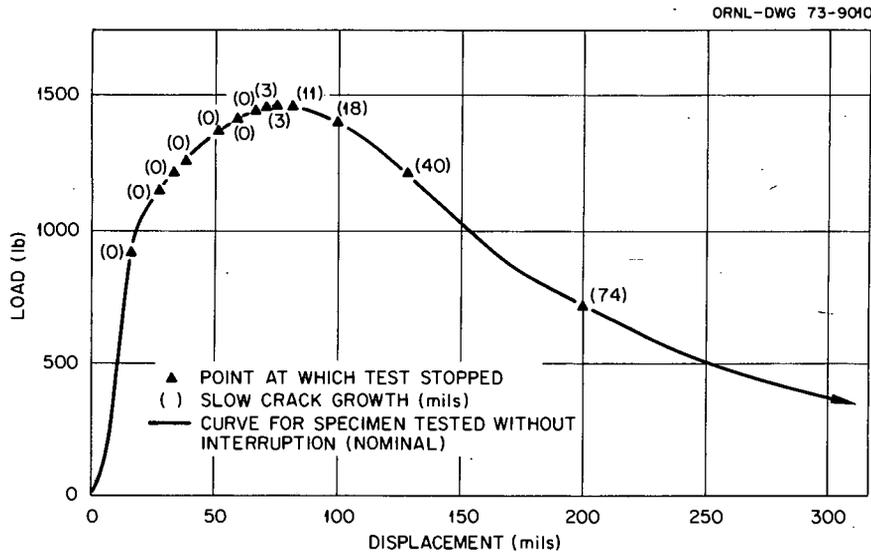
Fig. 2.6. Slow stable crack growth in precracked Charpy specimens obtained by interrupting the load at various deflections. Specimens tested in the slow-bend mode.

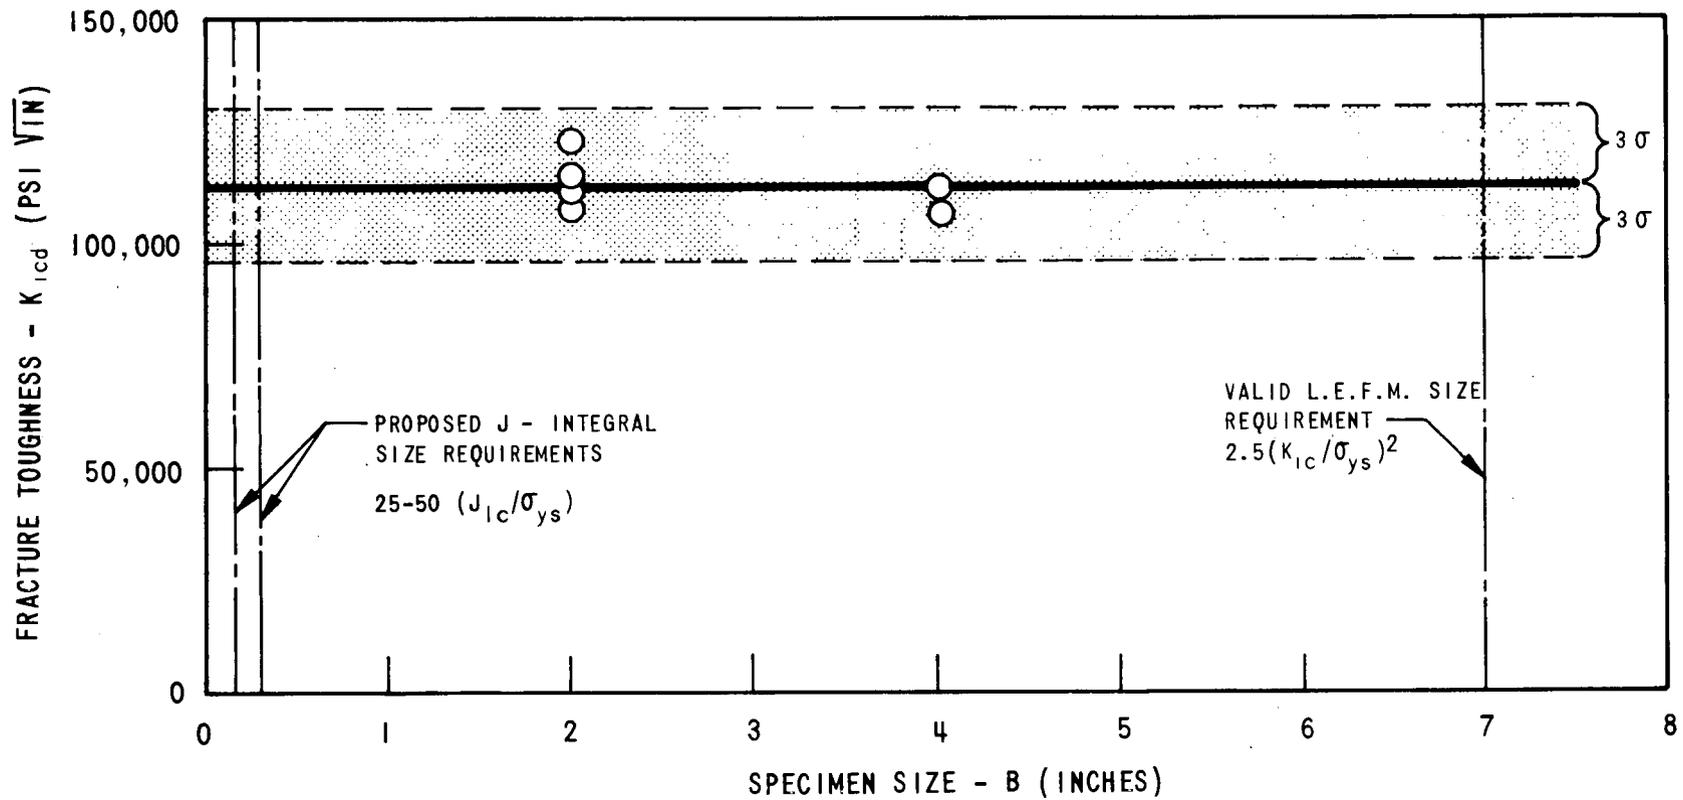
Fig. 2.7. Fracture toughness data from HSST plate 04-A using the equivalent-energy interpretation.

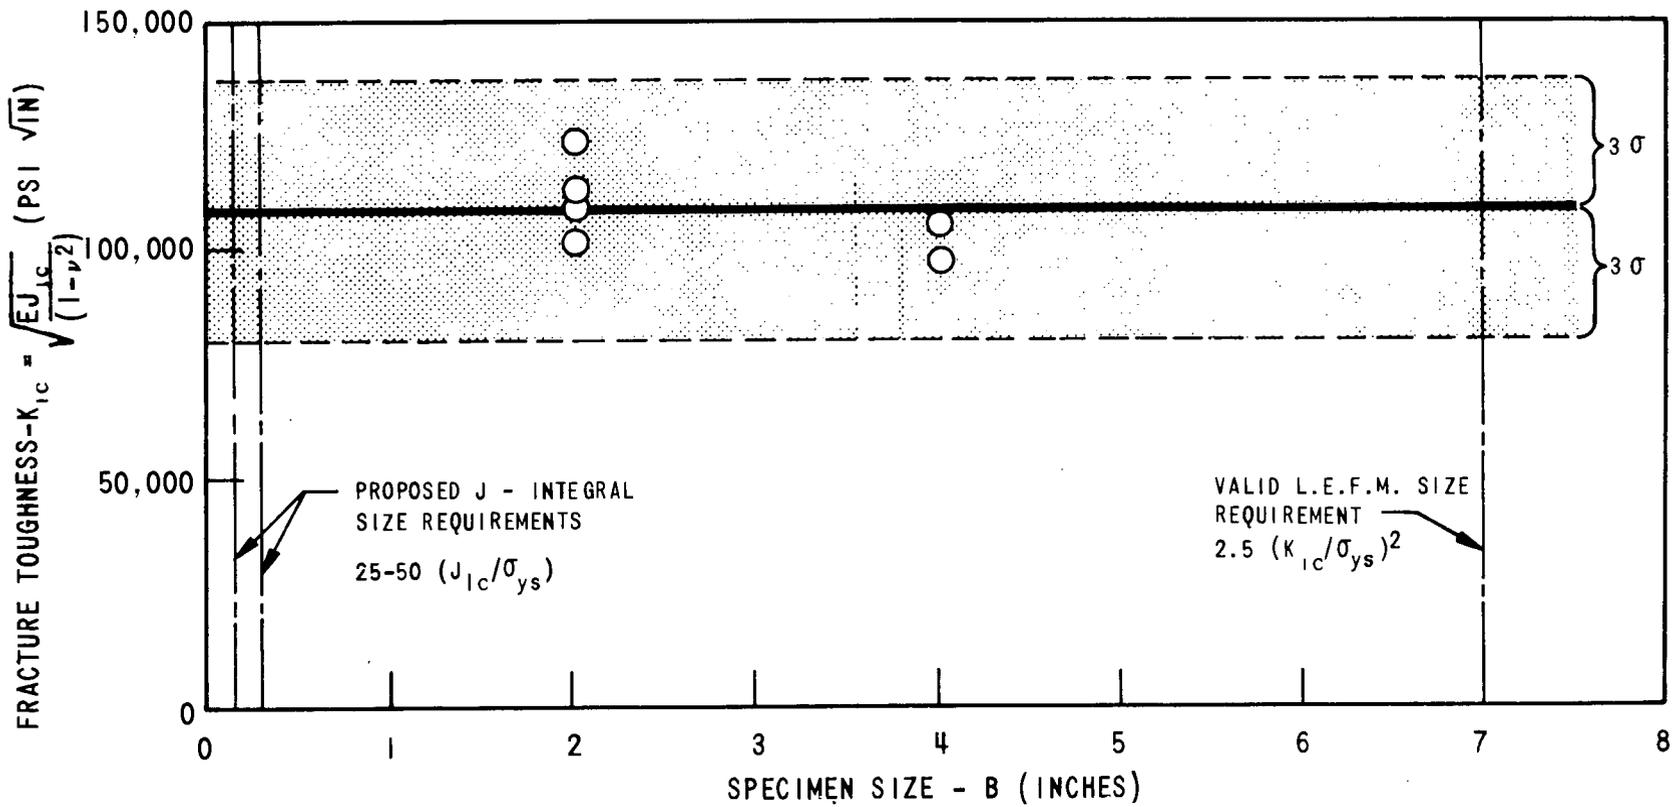
Fig. 2.8. Fracture toughness data from HSST plate 04-A using the J -integral interpretation.

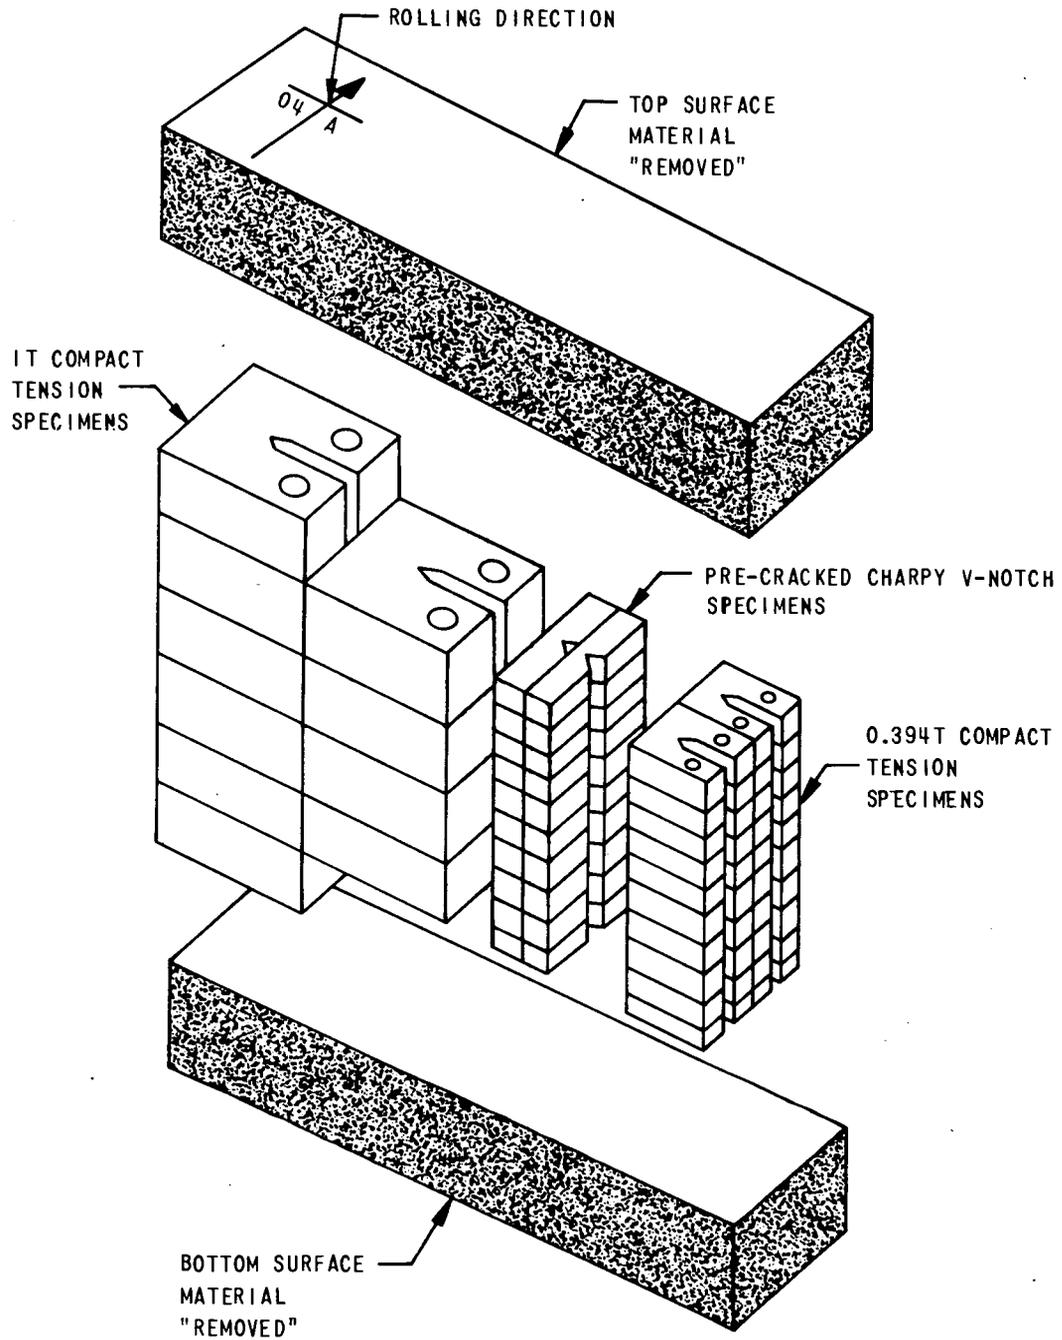
Fig. 2.9. Additional fracture toughness specimens from HSST plate 04-A for statistical study.

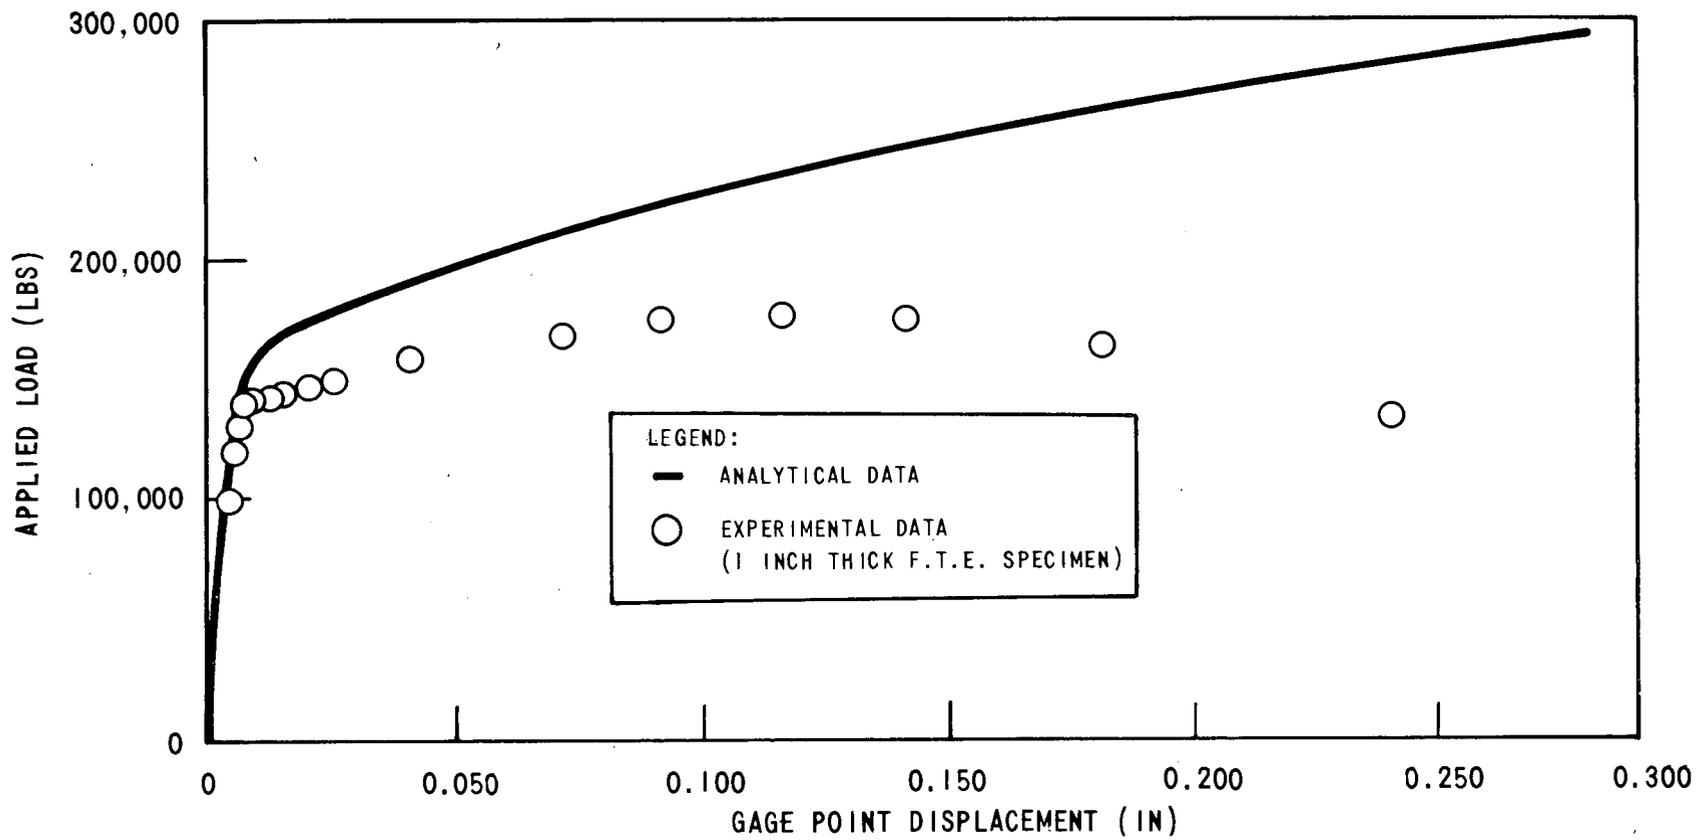
Fig. 2.10. Analytical and experimental compliance data for fracture theories evaluation specimen.

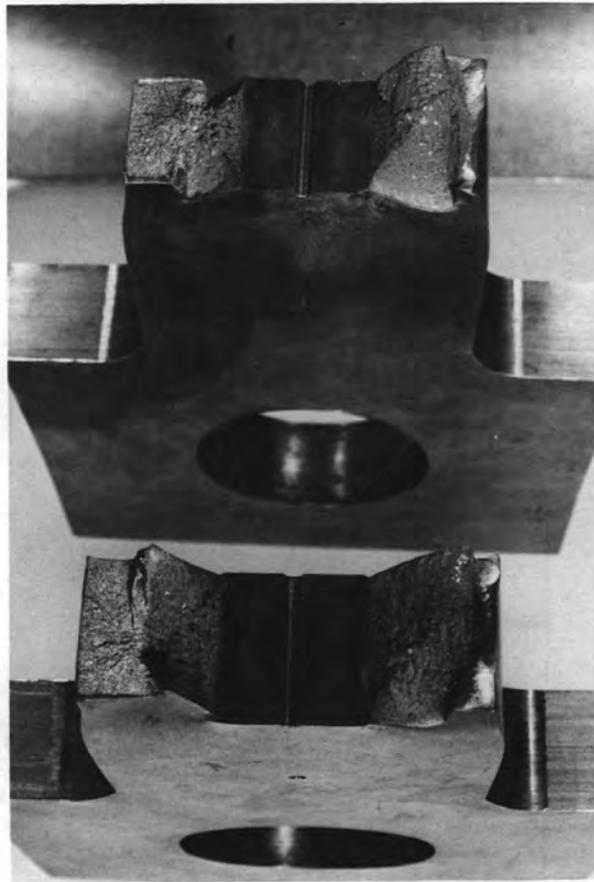
Fig. 2.11. Fracture surface from first (1-in.-thick) fracture theories evaluation specimen.

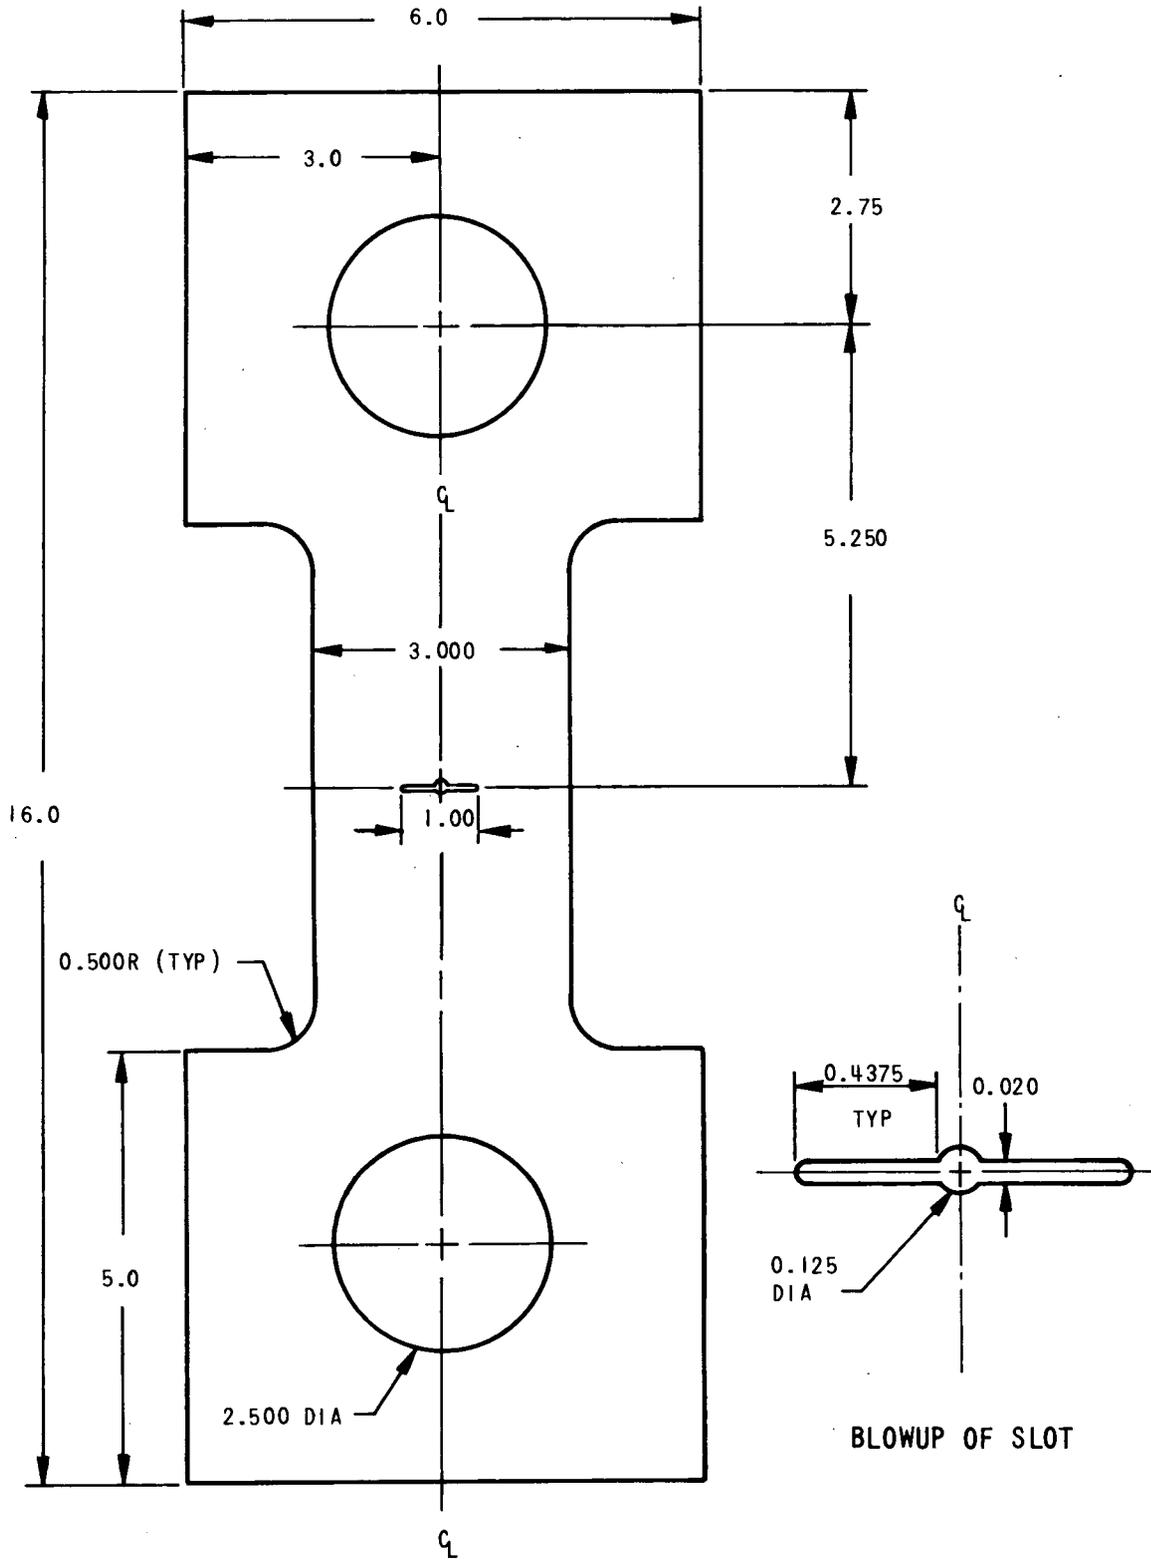
Fig. 2.12. Fracture theories evaluation specimen with rounded crack ends.

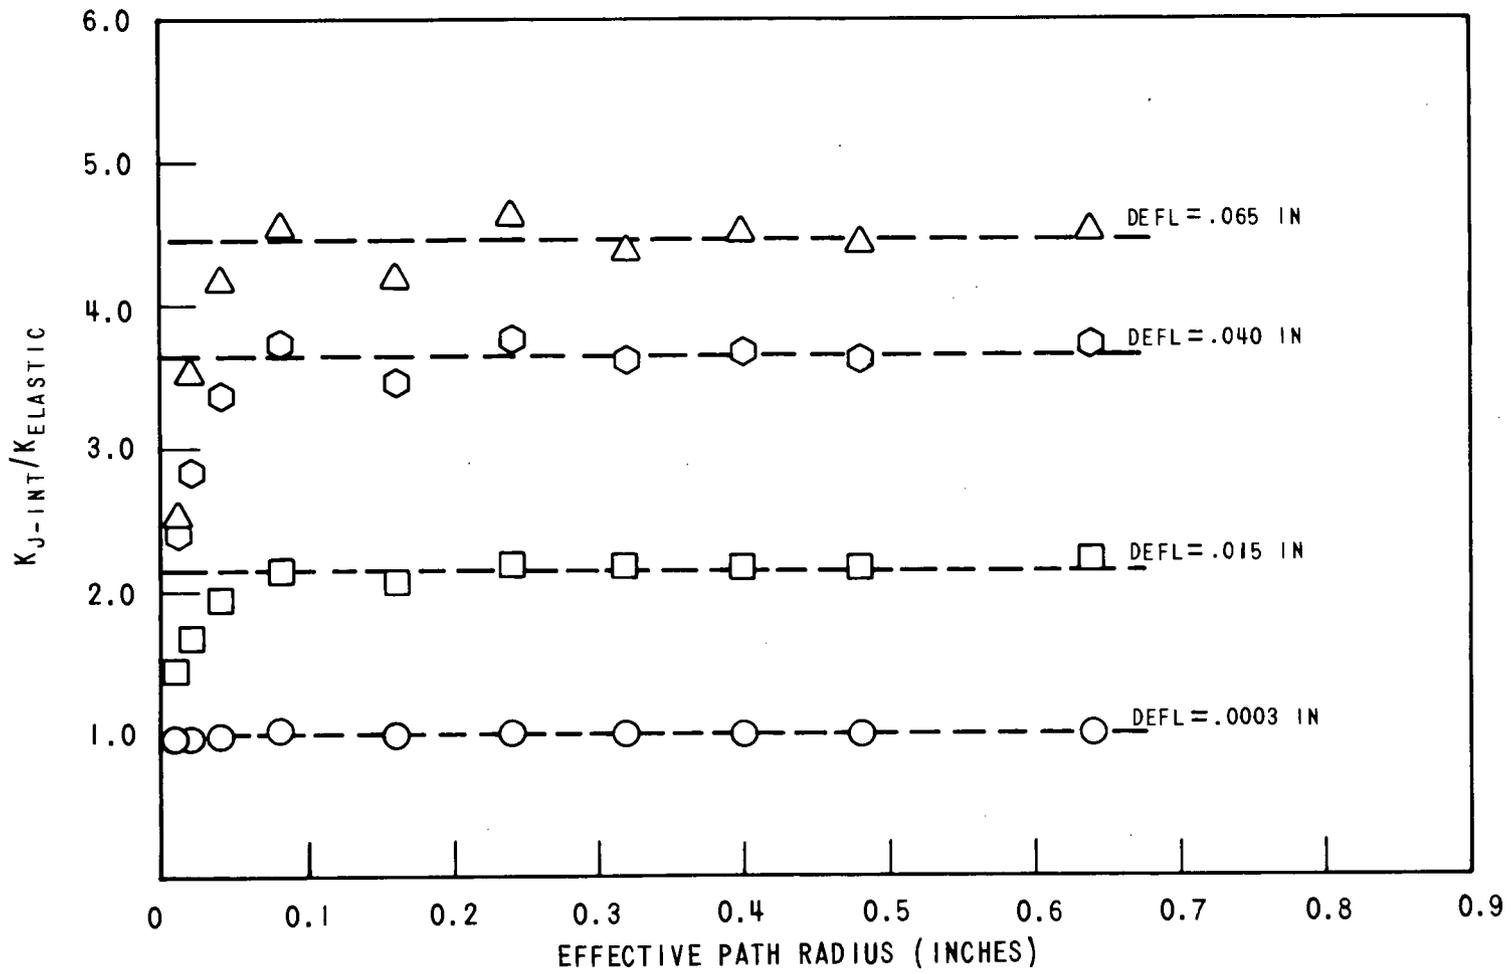
Fig. 2.13. Path dependence of analytical J -integral data.

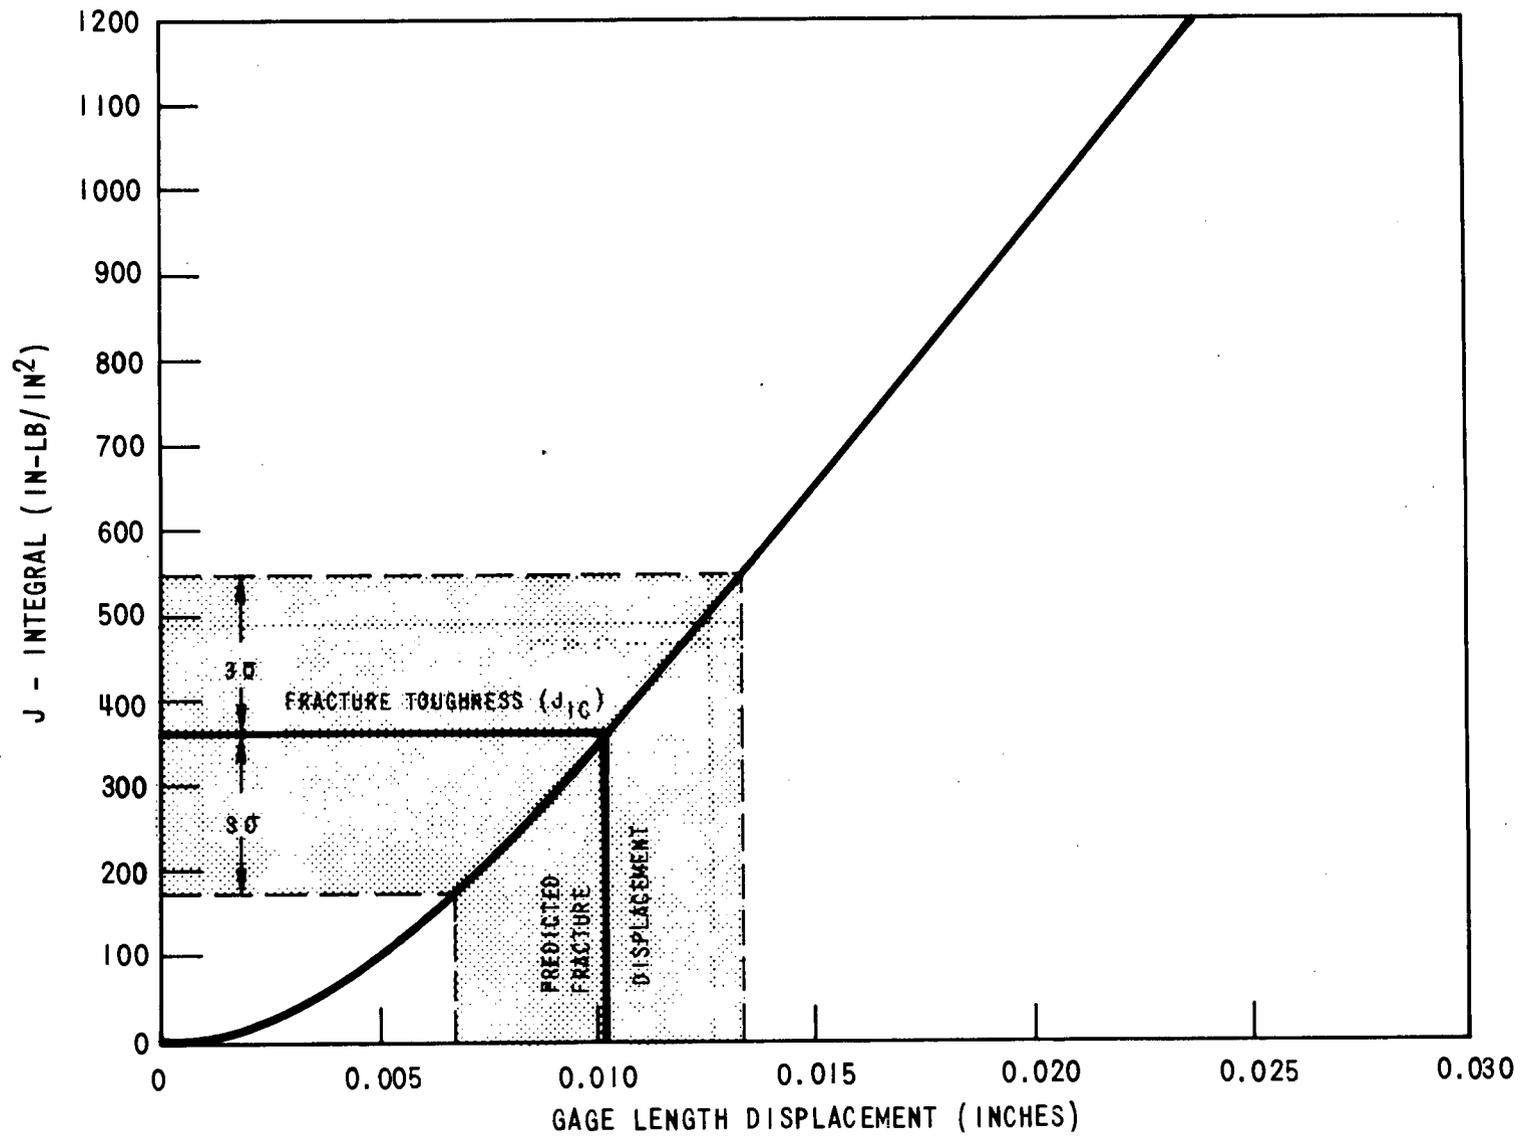
Fig. 2.14. Predicted fracture displacement of FTE specimen using the J -integral approach.

The average values of J over the paths, disregarding the anomalous paths near the crack tip, are plotted as a function of gage length displacement in Fig. 2.14. The J -integral fracture toughness data from Table 2.2, including the $\pm 3\sigma$ scatter band for the data, are also plotted on this figure. The intersection of the fracture toughness lines with the computed J -integral curve yields a predicted fracture displacement of 0.010 in., with a $\pm 3\sigma$ range of 0.007 to 0.013 in. for the J -integral approach.

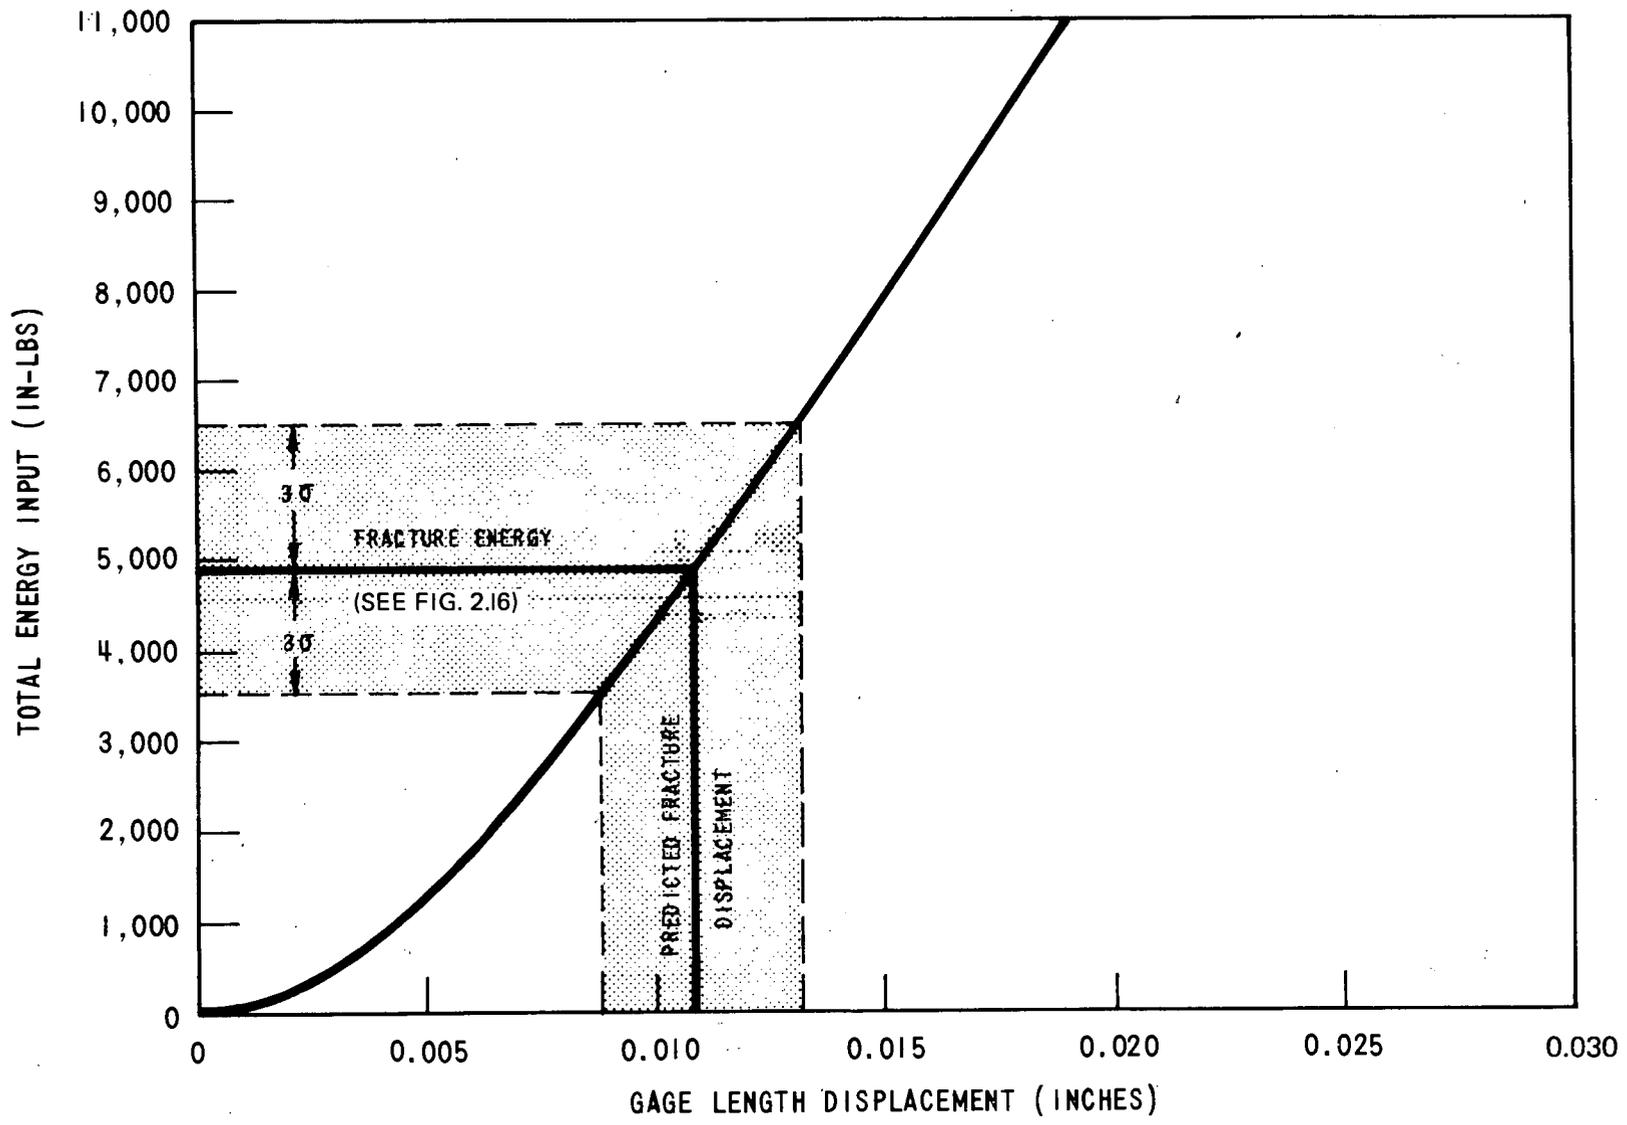
Fig. 2.15. Predicted fracture displacement of FTE specimen using the equivalent-energy approach.

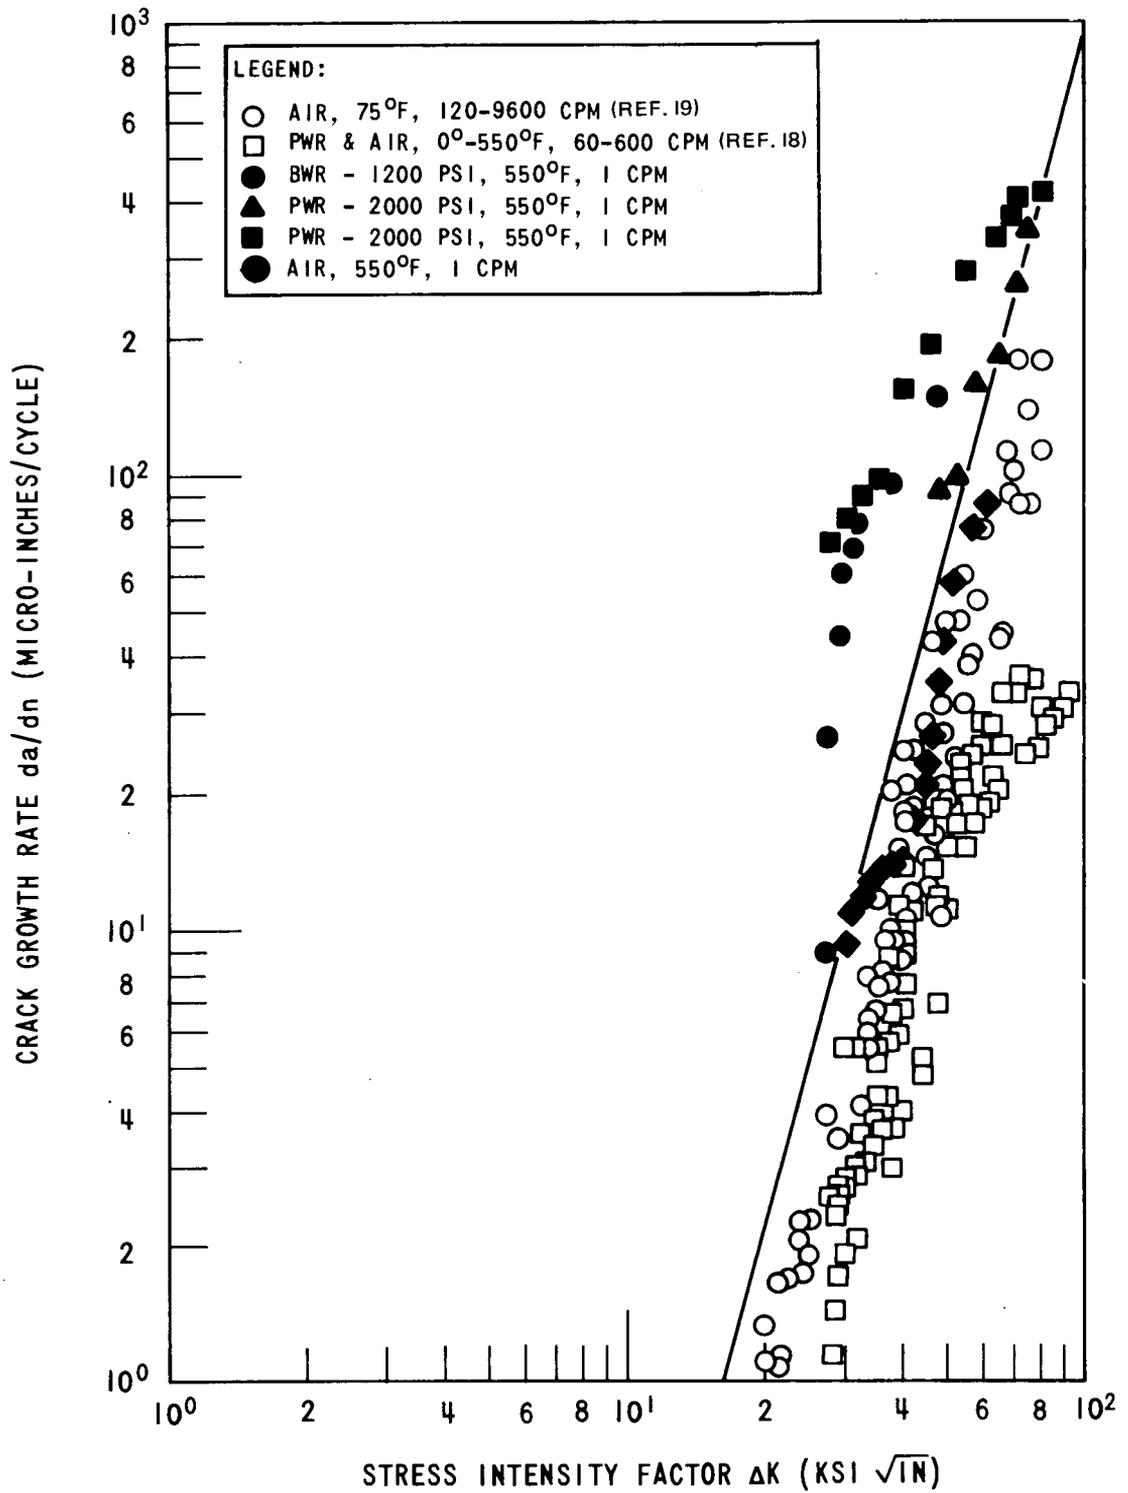
Fig. 2.17. Crack growth rates for HSST 02 material at 1 cpm frequency in PWR and BWR environments.

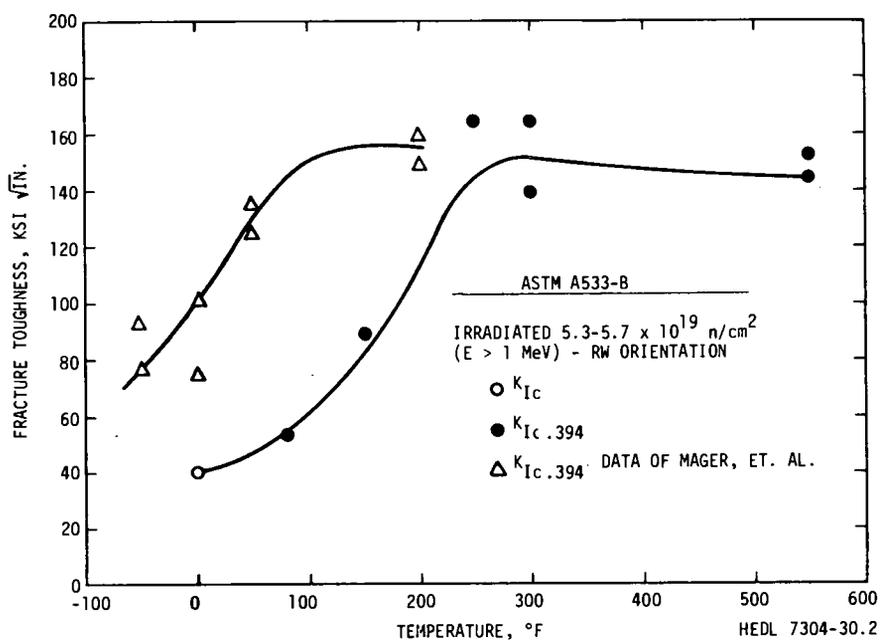
Fig. 3.1. Lower-bound $K_{Ic.394}$ toughness of ASTM A533-B, RW orientation, irradiated to 5.3 to 5.7×10^{19} neutrons/cm² ($E > 1$ MeV) at 550°F . The unirradiated data of Mager et al. are given in Ref: 6.

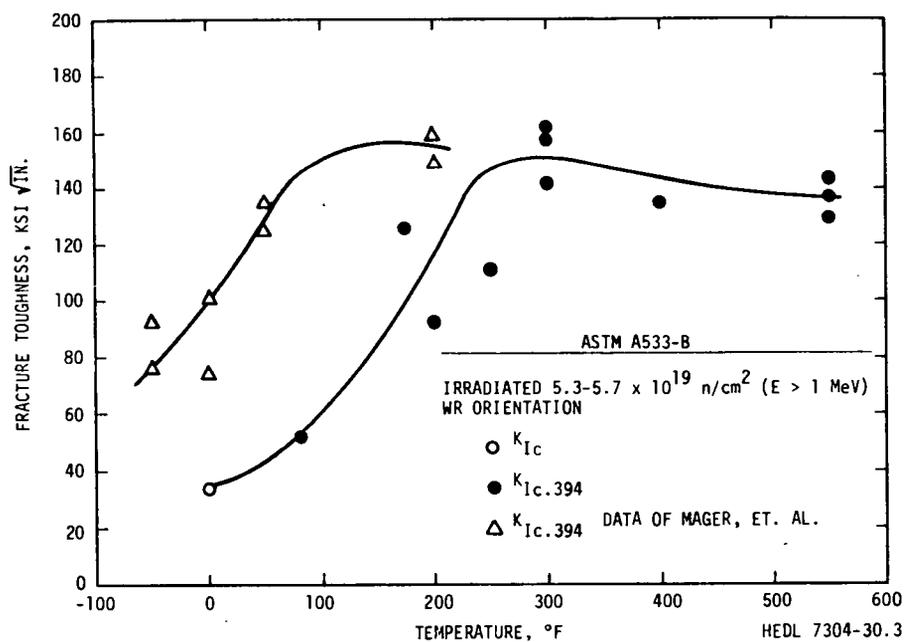
Fig. 3.2. Lower-bound $K_{Ic.394}$ toughness of ASTM A533-B, WR orientation, irradiated to 5.3 to 5.7×10^{19} neutrons/cm² ($E > 1$ MeV) at 550°F . The unirradiated data of Mager et al. are given in Ref. 6 and are from the RW orientation.

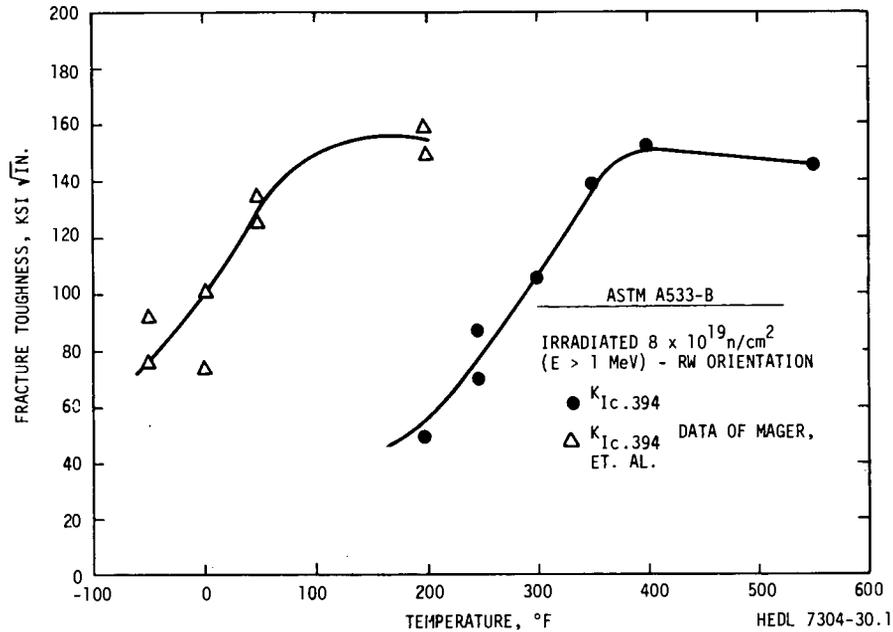
Fig. 3.3. Lower-bound $K_{Ic.394}$ toughness of ASTM A533-B, RW orientation, irradiated to 8×10^{19} neutrons/cm² ($E > 1$ MeV) at 540°F. Unirradiated data of Mager et al. are given in Ref. 6.

The results of ASTM A533-B, RW orientation, irradiated to a fluence of 8×10^{19} neutrons/cm² ($E > 1$ MeV) are shown in Fig. 3.3. A lower-bound $K_{Ic.394}$ fracture toughness of 100 ksi $\sqrt{\text{in.}}$ is reached at 290°F, and the $K_{Ic.394}$ upper shelf is fully developed at 400°F.
