ORNL-4918

HEAVY-SECTION STEEL TECHNOLOGY PROGRAM
SEMIANNUAL PROGRESS REPORT
FOR PERIOD ENDING FEBRUARY 28, 1973

F. J. Witt, Program Director

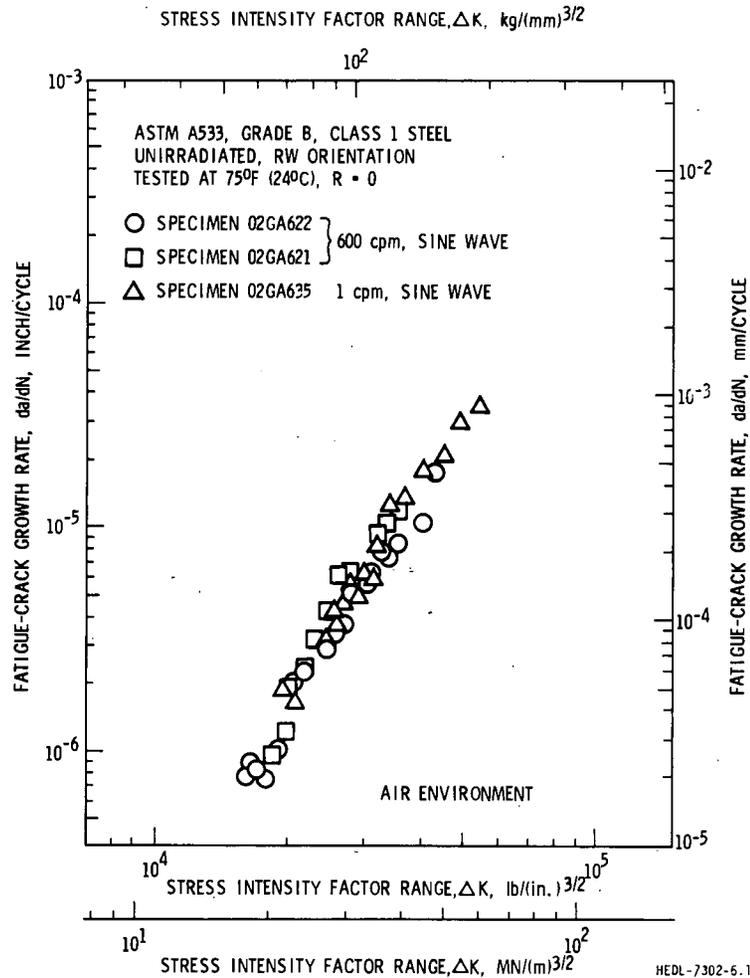
Fig. 3.4. Effect of cyclic frequency in air at 75°F on the fatigue-crack propagation behavior of ASTM A533-B.

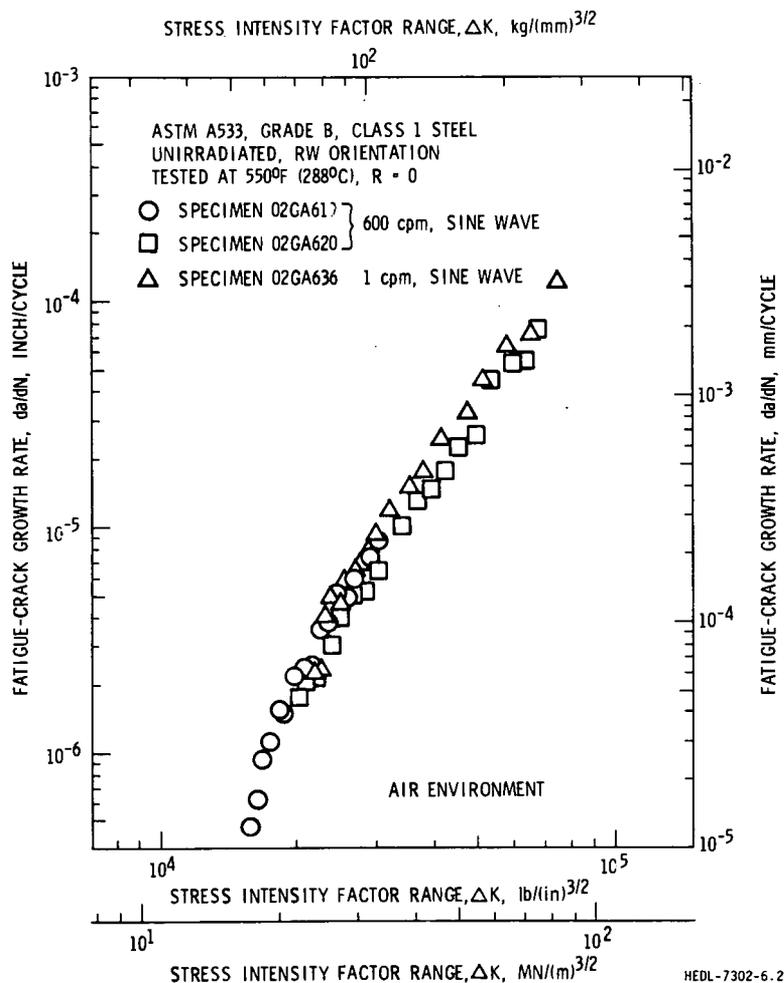
Fig. 3.5. Effect of cyclic frequency in air at 550°F on the fatigue-crack propagation behavior of ASTM A533-B.

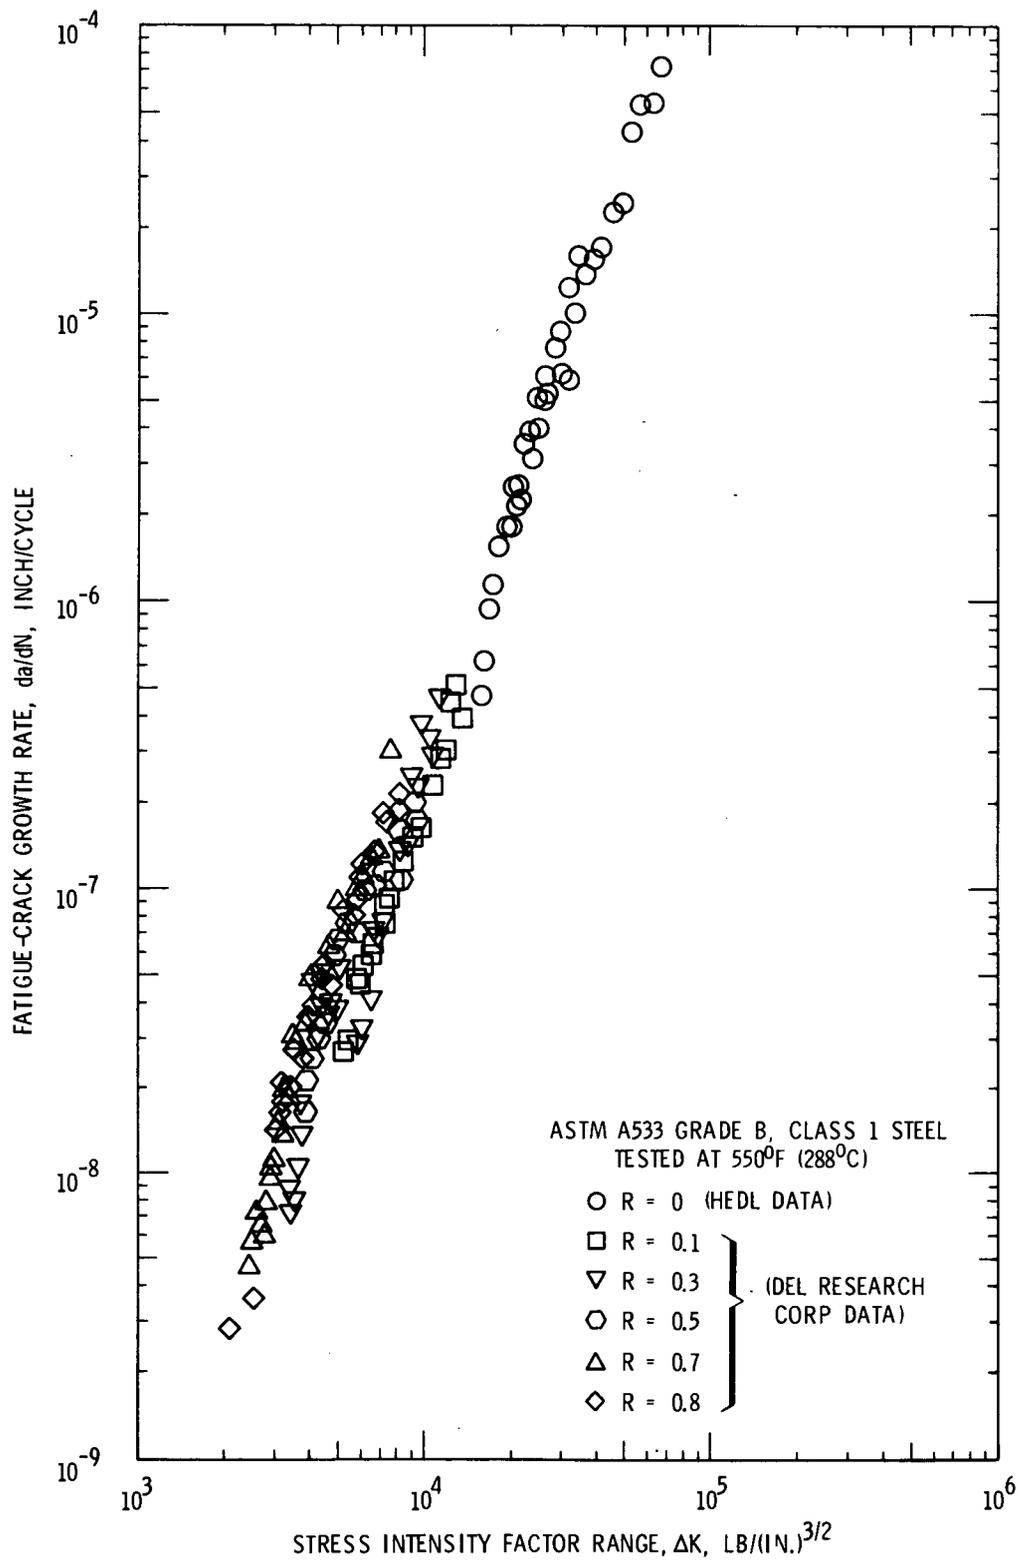
Fig. 3.6. Effect of stress ratio on the fatigue-crack growth behavior of A533-B steel at 550°F.

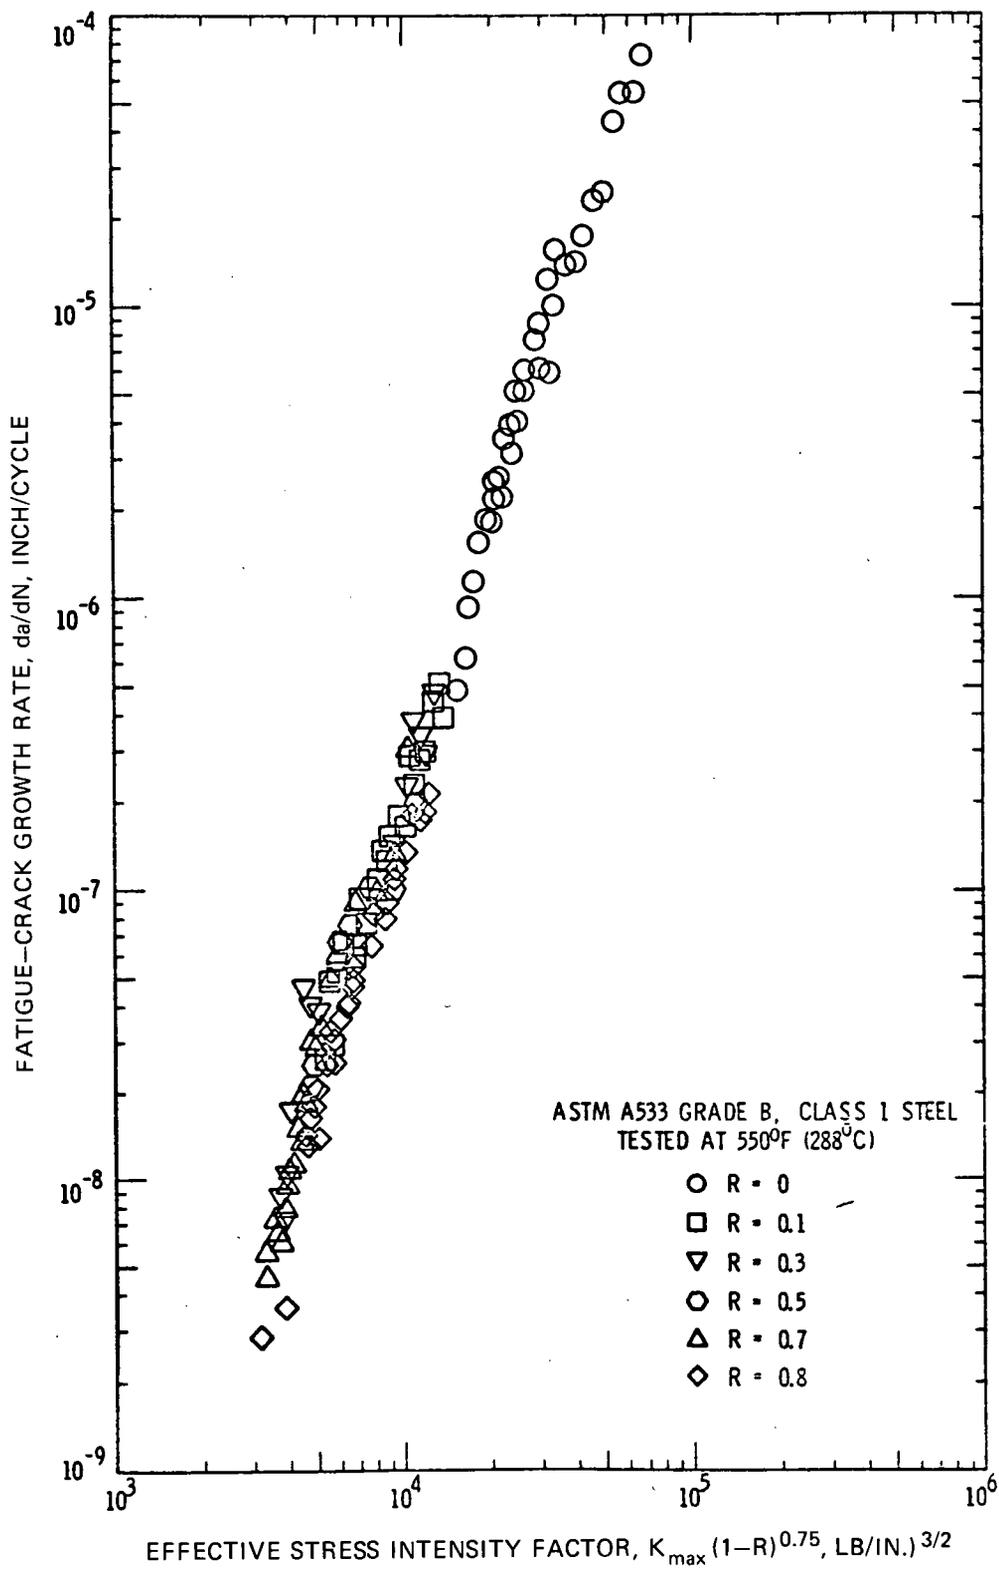
Fig. 3.7. Use of the effective stress intensity factor to correlate stress ratio effects for A533-B steel tested at 550°F.

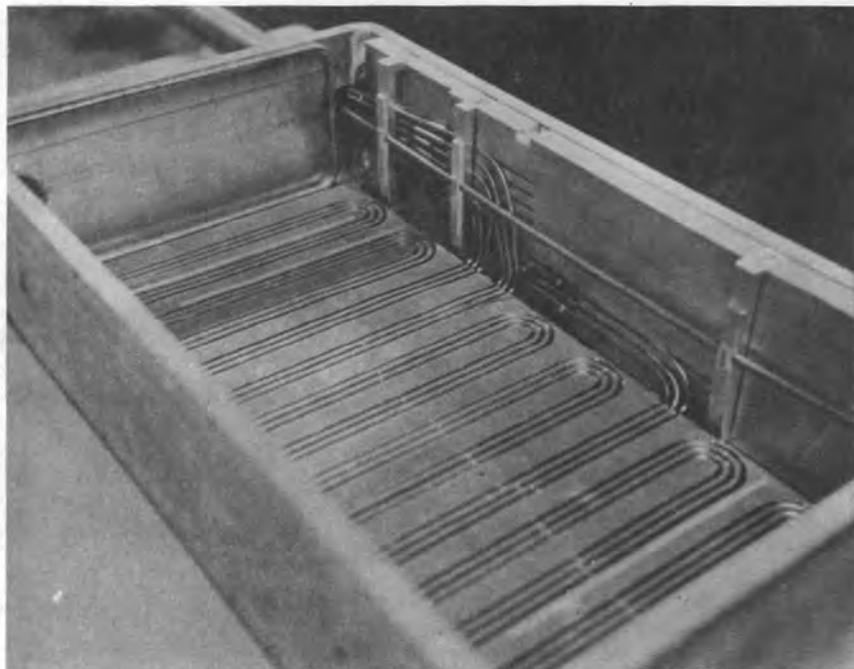
Fig. 3.8. Typical irradiation capsule prior to loading.

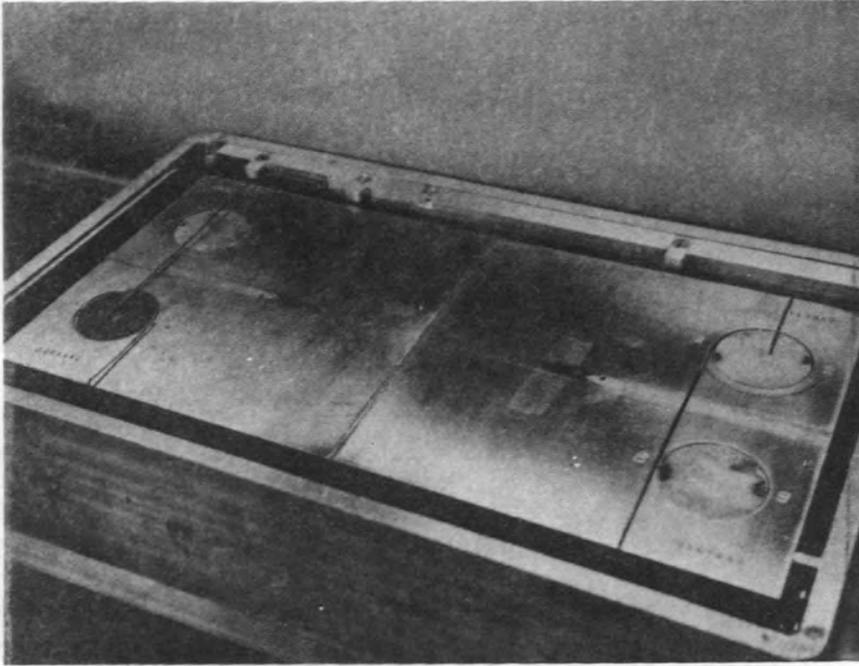
Fig. 3.9. Irradiation capsule WR showing specimens and thermocouples in place.

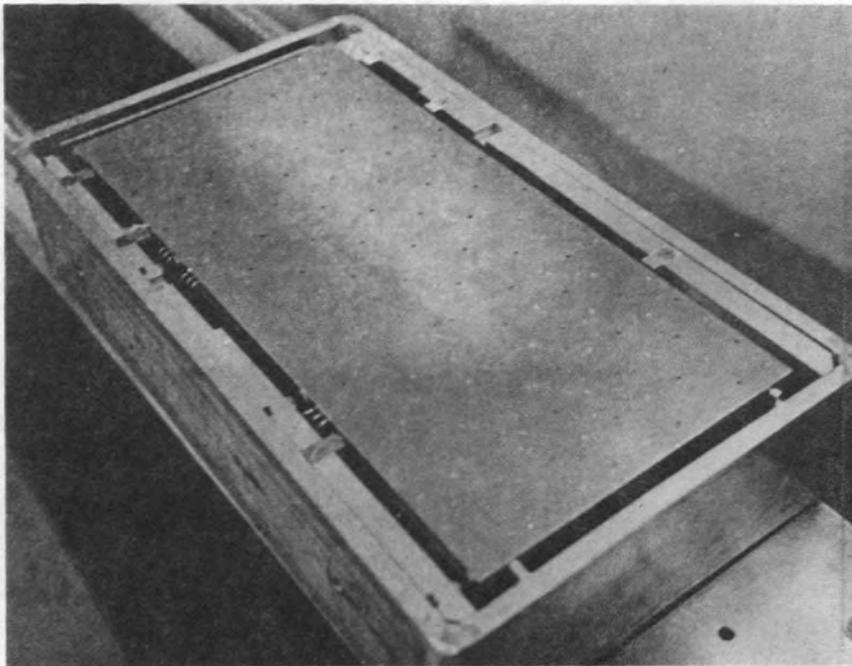
Fig. 3.10. Typical irradiation capsule with heater plate in position.

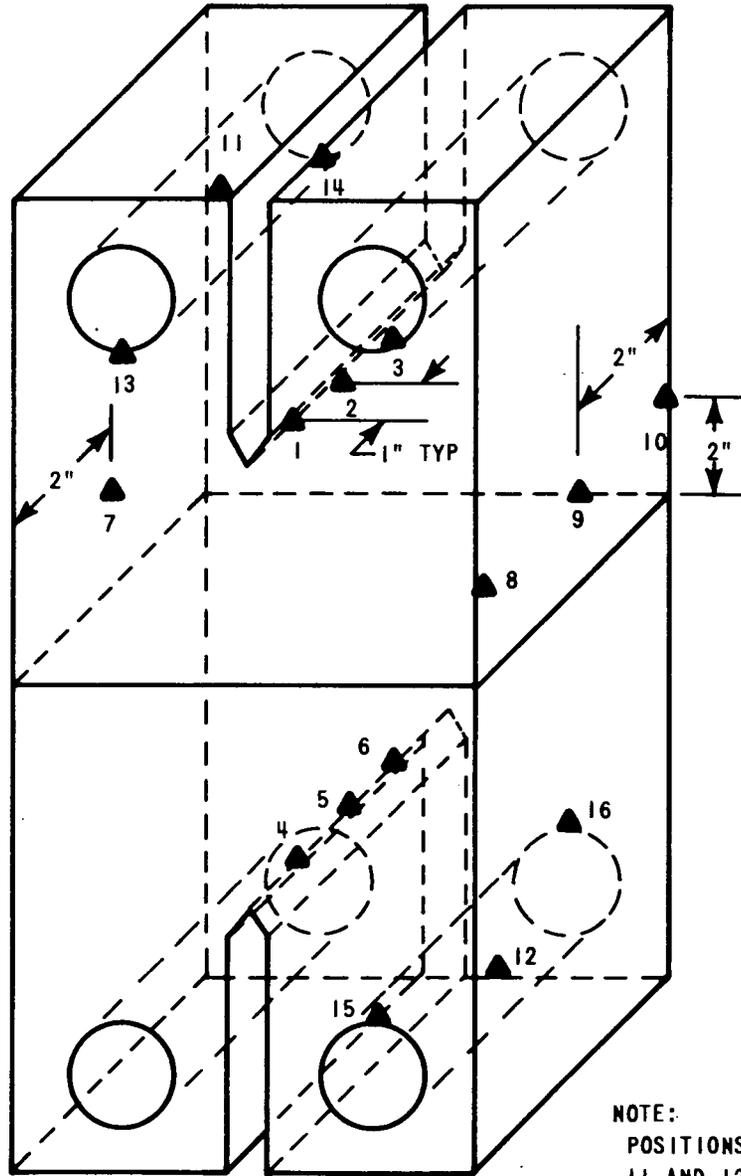
NOTE:
 POSITIONS NUMBERED
 11 AND 12 ARE DIRECT
 MEASUREMENTS OF SMALL
 SPECIMENS PACKED
 INSIDE THE HOLES.

Fig. 3.11. Thermocouple positions inside capsule.

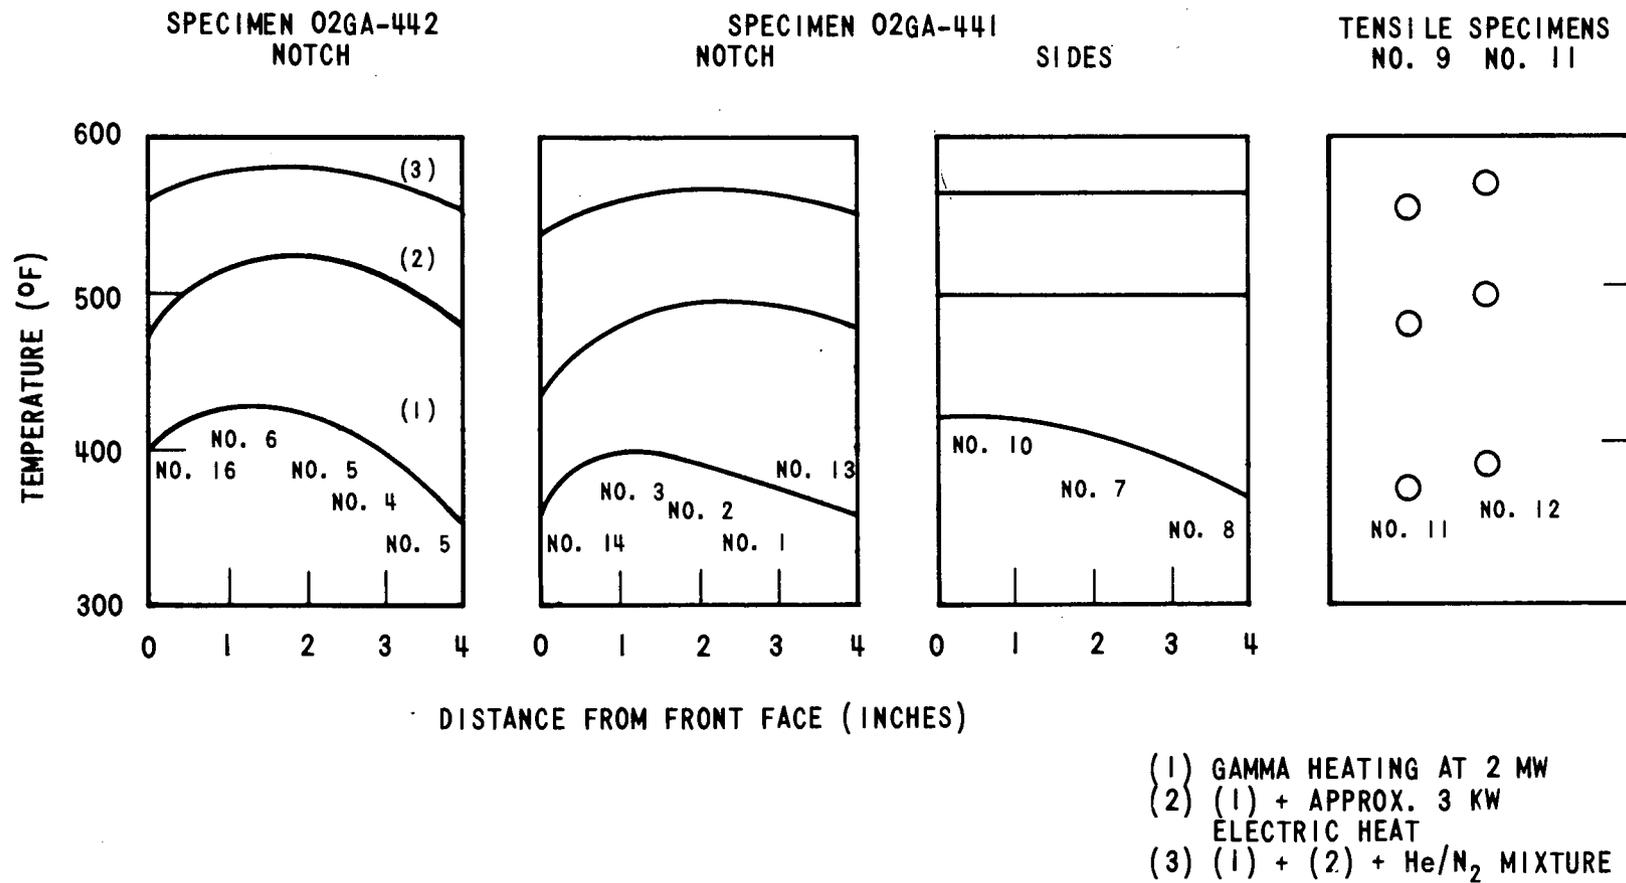
Fig. 3.12. Initial temperature data from capsule WR.

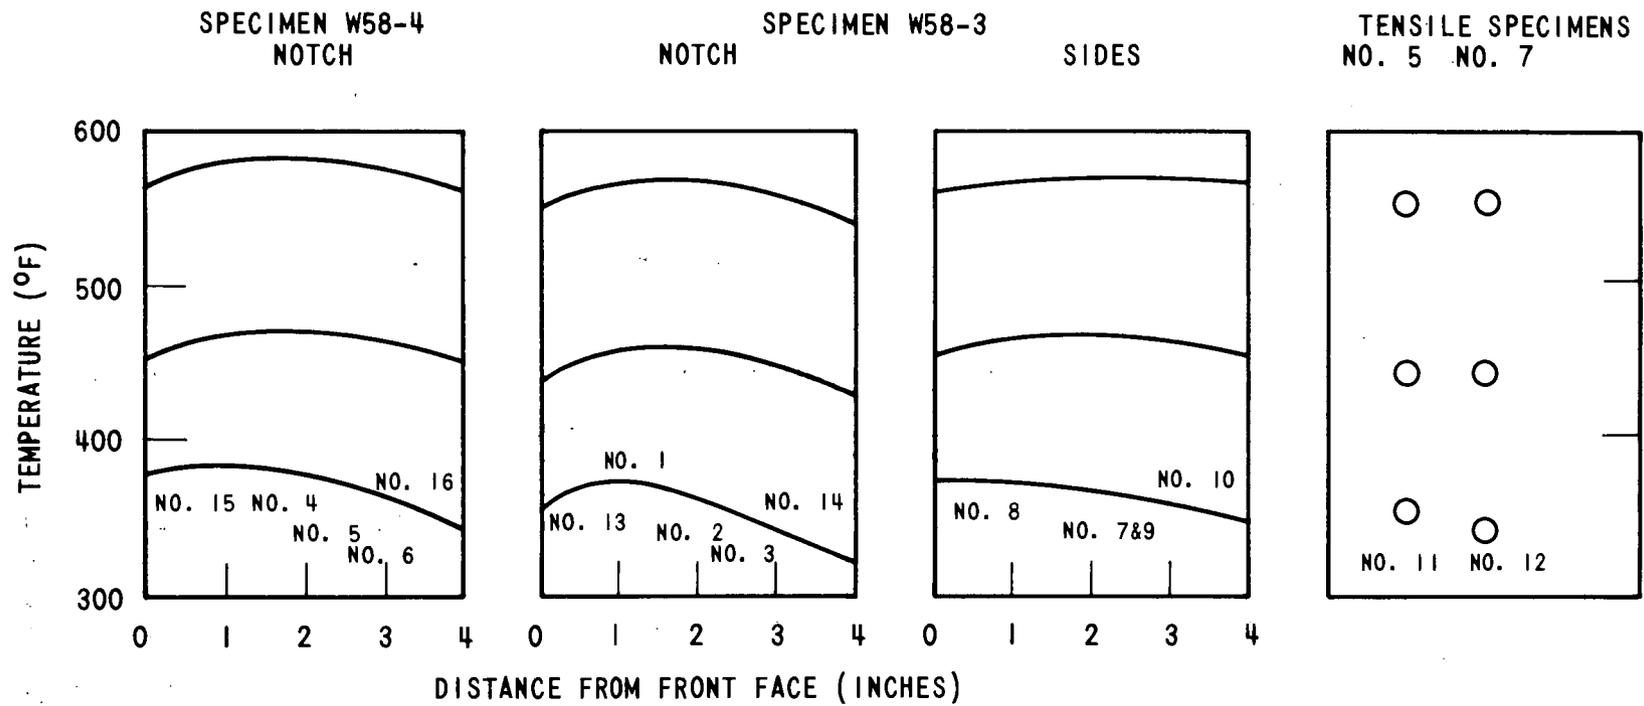
- (1) GAMMA HEATING AT 2 MW
- (2) (1) + APPROX. 2-3/4 KW ELECTRIC HEAT
- (3) (1) + (2) + He/N₂ MIXTURE

Fig. 3.13. Initial temperature data from capsule RW.

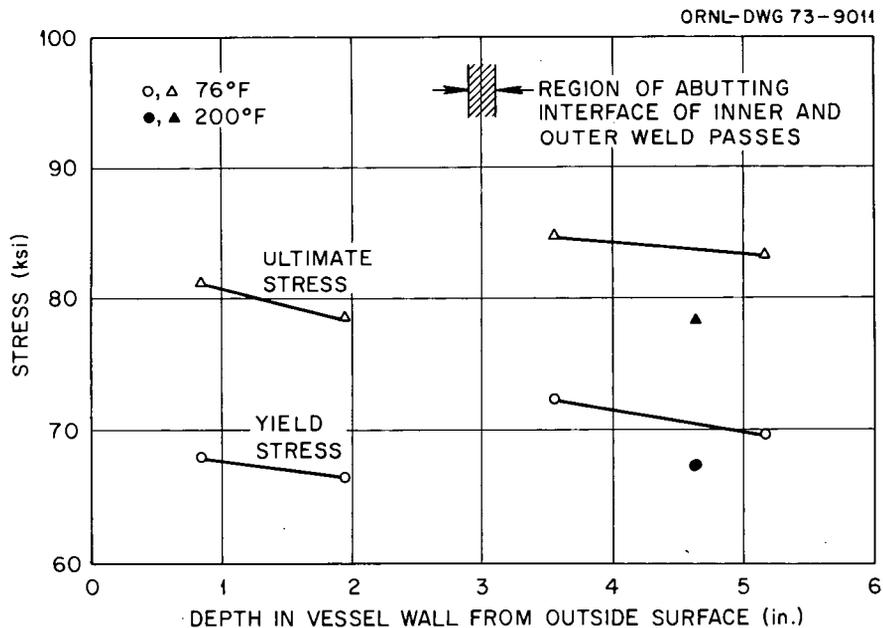
Fig. 4.1. Tensile properties obtained from intermediate vessel V-3 using C-oriented subsized tensile specimens from a 6-in.-thick weld in ASTM A508, class 2 forging steel.

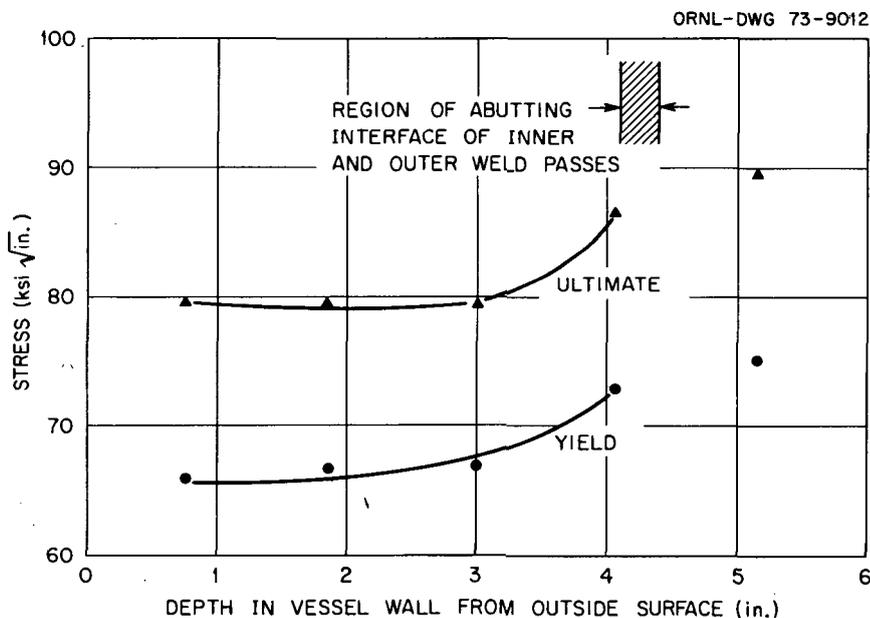
Fig. 4.2. Tensile properties obtained from intermediate vessel V-4 using C-oriented subsized tensile specimens from a 6-in.-thick weld in ASTM A508, class 2 forging steel.

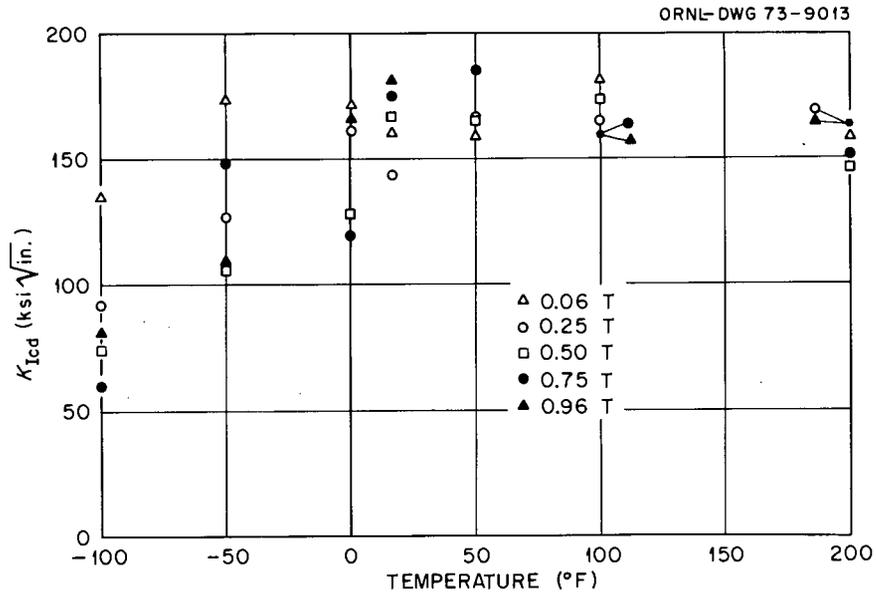
Fig. 4.3. Lower-bound fracture toughness values obtained from intermediate vessel V-2 using CA-oriented precracked Charpy-V specimens from 6-in.-thick ASTM A508, class 2 forging steel.

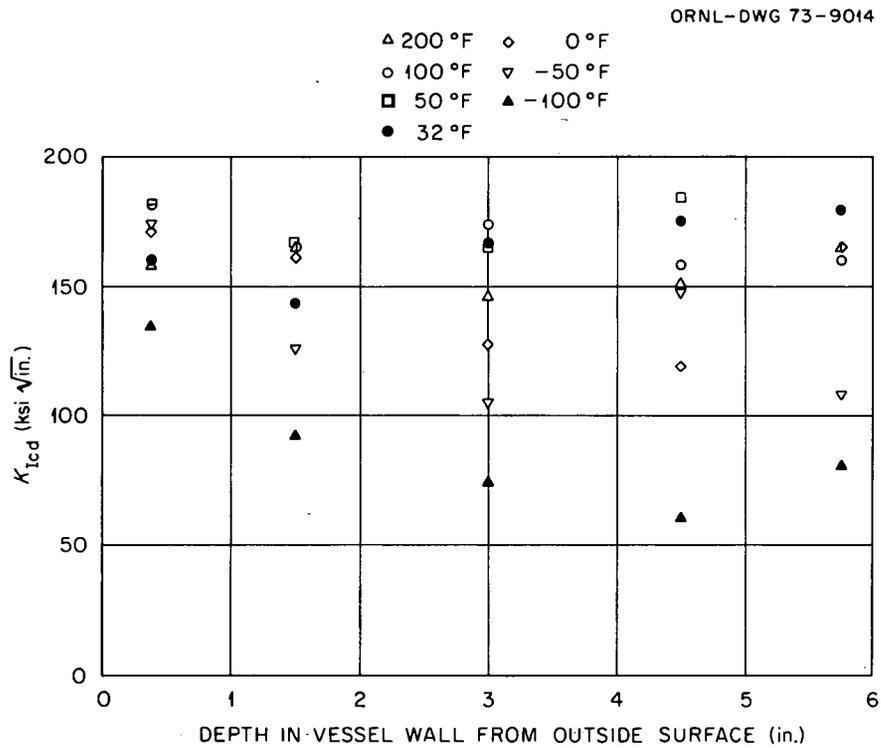
Fig. 4.4. Lower-bound fracture toughness values obtained from intermediate vessel V-2 using CA-oriented precracked Charpy-V specimens from 6-in.-thick ASTM A508, class 2 forging steel.

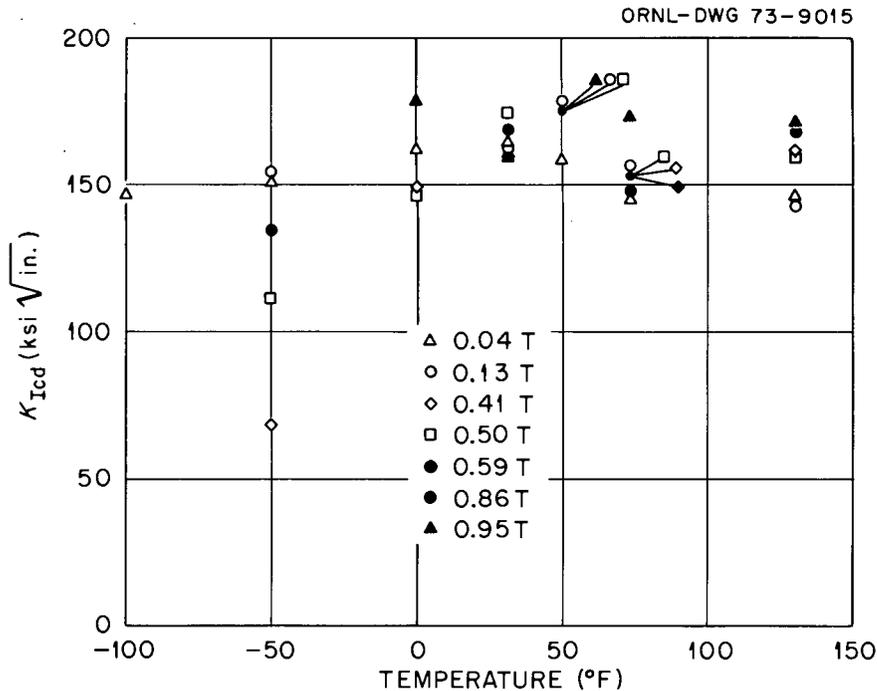
Fig. 4.5. Lower-bound fracture toughness values obtained from intermediate vessel V-4 using CA-oriented precracked Charpy-V specimens from 6-in.-thick ASTM A508, class 2 forging steel.

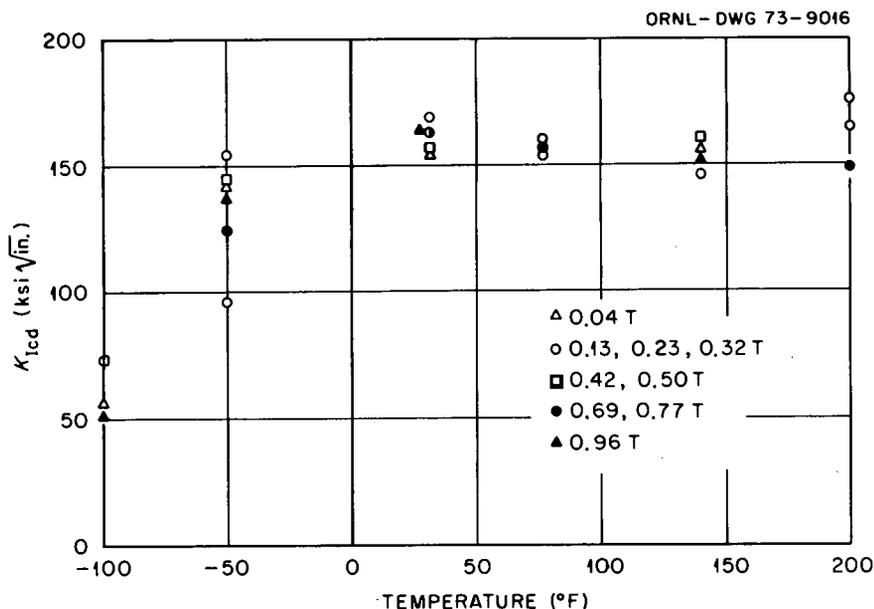
Fig. 4.6. Lower-bound fracture toughness values obtained from intermediate vessel V-3 using CA-oriented precracked Charpy-V specimens from a 6-in.-thick weld in ASTM A508, class 2 forging steel.

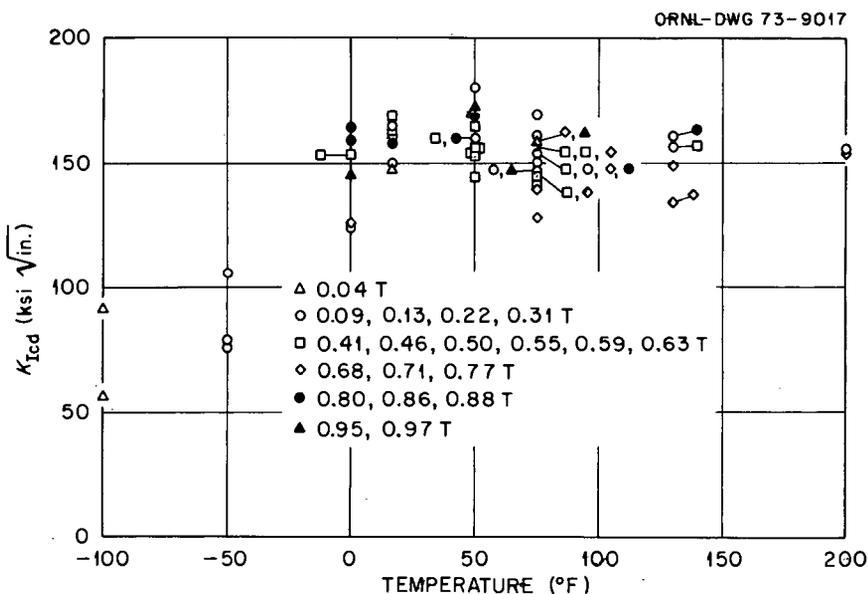
Fig. 4.7. Lower-bound fracture toughness values obtained from intermediate vessel V-4 using CA-oriented precracked Charpy-V specimens from a 6-in.-thick weld in ASTM A508, class 2 forging steel.

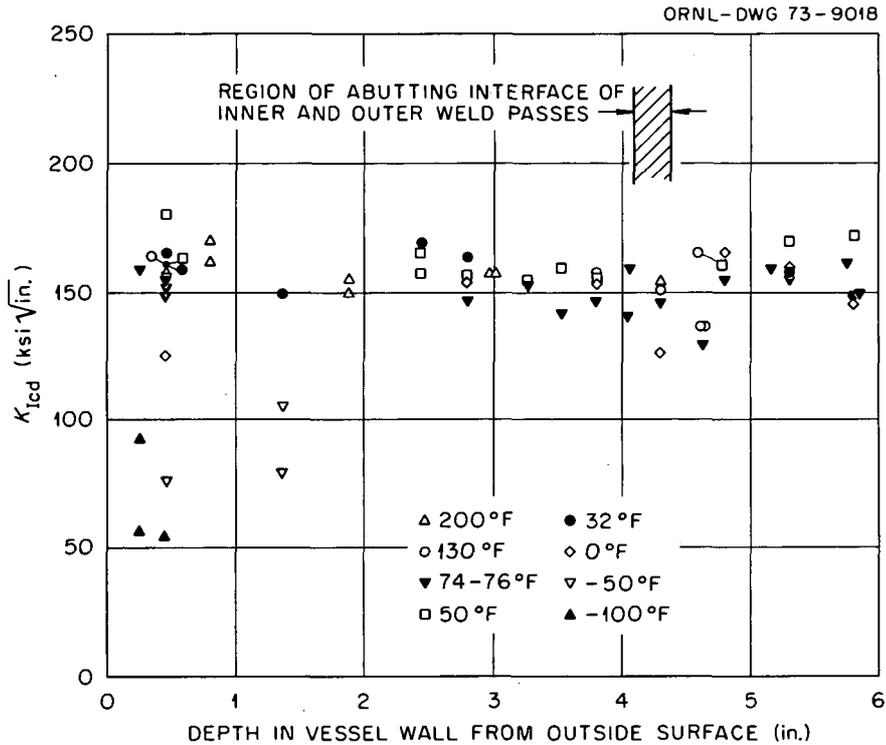
Fig. 4.8. Lower-bound fracture toughness values obtained from intermediate vessel V-4 using CA-oriented precracked Charpy-V specimens from a 6-in.-thick weld in ASTM A508 class 2 forging steel.

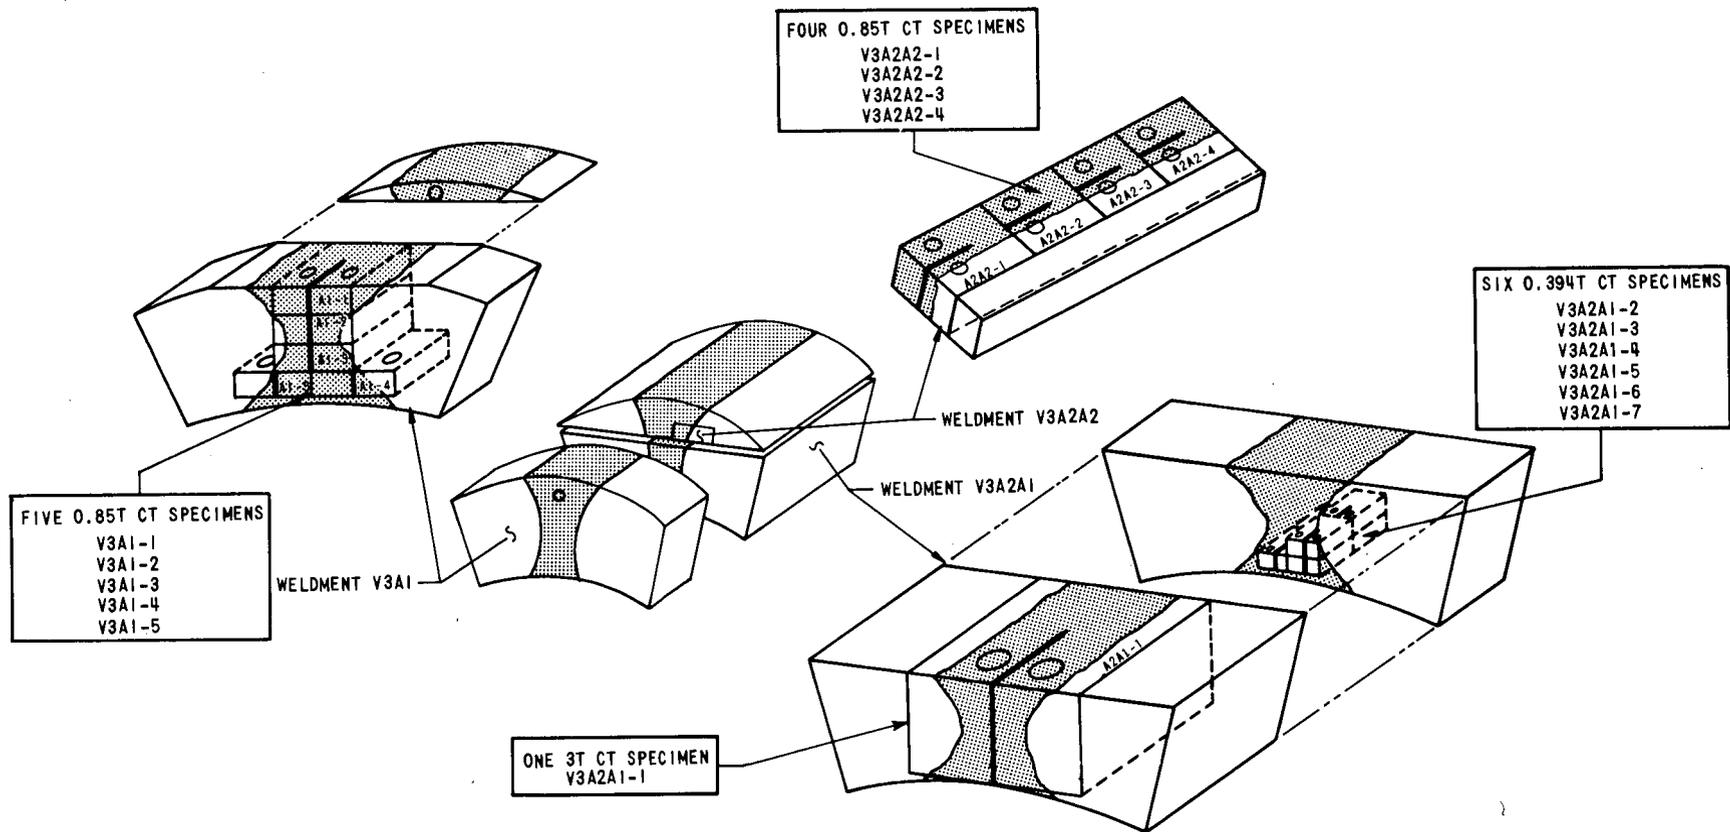
Fig. 4.9. Machining of fracture toughness specimens from HSST intermediate pressure vessel V-3 weldment.

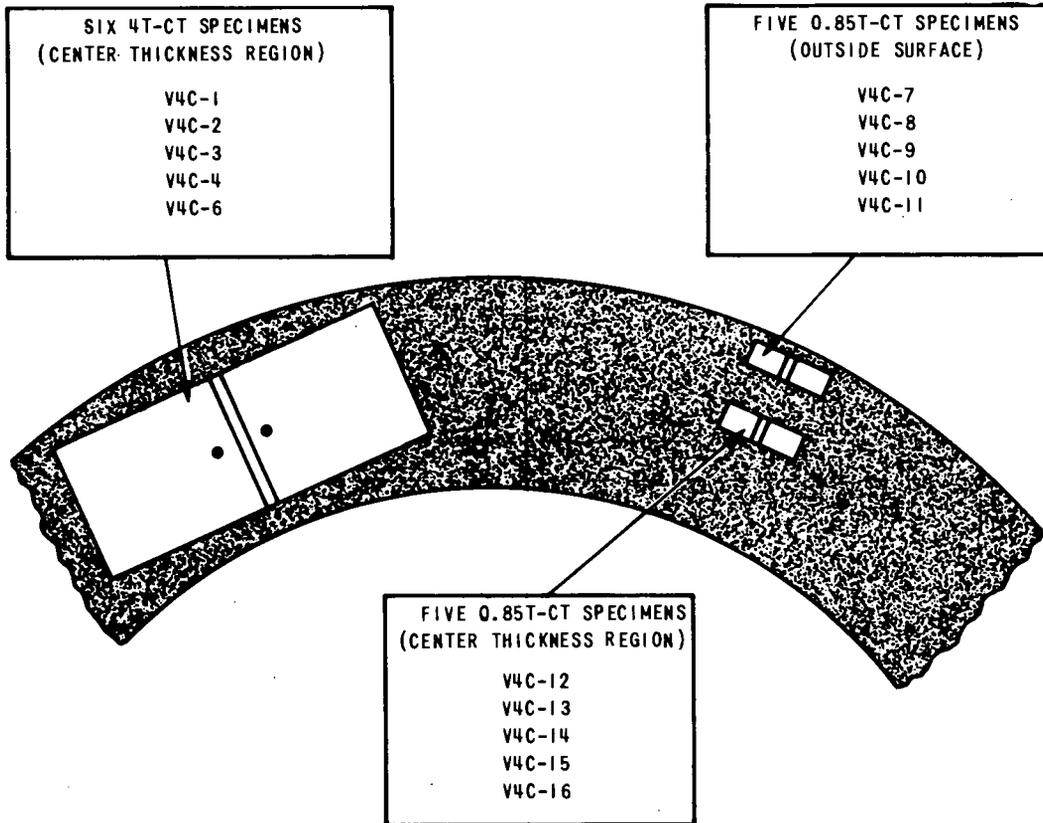
Fig. 4.11. Machining of fracture toughness specimens from HSST intermediate pressure vessel V-4 base metal.

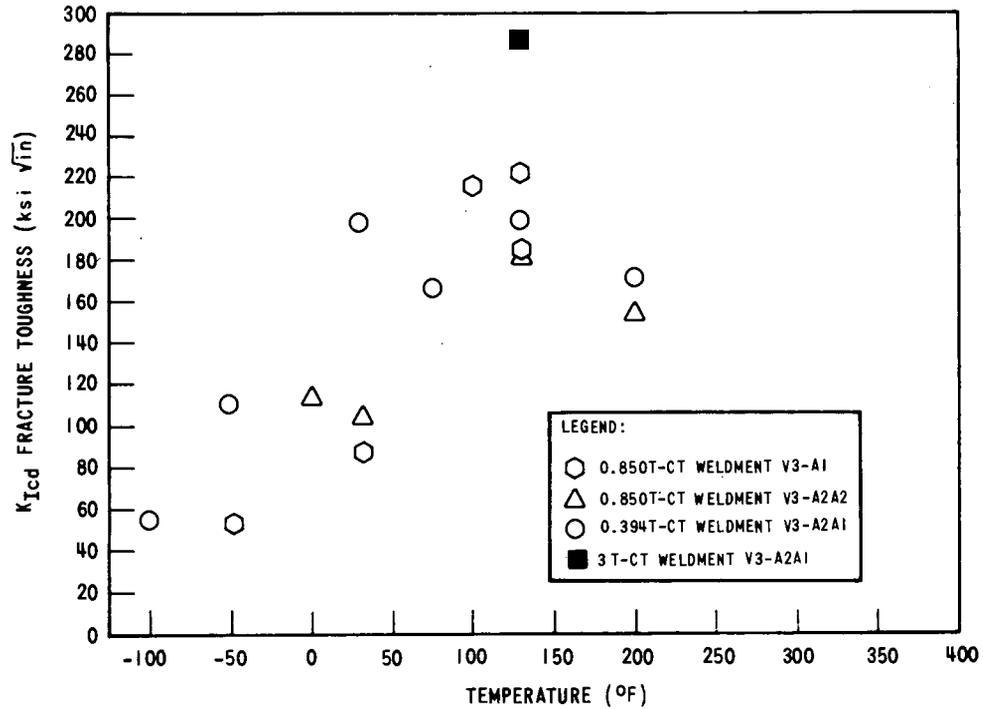
Fig. 4.12. Fracture toughness data for HSST intermediate pressure vessel V-3 weldment material.

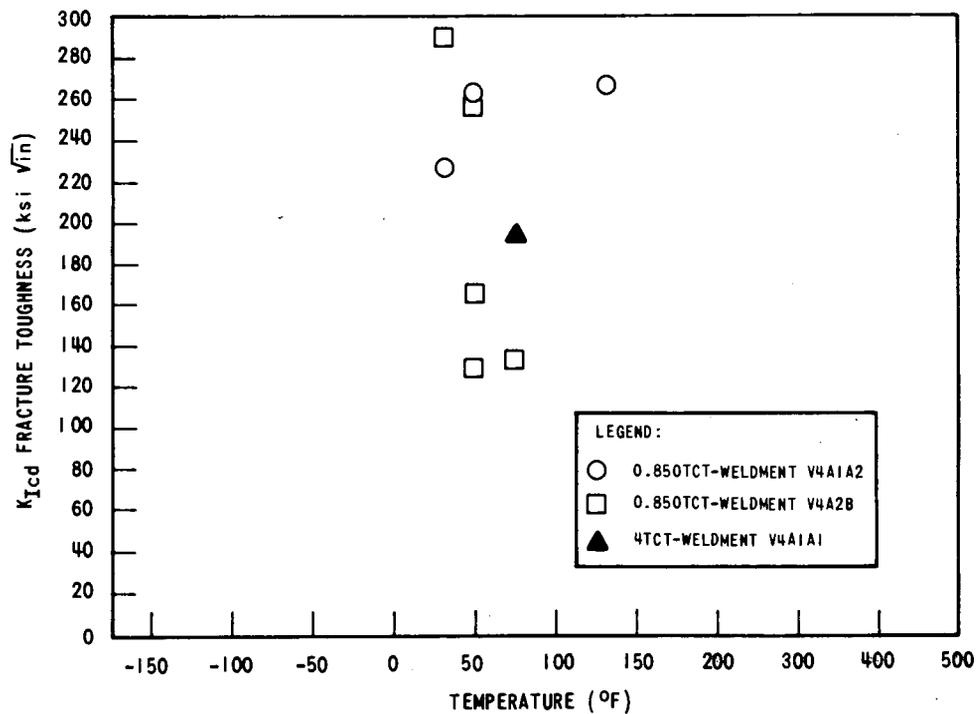
Fig. 4.13. Fracture toughness data for HSST intermediate pressure vessel V-4 weldment material.

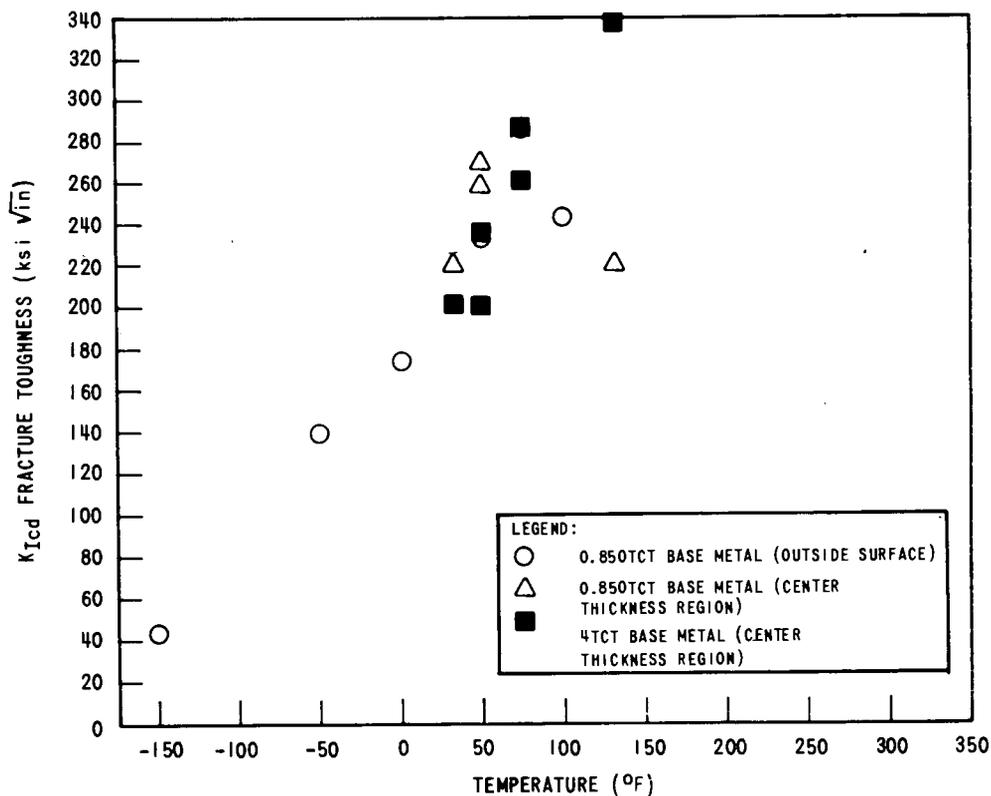
Fig. 4.14. Fracture toughness data for HSST intermediate pressure vessel V-4 base metal.

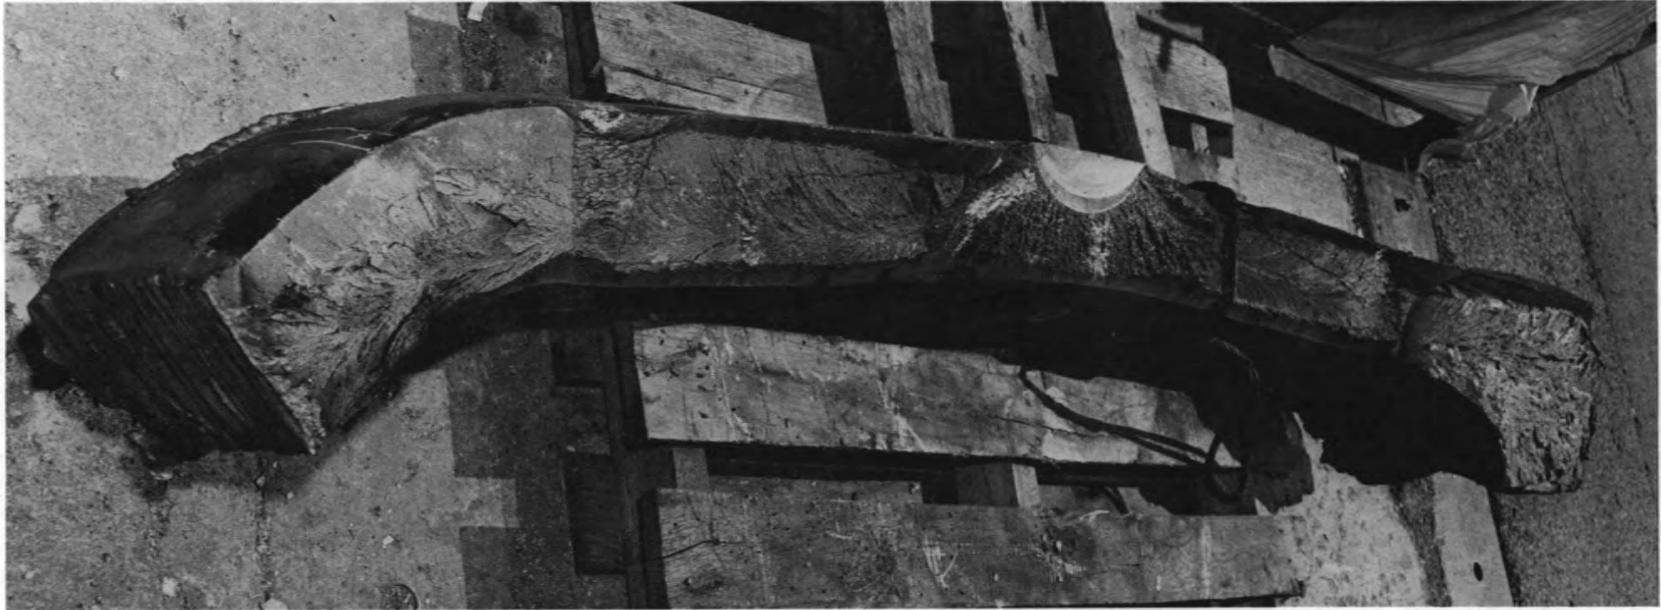
Fig. 4.15. Photograph of fracture surface from intermediate test vessel V-1.

A study of the fracture surface of intermediate test vessel V-1 revealed a mixed mode of fracture. Initial crack growth is by ductile tearing. The growth is by tunneling and continues until the flaw size is such that unstable crack growth can occur. This results in a transition from a dimpled fracture mode to one wherein cleavage was the mode of failure.

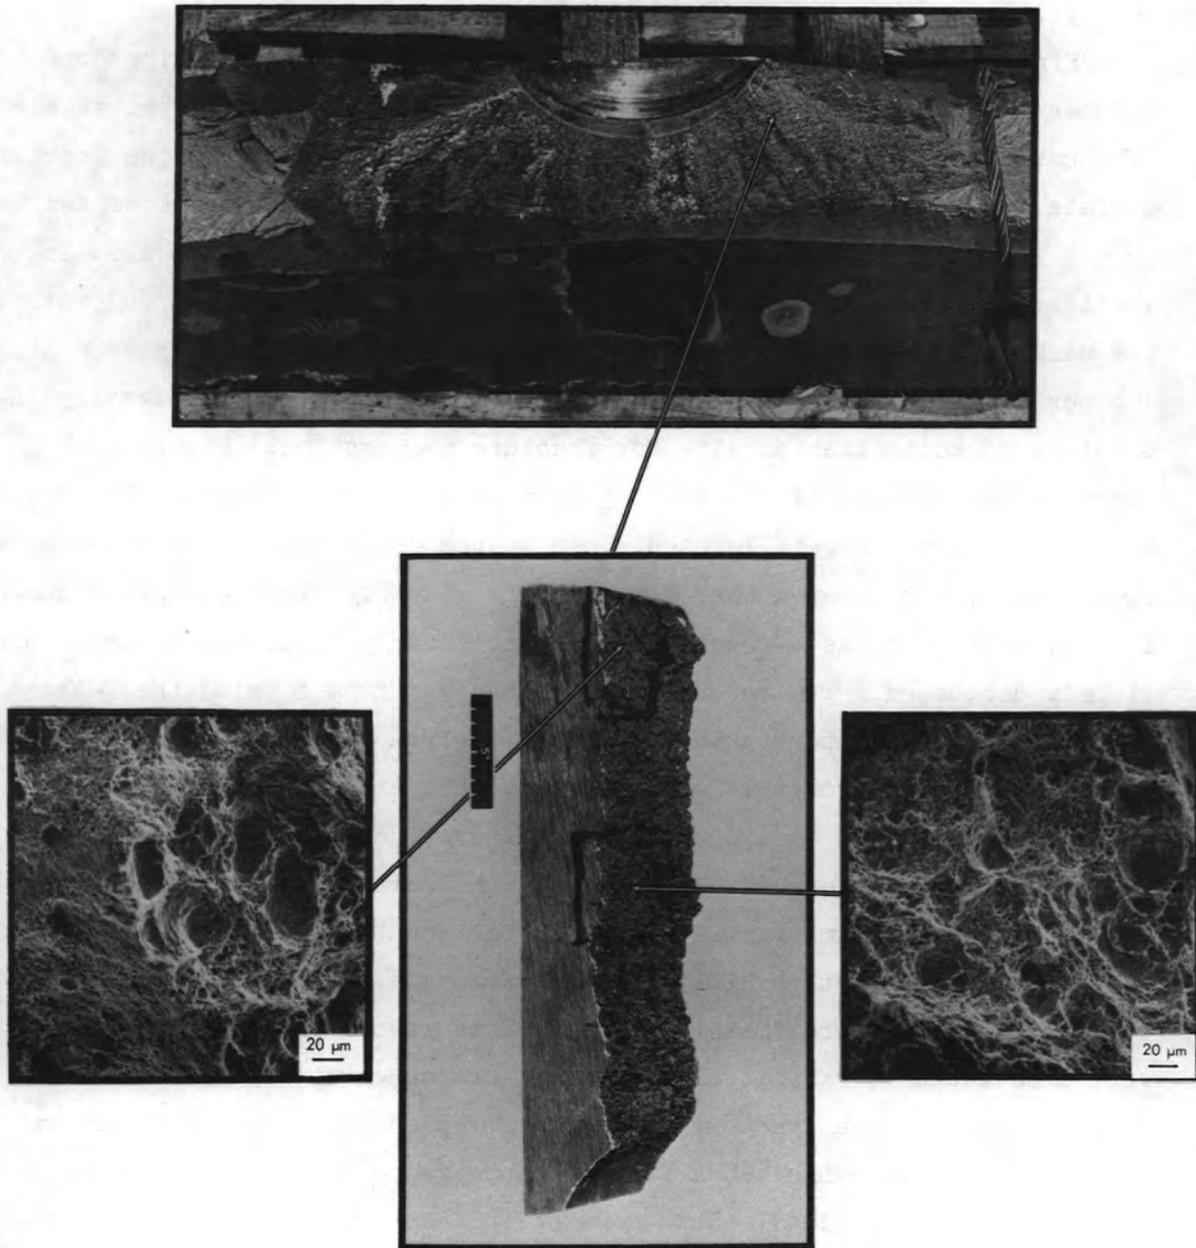
Fig. 4.16. Results of scanning electron microscopy study of fracture surface near the machined flaw. The two areas shown illustrate dimple mode of failure.
