ORNL-4918

HEAVY-SECTION STEEL TECHNOLOGY PROGRAM
SEMIANNUAL PROGRESS REPORT
FOR PERIOD ENDING FEBRUARY 28, 1973

F. J. Witt, Program Director

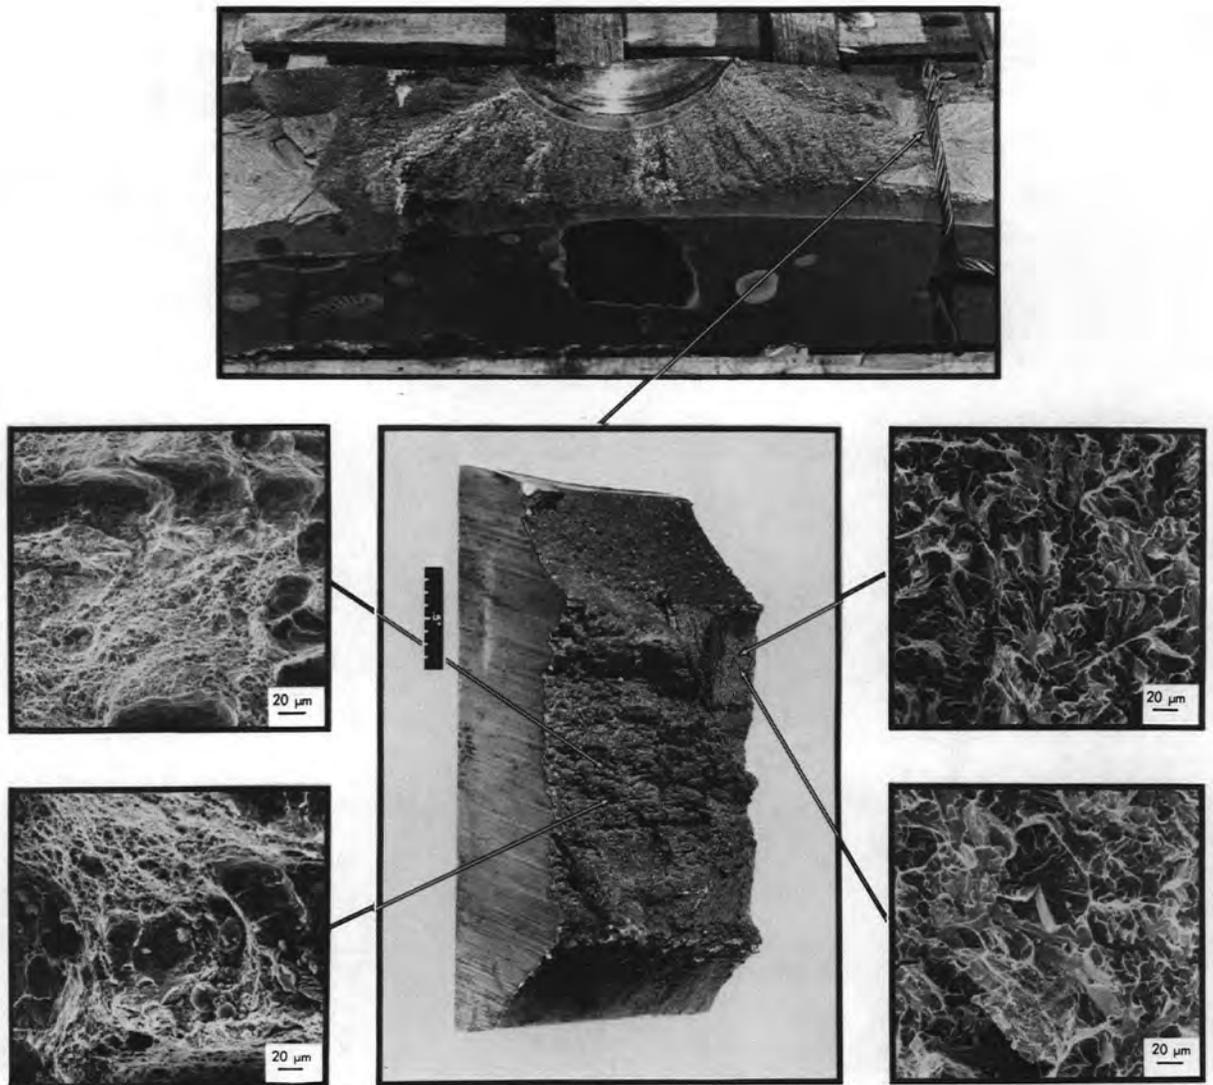
Fig. 4.17. Results of scanning electron microscopy study of region where failure mode changed from dimple to cleavage. SEM photomicrographs on left are dimples; those on the right show the cleavage mode of failure.

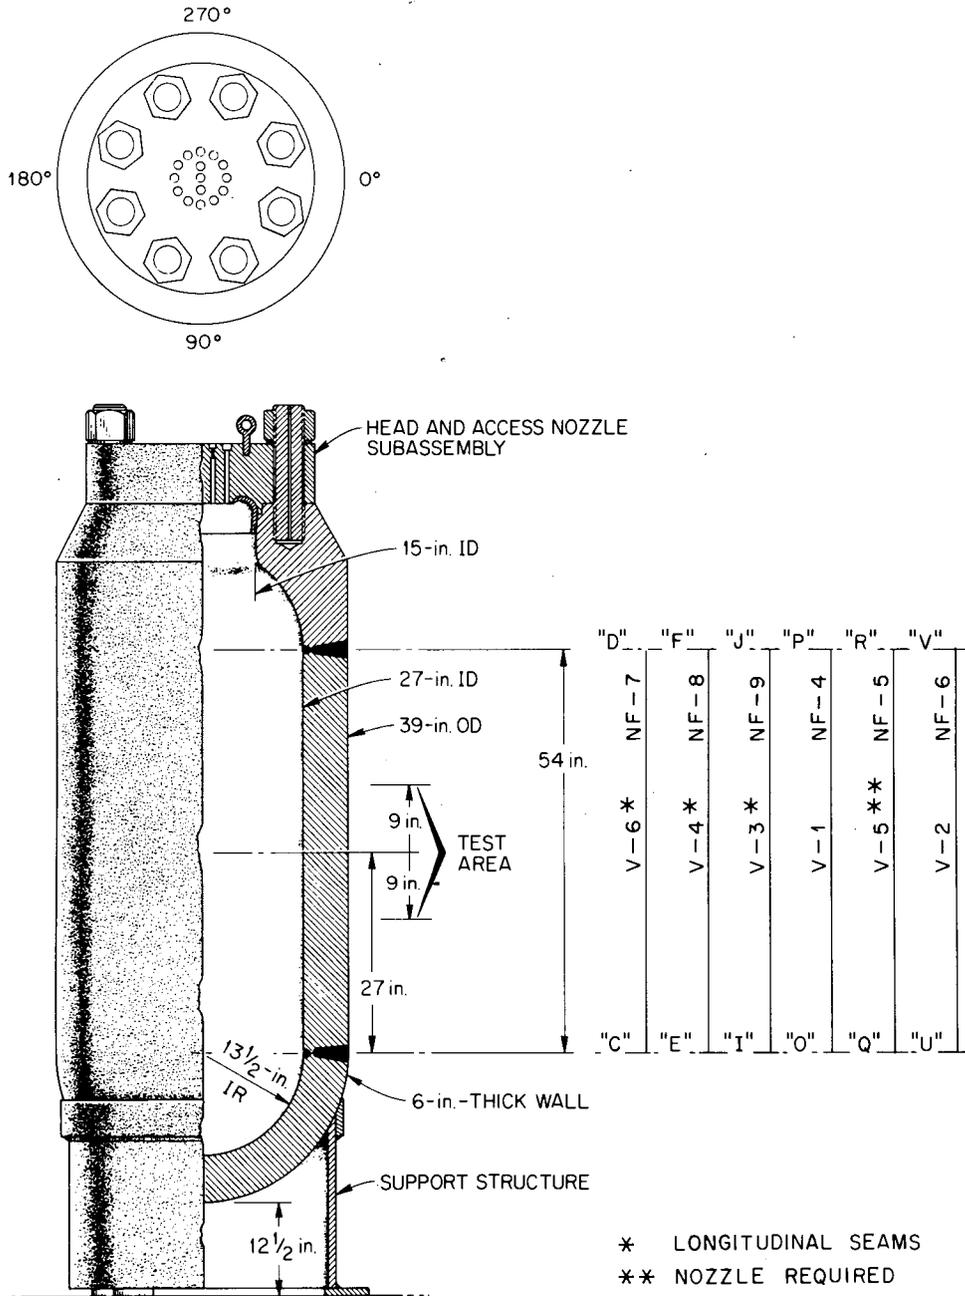
Fig. 4.18. Orientation of shell courses for intermediate test vessels.

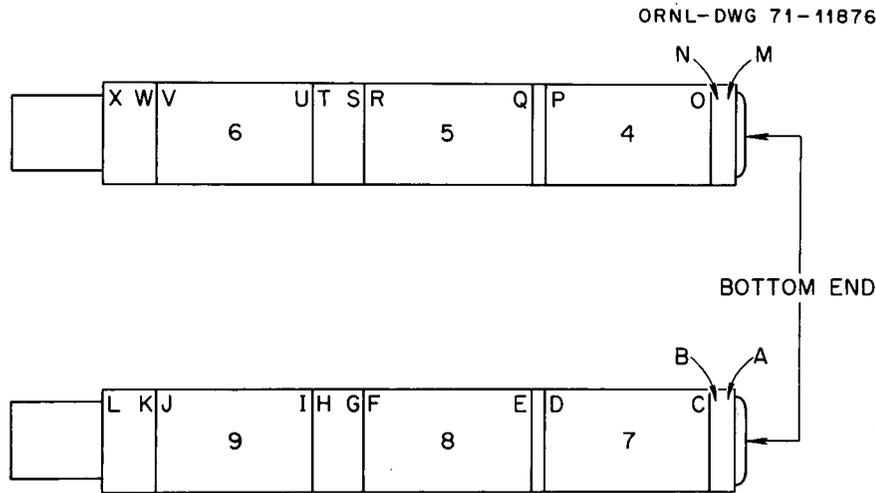
Fig. 4.19. Identification of shell courses by National Forge.

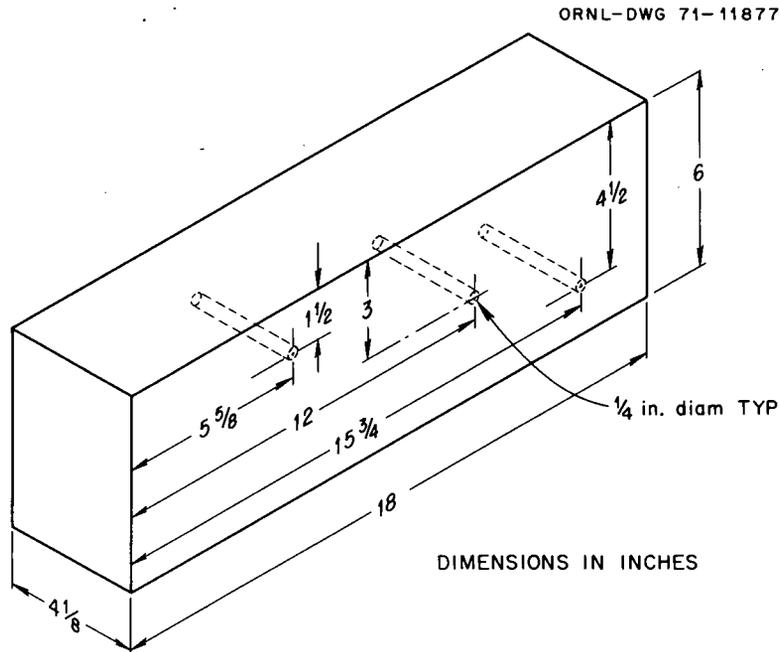
Fig. 4.20. Ultrasonic reference standard.

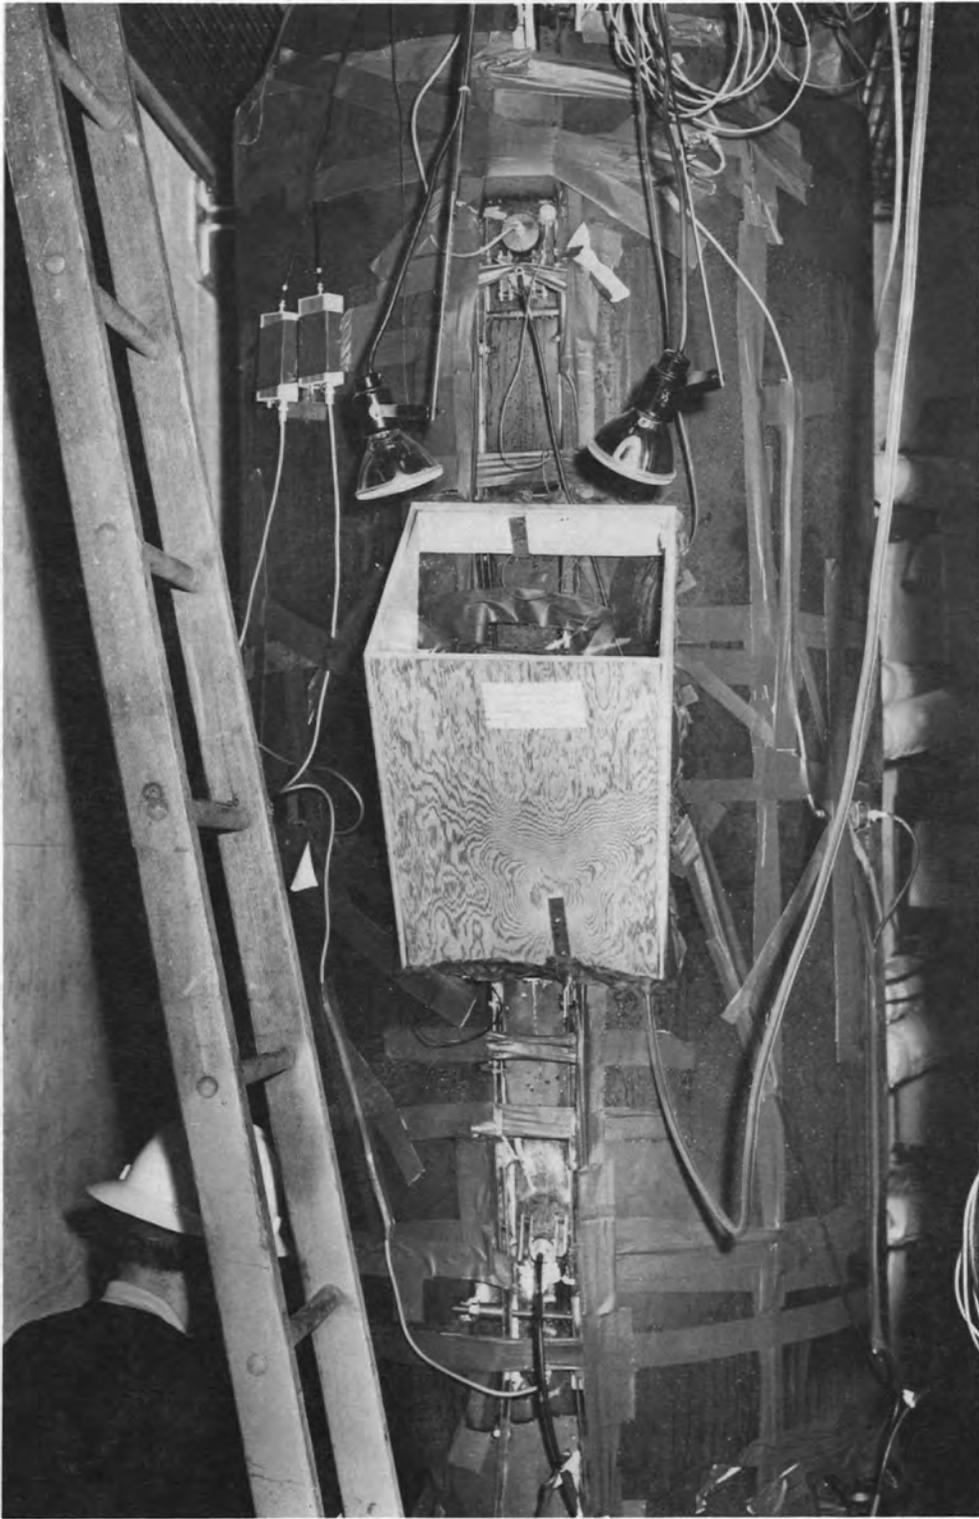
Fig. 4.21. Intermediate test vessel V-2 fully instrumented and ready for testing.

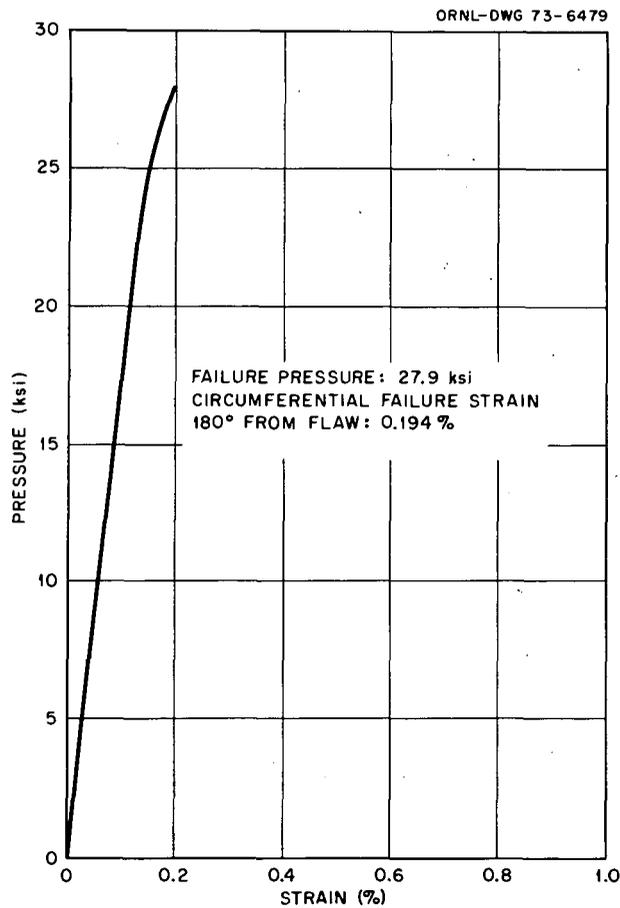
Fig. 4.22. Pressure-outside surface circumferential strain curve 180° from flaw - intermediate test vessel V-2.

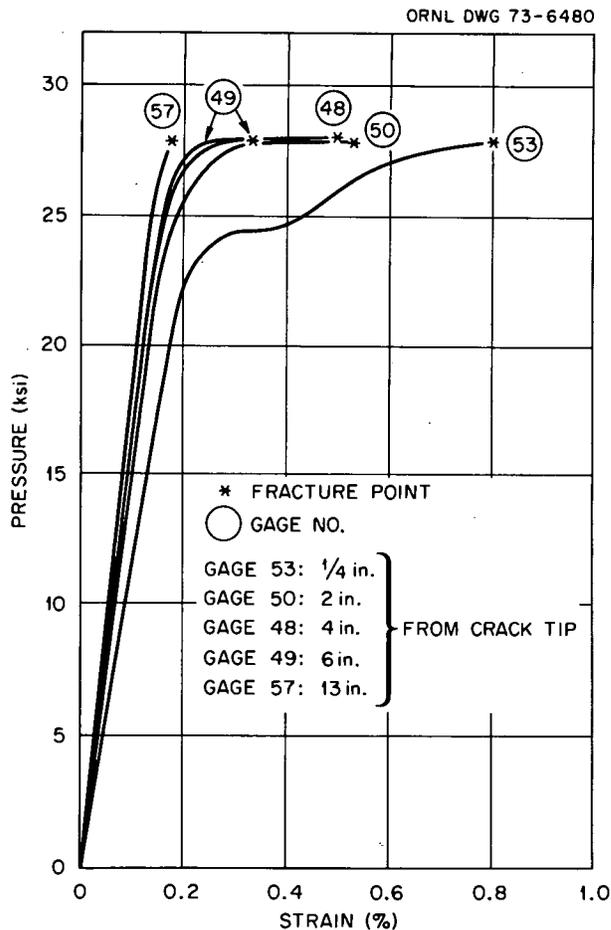
Fig. 4.23. Pressure—outside surface circumferential strain curves in line with flaw — intermediate test vessel V-2.

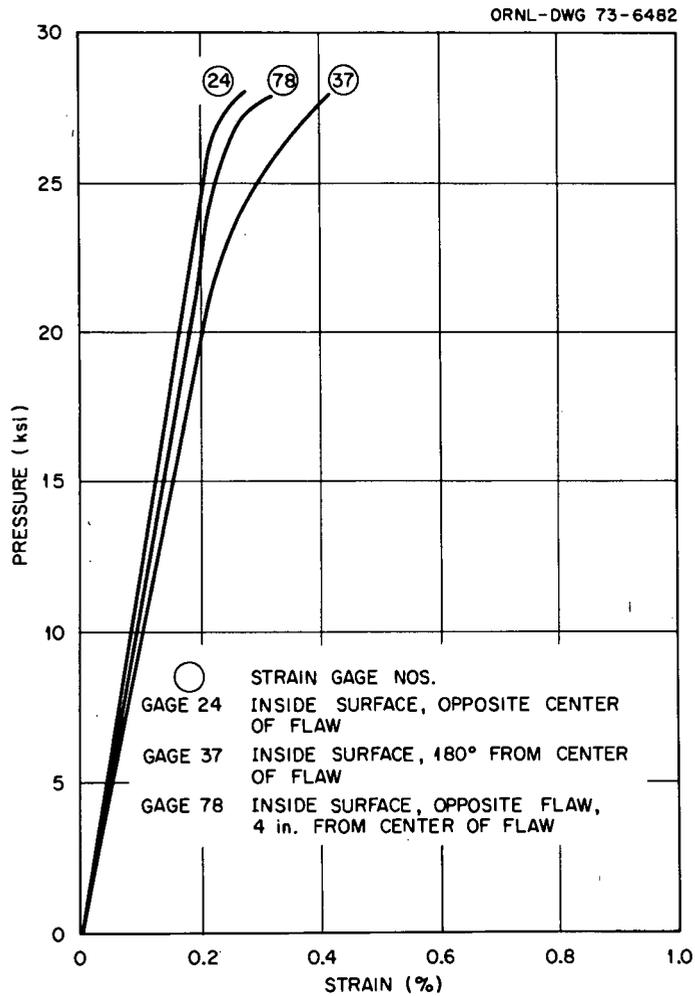
Fig. 4.24. Comparison of pressure-inside surface circumferential strain curves - intermediate test vessel V-2.

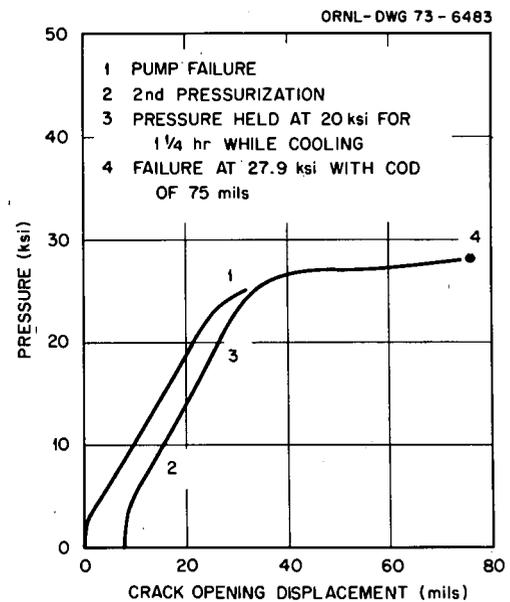
Fig. 4.25. Crack opening displacement vs pressure - intermediate test vessel V-2.

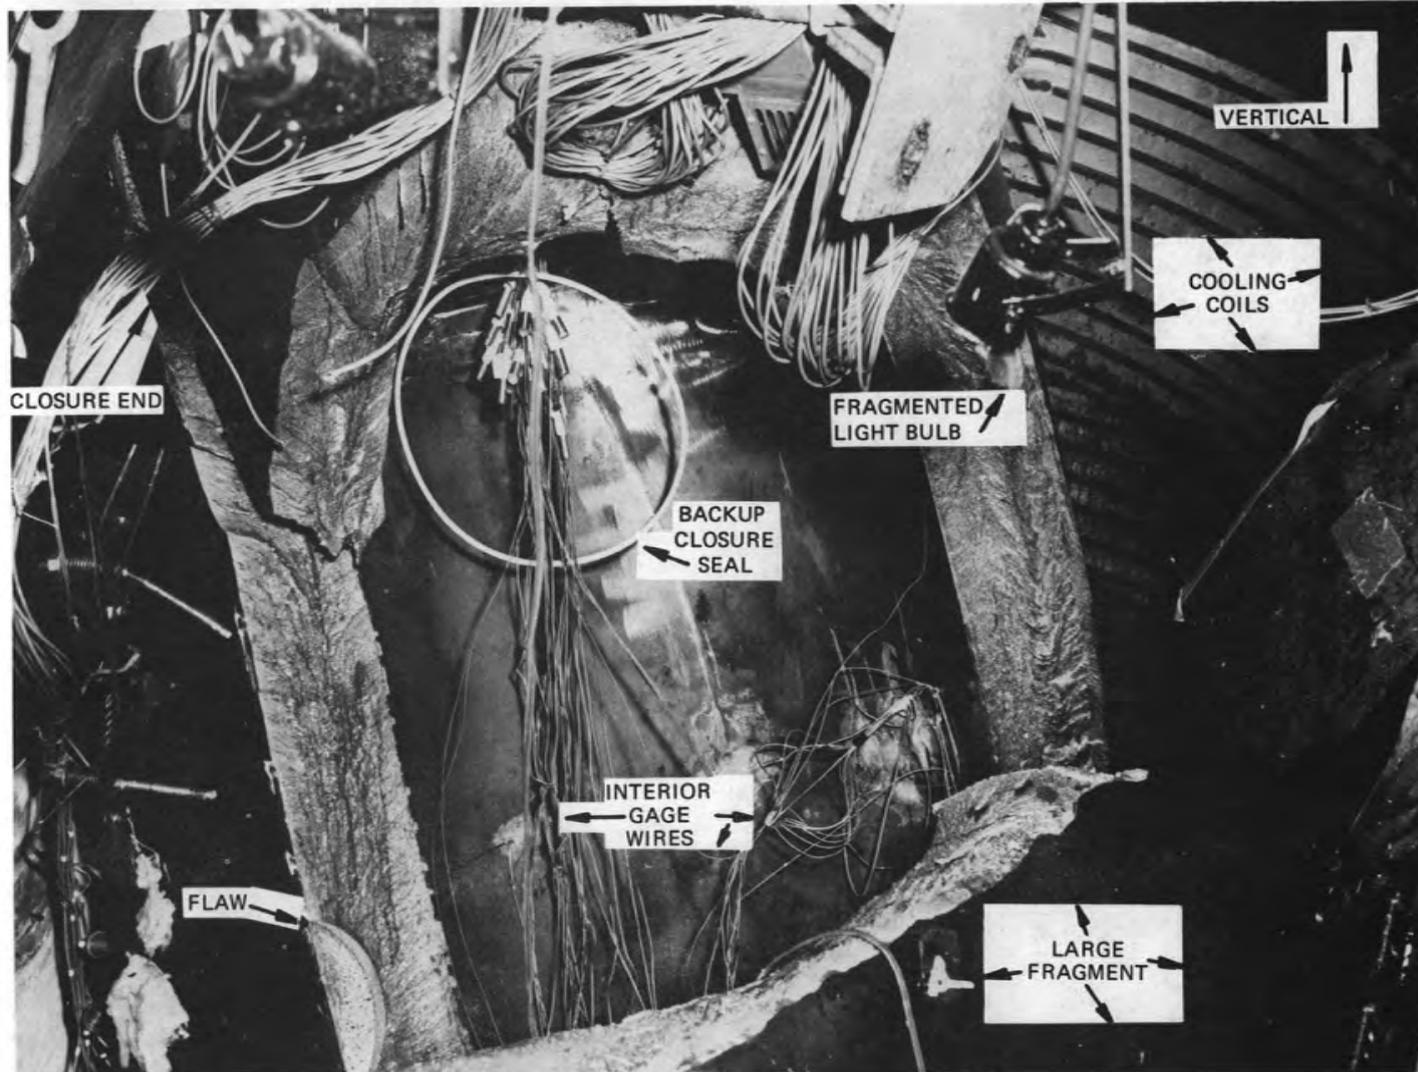
PHOTO 3647-72

Fig. 4.26. Intermediate test vessel V-2 immediately after fracture.

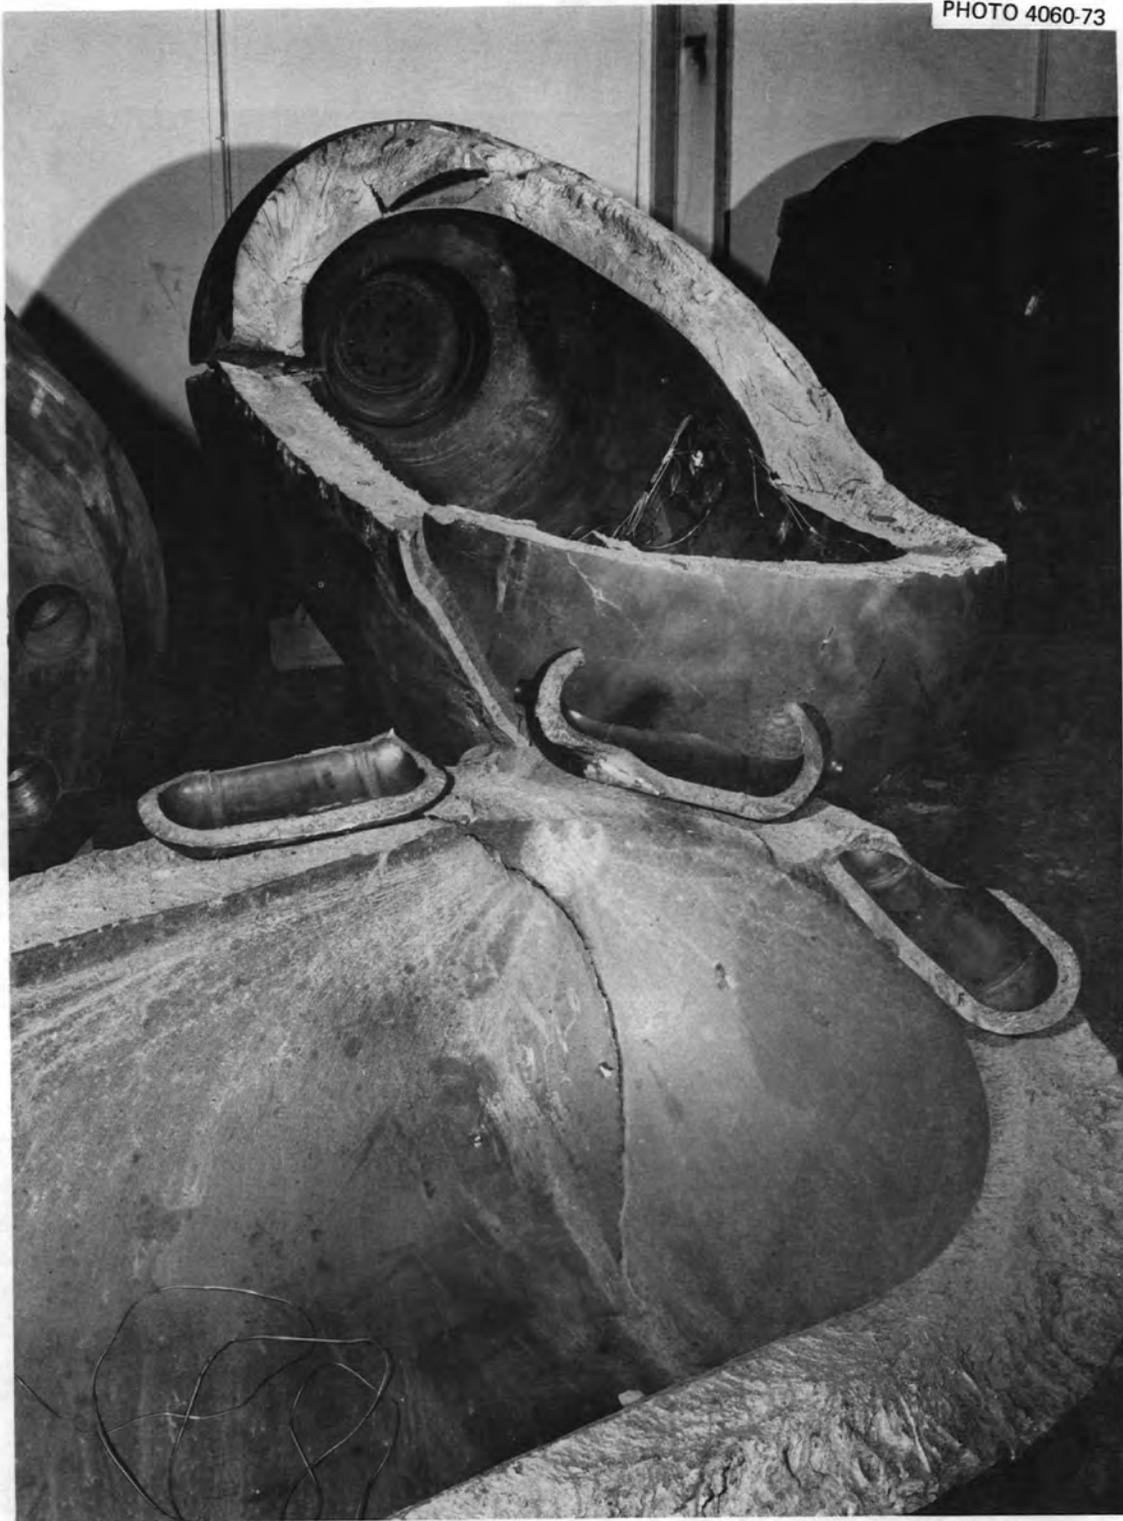
Fig. 4.27. Intermediate test vessel V-2 removed from test pit after fracture. Fragments of a small model vessel tested at -55°F are shown in foreground.

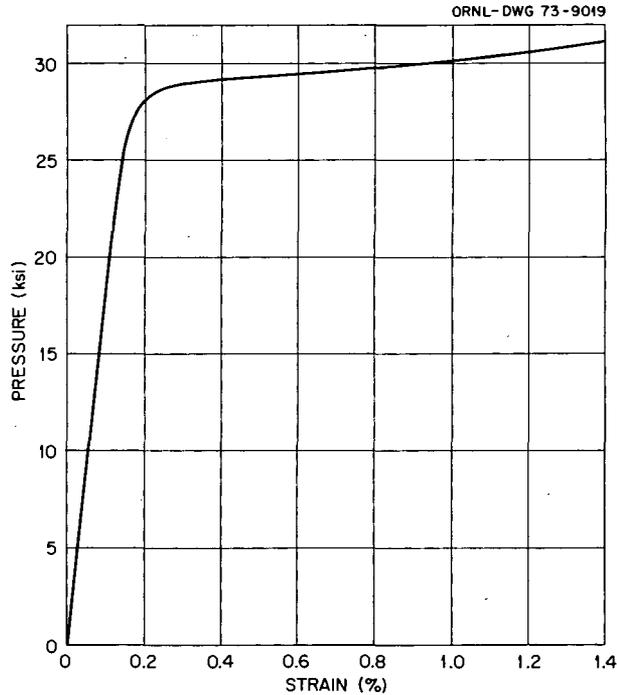
Fig. 4.28. Plot of pressure—outside surface circumferential strain curve 180° from flaw — intermediate test vessel V-3.

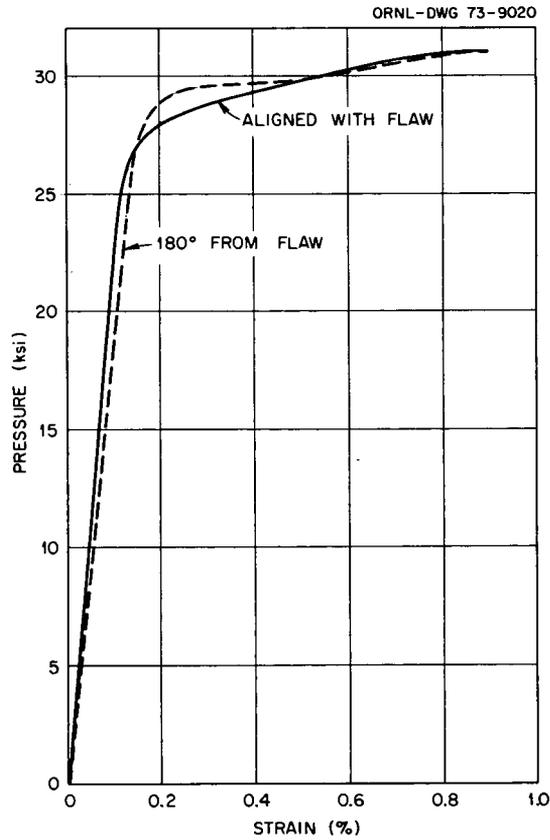
Fig. 4.29. Comparison between pressure—outside surface circumferential strain curves 17 in. from center line of vessel, one located 180° from flaw in base metal and one aligned with flaw in weld metal — intermediate test vessel V-3.

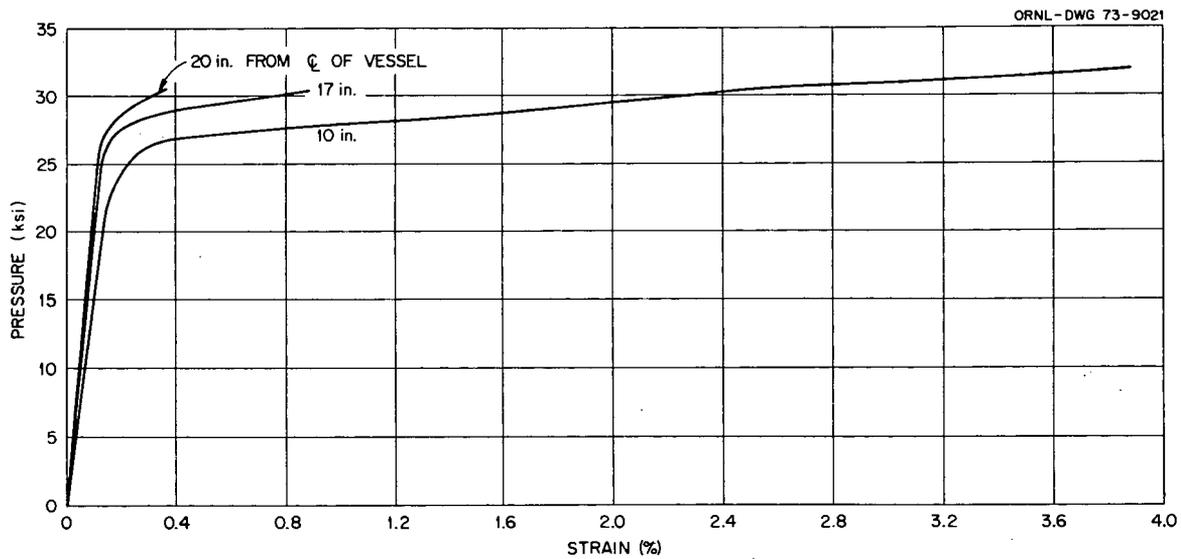
Fig. 4.30. Pressure—outside surface circumferential strain plots at various locations in weld seam aligned with flaw — intermediate test vessel V-3.

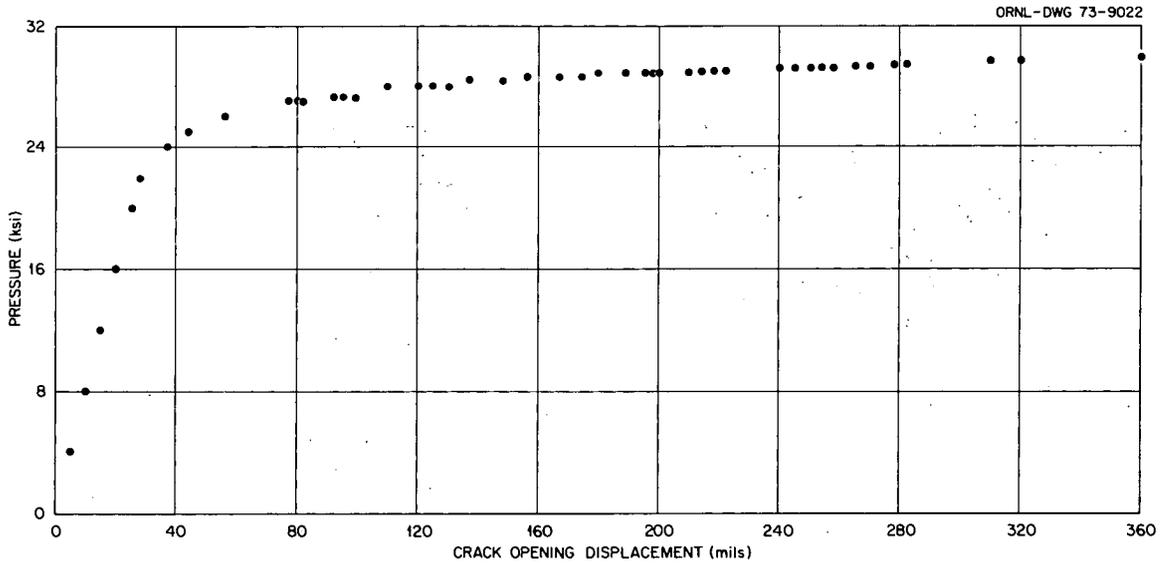
Fig. 4.31. Plot of pressure-crack opening displacement for intermediate test vessel V-3.

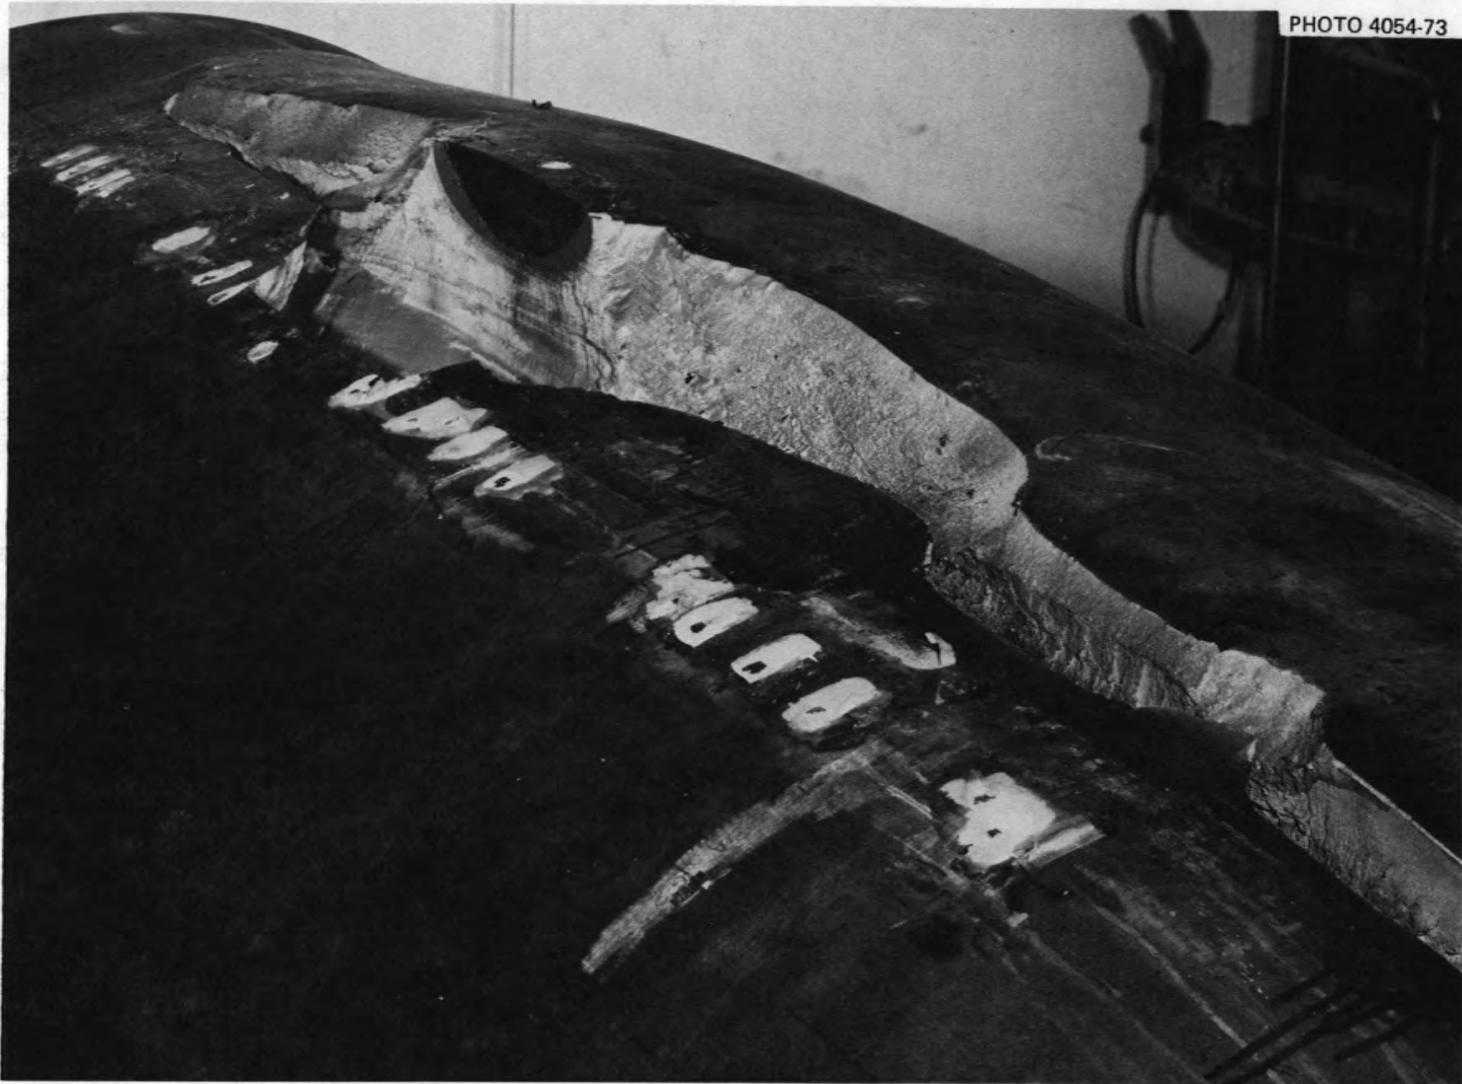
Fig. 4.32. Fracture region of intermediate test vessel V-3.

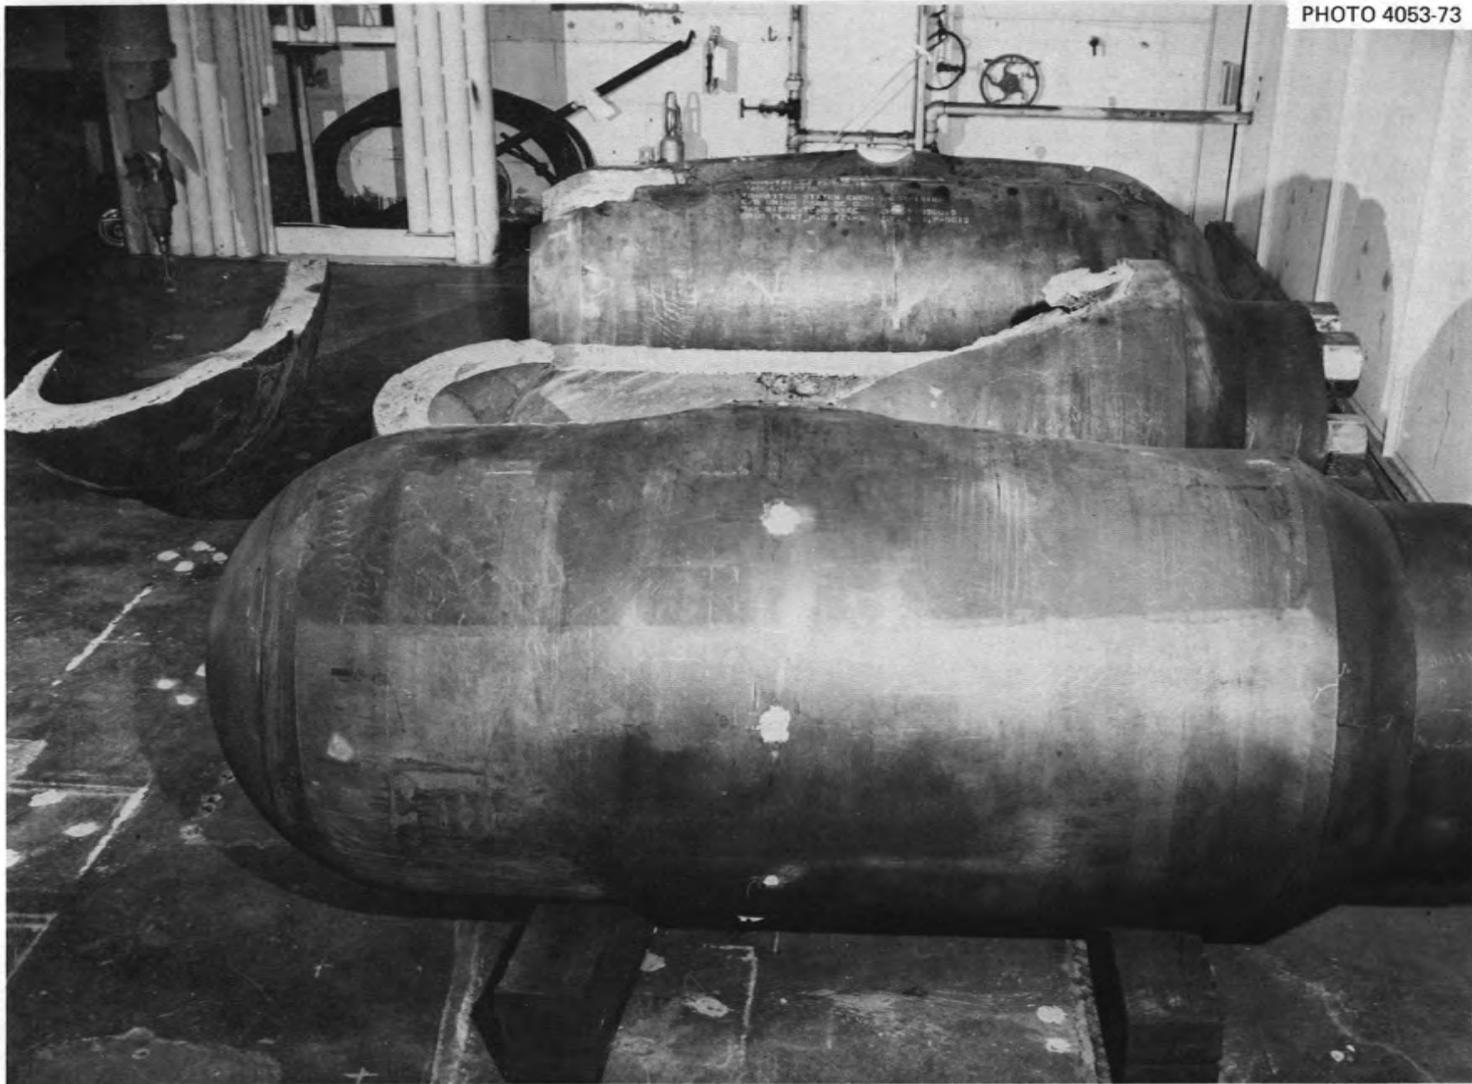
Fig. 4.33. Picture of the first three fractured intermediate test vessels.

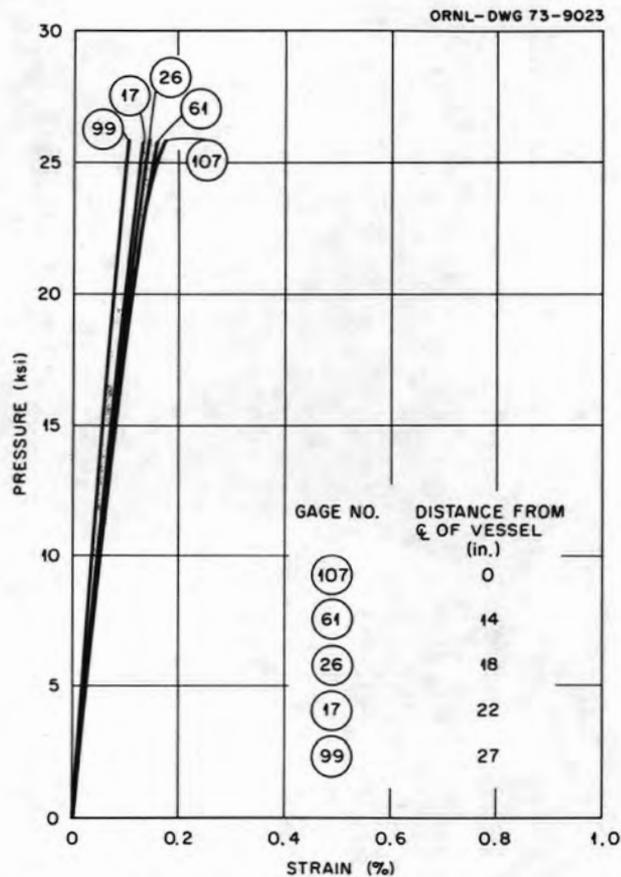
Fig. 4.34. Plot of pressure—outside surface circumferential strain along an axial element remote from the flaws as a function of distance from the center line — intermediate test vessel V-4.

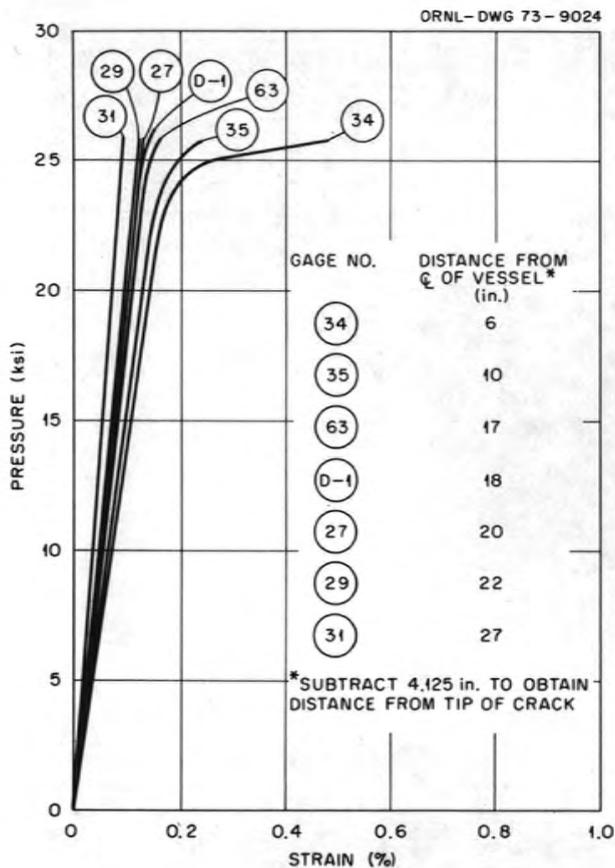
Fig. 4.35. Plot of pressure—outside surface circumferential strain aligned with the flaw in the weld metal — intermediate test vessel V-4.

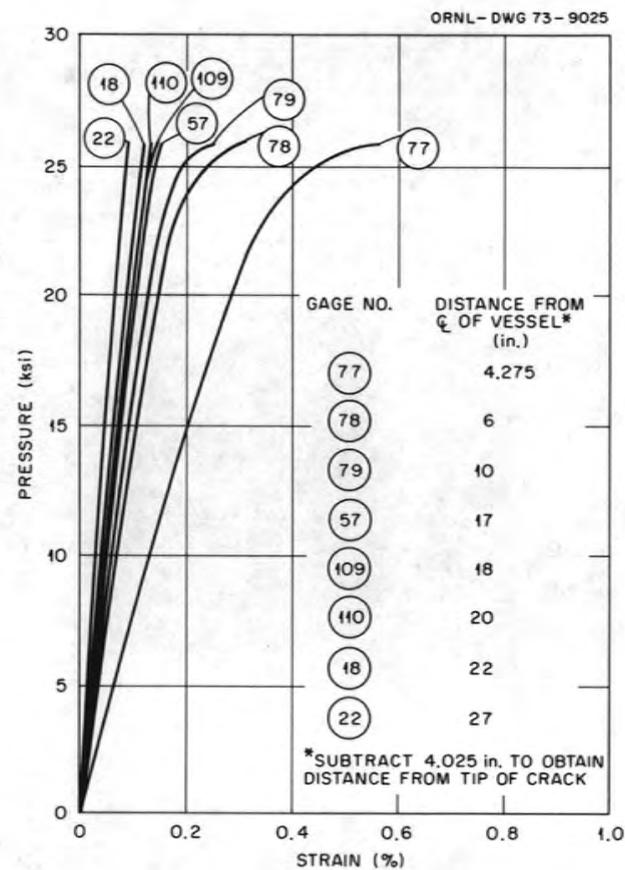
Fig. 4.36. Plot of pressure—outside surface circumferential strain aligned with the flaw in the base metal — intermediate test vessel V-4.

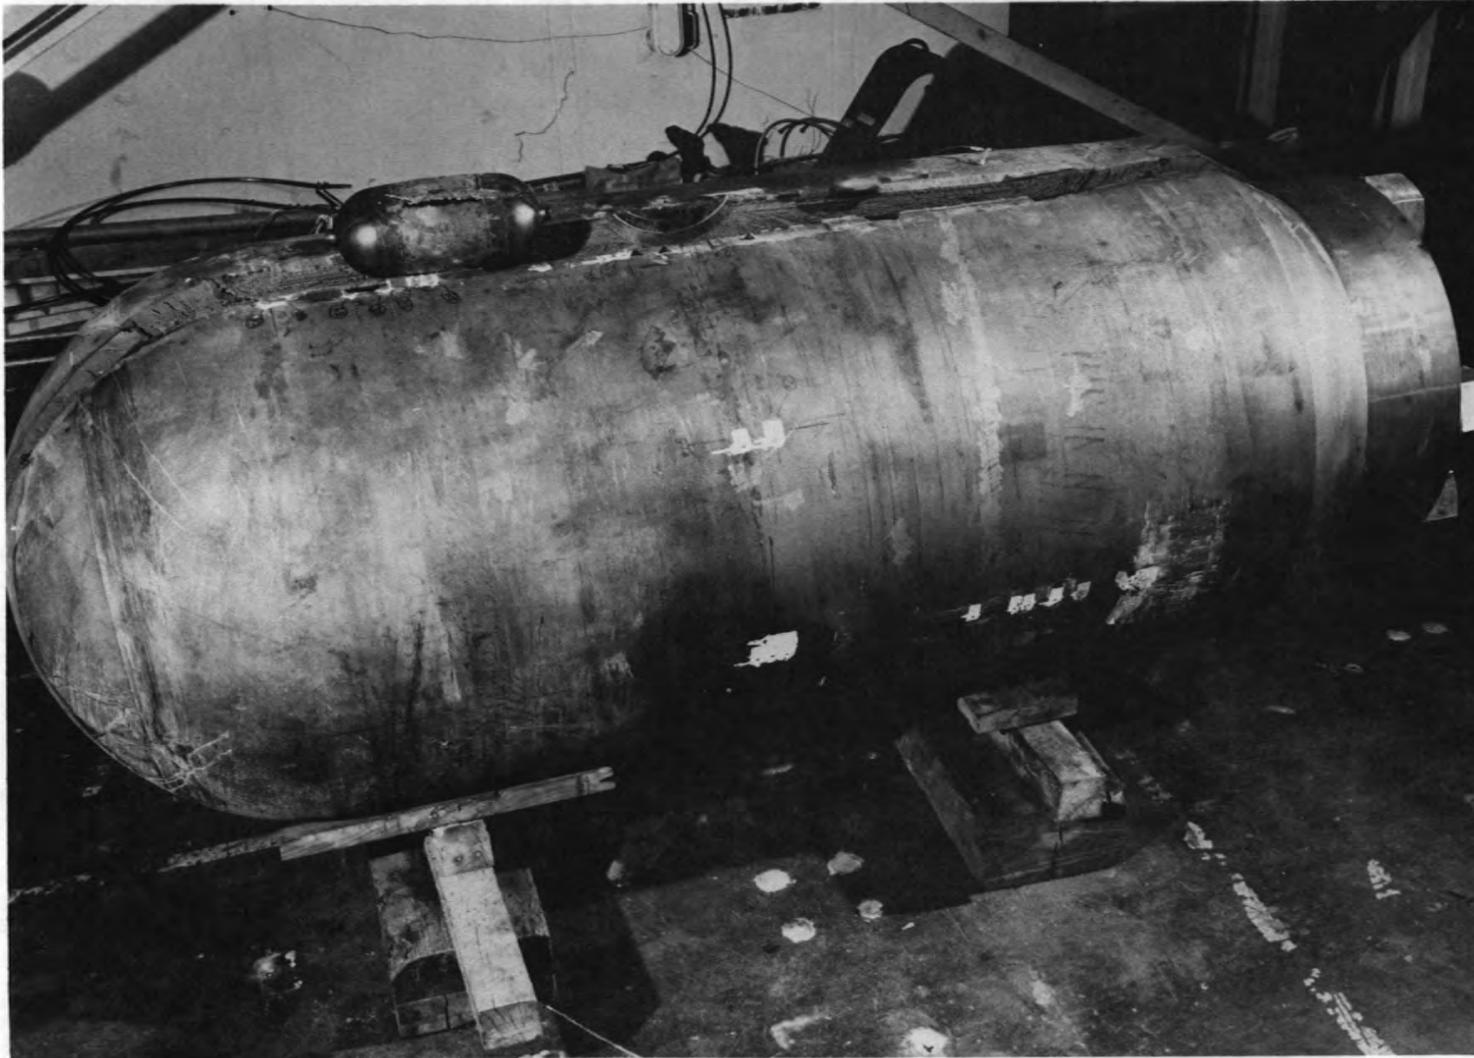
Fig. 4.37. Intermediate test vessel V-4 removed from test pit after fracture.

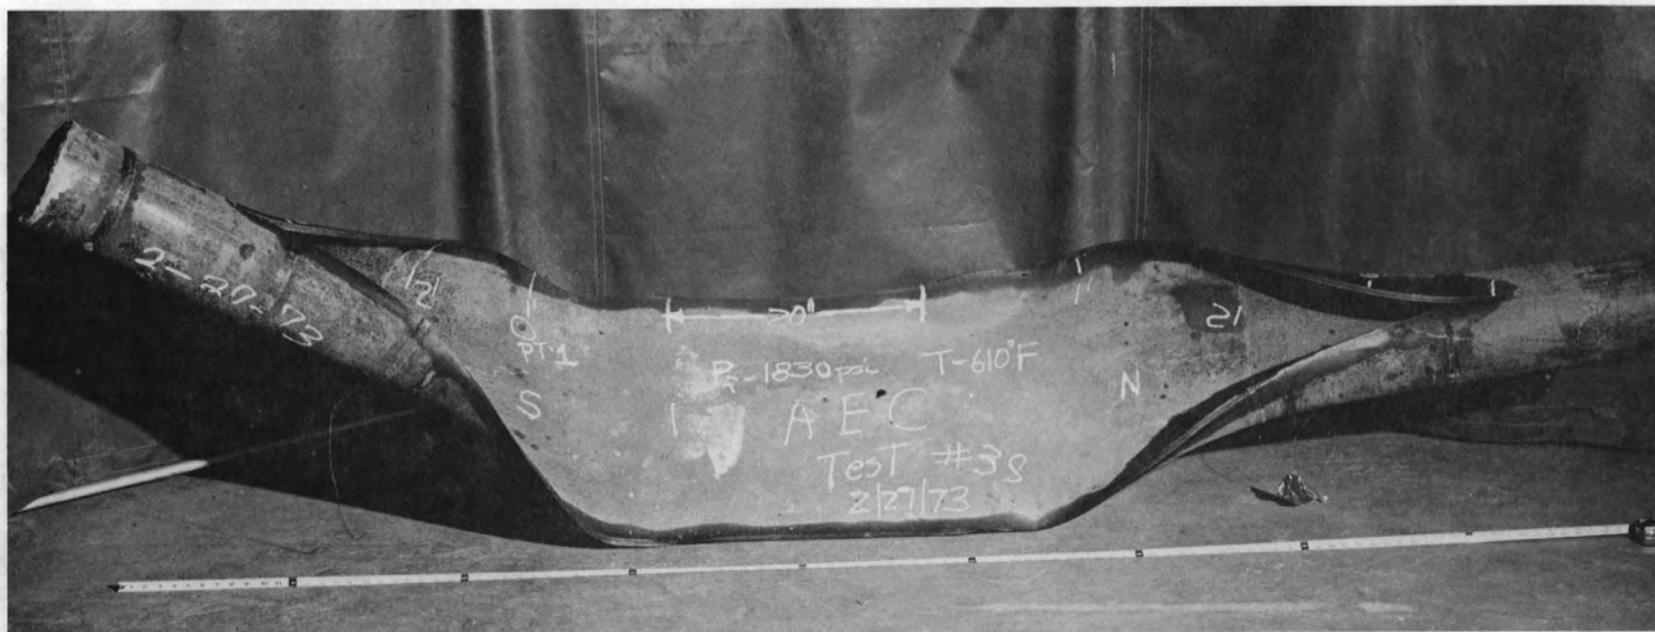
Fig. 4.39. Photograph showing the results of experiment 38. The failure pressure was 1830 psi, and the temperature was 610°F.
