ORNL/TM-5811

## Historic Sites Reconnaissance of the Oak Ridge Reservation Oak Ridge, Tennessee

Department of Anthropology  
University of Tennessee  
Knoxville, Tennessee  
August 1976

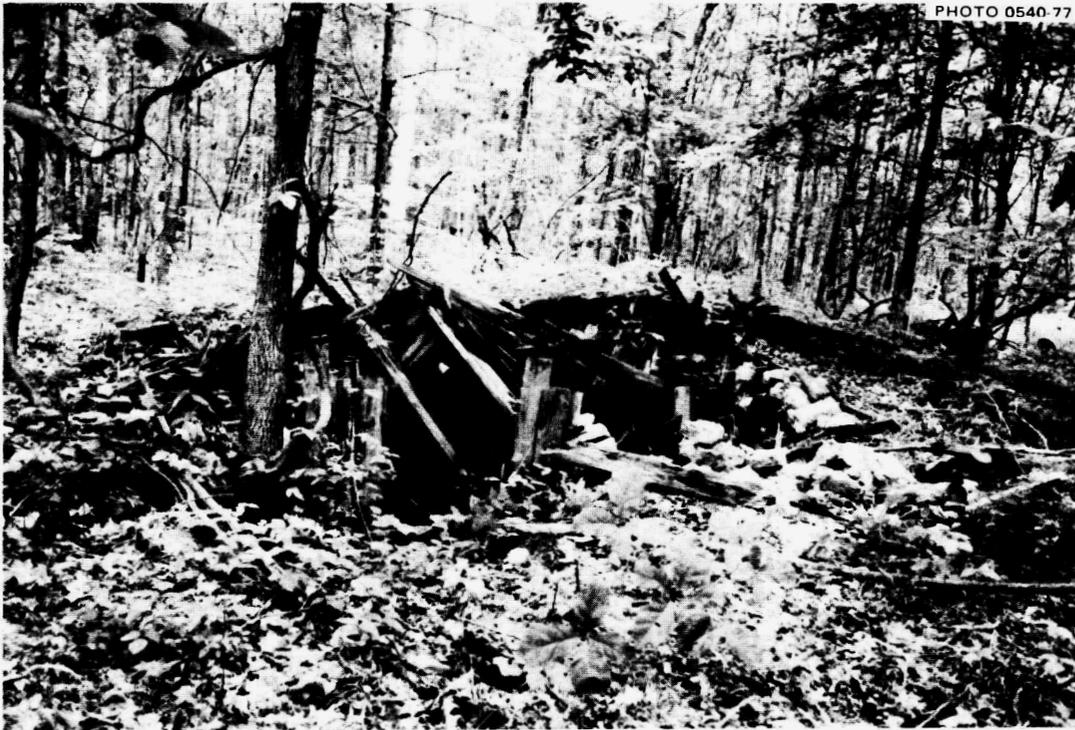
Fig. 3. Example of Condition Category 2--Foundation Only.

Category 2 includes building or structure sites where the fabric of the building (e.g. walls, roof, and other structural elements) has been removed from the site and only the foundation materials remain (Fig. 3). This category includes sites where only the scattered foundation piers or stone rubble from foundations and piers are observable on the surface.

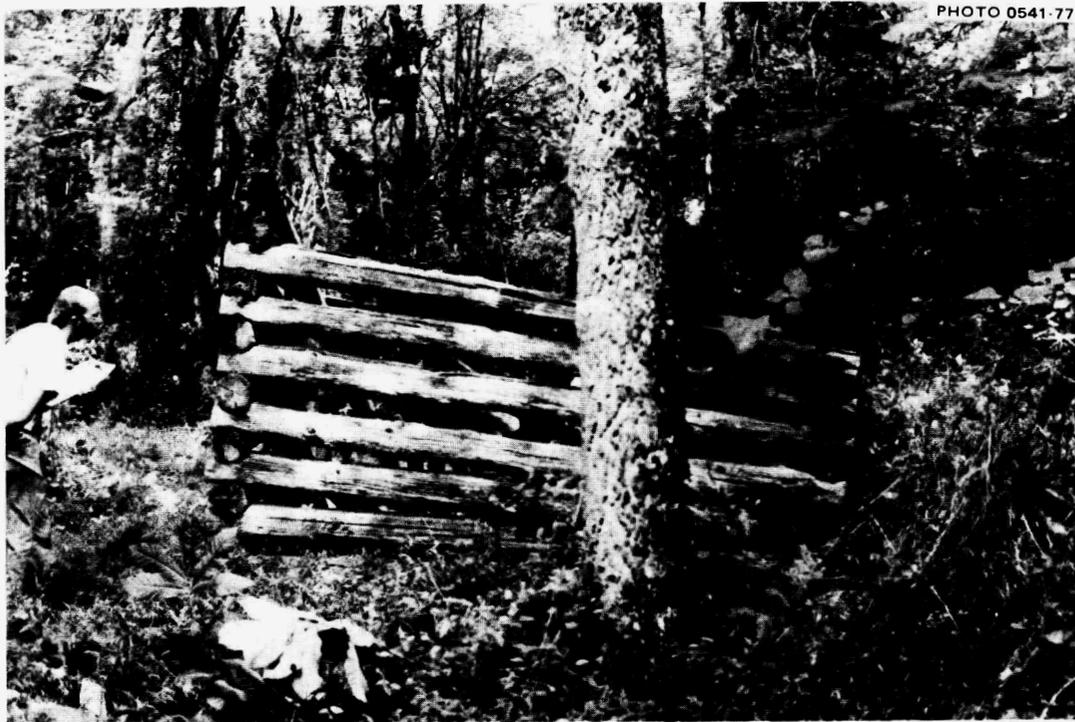
Fig. 4. Example of Condition Category 3--Partially Standing.

Category 3 includes sites where the building fabric is incomplete. Examples include structures for which one or two of the walls are in their original location but the roof, other walls, etc., are missing or deteriorated (Fig. 4). A structure in which the walls are standing and only the roof has been removed would be classed as belonging to Category 4.

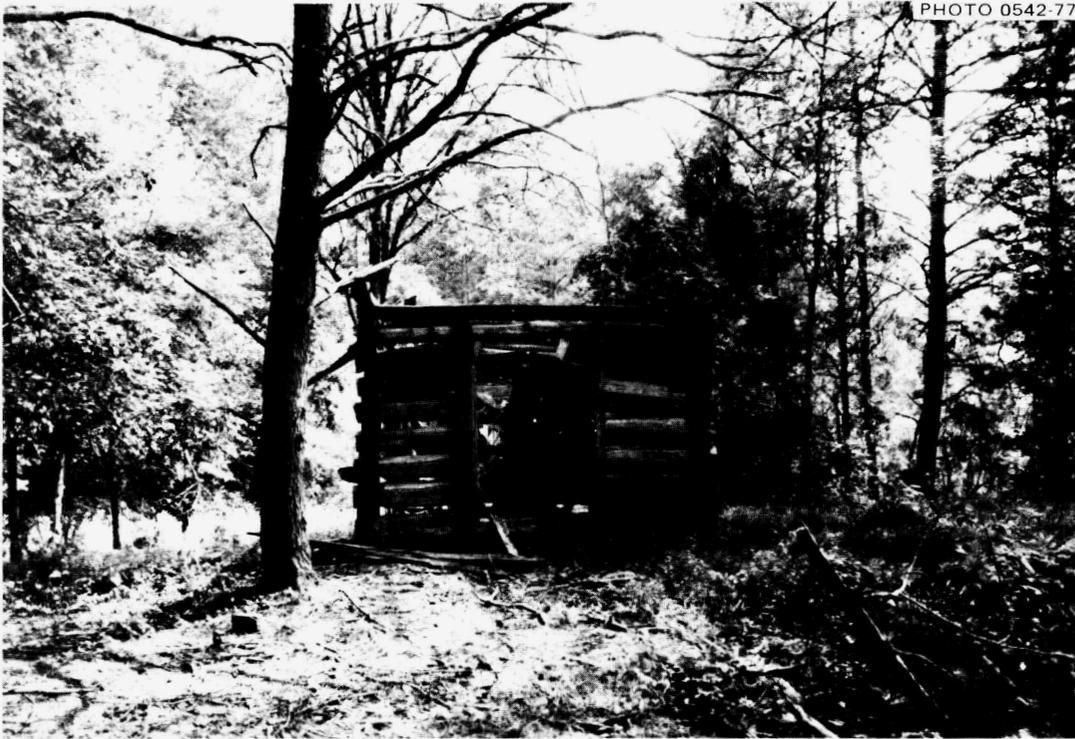
Fig. 8. Front Elevation of Structure 32B, a Log Crib.

Structure 32B is a log crib constructed from partially hewn pine logs (Fig. 8). It is typical of the small cribs found on many farmsteads in eastern Tennessee.

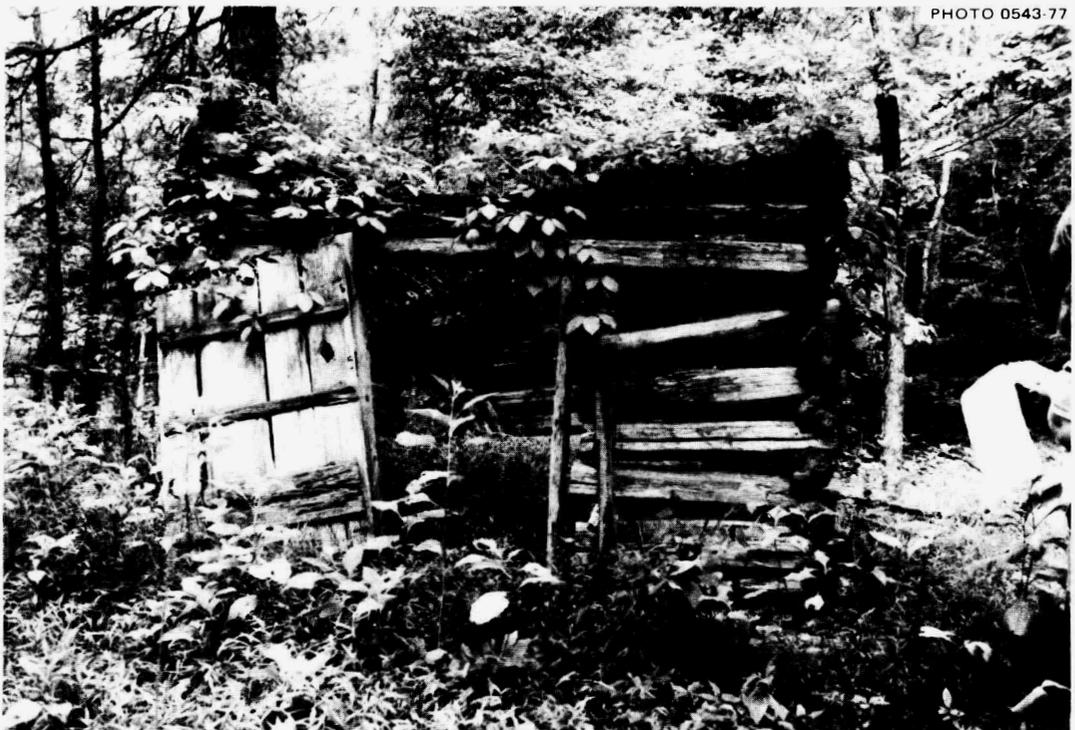
Fig. 9. Front Elevation of Structure 62B, a Log Crib with V-Notched Logs.

Structure 62B, a log crib without a roof, is in acceptable condition to relocate. This structure would require some restoration, however, before it could be used as a functional building (Fig. 9).

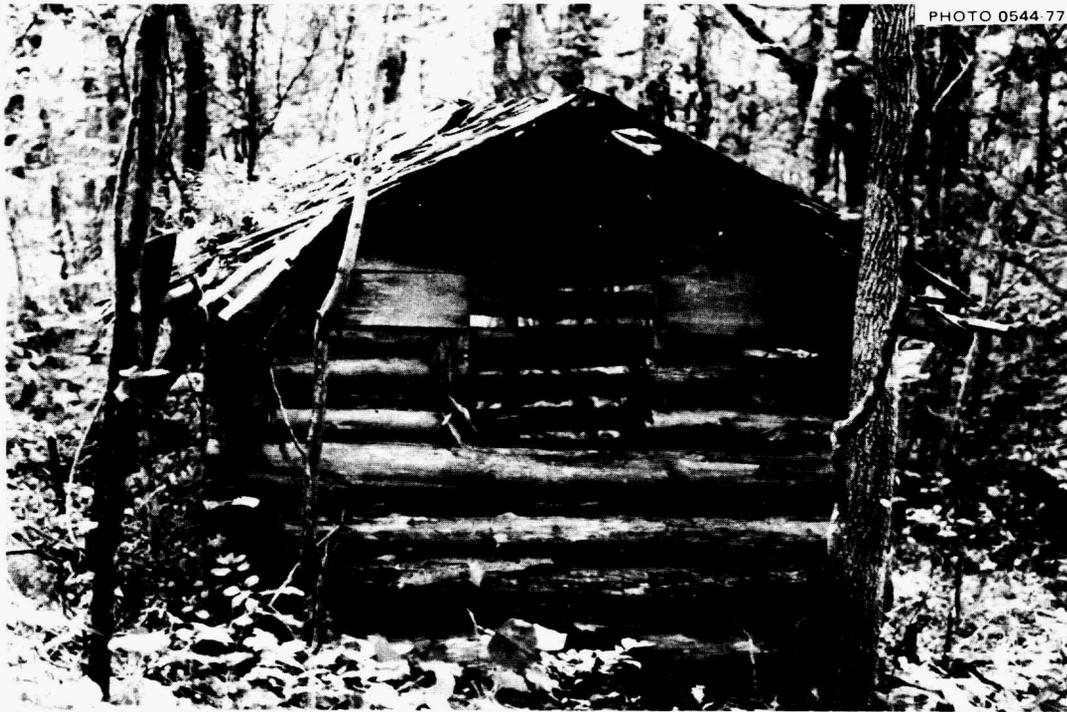
Fig. 10. Crib Constructed from Round Logs (Structure 643B).

Structure 643B is a good example of a round-log-constructed crib. The walls and roof are intact (Fig. 10).

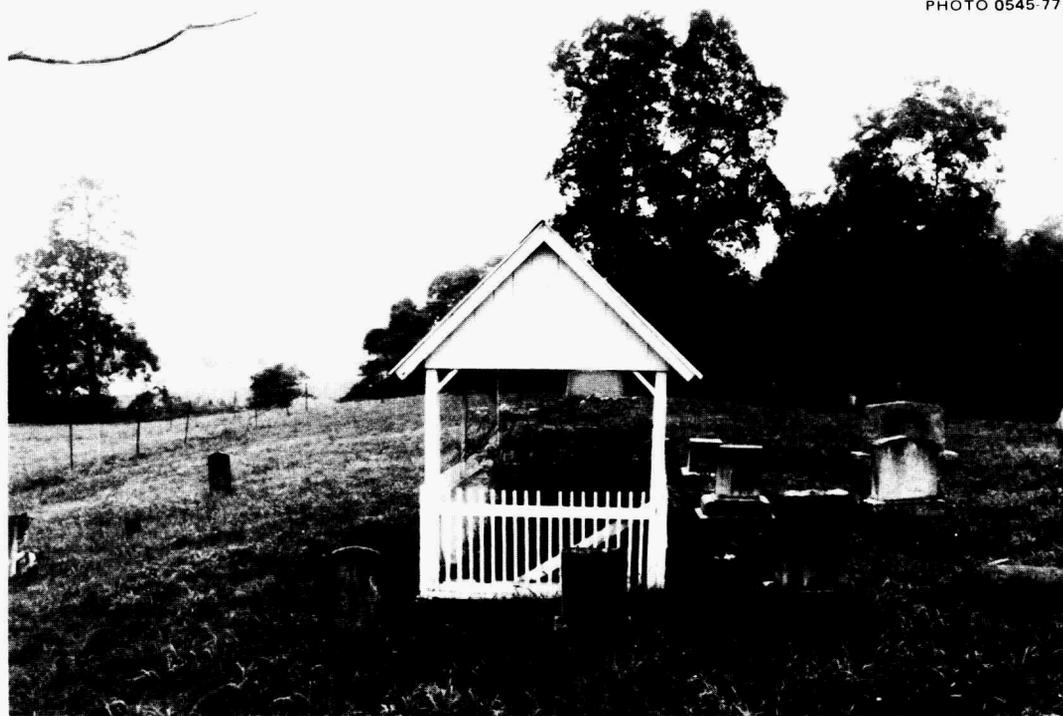
Fig. 11. Grave House in New Bethel Cemetery (Structure 16B).

Structures 16B and 16C. These two structures, quite unusual and very distinctive, are built over and enclosing marked graves in the New Bethel cemetery. The construction technique employed is frame with picket fence walls surrounding the grave (Fig. 11).

These two structures should be preserved in their present condition and maintained periodically. Their significance lies in their traditional form and as preserved examples of a kind of structure no longer found in contemporary cemeteries and memorial gardens.

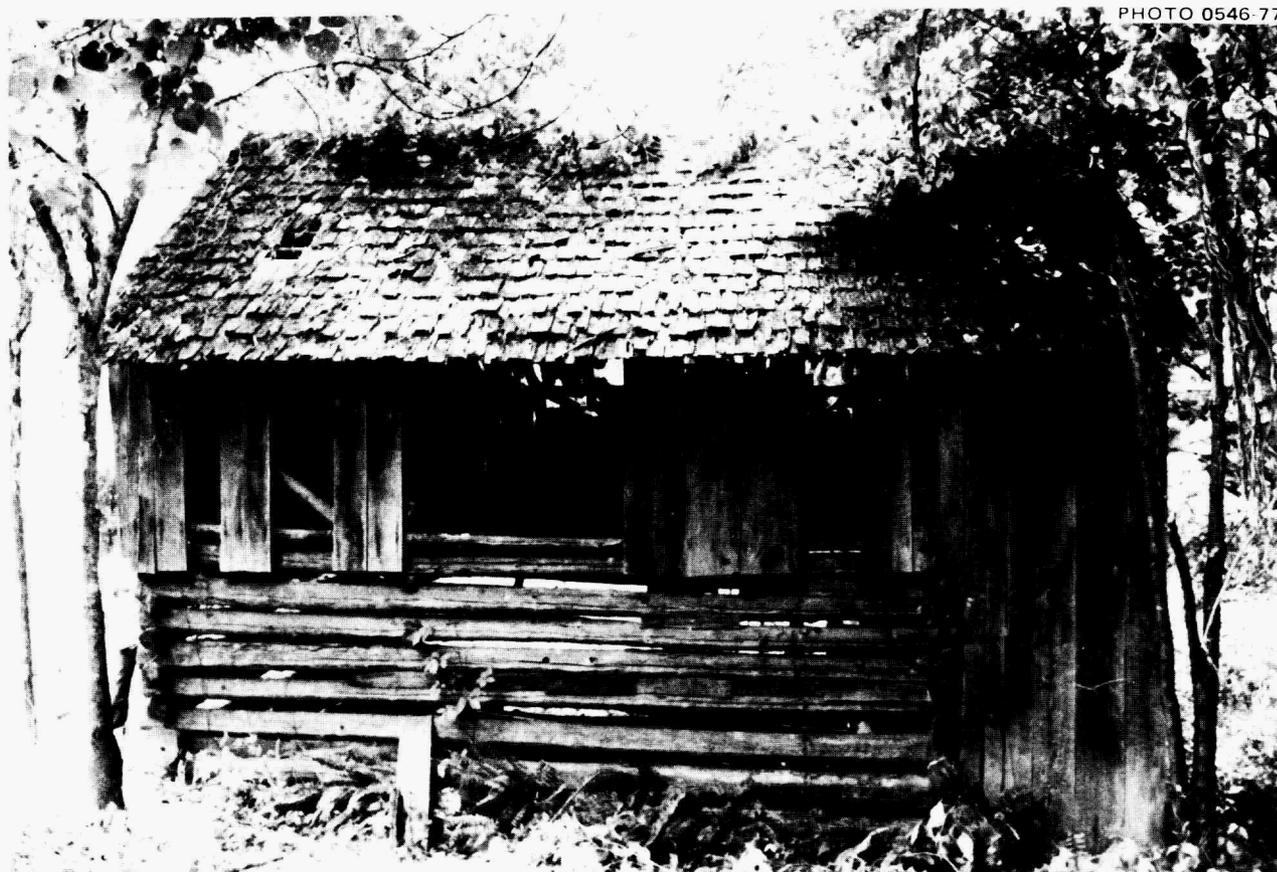
Fig. 12. Structure 39C, Single Crib Barn with Shake Roof.

Structure 39C. This structure is a small one-crib log barn with shake roof in good condition (Fig. 12). Based on the log sizes, corner-notching technique, and general appearance, this building was probably built in the twentieth century. It does, however, represent a traditional form and construction method and should be preserved through maintenance and periodic monitoring the condition. Should the building be threatened by construction or other potentially destructive activities, it should be described in detail and possibly relocated to more favorable surroundings.

It does not appear to meet the criteria for nomination to the National Register.

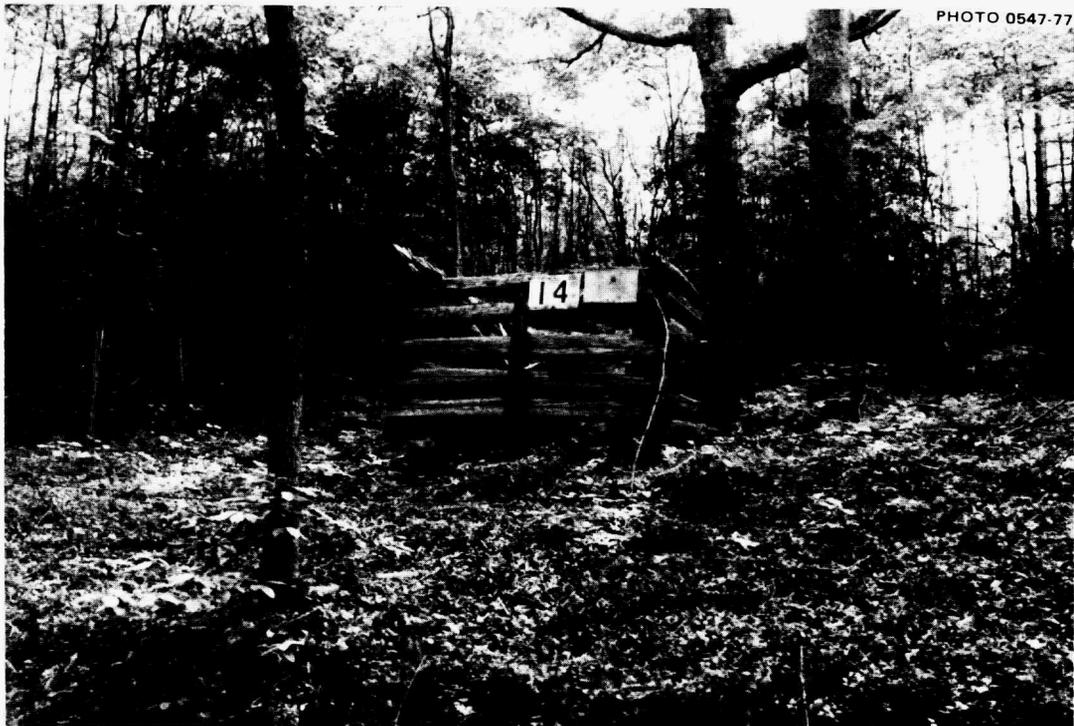
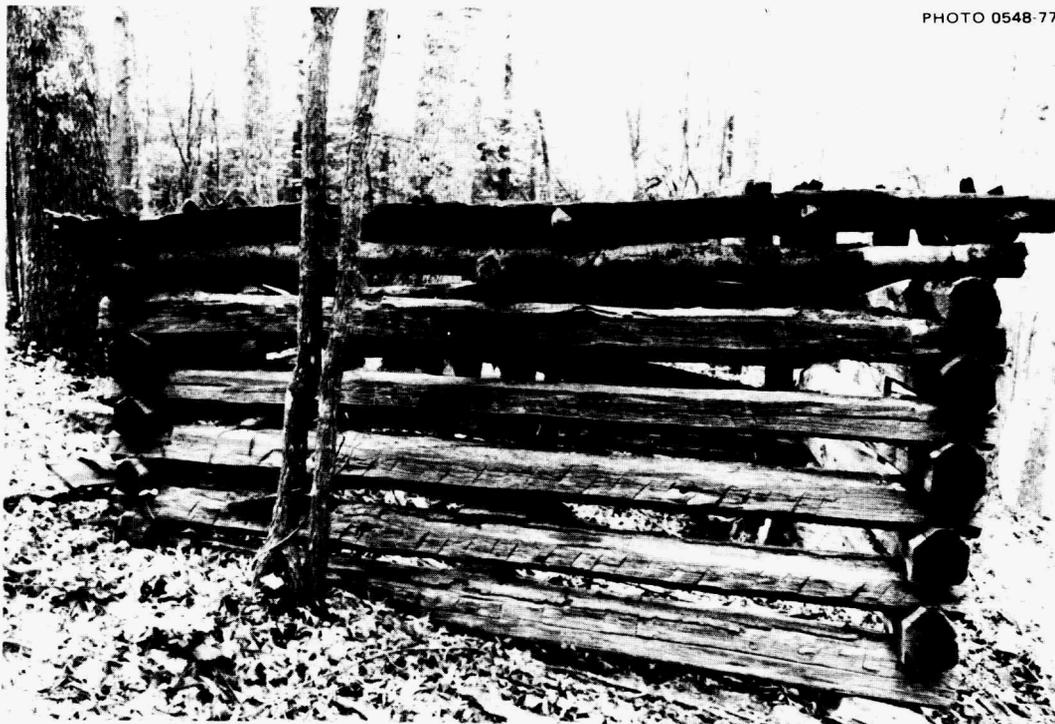
Fig. 13. Structure 57A, Log Construction Grave House Surrounding Two Graves.

Structure 57A. This structure is a rectangular-log-construction gravehouse built surrounding three grave markers. The fieldstone markers, two headstones and one footstone (two graves), are plain without any inscriptions. The gravehouse was constructed from partially hewn logs joined at the corners with a saddle V-notch (Figs. 13 and 14). It is in good condition and only the roof has collapsed. The cemetery associated with this structure is designated No. 14.

Fig. 14. Side View of Structure 57A.

It is highly recommended that the structure be restored by replacing the roof and that it be maintained in a good state of repair as part of the routine cemetery maintenance. This unusual building warrants preservation due to the very small number of log gravehouses remaining in Tennessee.

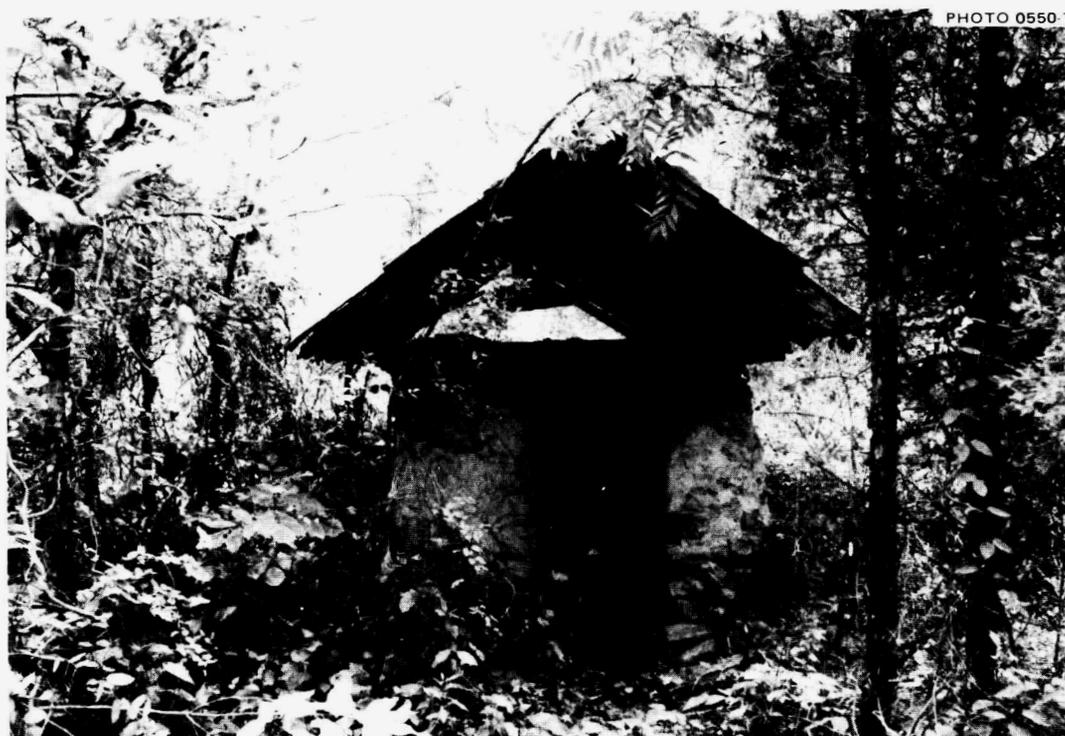
Fig. 16. Field Stone Construction Building, Structure 753A.

Structure 753A. This was the only stone building encountered during the survey. Built using fieldstone bonded with cement mortar, it has a rectangular plan and a gabled roof (Fig. 16). The field party

did not determine the function of this structure. Measured drawings and detailed photographs should be prepared of this building if it is threatened with destruction.

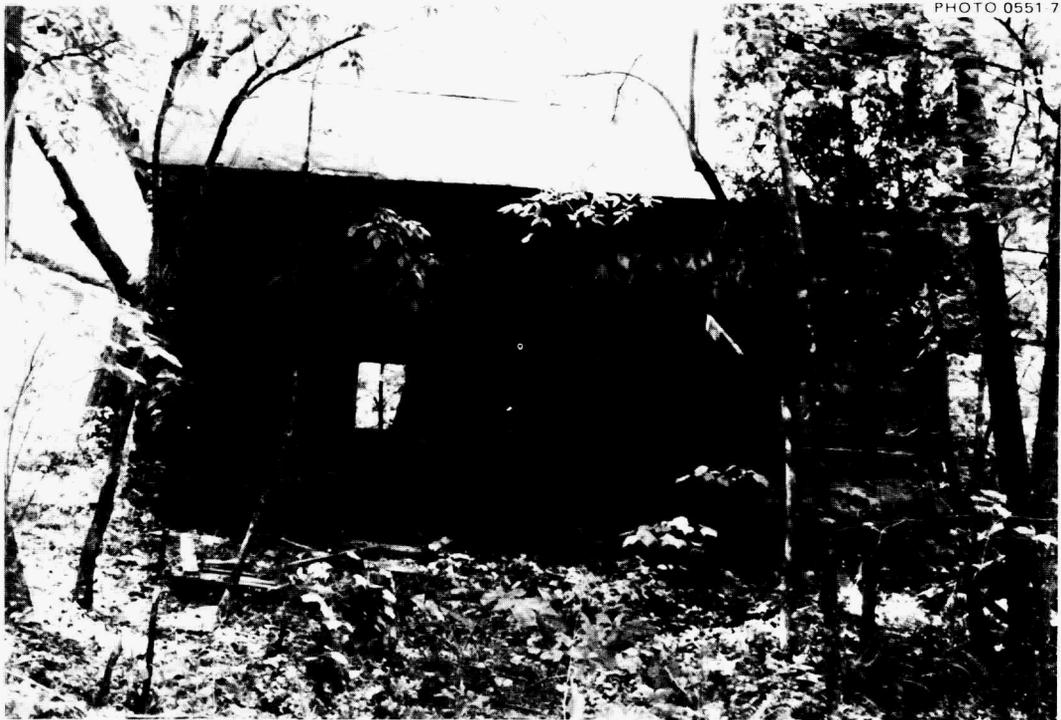
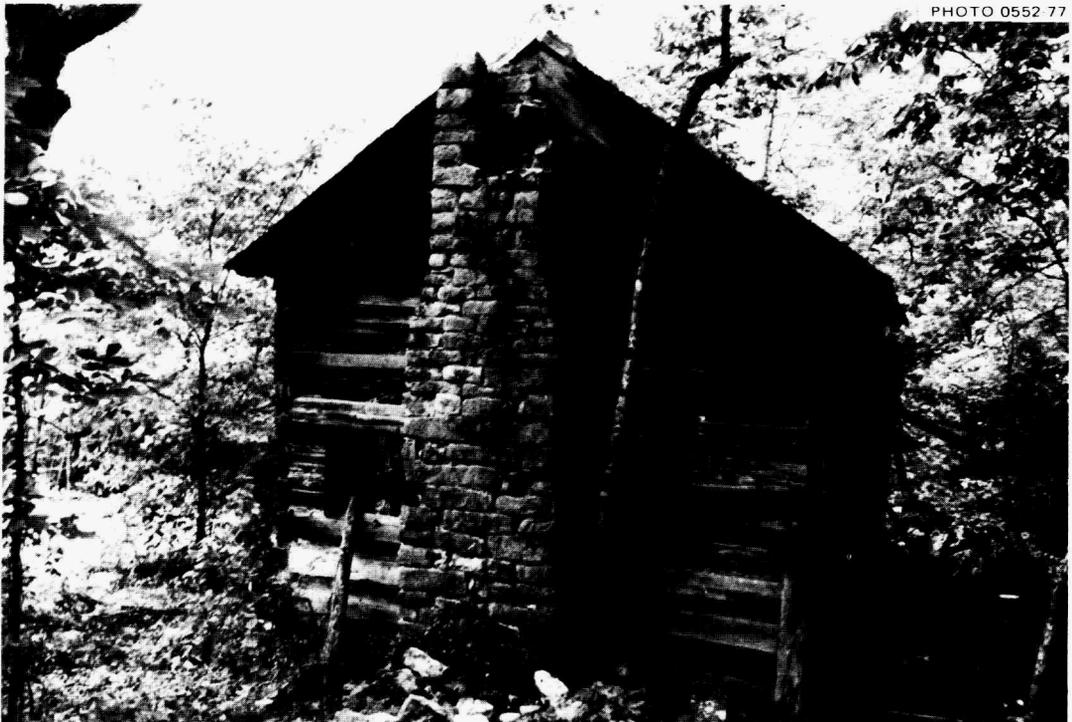
Fig. 17. Front Elevation, Structure 853A.

Structure 853A. Excluding the Freels Cabin, the best example of log architecture recorded by the survey party is Structure 853A, a single-pen rectangular-plan house with one external limestone block chimney (Figs. 17 and 18). The date of construction has not been determined from documentary sources; but based on the construction methods, size and location of windows, and type of chimney construction, it was possibly built in the first half of the nineteenth century. One end of the structure has been removed to accommodate a frame addition. The structure should be maintained in its present condition until historical research can establish a factual date of construction.

Fig. 18. Chimney Detail, Structure 853A.

2. The structures currently used for housing UT-CARL personnel should be maintained in their present condition and use.
3. The date of construction of Structure 853A, a log house with limestone chimney, should be determined through historical research. The type of construction and other structural details indicate the house was possibly built in the mid-nineteenth century or before.
