**ORNL/TM-9903**

## **Corrosion of Materials by High-Temperature Industrial Combustion Environments – A Summary**

Date Published: February 1986

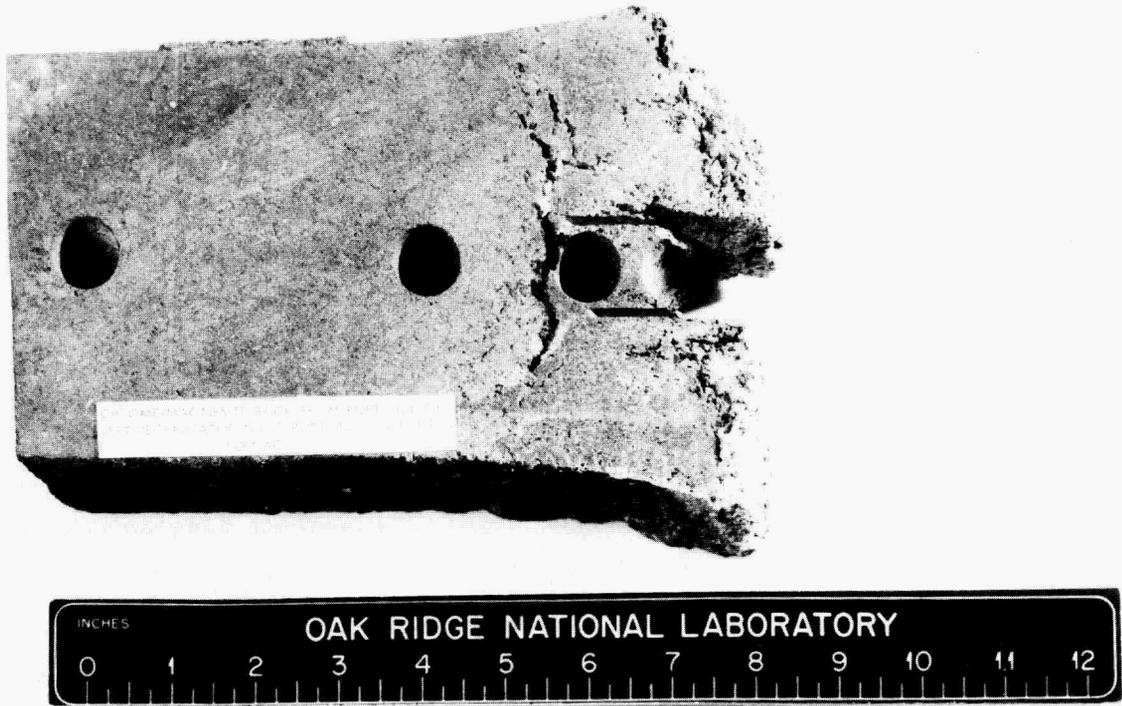
Fig. 1. Port-side chrome-magnesite brick after exposure to glass-furnace environment at 1540 to 1595°C for 3.5 years.

Exposure Conditions. Chrome-magnesite bricks (Fig. 1) were obtained from the port and target walls of an industrial glass furnace (Fig. 2), where the maximum hot-face temperature was 1540 to 1595°C. The high-MgO brick was obtained from the regenerator, where the maximum hot-face temperature was 1095 to 1150°C. The furnace was fired with No. 6 residual oil of unknown composition. Bricks in the regenerator experienced numerous thermal cycles and variations in oxygen potential as a result of alternating flow of combustion air and exhaust gases. The exposure time for the bricks was 3.5 years.

Results. Chrome-magnesite brick expanded about 43% and cracked. The composition changed considerably —  $\text{Cr}_2\text{O}_3$ ,  $\text{Al}_2\text{O}_3$ , and  $\text{Fe}_2\text{O}_3$  decreased while  $\text{SiO}_2$ ,  $\text{Na}_2\text{O}$ , and  $\text{NiO}$  increased.

Conclusions. NiO, a fuel impurity, was mostly responsible for degradation of chrome-magnesite bricks by formation of new phases having higher specific volumes than those of the reactants. Degradation of high-MgO bricks was caused by the periodic freezing and melting of  $\text{Na}_2\text{SO}_4$  and by crystallization of that compound within periclase grains.

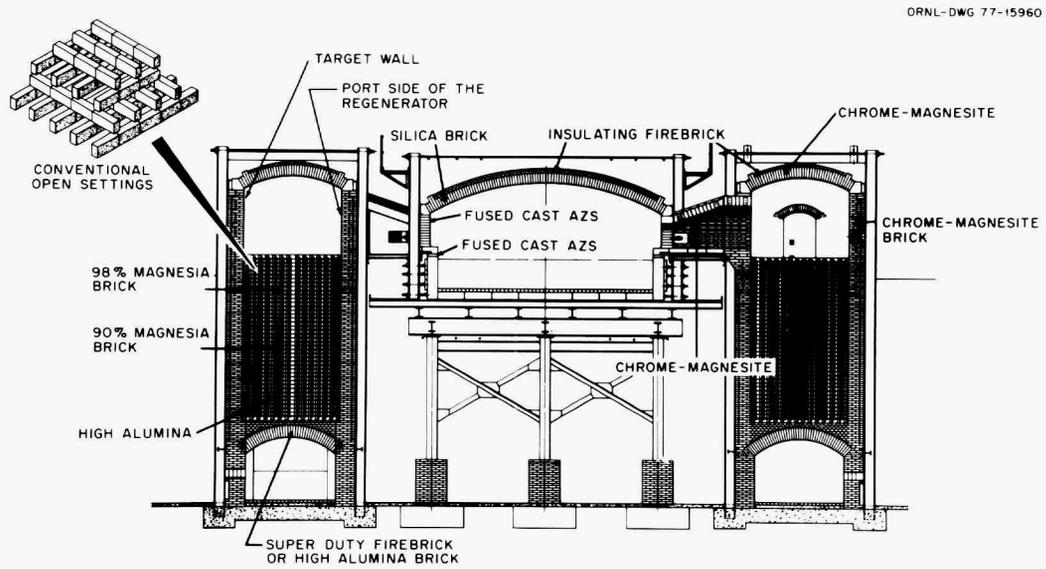
ORNL-DWG 77-15960

Fig. 2. Typical side-port glass tank melting furnace and regenerators.

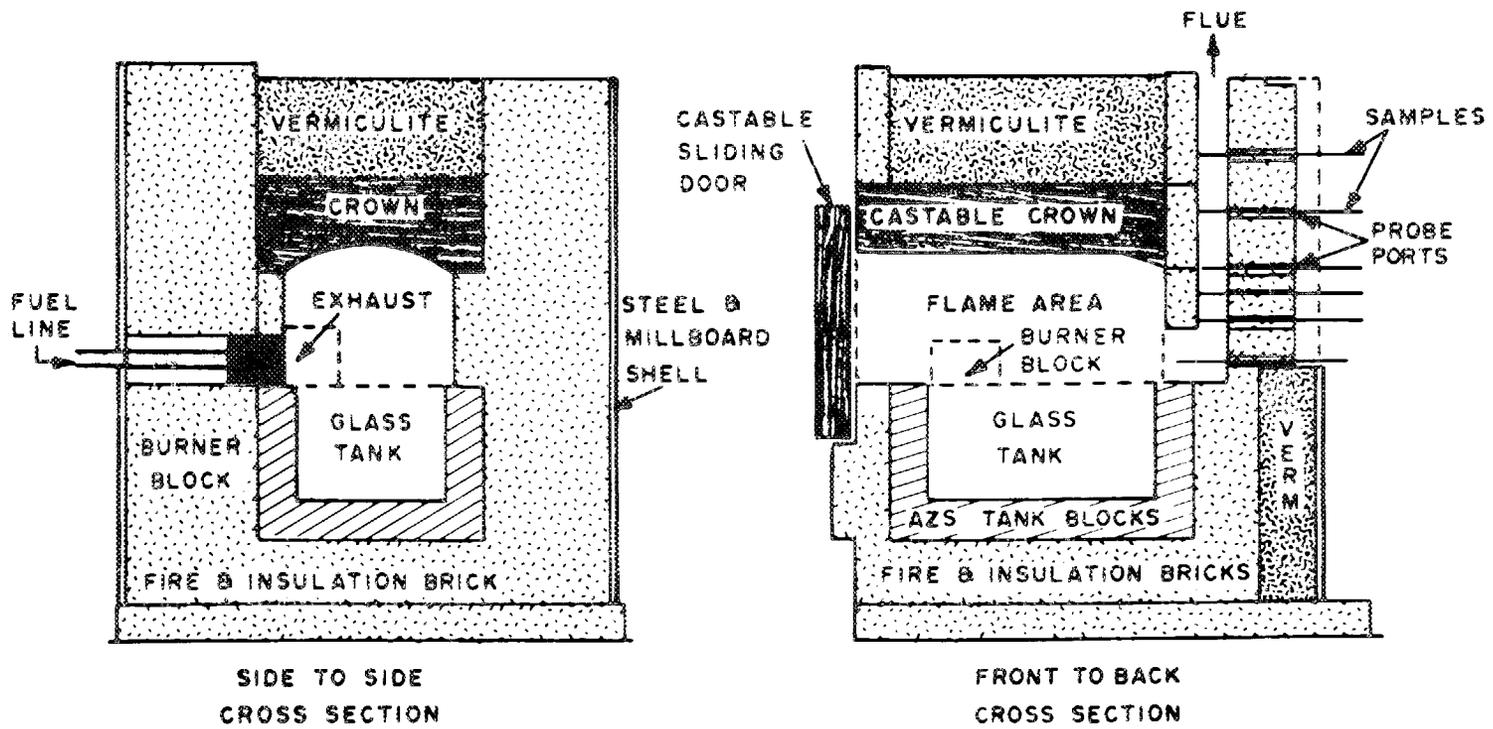
Fig. 3. Special day tank glass furnaces used for exposure tests.

Exposure Conditions. Specimens were located in the flue of a glass furnace (Fig. 3). The combustion atmosphere contained dust and evaporated species from the soda-lime glass charging and melting operations. The glass composition was approximately 66 wt %  $SiO_2$ , 14 wt % each CaO and  $Na_2O$ , 2 wt % each  $Al_2O_3$  and MgO, 0.5 wt % each  $B_2O_3$  and BaO. The glass also contained 0.6 wt % F. Materials were exposed to temperatures of 1150 to  $1550^\circ C$ , depending on location in flue, for periods of 4 to 117 days.

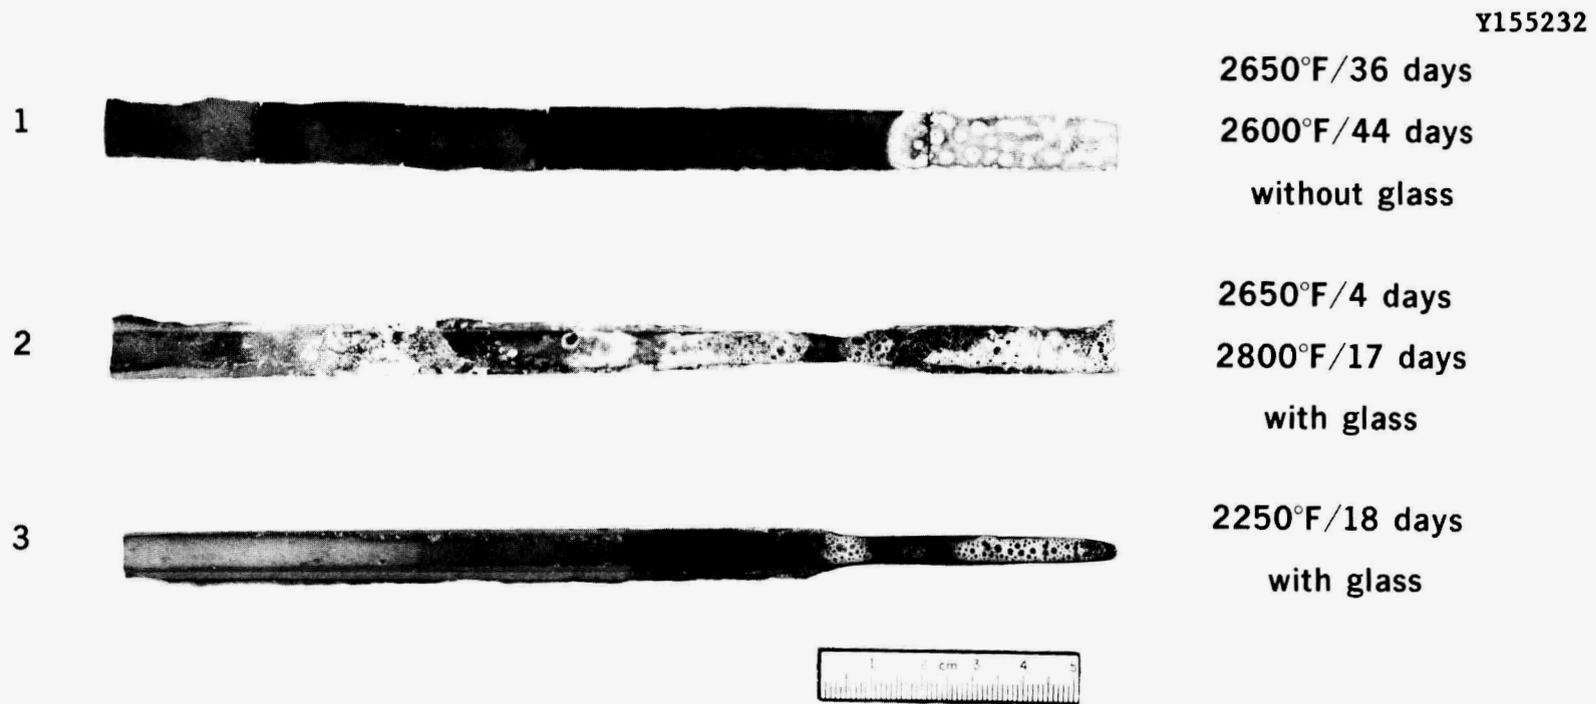
Fig. 4. Sintered alpha SiC exposed to glass furnace environment.

Discussion. The observed increase in corrosion rate with decreasing temperature in SiC and Si<sub>3</sub>N<sub>4</sub> was attributed to a lowering of the viscosity of the normally protective silica film by condensation of alkali and iron oxides. The lowered film viscosity allowed active oxidation at the interface between the SiC (or Si<sub>3</sub>N<sub>4</sub>) and the film under low oxygen partial pressure conditions via the reaction

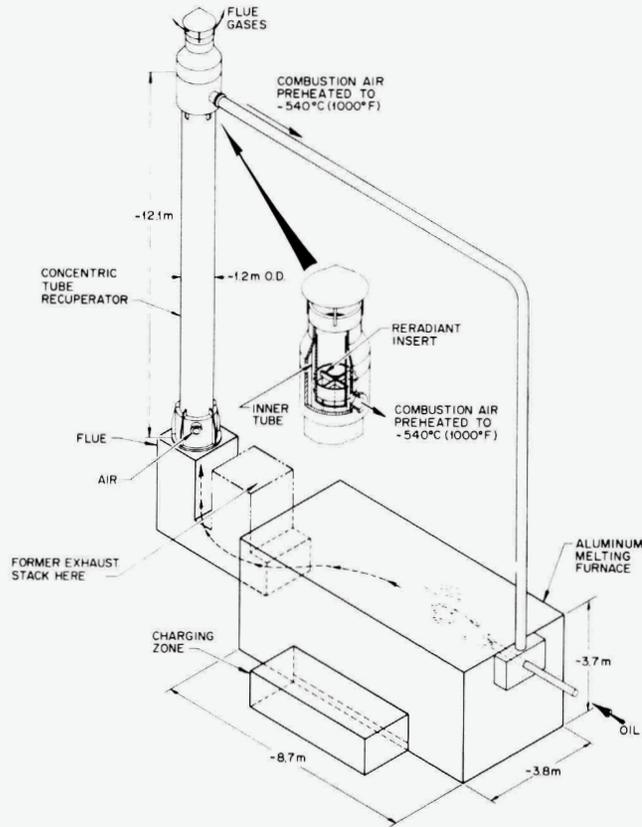
Fig. 5. Stainless steel recuperator on an aluminum-remelt furnace.

Exposure Conditions. A radiant recuperator constructed of type 309 stainless steel was exposed to flue gases from an aluminum-remelt furnace burning No. 2 oil (Fig. 5). A flux consisting of NaCl-45% KCl-5% Na<sub>3</sub>AlF<sub>6</sub> was charged along with aluminum scrap. The flue gases probably contained many chemical species derived from oil combustion, furnace refractories, impurities in the scrap metal, and the flux. Some constituents likely present are N<sub>2</sub>, O<sub>2</sub>, CO<sub>2</sub>, H<sub>2</sub>O, SO<sub>2</sub>, NaCl, KCl, NaF, and AlF<sub>3</sub>. The flue gas temperature at the inlet to the recuperator was about 950°C except during a temperature excursion lasting about 3 days when the temperature was probably 1100 to 1200°C. The exposure time was 30 days of normal operation and 3 days during which excessive temperature occurred.

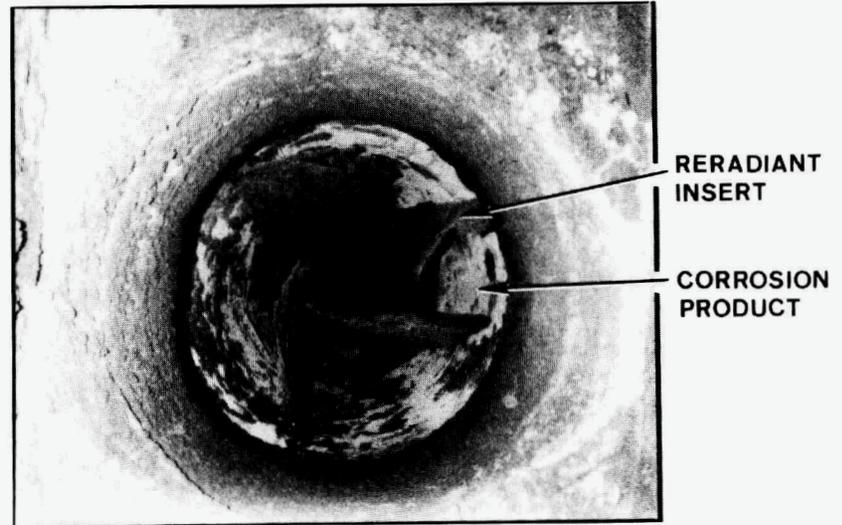
Y163944

Fig. 6. Corroded partition wall and reradiant inserts at the bottom of the recuperator after exposure to aluminum-remelt furnace flue gases for 30 days at 950°C and 3 days at 1100 to 1200°C.

Results. The recuperator was severely damaged on the gas inlet end. A type 309 reradiant insert, originally about 5 mm thick, was completely corroded in some locations and less than 1 mm thick in other locations (Fig. 6). The alloy exhibited extensive intergranular attack beneath a thick scale of iron and chromium oxides. The scale contained Cl, K, Na, and S, and the corroded grain boundaries contained Cl, K, and S.

Conclusions. The corrosion mechanism was primarily sulfidation-oxidation in which low-oxygen, high-sulfur atmospheres resulted in formation of sulfides under conditions in which the steel could not maintain a normally protective oxide film. Chlorides in the flue gases contributed to corrosion by further reducing the ability of the steel to form a protective oxide film. Excessive temperatures caused extensive oxidation during the final 3 days of operation.

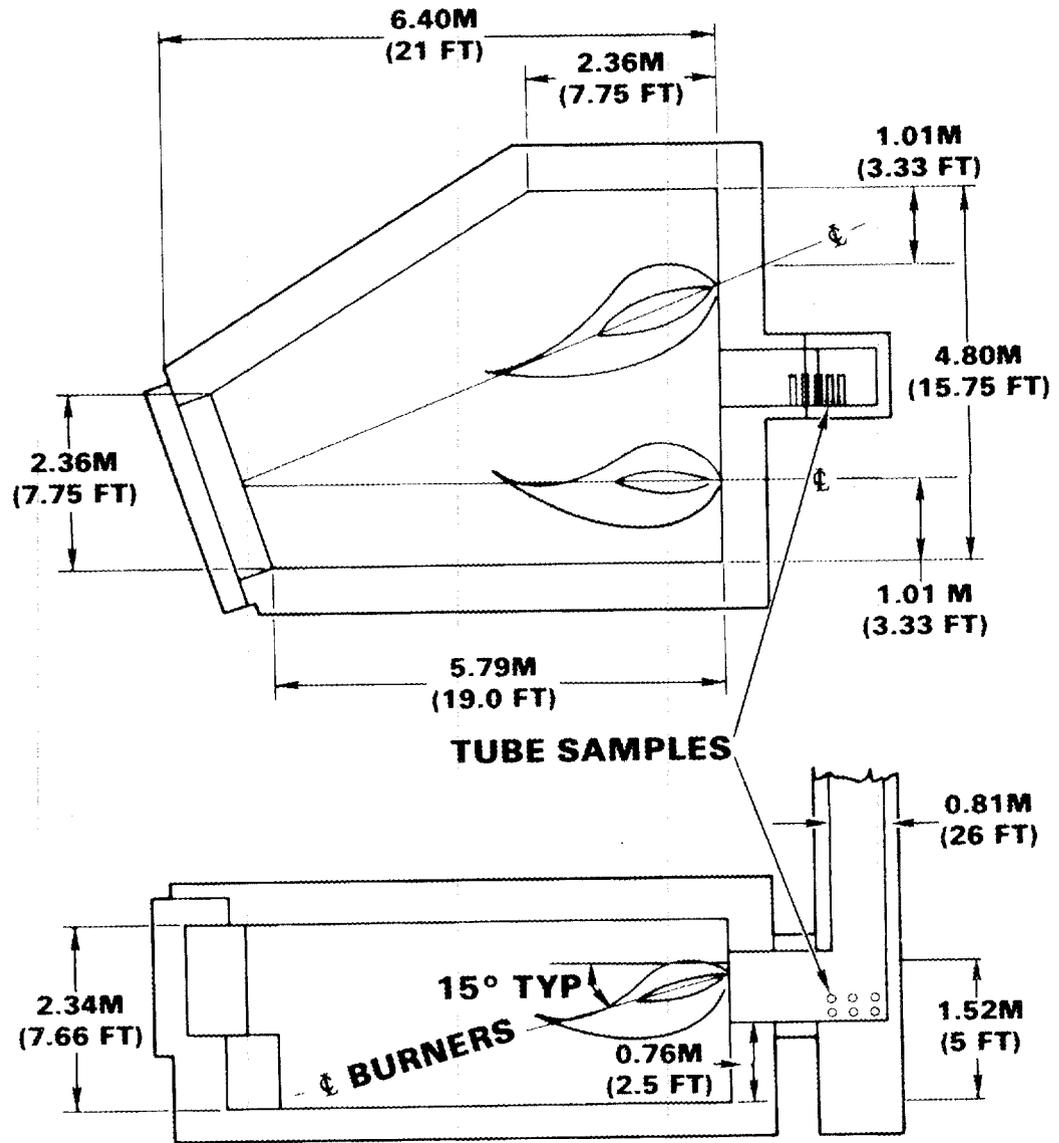
Fig. 7. Aluminum-remelt furnace used for exposure test.

Exposure Conditions. Six industrial furnaces were used for exposure tests: two aluminum-remelt furnaces (Fig. 7), a steel-forge furnace, a steel-reheat furnace, and two steel-soaking pits. All six furnaces burned natural gas. The combustion products contained constituents of the materials and refractories being heated. Deposits on the specimens in the aluminum-remelt furnaces (Fig. 8) contained substantial amounts of Al, Fe, K, Na, Si, and Zn and other elements in lesser amounts. The combustion products probably also contained halide species, which were derived from fluxes. Deposits on specimens in a steel-soaking pit contained major amounts of Cr, Fe, and Si and substantial amounts of Ca, Cu, K, Mn, Na, and Ni. These elements evidently derived from the steel billets and topping compounds. No substantial deposits formed on specimens exposed to the steel-forge furnace, steel-reheat furnace, and the other steel-soaking pit. Either the atmospheres were cleaner in those three furnaces or the specimens were in protected locations. Exposure temperatures and times were:

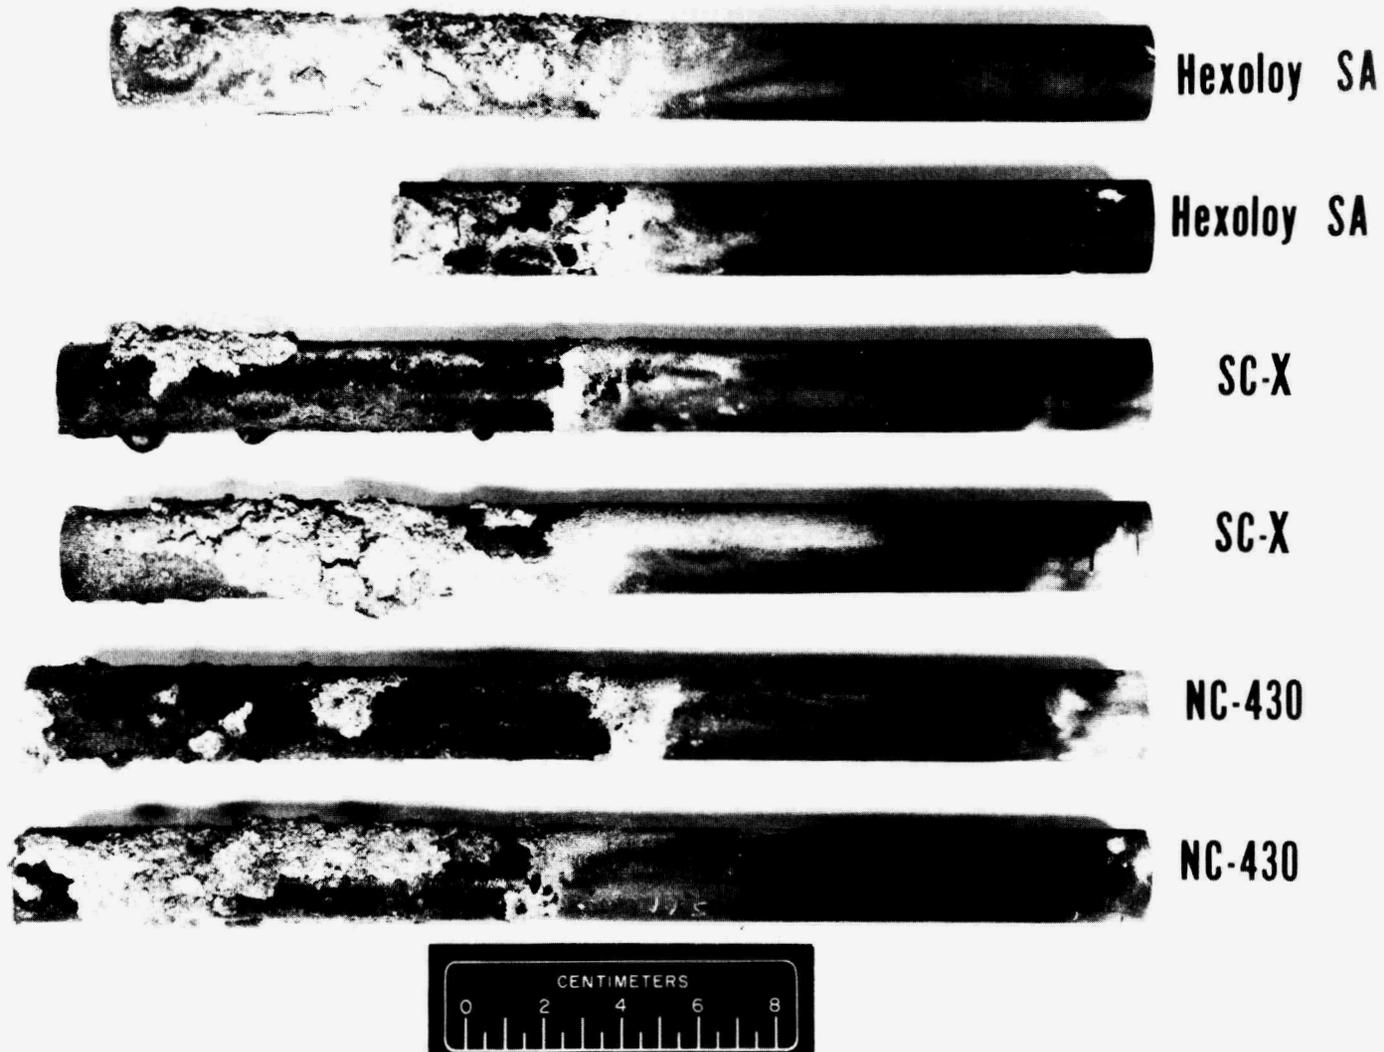
Fig. 8. SiC ceramics exposed to aluminum-remelt furnace environment for 5545 h at a maximum temperature of 1040°C.

1. Glassy and loosely adhering coating in No. 1, glassy coating only in No. 2.
2. Surface recession in SiC ceramics of 0.1 to 0.6 mm/year linearly projected from 0.6-year exposure.
3. Flexural strength decreases of sintered alpha SiC and NC-430, the only materials tested, attributed to corrosion and/or thermal history.

4.  $\text{Si}_3\text{N}_4$ -bonded SiC ceramics (C/75 and CN-178) cracked, deformed, and had significant surface recession.

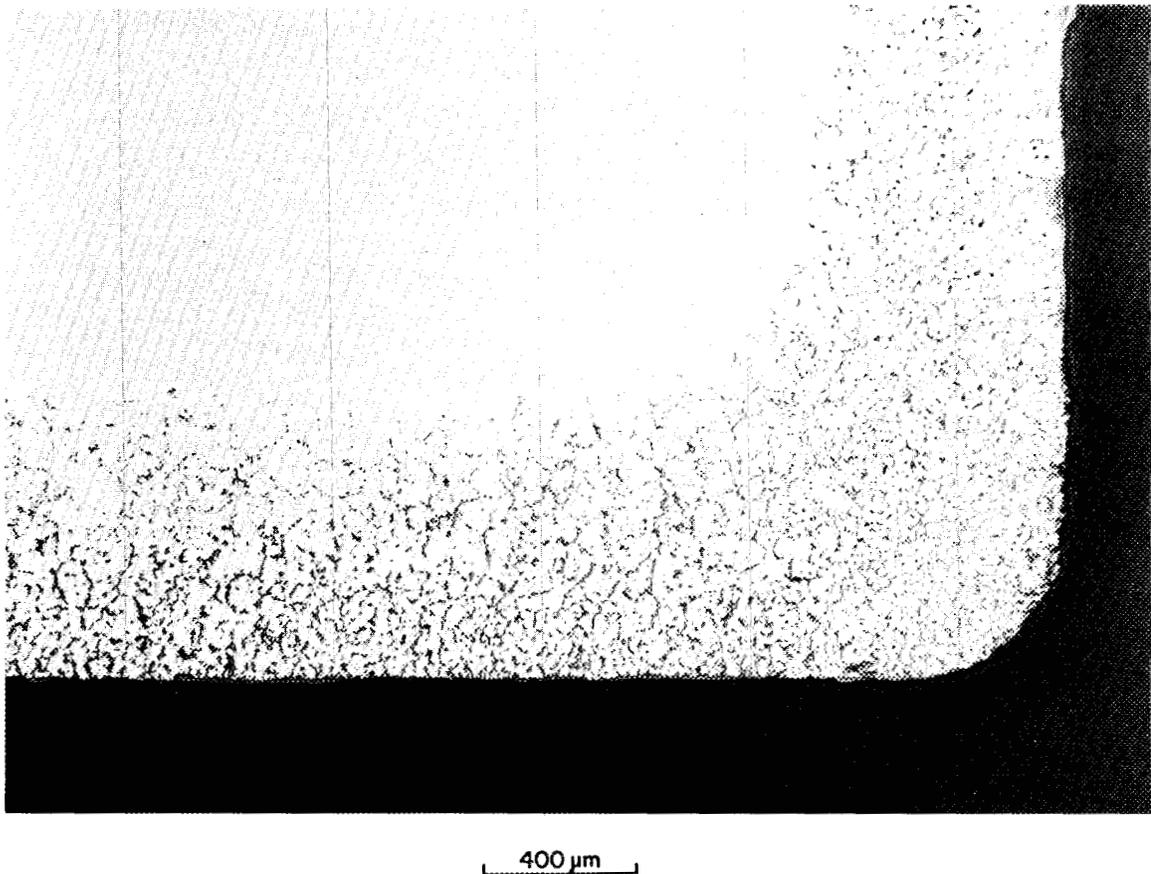
Fig. 9. Uncoated Inconel 625 exposed to aluminum-remelt furnace flue gases for 2250 h at a maximum temperature of 1000 to 1150°C. As polished.

Results. For the alloys, air oxidation caused surface scales, sub-surface porosity (or oxidation), and intergranular attack in some alloys. Aluminum coatings generally protected the alloys against oxidation, but SiO<sub>2</sub> coatings detached and were not protective. Uncoated Inconel 625 corroded by intergranular attack at a projected rate of 2.6 mm/year in an aluminum-remelt furnace (Fig. 9). Aluminum-coated Inconel 625 corroded more slowly (1.2 mm/year) in an aluminum-remelt furnace. Aluminum coatings did not consistently protect alloys in an aluminum-remelt furnace; SiO<sub>2</sub> coatings detached and provided no protection.

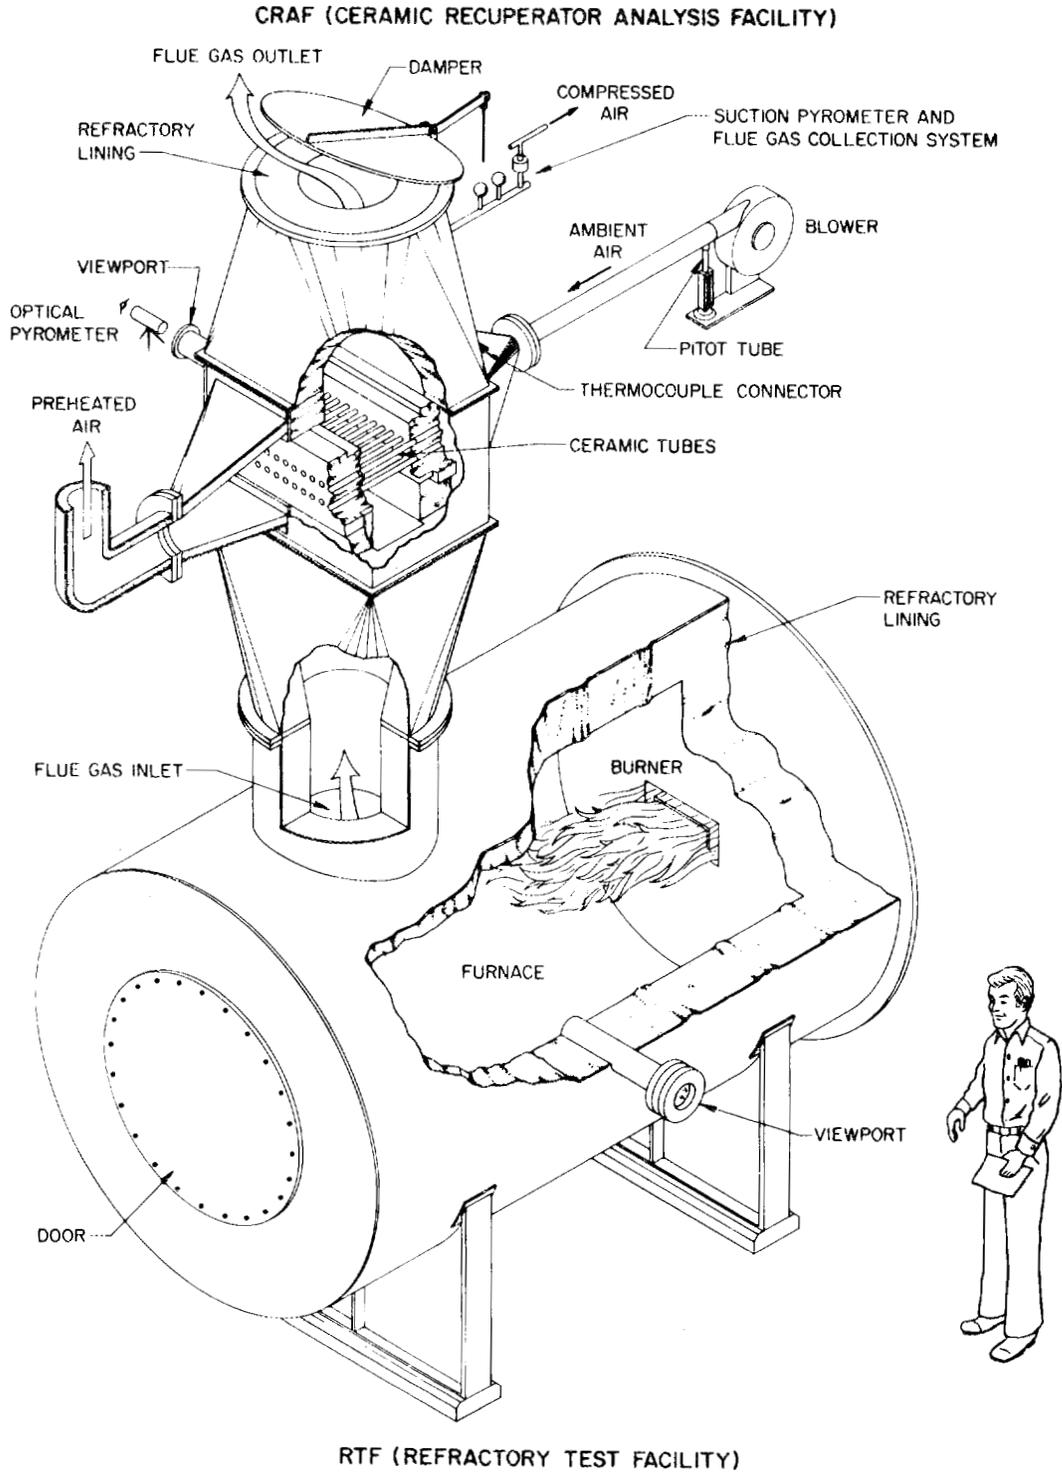
Fig. 10. Refractory Test Facility (furnace) and Ceramic Recuperator Analysis Facility.

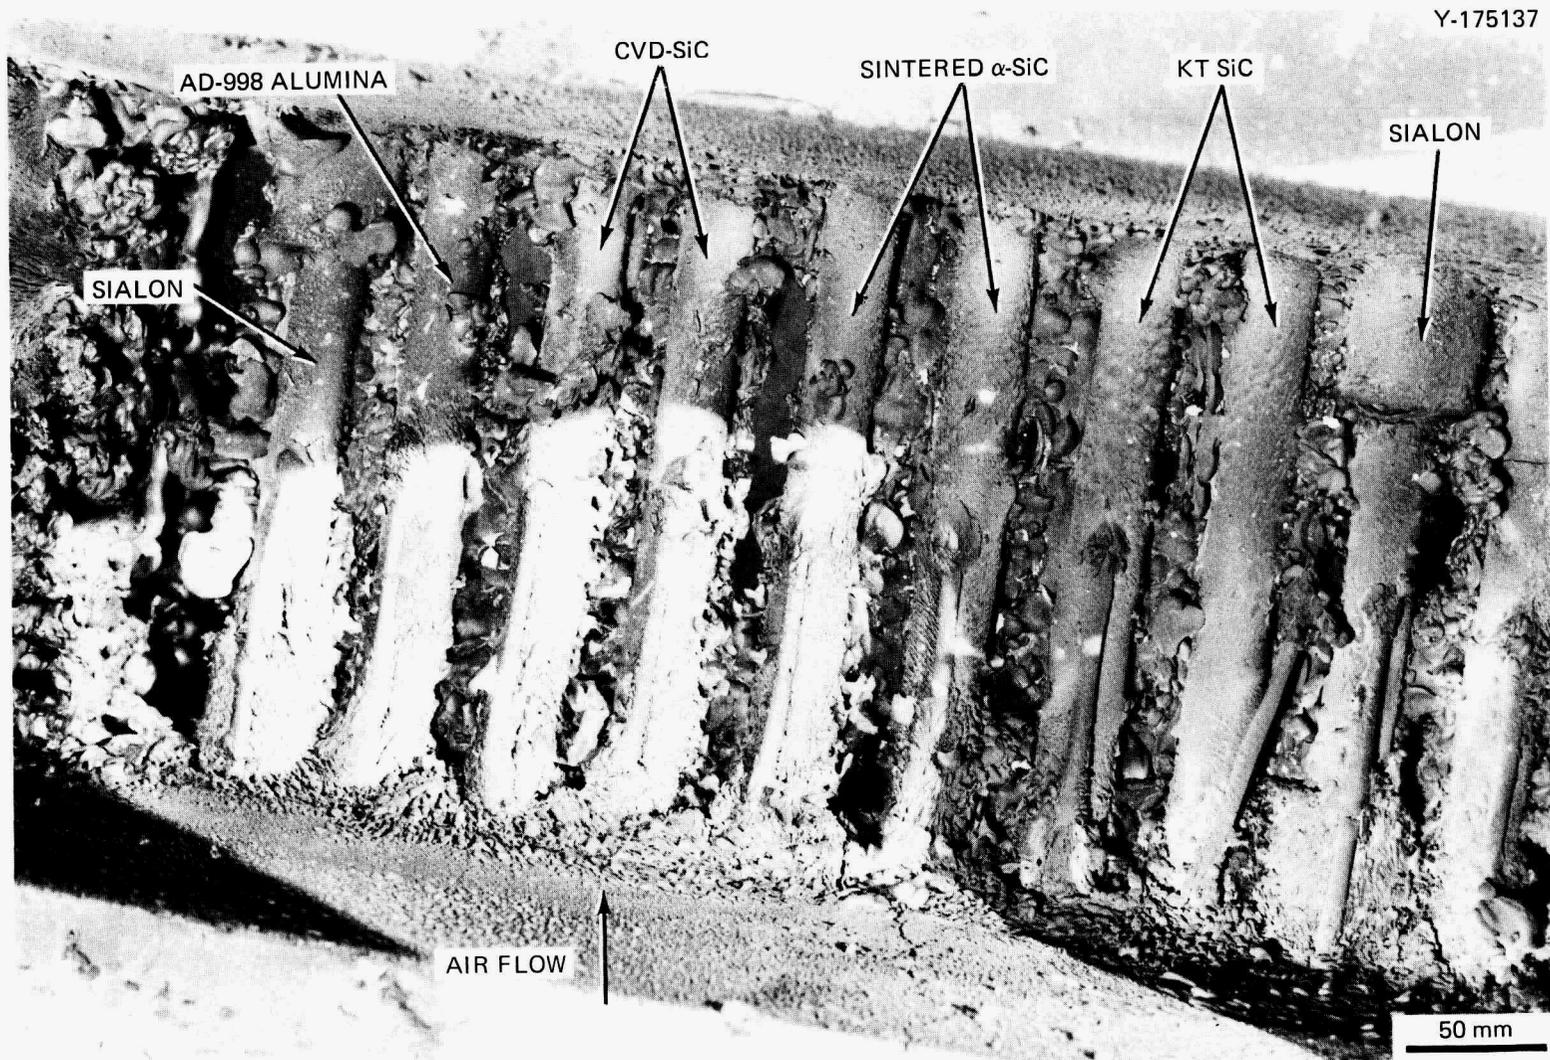
Fig. 11. Downstream surfaces of ceramic tubes after exposure to combustion products of a coal-oil mixture for 496 h at 1200°C.

Discussion. Corrosion of SiC ceramics was attributed to formation of iron and nickel silicides at the slag-ceramic interface. The silicides subsequently detached from the SiC and eventually dissolved in the fluid slag. The AD-998 alumina corroded by formation of iron-nickel aluminate, which subsequently dissolved in the slag. Corrosion of SiC ceramics and AD-998 alumina produced microscopically rough surfaces, which contributed to reductions in room-temperature fracture strengths.

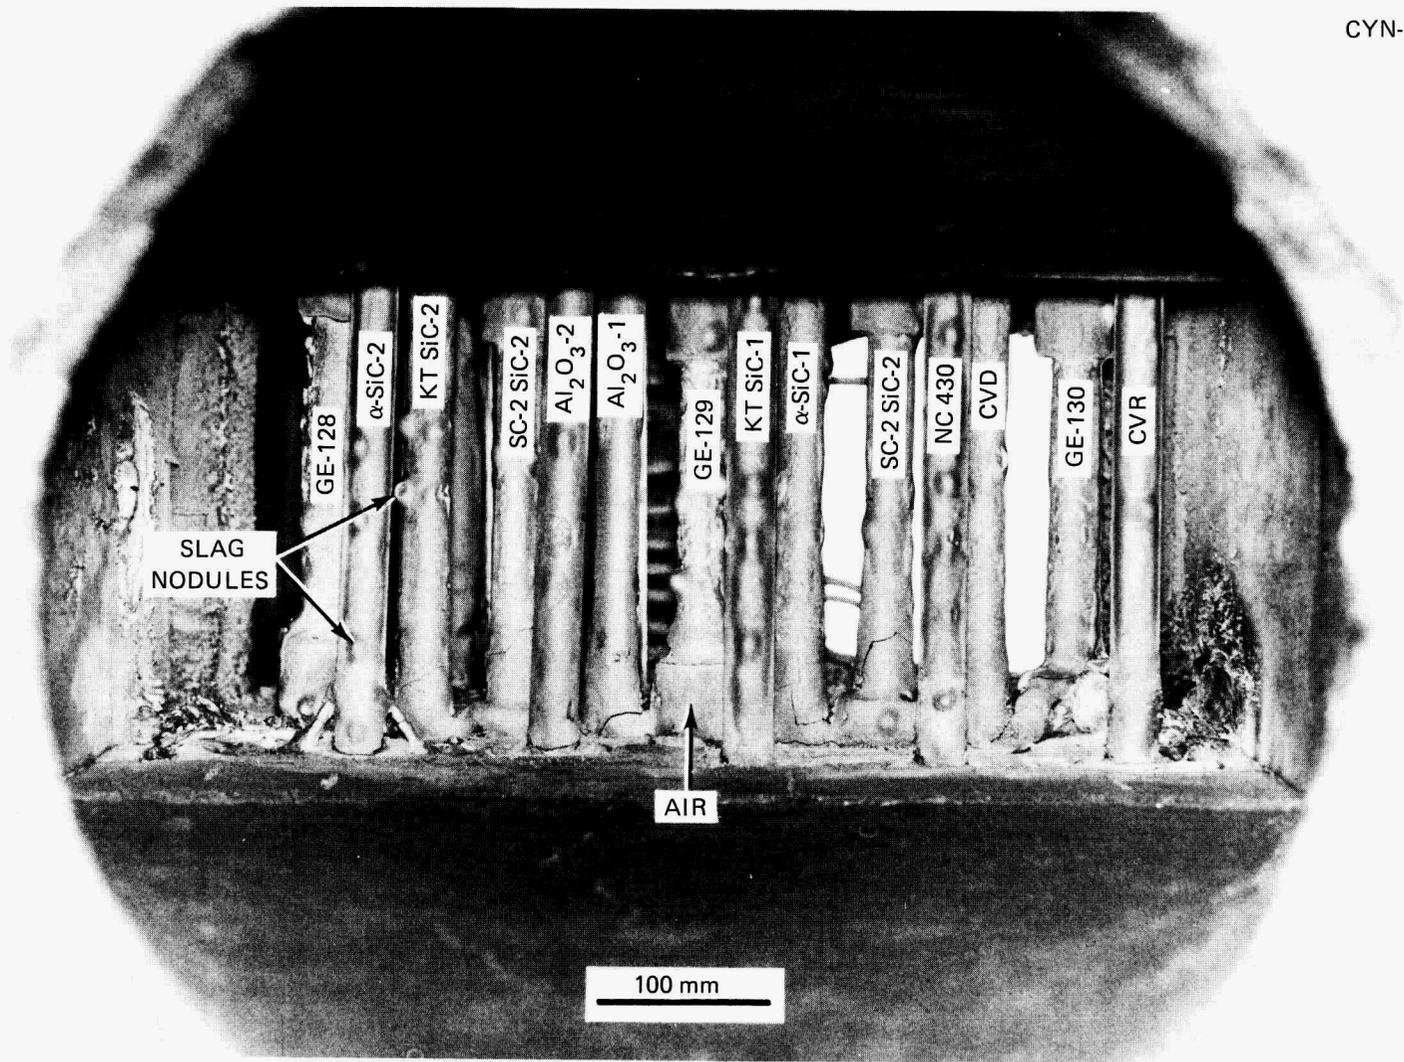
Fig. 12. Upstream surfaces of ceramic tubes after exposure to combustion products of a coal-oil mixture for 240 h at 1200°C.

Conclusions. On the basis of surface recessions on the upstream side of the tube specimens, none of the materials have sufficient corrosion resistance to serve as heat-exchanger elements under high-temperature fluid basic coal slag conditions, unless very thick sections are used.

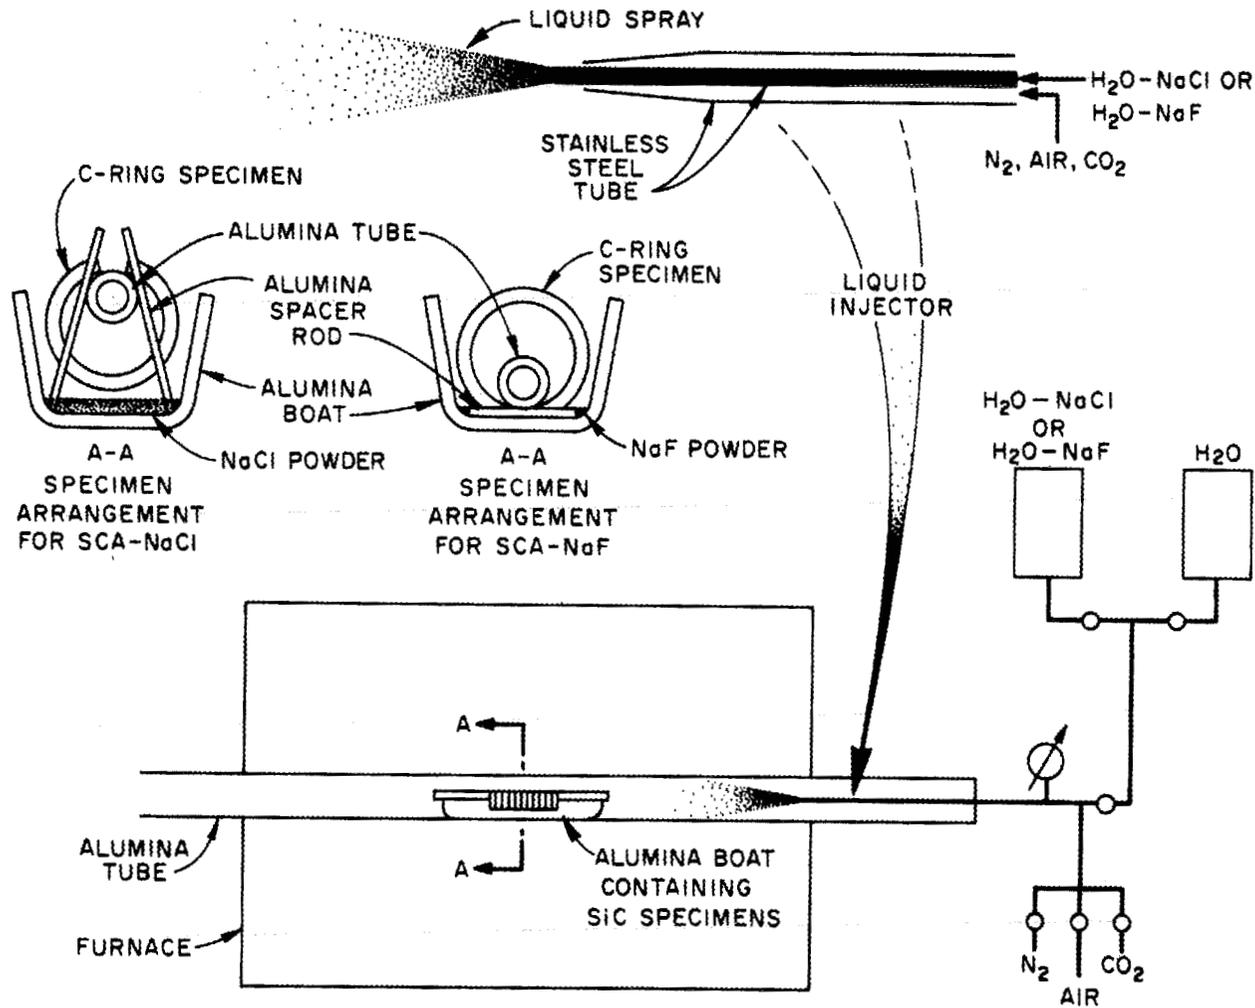
Fig. 13. Apparatus for exposing C-ring specimens of SiC ceramics to synthetic combustion atmospheres.

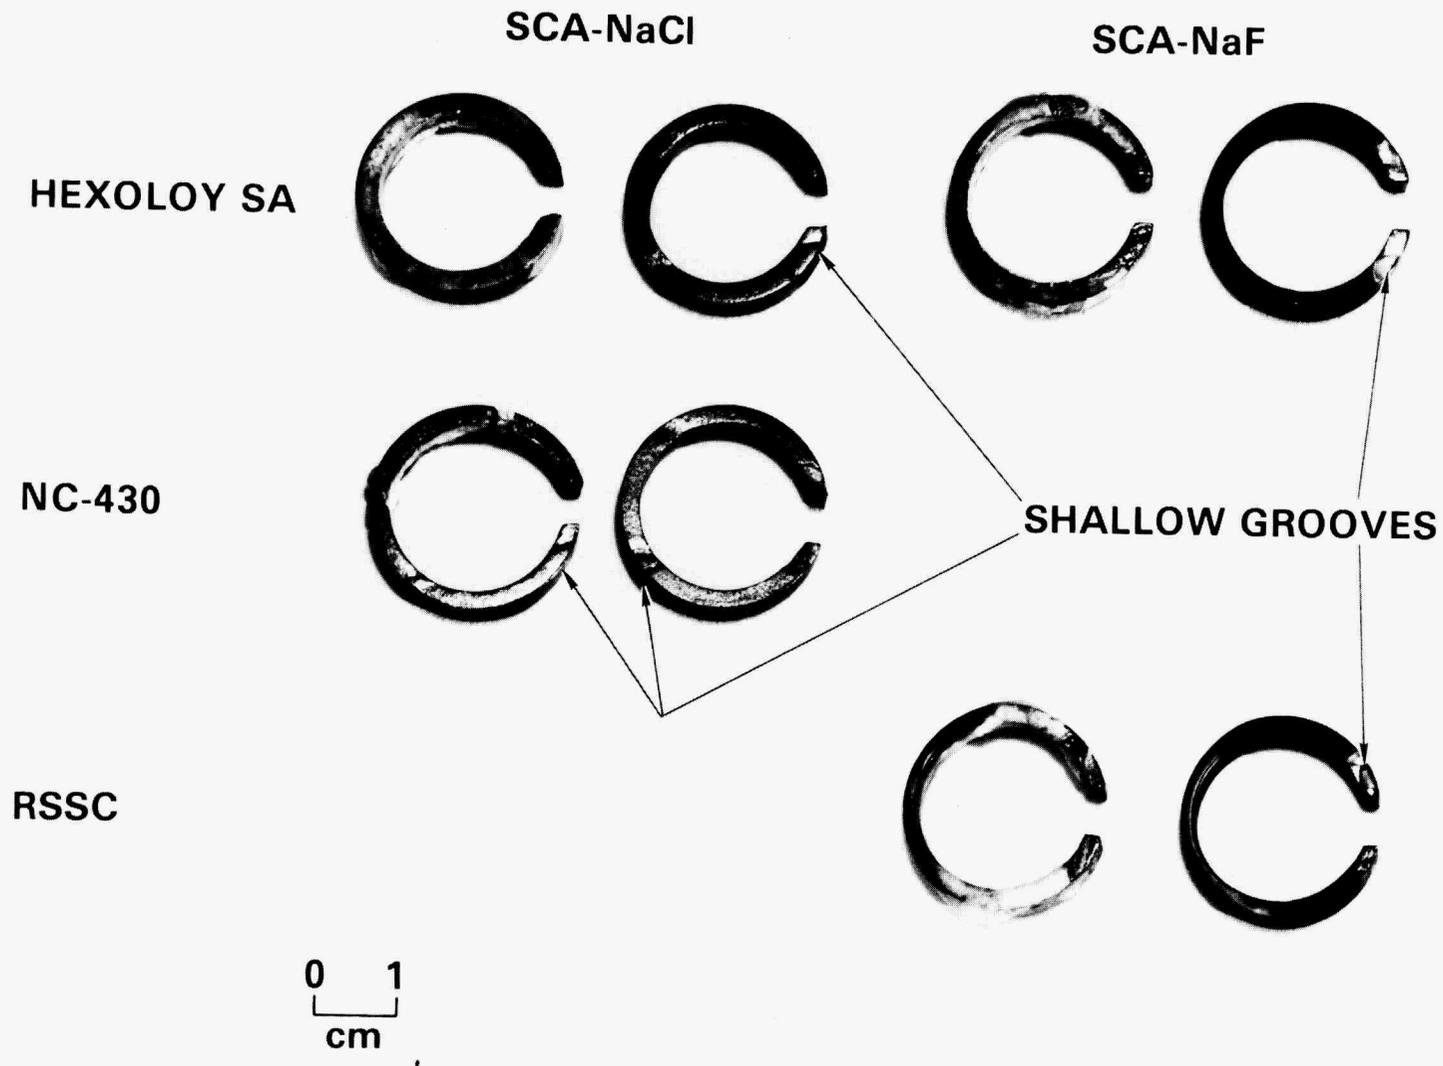
Fig. 14. SiC ceramics after exposure to SCA-NaCl and SCA-NaF for 1000 h at 1200°C.
