# Wind-washing effects on mineral wool insulated sheathings

Dr John Straube, P.Eng.

*RDH Building Science, Waterloo, ON*

*Roxul Inc., Milton, ON*

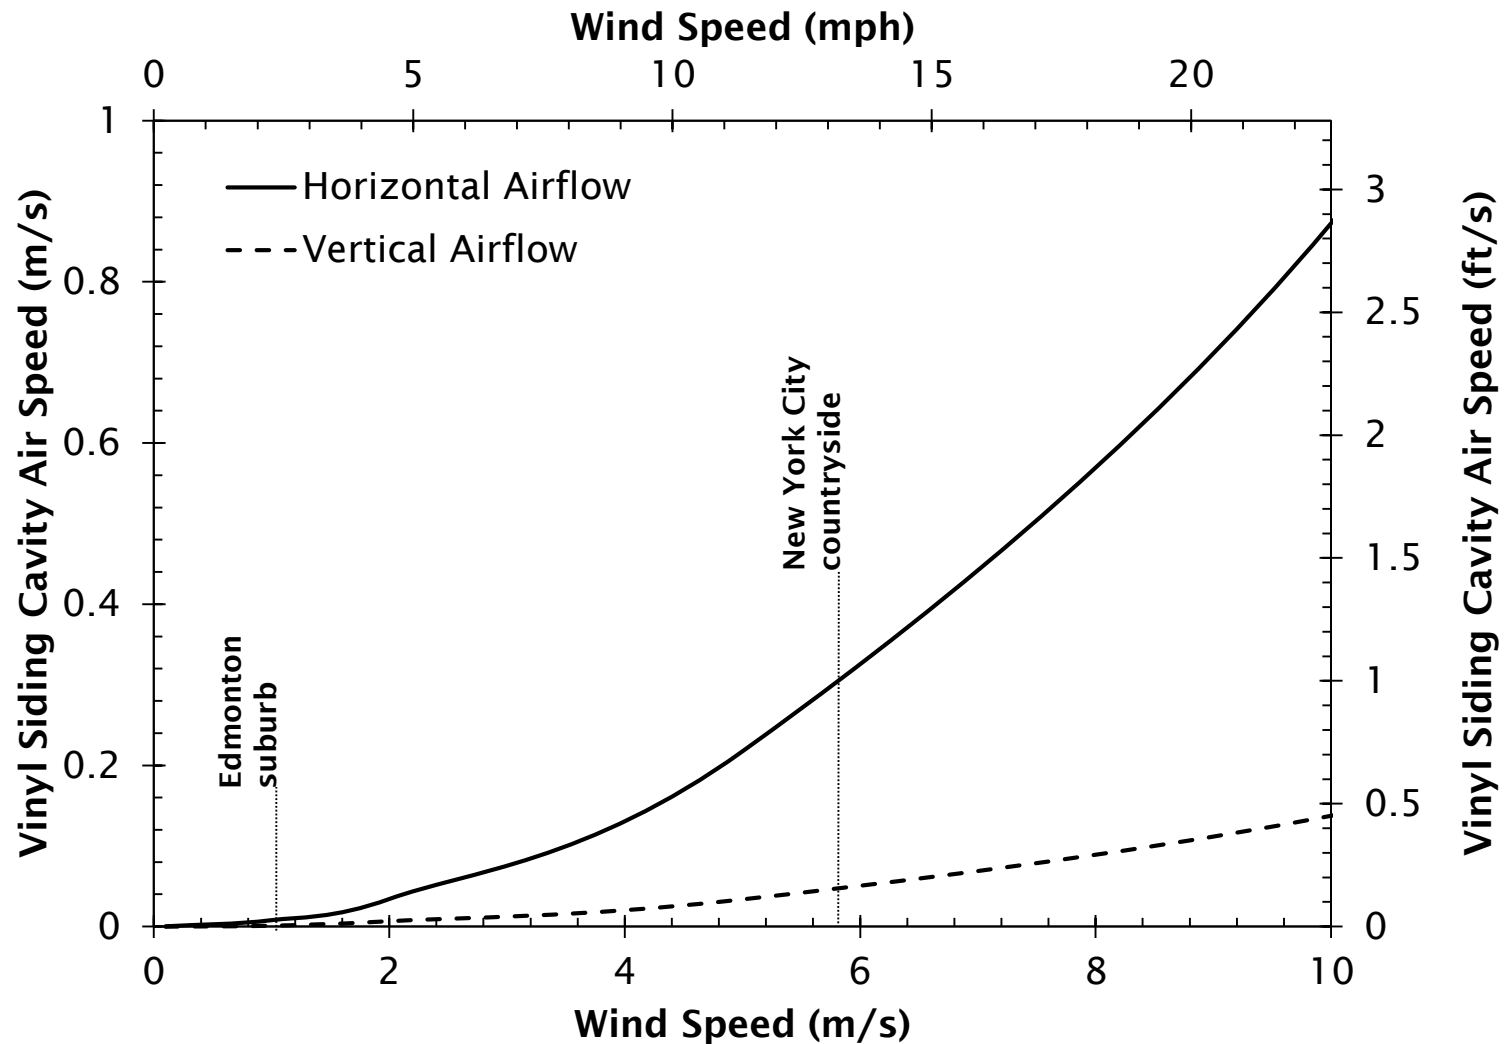
# Vinyl Siding Cavity Flow

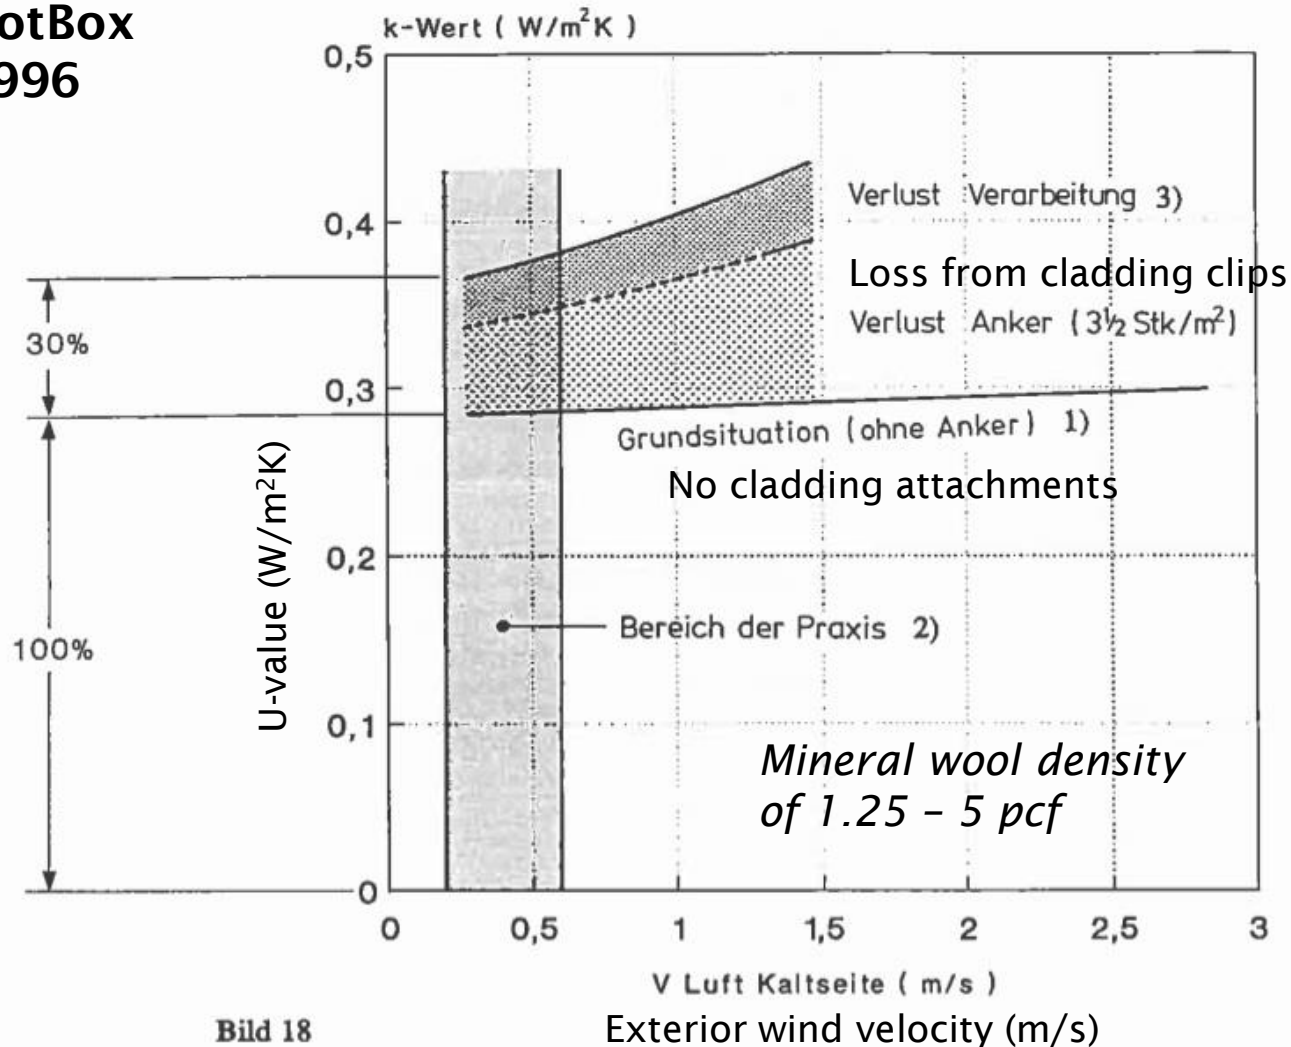
Bild 18

# EMPA HotBox Study 1996

Exterior wind velocity (m/s)

- 1) 1990 wurden an der EMPA verschiedene k-Wert-Prüfungen an Mineralfaserdämmplatten gemacht, wobei die kaltseitige Luftströmung über die Oberfläche der perfekt versetzten Dämmplatten variiert wurde. Im Bereich der geprüften Rohdichten (20 - 62 kg/m<sup>3</sup>) hatte die Luftgeschwindigkeit von 0.3 - 1.0 m/s (was den in der Praxis vorkommenden Bereich abdeckt) praktisch keinen Einfluss auf den gemessenen k-Wert.

- Limited lab measurements by some
- EMPA (Switzerland 1996)
  - Hot box test w/ Simulated wind
  - No cladding over mineral wool (1.25-5 pcf)
  - Small, marginal impact (under 5%)

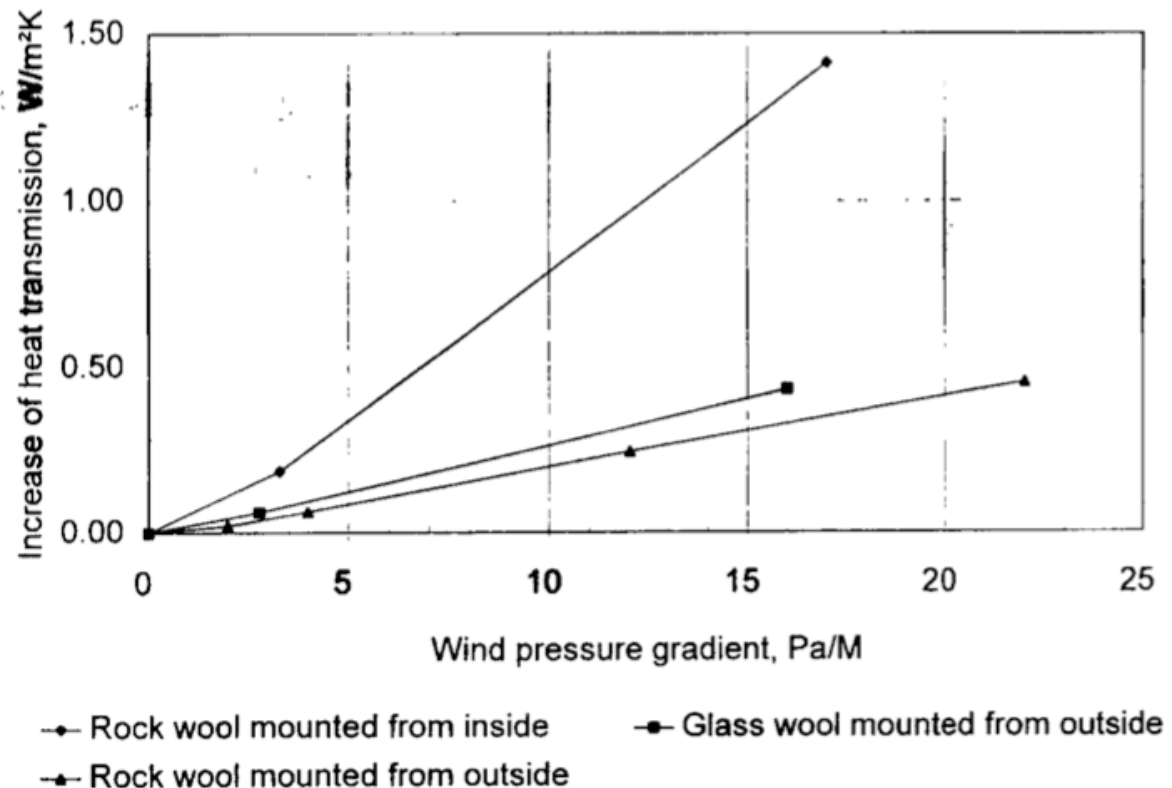
# Uvslokk (1996)

Low-density batt product (22 & 32 kg/m<sup>3</sup>)  
High pressure gradients = high flow  
Low density and poor installation are critical

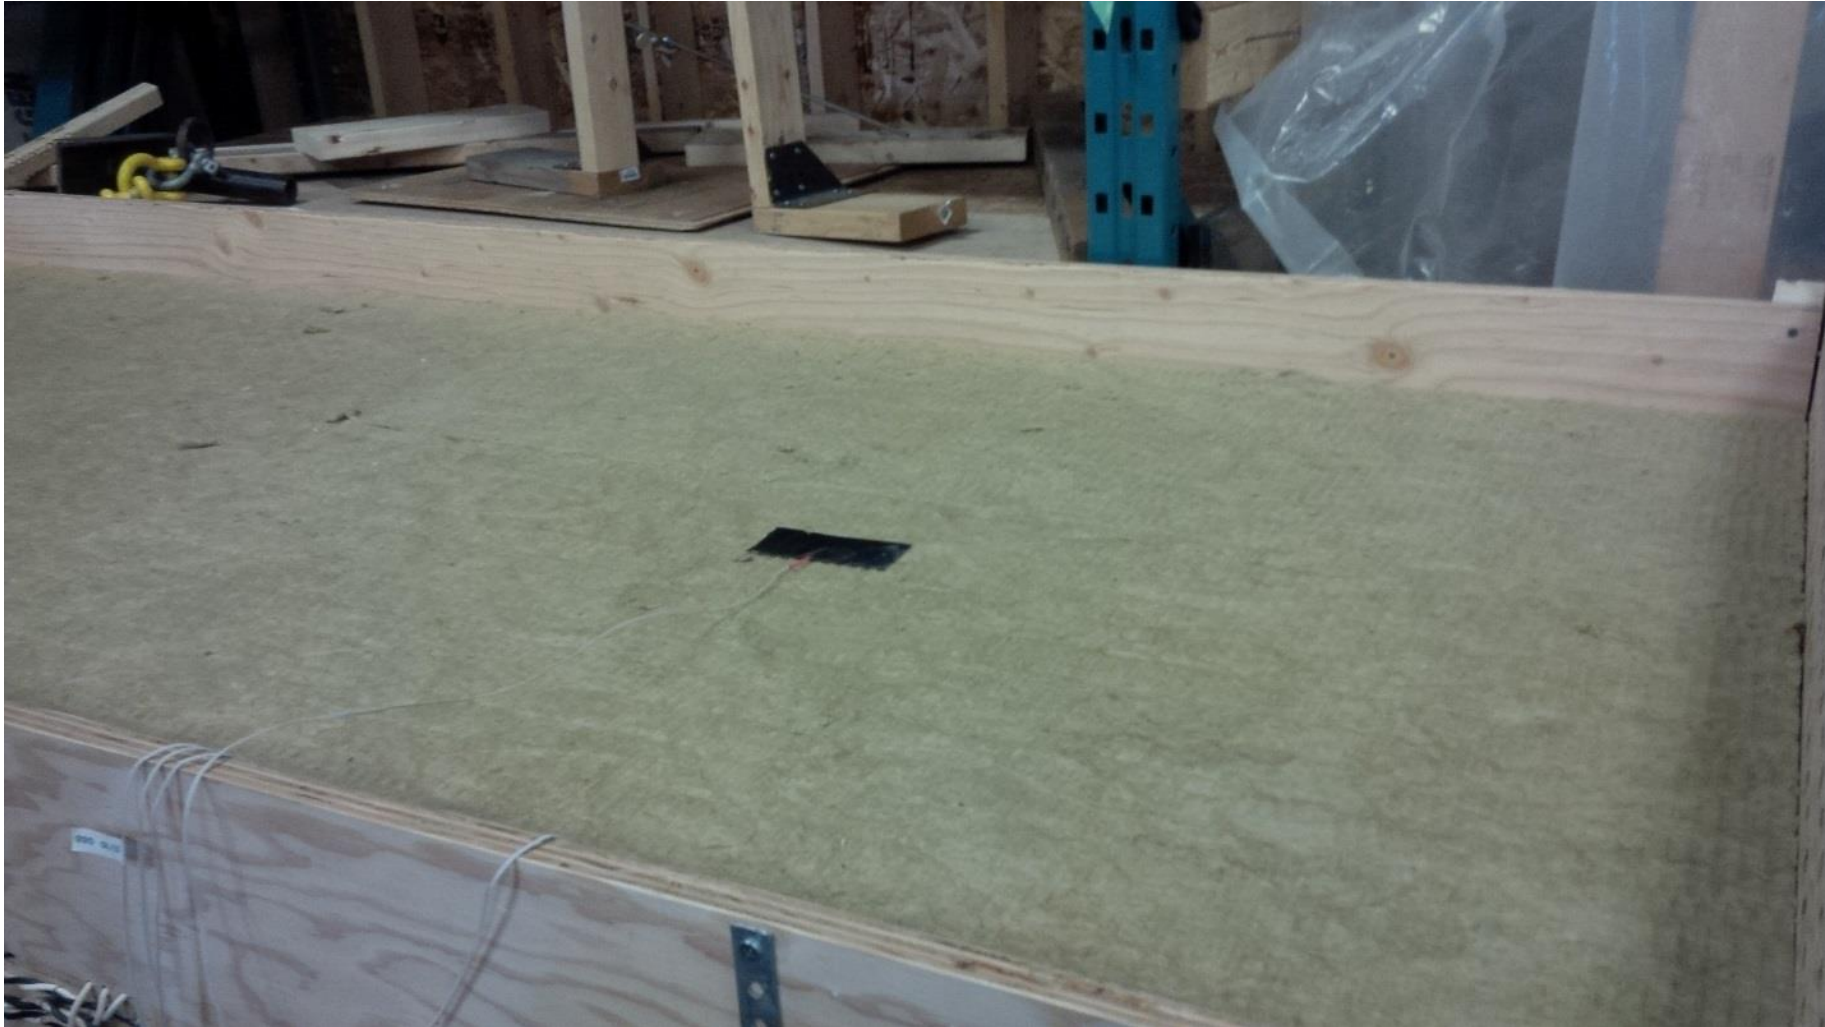
# Temperature of exterior insulation

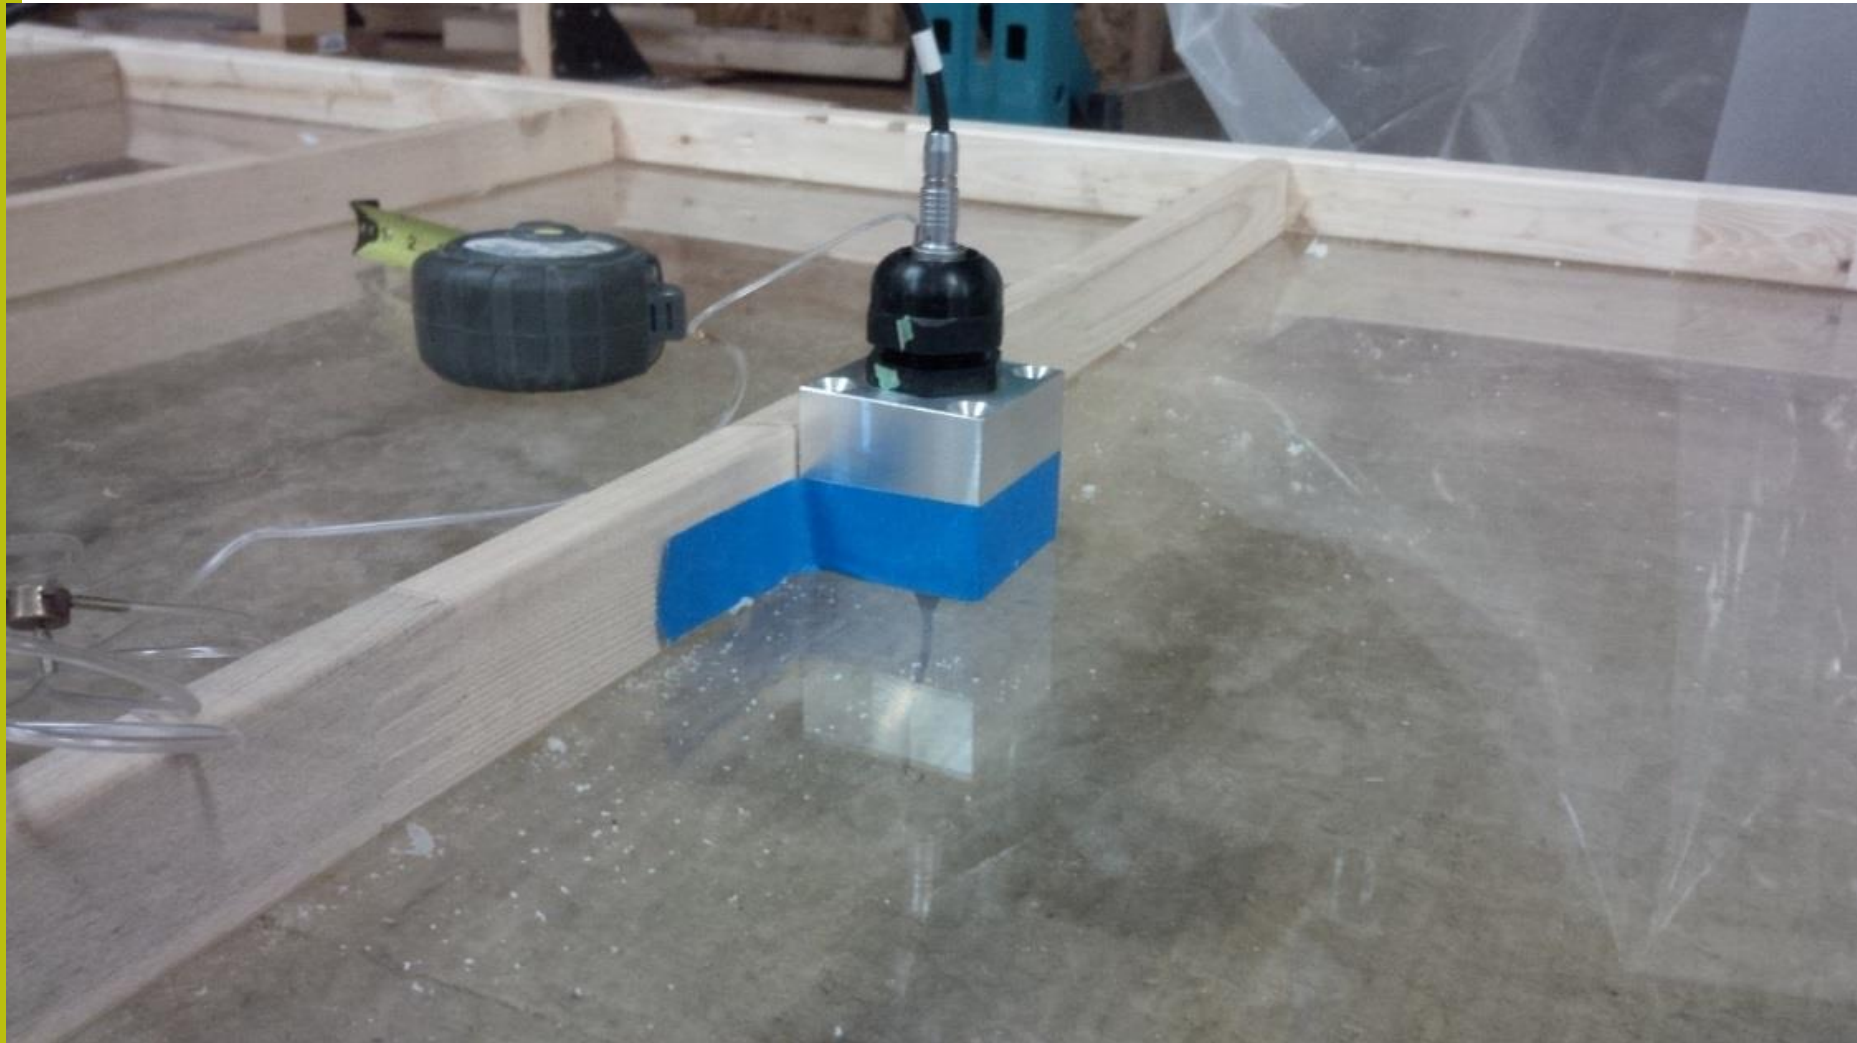
# Velocity sensor @ meter area
