Thermal Performance of the Exterior Envelopes of Whole Buildings XIII

Sealed Attics Exposed to Two Years of Weathering in a Hot and Humid Climate

William Miller, Ph.D., PE, ORNL Sudhir Railkar, Ph.D. GAF Ming Shiao, Ph.D., GAF Andre Desjarlais, PE, ORNL

Natural Exposure Test Facility in Charleston, SC

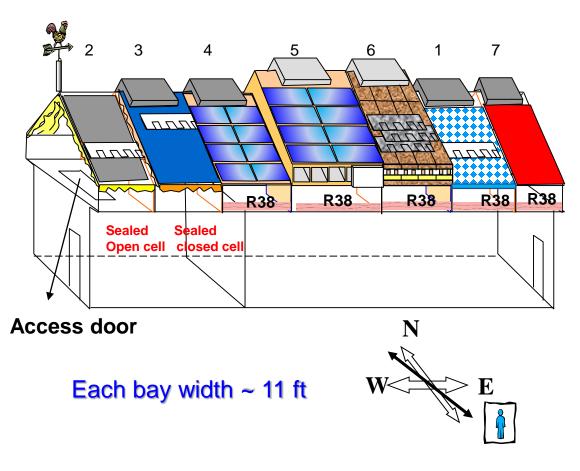
Attic Cavity	Acronym		
Attic 01	CTRL (16 Perm) Vapor permeable underlayment		
Attic 02	SLD (8 Perm) Semi permeable		
Attic 03	NB (0.04 Perm) Vapor impermeable		
Attic 04	CC (0.04 Perm) Vapor impermeable		
Attic 05	ASV (8 Perm) Semi permeable		
Attic 06	RB (8 perm) Semi permeable		
Attic 07	FF (0.10 Perm) Vapor semi impermeable

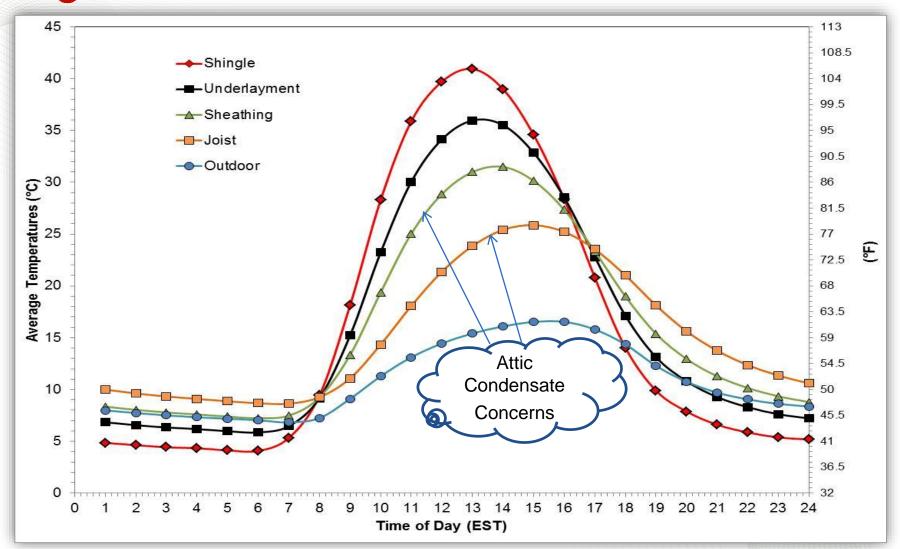
Ventilated Attics: Potential for Condensation occurs ≤ 5% of 5760 hrs

Attic 01 Vent 1:300, Vapor permeable underlayment (16 perm)

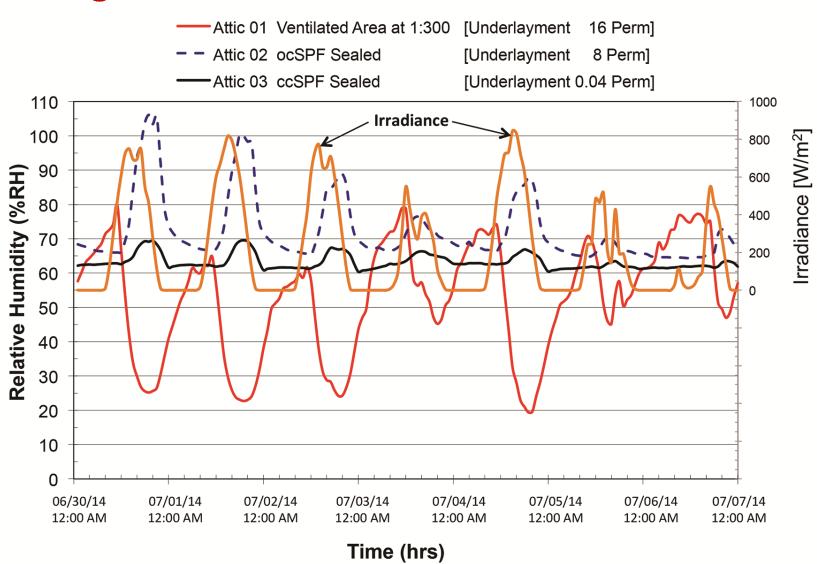
Sealed attic assembly shows evidence of moisture intrusion

Moisture Intrusion trend not observed in winter months

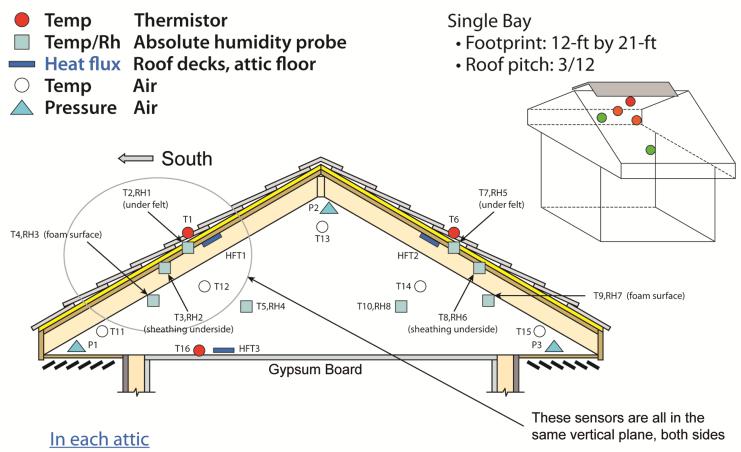
Instrumentation for Sealed Attics

- Thermistors (16), Rh sensors (8), Heat flux sensors (3)
- Total 27 sensors per bay

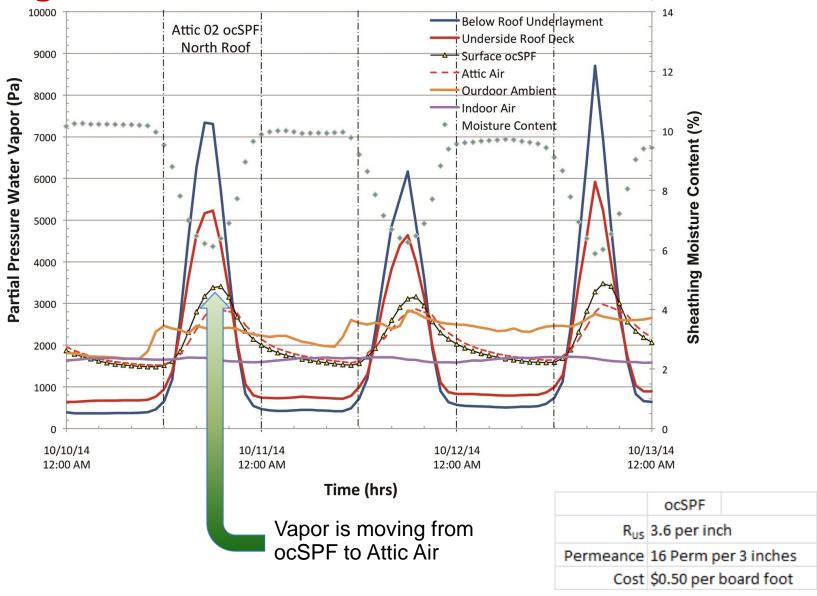
Attic 02 Data for Oct 2014 [sealed with ocSPF]

No Internal Moisture Load. No Occupants in NET facility.

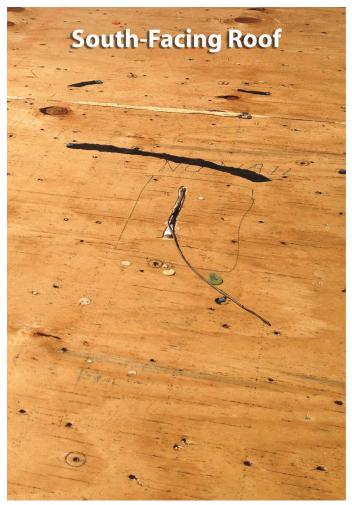
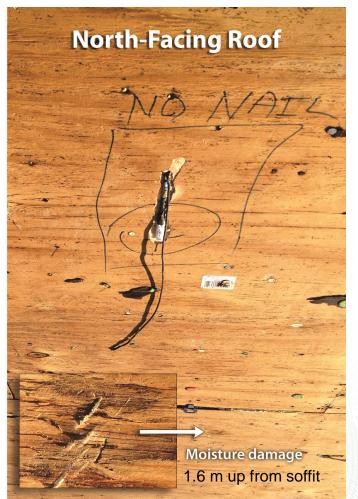
Plywood deck (½-in) shows moisture damage after 2 years of exposure to hot, humid climate and ocSPF insulation

Delmhorst measures showed south- and north-decks dry Moisture damage comes from attic interior

- 3. Moisture was physically observed along the 2 by 6 rafters of the attic sealed with ocSPF. Water damage to plywood deck was observed about 1.6 meters up from the soffit.

- 4. The field study did not show evidence of moisture marks or damage near the ridge, rather water marks were observed along the rafters about mid span of the roof.

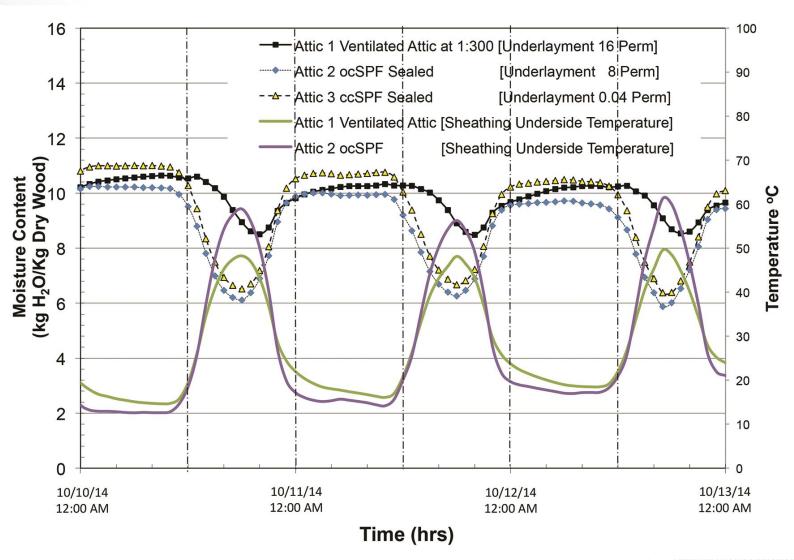
Cyclic Effect of Moisture Content in Roof Deck not as Severe if Attic Ventilated

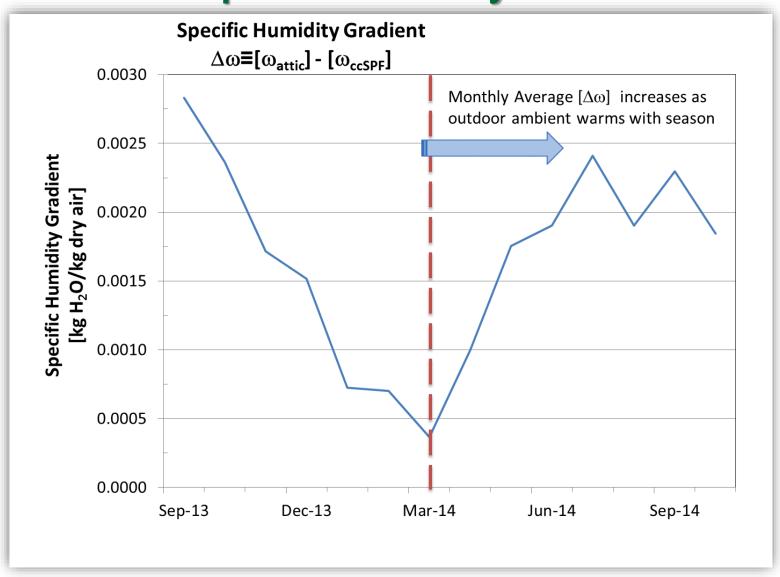
Monthly Average Specific Humidity of Attic Exceeds Specific Humidity in the ccSPF

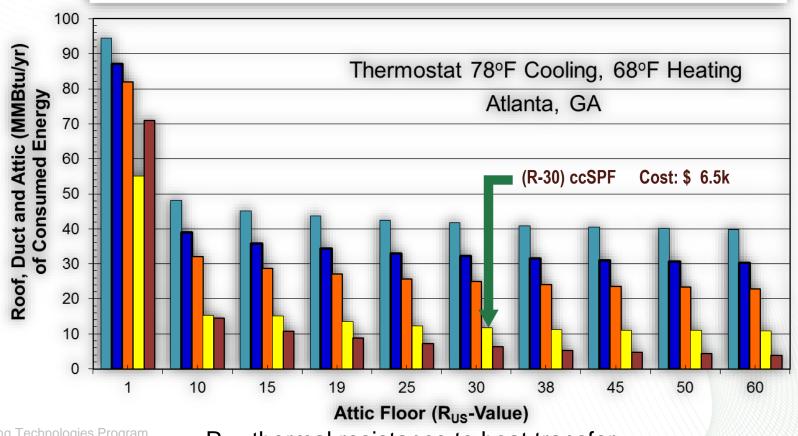
Diminishing Returns for Adding Ceiling Insulation (Leaky Duct Losses \$)

- Dark Shingle roof, attic contains 20% leaky ducts; attic floor is not sealed
- Dark Shingle roof, attic contains 10% leaky ducts; attic floor is not sealed
- Dark Shingle roof, attic contains 4% leaky ducts (R-8 insulation); attic floor is sealed
- □ Dark Shingle Roof with Sealed Attic, 10% leaky duct; attic floor is not sealed
- Dark Shingle but with ducts removed from attic; attic floor sealed

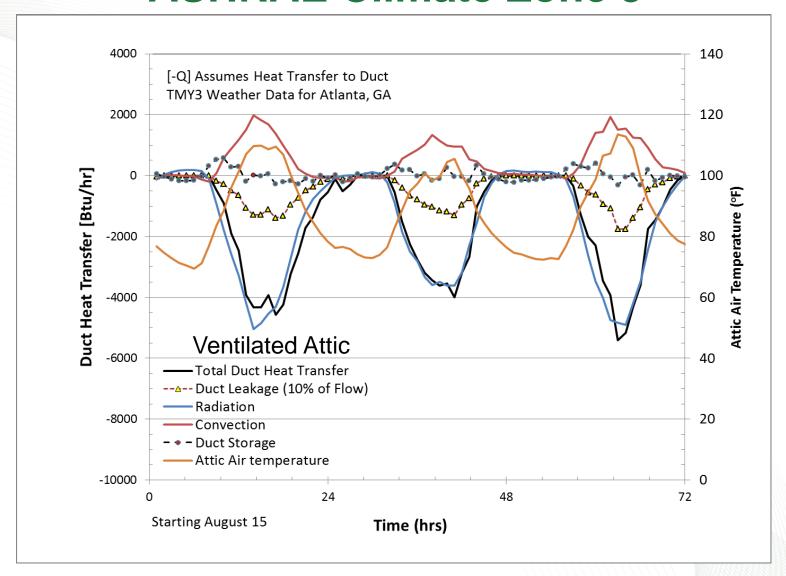
Summer Operation of HVAC Duct in ASHRAE Climate Zone 3

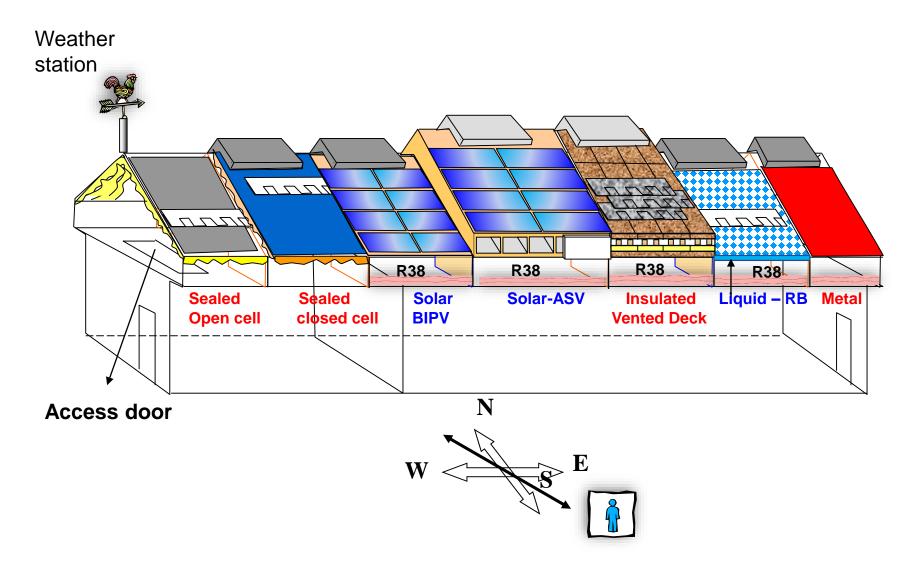
NET Field Experiments Sealed Attics Insulated to R-22

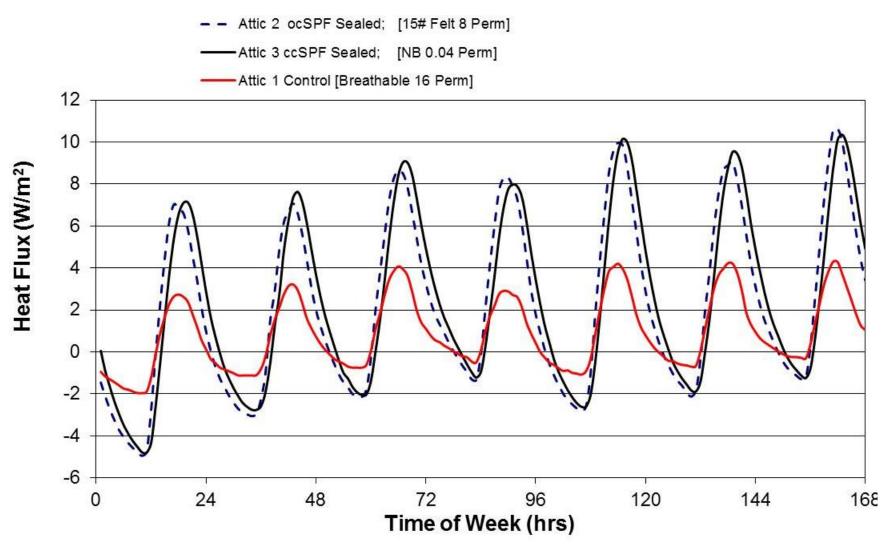
Ceiling Flux Crossing Sealed Attics Insulated to R-22 at Roof Deck is at Least Double that of R-38 Blown Fiber on Ceiling in Ventilated Attic

- Sealed attic insulated with spray polyurethane foam that is less than code level of insulation will have significantly higher heat flows crossing the attic floor.

- difference in thermal resistances of bare drywall as compared to an insulated ceiling predominates over the benefit of the reduced attic air temperature
