EFFECT OF HEAT TREATMENT AND TEST METHOD ON DBTT OF A V-5Cr-5Ti ALLOY - Huaxin Li (Associated Western Universities--Northwest Division), M. L. Hamilton and R. H. Jones (Pacific Northwest Laboratory)\*

The purpose of this research is to investigate further the effect of heat treatment (HT) on fracture properties of a V-5Cr-5Ti alloy in the temperature range -190 to 90°C, and also to investigate how its DBTT depends on HT and test method.

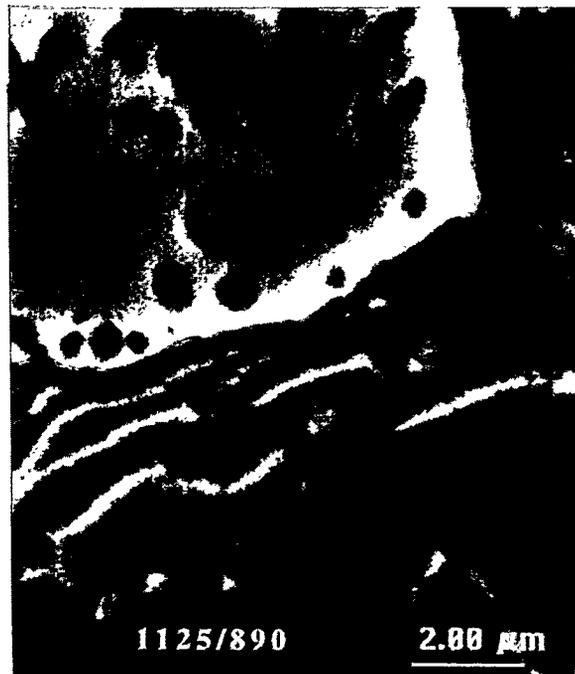
(a)

Fig. 3. SEM micrographs at higher magnification showing the microstructure resulting from treatment of 1125°C/1 h/furnace cooled plus 890°C/24 h/furnace cooled. a) pores and second phase;

The HT2 also produced significantly more second-phase precipitates than HT1, as shown in Figs. 1a and 1b. SEM photos at higher magnification showed that the HT2 specimen contained pores and second phase particles, as shown in Figs. 2 and 3. EDS analysis showed that the second phase was enriched slightly with Ti, as compared with that of the matrix. The chemical composition from the second phase and the matrix is given in Table 4. It should be noticed that due to the small size of particles and the penetration of SEM electron beam, the composition for the second phase must be a mixture of the second phase and matrix. The actual Ti concentration in the second phase will be higher than that in Table 4. The pores probably resulted from local dissolution during etching. This feature suggested that HT2 may produce two types of precipitates because the HT1 specimen did have as many pores when etched identically. In order to gain more accurate chemical composition and nature of the dissolved particles, TEM examination is under way.

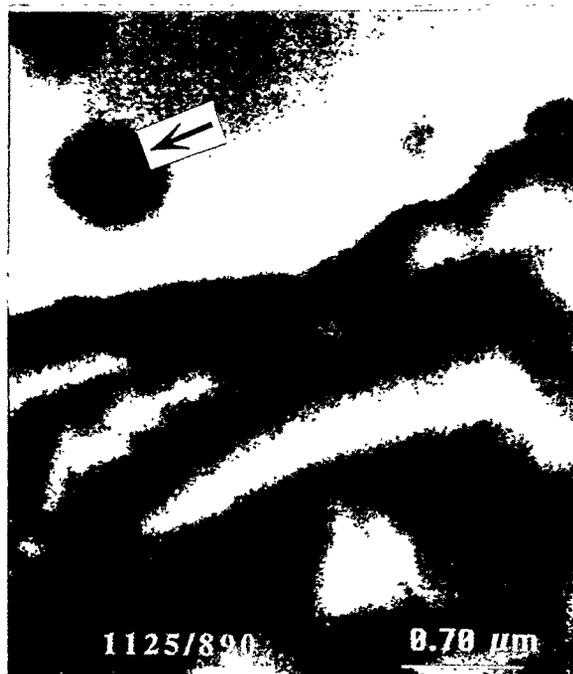
(b)

b) same location as (a) at higher magnification; the arrow indicates a precipitate particle.

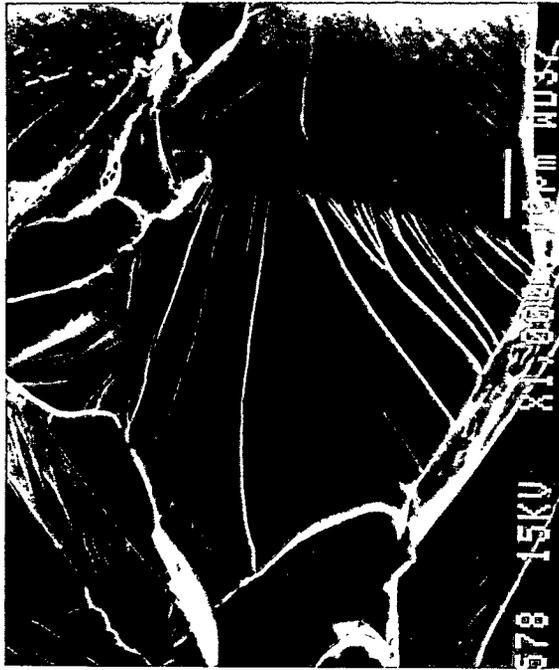
(b)

b) a cleavage fracture facet showing that the cleavage crack initiates at a grain boundary and passes through the whole grain.

Fig. 5 shows the dependence of fracture toughness on testing temperature.  $J_{I0}$  at RT was 52 kJ/m<sup>2</sup>. The specimen fractured with a mixture of intergranular and cleavage failure, as shown in Fig. 6. Fig. 6b shows that cleavage facets appear to initiate at the grain boundaries and propagate through the grains. When tested at 100°C, the material was ductile and exhibited stable crack growth.  $J_{I0}$  was about 485 kJ/m<sup>2</sup> and the tearing modulus was 250 mJ/m<sup>3</sup>. Despite the high  $J_{I0}$  value at 100°C, the fracture surface consisted of intergranular and microvoid coalescence features[2]. The intergranular portion made up about 40% of the total fracture surface. However, the grains experienced a large amount of plastic deformation before they fractured along the grain boundaries, yielding high fracture toughness.
