BRAZED DISPERSION STRENGTHENED COPPER: THE EFFECT OF NEUTRON IRRADIATION AND TRANSMUTATION ON BOND INTEGRITY

D.J. Edwards^(a), F.A. Garner, M.L. Hamilton^(b), and J.D. Troxell^(c)

SUMMARY

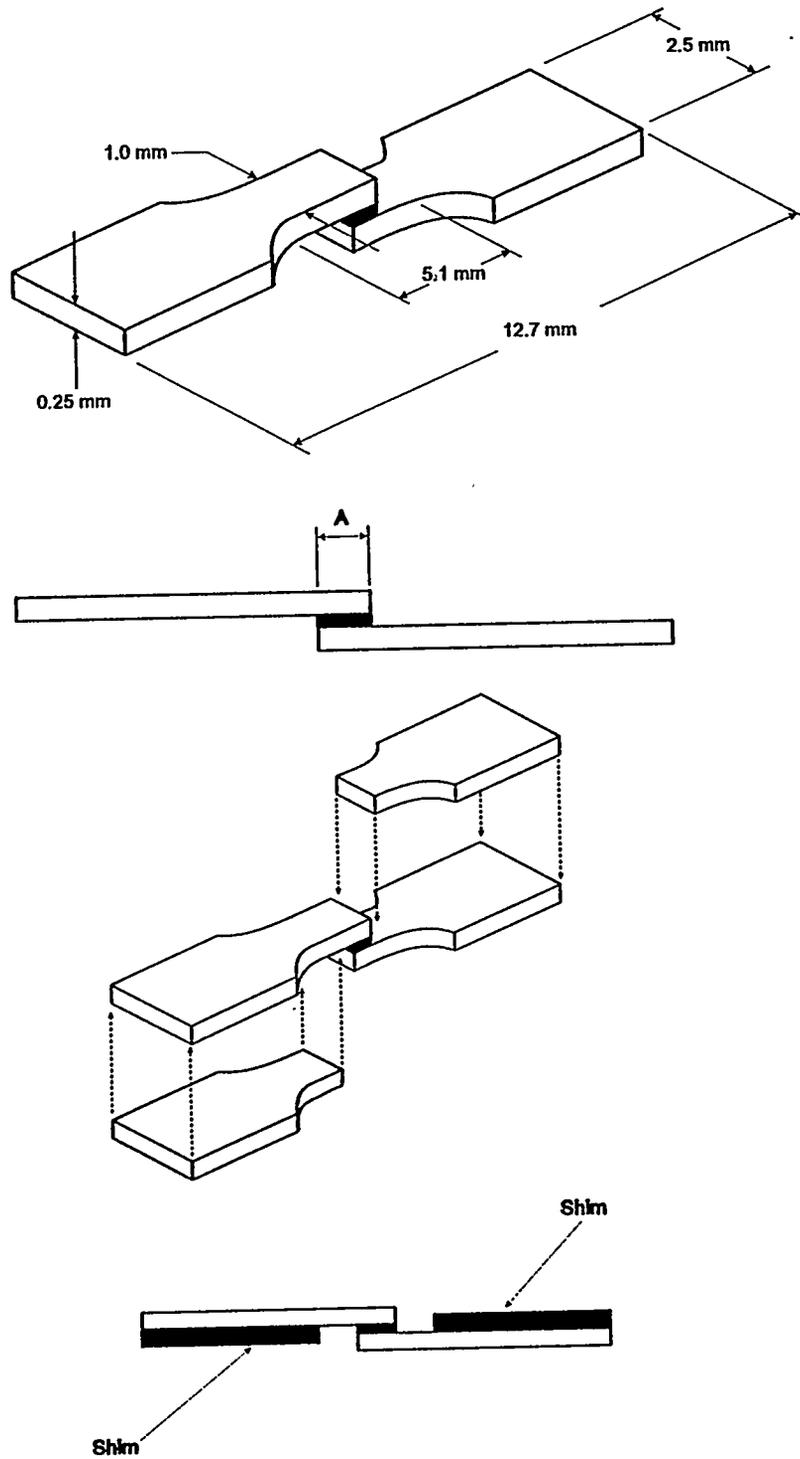
Figure 1. Geometry of miniature lapped tensile specimens.

Figure 2. Use of shims during the testing to maintain the uniaxial testing condition.

An illustration of the test configuration used for the lapped miniature tensile specimens is provided in Figure 2. Because the two specimen halves were offset, bending stresses were introduced during testing. These were minimized by placing shims in the position indicated in Figure 2. The shims were fabricated by cutting the grip ends off of extra specimens of the base material. It was initially thought that the shims might slip during the testing, but by tightening the grips sufficiently this problem did not occur. Since no adhesive was required to prevent slippage, this simplified the testing procedure and reduced both the radiation exposure to the operator and the potential for contamination.

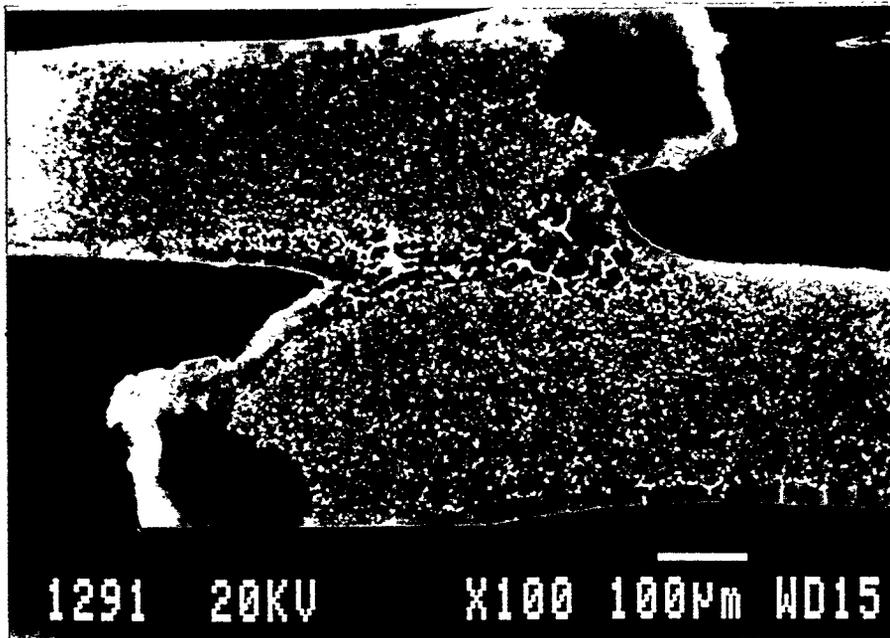
Figure 3. Poor quality TiCuAg braze joint due to silver diffusion out of the joint and into the base metal.

Of the four brazing alloys tested, the TiCuAg and TiCuNi did not produce acceptable joints. Figures 3 and 4 illustrate the poor quality of the joints produced using these alloys. Referring to the TiCuAg joints in Figure 3a, massive migration of the silver occurred from the braze into the base material over a distance of several hundred microns. A close look at the surface (Figure 3b) shows that the silver is concentrated primarily at the grain boundaries due to grain boundary diffusion. The dark regions represent porosity at the grain boundaries rather than regions high in titanium or aluminum. Some of the specimens appeared to be warped, possibly as a result of the silver diffusion and the porosity formation in the joint. All of the TiCuAg specimens tested in both the unirradiated and irradiated state failed prematurely. Surprisingly, the specimens failed outside the joint in the region where the silver had reached the limit of its migration. In contrast to the TiCuAg joints, the CuAg joints were in general quite good, although there were a few specimens that had small amounts of porosity in the joint. It is not clear why the TiCuAg joints were of such poor quality. Both the CuAg and the TiCuAg joints were formed using clad CuAl25 from the same stock. The brazing temperature for the TiCuAg was higher by ~80 K, which is the only known variable in the process and may have been responsible for the problem.

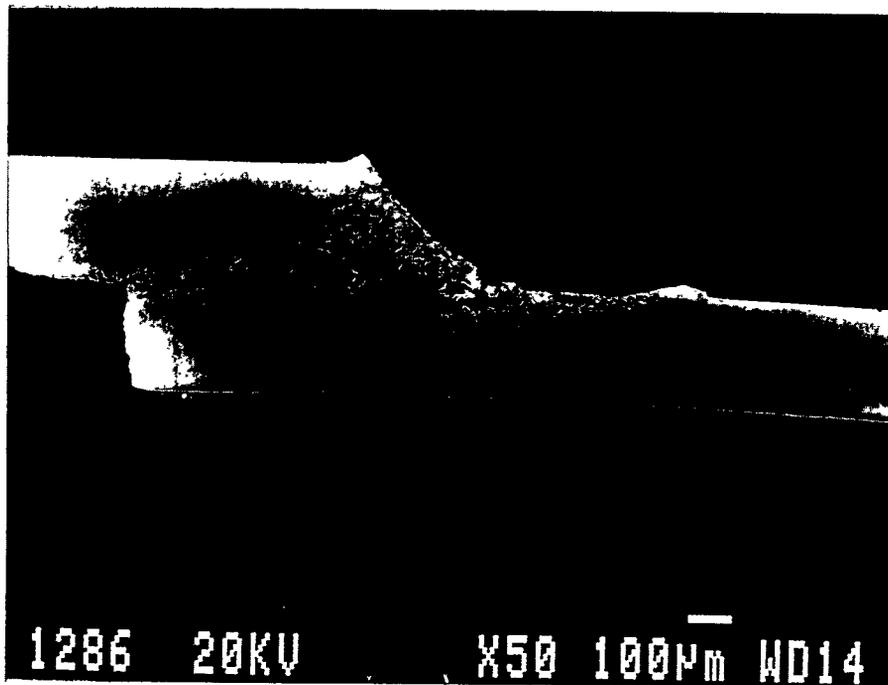
Figure 4. Melted base material and Widmanstatten structure in the TiCuNi brazed joint

The TiCuNi joint in Figure 4a illustrates that the base metal was melted during the brazing. The resulting microstructure of the joint is rather complex, consisting of intermetallic phases and a Widmanstätten microstructure of beta and alpha titanium. A closeup of a Widmanstätten colony is shown in Figure 4b. The darker regions in the micrograph are regions that contain a high concentration of titanium. The darker the appearance, the more titanium that is present. As with the TiCuAg brazed specimens, the specimens also failed prematurely in both the unirradiated and irradiated specimens. The yield and UTS values for the TiCuNi specimens exhibited a large amount of variability because the melting that occurred in the joint produced uneven cross-sections. The specimens tended to fail in regions near the outer edge of the joint where the specimen was the thinnest.

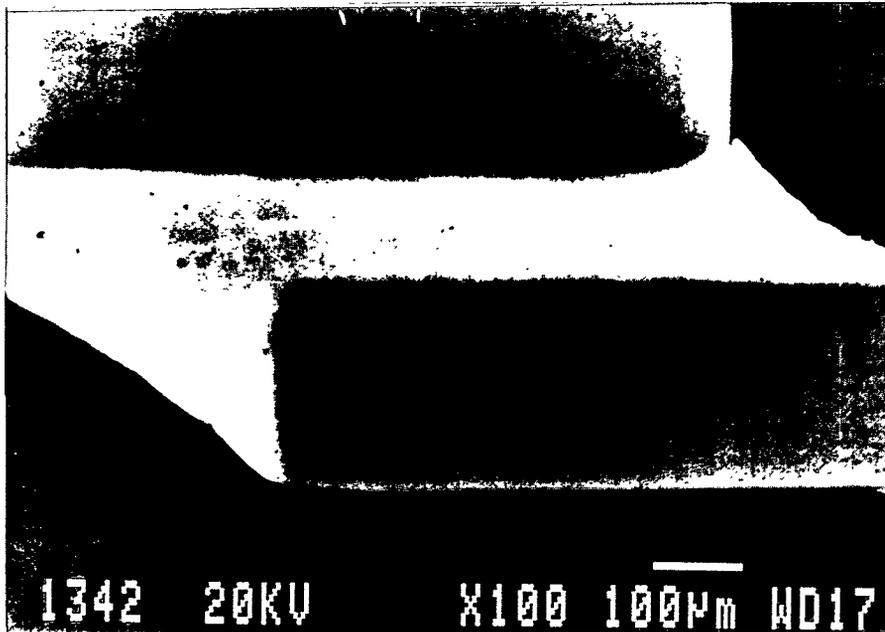
Figure 5. (a) Typical joint in a specimen containing a CuAu braze.

Figure 5. (b) Eutectic microstructure of the CuAg braze.

The remaining two alloys showed the most promise judging by the quality of the joint in the unirradiated specimens. An example of a CuAu braze joint is shown in Figure 5a, again imaged using backscattered electron imaging. The CuAg joints were identical in overall appearance, although closer examination revealed a eutectic microstructure, which is to be expected considering the eutectic composition of the braze. An example of the eutectic microstructure is shown in Figure 5b.

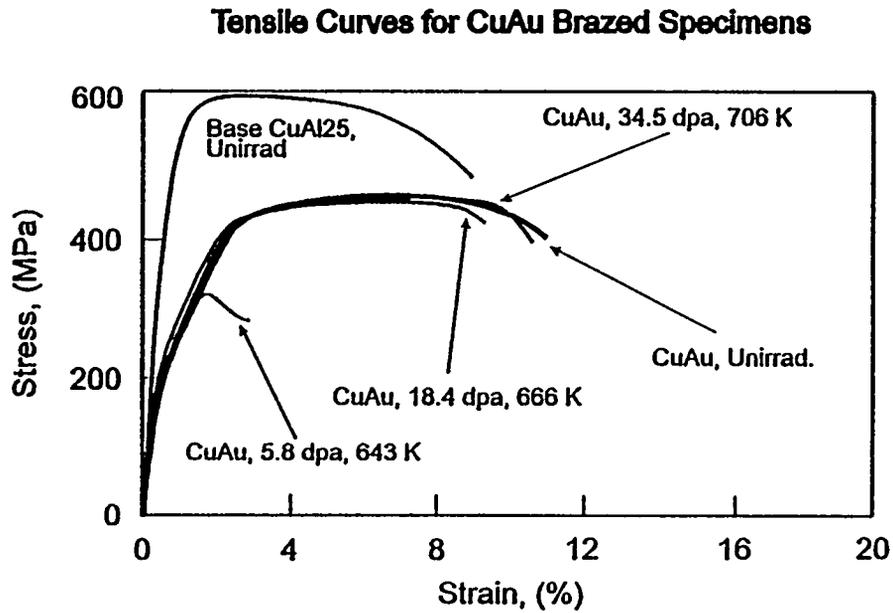
Figure 6. Tensile curves for the CuAu brazed specimens in the unirradiated and irradiated conditions, as well as the unirradiated base CuAl25 used for comparison.

The tensile data for the unirradiated and irradiated specimens of the base CuAl25 (perpendicular and parallel) and the CuAg and CuAu brazed specimens are listed in Tables 3 through 6. All of the unirradiated specimens of CuAu and CuAg failed in the base metal, not in the joint. The data for TiCuAg and the TiCuNi were not included since the specimens failed prematurely and produced data with significant scatter. Representative tensile curves for the CuAu brazed specimens and base CuAl25 (parallel orientation) are provided in Figure 6. Several things bear mentioning with respect to these curves and the tabulated data.

All of the brazed specimens, unirradiated and irradiated, exhibited a noticeable change in the slope of what corresponded to the elastic region in the standard CuAl25 specimens. While this could certainly result from a change in the elastic modulus due to the presence of the braze, it was observed after the tensile tests that the joint alignment had changed in all of the brazed specimens, i.e., the joint rotated during the test such that the lap was actually at an angle to the tensile axis.
