Fæstningens Materialgård

Model locating feasible refurbishment measures

Table 1. Feasible refurbishment measures for the three case studies

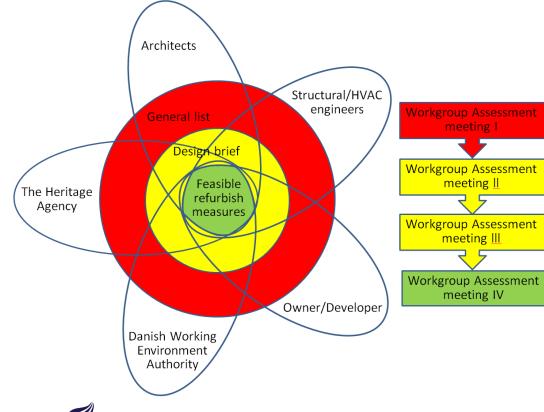
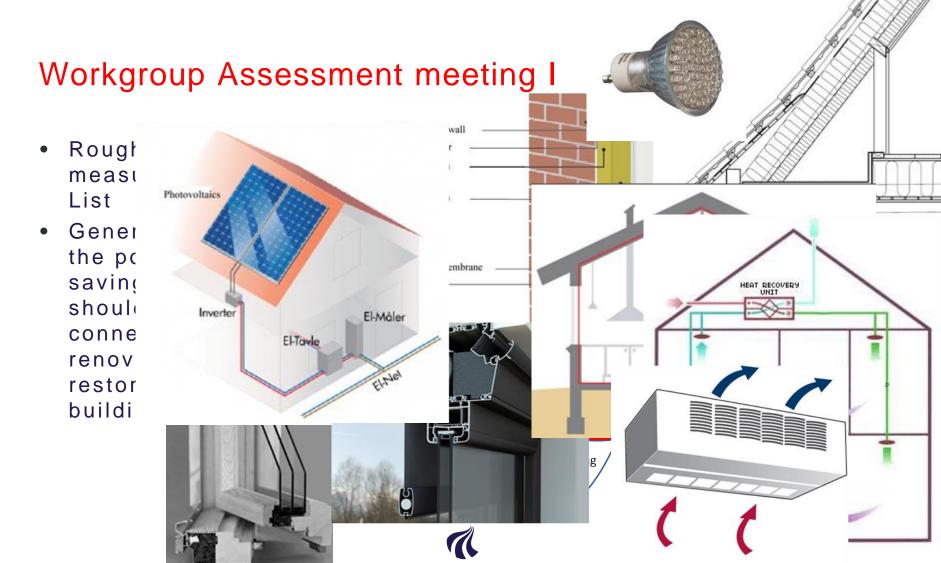
- Develop a model that can be used for refurbishment of heritage buildings
- The model helps to choose, evaluate and implement measures creating synergy between the interests of preserving the heritage values and to create an affordable refurbishment, meeting the requirements for the use, of the building.
- The model focus on the cooperation and dialogue between authorities and owners who refurbish heritage buildings finding fiasable measures.

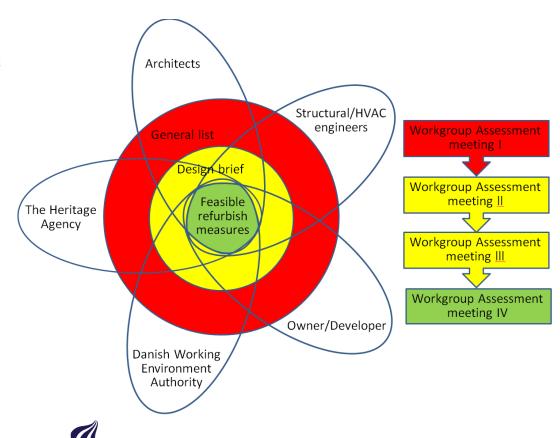
Workgroup Assessment meeting II – III...

- A row of meetings narrowing down the list of possible refurbishment measures.
- Based on:
 - indoor climate-, energy consumptionand measurement of synergy simulations
 - cost benefit evaluations
 - identified heritage values

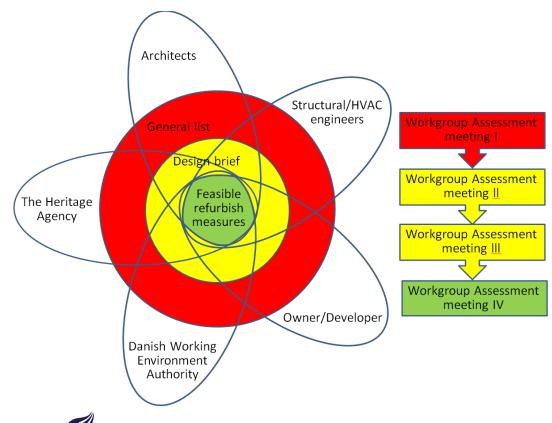
Workgroup Assessment meeting IV

- Final meeting narrowing down the list of possible refurbishment measures to Feasible refurbishment measures.
- Based on:
 - indoor climate-, energy consumptionand measurement of synergy simulations
 - cost benefit evaluations
 - identified heritage values
