Field demonstration of an attic retrofit strategy using cellulose insulation and phase change material

Buildings XIII Conference

December 5, 2016

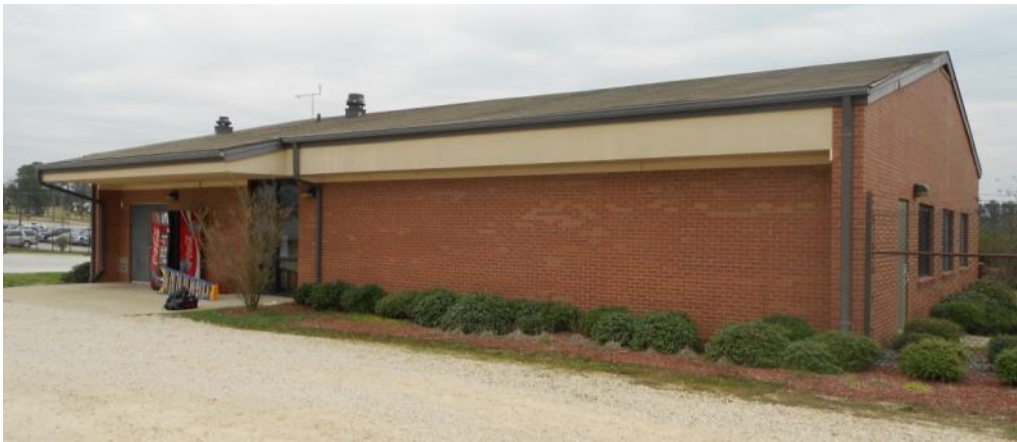
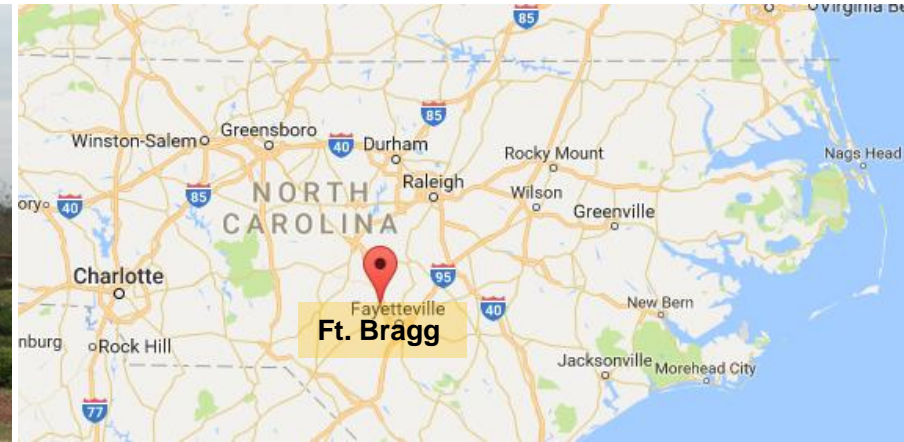
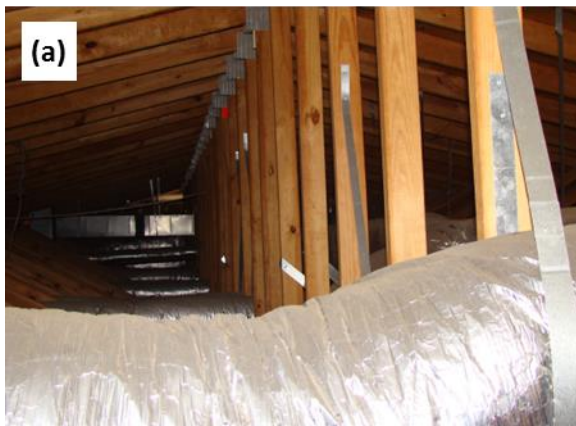
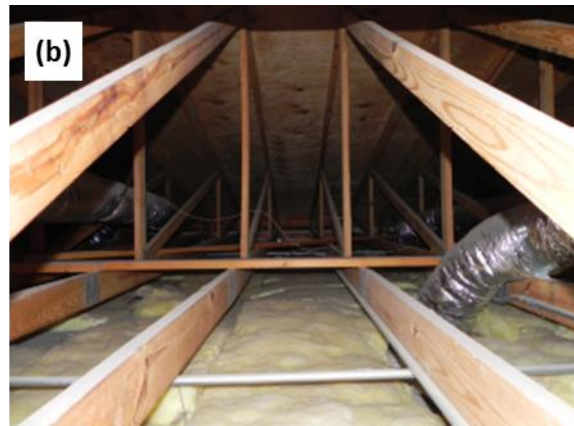
Classroom building at Ft. Bragg, NC

- Located in ASHRAE climate zone 3 (mild winters and hot summers)
- Vented attic with ducts and R19 ceiling insulation

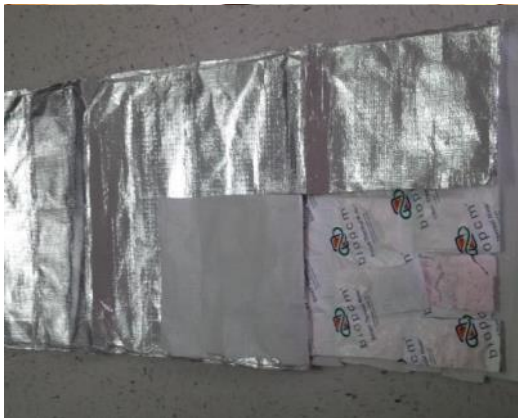
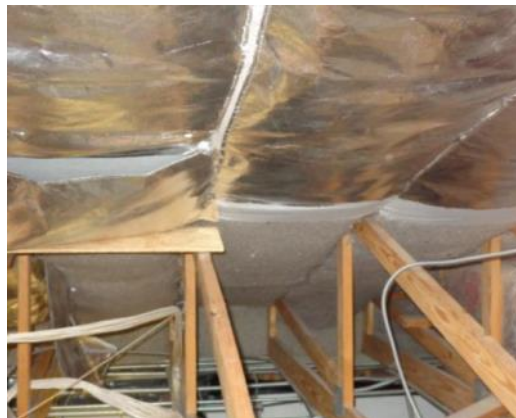
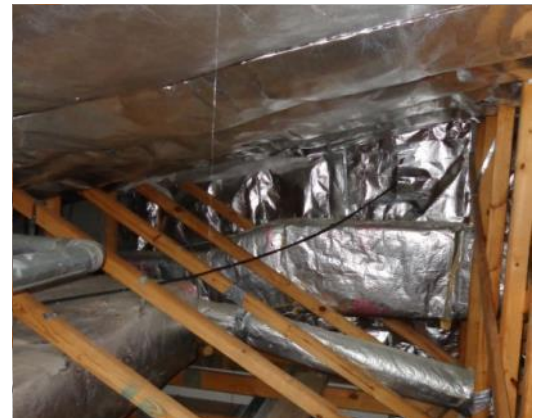
- Phase 1: Existing condition (Feb 2012 – Jul 2013)
- Phase 2: Attic sealed; R29 cellulose insulation added to roof decks and gables; ceiling insulation removed (Jul 2014 – Jun 2015)
 - R16.5 cellulose batt + R12.5 dense-packed cellulose
- Phase 3: PCM added to roof decks and gables, in addition to the existing cellulose insulation (Jul 2015 – Jun 2016)
 - PCM: fatty acid/ester blend; nominal melting/freezing point – 25/22° C; phase change enthalpy – 200 kJ/kg

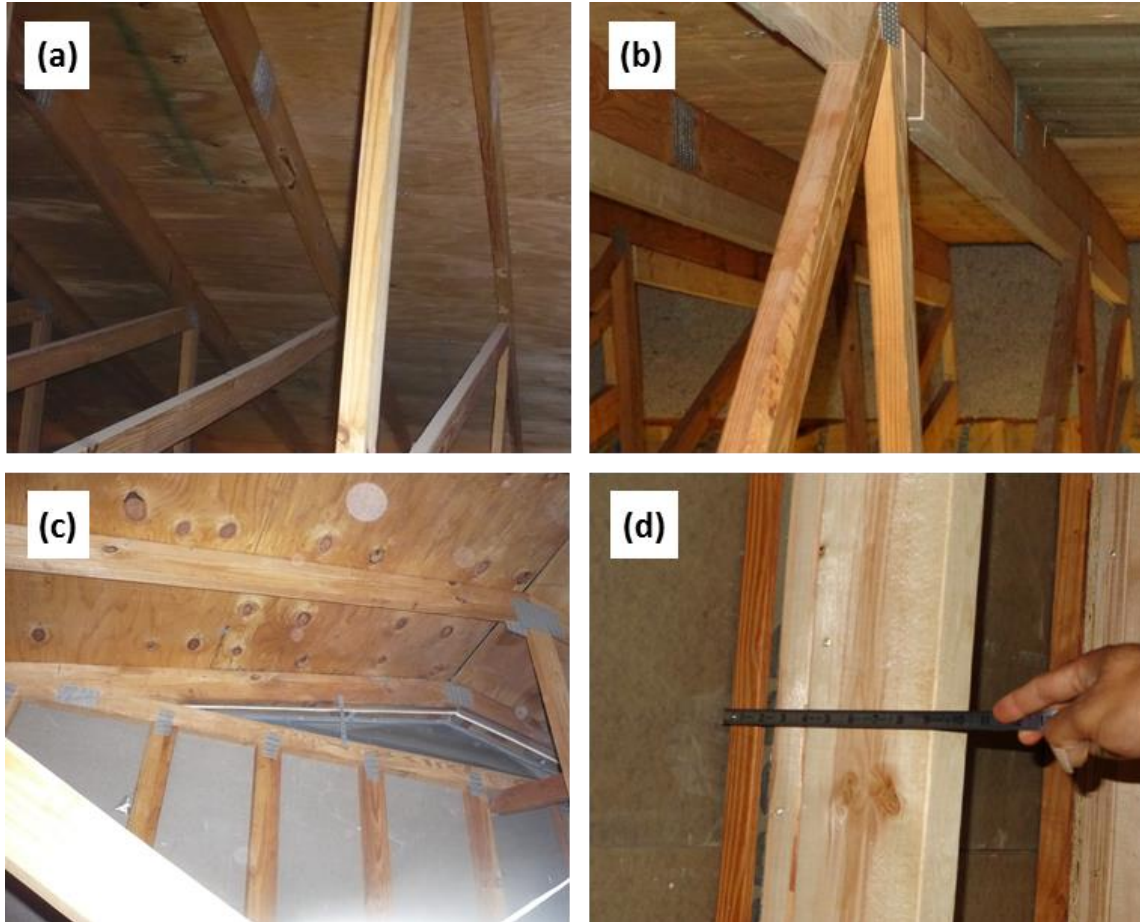
Structural changes in the attic

- Changes needed to add sufficient R-value at the roof decks and gables
- (a) original '2x6' rafters, (b) extended rafters with '2x4' studs added, (c) original framing at gable ends, and (d) extended framing at gable ends

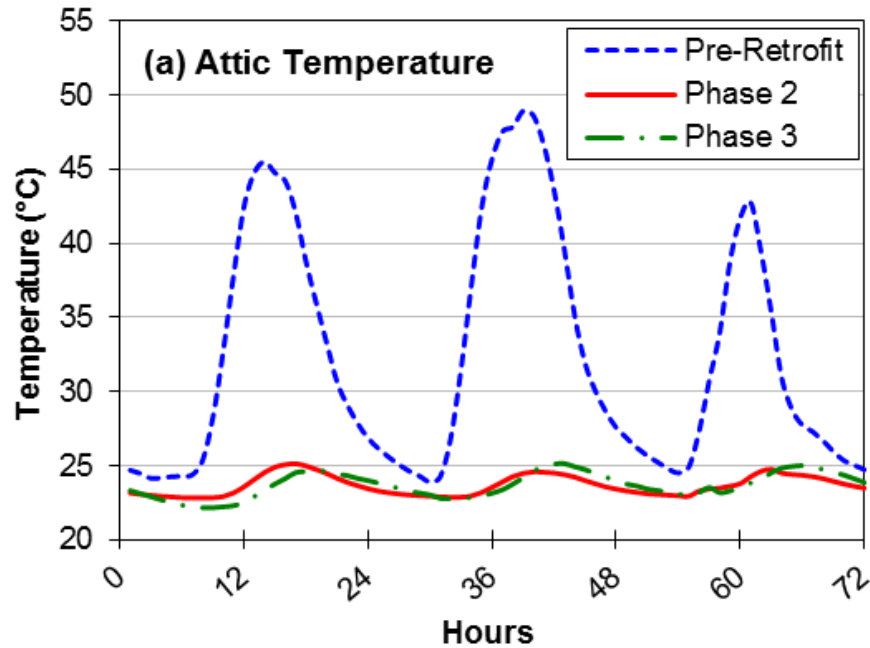
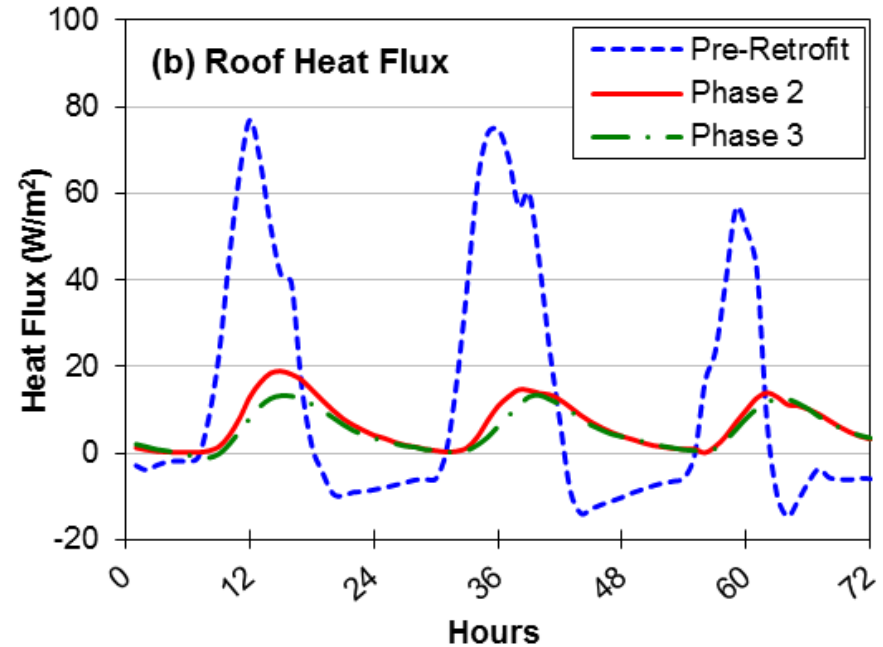
Attic temperatures and roof heat flux

- Data shown for three summer days during the three phases
 - Similar weather conditions (ambient temperatures, solar irradiance, etc.)
- As expected, peak attic temperatures and roof heat fluxes were substantially lower during phases 2 and 3.

- Two-phase attic retrofits of a one-story classroom building in climate zone 3 is reported
- The summer-time peak heat fluxes through the roof were reduced by 75-80% by adding the insulation and PCM
- Building energy consumption analysis indicated 14% reduction between phase 1 (pre-retrofit) and phase 2 (cellulose-only retrofit), but 5% increase during phase 3 (cellulose + PCM)
 - Analysis continuing to determine causes of the increase during phase 3
- Whole building energy simulations are underway to determine the energy benefits under different climate conditions

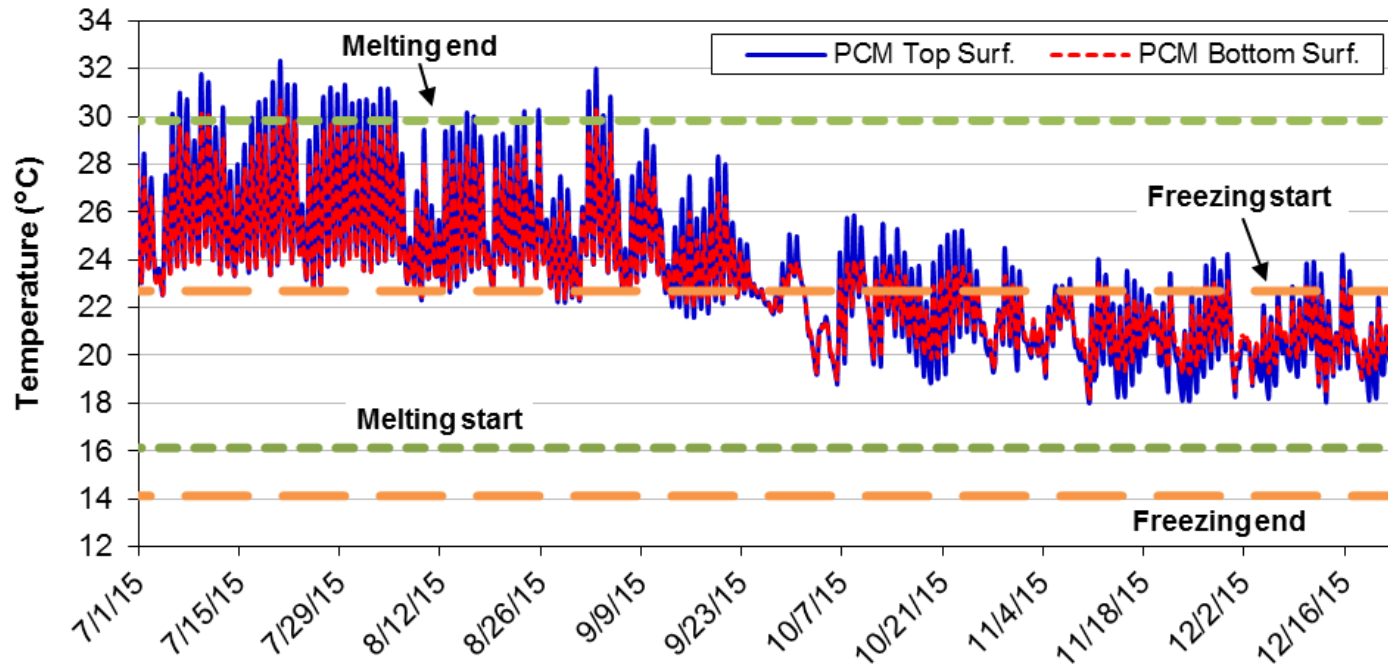
PCM behavior

- Difficult to gauge impact of PCM from experimental data alone
- Comparison of measured PCM surface temperatures with known melting/freezing temperature ranges suggests long periods of inactivity
 - EnergyPlus modeling is underway to determine impact of PCM with current and varying levels of cellulose insulation

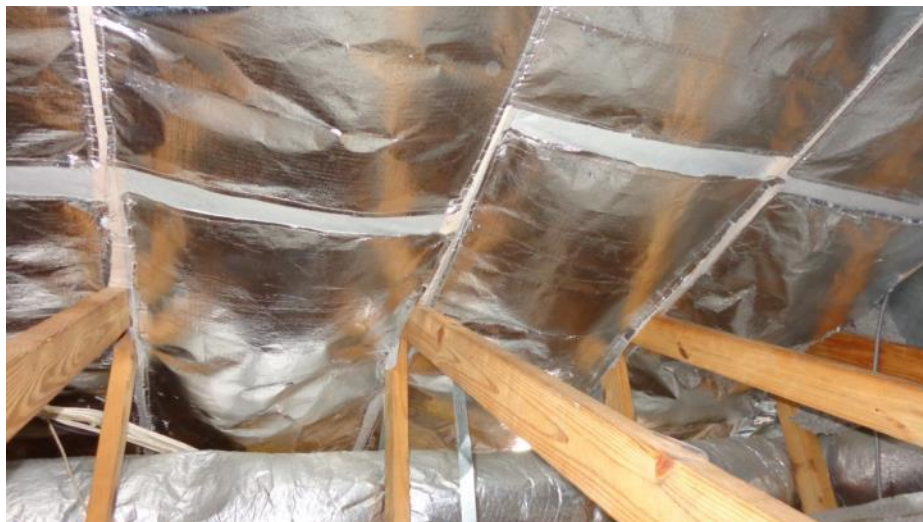
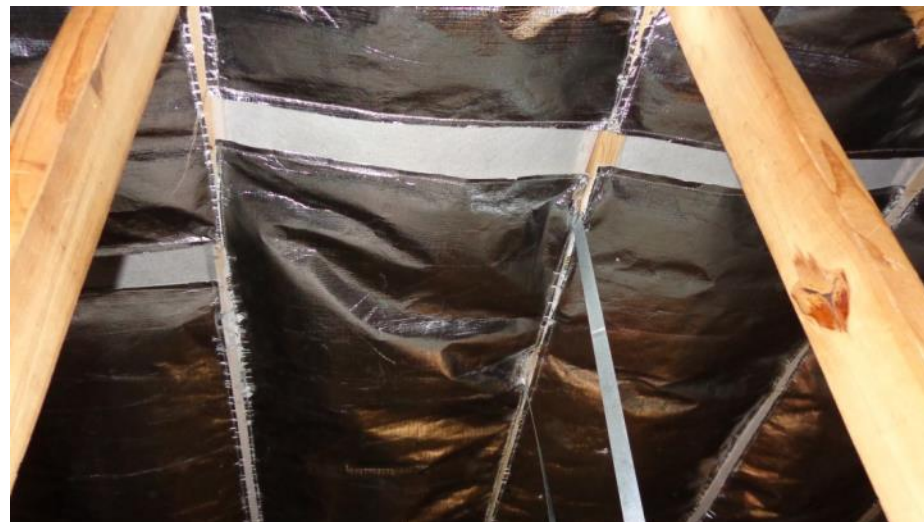
Moisture concerns with PCM

- Addition of the PCM layer adds to the potential for moisture issues at the roof decks
- Due to requirements at Ft. Bragg, a PCM with Class A fire rating was used
 - Permeability of the encapsulated PCM is 0.09 perms (class I vapor retarder)
 - Preliminary hygrothermal modeling had suggested use of PCM with class III vapor retarder (1-10 perms)
- To alleviate potential issues, PCM sheets were installed with ~1 inch gaps

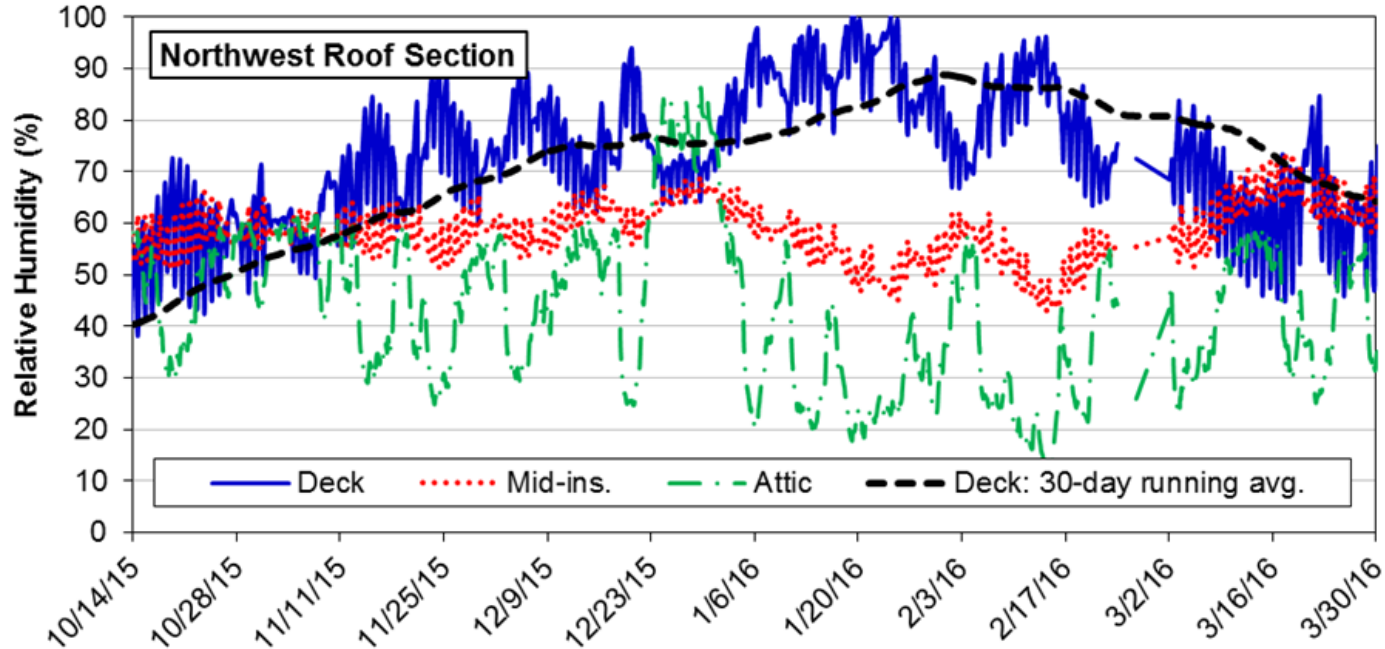
Moisture concerns with PCM (contd.)

- Even with gaps, the 80-day running average RH peaked at 88% and remained above 80% for several weeks
- Based on this finding, it was recommended to the project team and Ft. Bragg point-of-contact to remove the PCM
 - Removed mid-November, 2016.
