Effective Floor Cavity and Knee Wall Construction Techniques in Two-Story Homes in Hot Climates

Buildings XIII Conference, Clearwater, FL
Session 6 Practices - 3:30 PM-5:00 PM
December 6, 2016

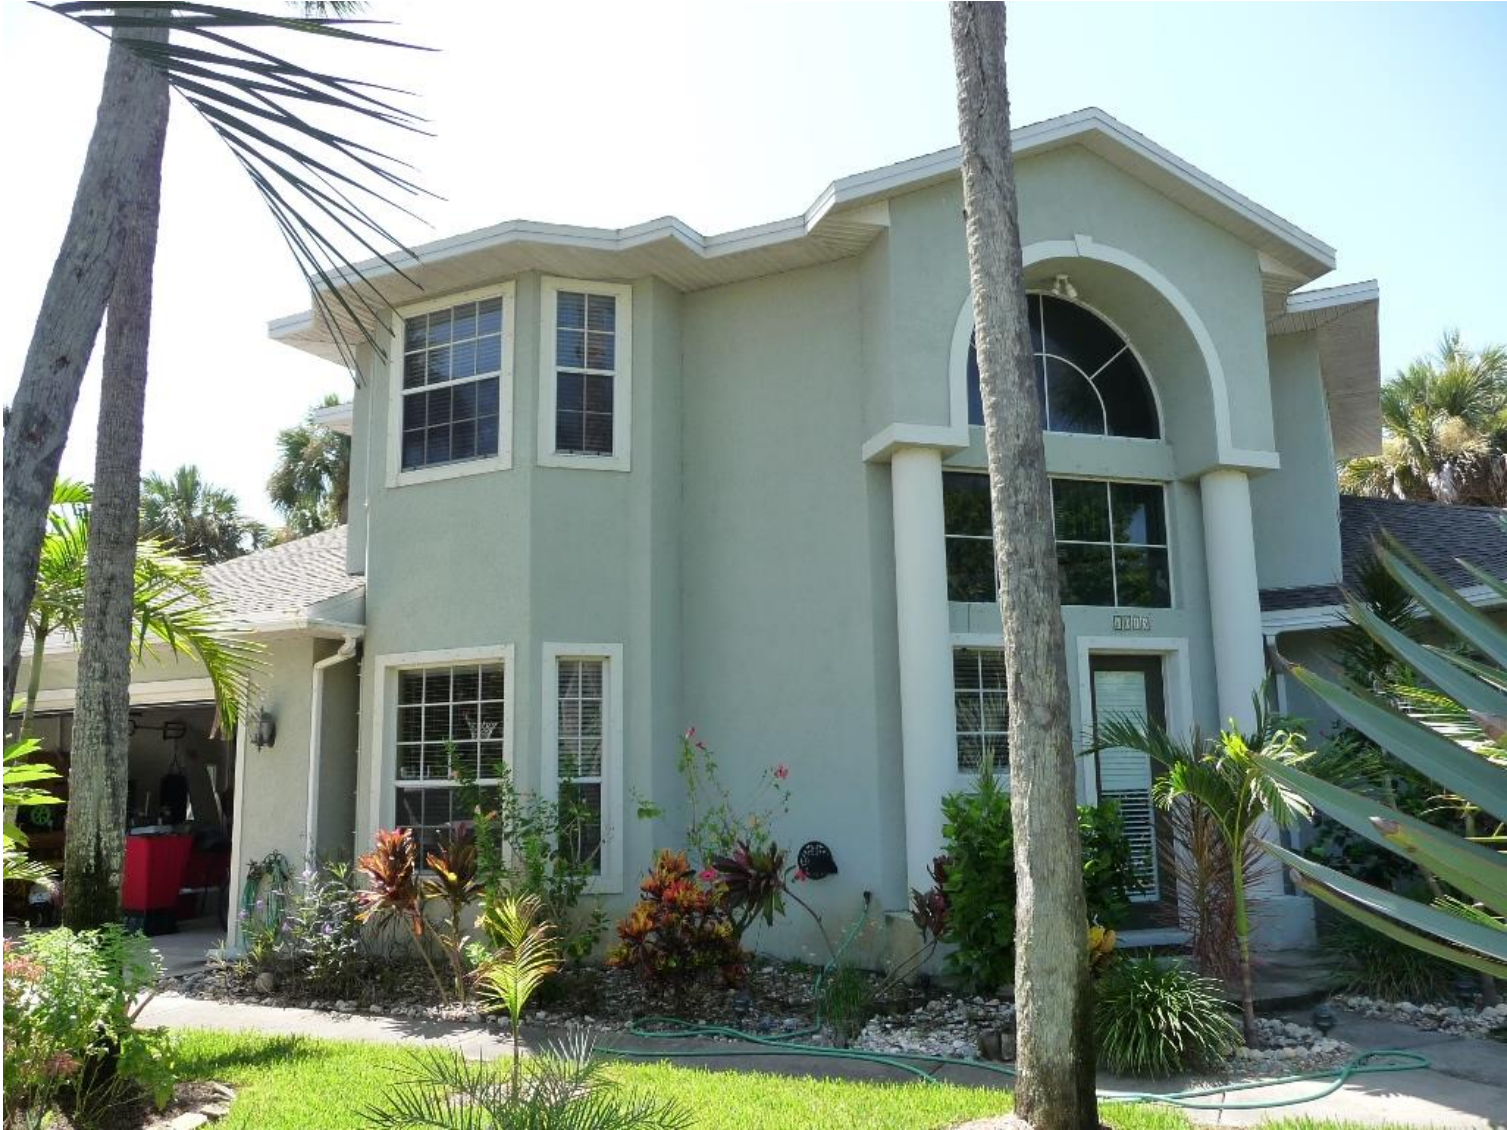
Home with High Wind Washing Potential

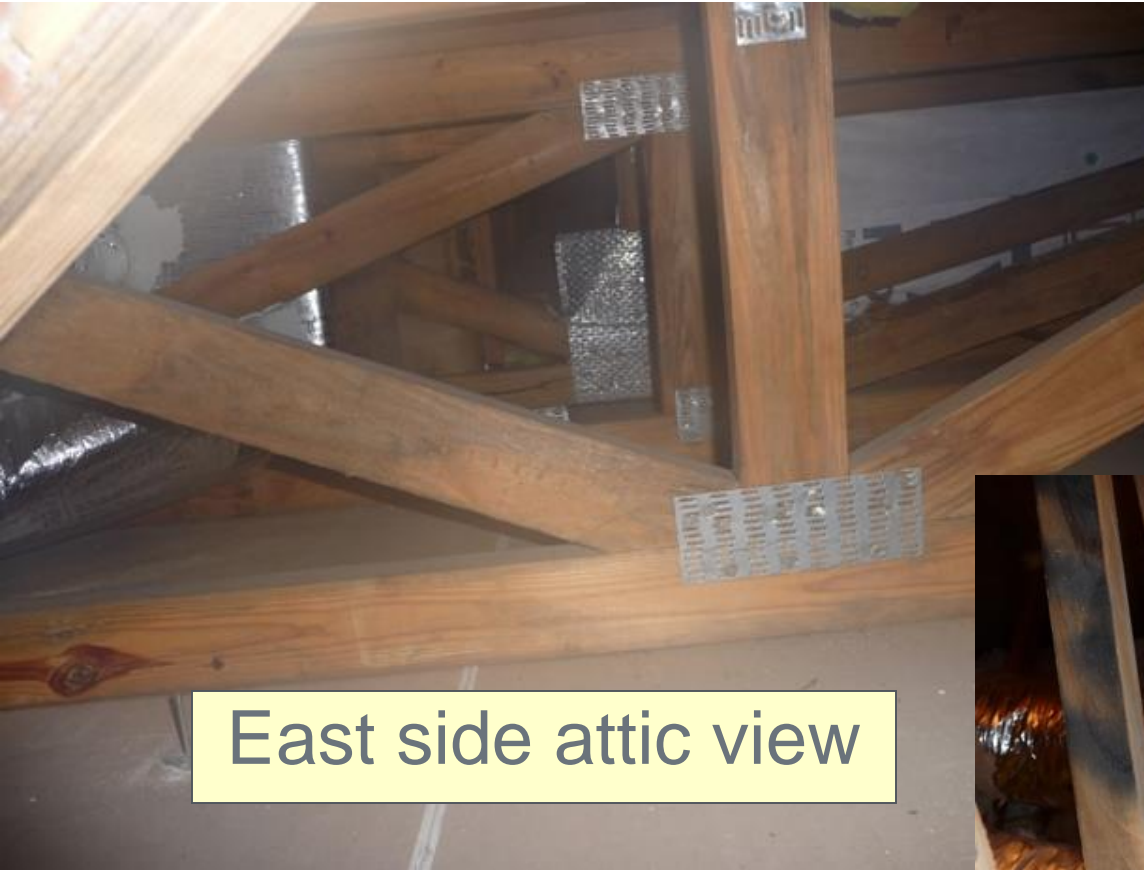
2nd Story Floor Space Open to Vented Attic

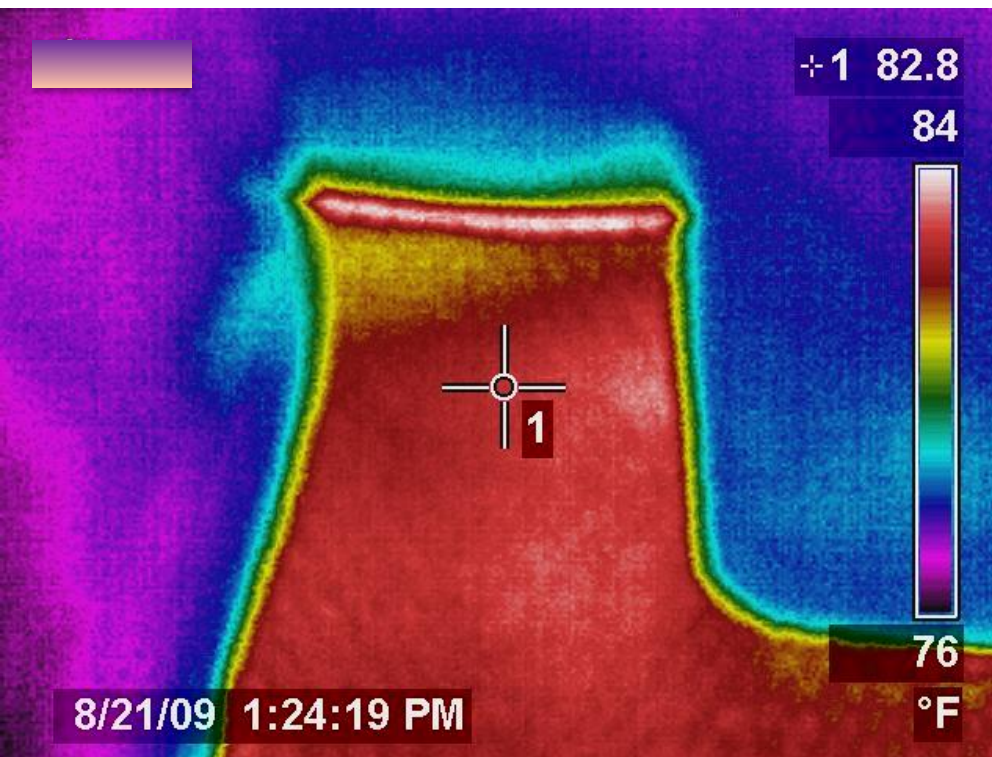
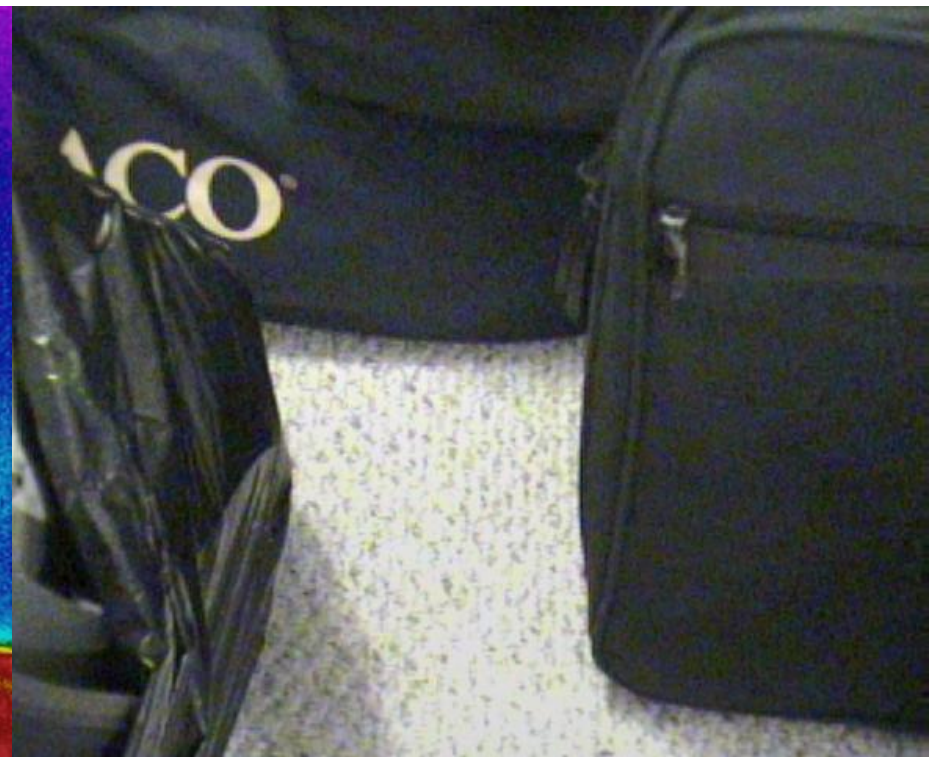
2nd Story Floor Cavity Heated By Attic Air

2nd story floor surface is very warm

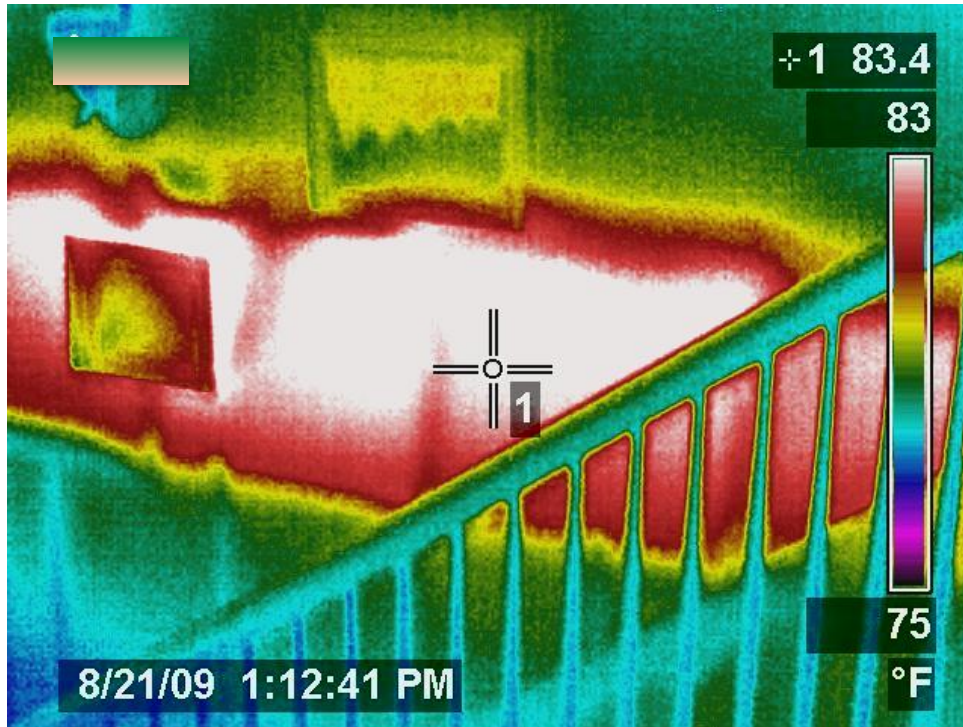
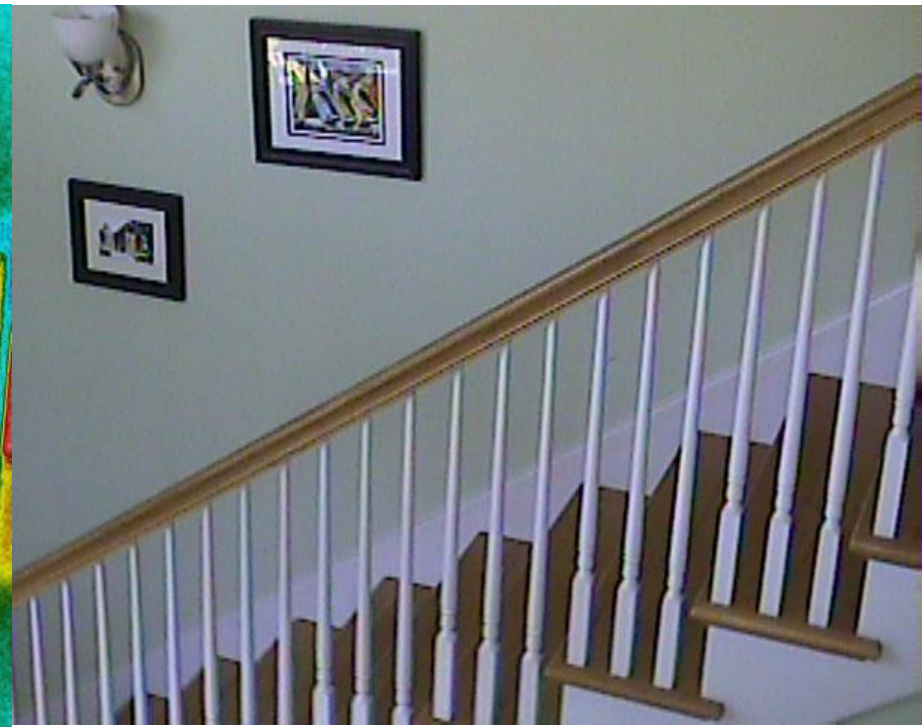
2nd Story Floor Cavity Heated By Attic Air

Floor space on other side of very warm wall section.

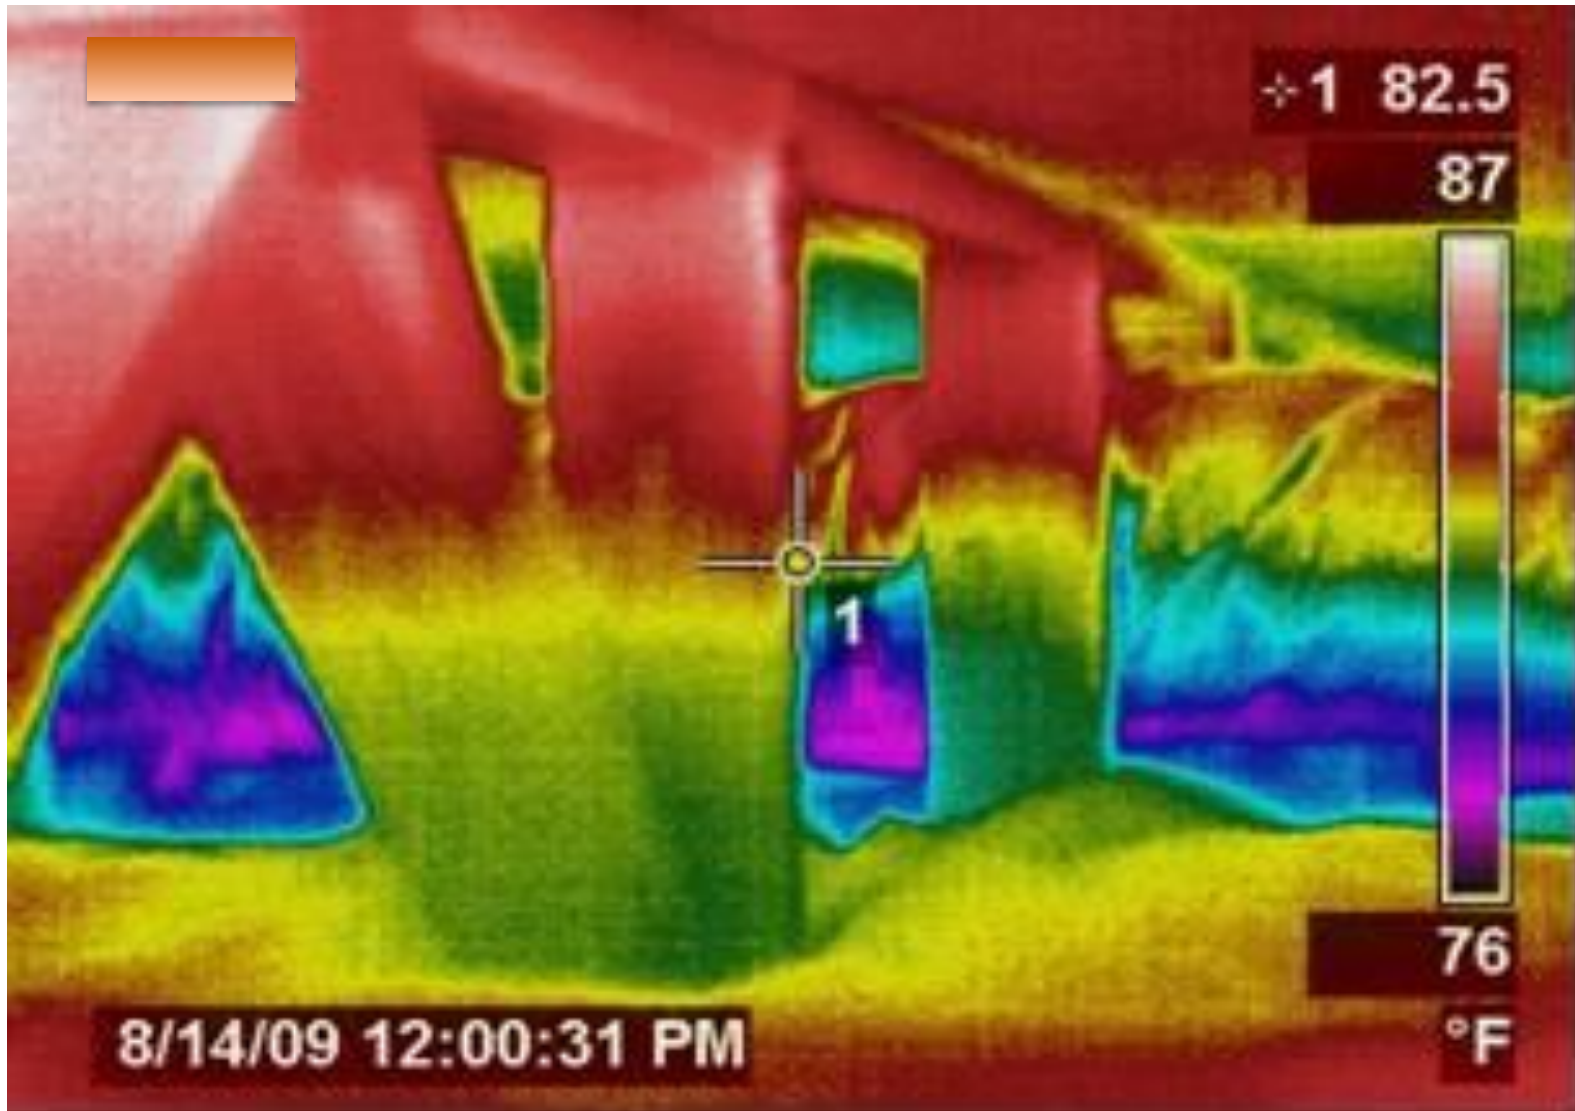
IR Image Inside Floor Cavity Open to Attic

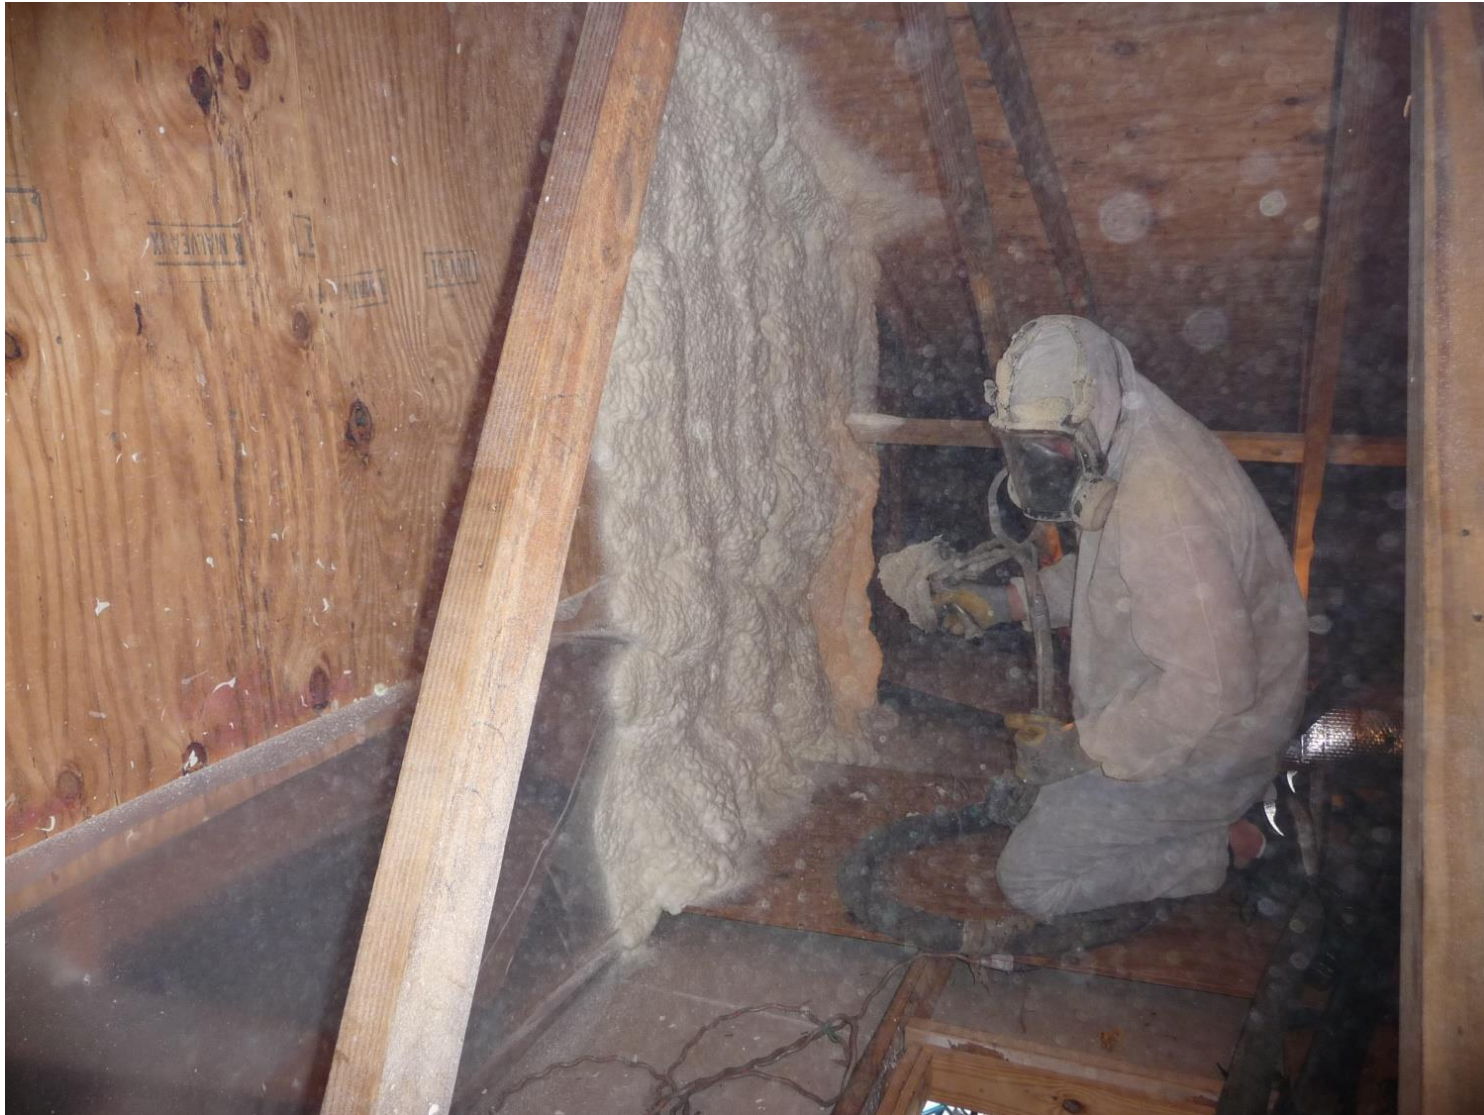
House Repair With Low Density Foam

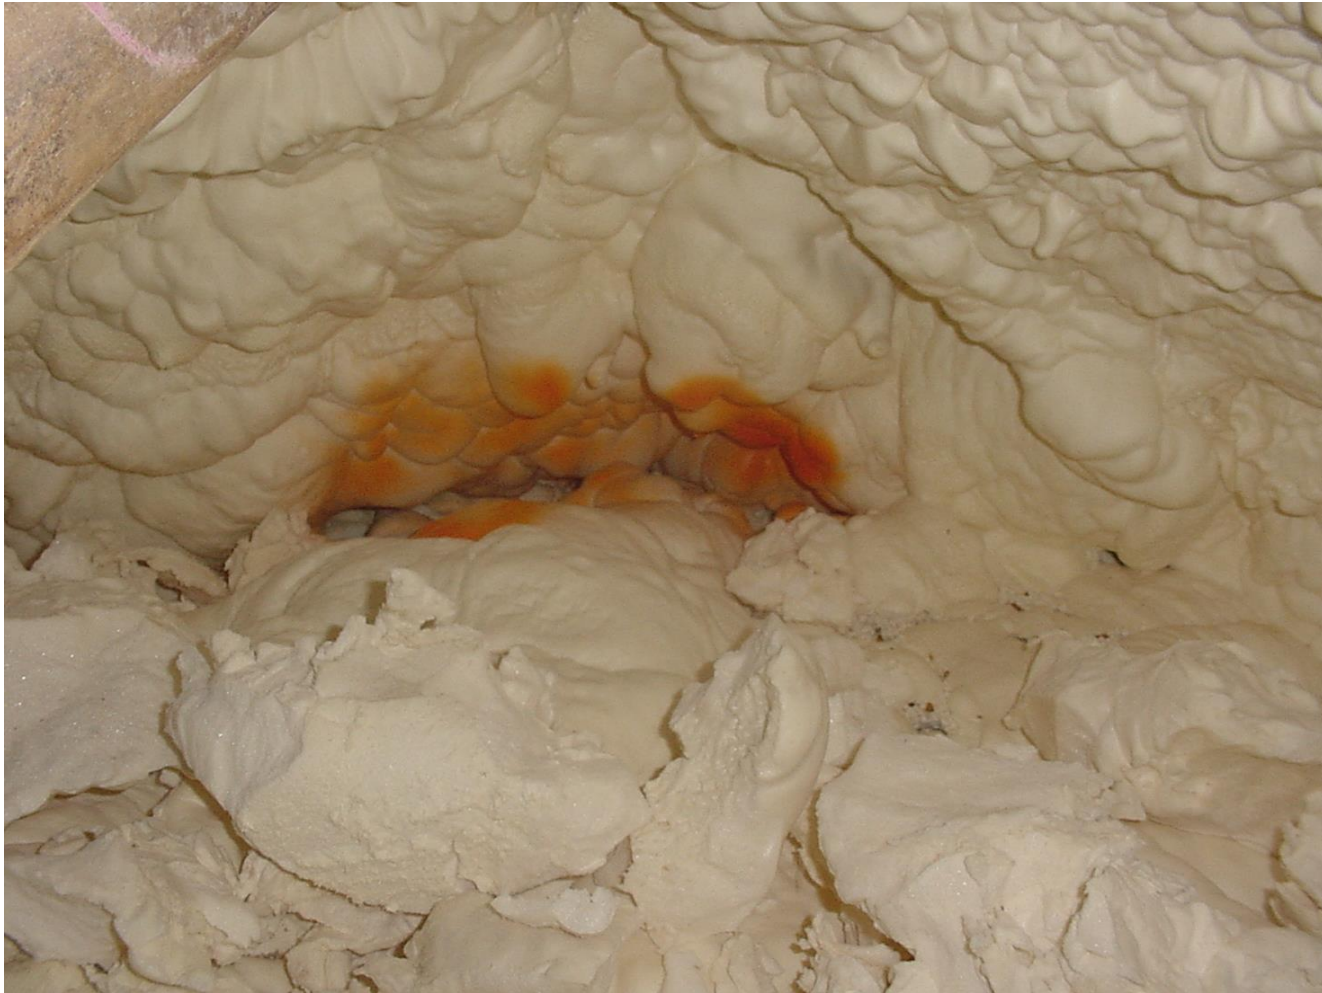
Yes, Foam Can Leak Too

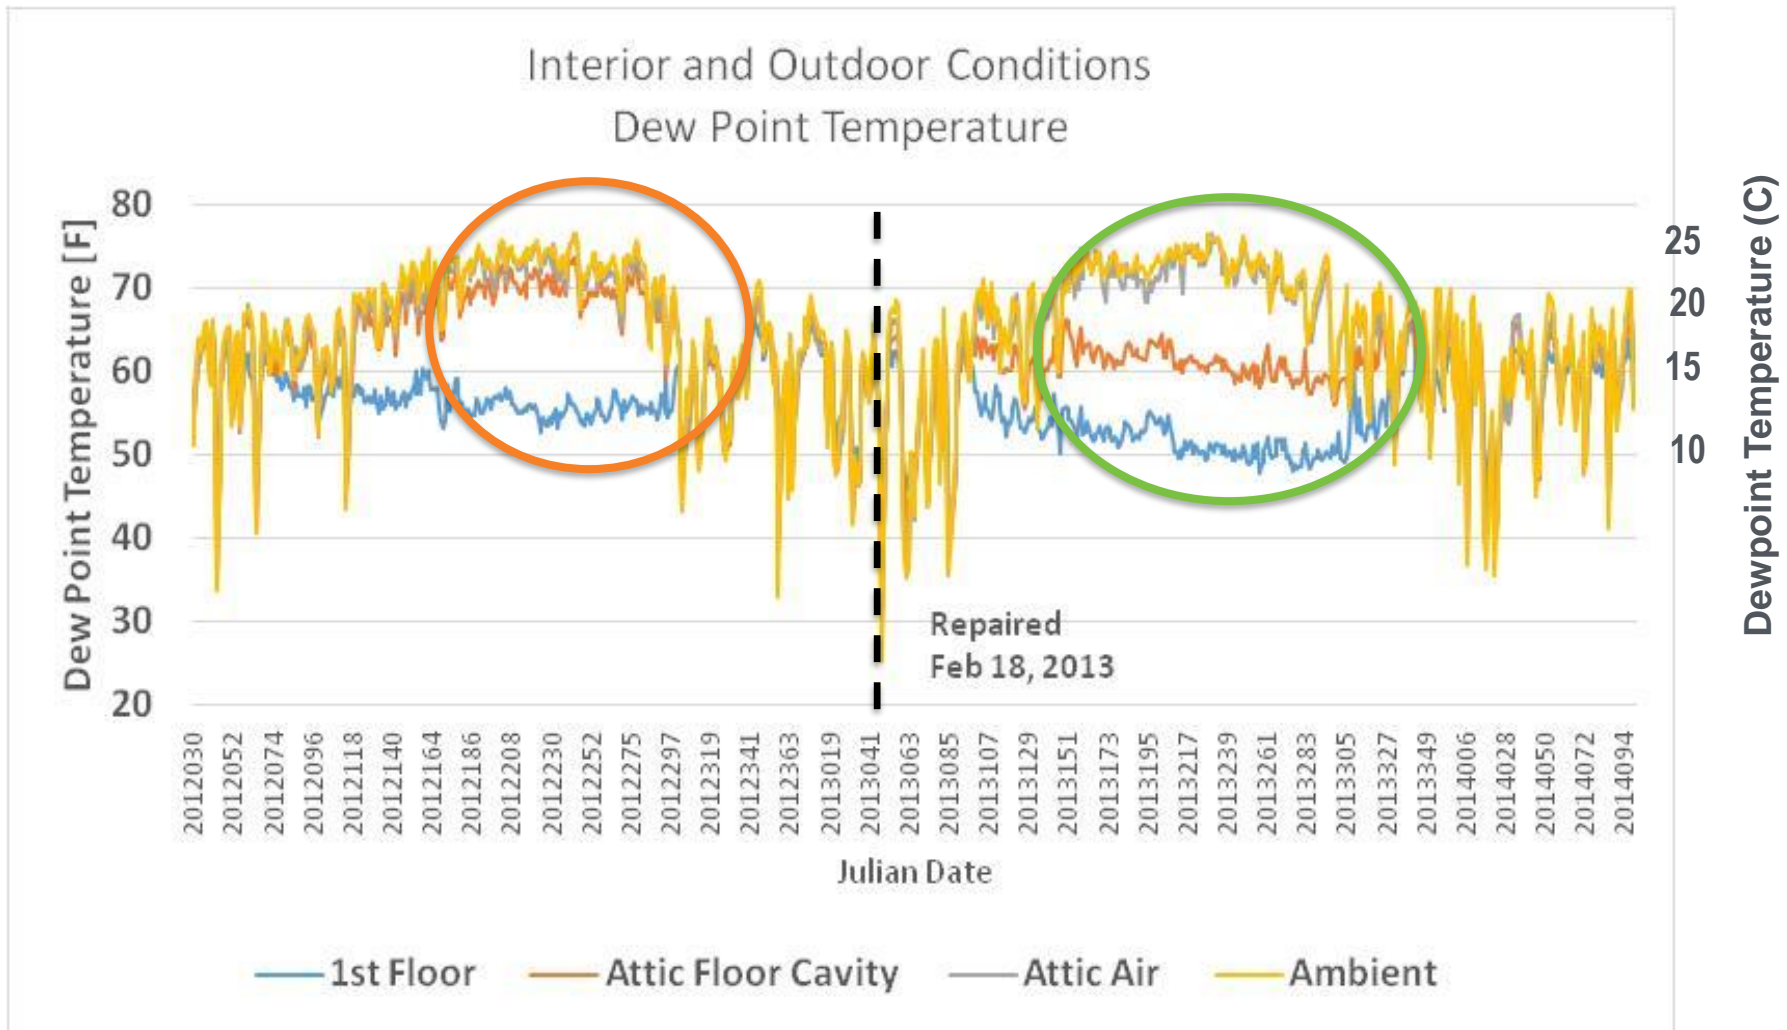
House Floor Cavity Before and After Repair- Summer Impacts

Floor cavity becomes drier; Cooling savings 10.5%

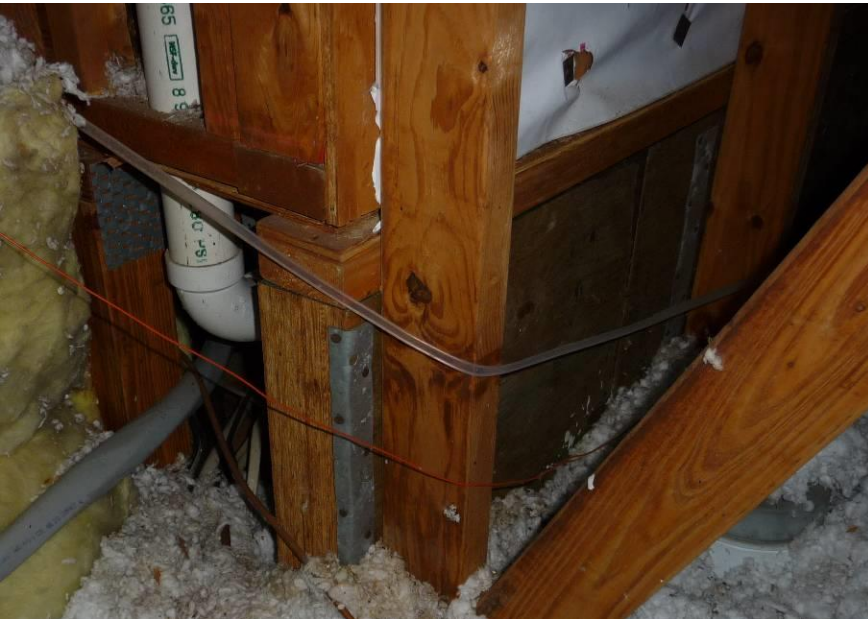
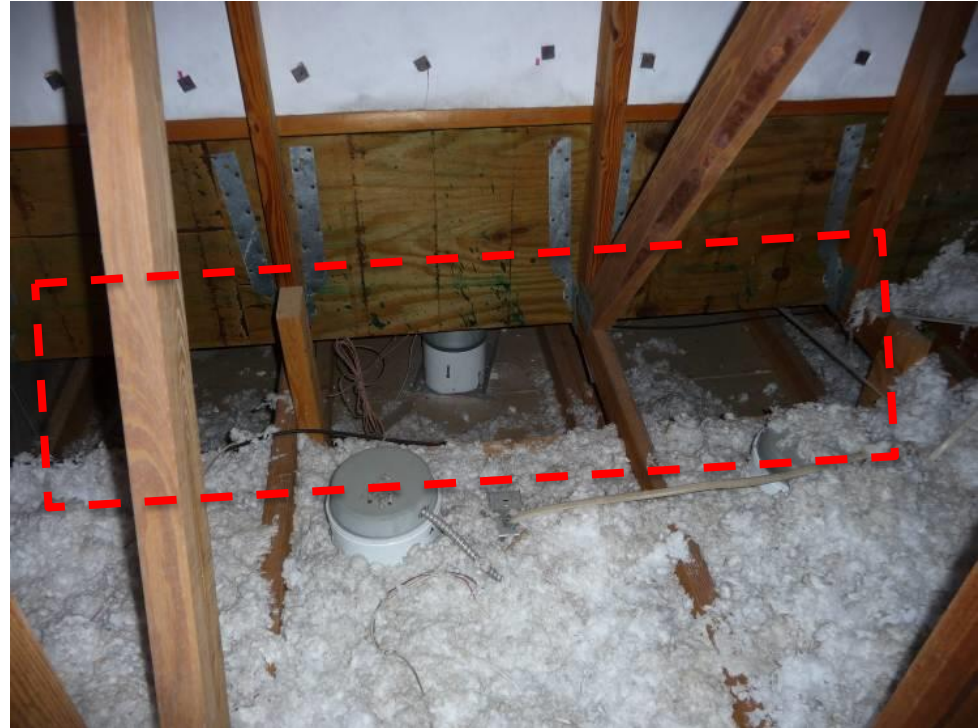
Floor Cavity Repair Using Batt Insulation

Open pathways due to dropped ceiling area over kitchen (right) and around utility penetrations (below).

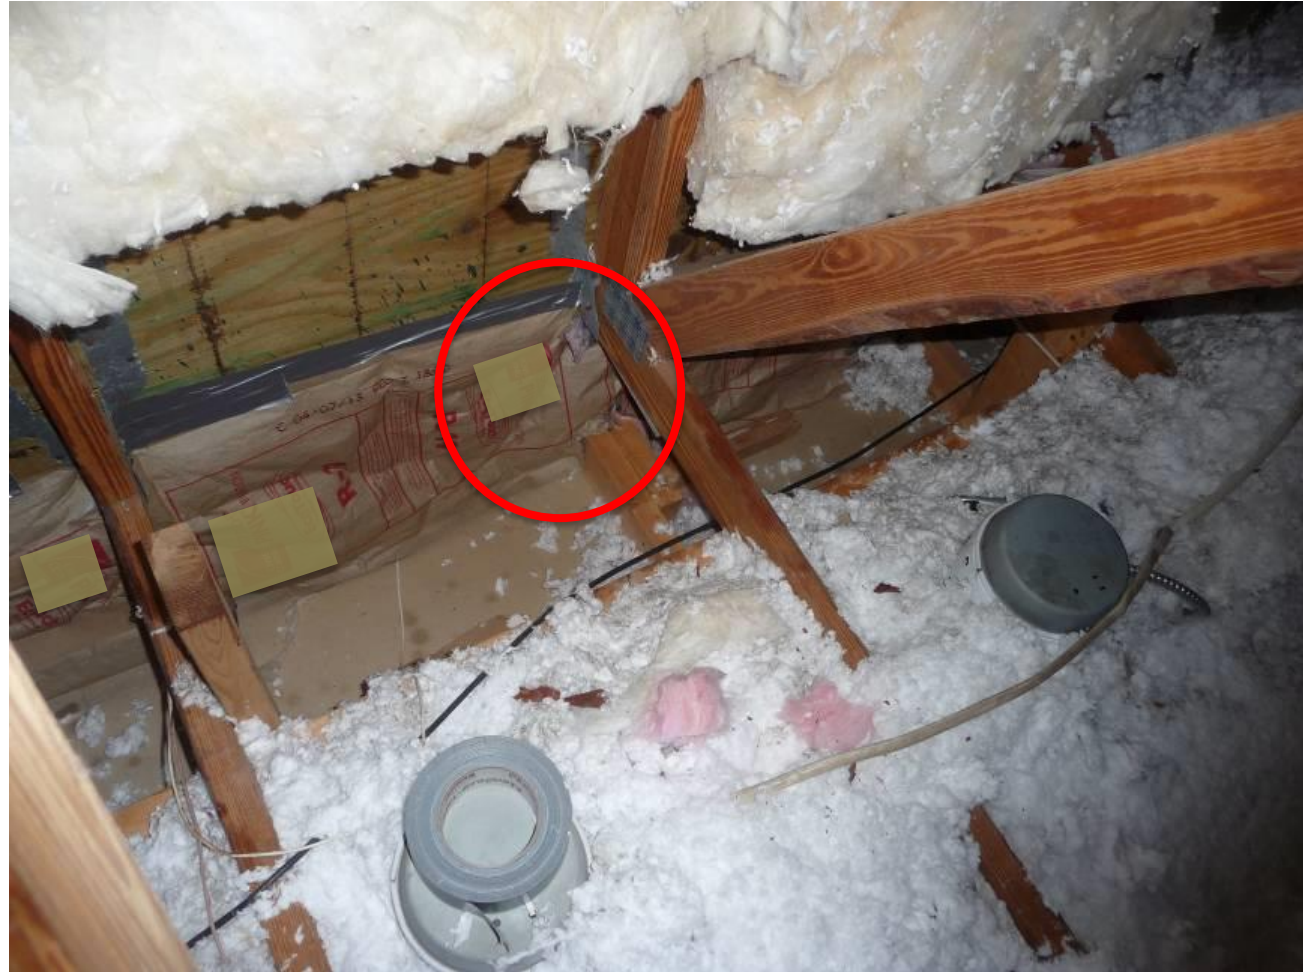
Floor Cavity Repair Using Batt Insulation

Faced batts can be used if installed carefully. Cut edges to fit penetrations. Mechanically fasten and seal at perimeter. (Duct tape does neither of these).

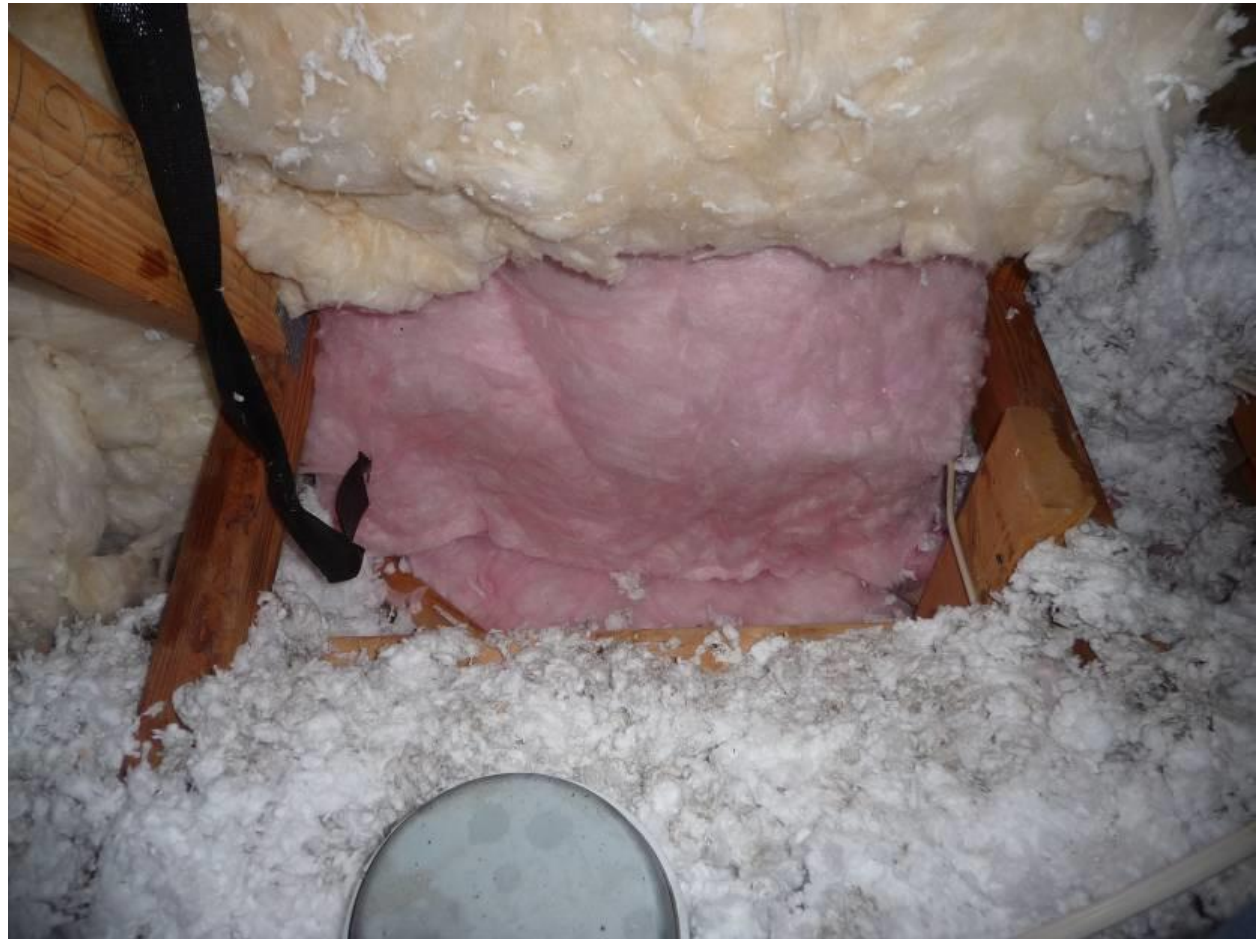
Floor Cavity Repair Using Batt Insulation

Faced batts can be used if installed carefully.

Paper face should not be exposed to attic according to building code and manufacturer (fire safety).

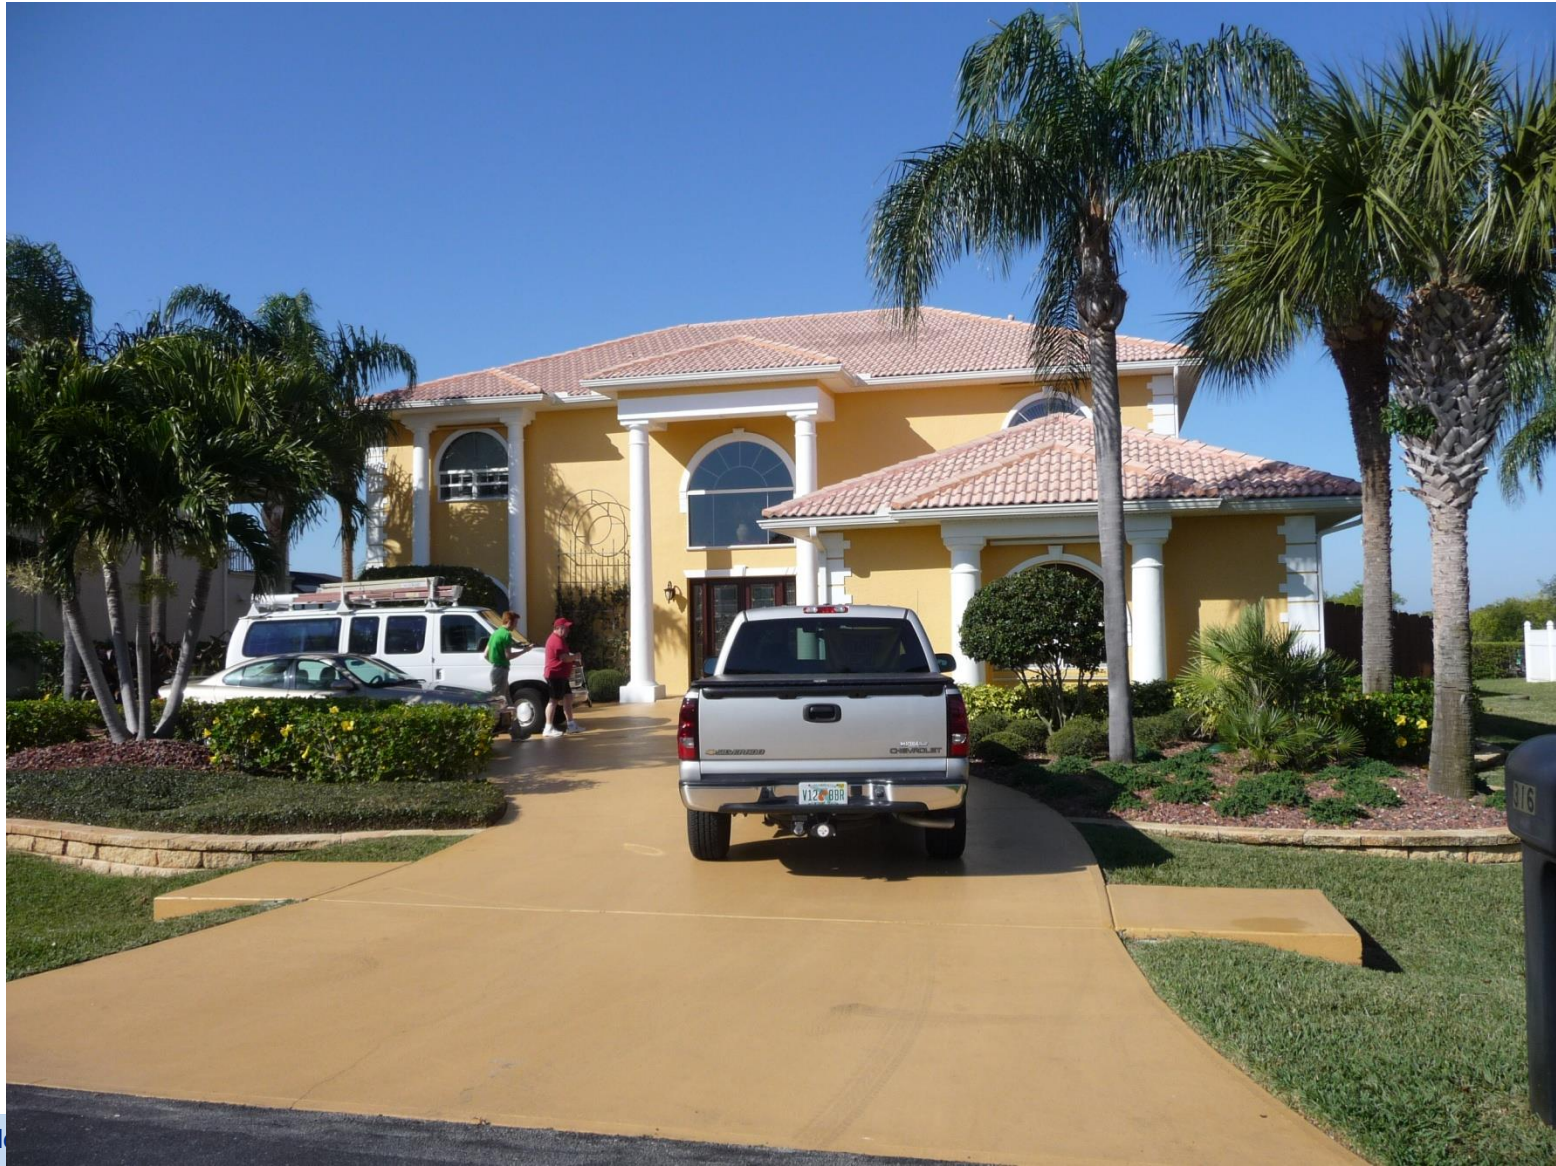
Moisture Damage From Wind Washing

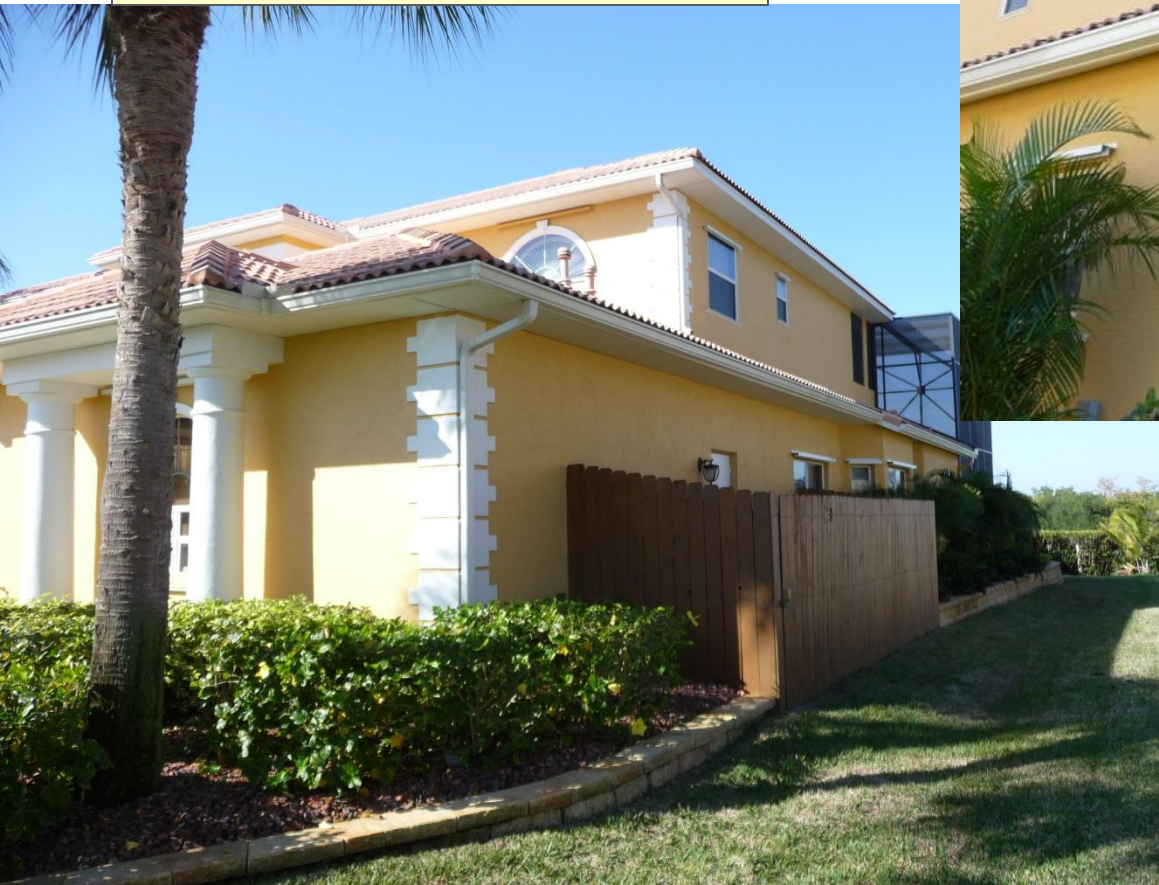
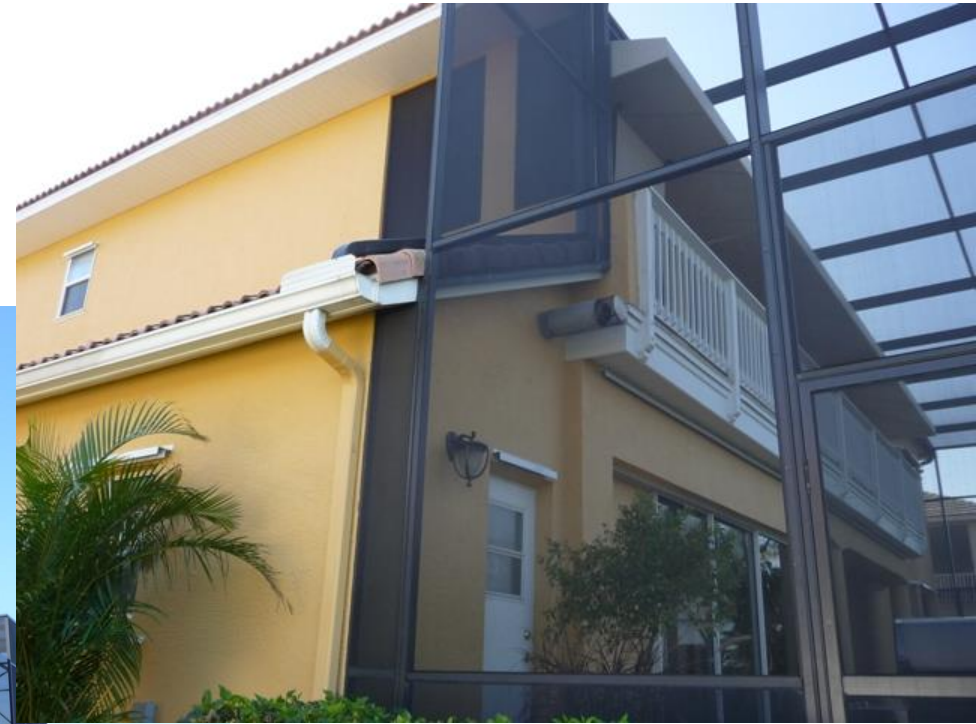
Complimentary Pathway Through Floor- East to West

NE corner view

NW corner view

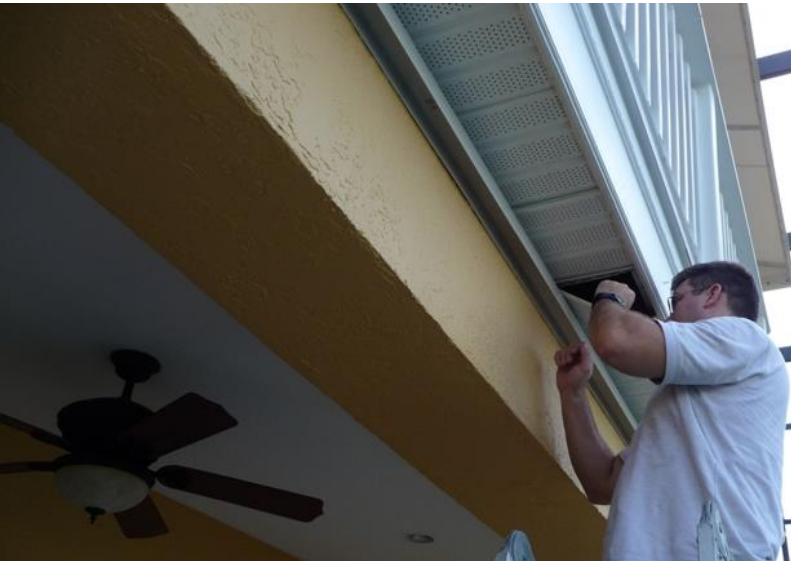
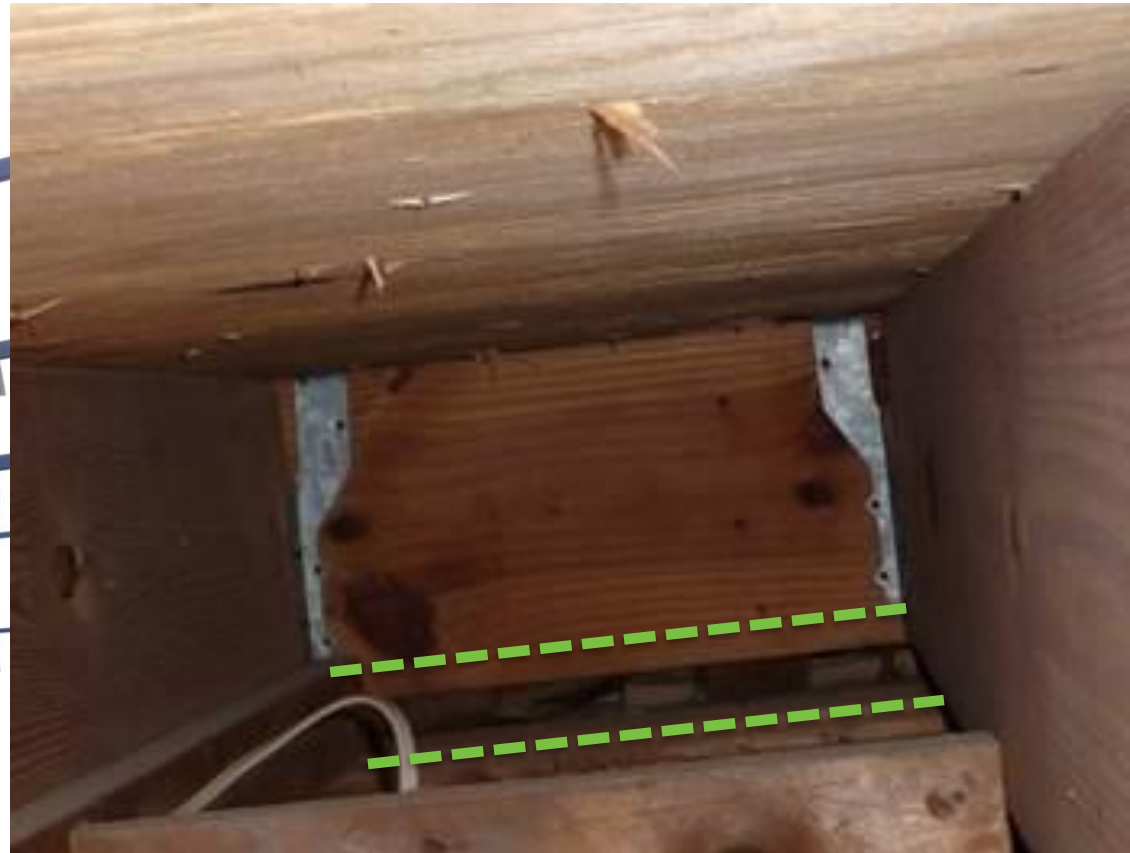
Inspection

Access into west side soffit open to floor space

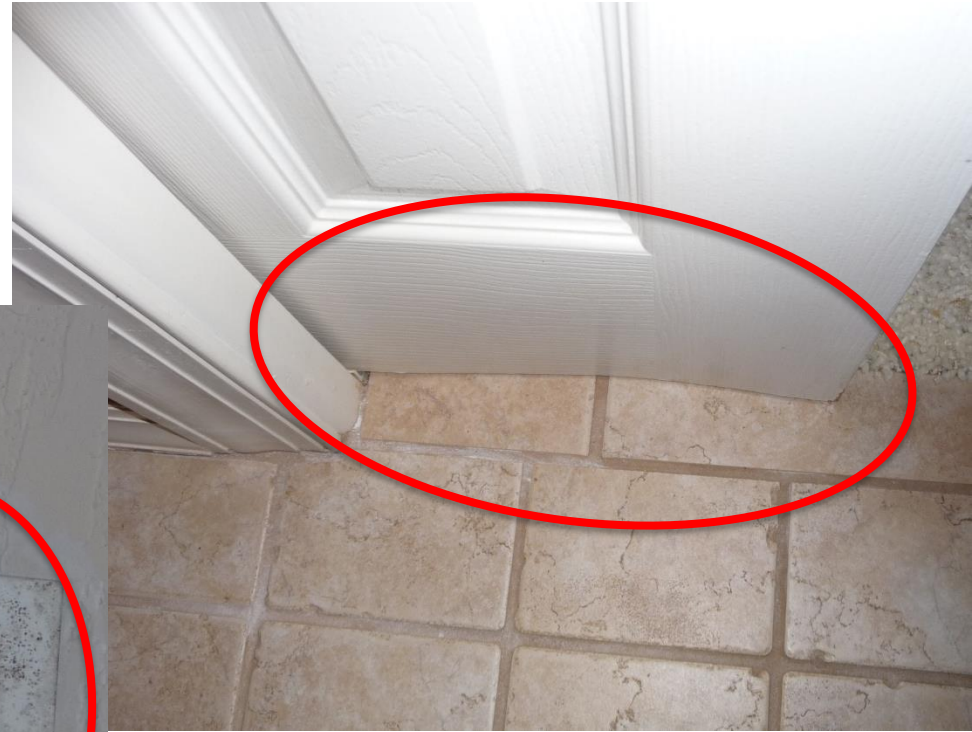
History of Summer Moisture Related Problems

- Mildew stains and moisture on supply grills
- Condensation on duct in floor space dripping onto first floor ceiling.

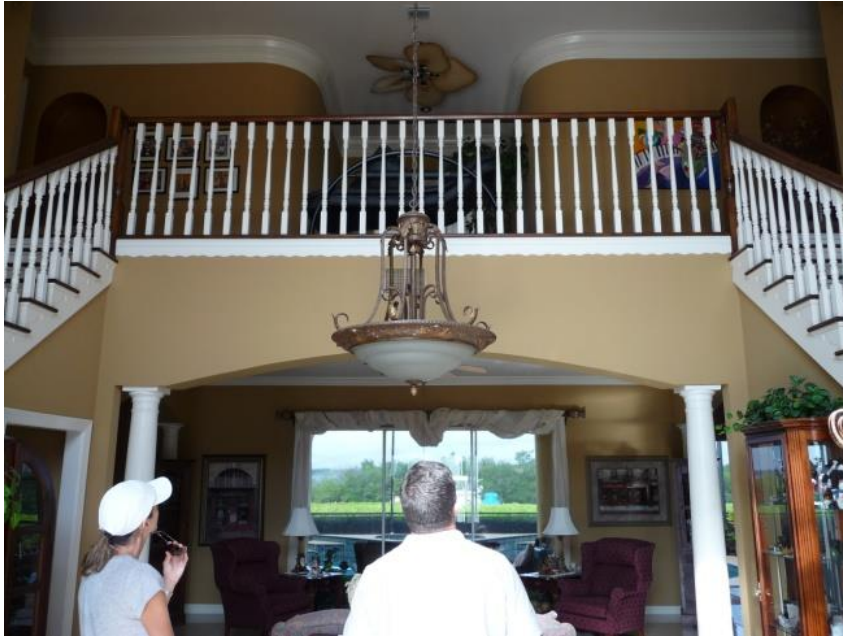
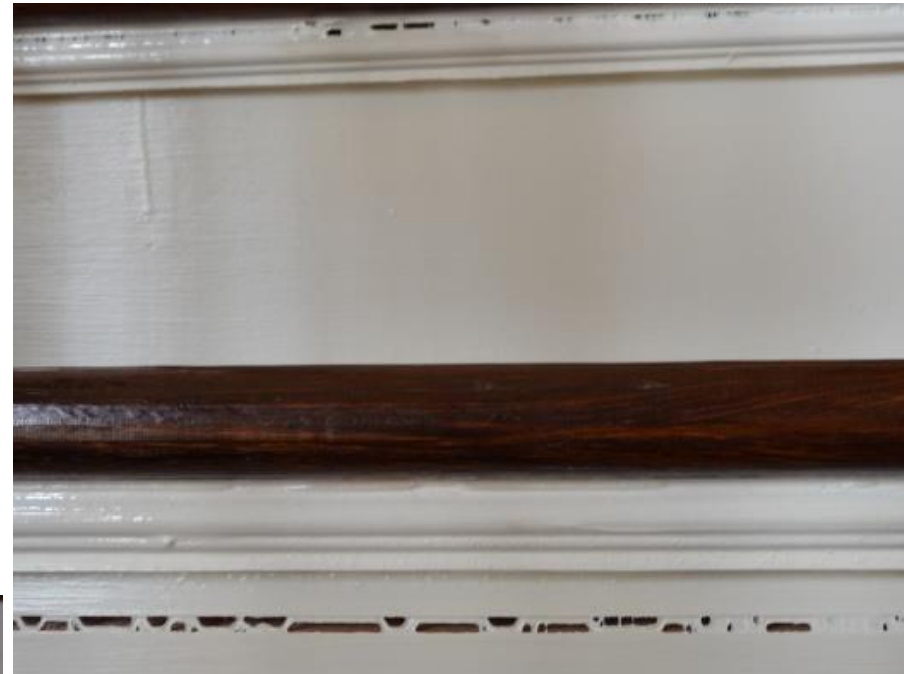
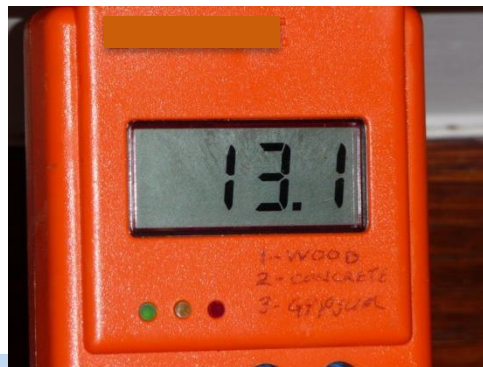
Moisture Damaged Stairs, Floors and Ceilings

- Moisture damage before repair on stair risers
